SITE INSPECTION REPORT

Site Name: Chem-Trol **Site Number:** 915015

Location: 4818 Lake Ave, Hamburg, NY, 14107

Inspection Date: 6/10/2026

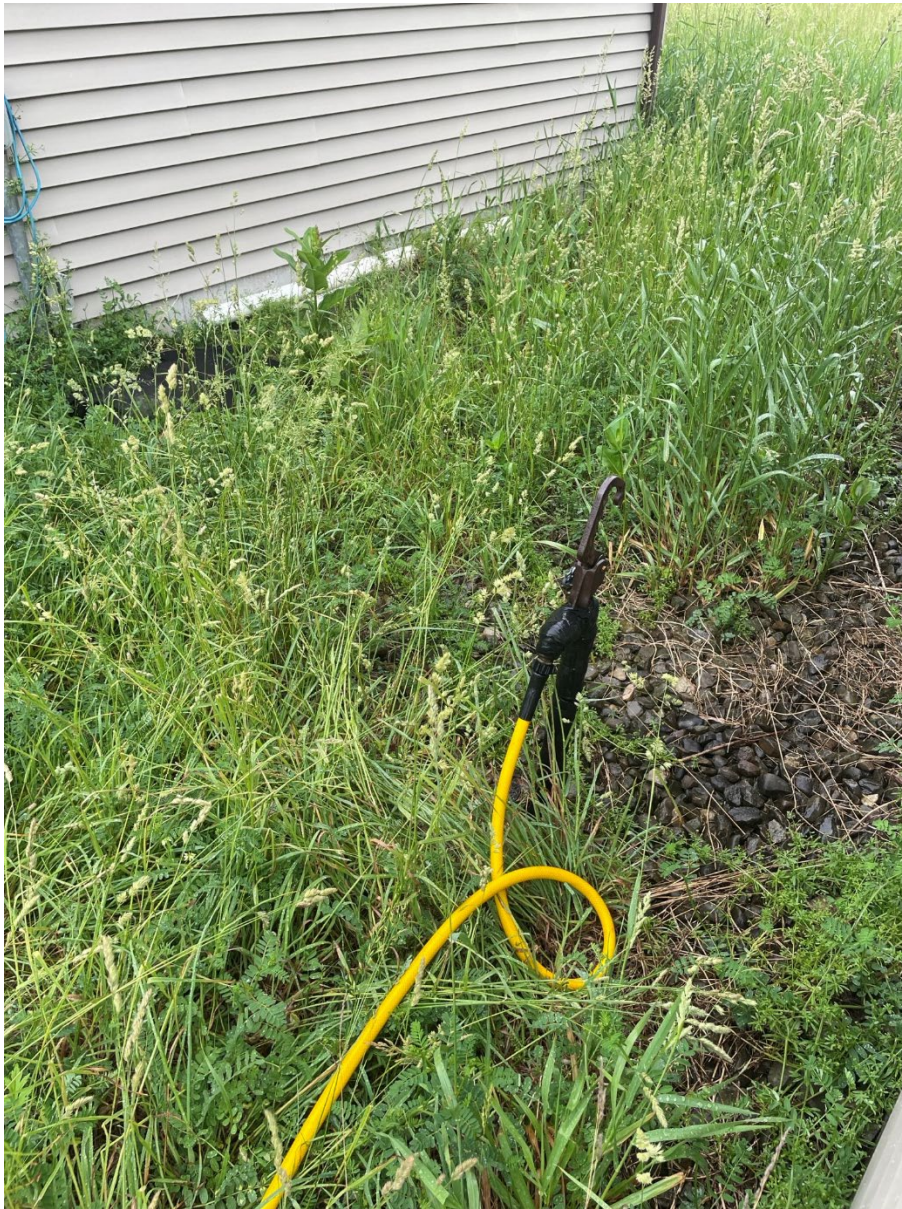
Onsite water source.

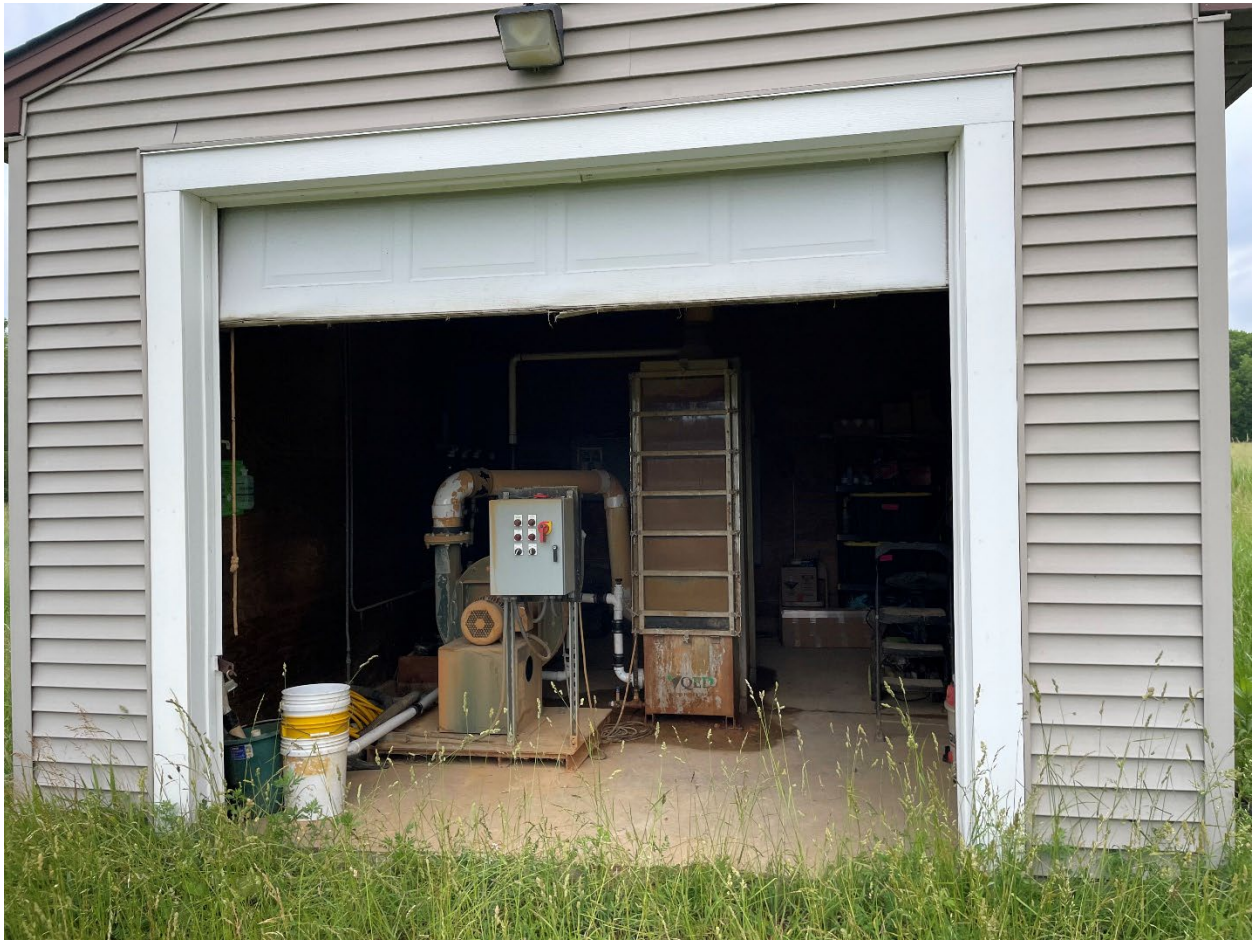
Water treatment building.

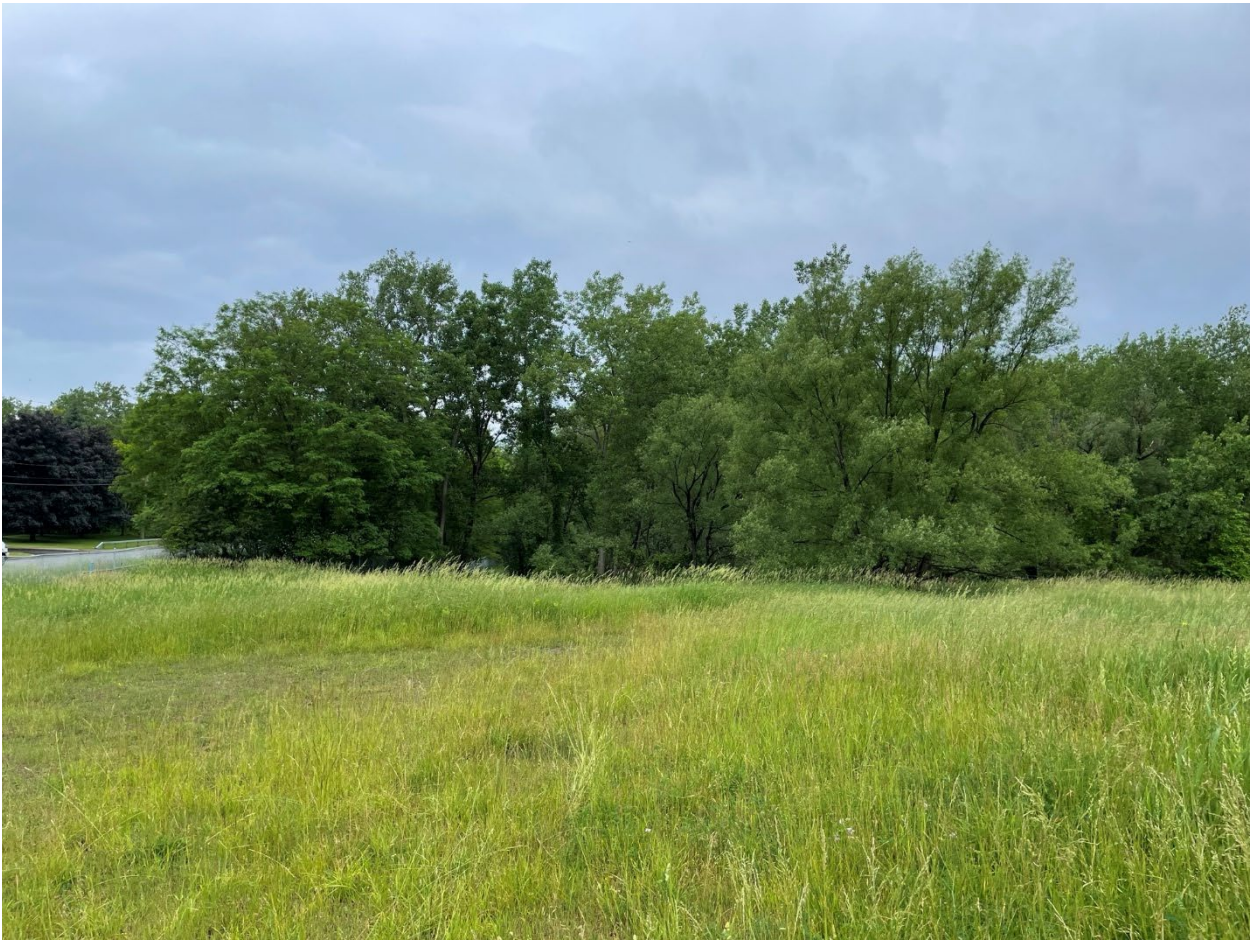
- Site cover appears to be in good shape although tall vegetation was preventing further inspection.
- Observed pumping and monitoring wells were in acceptable condition.

Vegetative cover/site conditions.

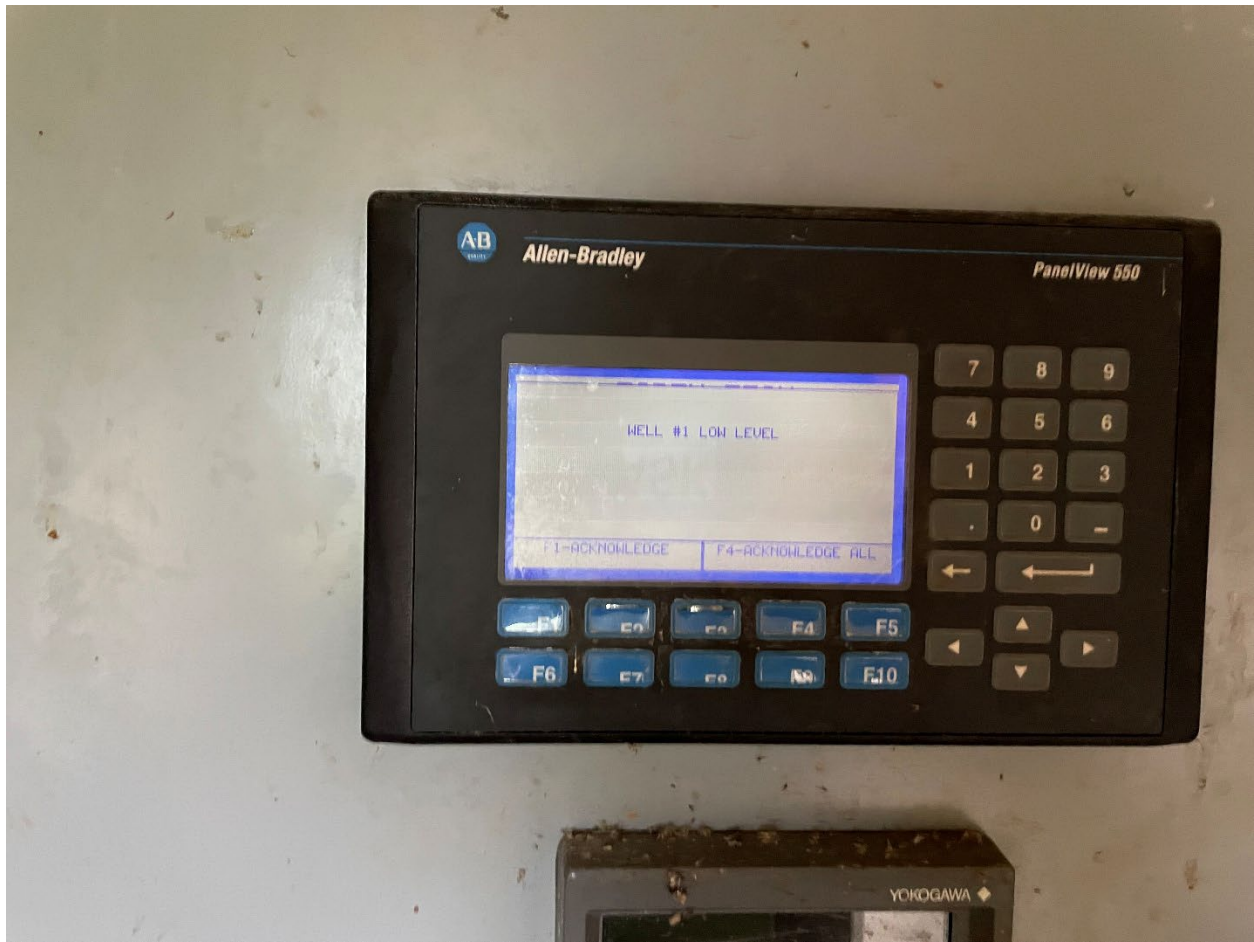
Alarm panel.

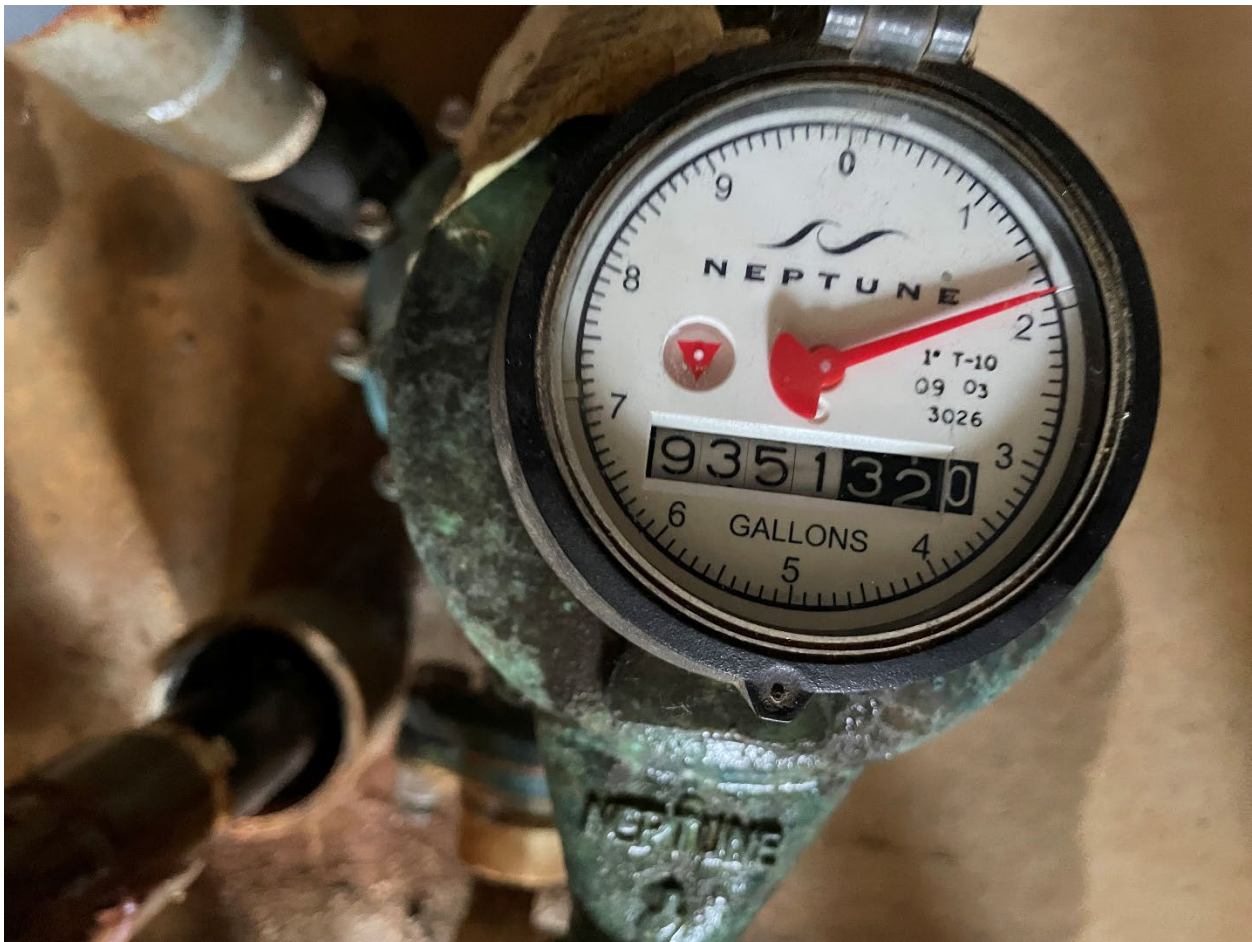
Treatment system flow meter.

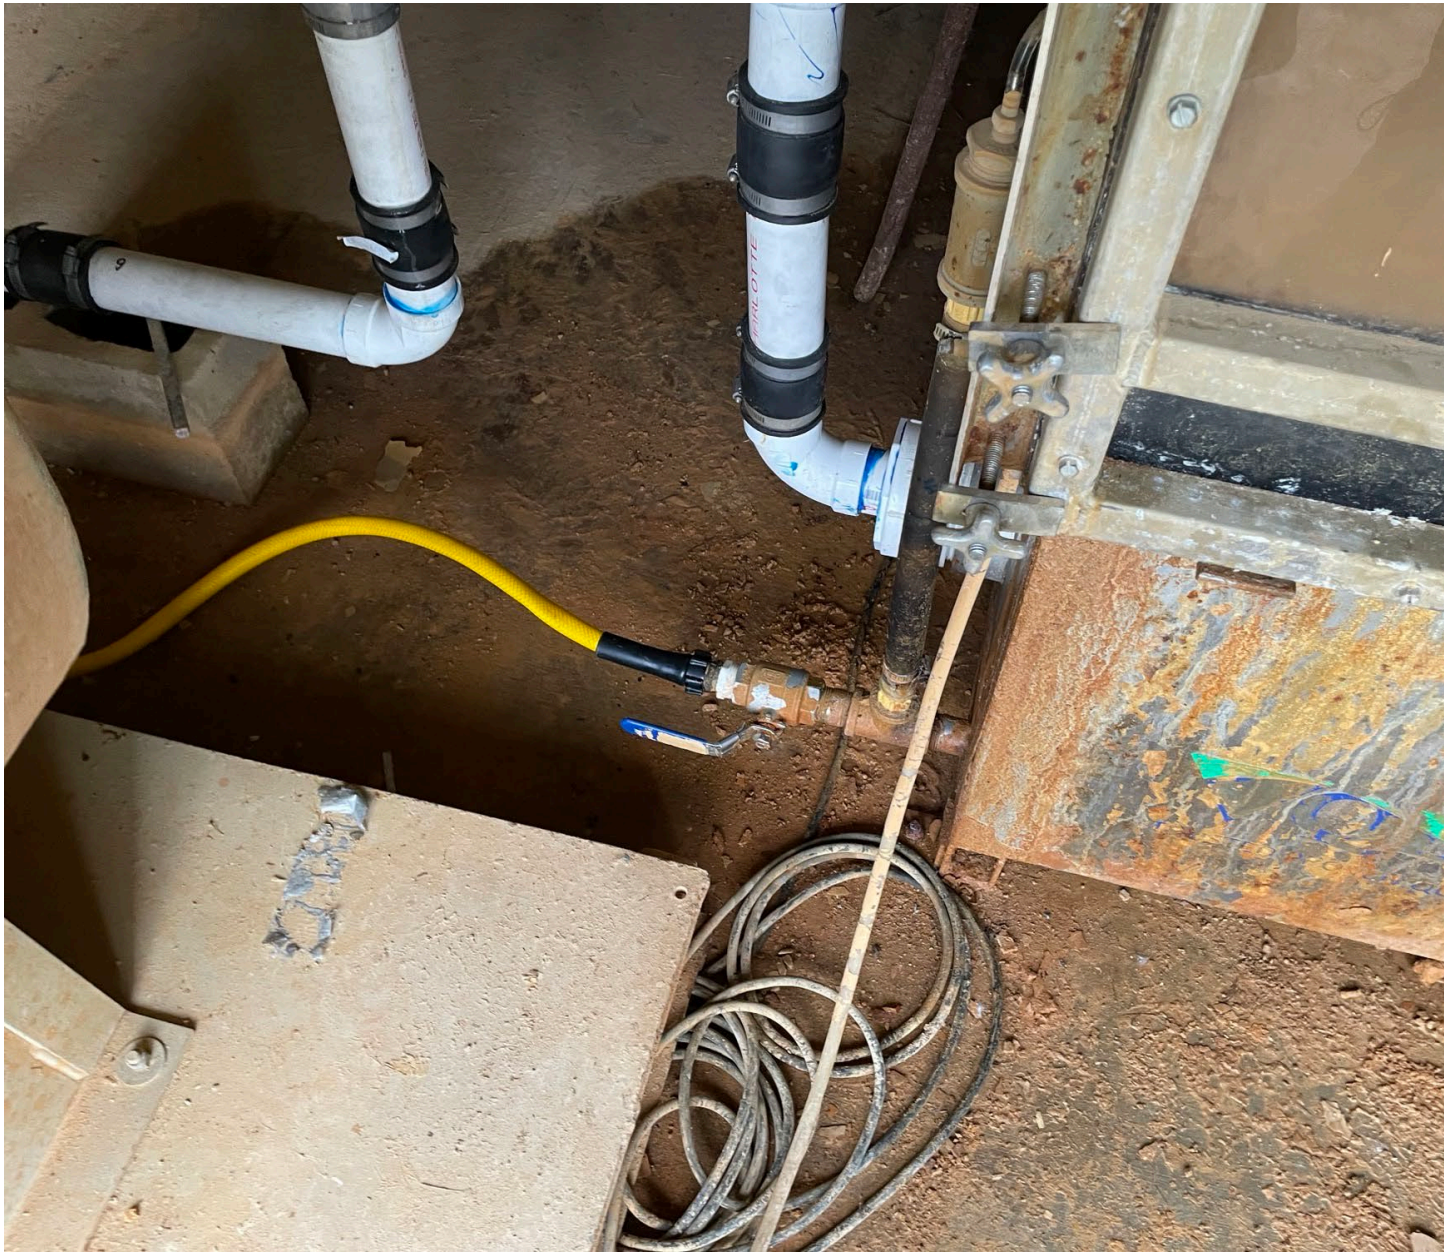
Air stripper cabinet drain hookup (drained prior to removing trays for cleaning).

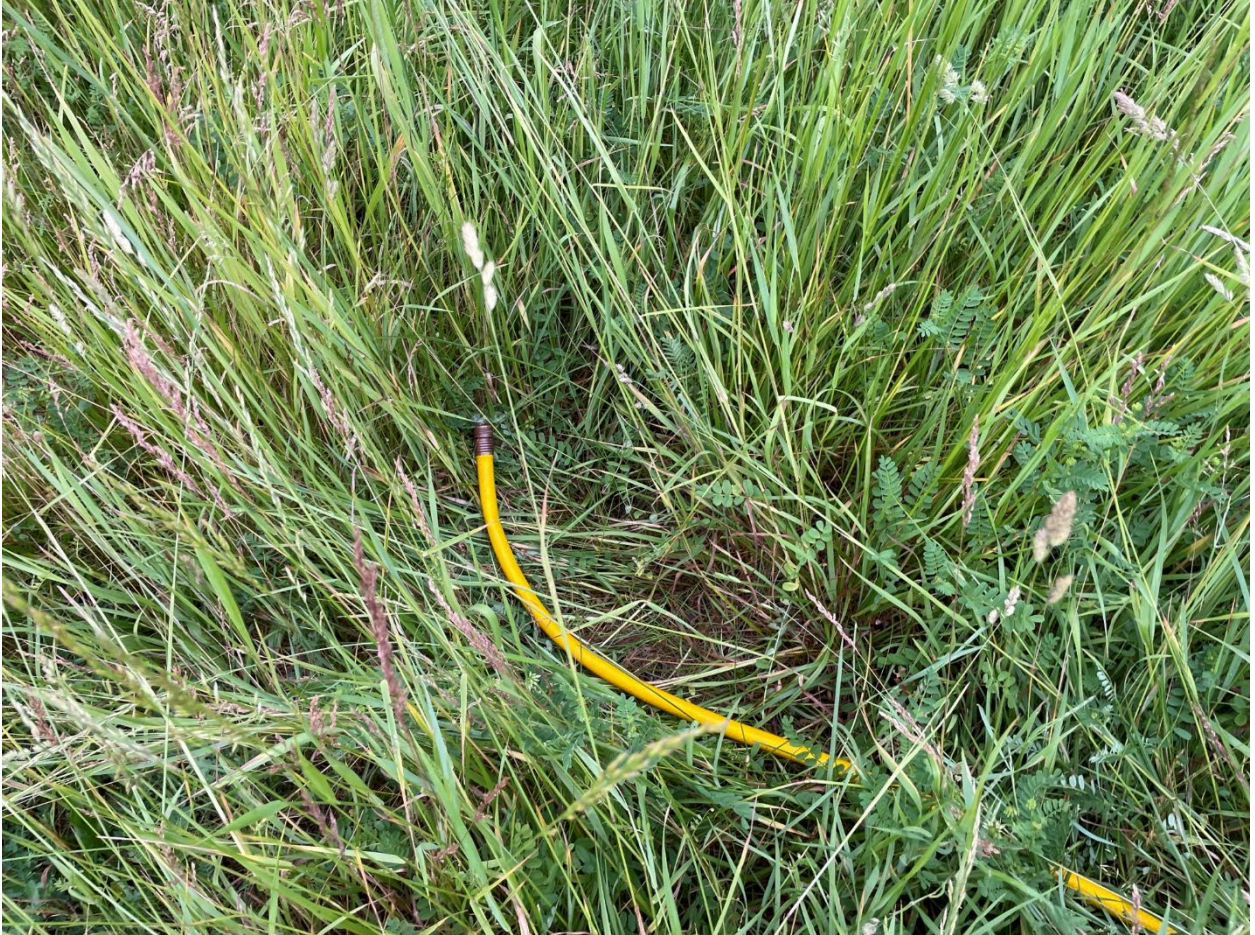
Discharging stripper cabinet liquids to site surface.

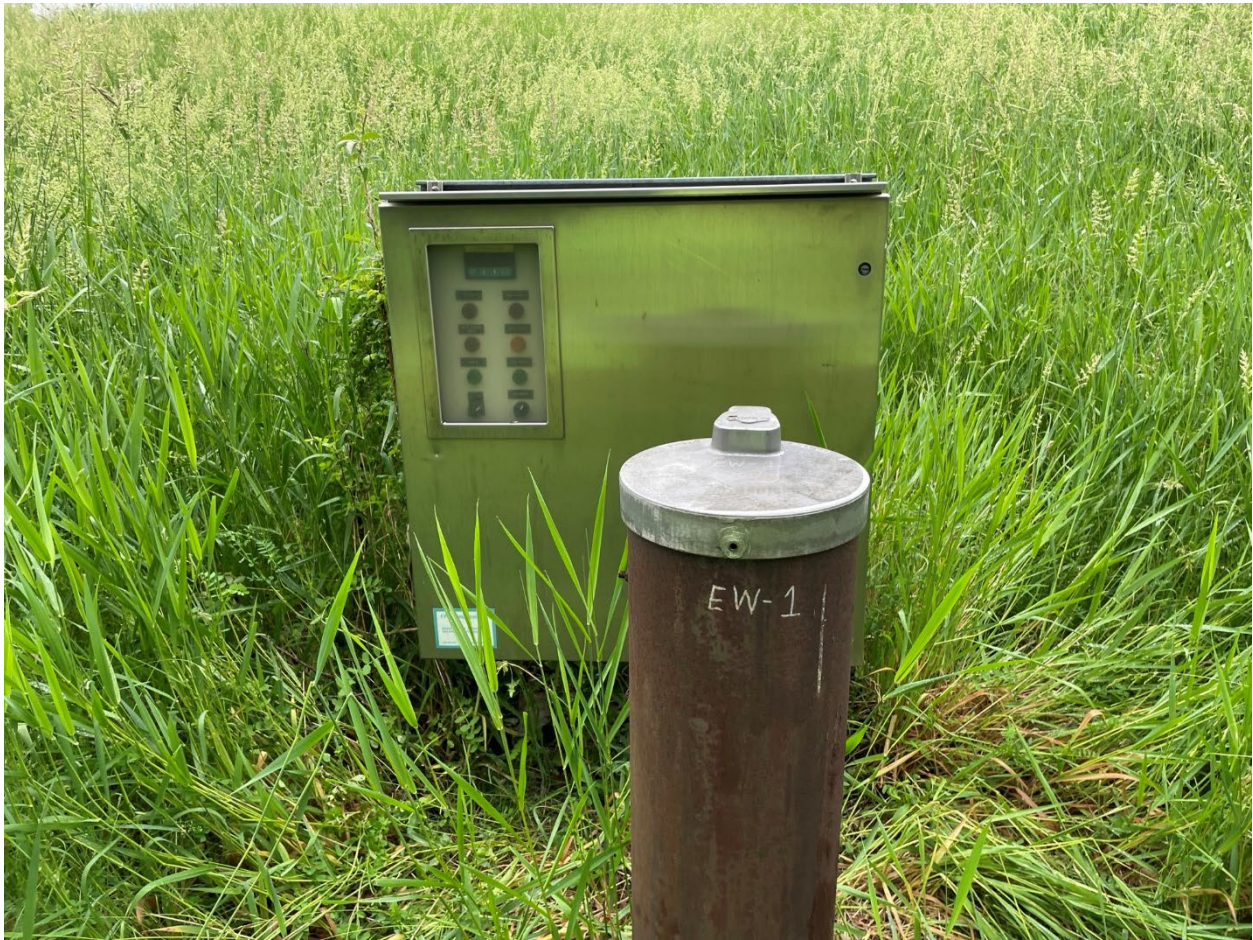
Extraction well (typical, 1 of 3).

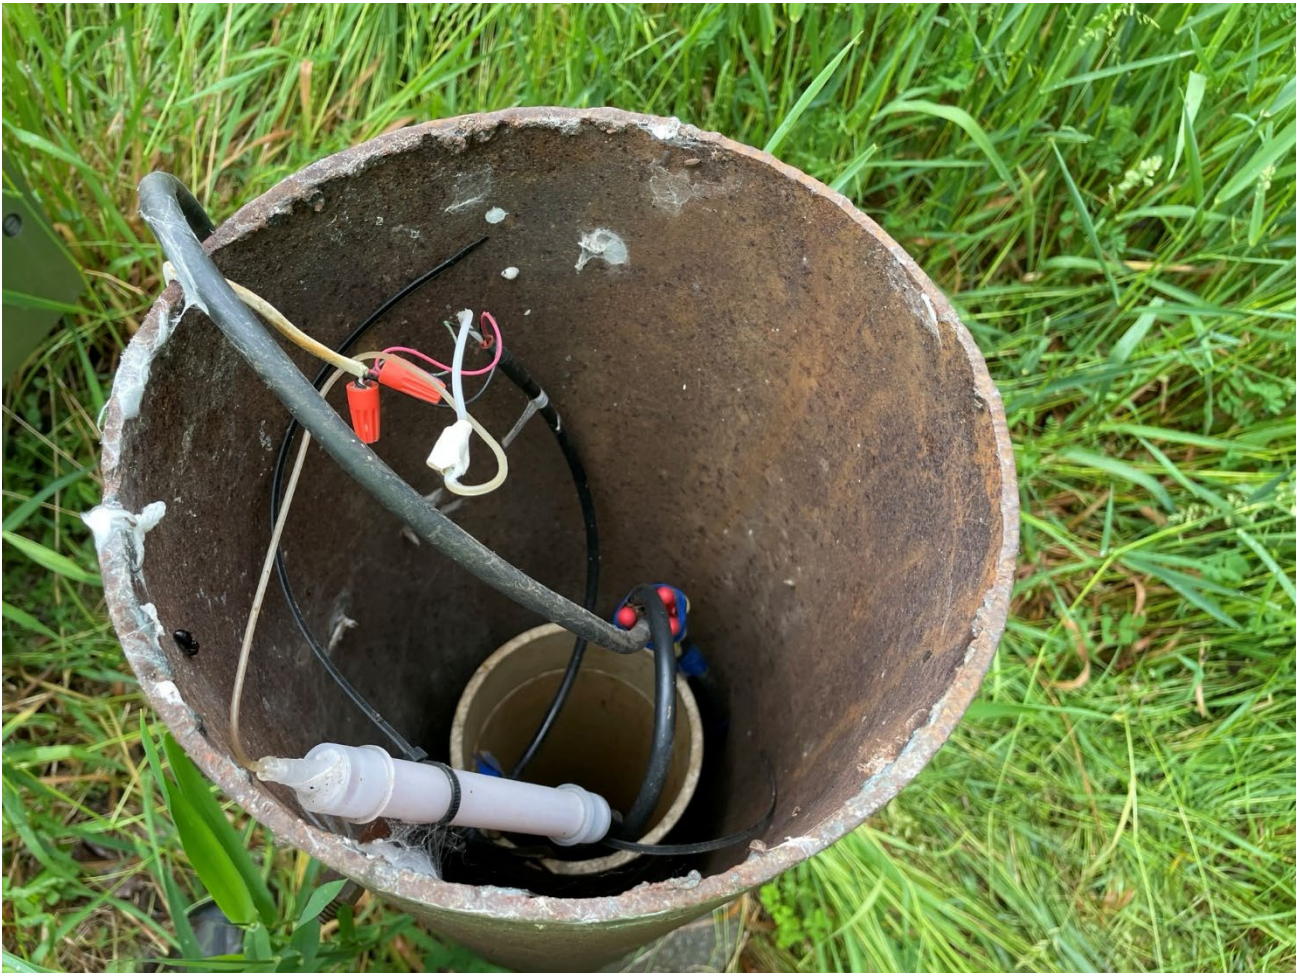
- NYSDEC observing AECOM performing monthly site check and air stripper tray cleaning (every other month).
- AECOM informed NYSDEC that pumping well EW-1 was offline upon arrival and could not be restarted. System maintenance contractor Matrix has been informed and will schedule a site visit to troubleshoot.

Inside of extraction well EW-1.

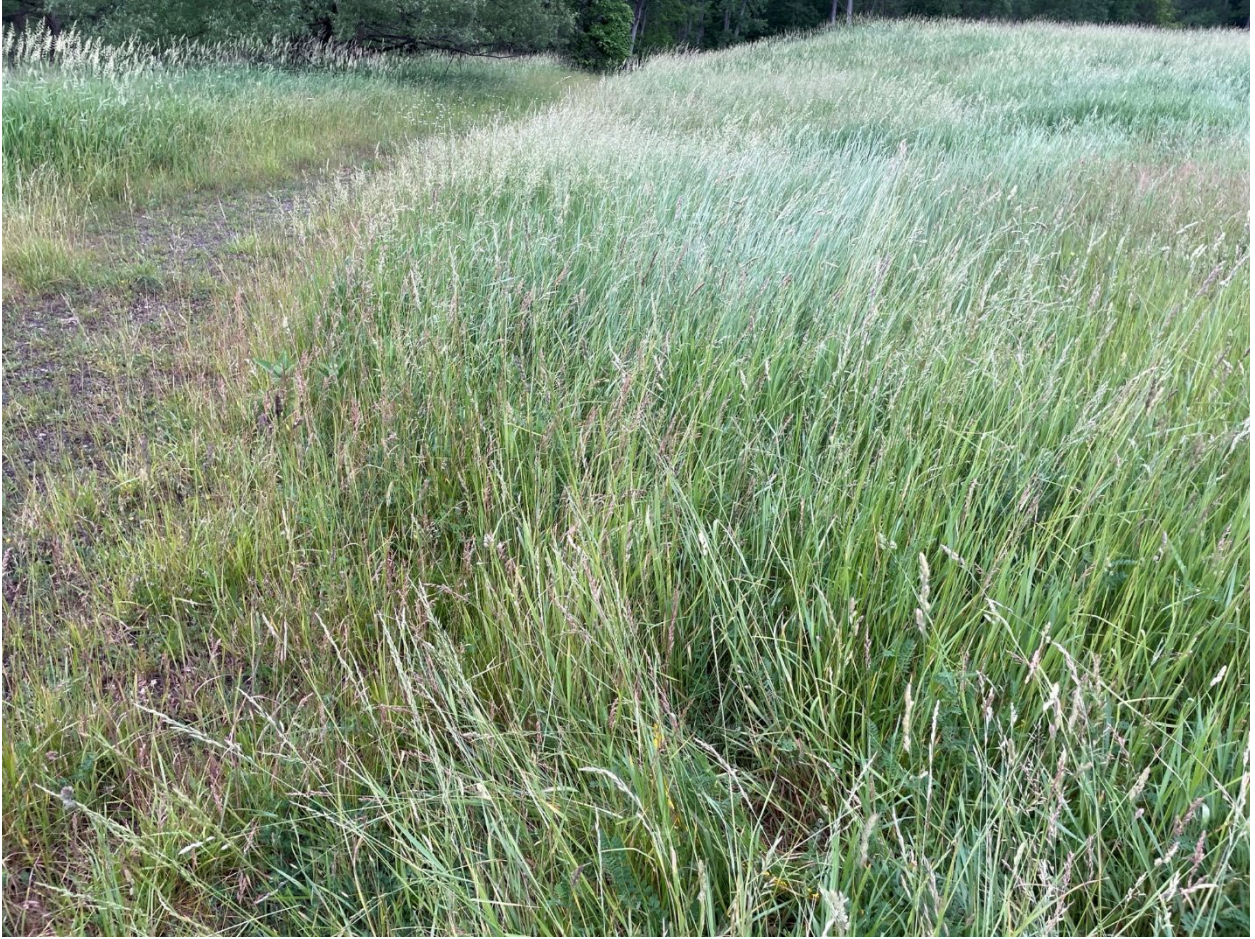
Vegetative cover/site conditions facing North.

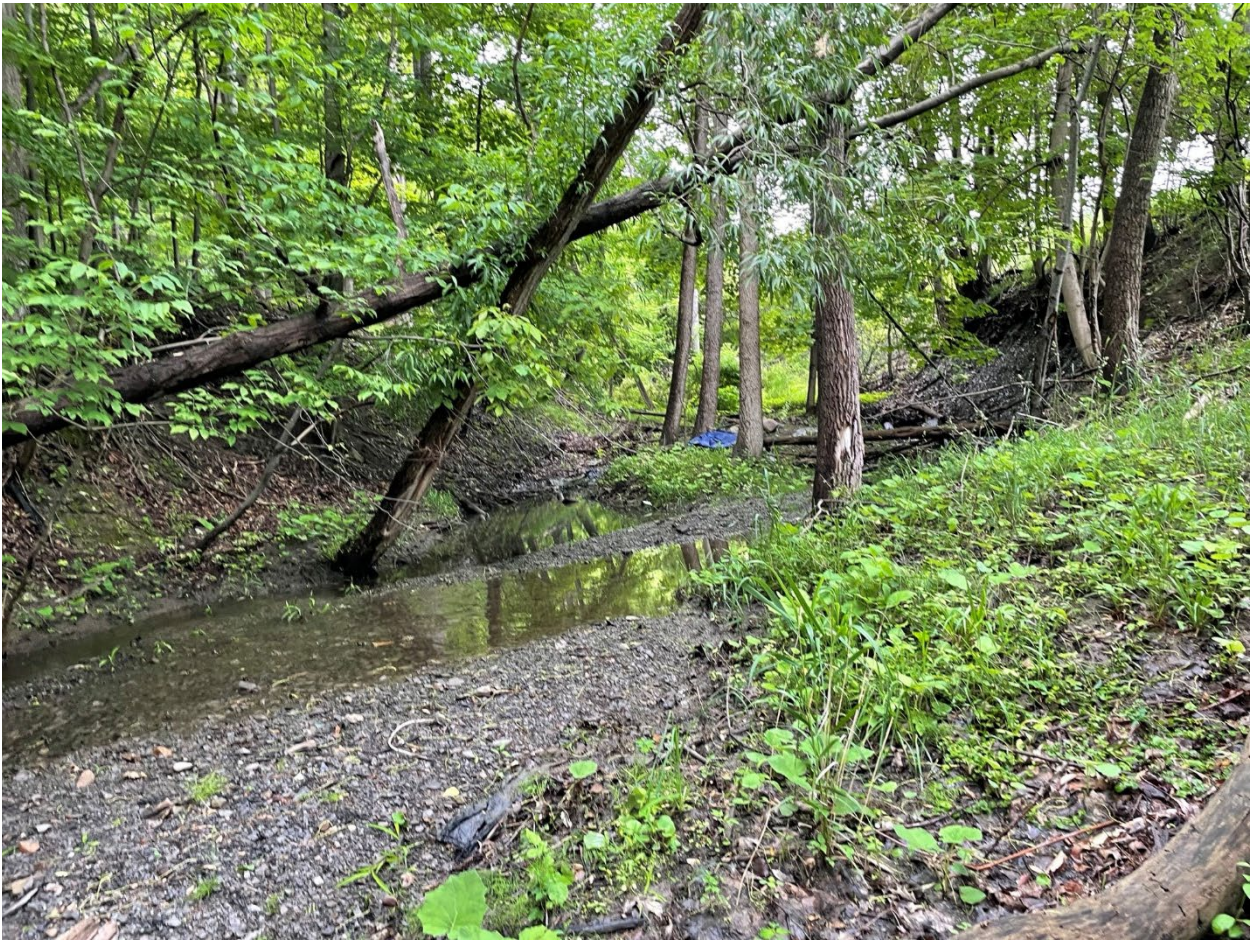
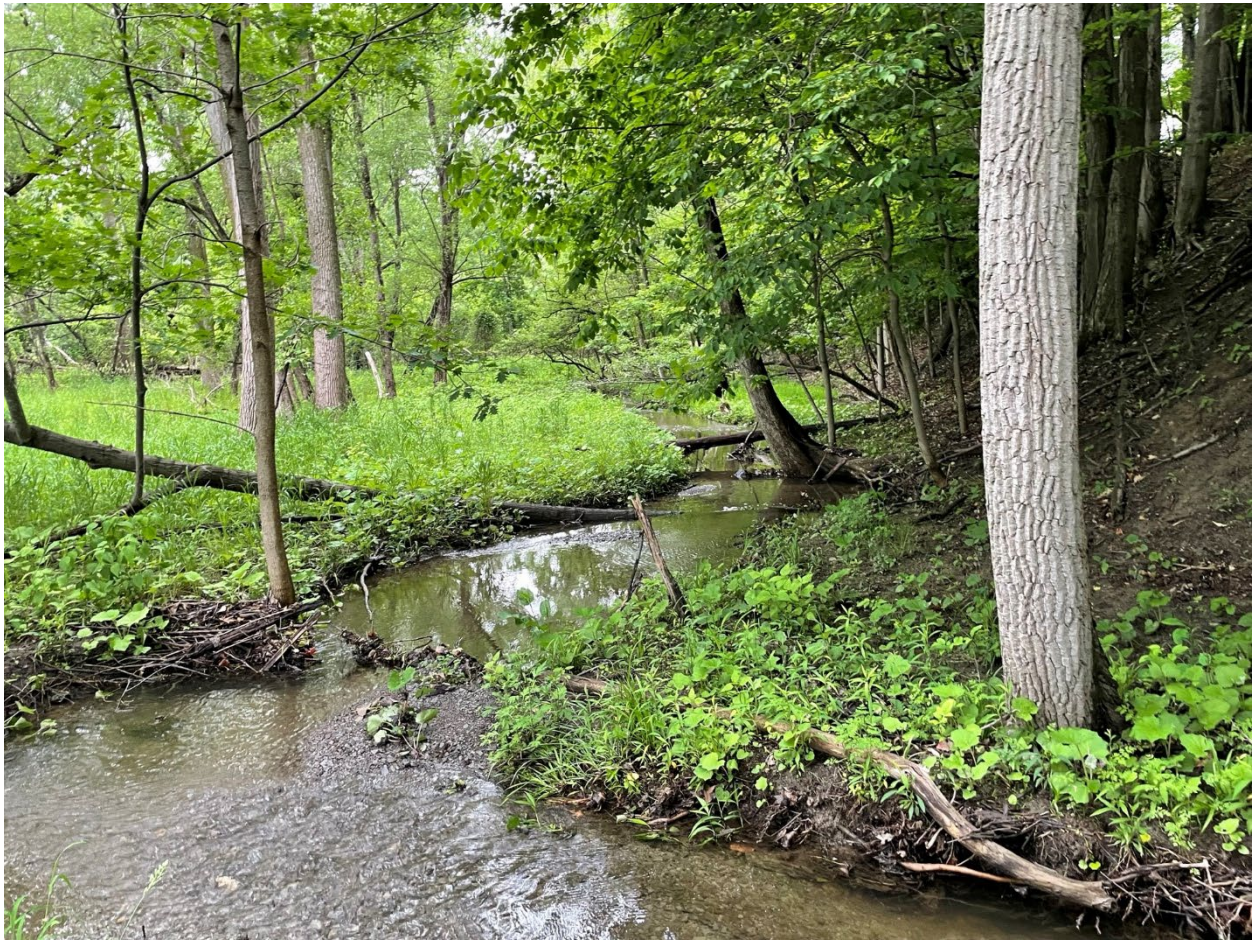
Tributary to Smokes Creek, Northern site boundary.

Same as above, alternative view.

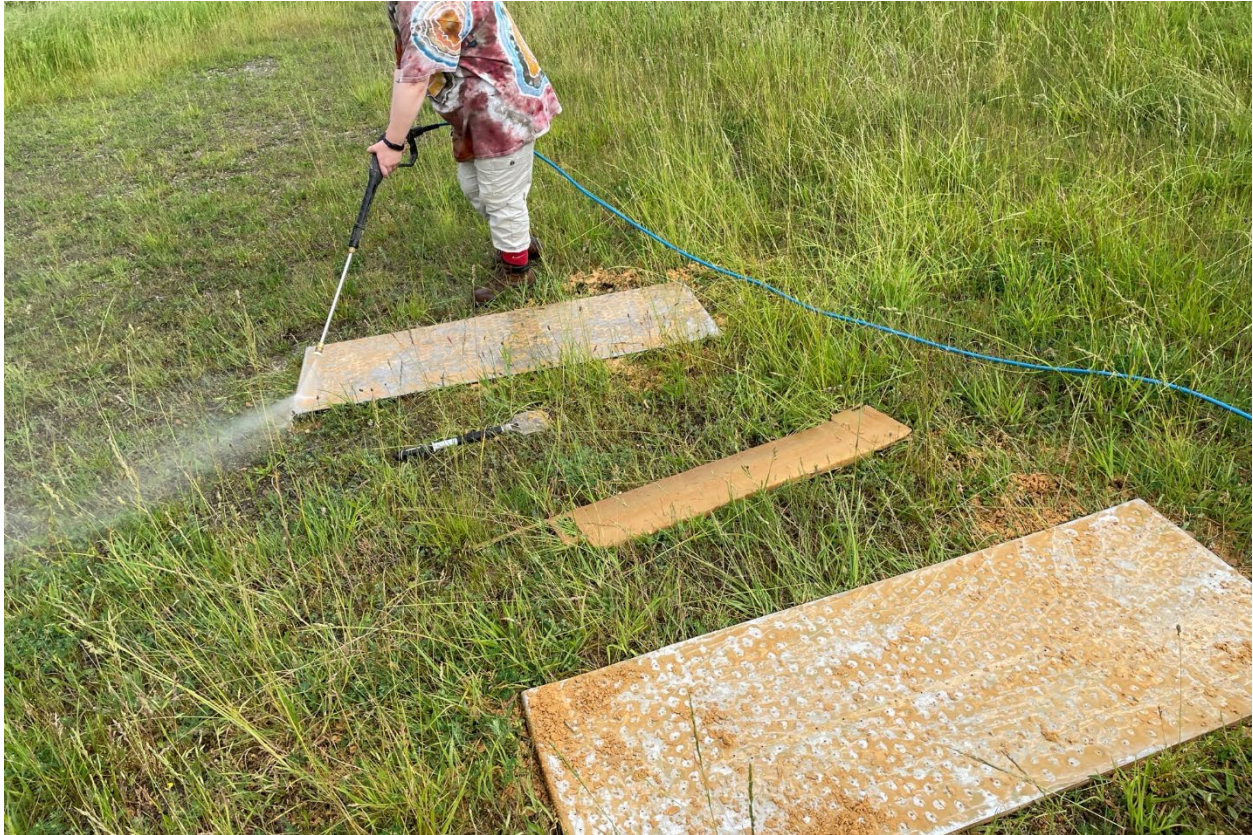
- AECOM manually removing and power washing mineral accumulation from air stripper trays. Power washer supplied by site onsite tap of Erie County Water Authority.

Power washing air stripper trays. Orange/brown accumulation is typical due to high iron groundwater concentrations.

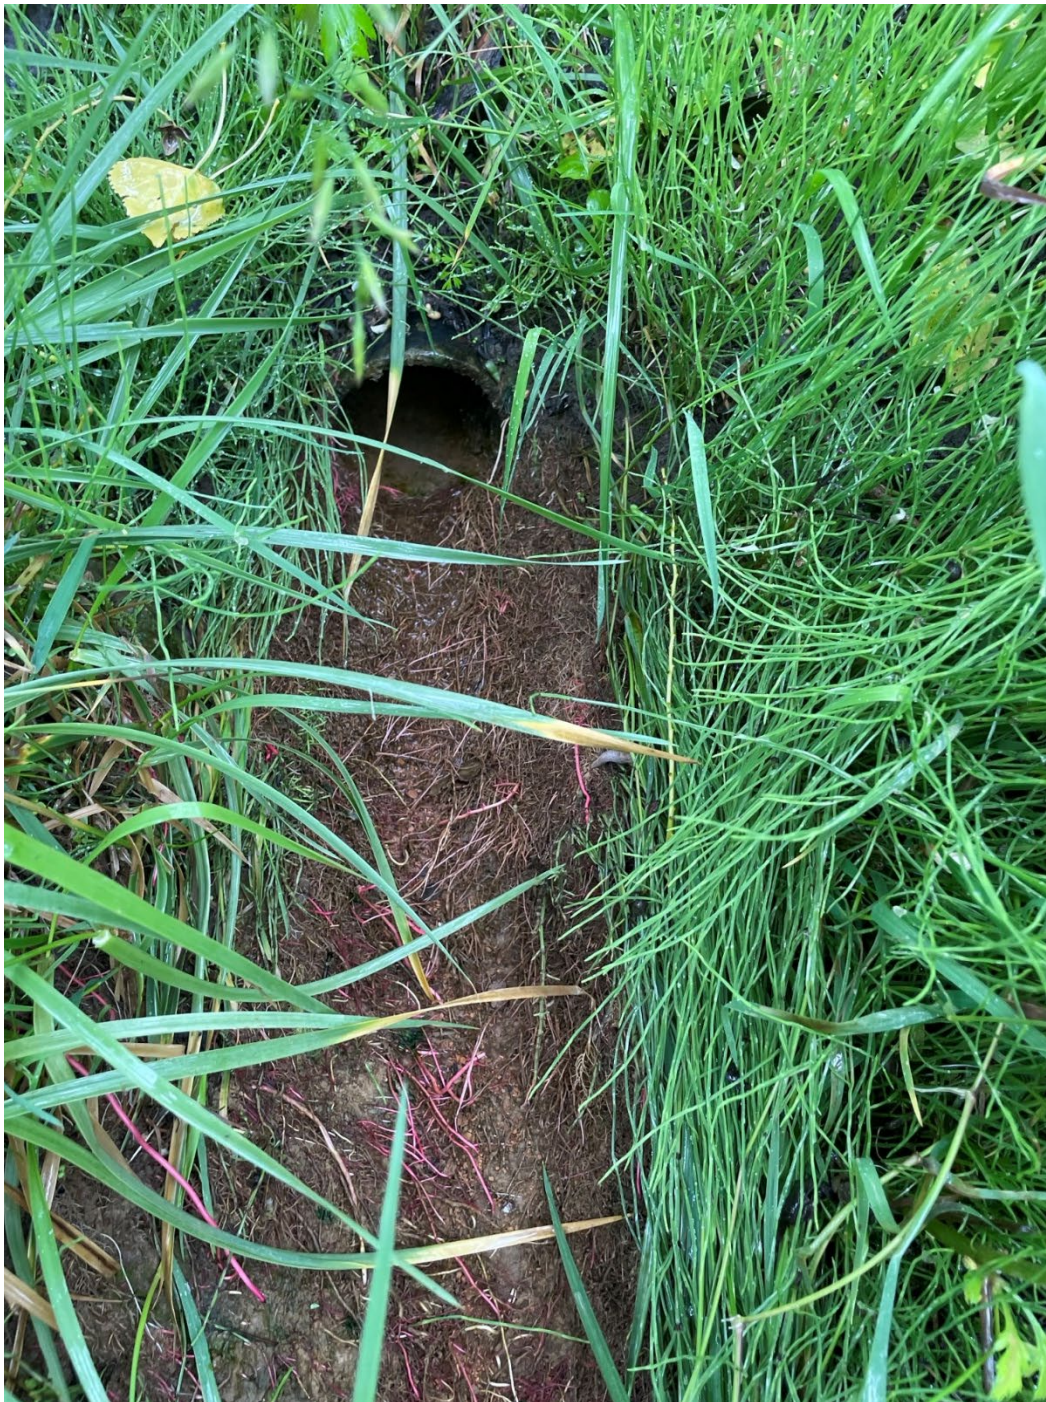
- NYSDEC observed brown/orange staining at system discharge pipe near Smokes Creek consistent with historic observations and mineral accumulation color/material of air stripper trays. No unusual observations were made at Smokes Creek or its northern onsite tributary.

Site treatment system outfall line.

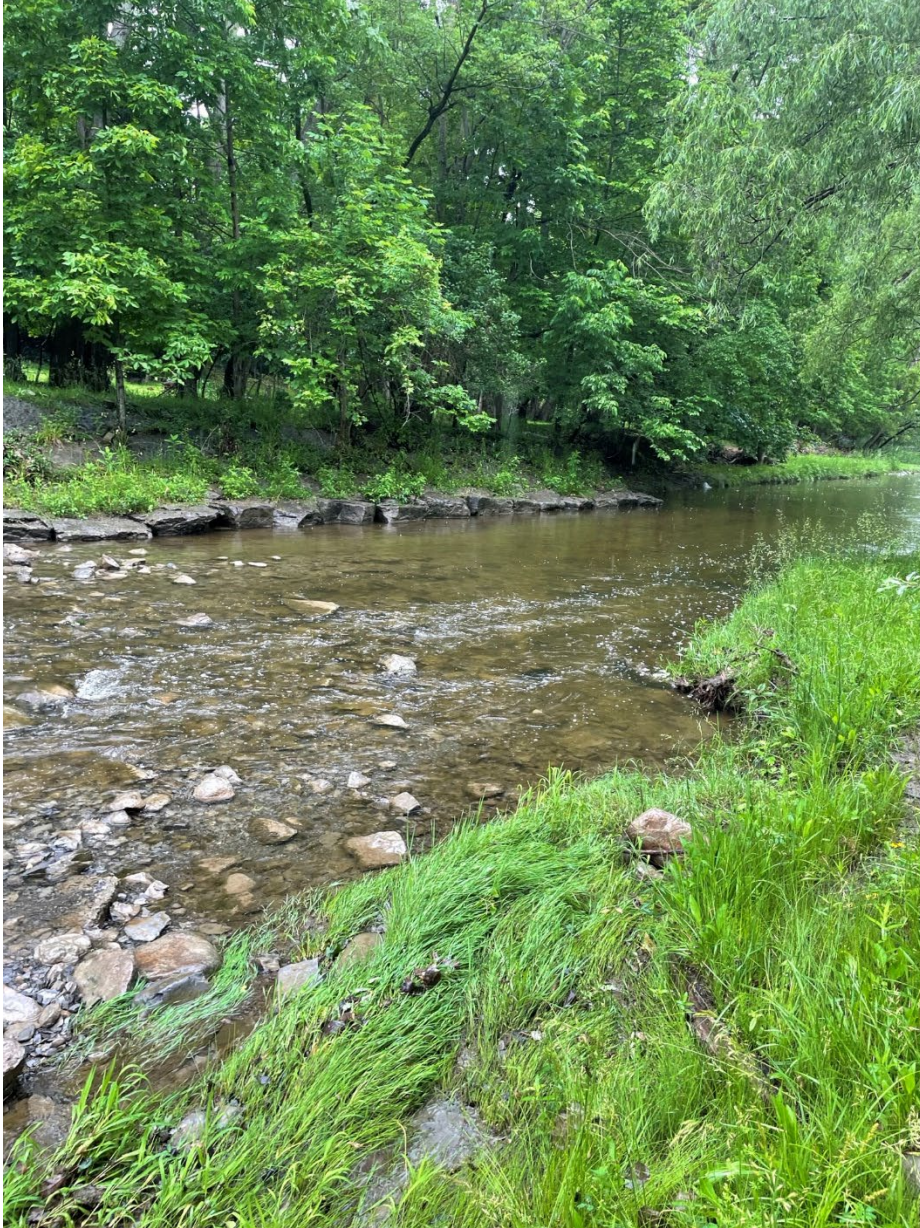
Smokes Creek at outfall.

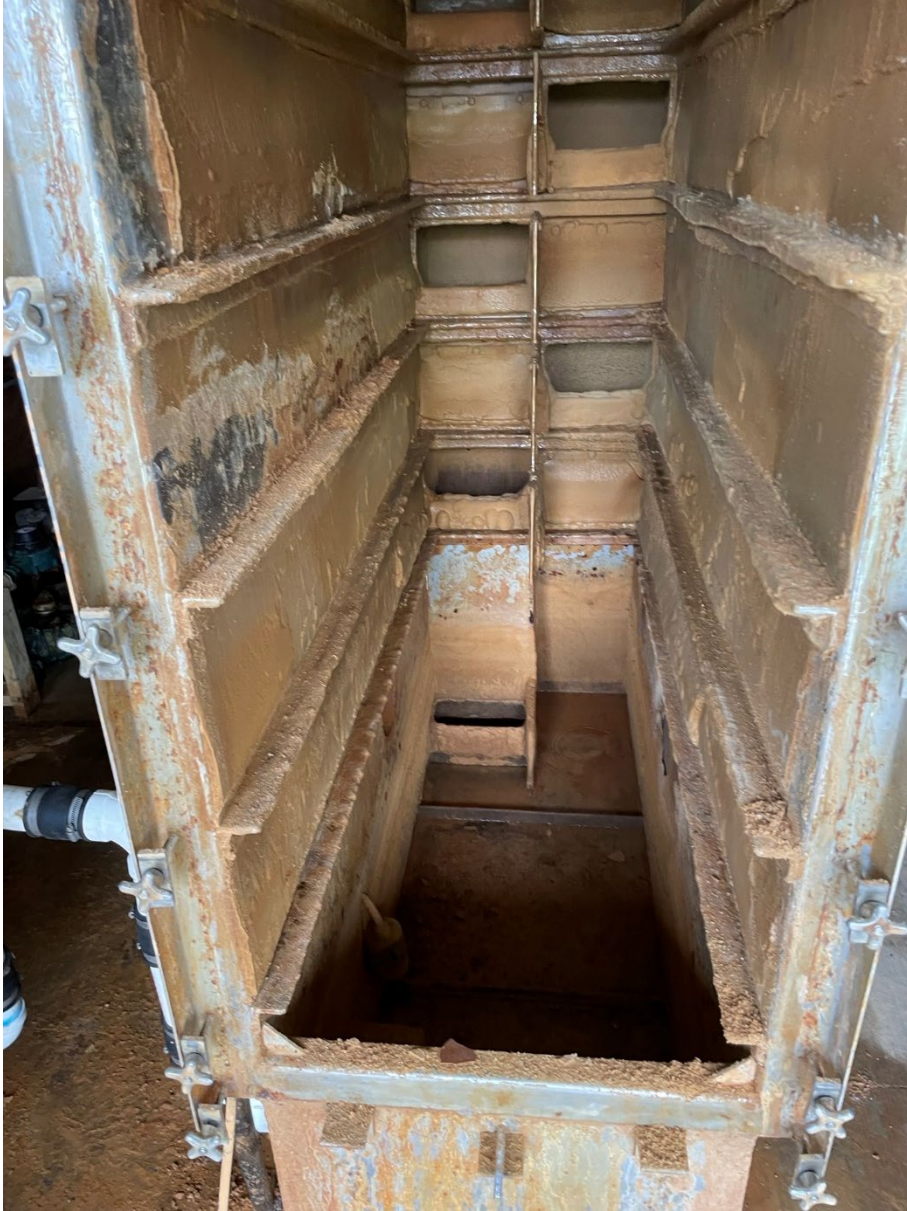
Air stripper cabinet, prior to cleaning.

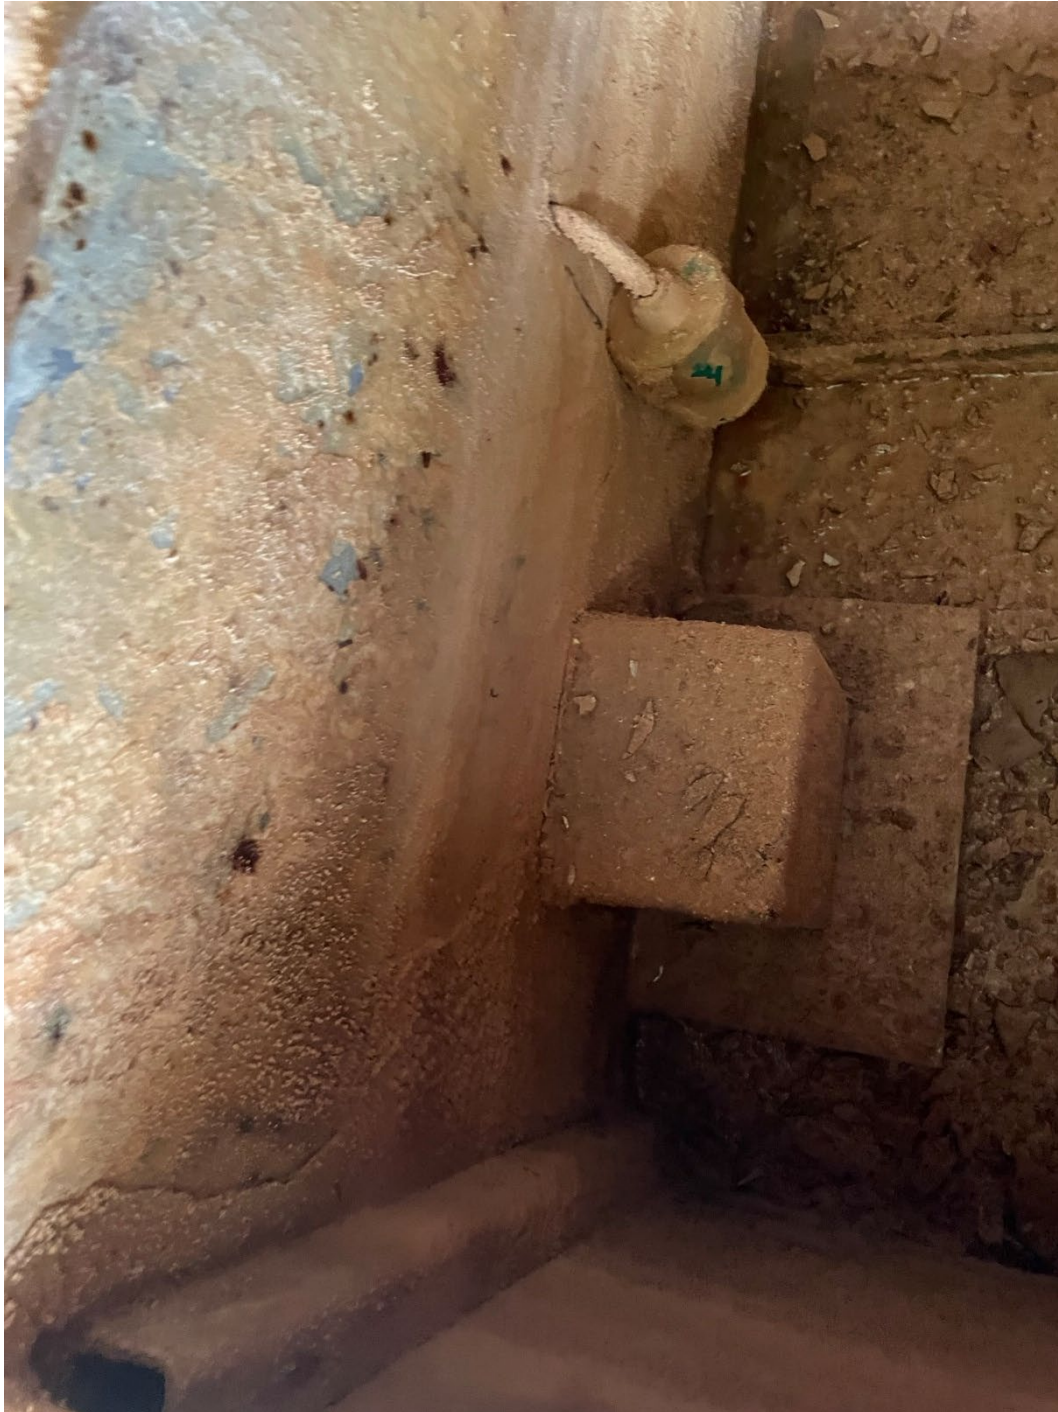
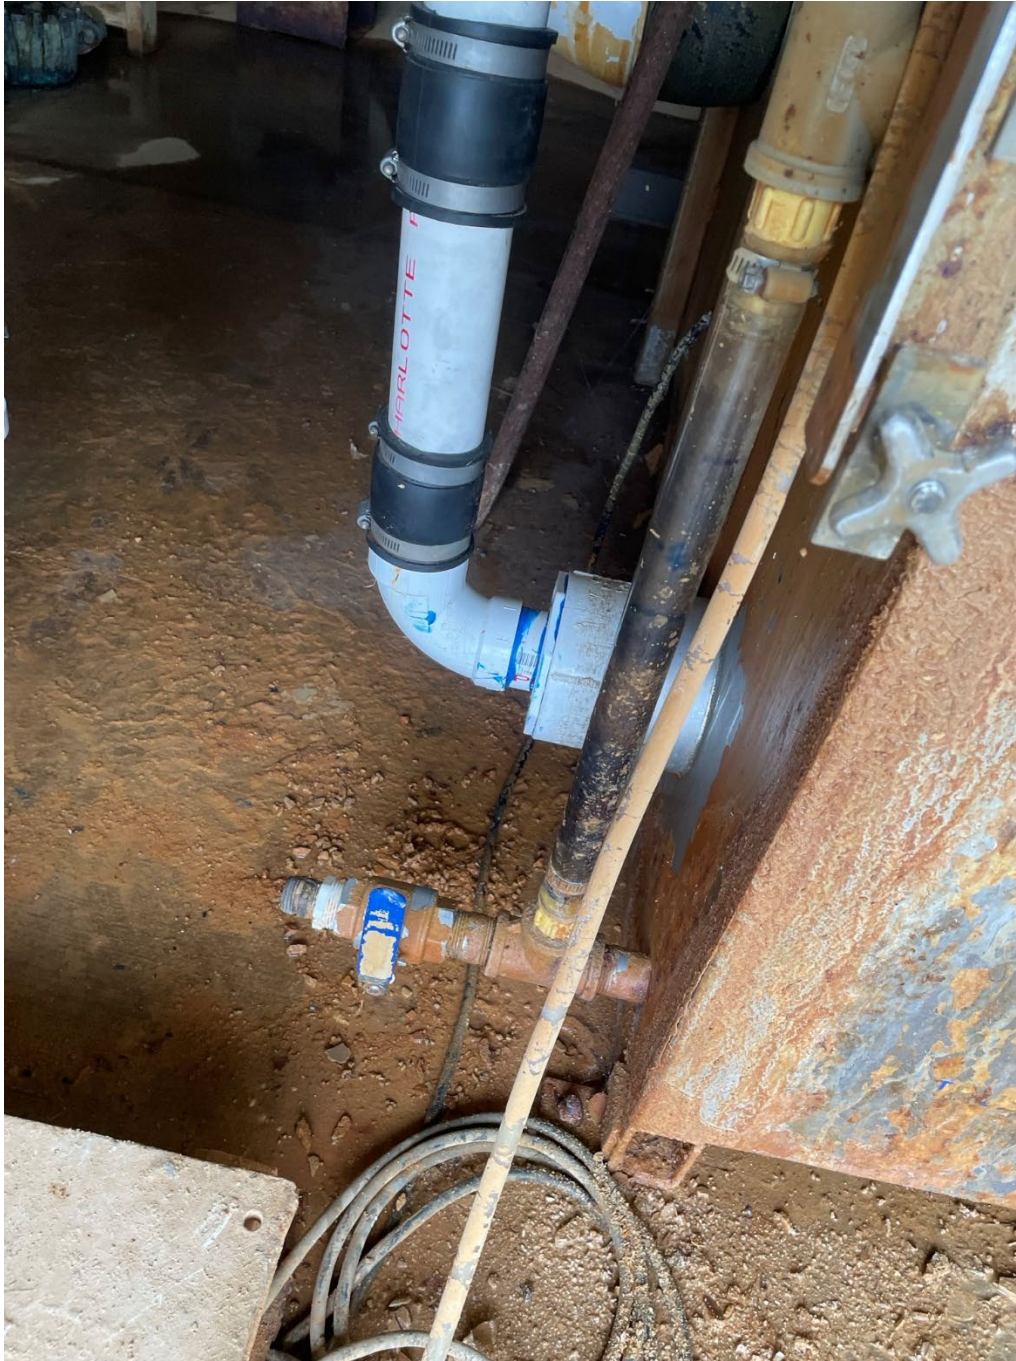
- 90-degree elbow inside air stripper cabinet is believed to be accumulating mineral buildup. AECOM said they were going to consult Matrix on how to access and clean that part of unit.

90-degree elbow cover at inside of cabinet. Per AECOM it is difficult to access bottom to clean due to welds.

Same as above, outside cabinet connection view.
