Re: Consent Order No. 90-105,
Final Report, Wastewater Pond Cleaning

DUNLOP TIRE CORPORATION
BUFFALO PLANT

FINAL REPORT
WASTEWATER POND CLEANING

AS REQUIRED UNDER CONSENT ORDER NO. 90-105 OF THE
NEW YORK STATE DEPARTMENT OF ENVIRONMENTAL CONSERVATION

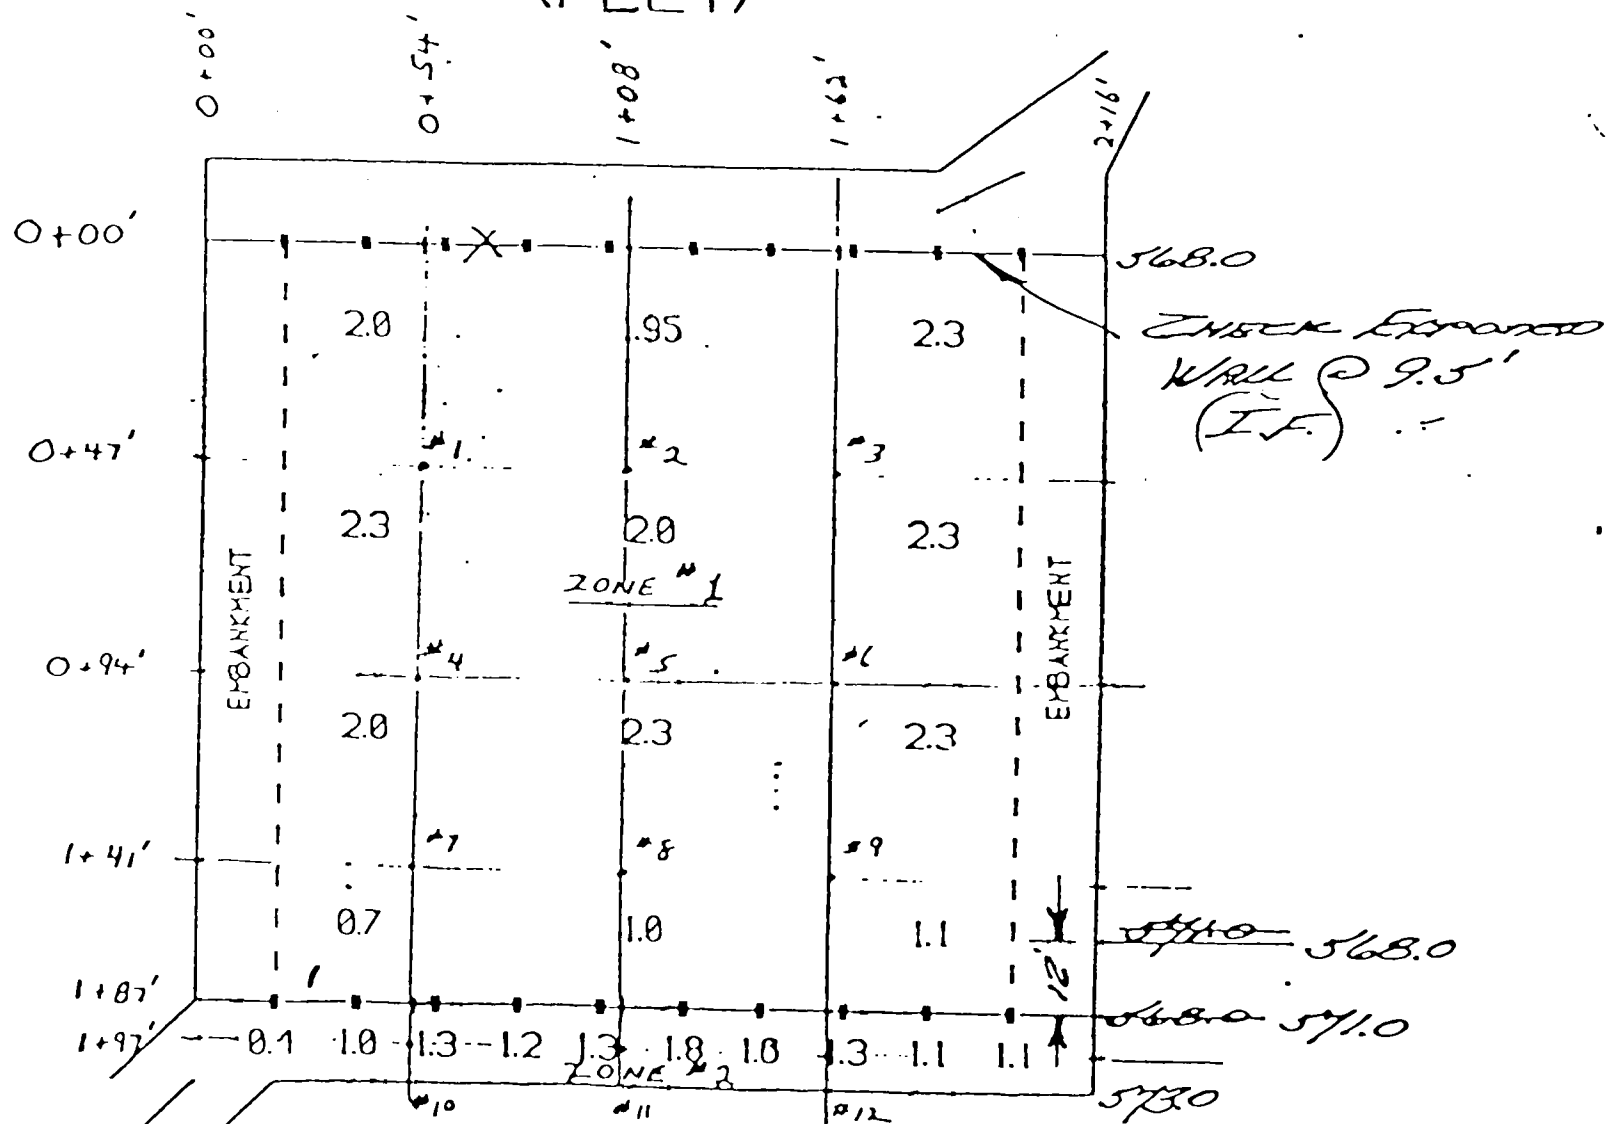
FIG. 5
POND SAMPLING

AVERAGE ELEV. #1 → #9 = 566.63'

STATION	ELEVATION
1	567.50
2	567.45
3	567.14
4	567.00
5	566.74
6	566.69
7	566.53
8	565.09
9	565.63
10	571.18
11	571.81
12	571.90

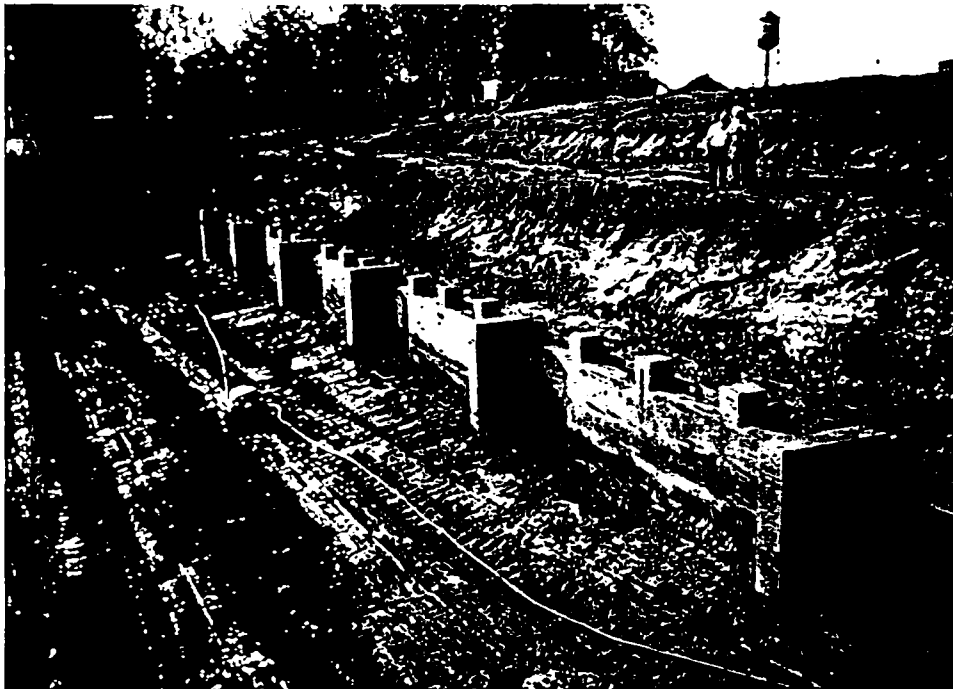
#12
VIEW OF
BAFFLE WALL
AFTER CLEANING

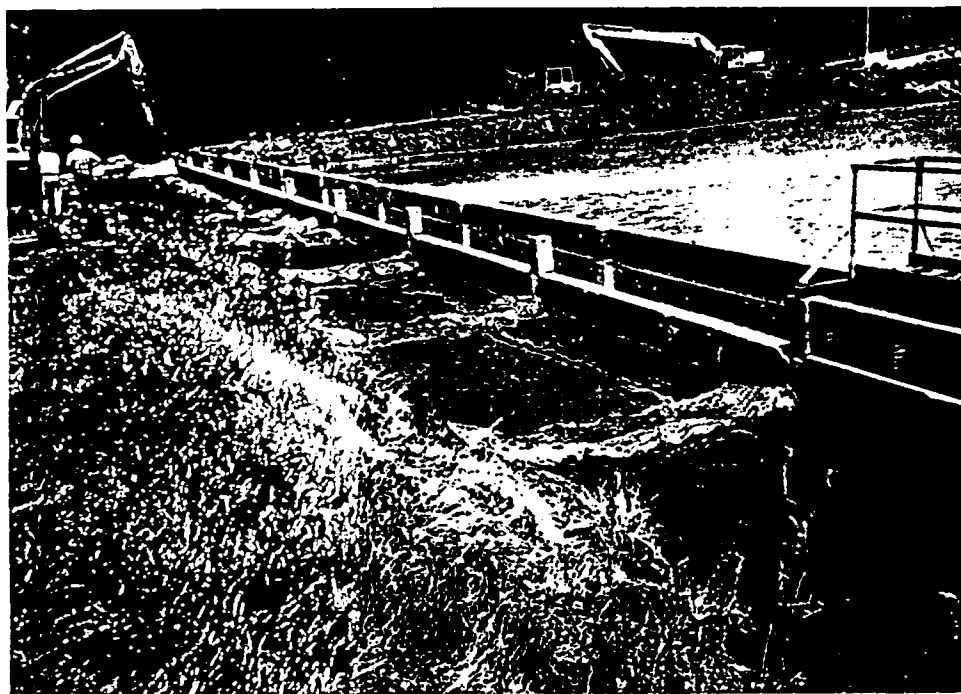
#16

PULLING GABIONS
AS POND SLOWLY
FILLS

NOTE BUILD-UP
OF SOLIDS WHICH
WERE REMOVED
PRIOR TO POND
OVER FLOW
