ENGINEERING INVESTIGATIONS AT INACTIVE HAZARDOUS WASTE SITES

PHASE II INVESTIGATION

Ferro Corporation - Electro Division Site No. 915020
City of Lackawanna Erie County

DATE: February 1990

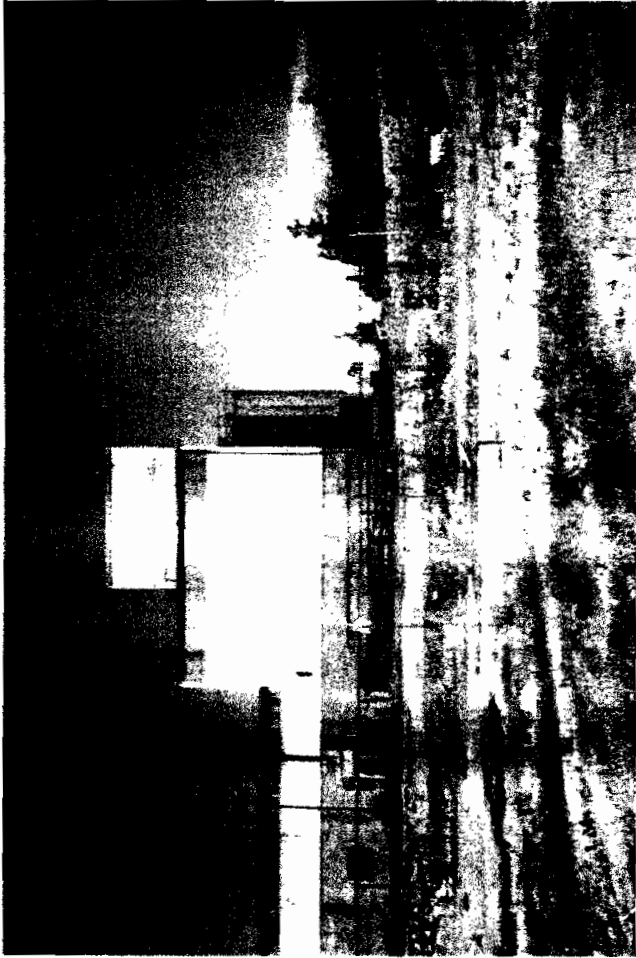
PHOTO 5. Site for GW-3, looking north.

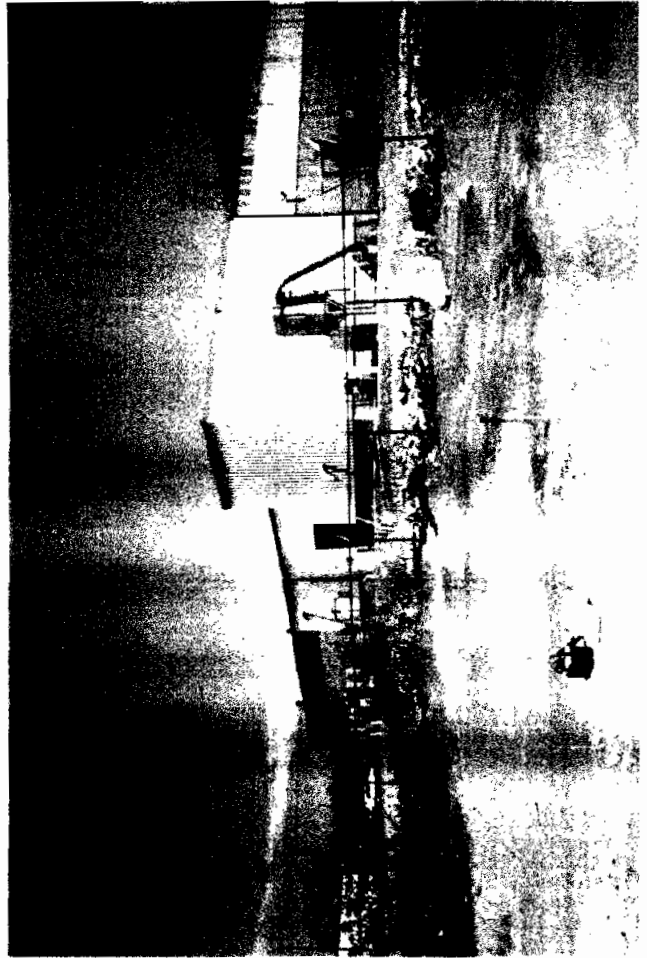
The initial 9.5 ft of the boring was advanced through dry, dark-gray clay and weathered gray shale. The auger cuttings and split-spoon samples remained dry after two days of rain, indicating that the overburden had very low permeability. Water did not appear to be percolating through the overburden to the bedrock. The HNU detected 0.2 to 1.4 ppm organic vapors in the samples collected from 4 to 6 ft and 1-16 ppm on those taken from 8 to 10 ft; a slight petroleum odor was noted in the 8- to 10-ft sample.

Competent bedrock was encountered at approximately 9.5 ft below the top of the augers. Following standard diamond bit coring procedures and using an NX-size core barrel, a 5-ft rock core sample was taken from 9.5 to 14.5 ft. The core sample (Appendix E) showed that the bedrock was highly fractured dark-gray shale. Water was encountered at a depth of 11 ft.

PHOTO 7. Site for GW-2, looking northeast.
