Re: Long Term Monitoring  
Strippit, Inc.  
Akron, New York  
NYSDEC Site ID: 9-15-053

LONG-TERM QUARTERLY MONITORING REPORT  
INTERIM REMEDIAL MEASURE  
STRIPPIT, INC. 1863 R-99  
AKRON, NEW YORK

Date of Inspection: April 10, 2006

1863R-99  
Strippit – Landfill Monitoring  
Akron, New York  
04/10/06

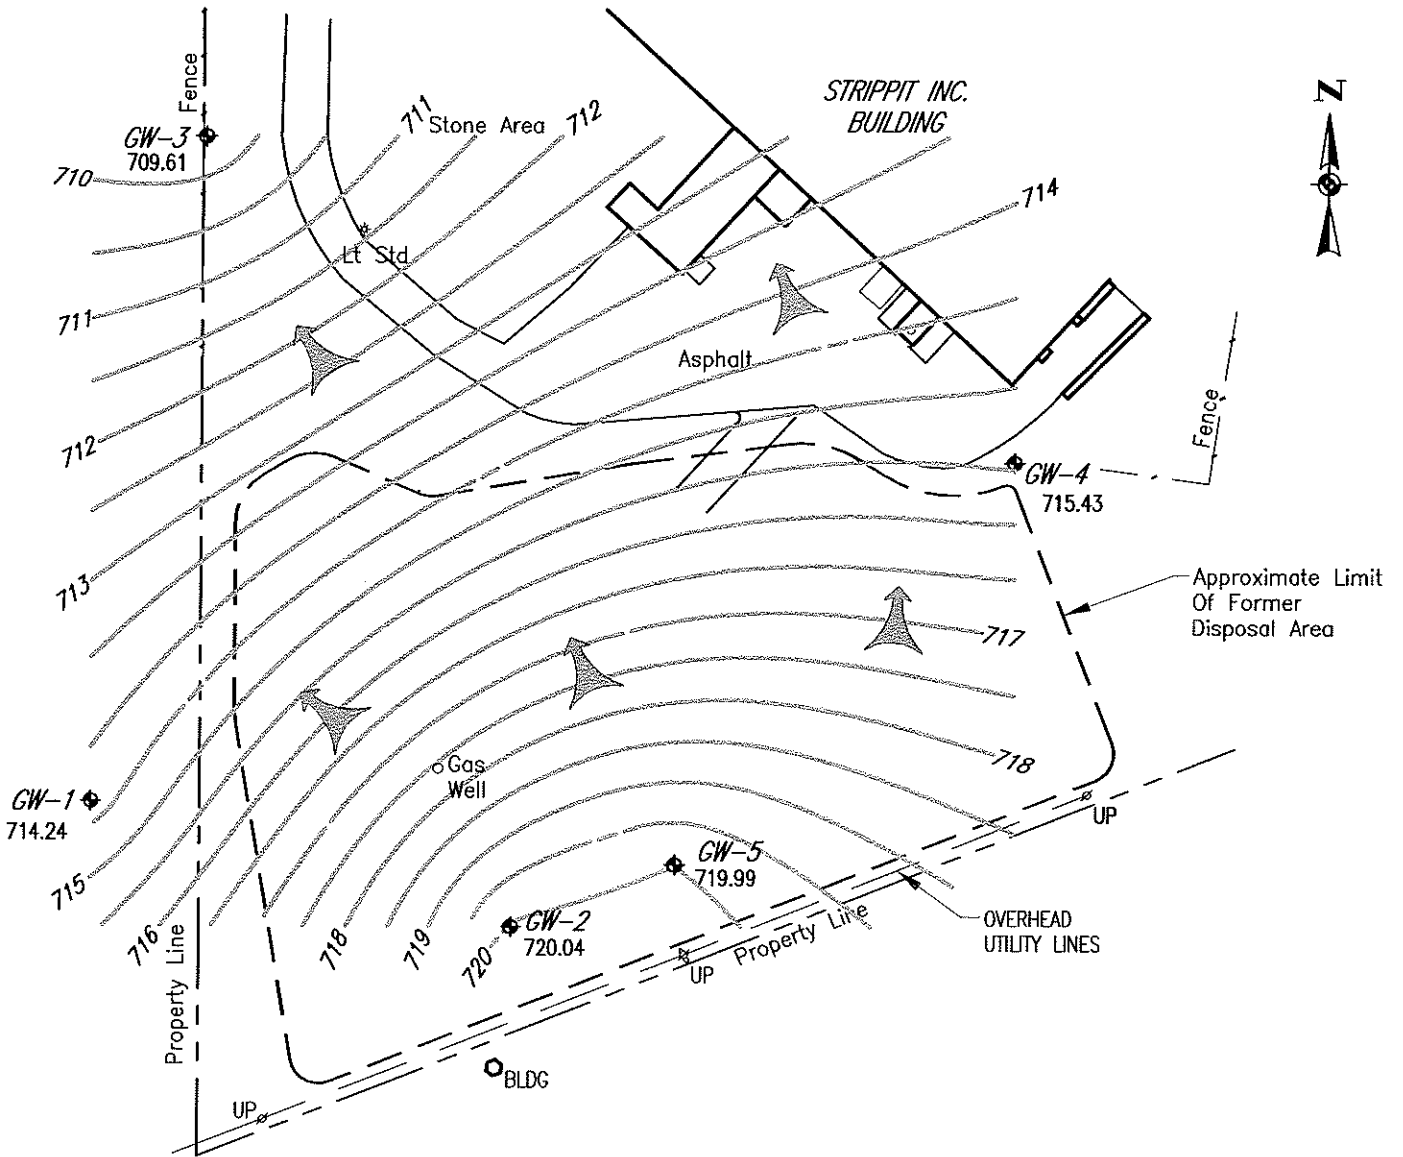
**FIGURE 1**

A groundwater contour map developed for the April 10, 2006 monitoring event is attached as Figure 1. As shown, groundwater flow at the Site is generally to the north and northwest. The groundwater levels measured on April 10, 2006 are generally higher than those measured during the monitoring event conducted on December 29, 2005 (i.e., due to seasonal variations), but the flow direction is similar for each monitoring event. Based upon the groundwater flow direction, monitoring wells GW-2 and GW-5 are located in hydraulically upgradient positions and monitoring wells GW-1, GW-3 and GW-4 are located in hydraulically downgradient positions.

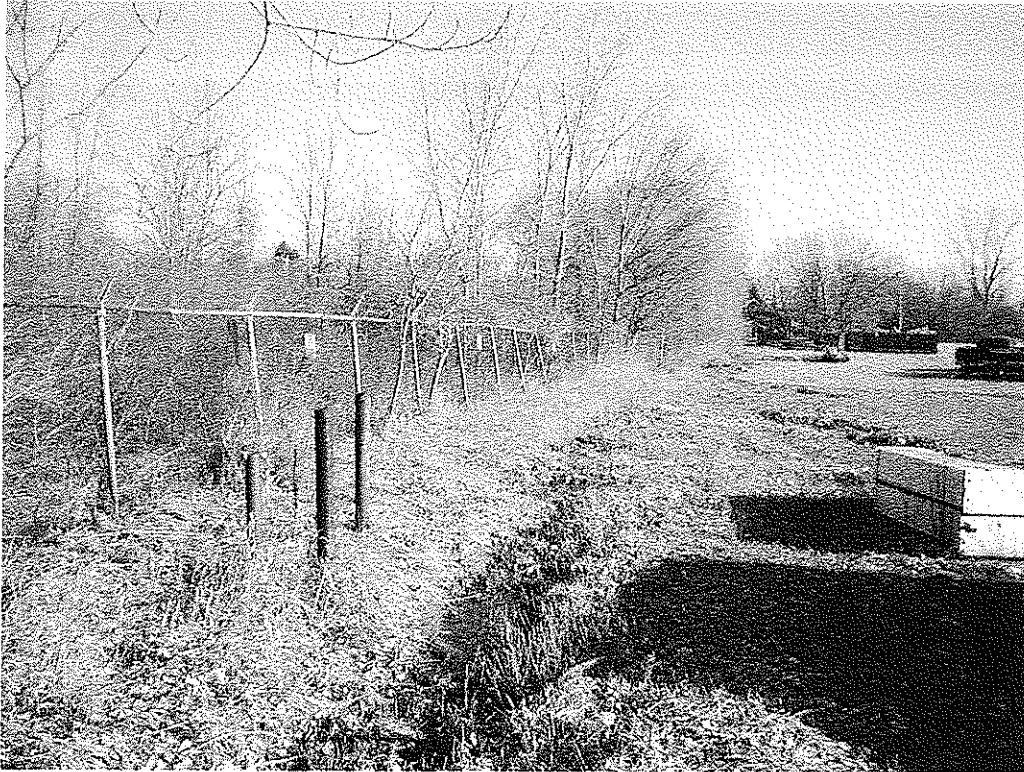
Monitoring Well GW-3

Condition of monitoring wells and gas wells: Gas wells in good condition, Monitoring wells are in good condition - outer casing rusting - dedicated rope needs to be replaced on wells due to fraying.

The drainage ways should be cleaned to assure flows are not impeded. In addition, selected monitoring wells should be repaired (e.g., repainted, locks oiled, etc.) and dedicated rope for the bailers replaced during the next sample event.

Bring ~~new~~ rope for bailers next visit.  
Continue monitoring groundwater wells (ie casing, locks,  
rope, bailers, etc.) replace or repair as needed.  
Clean out garbage, debris & overgrowth in drainage  
way.

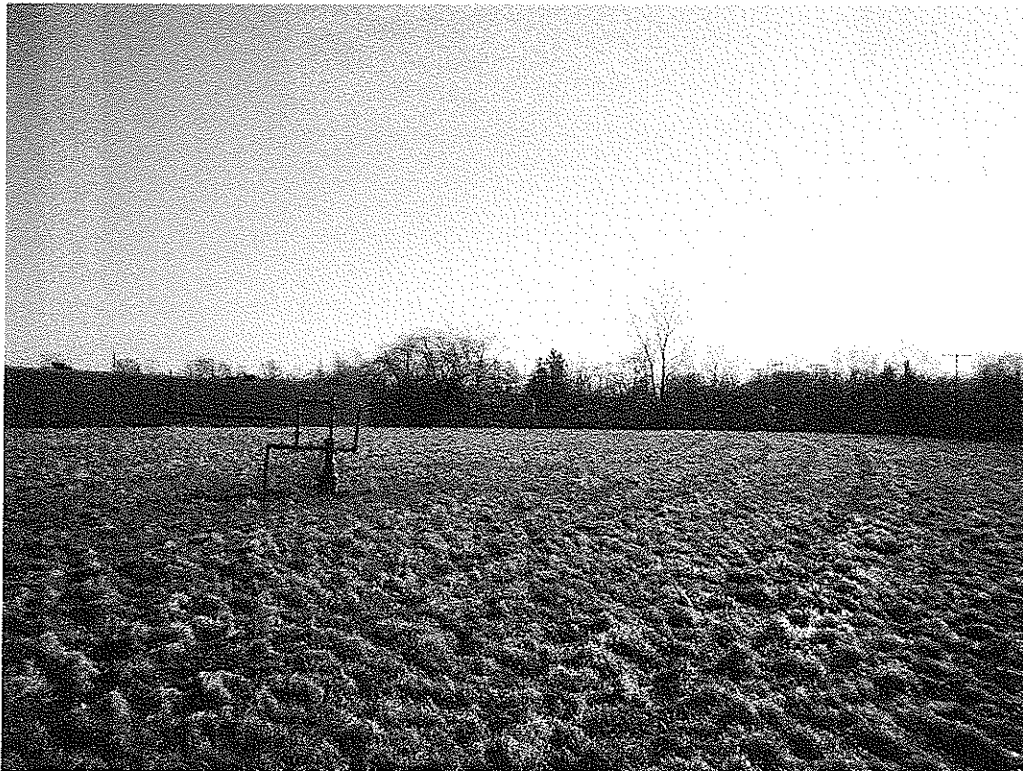
View of closure cover gas well, looking northeast.

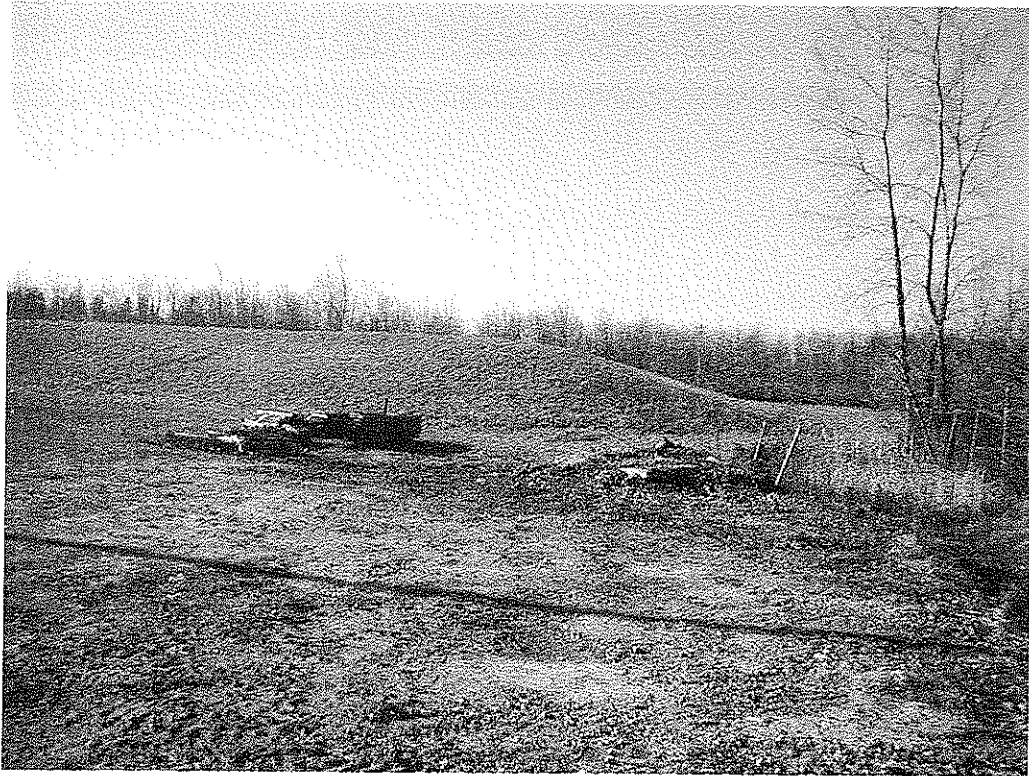
General Condition of Cover: Cover appears to be in good condition approximately 0.3 feet of vegetation cover at the time of visit.

View of northwest end of closure cover, looking southeast.

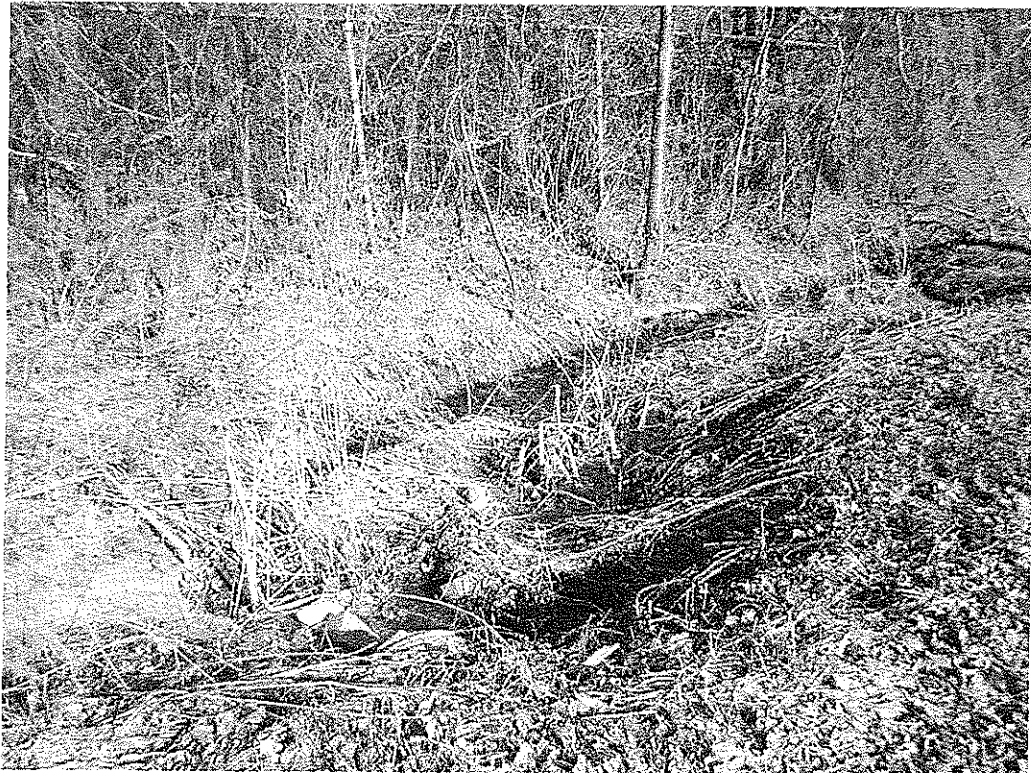
Condition of drainage ways (discuss amount of water/sediments present, vegetative growth unusual staining, blockage, etc.): Drainage ways contained a significant amount of overgrowth, sticks, fallen limbs, leaves & a lot of garbage, needs to be cleaned, water still runs through, small amount of standing water.

View of drainage swale on western side of parking lot, looking north.
