PERIODIC REVIEW REPORT
REPORTING PERIOD: JANUARY 31, 2022 THROUGH JANUARY 31, 2025

12975 CLARENCE CENTER ROAD
AKRON, NEW YORK
NYSDEC SITE NO. 915053

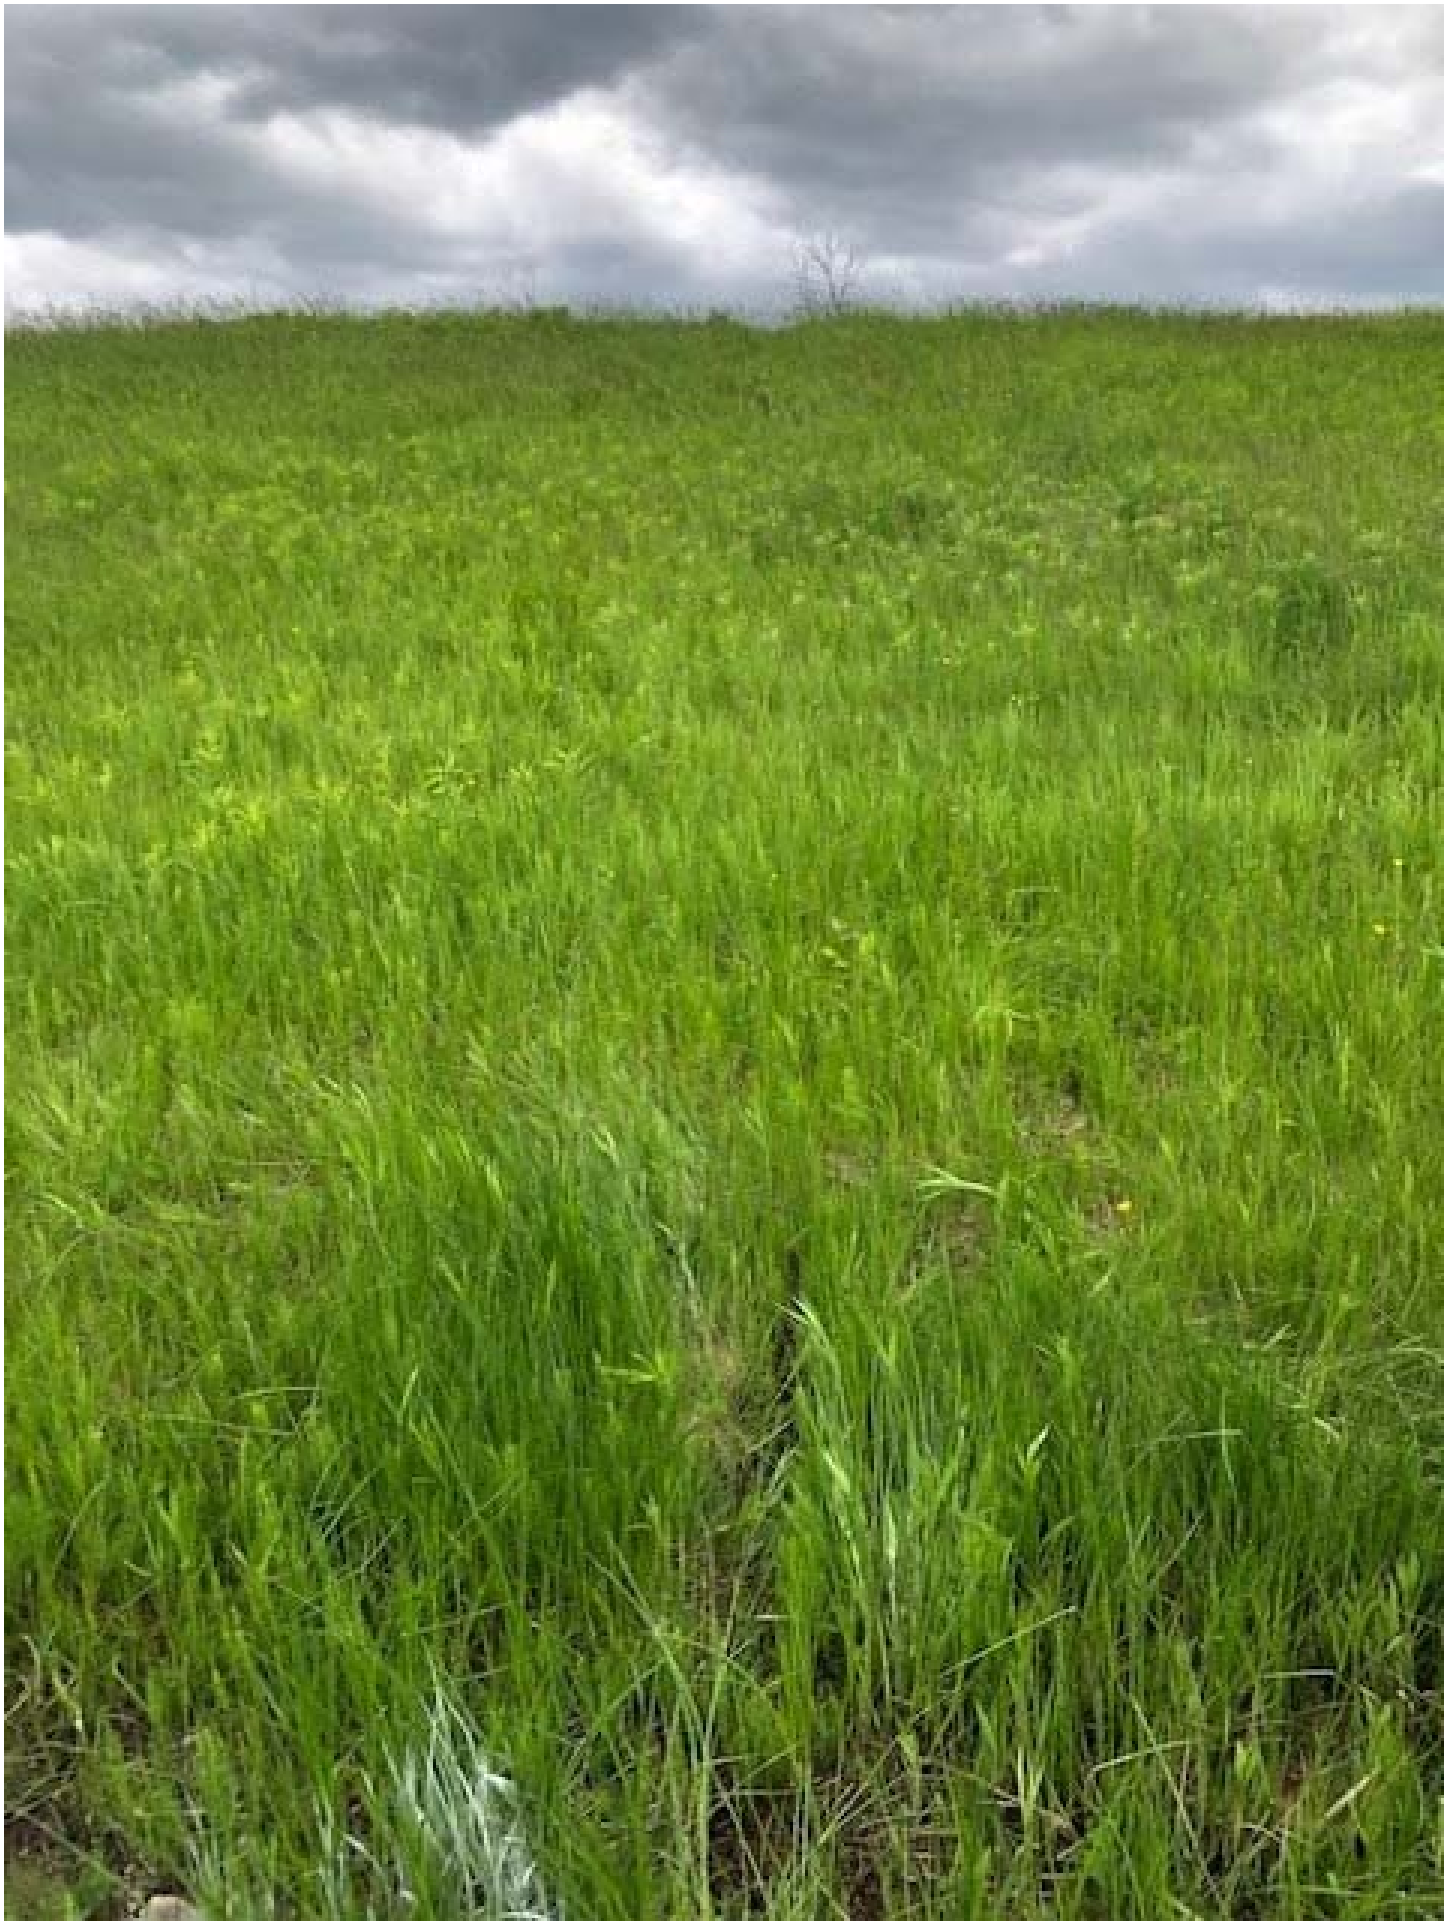
HW axis located on the north slope of the landfill where repairs were made to correct cracking of the soil cover, facing south.

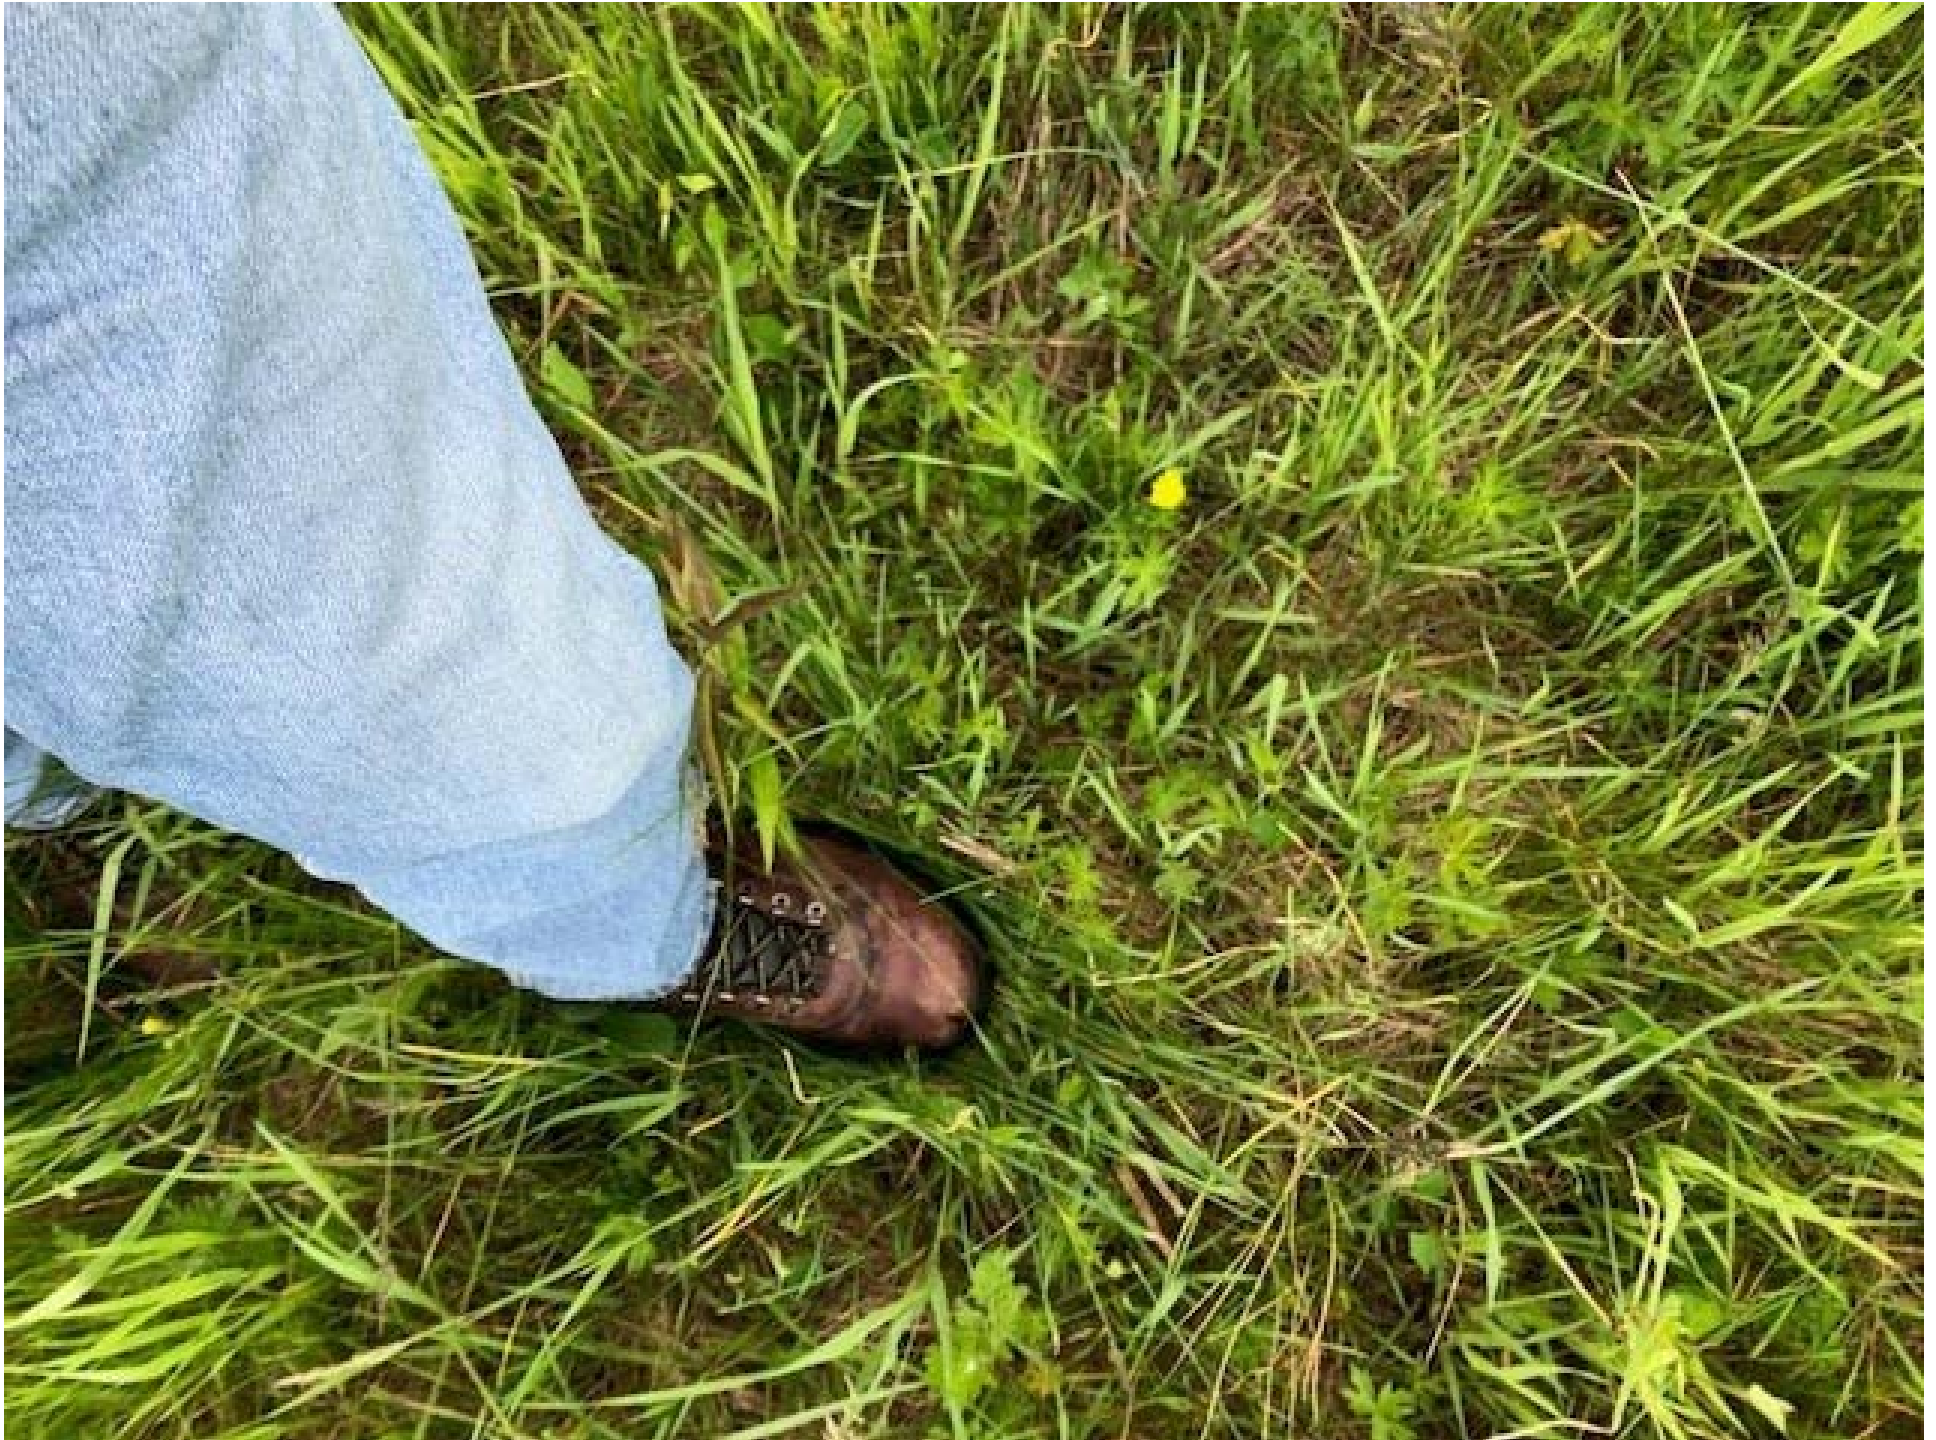
Close up view of the repaired area of cracking located on the northern slope of the landfill.

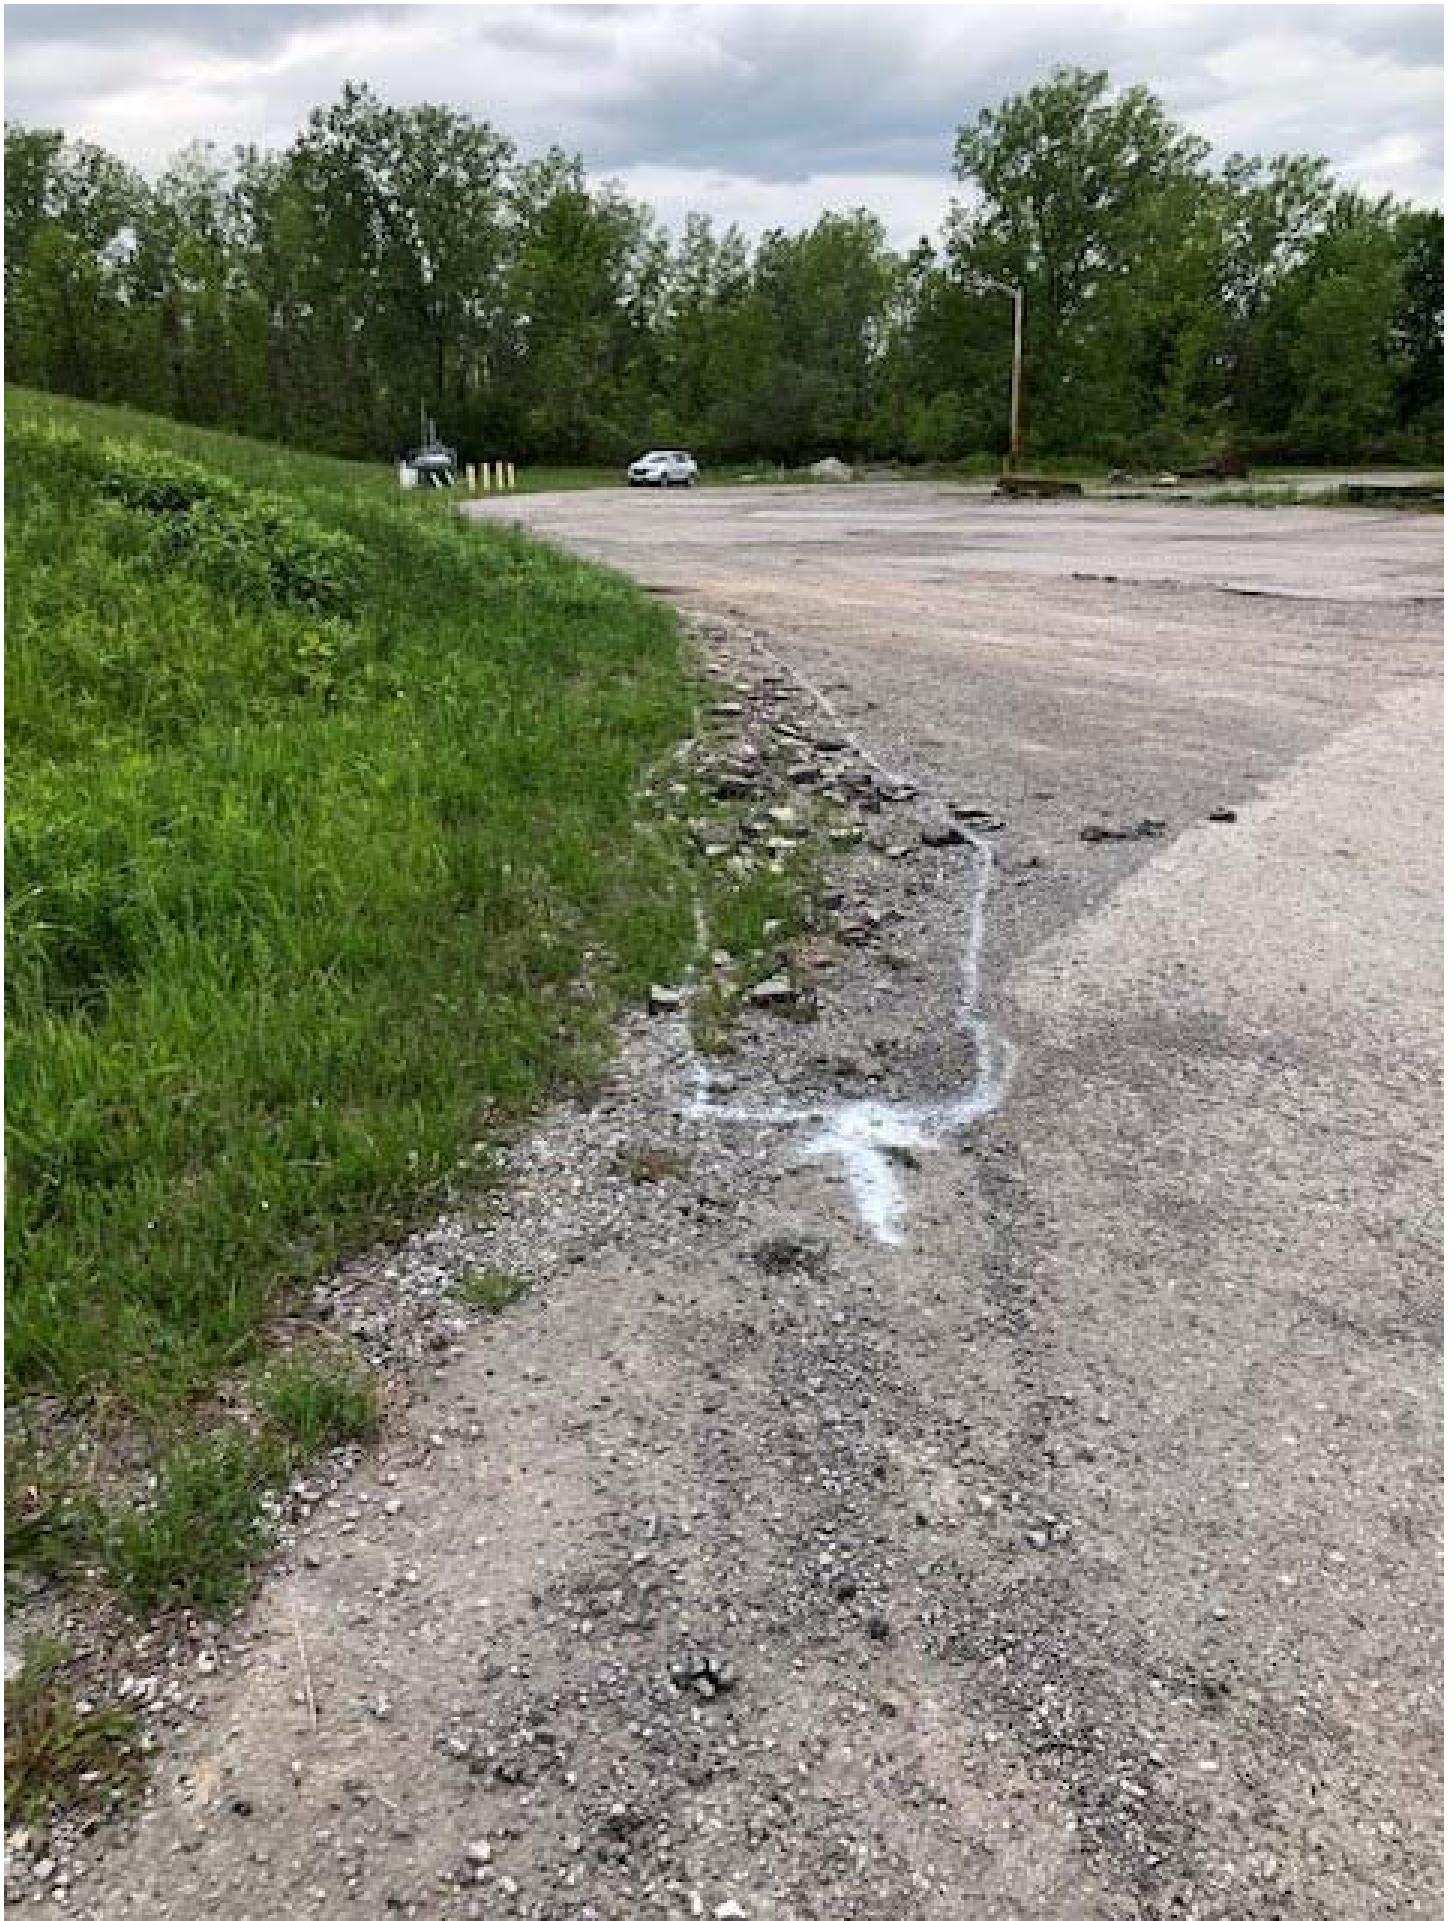
View of marking paint delineating an area of asphalt to be repaired at toe of the northern slope of the landfill area (center), and the repaired slough area adjacent (left) on the landfill slope, facing west.

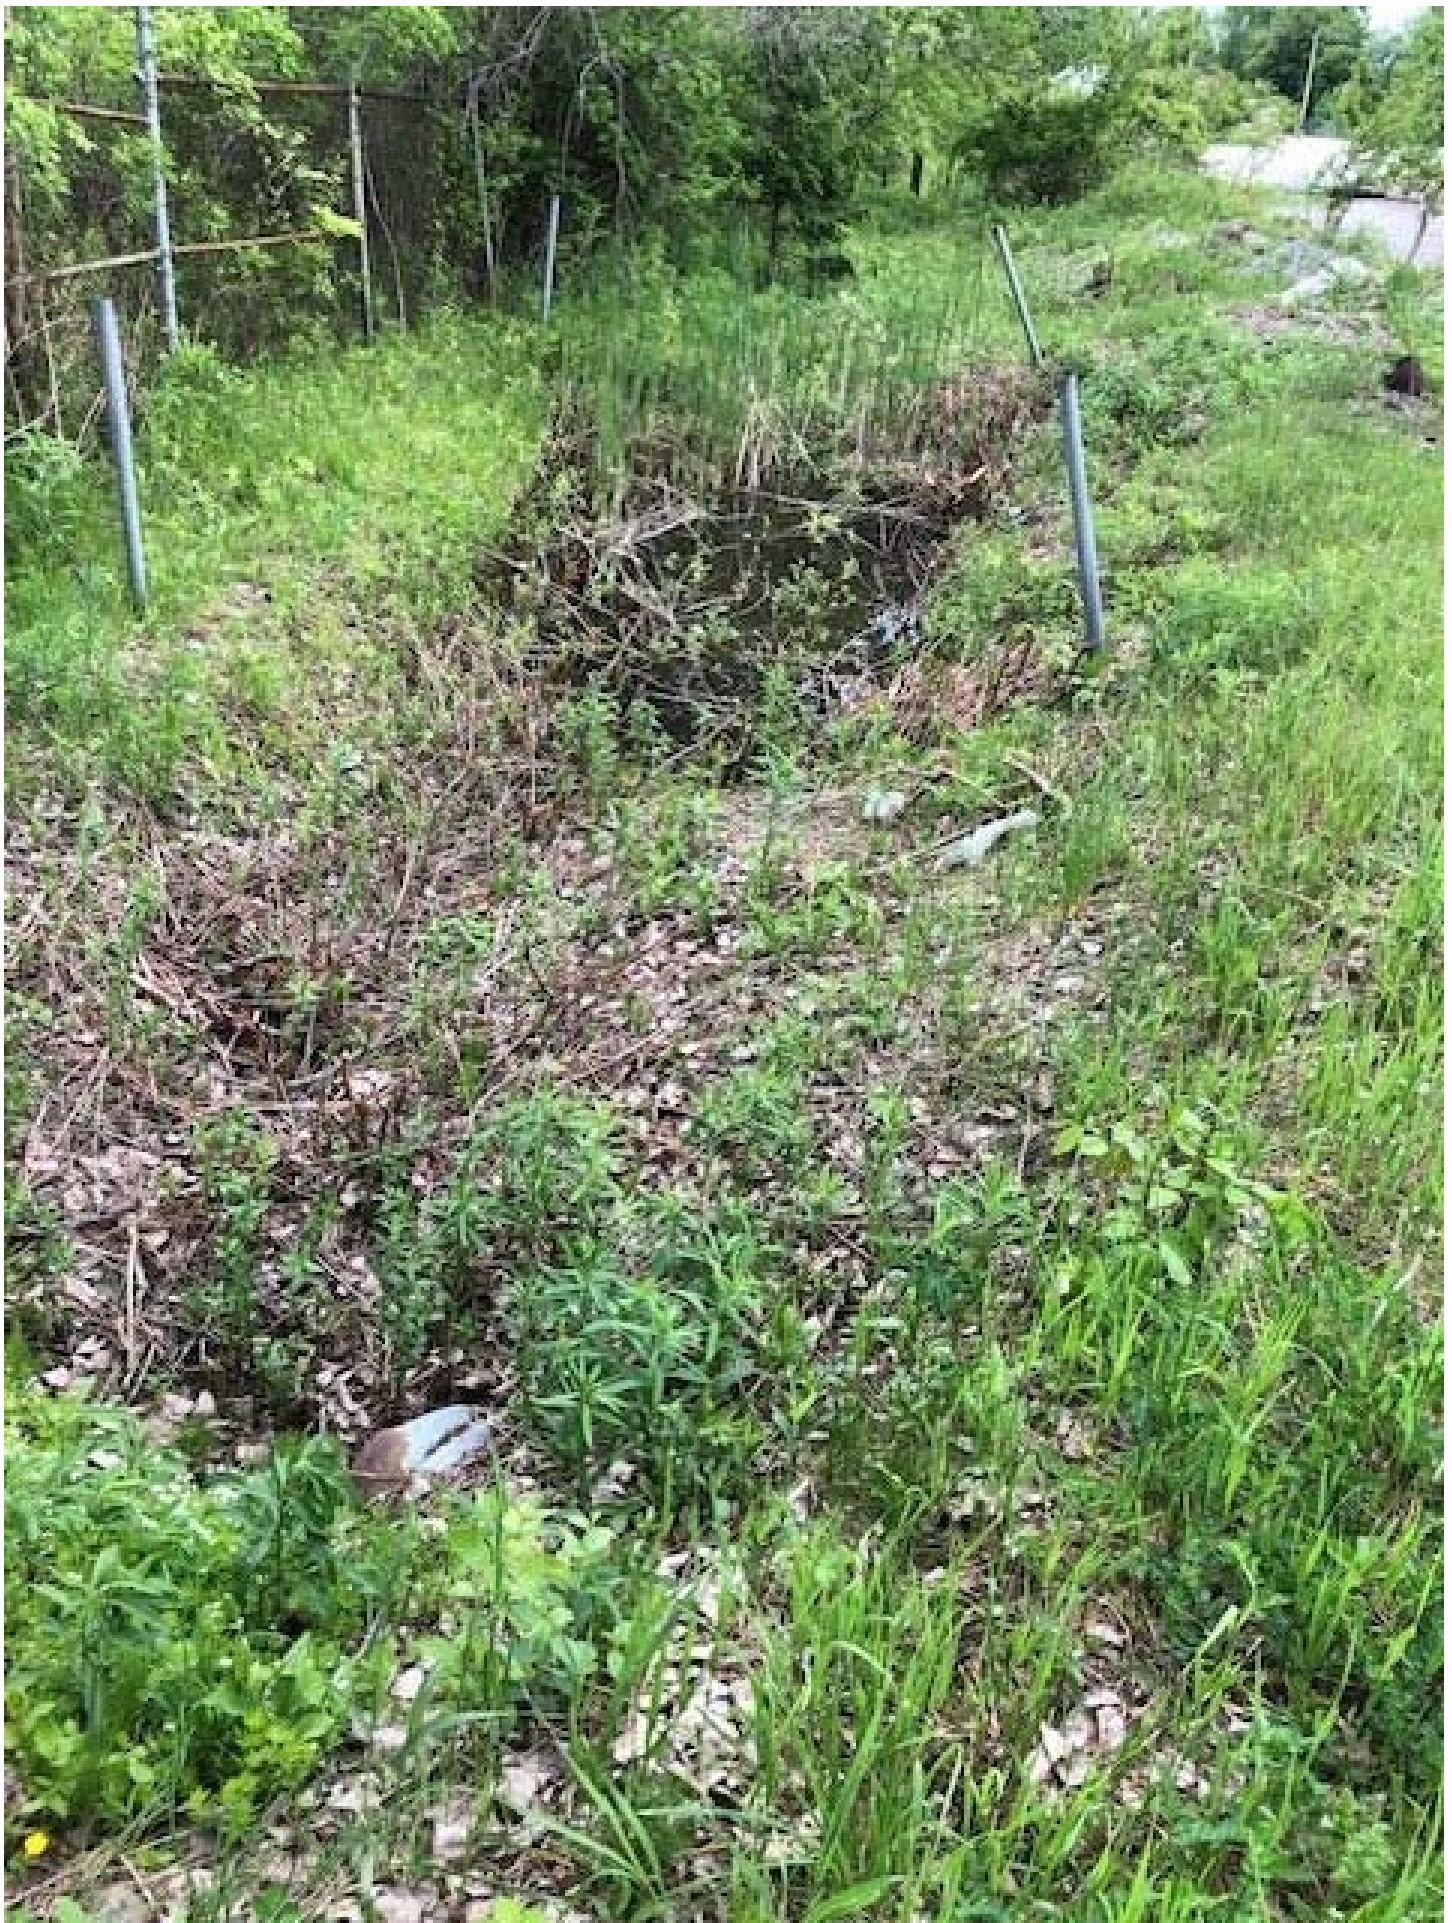
View of the drainage way located to the northwest of the landfill area, where overgrown vegetation was cut/cleared to prevent blockage of the drainage way, facing northwest.

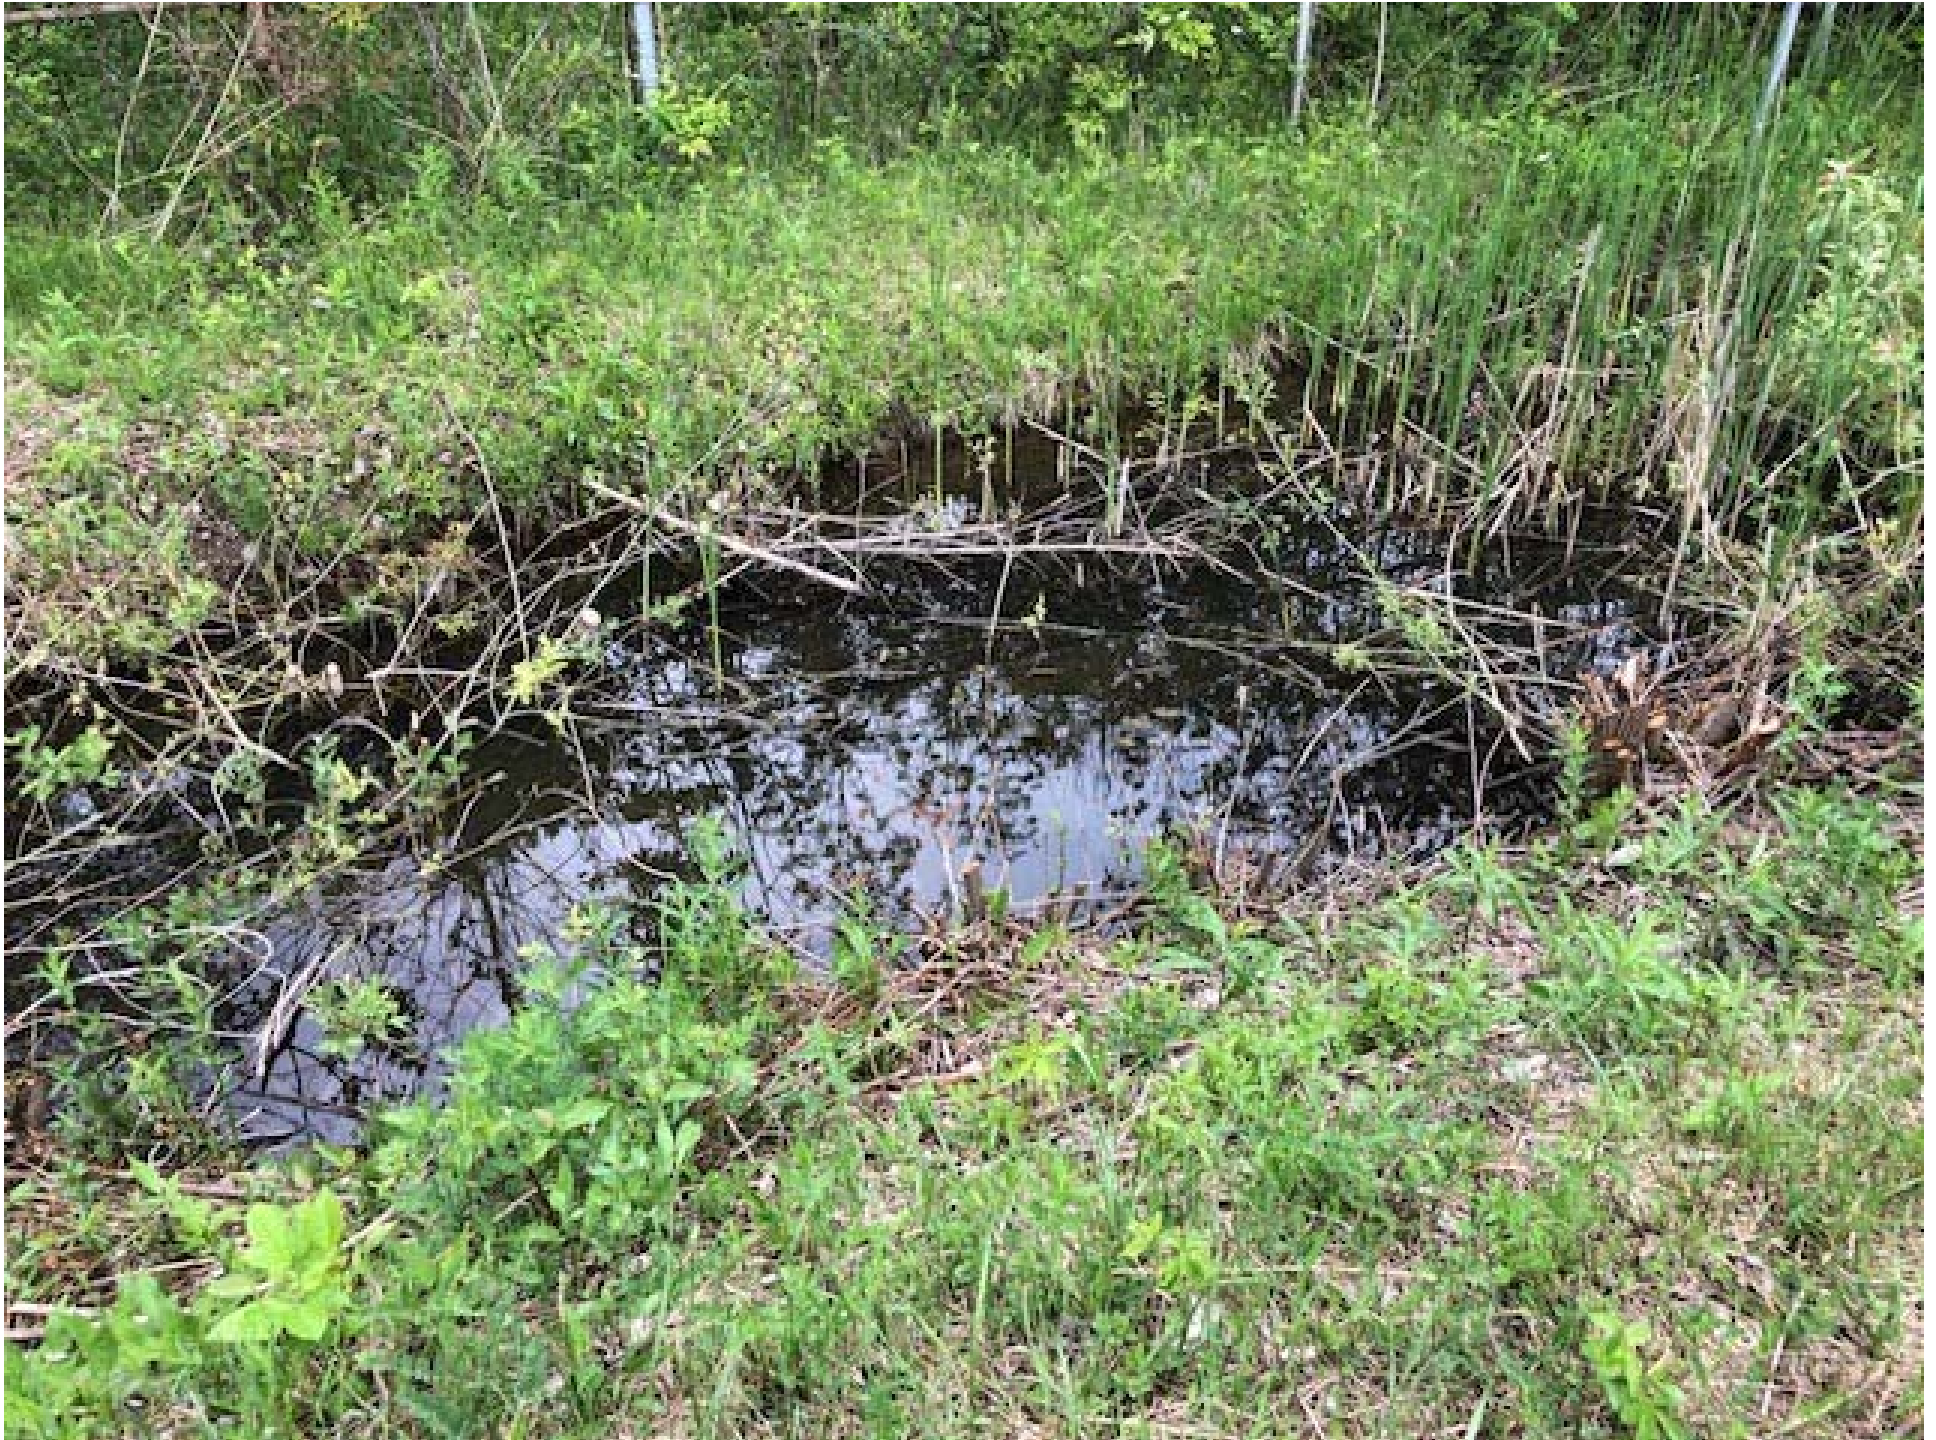
View of the drainage way located to the northwest of the landfill area, where overgrown vegetation was cut/cleared to prevent blockage of the drainage way, facing west.

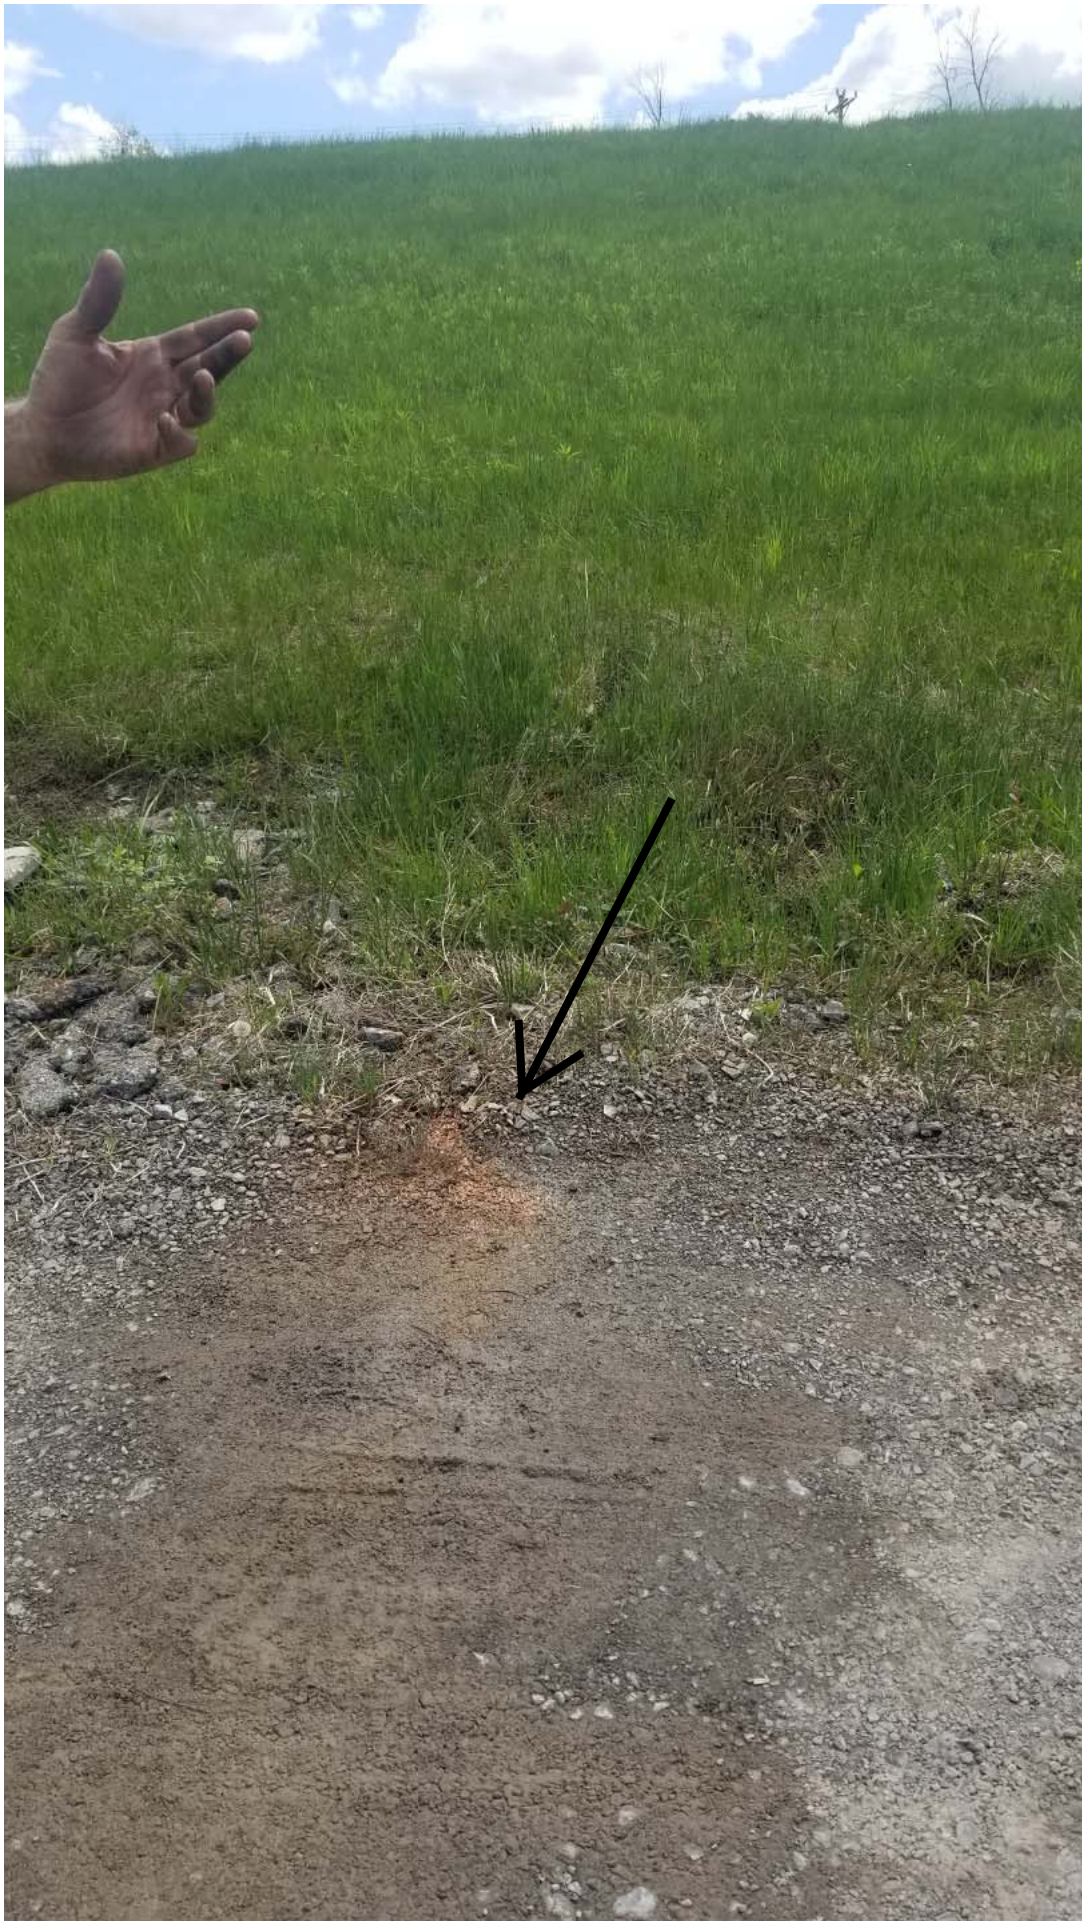
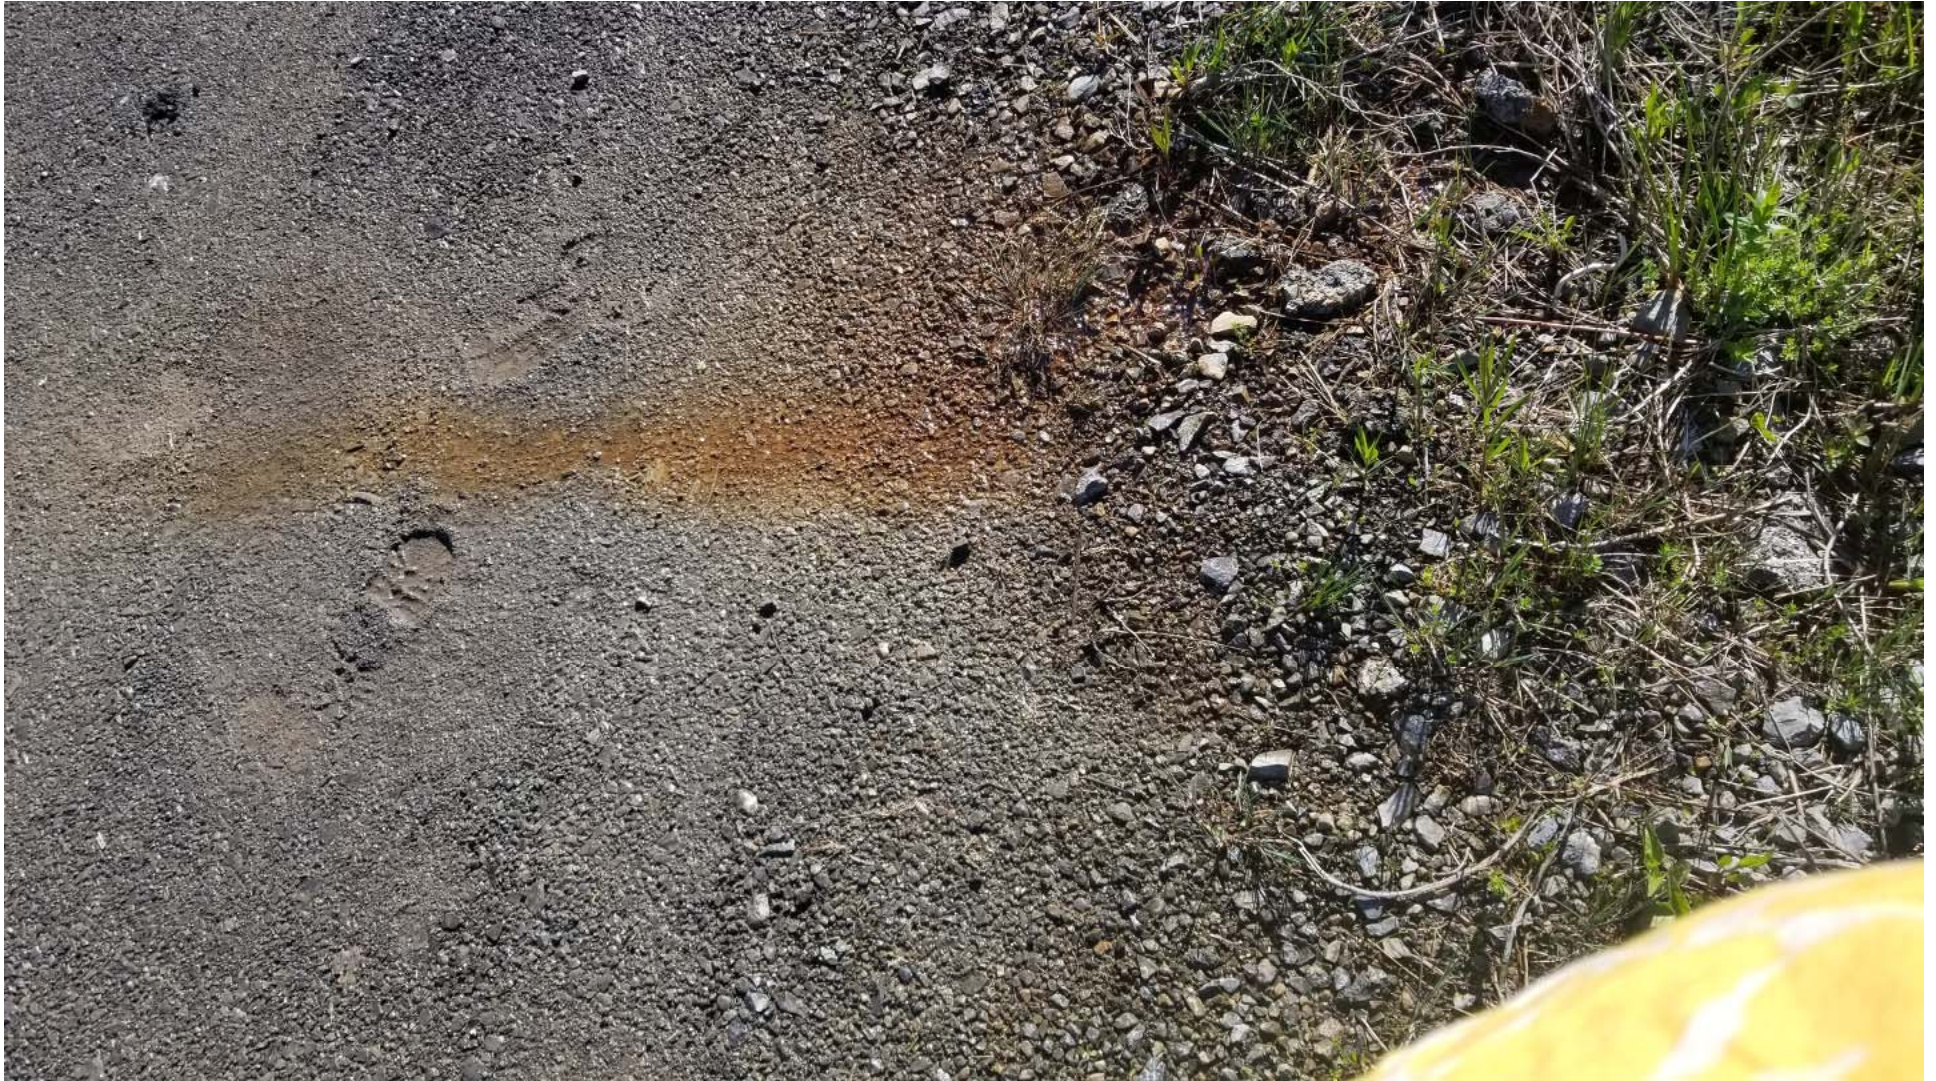
- July 22, 2022: mild, iron-stained seepage was noted in one area on north side of landfill near the asphalt pavement of the access road to facility;
- November 28, 2022: a low, apparent drainage-like channel filled with snow was evident on the northeastern slope of the landfill. However, no water flow observed in this drainage-like channel.

View of the mild, iron-stained seepage observed on the north side of the landfill, facing south

View of the mild, iron-stained seepage observed on the north side of the landfill.

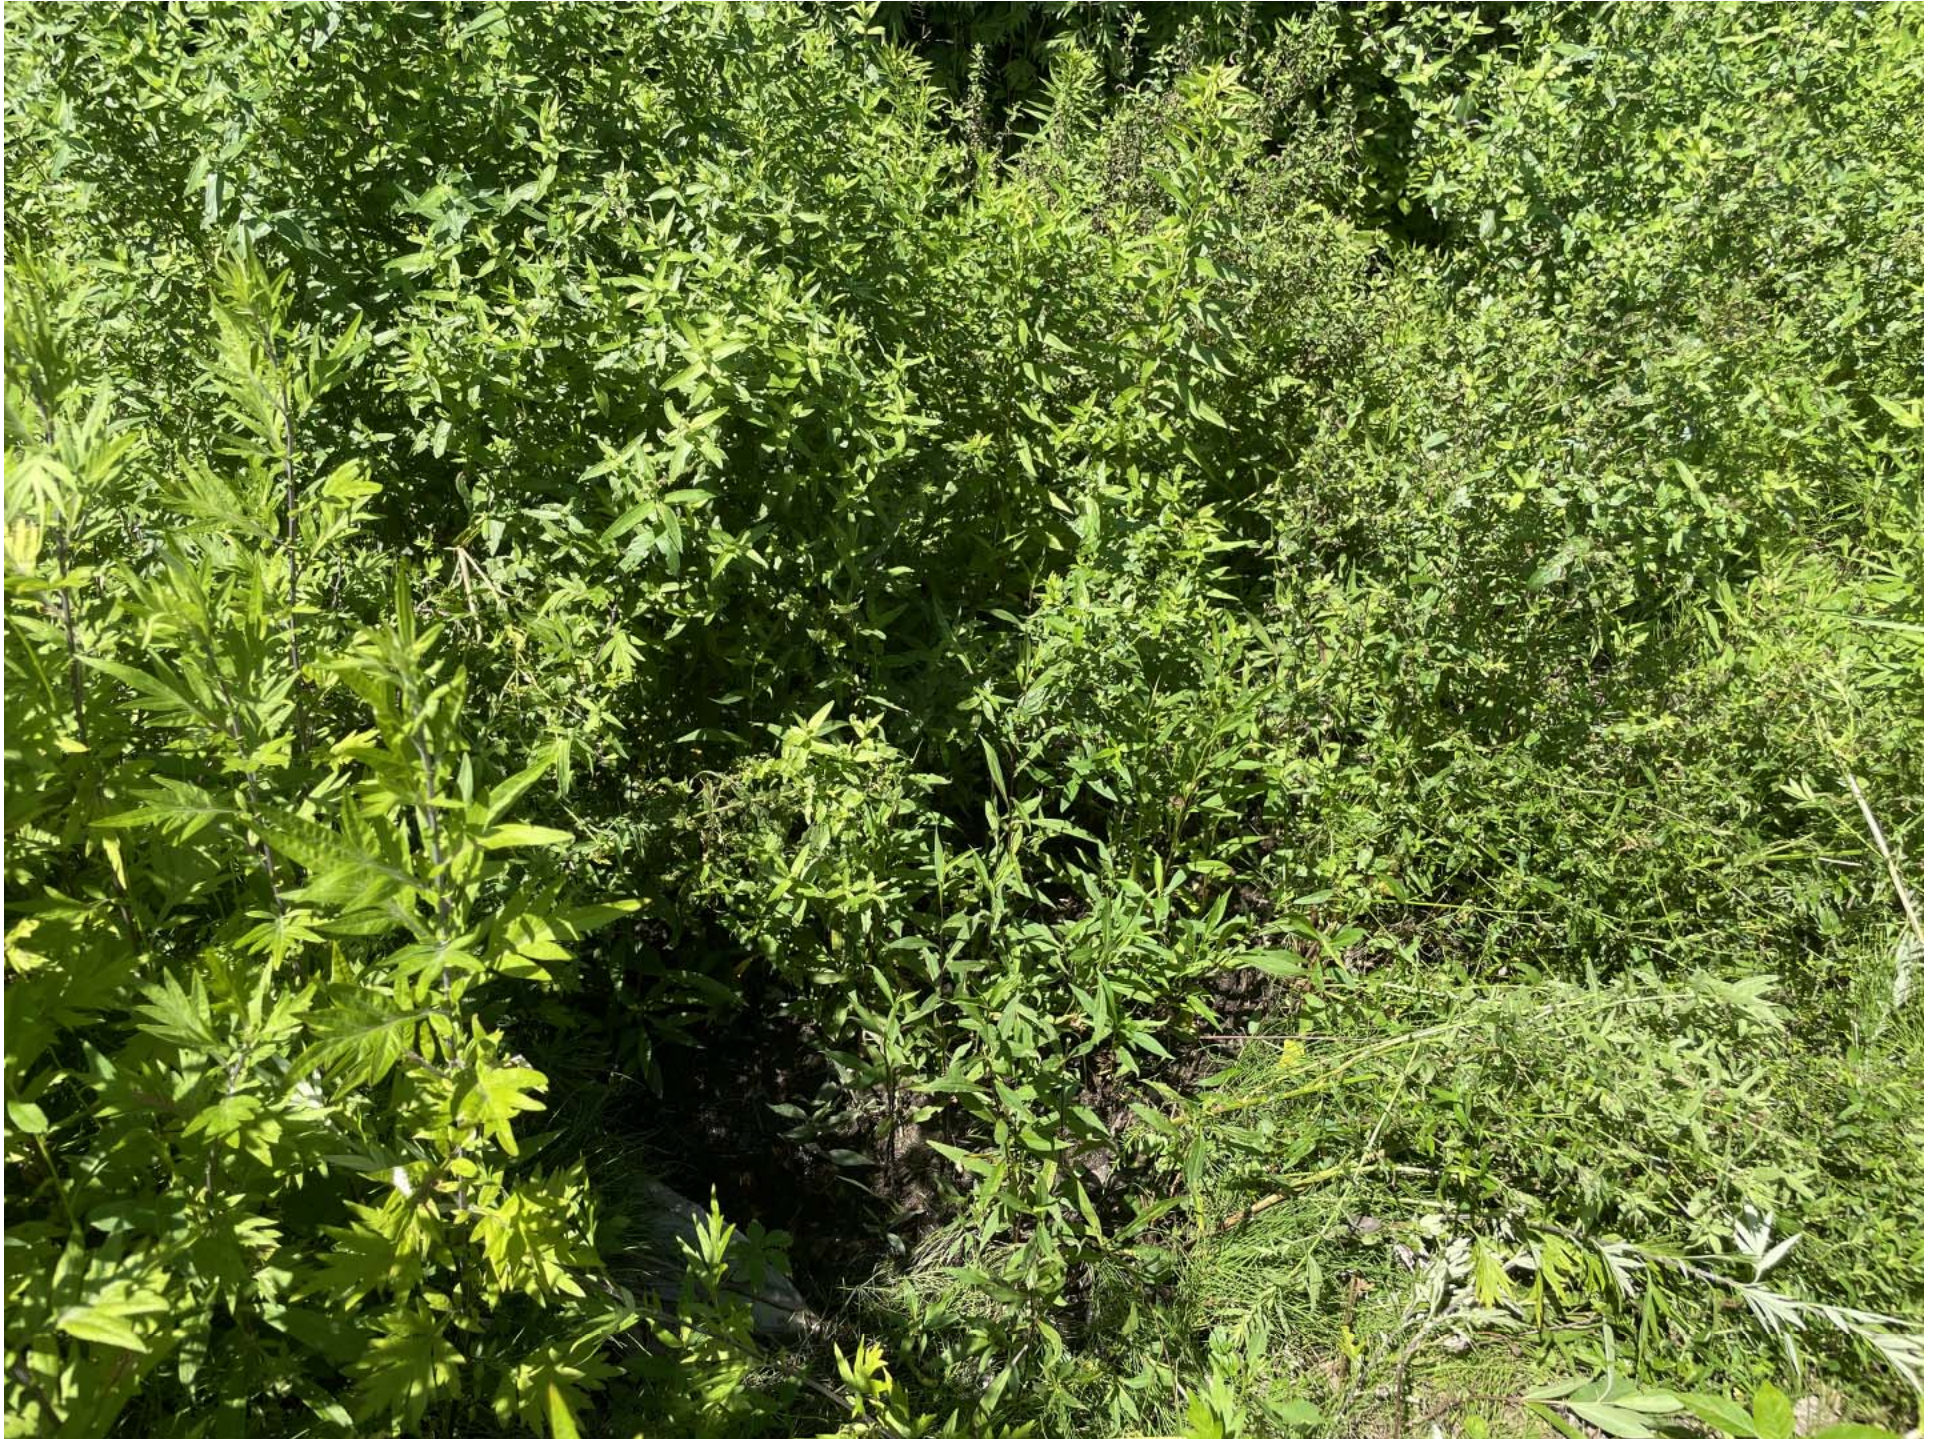
View of overgrown vegetation, observed in the drainage way located to the northwest of the landfill, facing northwest.
