PERIODIC REVIEW REPORT
REPORTING PERIOD: JANUARY 31, 2022 THROUGH JANUARY 31, 2025

12975 CLARENCE CENTER ROAD
AKRON, NEW YORK
NYSDEC SITE NO. 915053

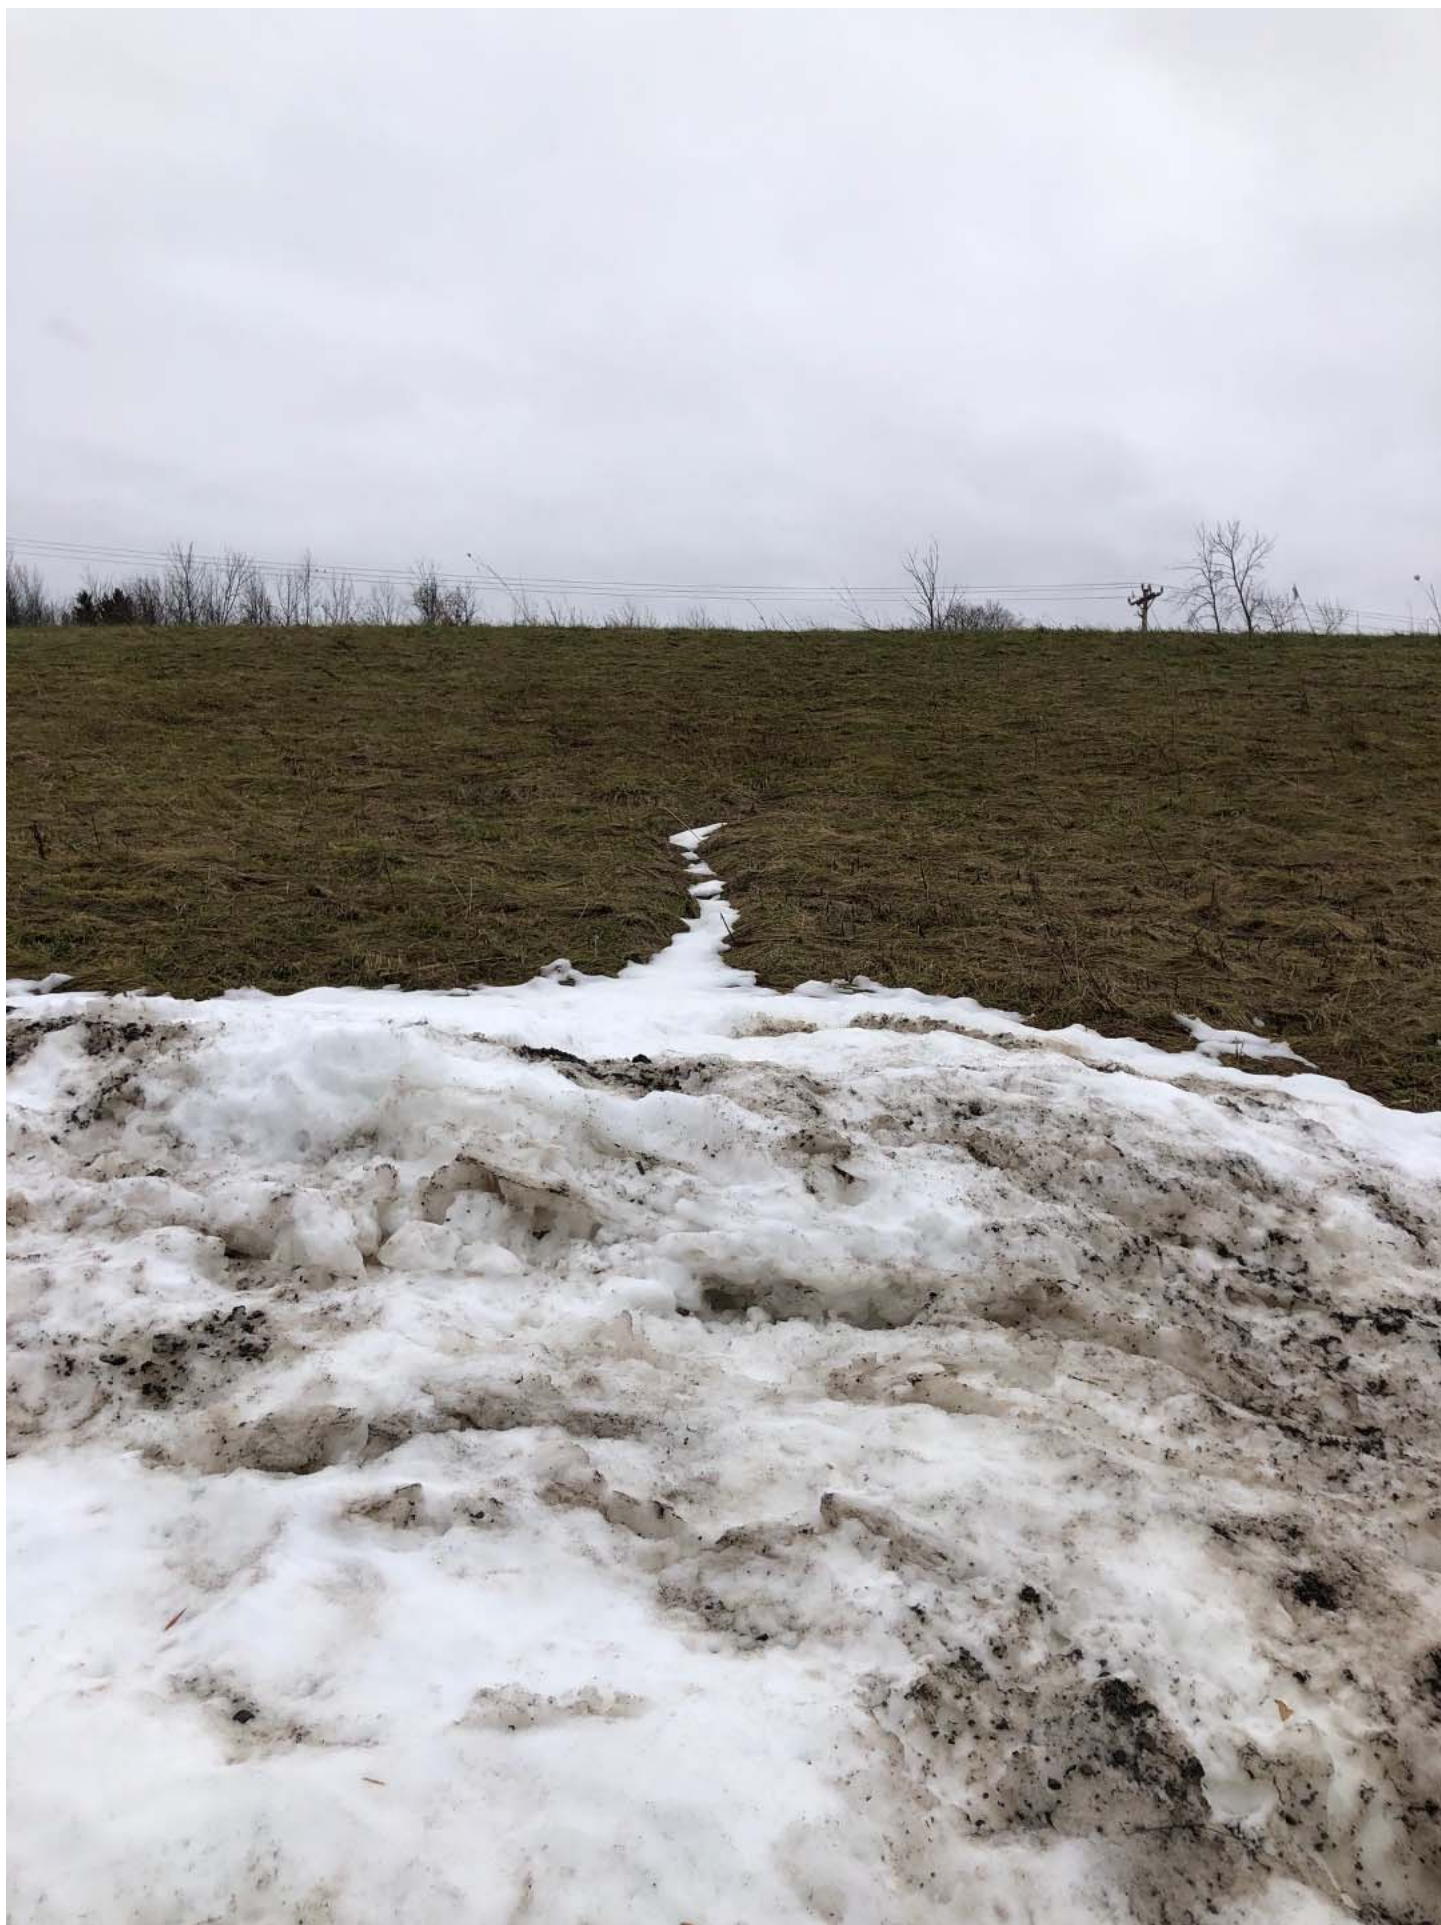
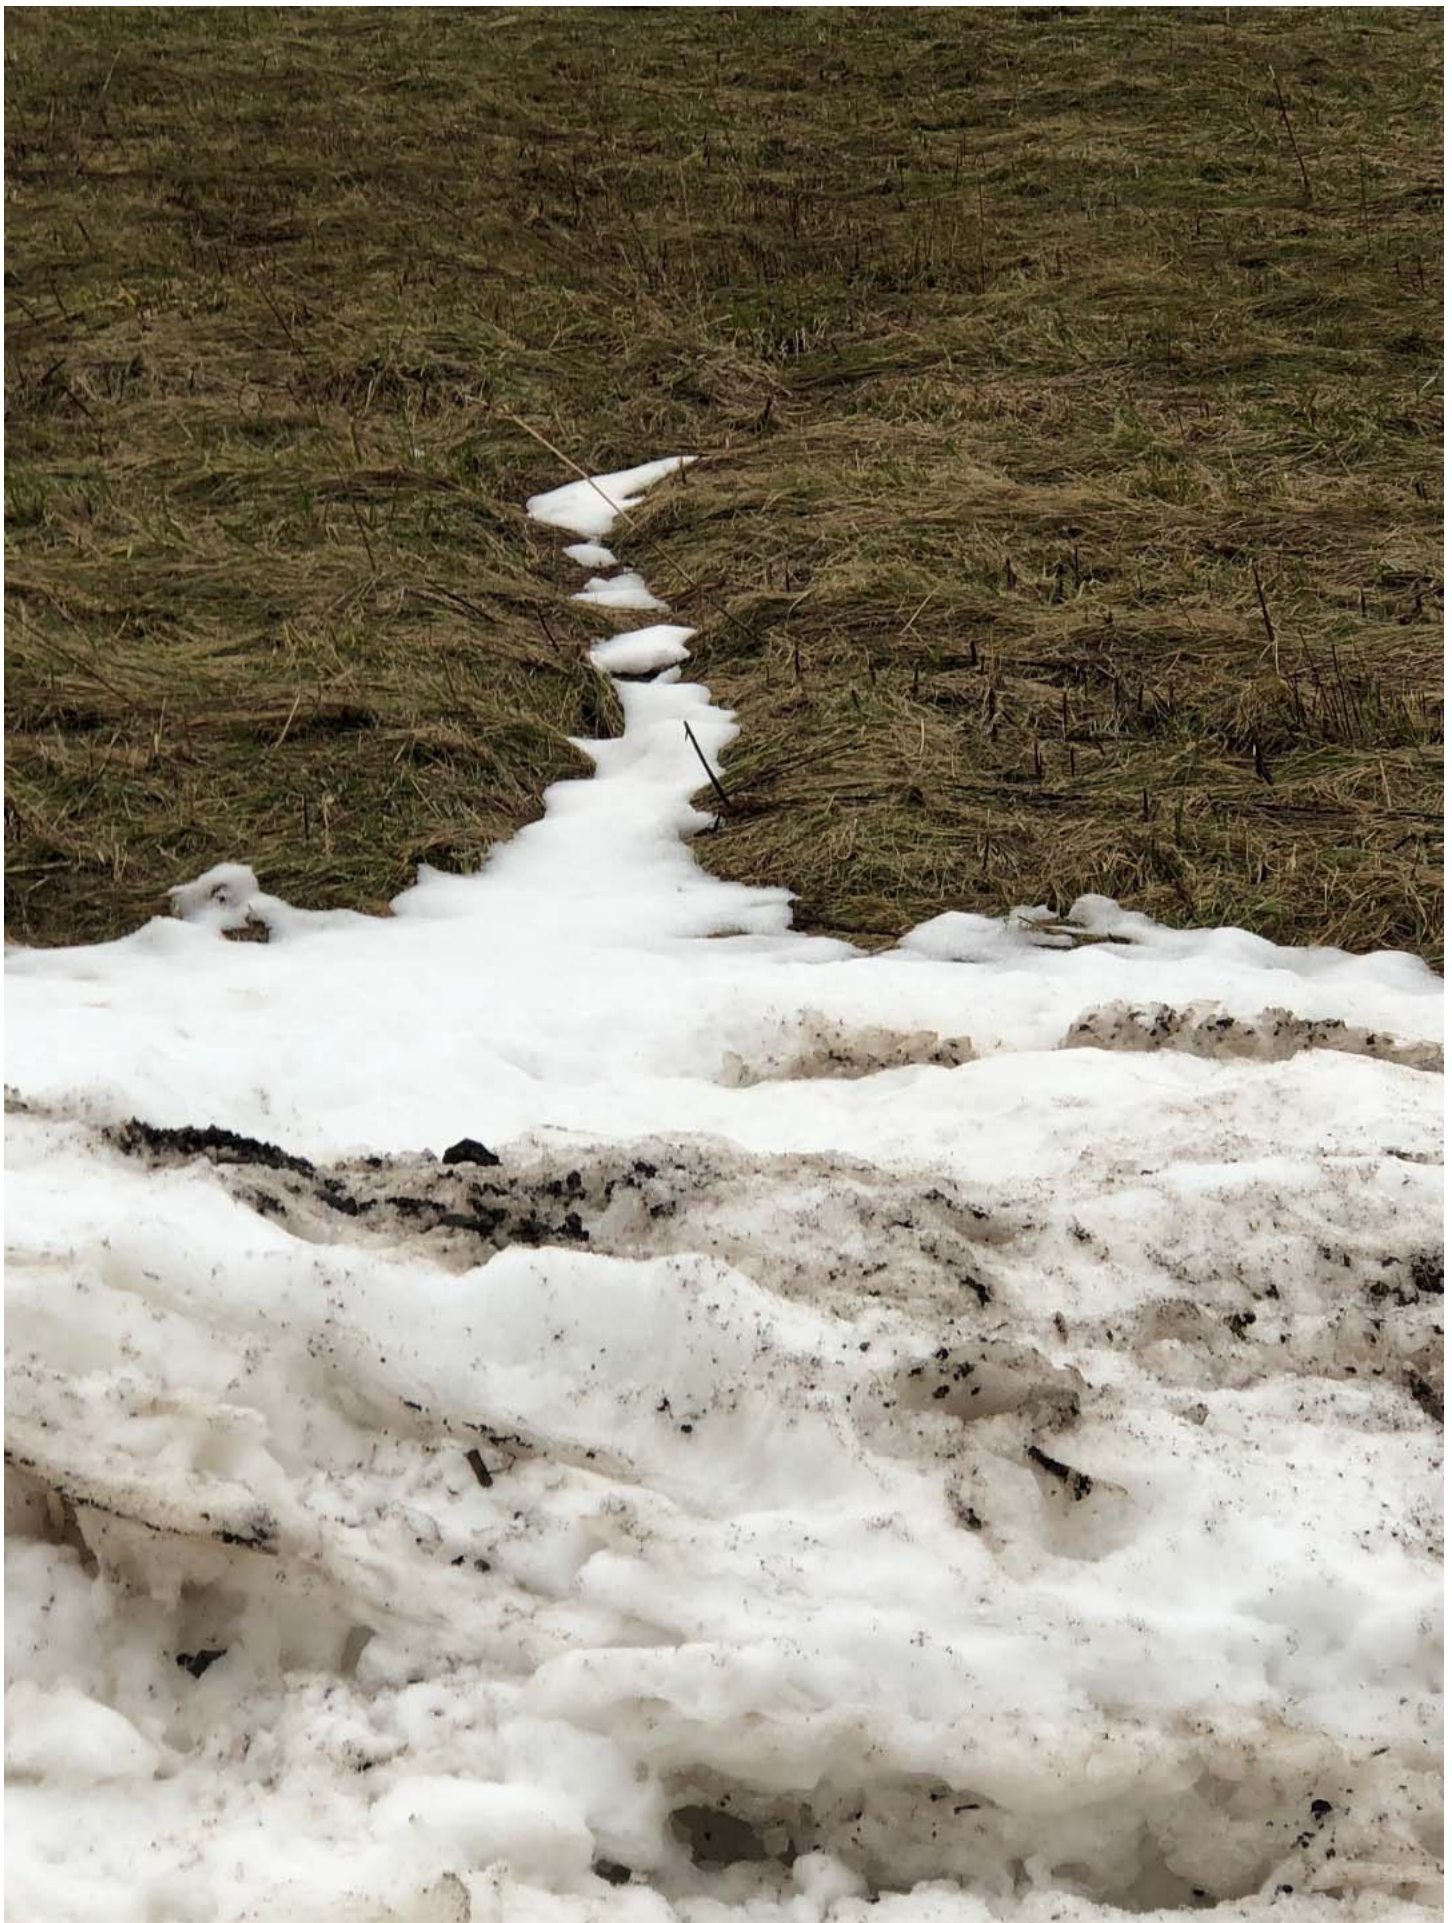
View of the apparent drainage-like channel filled with snow observed on the northeastern slope of the landfill, facing north.

Close-up view of the apparent drainage-like channel filled with snow is evident on the northeastern slope of the landfill, facing north.

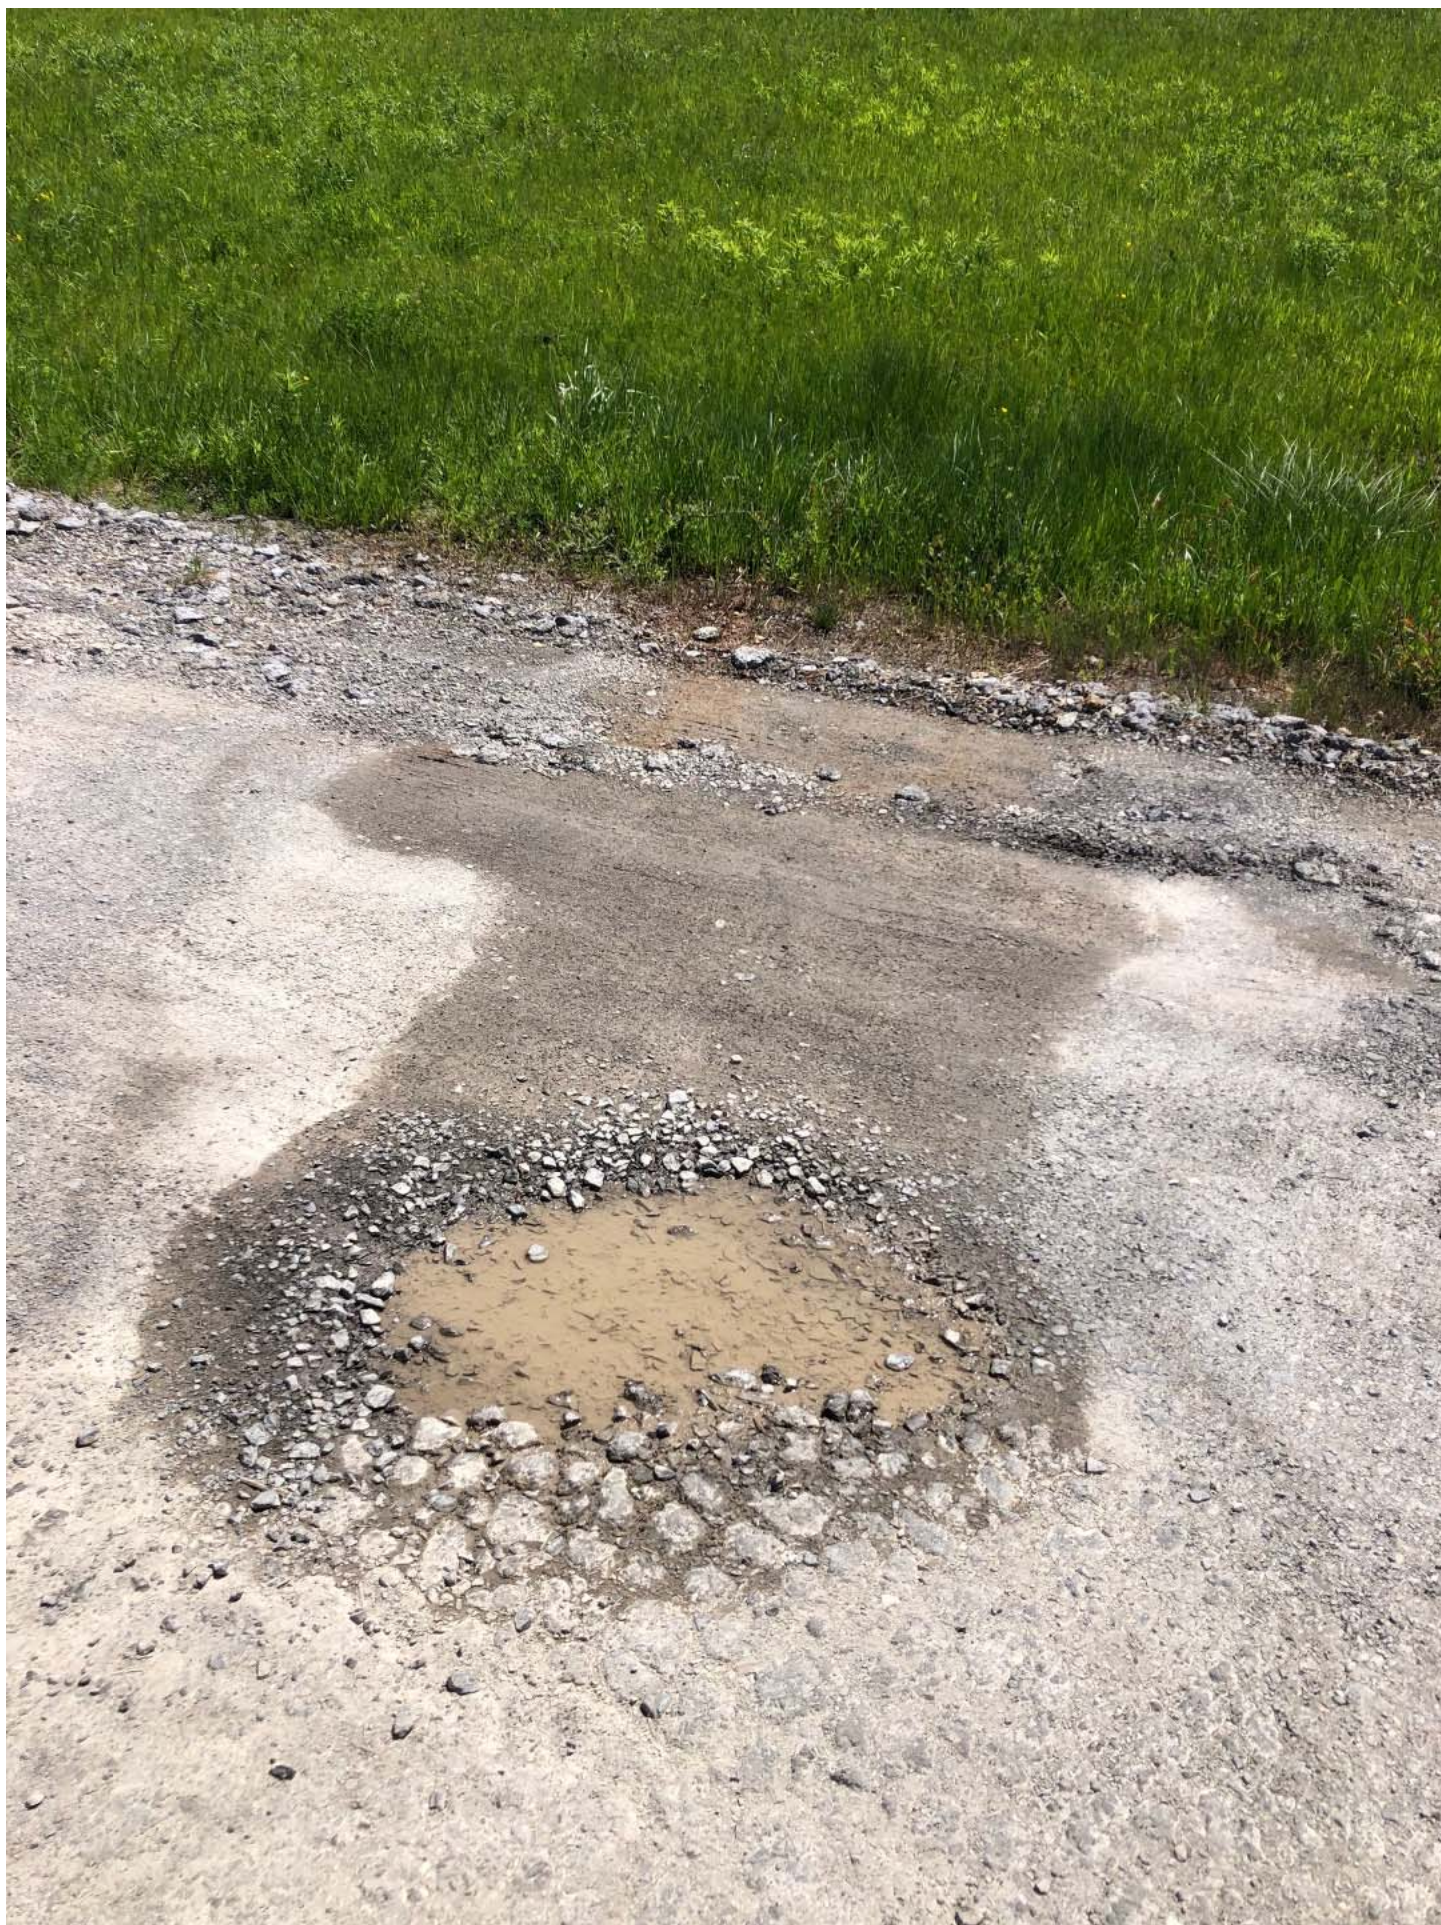
- May 26, 2023: an area of minor erosion was observed near toe of slope on the northeastern side of the landfill in proximity of access road to facility. In addition, two areas of water seepage were observed exiting the northeastern slope of the landfill with slight discharge onto the paved access road and a rust-colored precipitate evident in the standing water.

View of first area of water seepage observed exiting the northeastern slope of the landfill, facing southeast.

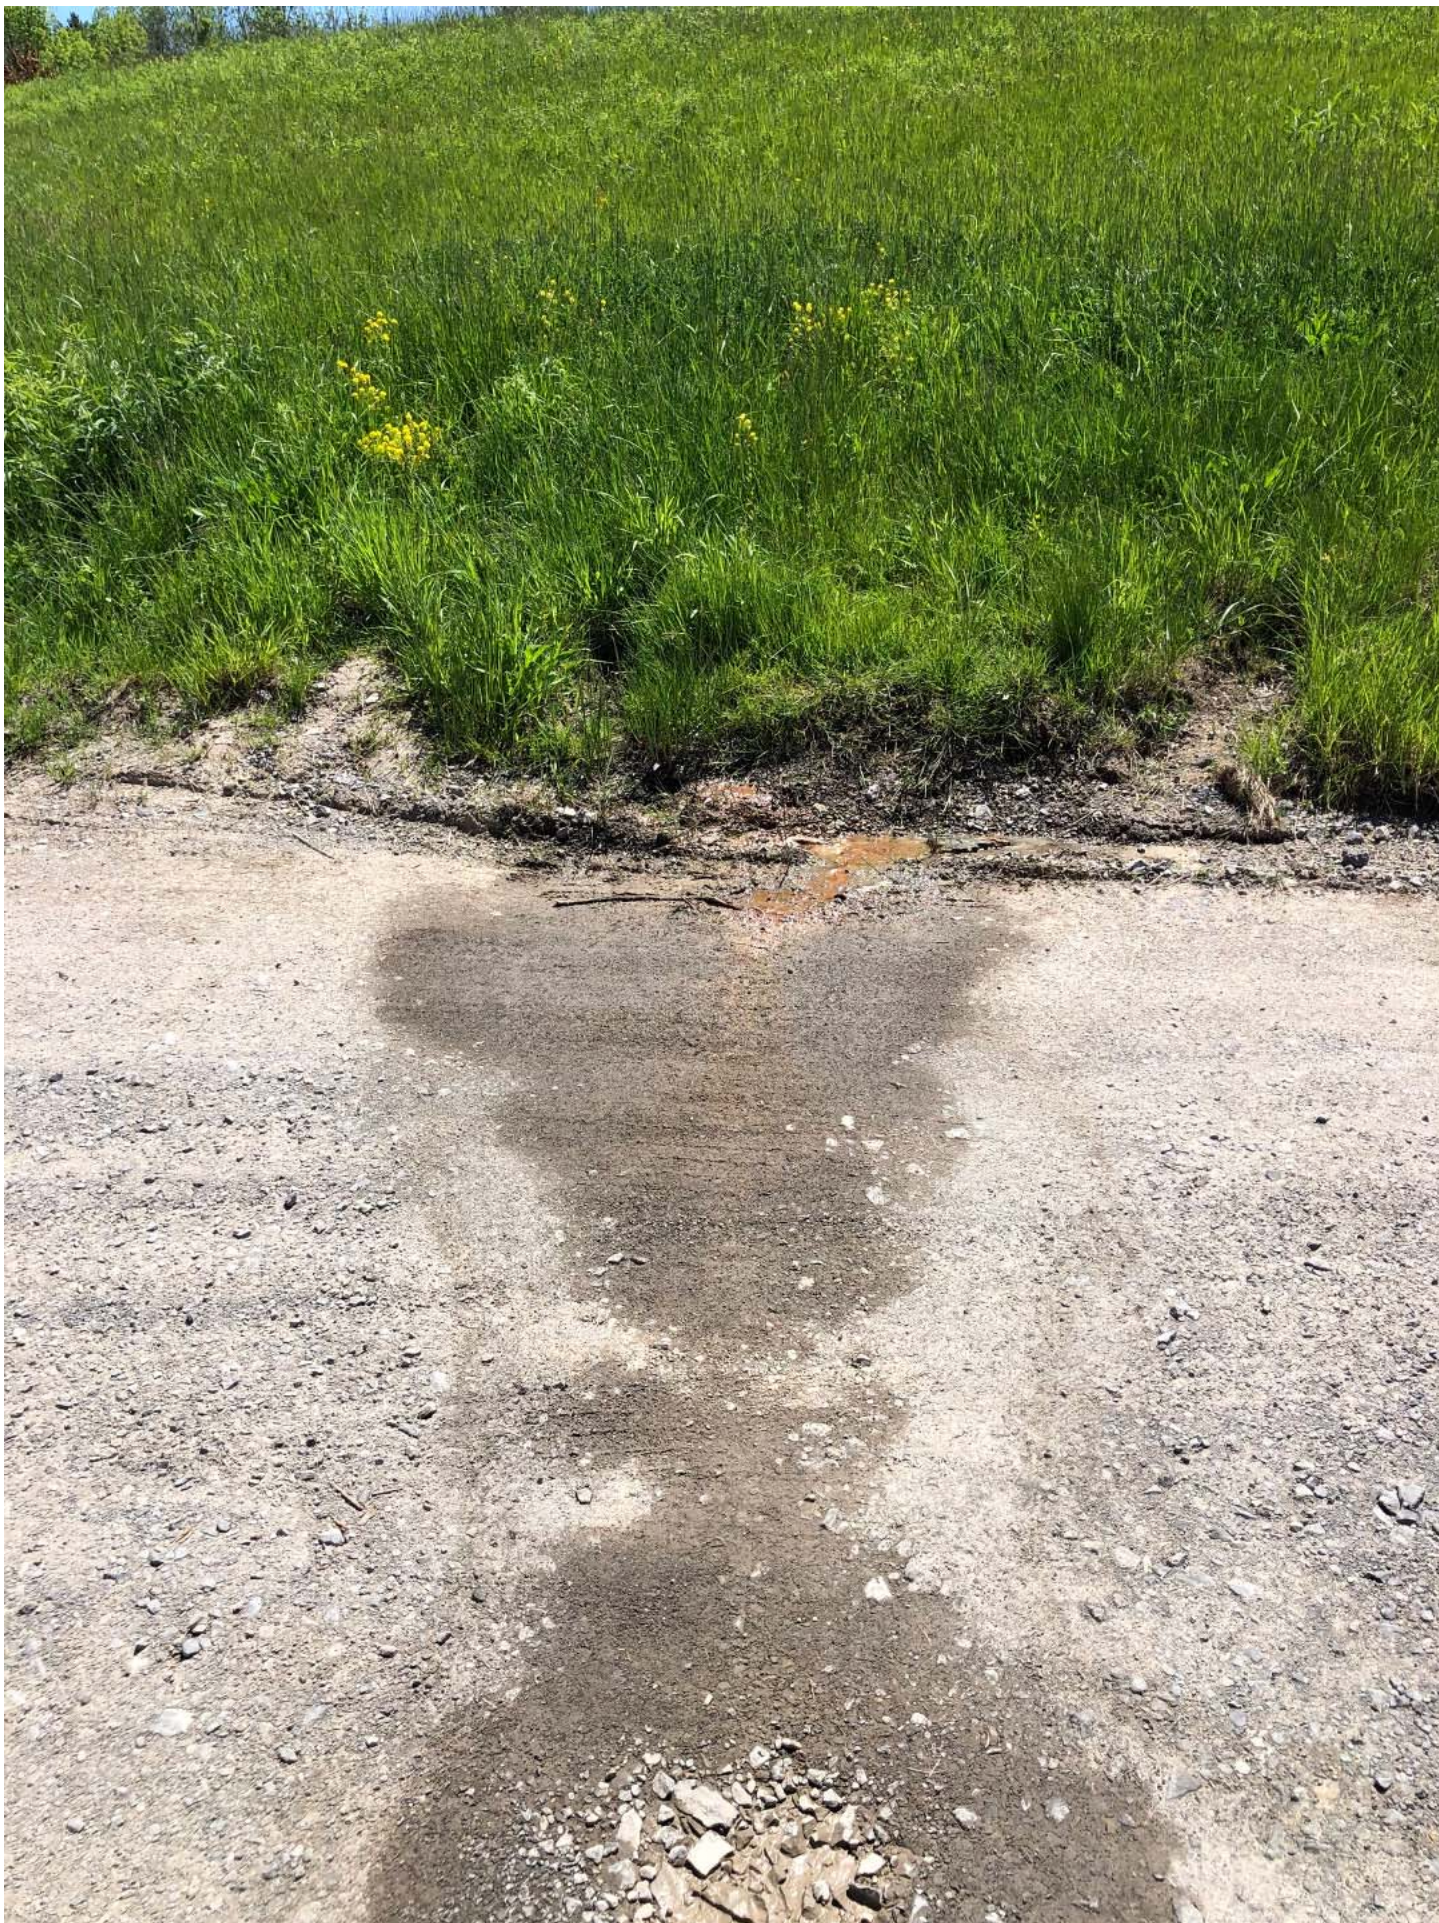
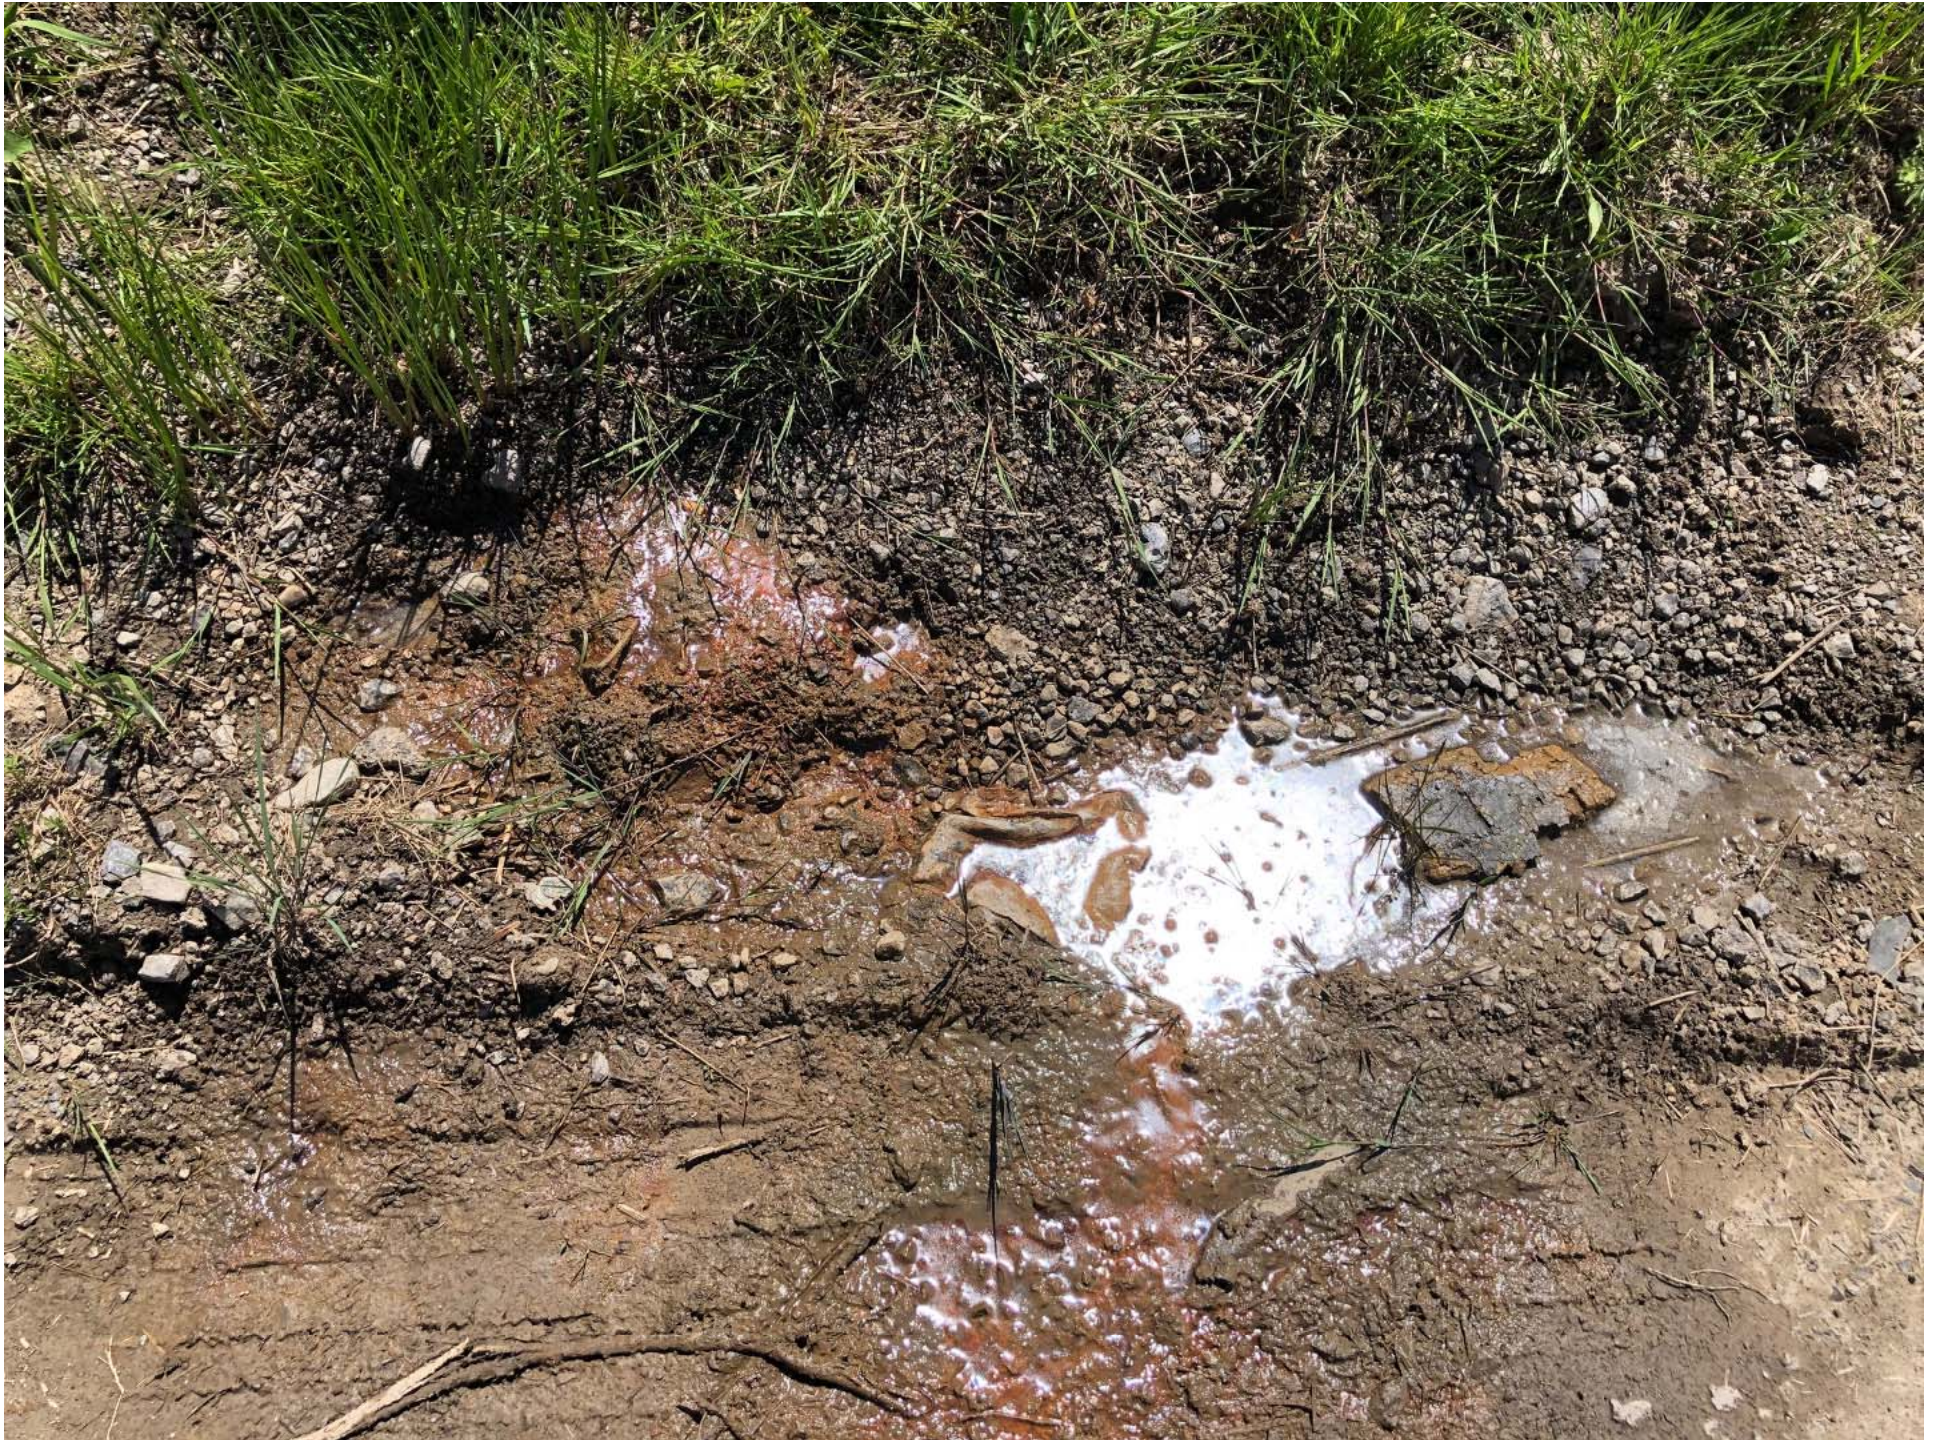
View of second area of water seepage observed exiting the toe of the northeastern slope of the landfill, facing southeast.

Close-up view of second area of water seepage, and the rust-colored precipitate evident in the standing water.

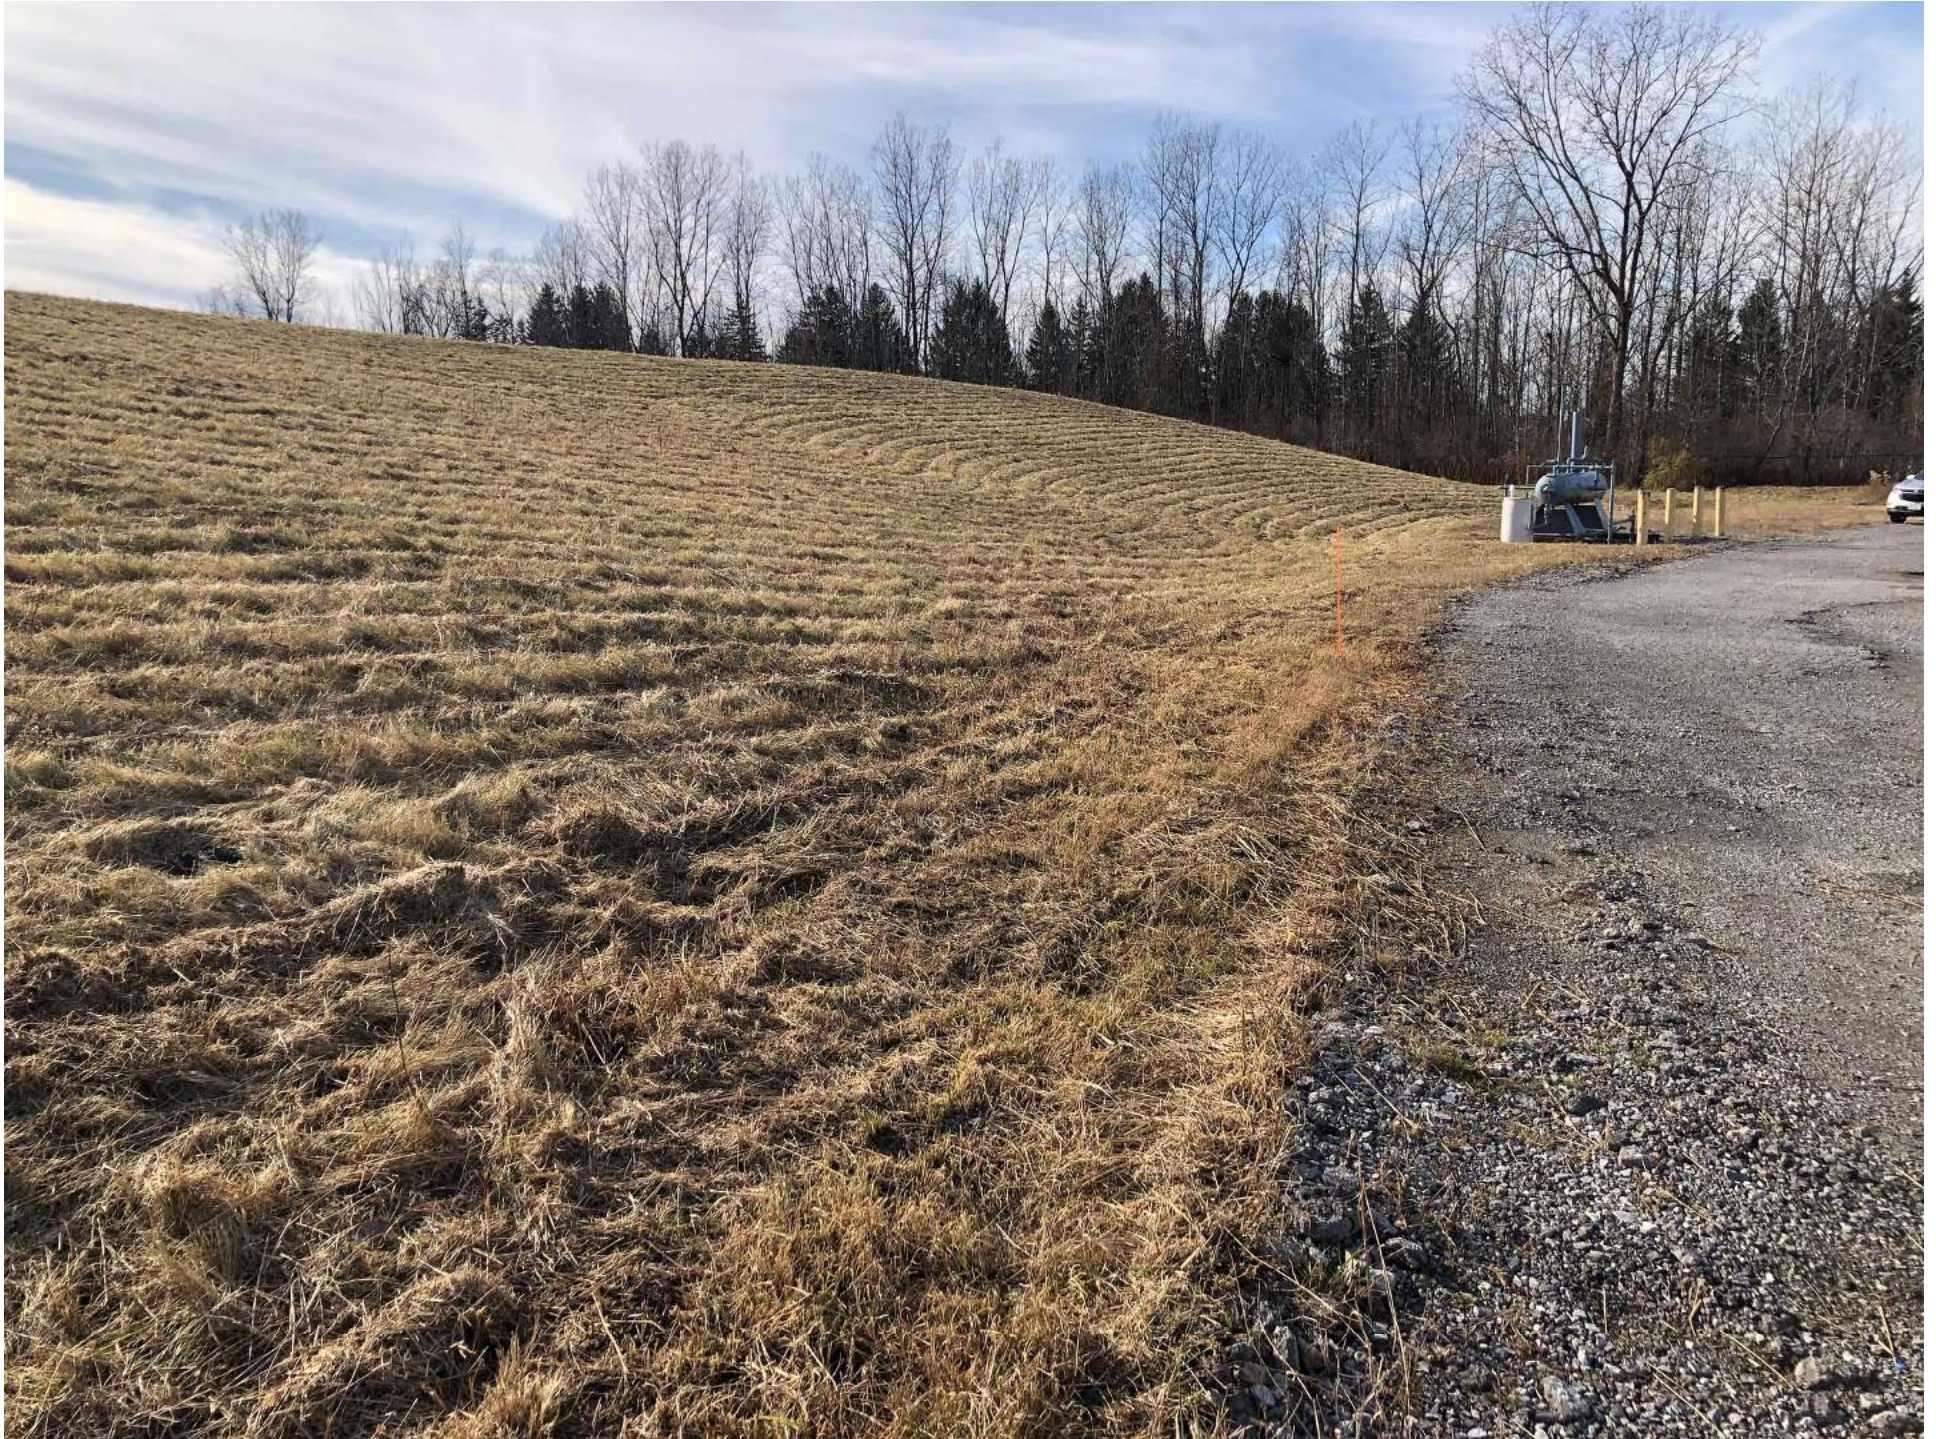
- November 20, 2023: minor rutting was observed on the northeastern slope of the landfill and possible historic erosion, or rutting from trucks entering the loading dock, was observed near toe of slope on northeastern side of the landfill.

Area of possible historic erosion observed near the toe of the northern slope of the landfill area, facing west.

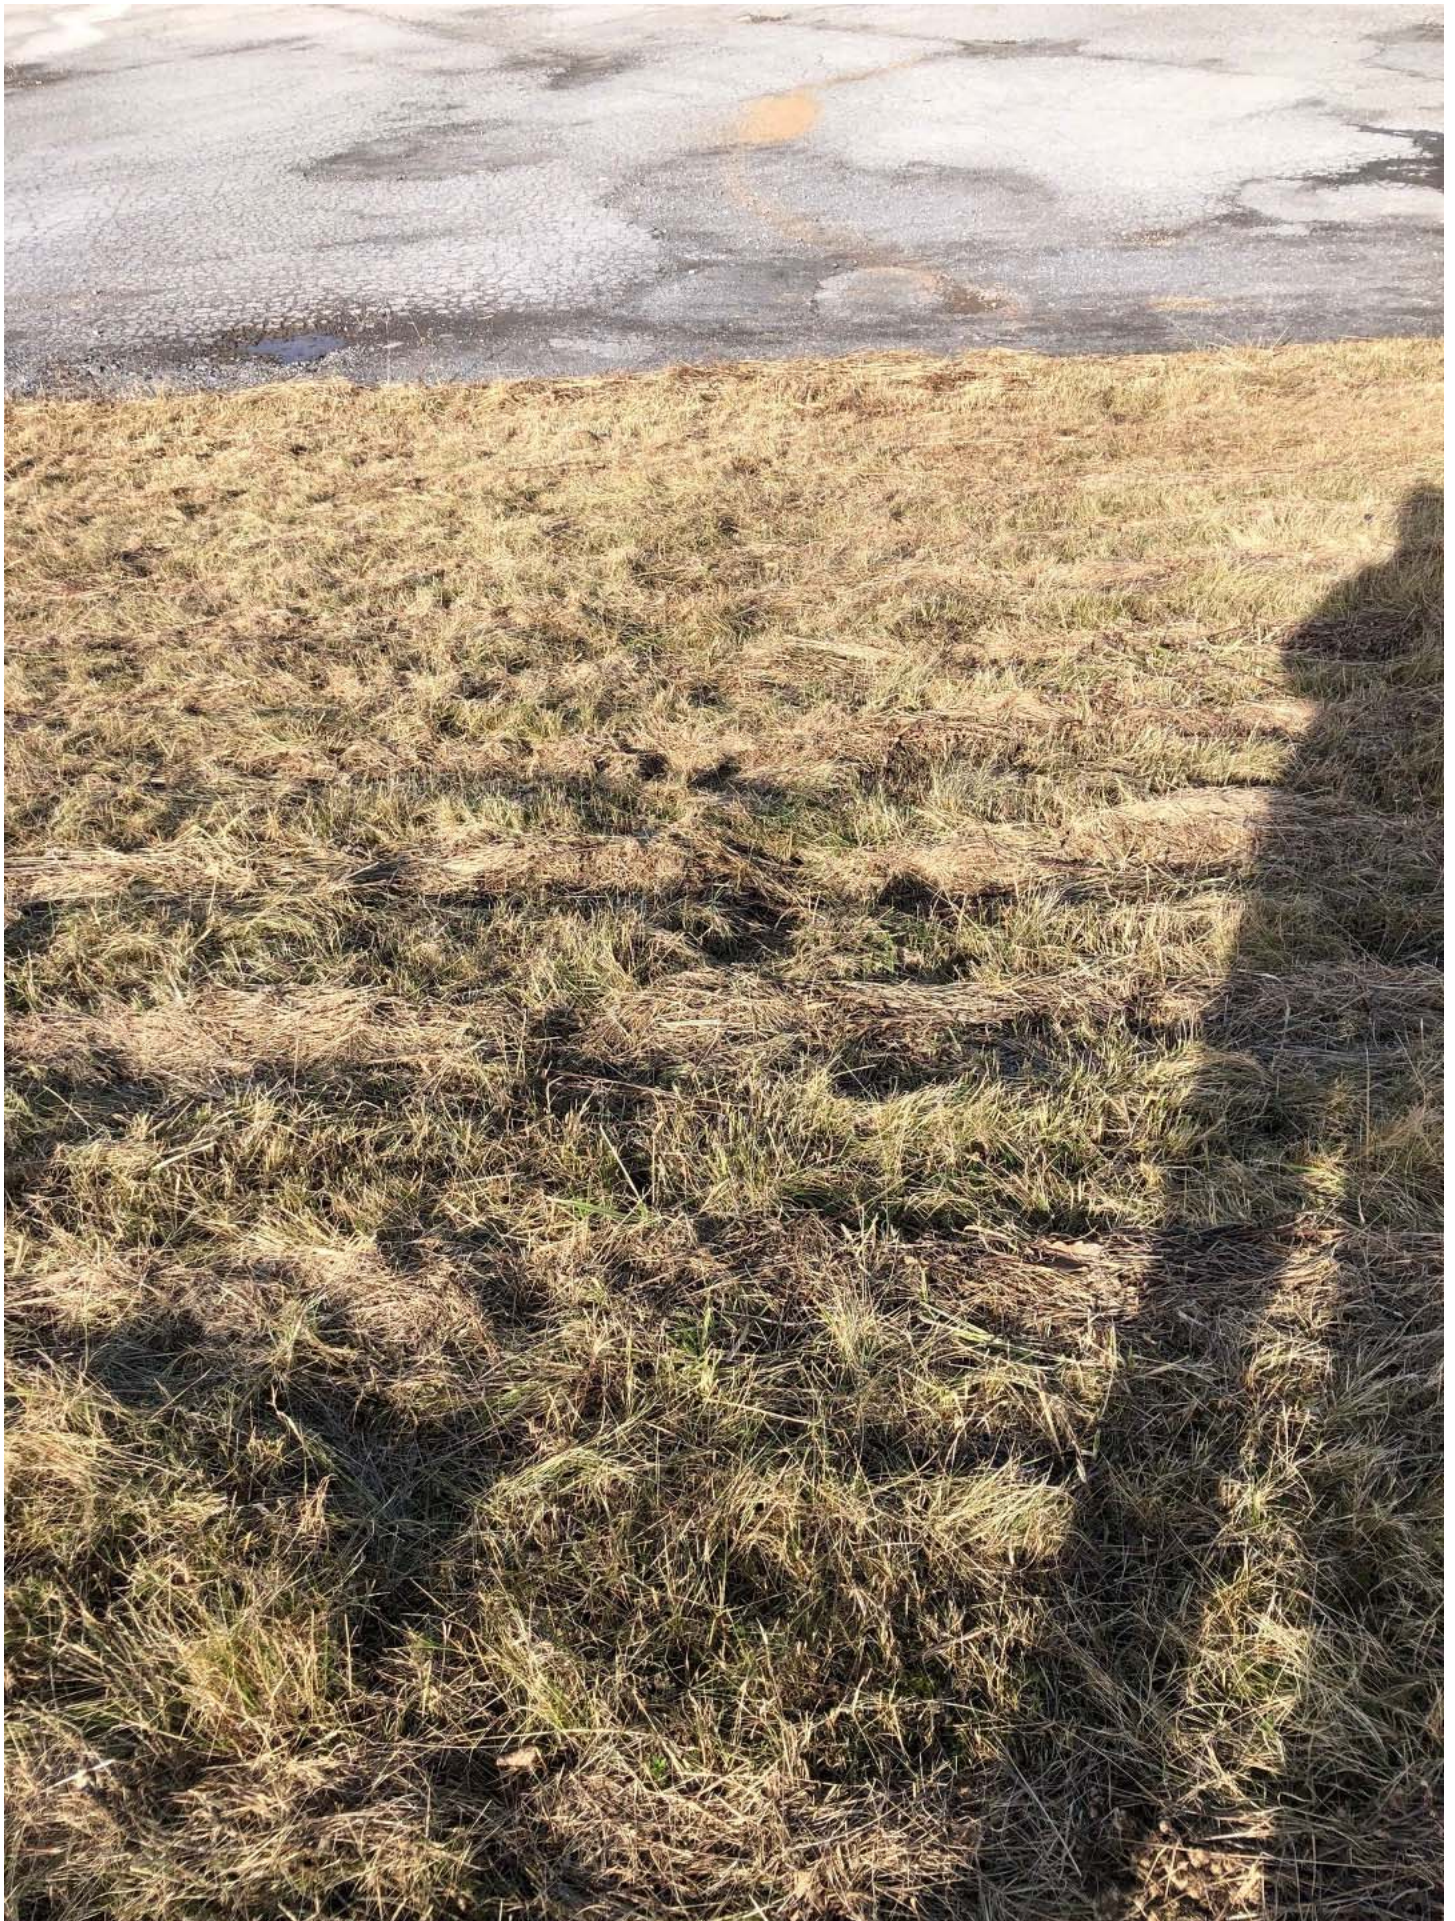
View of the area of minor rutting located on the northern slope of the landfill area, facing north.

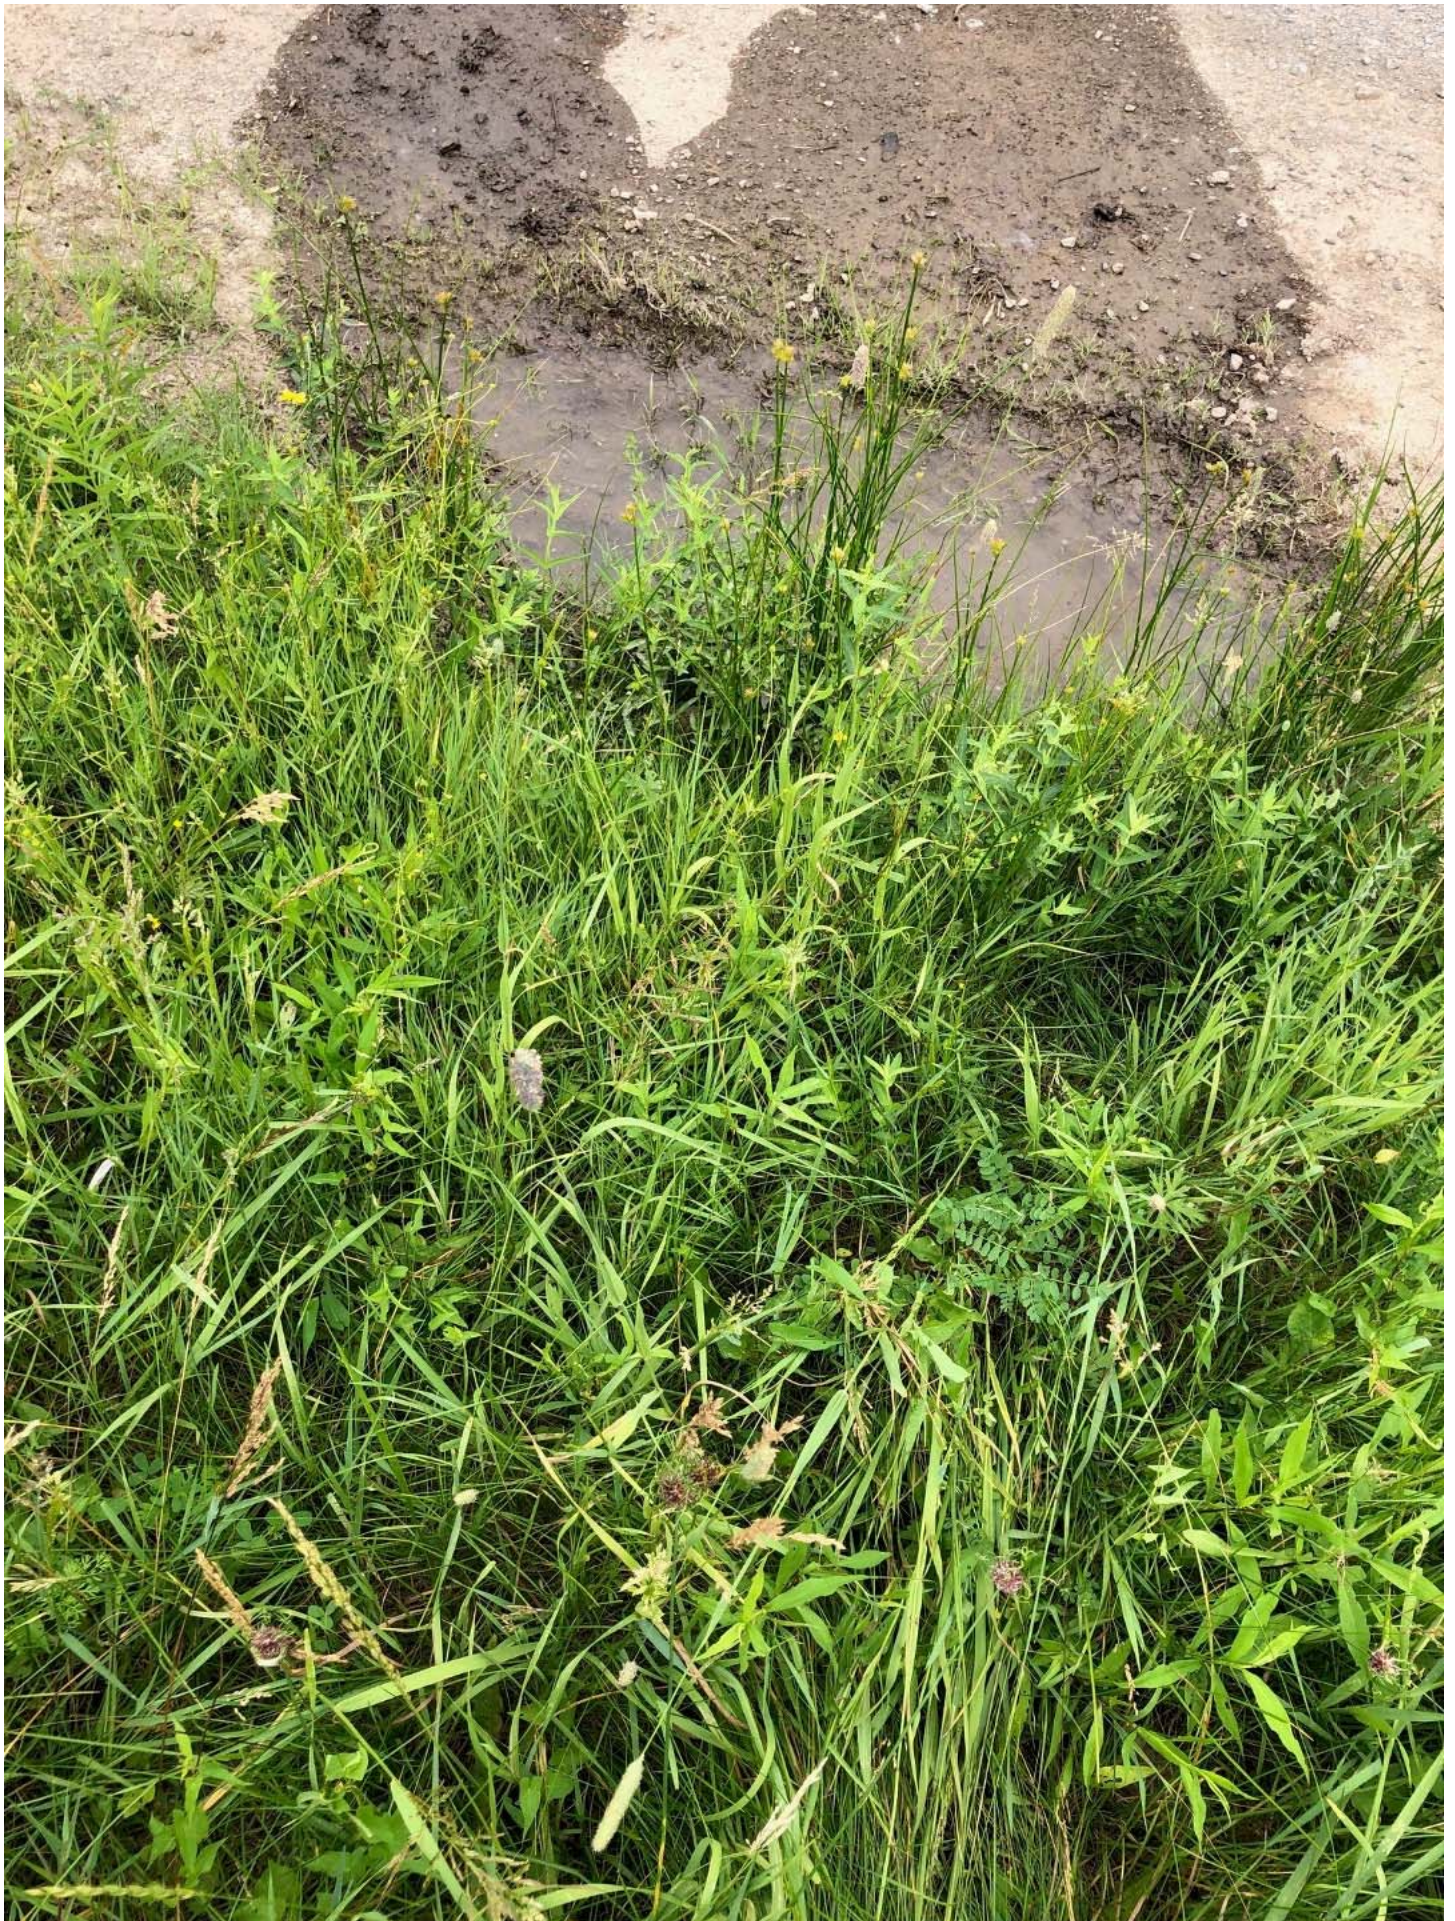
- June 26, 2024: Some rutting along the northeastern slope of the landfill was observed, but evidence of erosion was not observed.
- September 12, 2024: apparent deficiencies were not noted.

View of standing water, present at the base of the northeastern slope in an area where rutting from truck traffic is evident, facing north.
