## SITE INSPECTION REPORT

**Site Name:** Houdaille Industries, Strippit Division

**Site Number:** 915053

**Inspection Date:** 8/7/2026

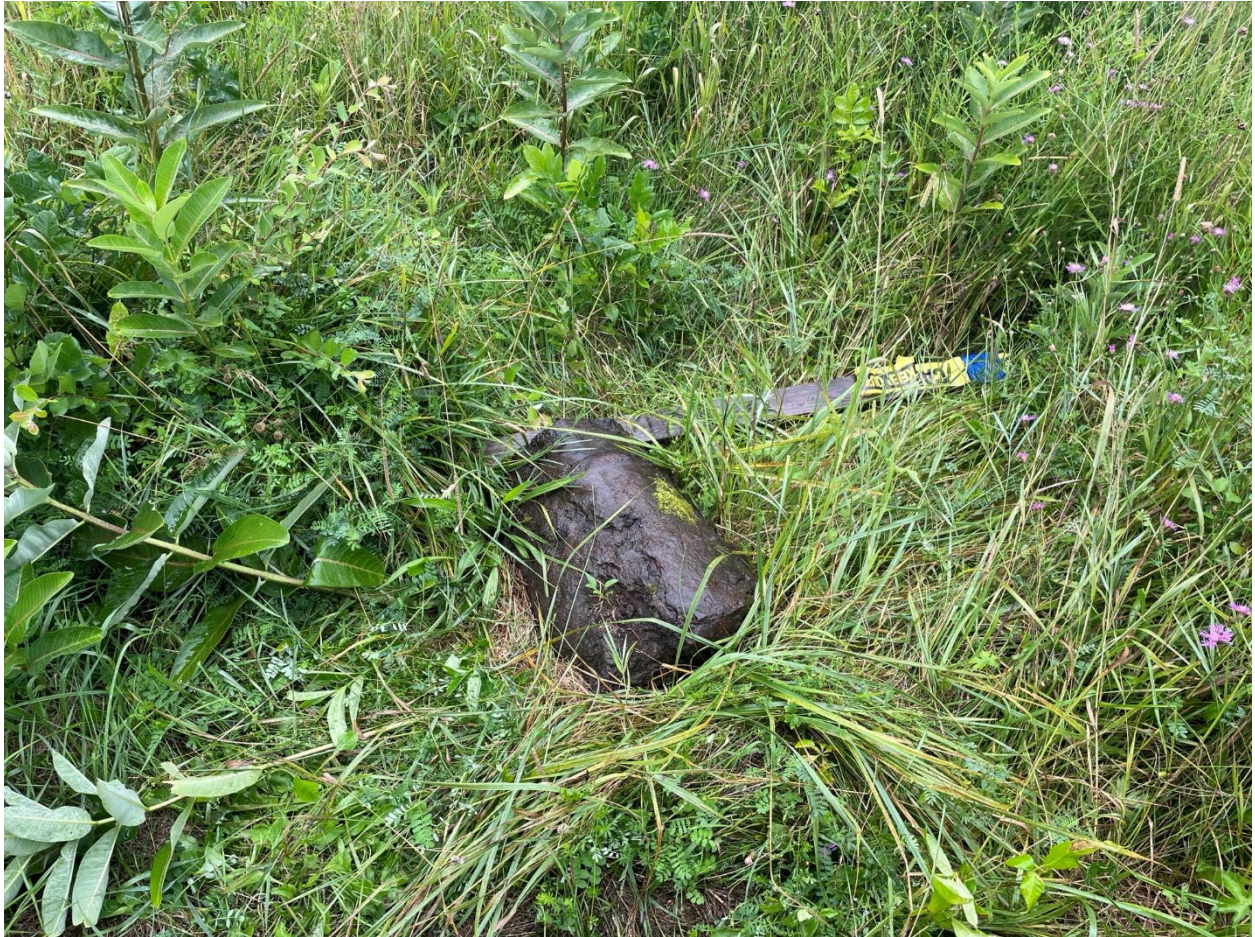
- NYSDEC observed removal of possible drum remains discovered just outside of capped area during the last landfill inspection completed by Day. Material was hardened, rock-like with rust color on the outside, possibly indicating the shell of a drum that was missed during consolidating/capping operations over 30 years ago.

Material to be removed.

- Material was sampled for waste characterization and placed in a 55-gal drum along with the 4-6 inches of soil beneath it. NYSDEC noted no odors, discoloration, or residual material left behind. No stressed vegetation was observed in the area. As the material was located outside of the landfill footprint no cover material was used to backfill the approximately 1ft x 2.5 ft x 6-inch depression. Drum was placed on Strippit property to be removed later pending waste characterization results.

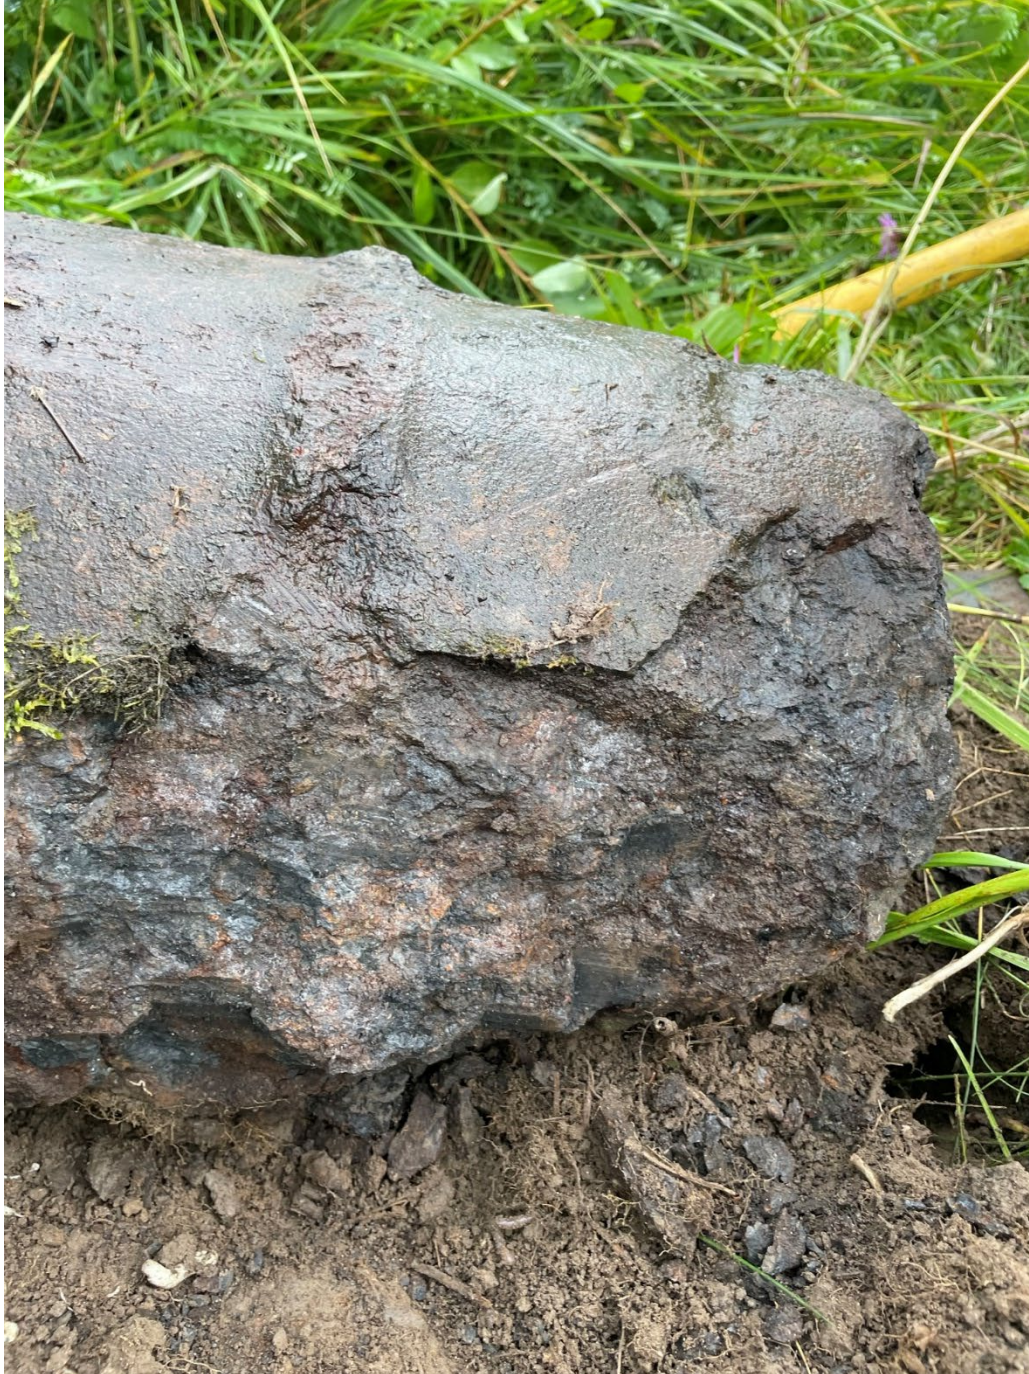
Same as above, closeup view.

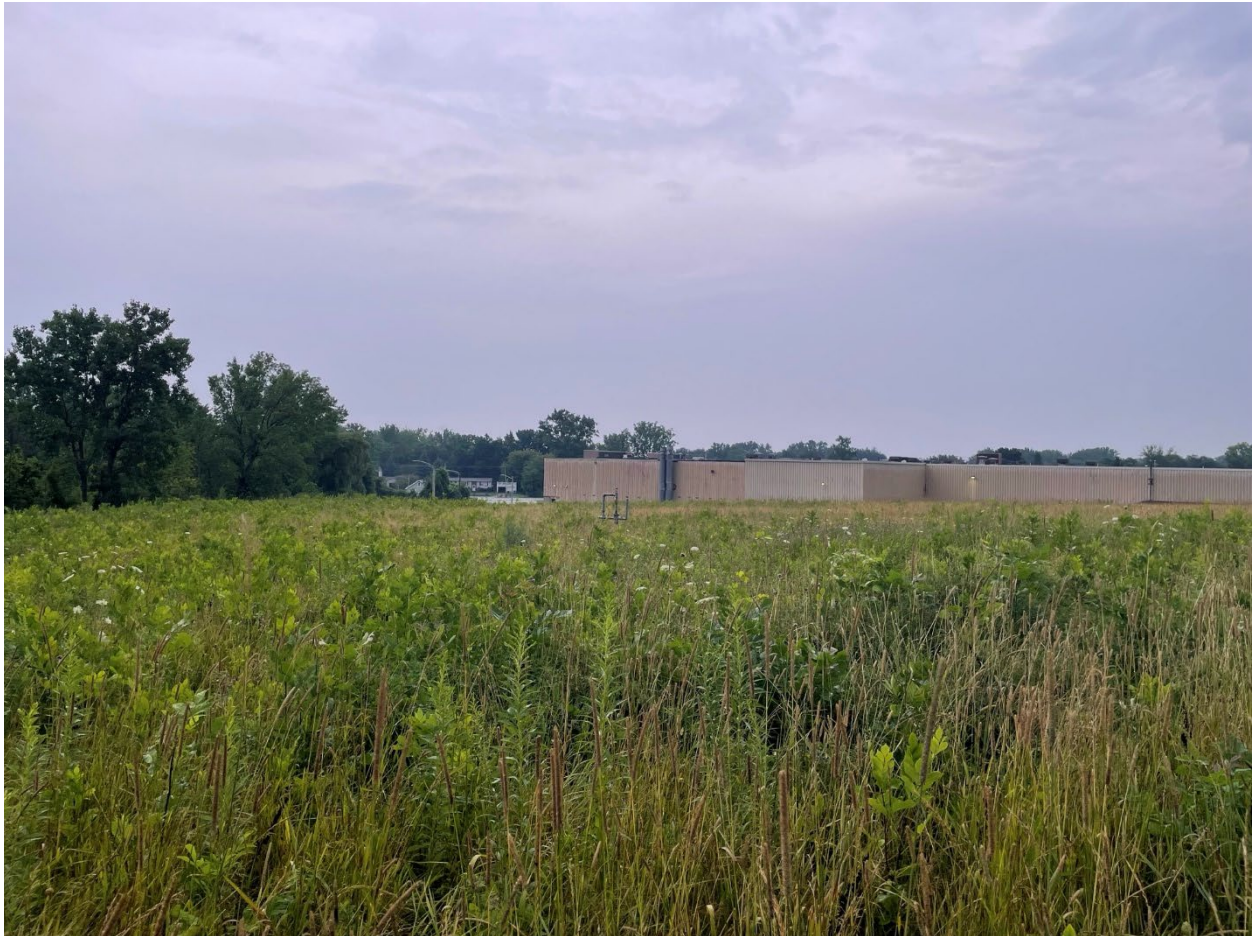
- No other environmental conditions of note were observed while walking the landfill area.

Landfill conditions.
