RECONNAISSANCE REPORT

May 22, 2001 rev. July 2, 2001

Site Name: Roblin/Envirotek 2

Project Description: Reconnaissance of Sewer Lines
and Utility Pits.

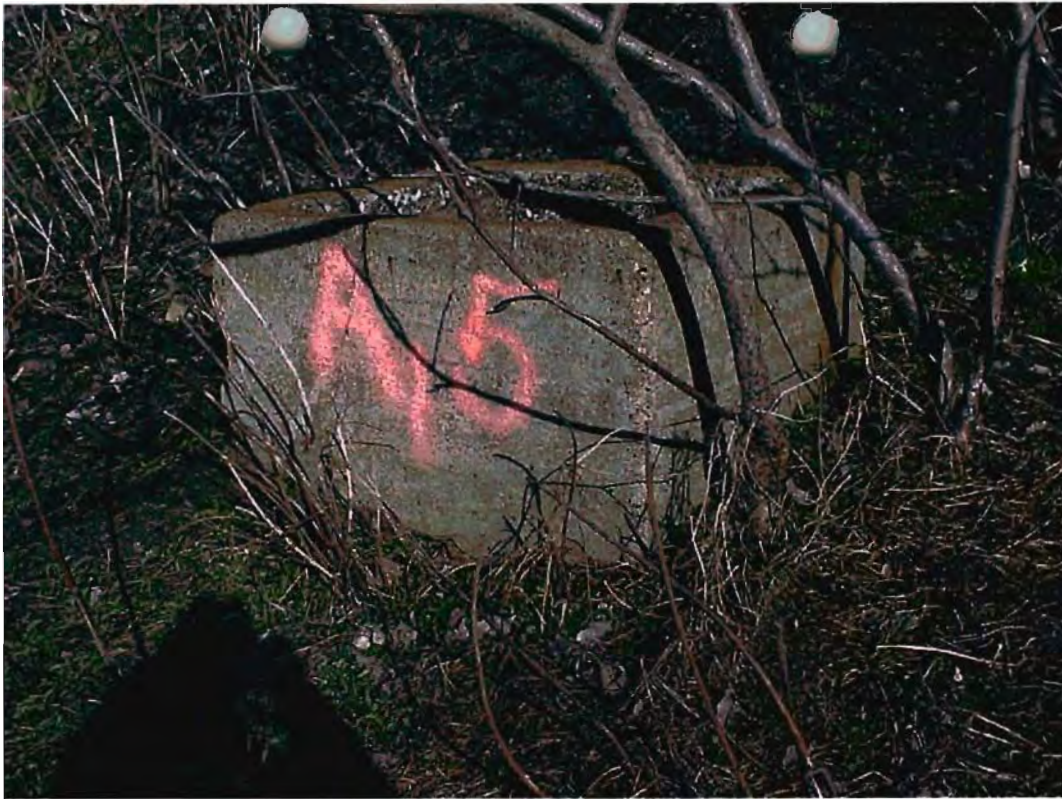
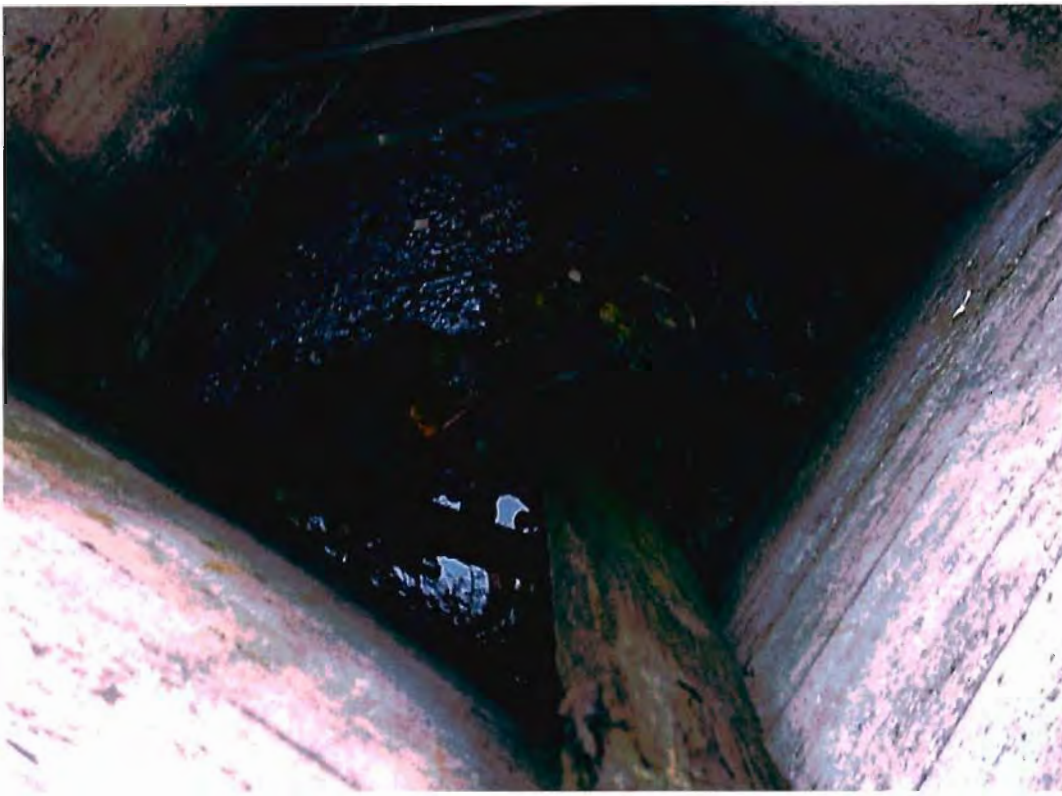
Page 1. Pit A1-5; See Attachment 1, Sewer Layout: Most downstream manhole in Line A1 upstream of the sump outfall to the Niagara River. This line is inactive. Various debris of wood and rubble is present. Groundwater flow was observed and is estimated to be less than one-half gallon per minute.

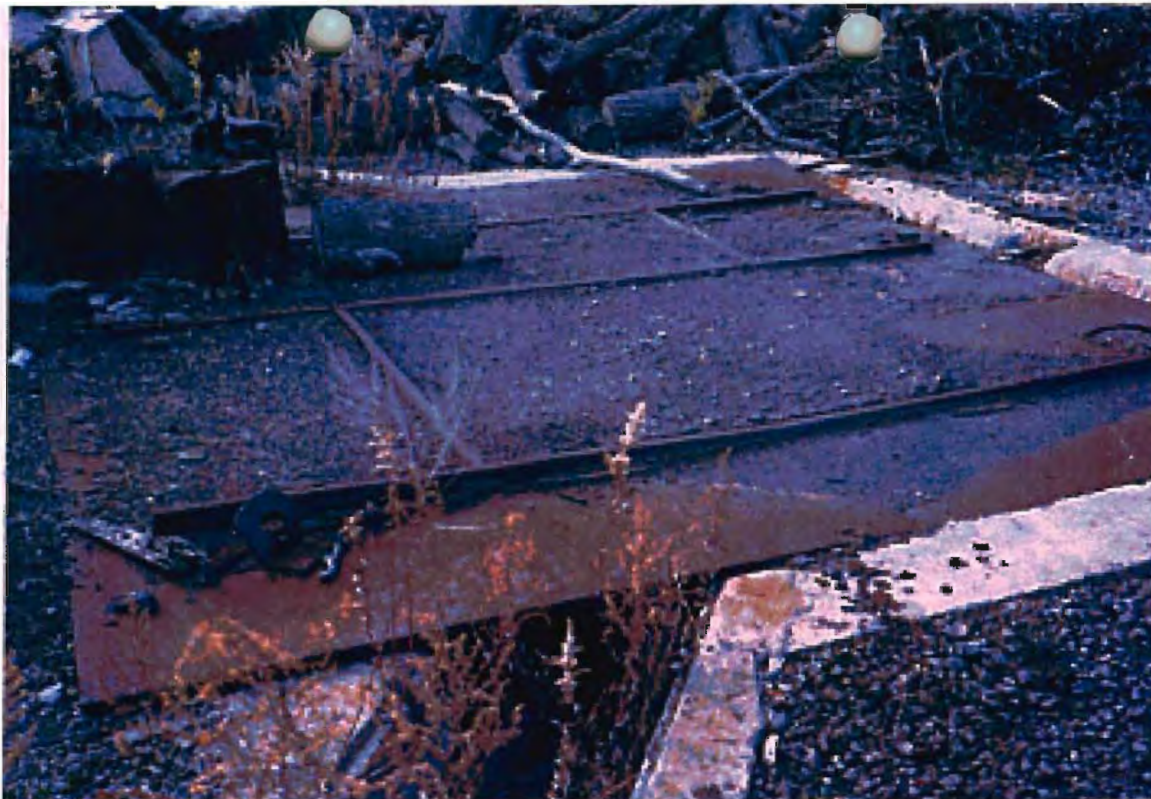
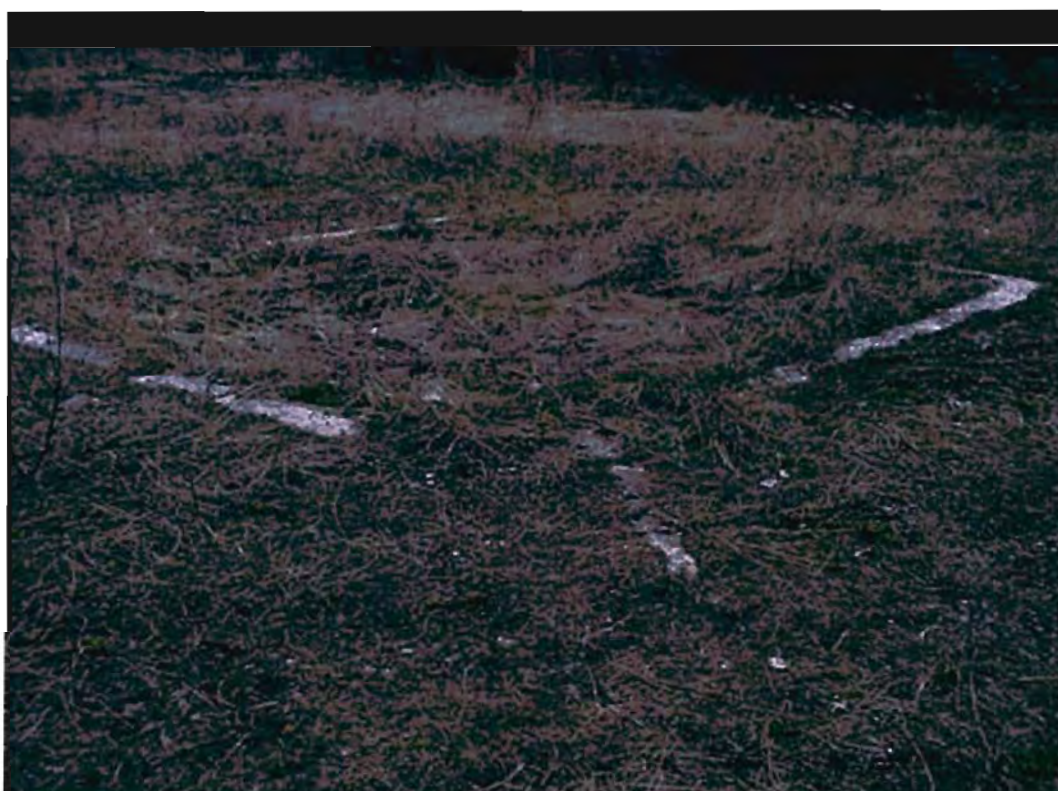
Page 2. Photo 60. Exact location of former sump. Remnant of entrance trench and foundation remain.

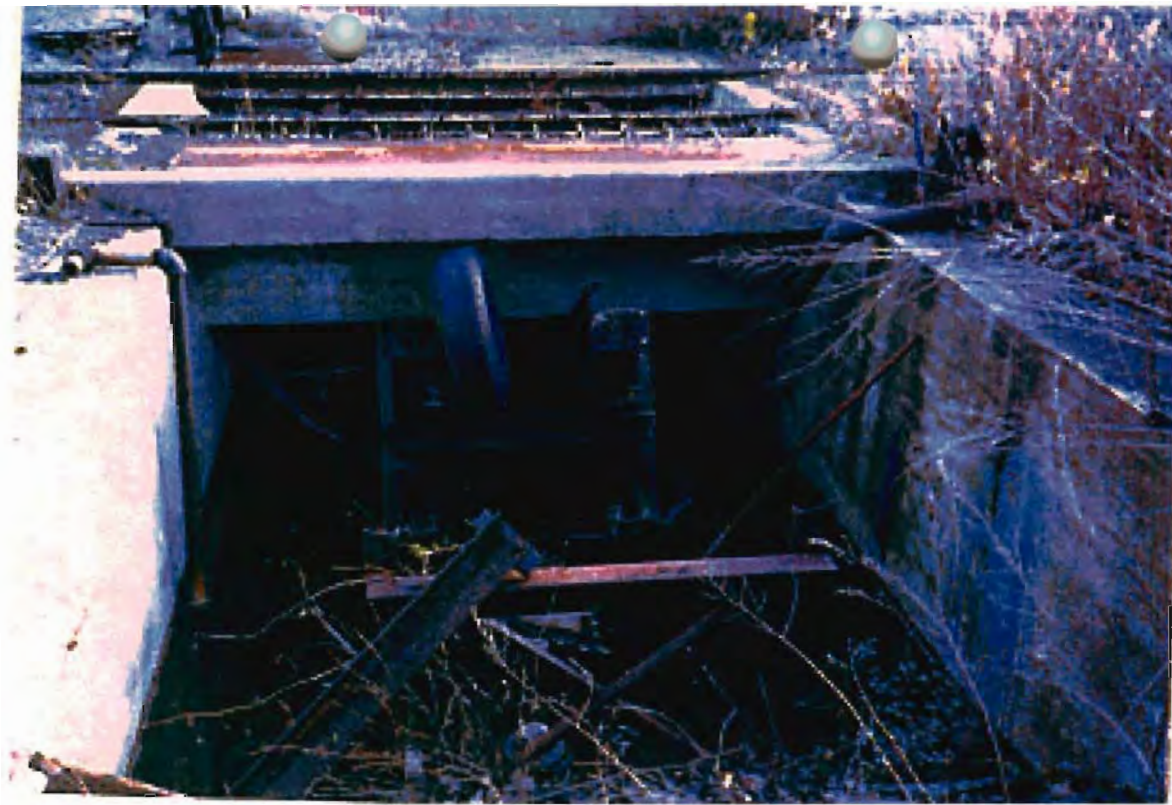
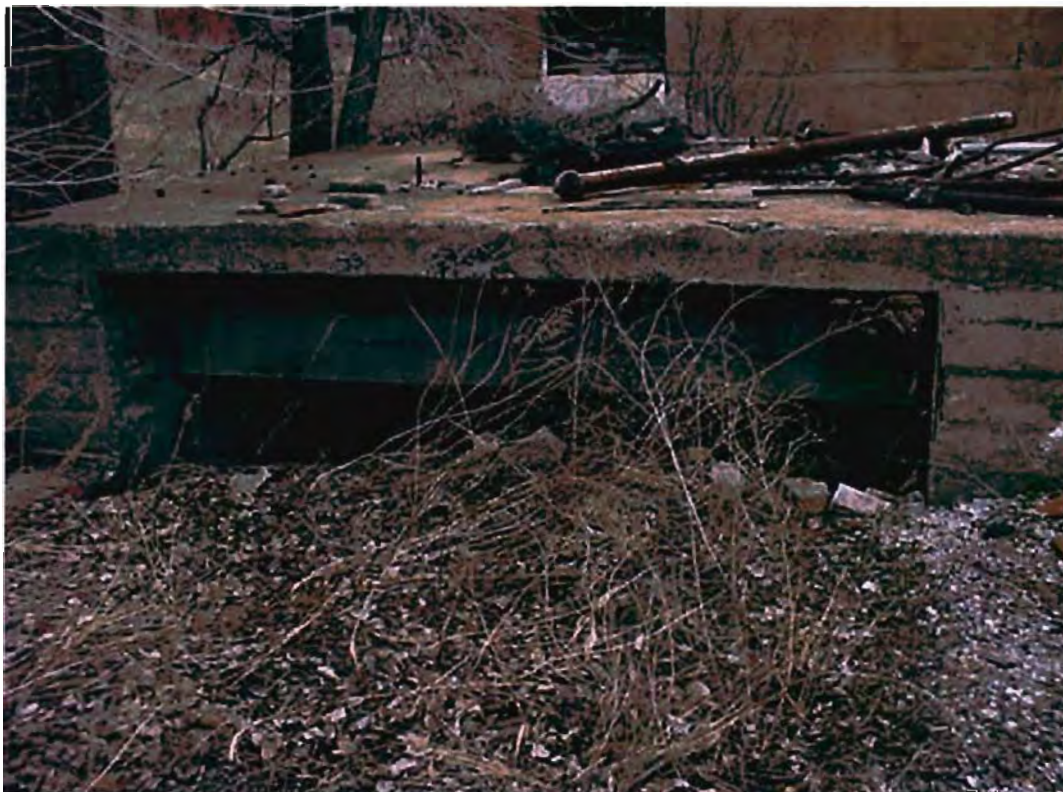
Page 4. Photo 64. Exact location. Channeling side walls not present. Entrance mostly filled by earth and rubble.

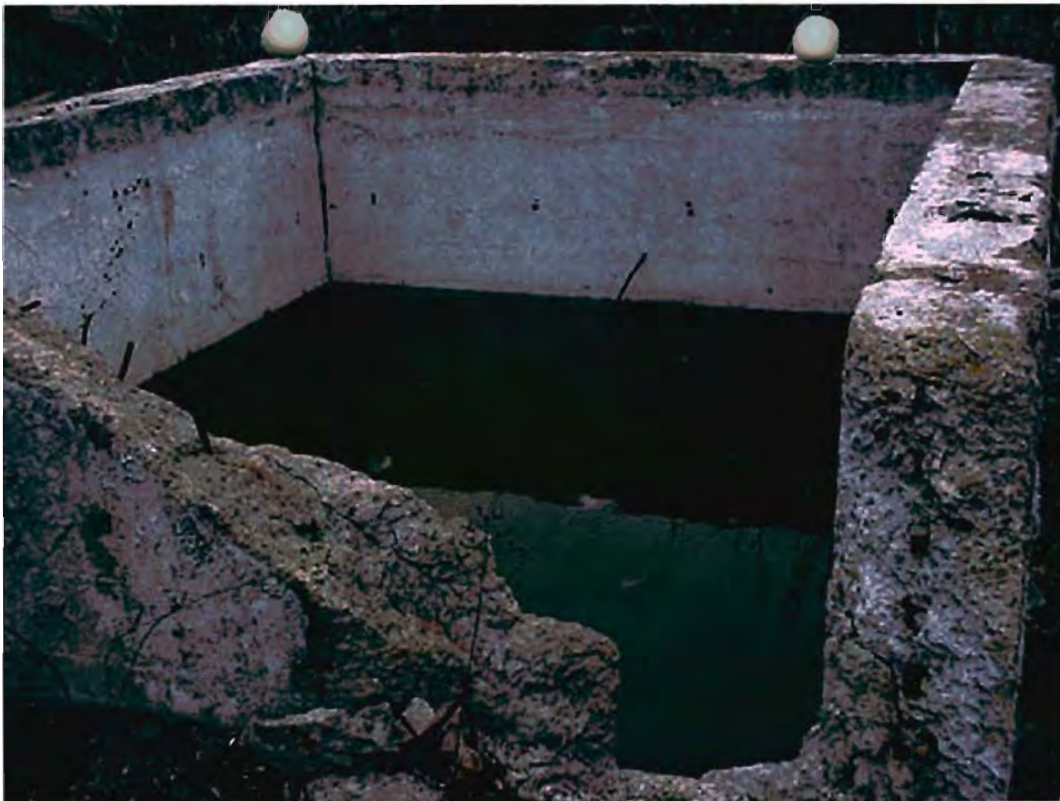
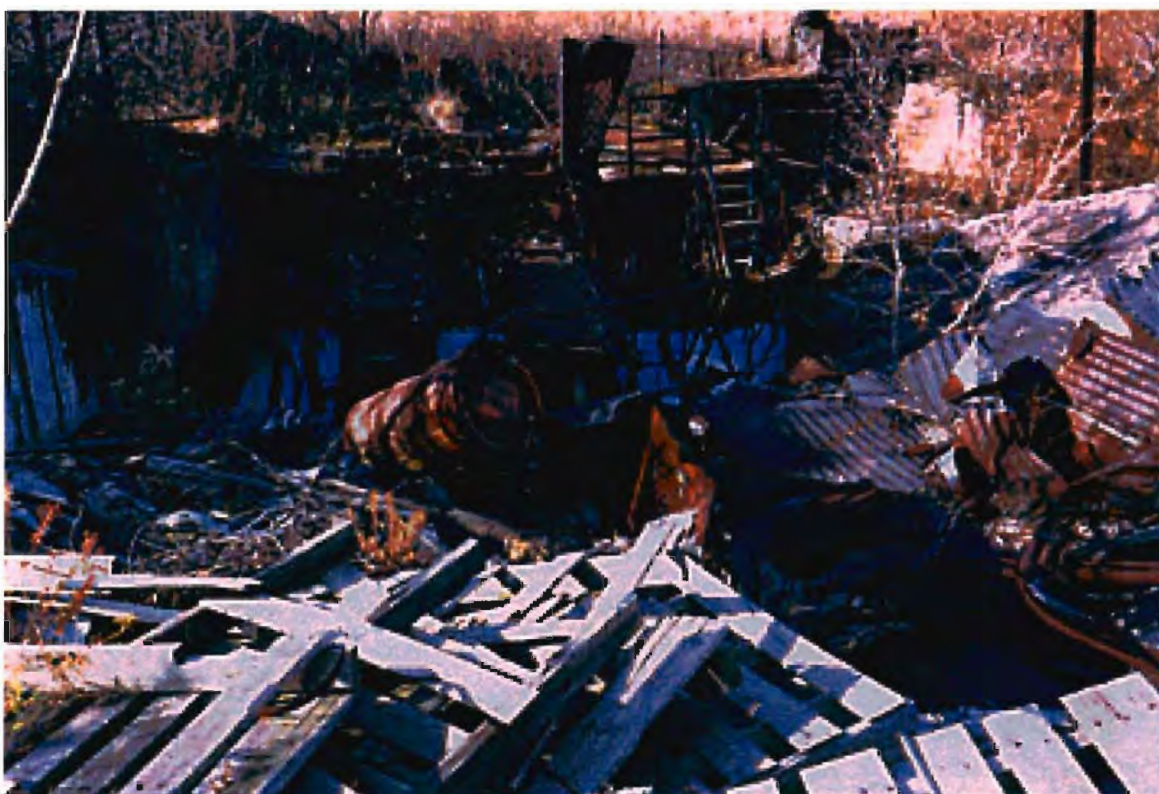
Page 5. Photo 68 and 68A. Area significantly changed. 68A taken as this pit was in the area and had the potential to contain hazardous waste. Further investigation revealed no odor or sheen from or on the water.

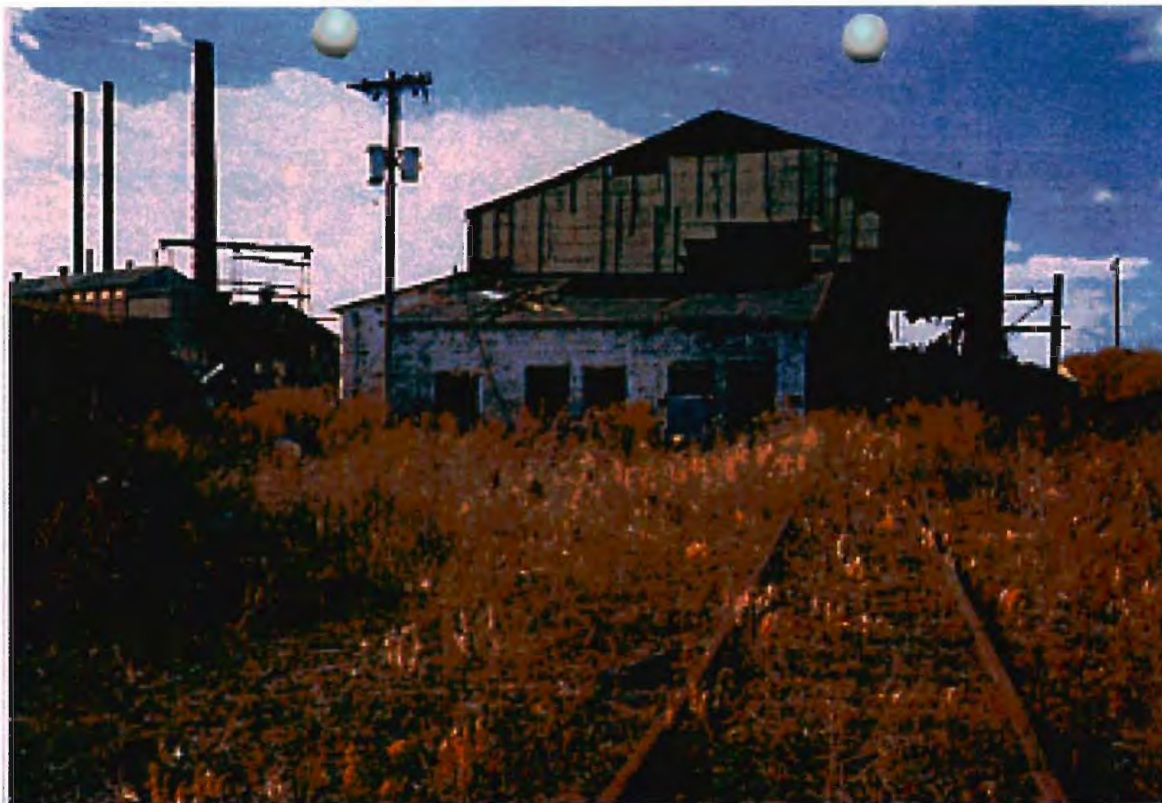
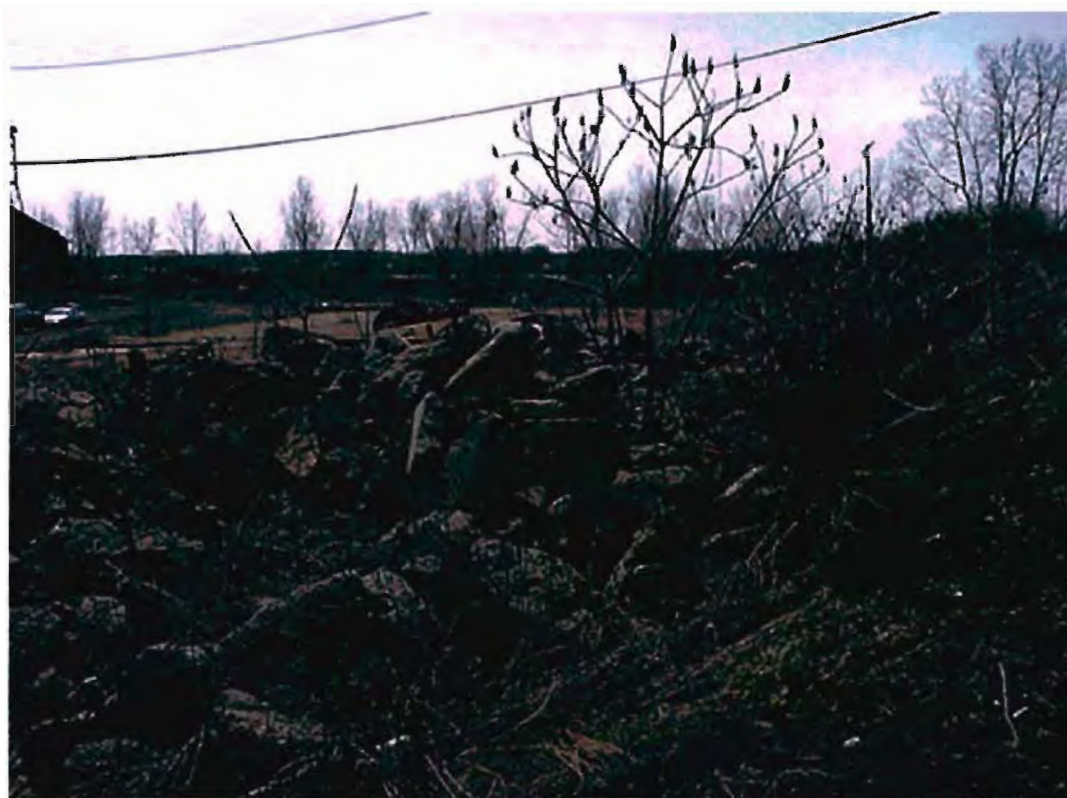
Page 6. Photo 75. Generally the same location. Rubble and earth remaining of Ascension Chemical/ General Refractories Warehouse.

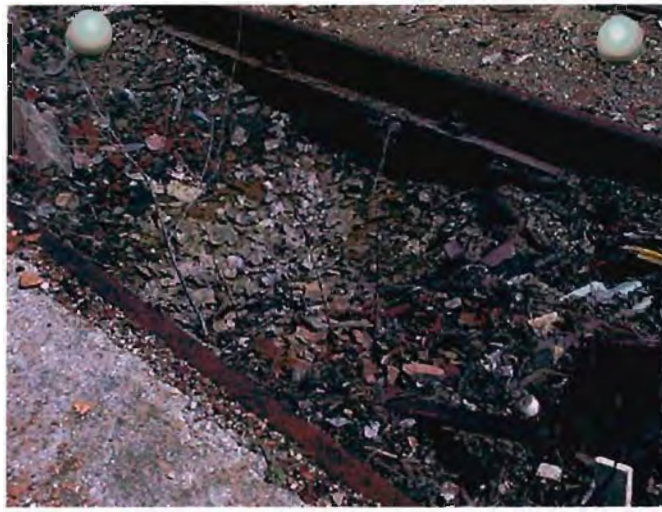
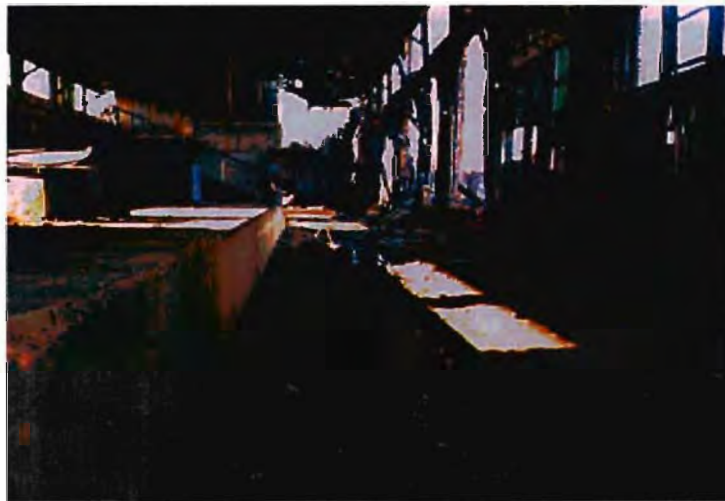
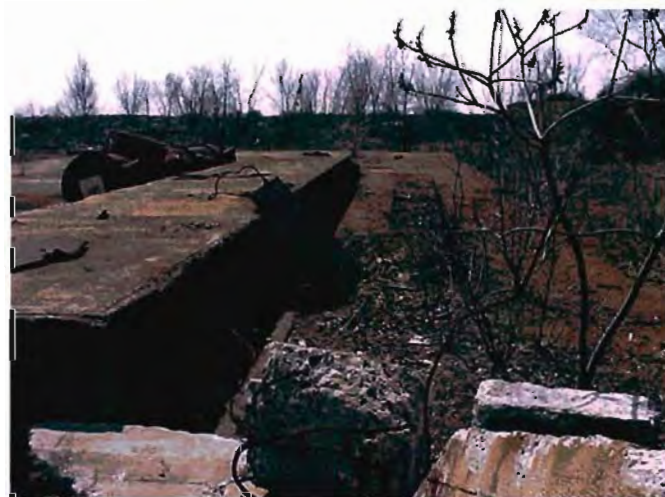
Page 7. Photo 79. Exact location. Concrete slab, loading dock, and railroad tracks remain of the Ascension Chemical/General Refractories Warehouse.

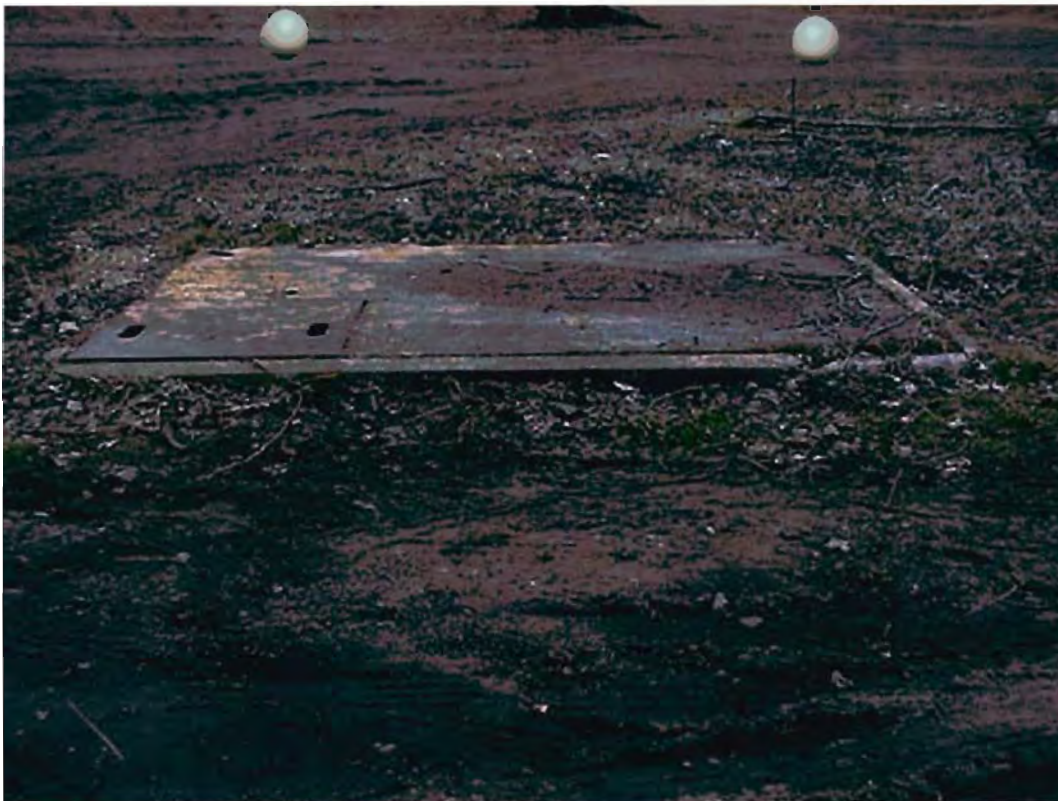
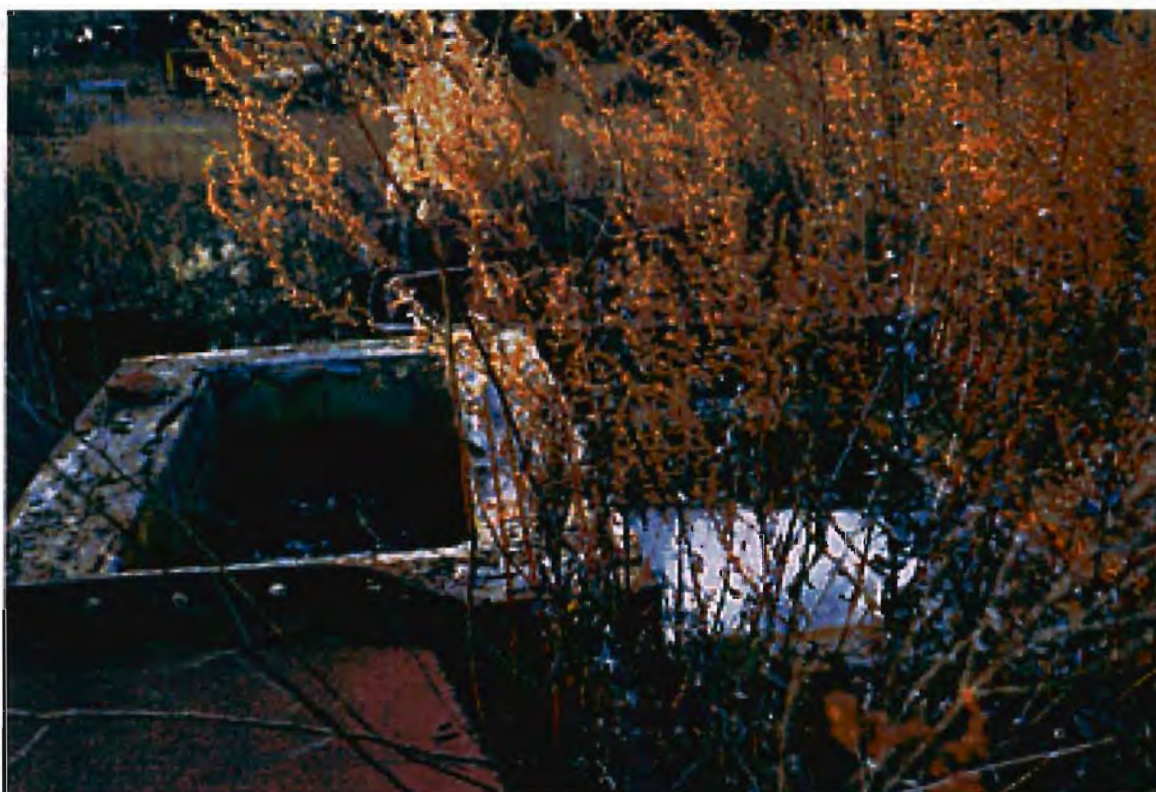
Page 8. Photo 89 and 89A. Location given in the Phase II Report appears to be questionable. Further investigation revealed that pit shown in Photo 89A is a former valve chamber. The inside detail of this valve pit is shown on Page 12, and is described below in Page 12 Entry.

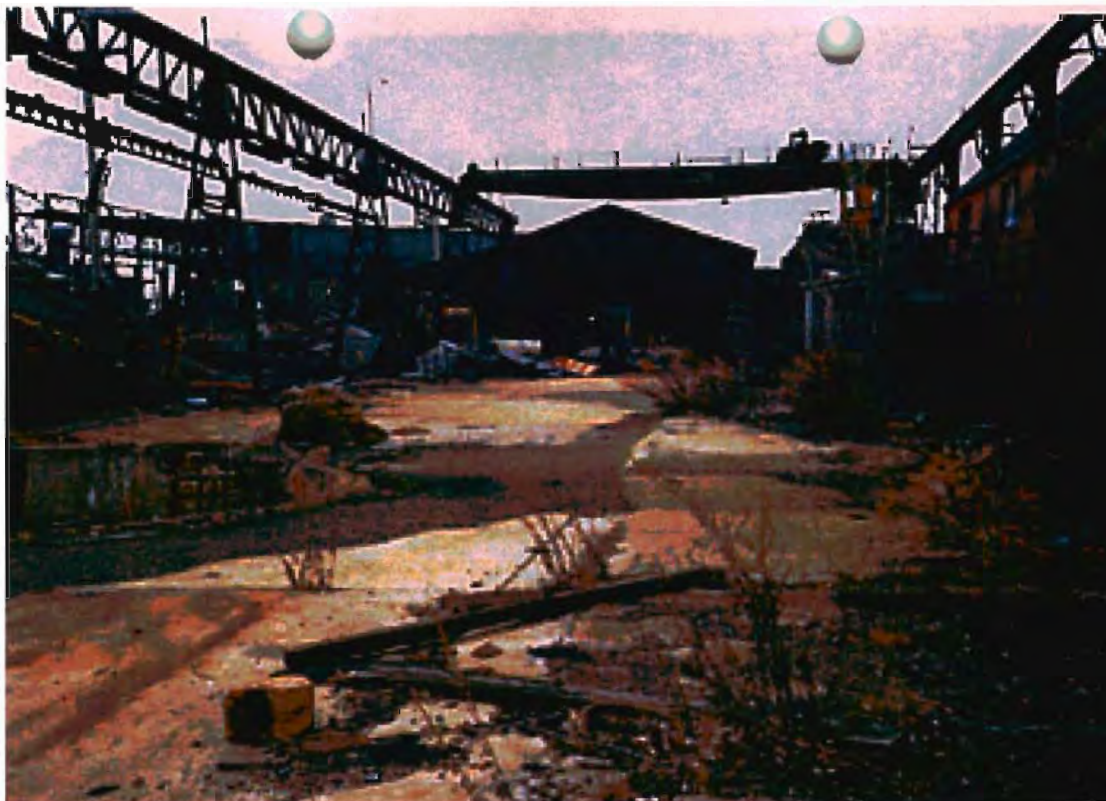
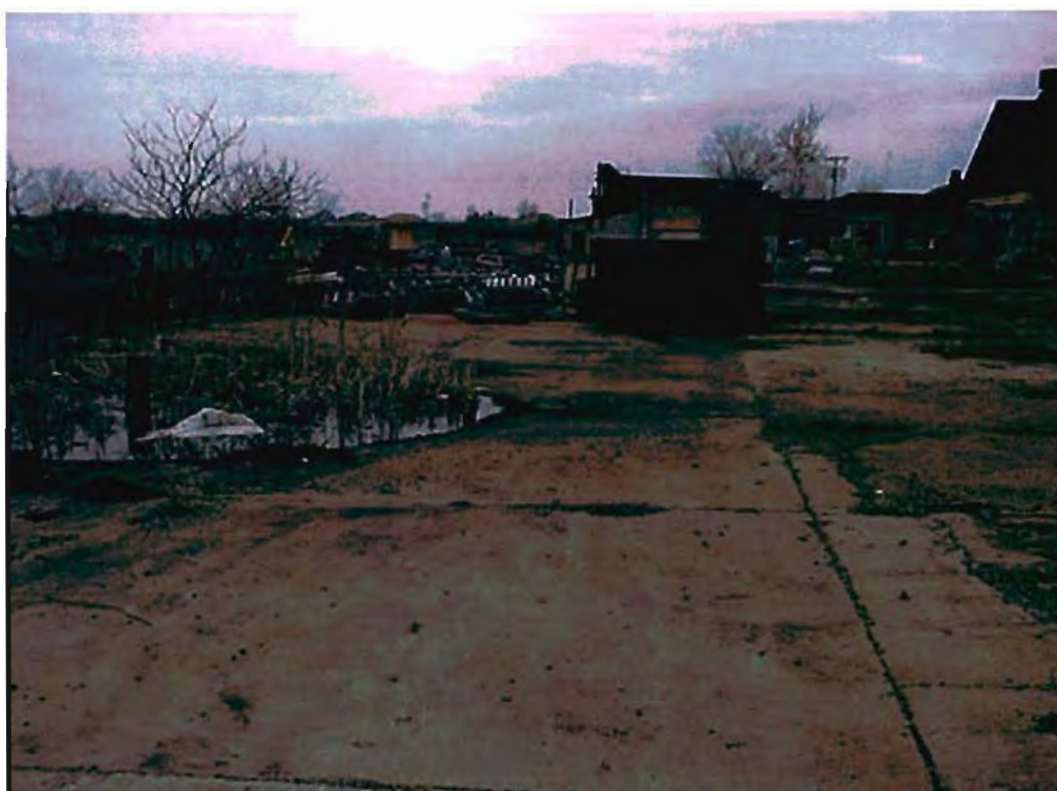
Page 9. Photo 108. Exact location; most of the buildings and overhead rod yard conveyor system have been razed.

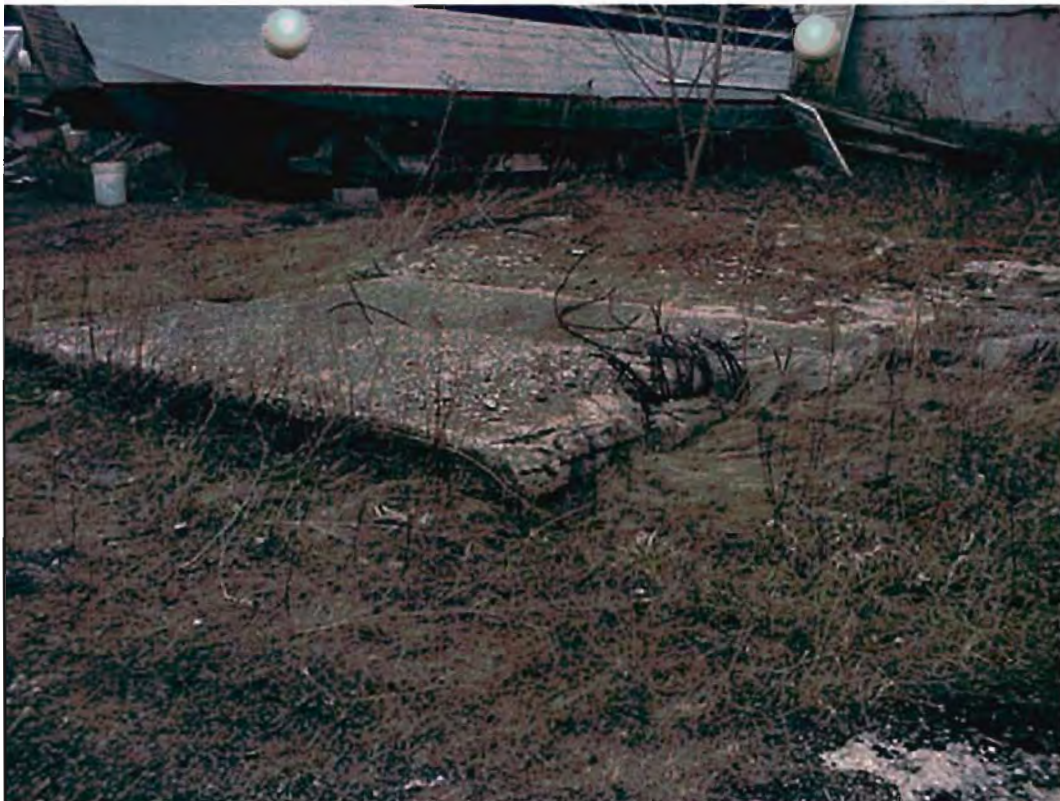
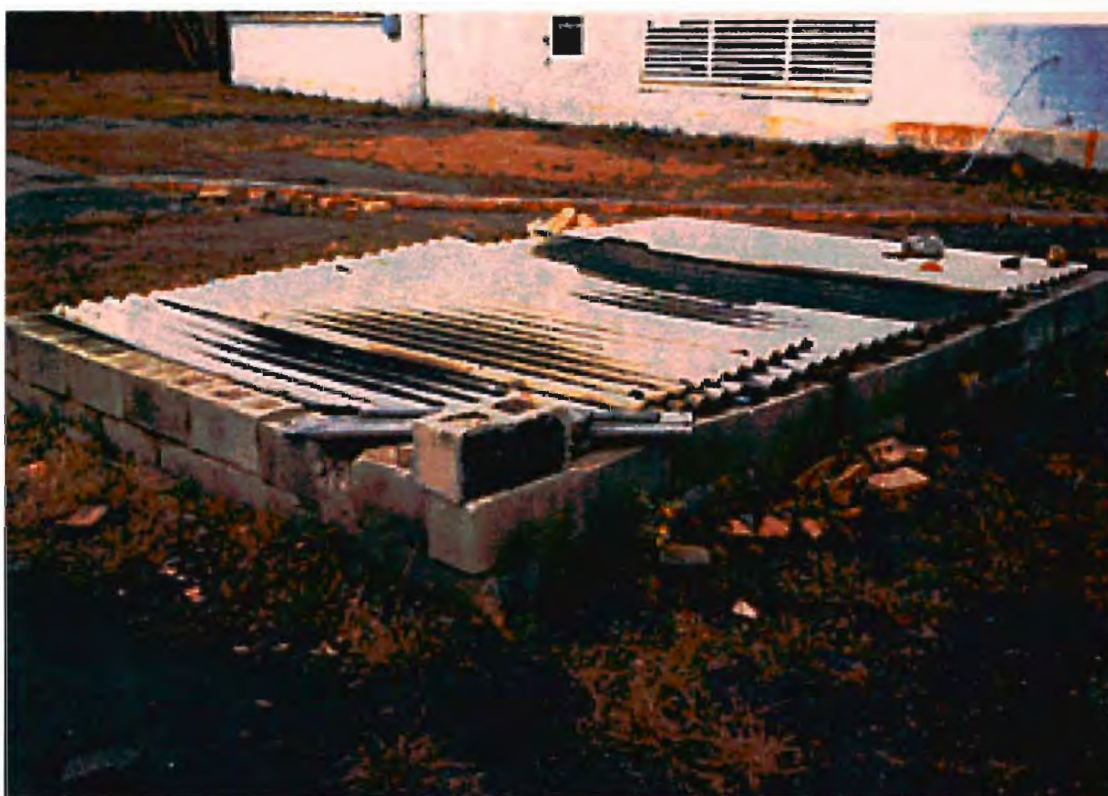
Page 10. Photo 122 and 122A. Probable location. Appears that the upper two courses of cinder blocks were removed and the opening was covered with a solid concrete lid.

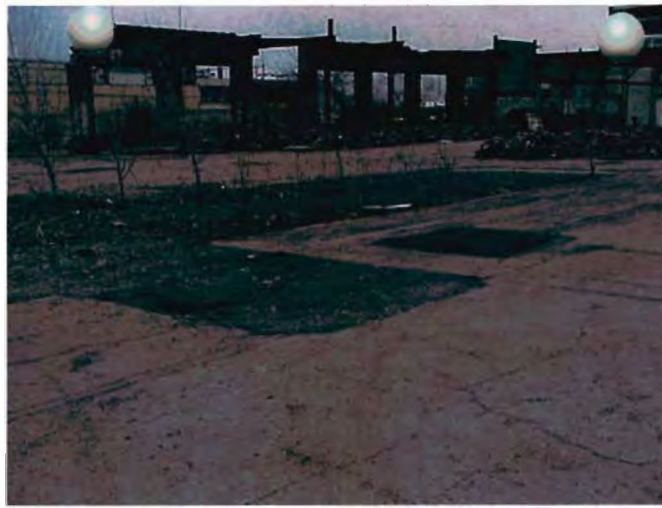
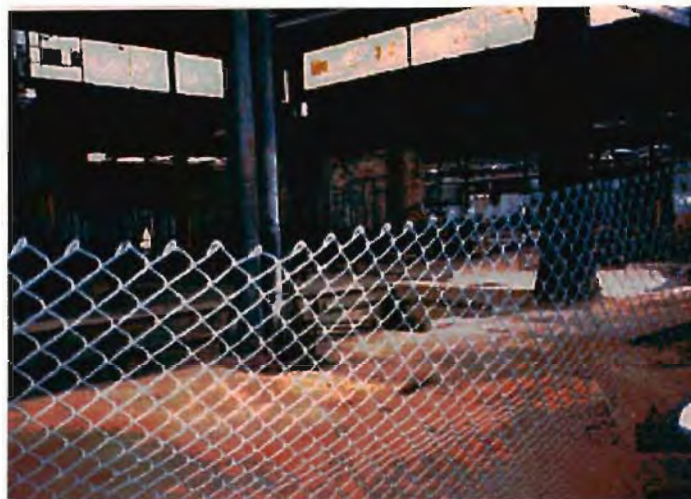
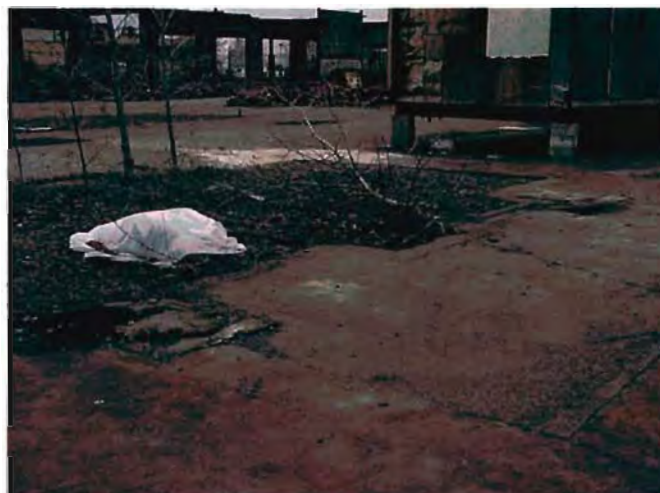
Page 11. 125 and 125A. Exact location. One pit area where the EPA did a removal action of hazardous waste. Note the remains from the column bases. 125A is a close up of the upper portion of 125. It is believed that this area was also remediated before backfilling.

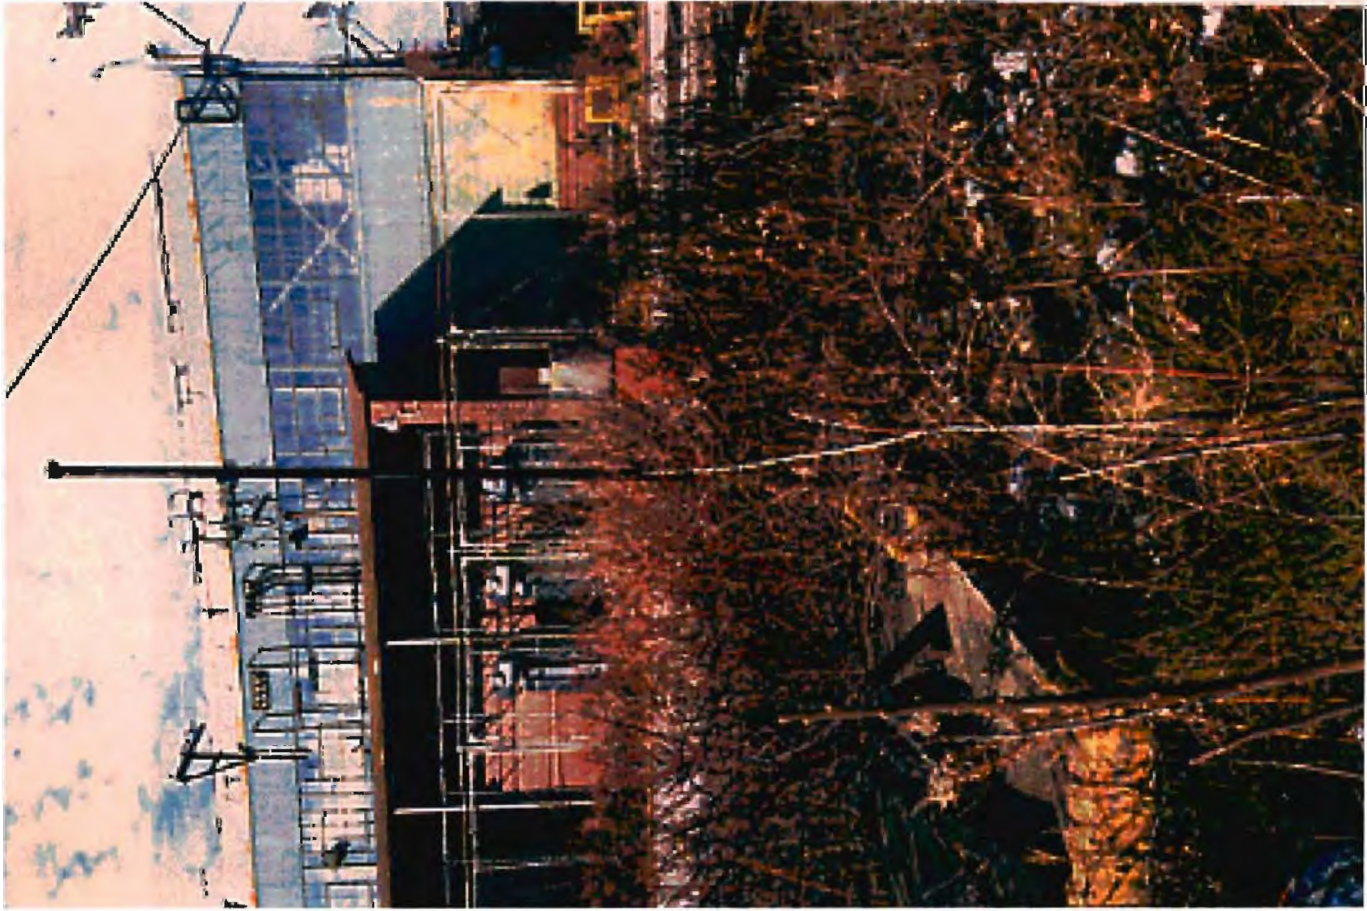
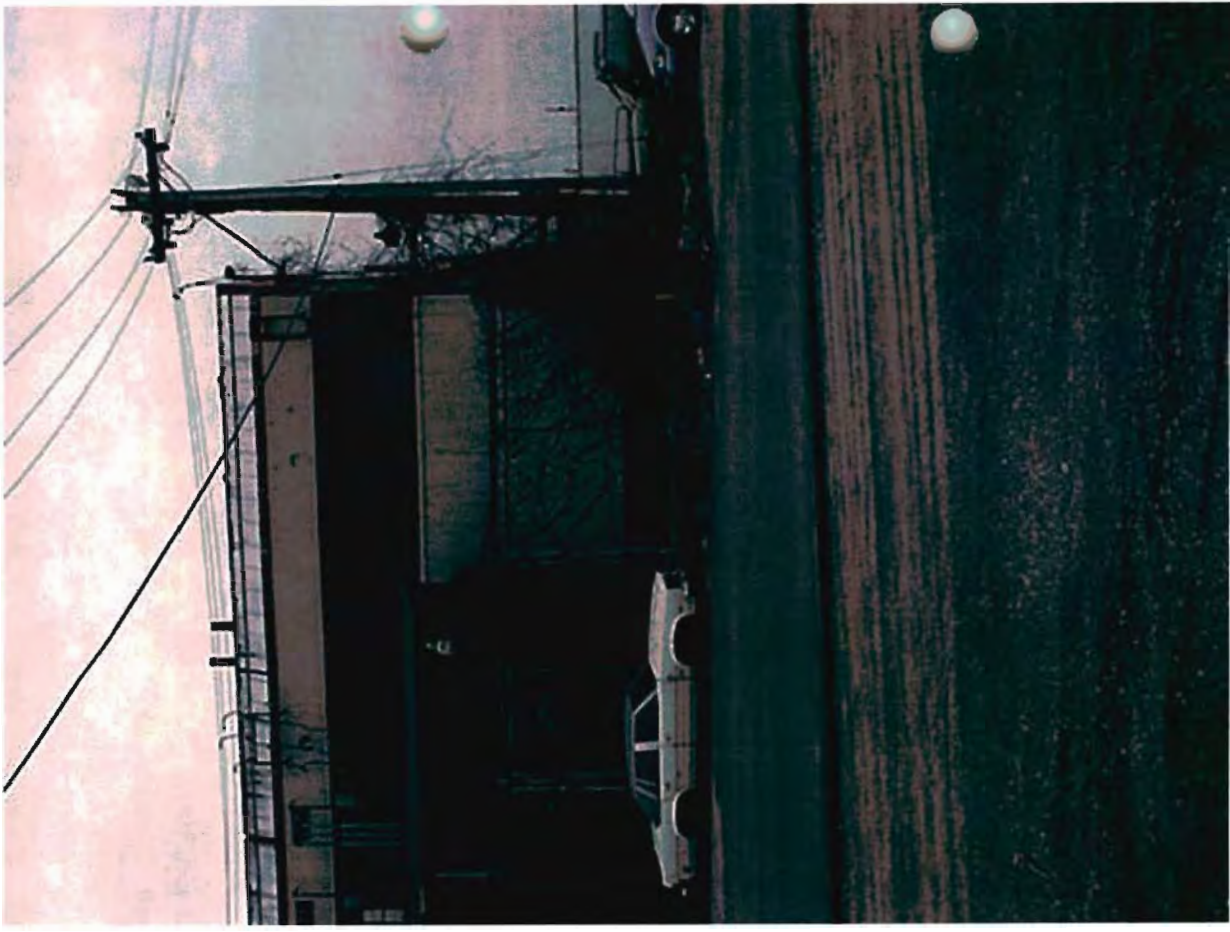
Page 3. Photo 37. Exact location. Area now has more gravel and asphalt. Transformer vault no longer present.

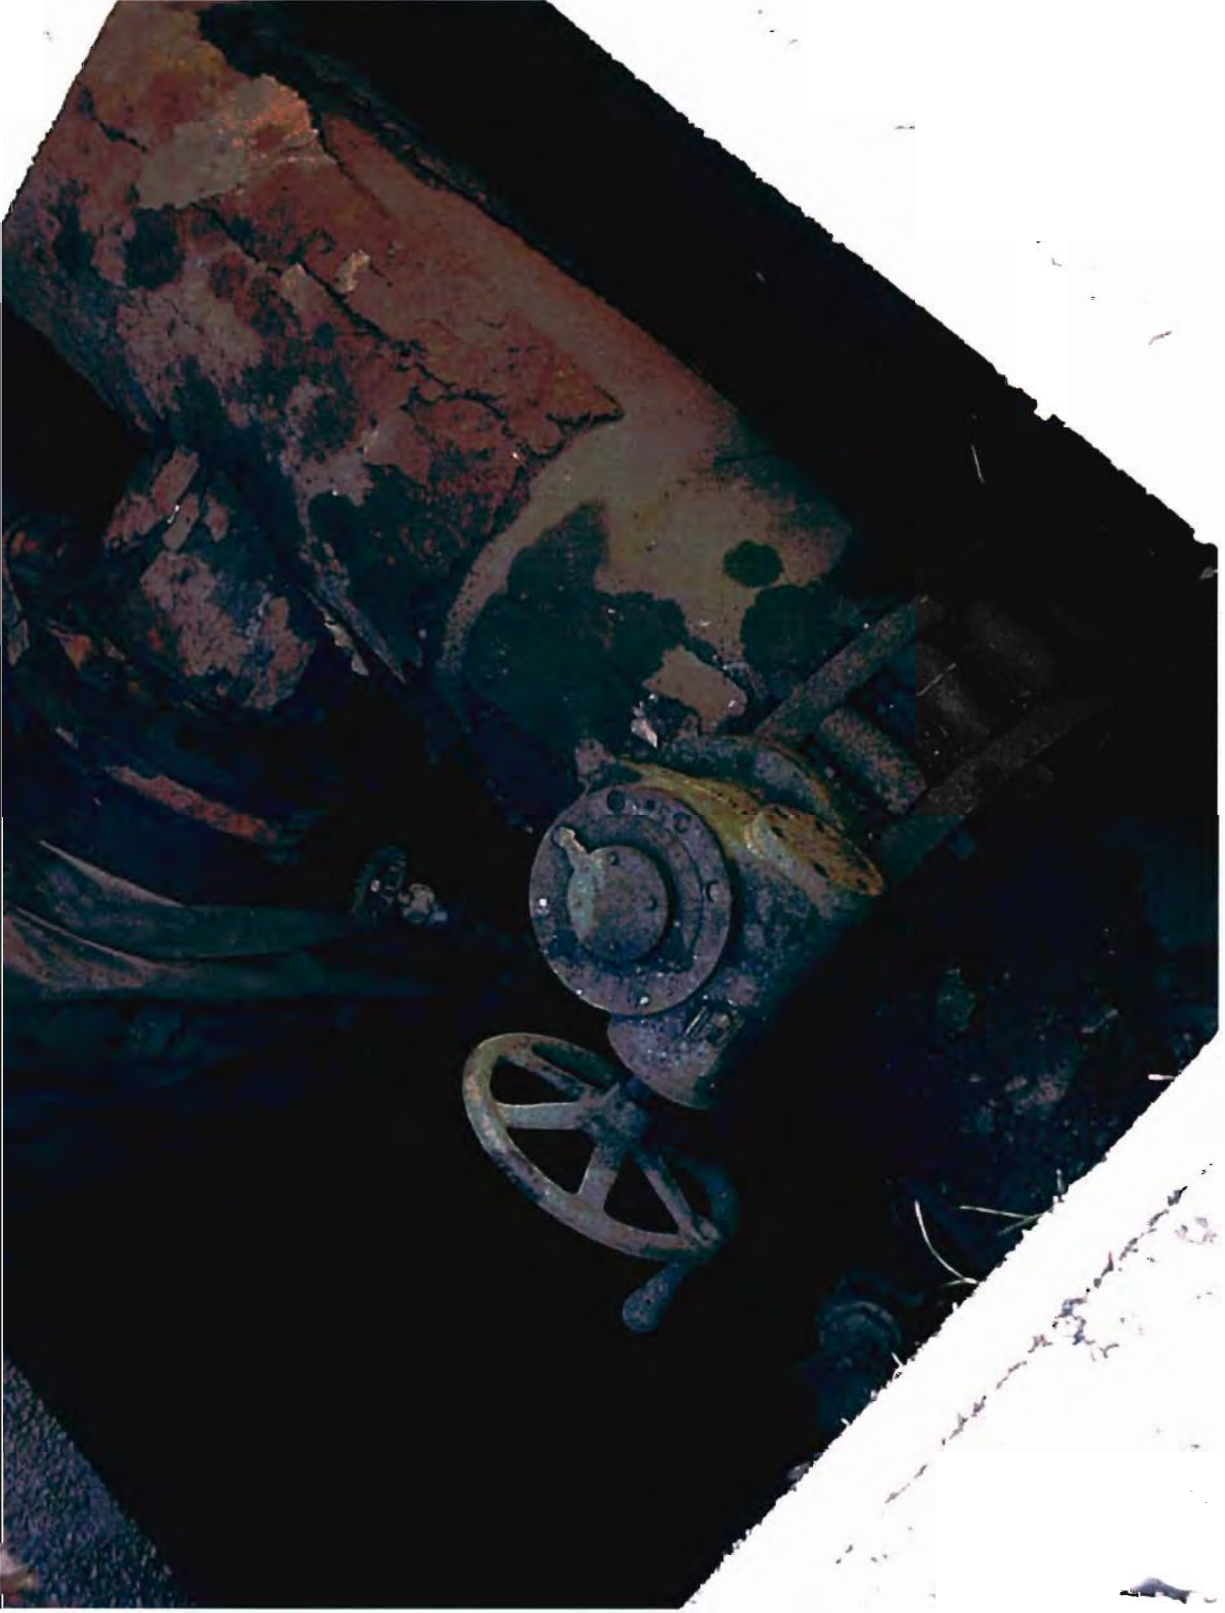
Valve Chamber

Page 12. This photo is the inside detail of 89A. Both pipes are 24 inches in diameter. One runs east and west, originating from the pipe bridge across River Rd. The other pipe intersects from the south and is believed to have originated from the former building (1971) of Ascension Chemical Co.
