# CHERRY FARM SITE SHORELINE STABILIZATION EVALUATION REPORT

**Cherry Farm/River Road Site**  
4290 River Road  
Tonawanda, NY 14150

CHA Project Number: 093558.000

**April 2025**

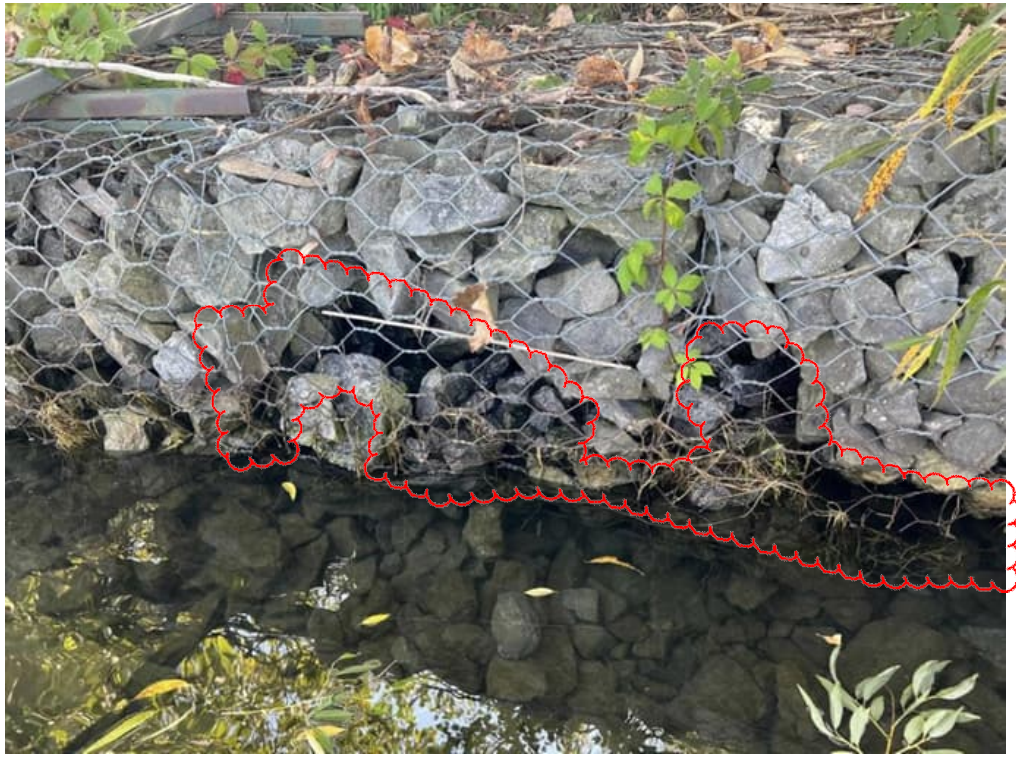
**Photograph 1.** Gabion wall voids at the location of stream gauge. View is from the Niagara River.

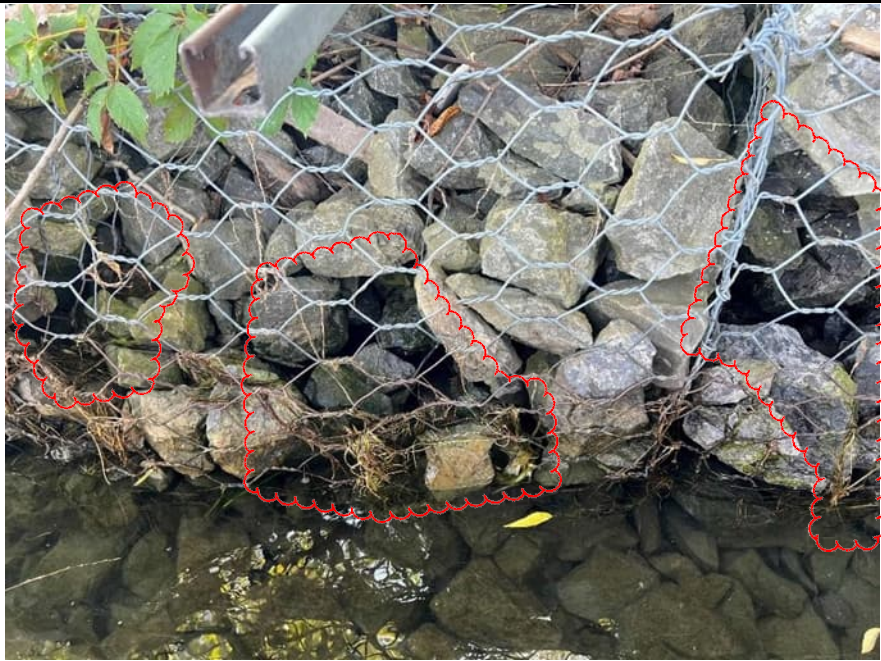
**Photograph 2.** Closer view of the gabion wall voids at the stream gauge. View is from the Niagara River.

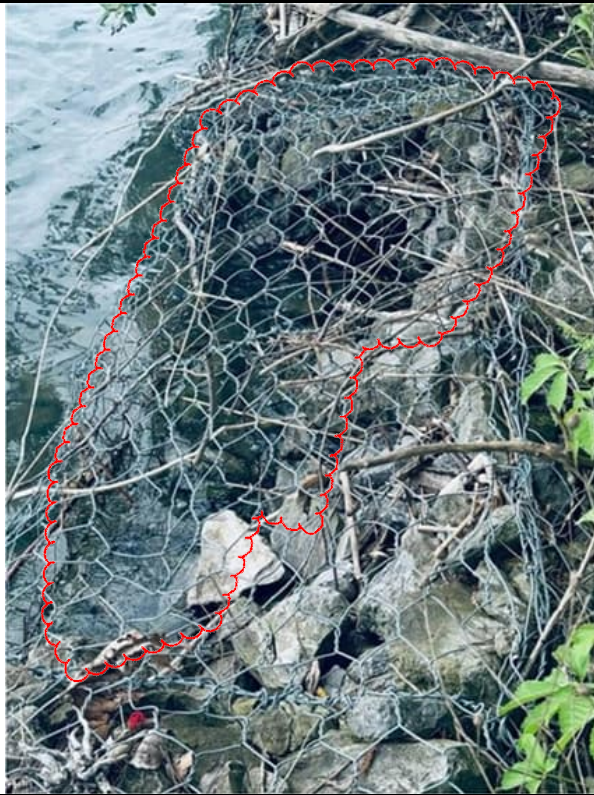
**Photograph 3.** Gabion wall deterioration just north of the stream gauge.

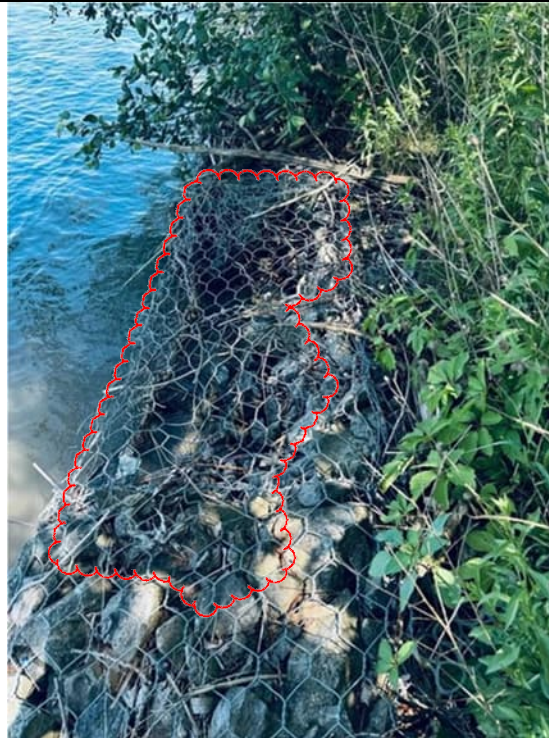
**Photograph 4.** Gabion wall deterioration/voids just north of the stream gauge.

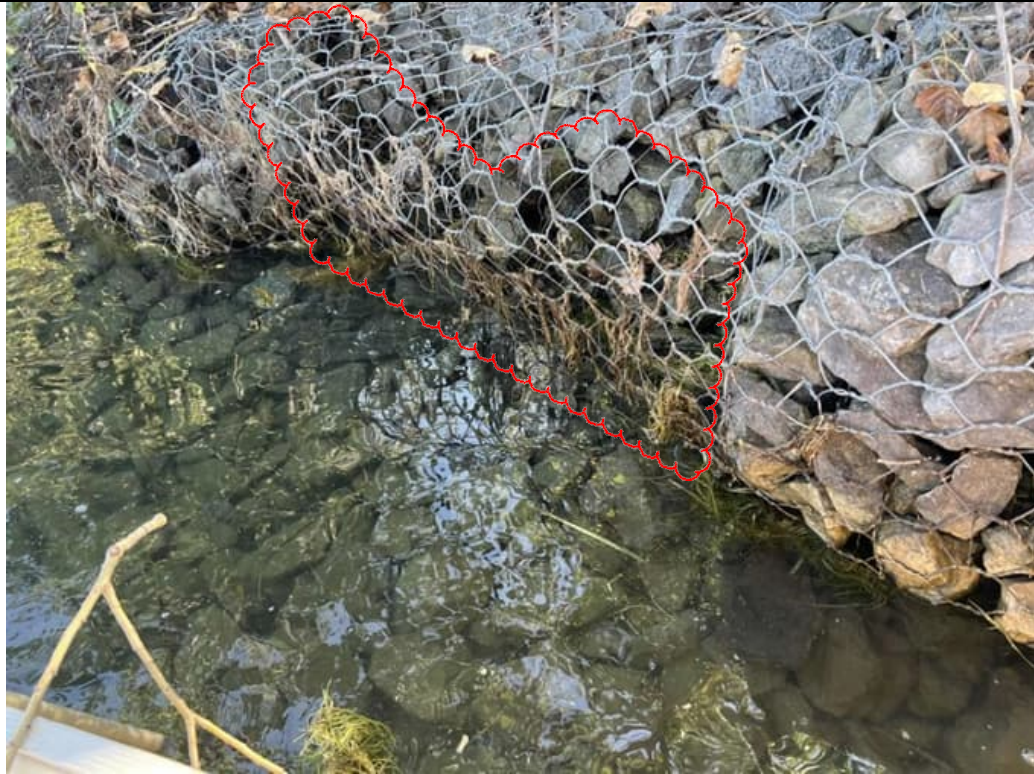
**Photograph 5.** Closer view of the gabion wall deterioration just north of the stream gauge. View is from the Niagara River.

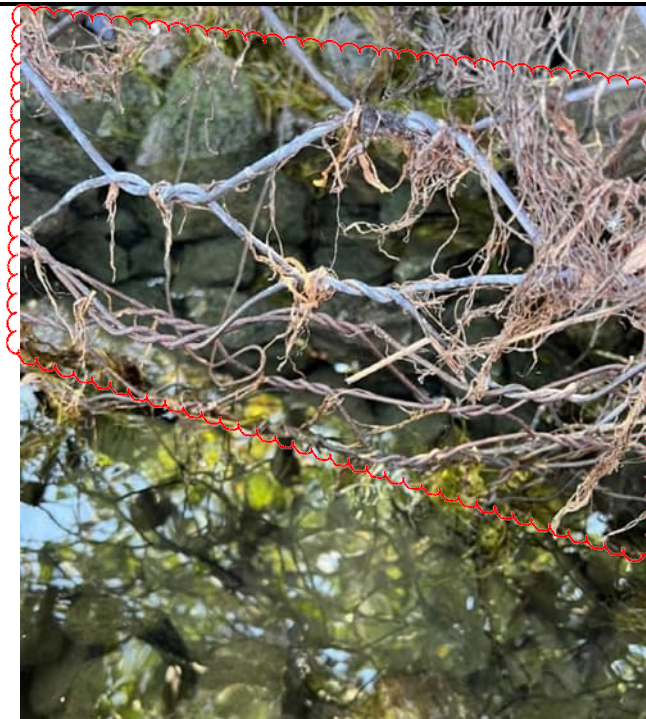
- Based on visual inspection of sections of deteriorating gabion basket metal mesh, it appears that the galvanized coating on the metal mesh has corroded over time due to sediment scouring followed oxidation of the exposed steel.

**Photograph 6.** Closer view of the wire mesh failure on the gabion wall. View is from the Niagara River at the spot just north of the stream gauge.

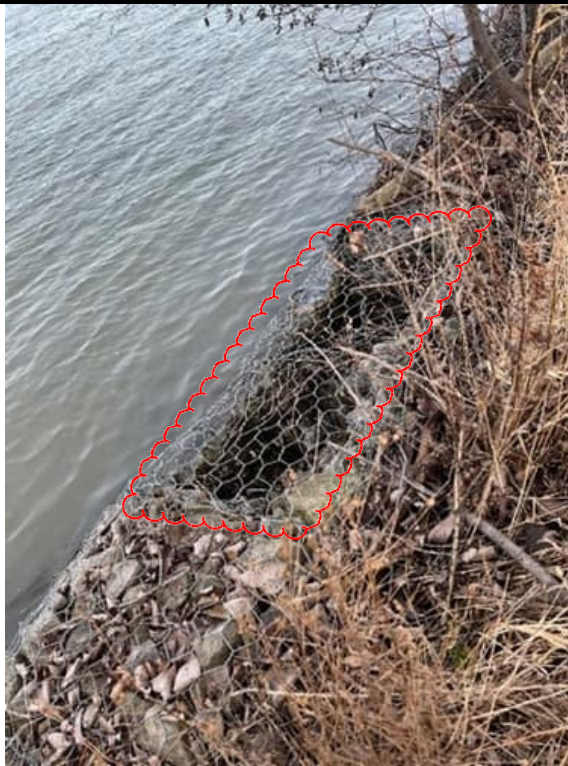
**Photograph 7.** View of the gabion wall just north of the stream gauge. View is from the Niagara River.

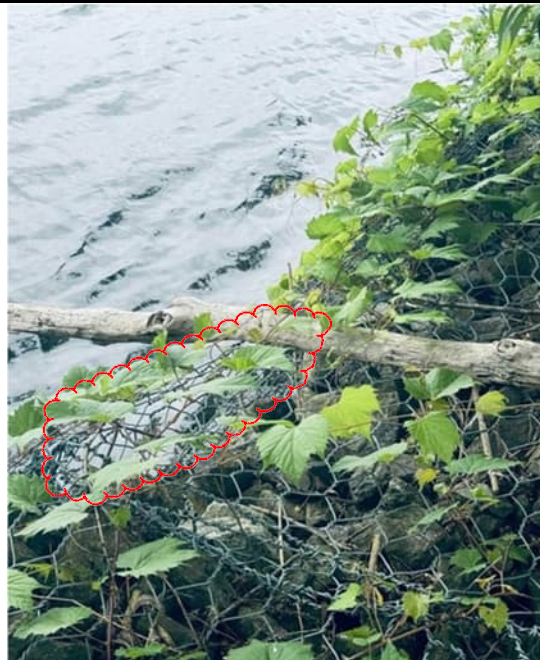
**Photograph 8.** Between OW-1 and MW-3, shows area of the northern-most gabion wall.

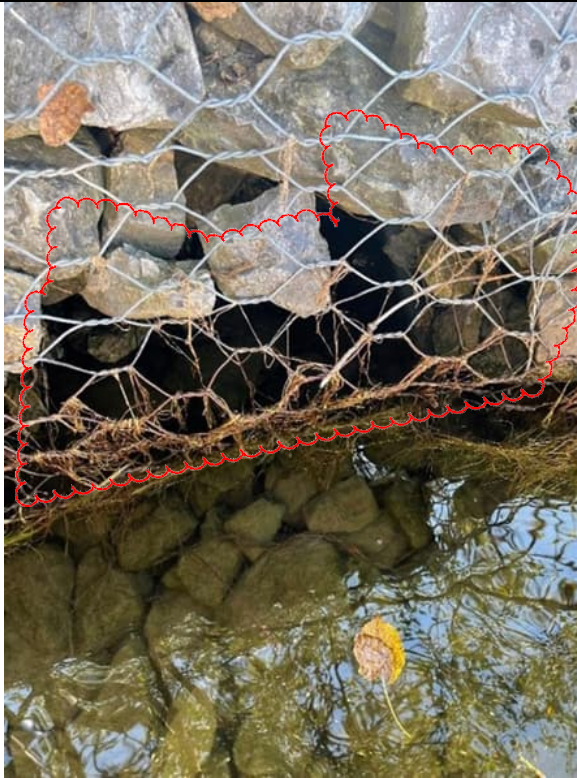
**Photograph 9.** Closer view of the Gabion Basket voids.

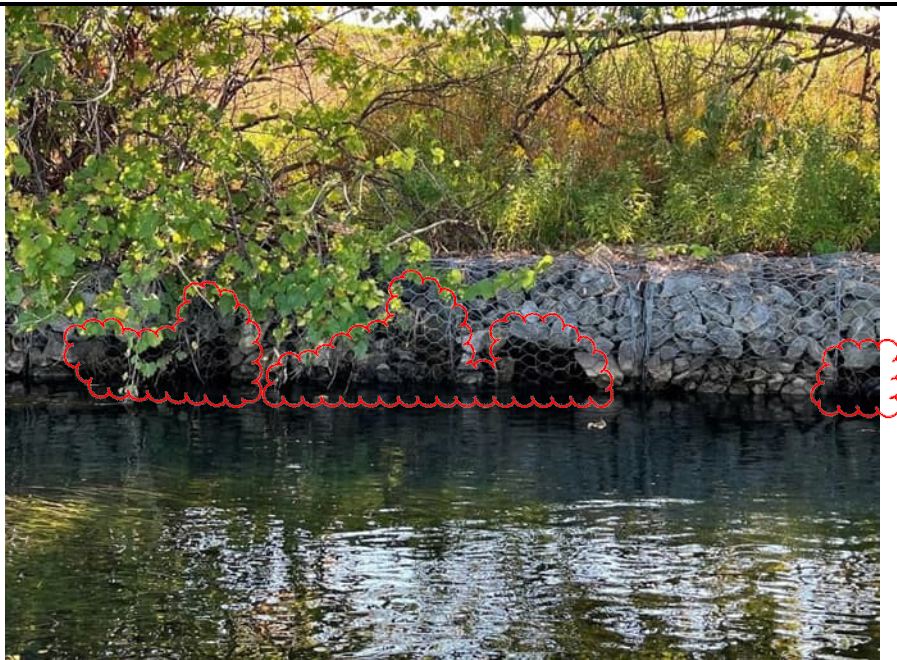
**Photograph 10.** Additional locations along the gabion wall that show additional rock material falling out of the upper baskets. View is from the Niagara River as the boat travels north along the western side of the Niagara Mohawk-Cherry Farm Site. Location appears to be near Sump 2.
