**NY STATE SUPERFUND STANDBY CONTRACT
DIARSENOL COMPANY - KINGSLEY PARK SITE
City of Buffalo, Erie County**

WORK ASSIGNMENT NO. D002478-28
SITE NO. 9-15-124

CONSTRUCTION CERTIFICATION REPORT
FOR
INSTALLATION OF A SUBSURFACE GROUNDWATER COLLECTION TRENCH
AT
DIARSENOL COMPANY, KINGSLEY PARK SITE
(SITE NO. 9-15-124)
BUFFALO, NEW YORK

JANUARY 1995

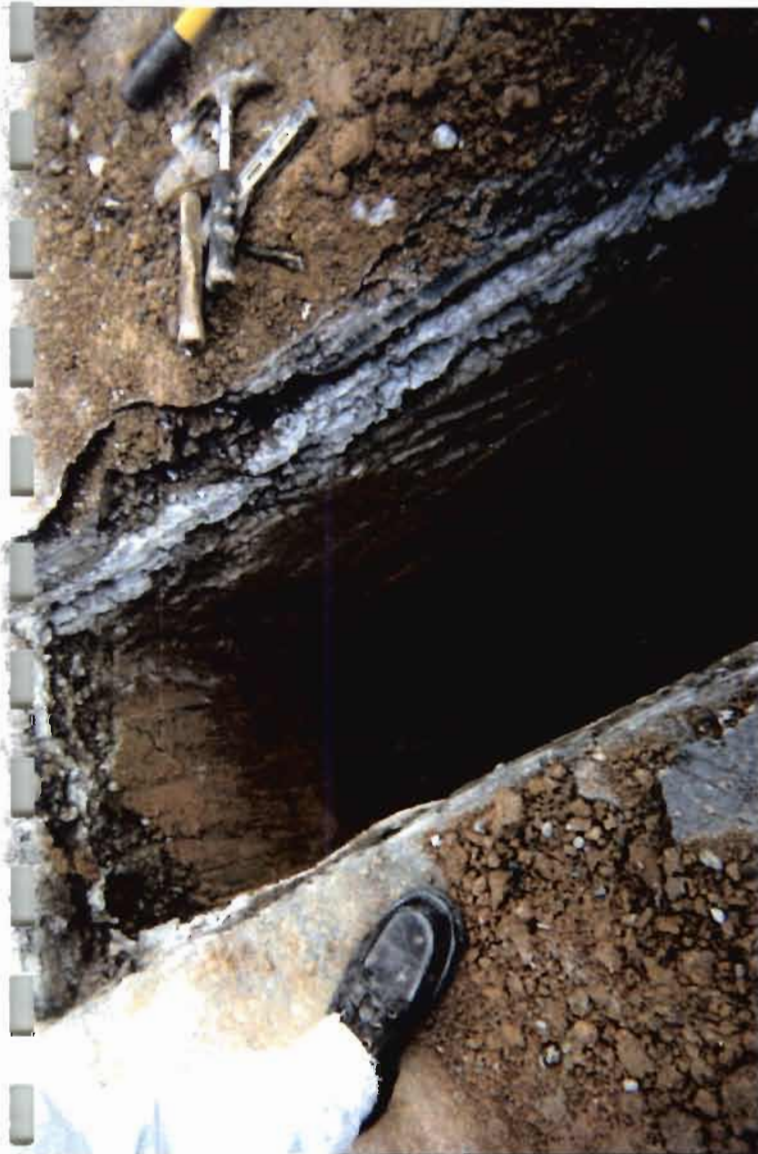
PROJECT: Diarsenol Subdrain Installation
LOCATION: _____
NUMBER: 726035.04
CLIENT: Diarsenol
Date: 11/15/94
Description: 22-inch sewer main in
Riley St. used for subdrain discharge. Pipe was vitrified
clay pipe.

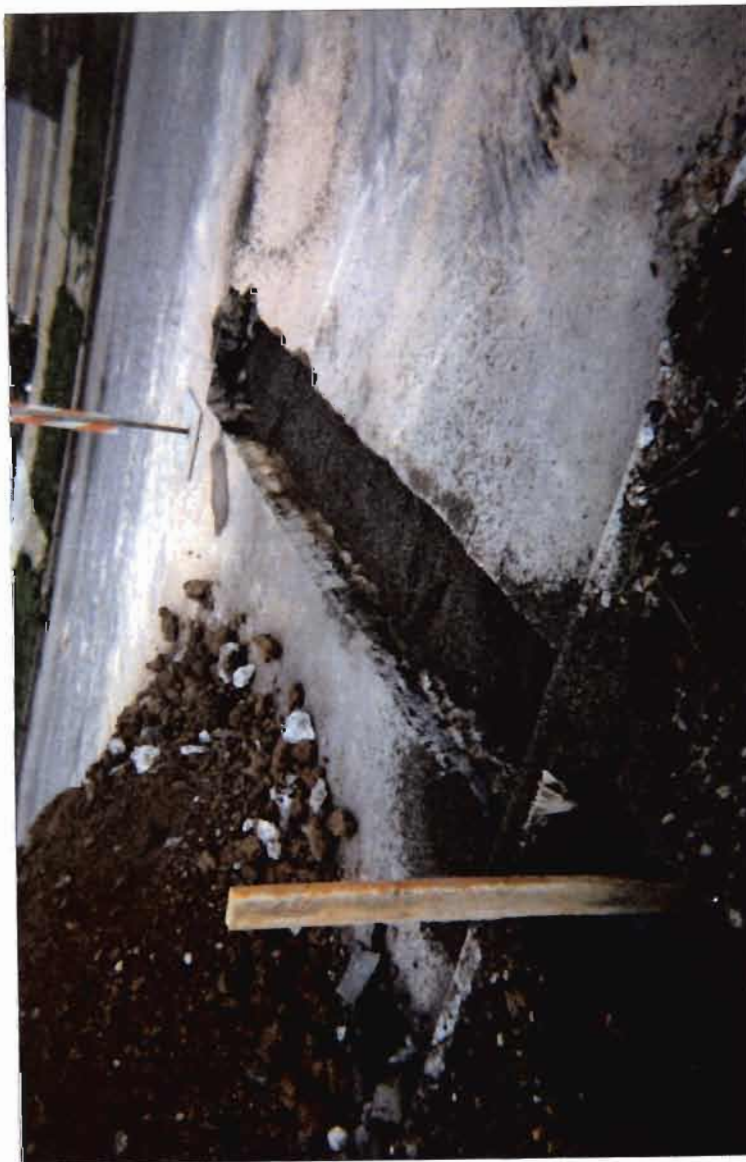
Date: 11/15/94
Description: Crushed gravel backfill in

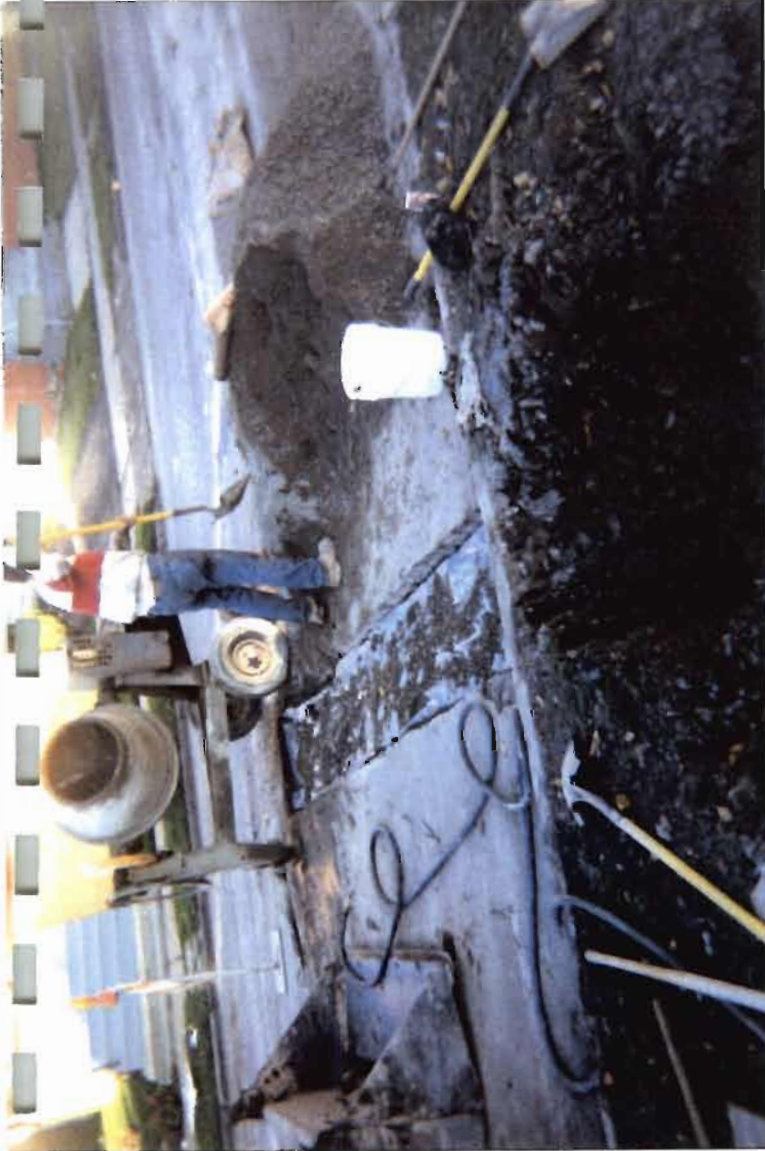
PROJECT: Diarsenol Subdrain Installation
LOCATION:
NUMBER: 726035.04
CLIENT: Diarsenol
Date: 11/16/94
Description: Plumbing crew replacing road surface

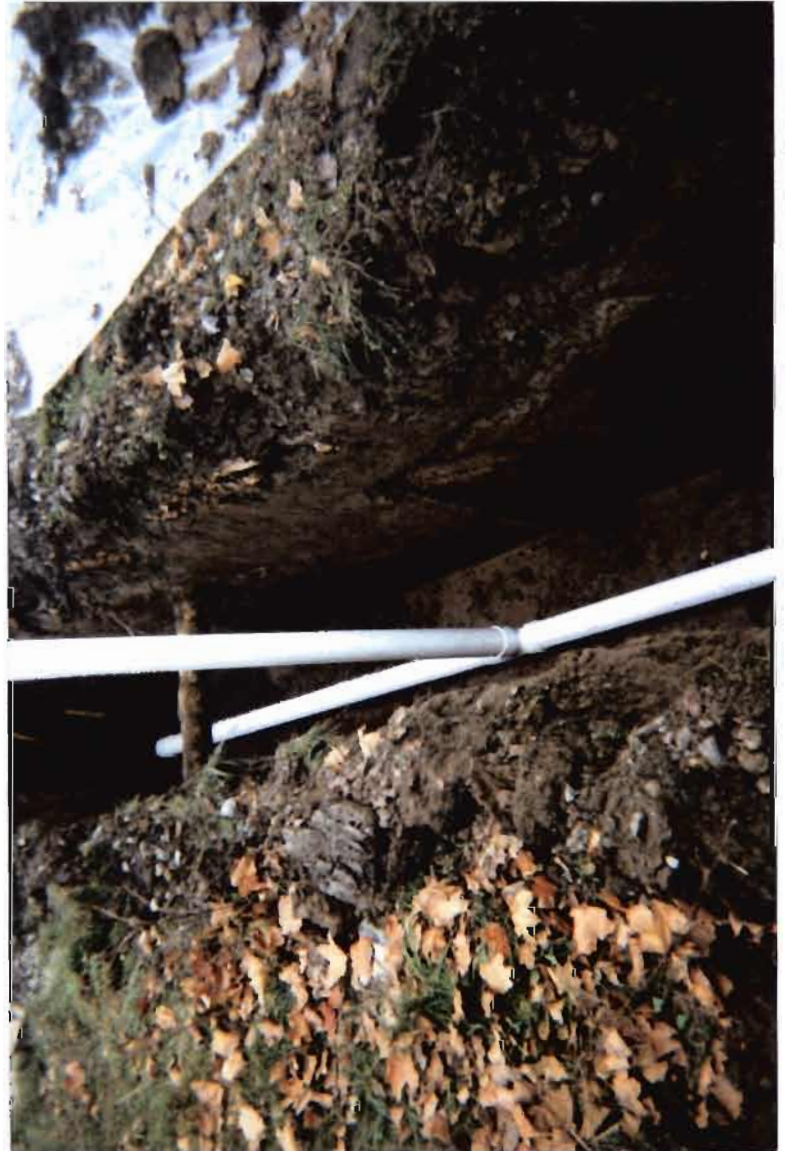
Date: 11/16/94
Description: Subdrain conduit discharge pipe
and clean-out access pipe near Riley St.

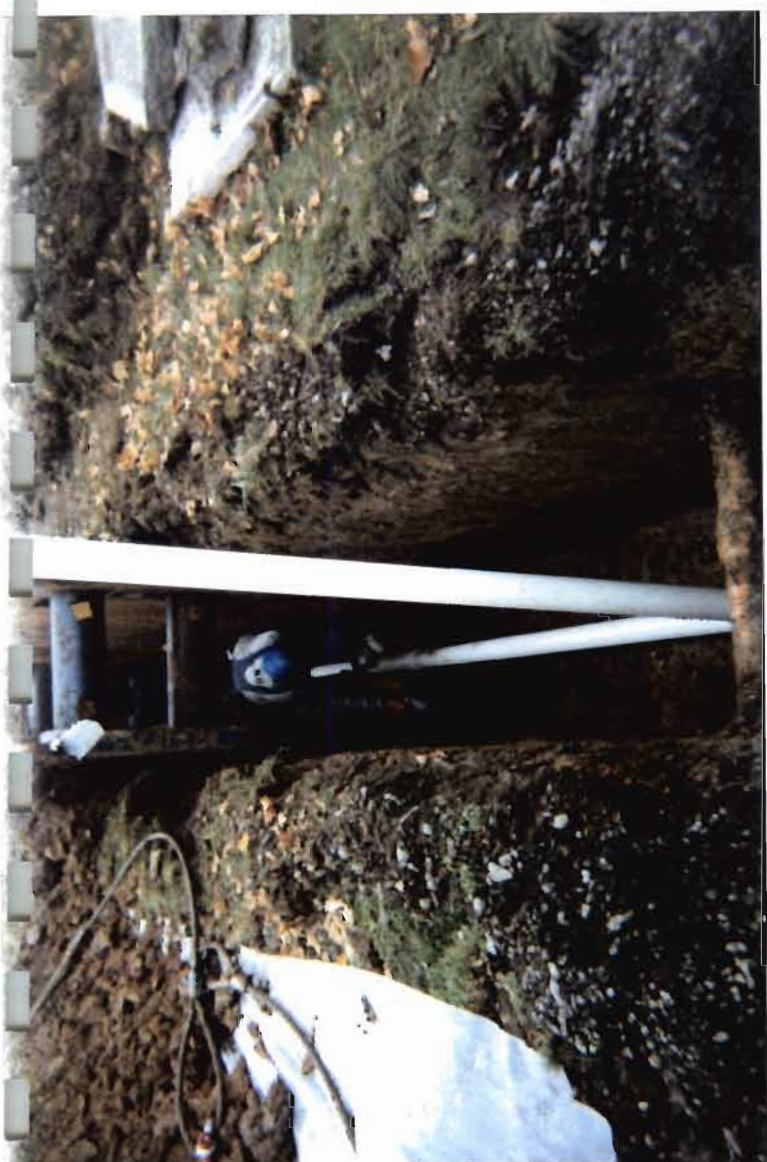
PROJECT: Diarsenol Subdrain Installation
LOCATION: 726035.04
NUMBER: Diarsenol
CLIENT: 11/16/94
Date: 11/16/94
Description: Crew member installing conduit
pipe inside trench box (34" O.D.)

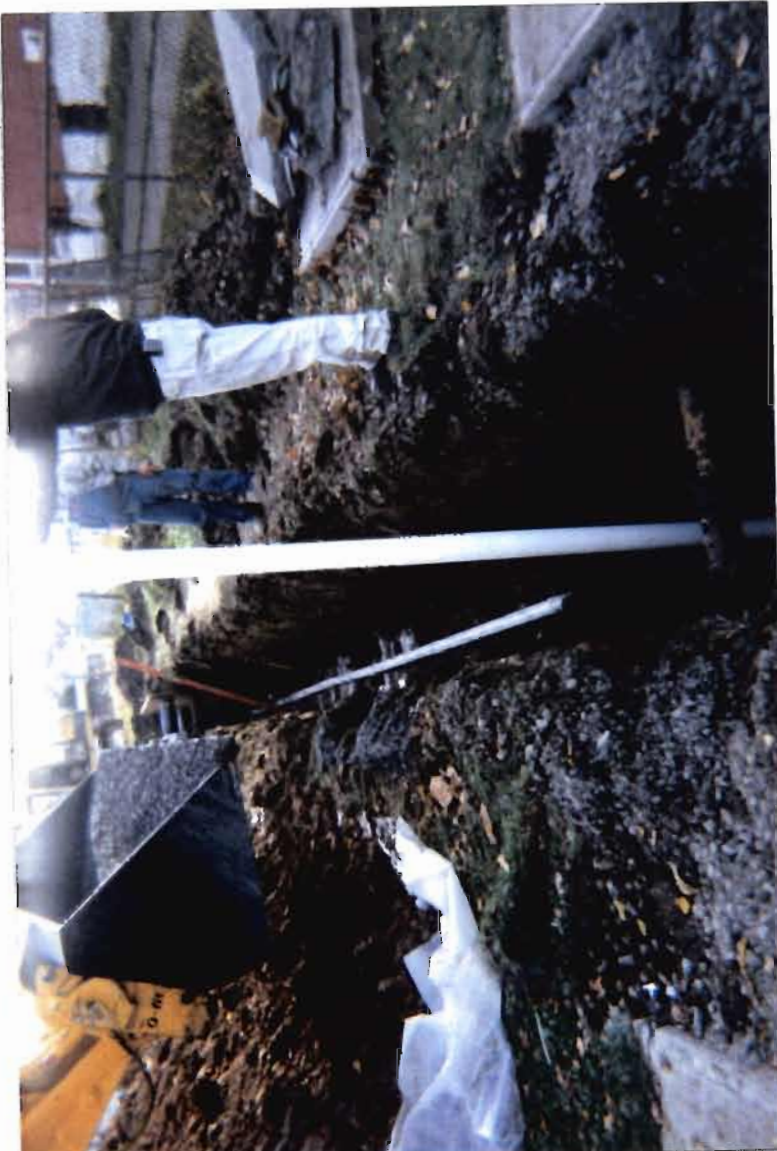
Date: 11/16/94
Description: Initial backfilling with crushed
gravel Pipe bedded 4" over to with #1A stone

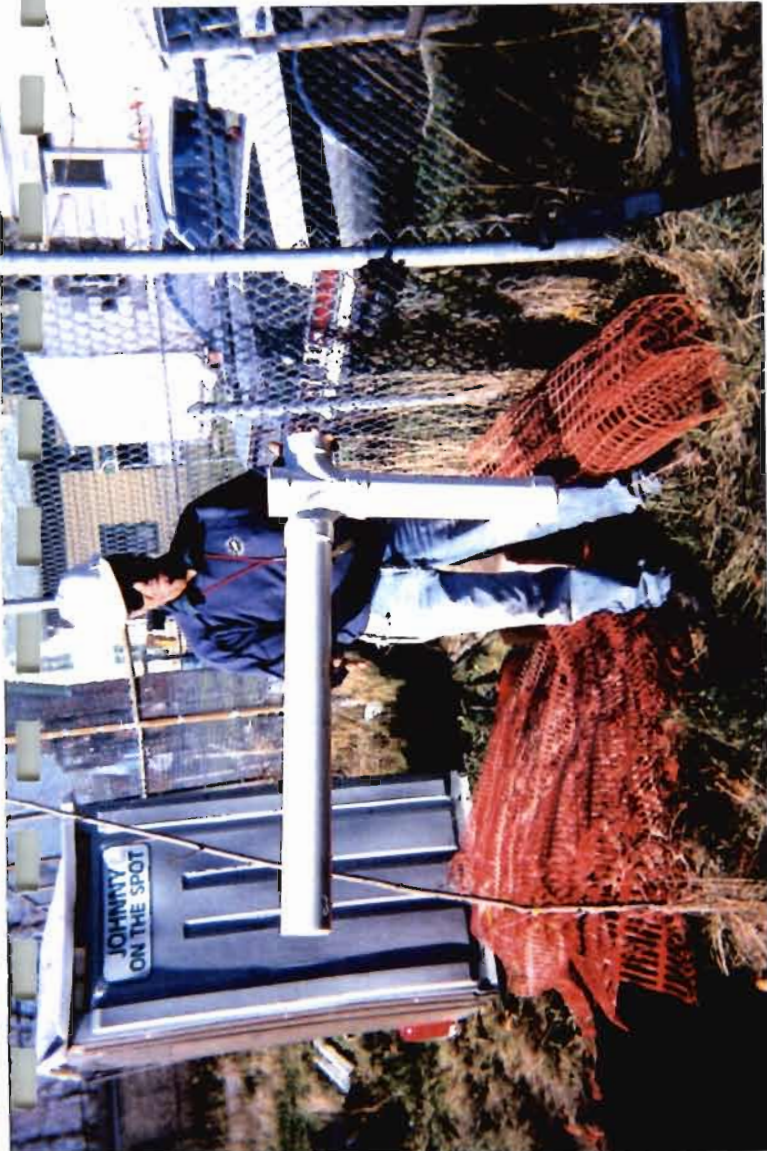
PROJECT:	Diarsenol Subdrain Installation
LOCATION:	
NUMBER:	726035.04
CLIENT:	Diarsenol
Date:	11/17/94
Description:	View of sampling sump prior to
Photo By:	DRD-ES

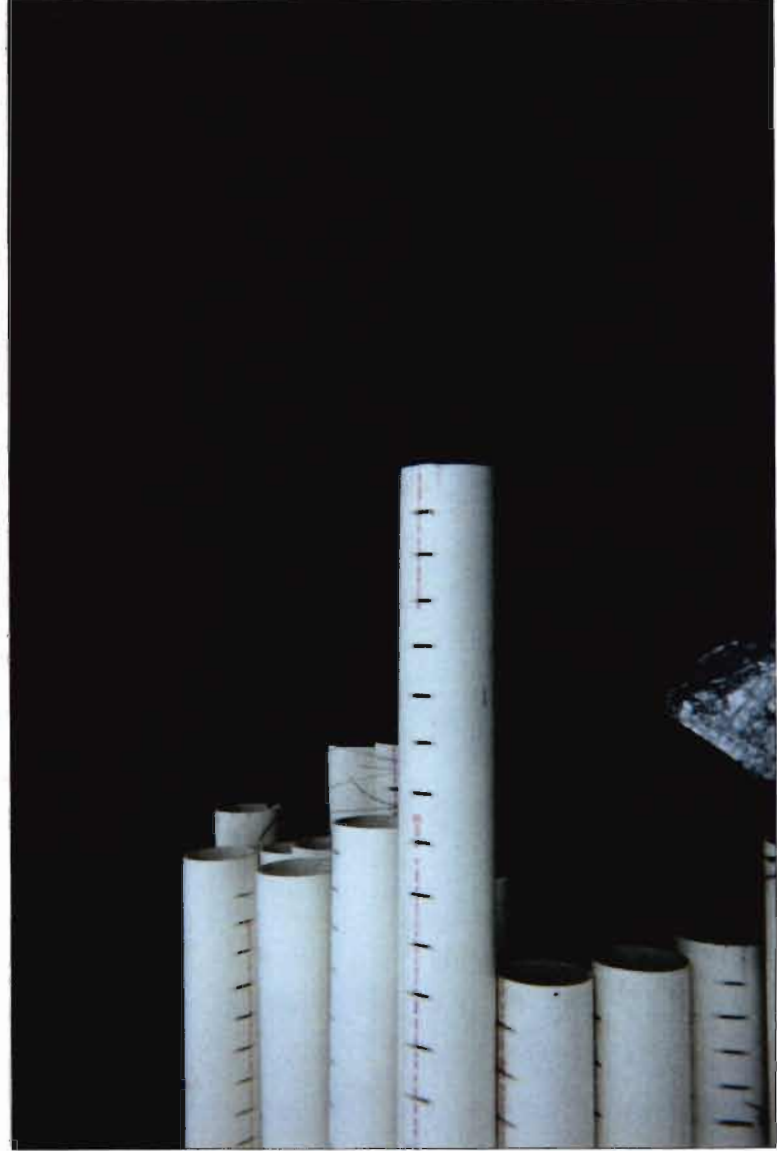
Date:	11/17/94
Description:	Schedule 40 slotted PVC for subdrain piping. Perforations made with a circular saw.
Photo By:	DRD-ES

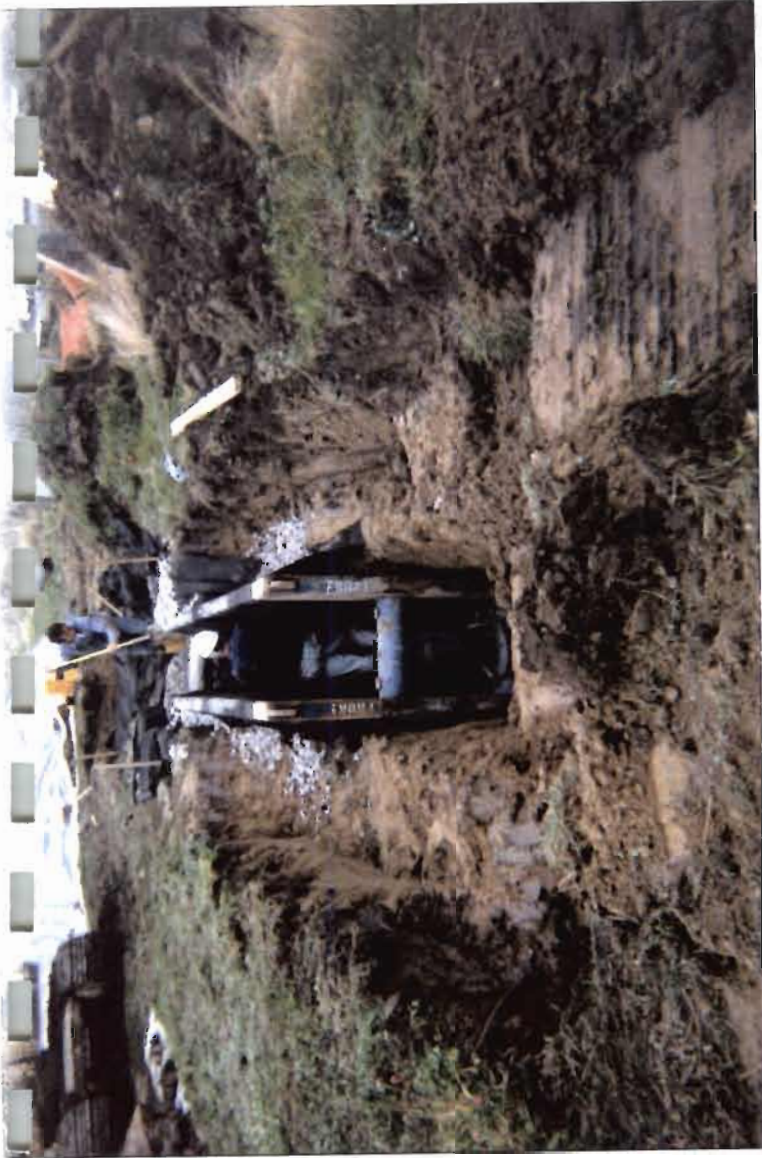
Description: Crew working on subdrain pipe

installation. Sides of trench pulled back to prevent cave

in during trenchbox movement

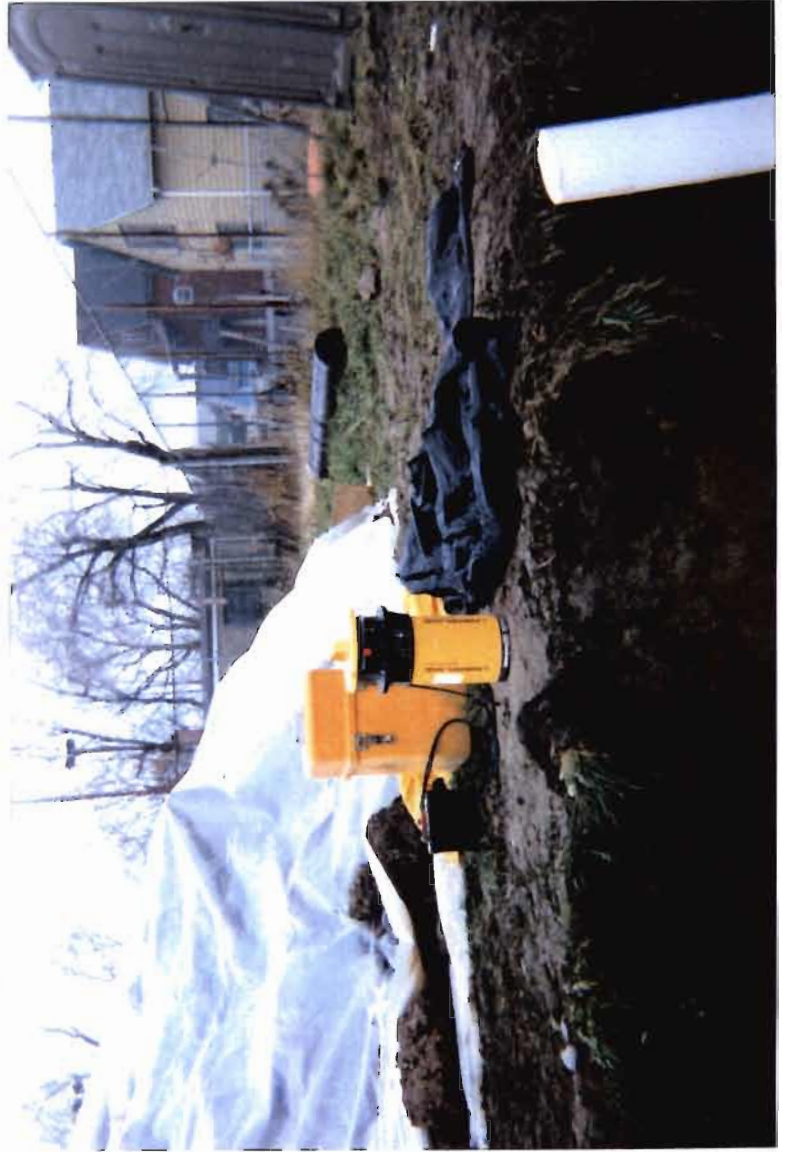
Description: Laser transit used for setting pipe

elevation.

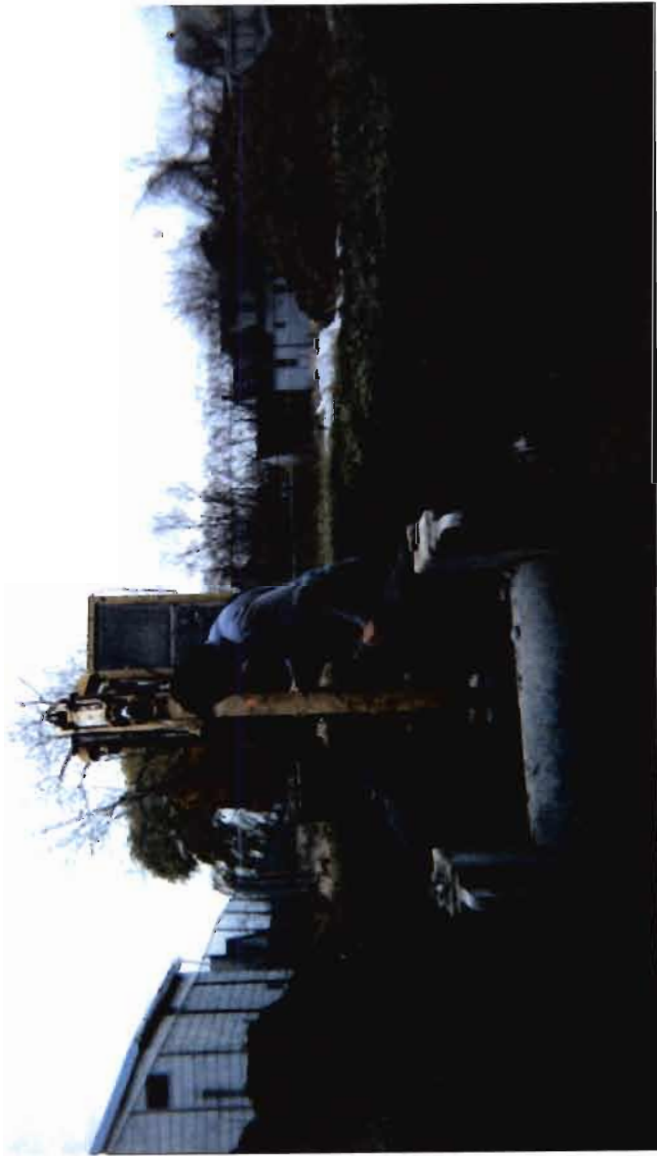
PROJECT:	Diarsenol Subdrain Installation
LOCATION:	
NUMBER:	726035.04
CLIENT:	Diarsenol
Date:	11/22/94
Description:	Crew member checking pipe elevation with lazer transit.
Photo By:	DRD—ES

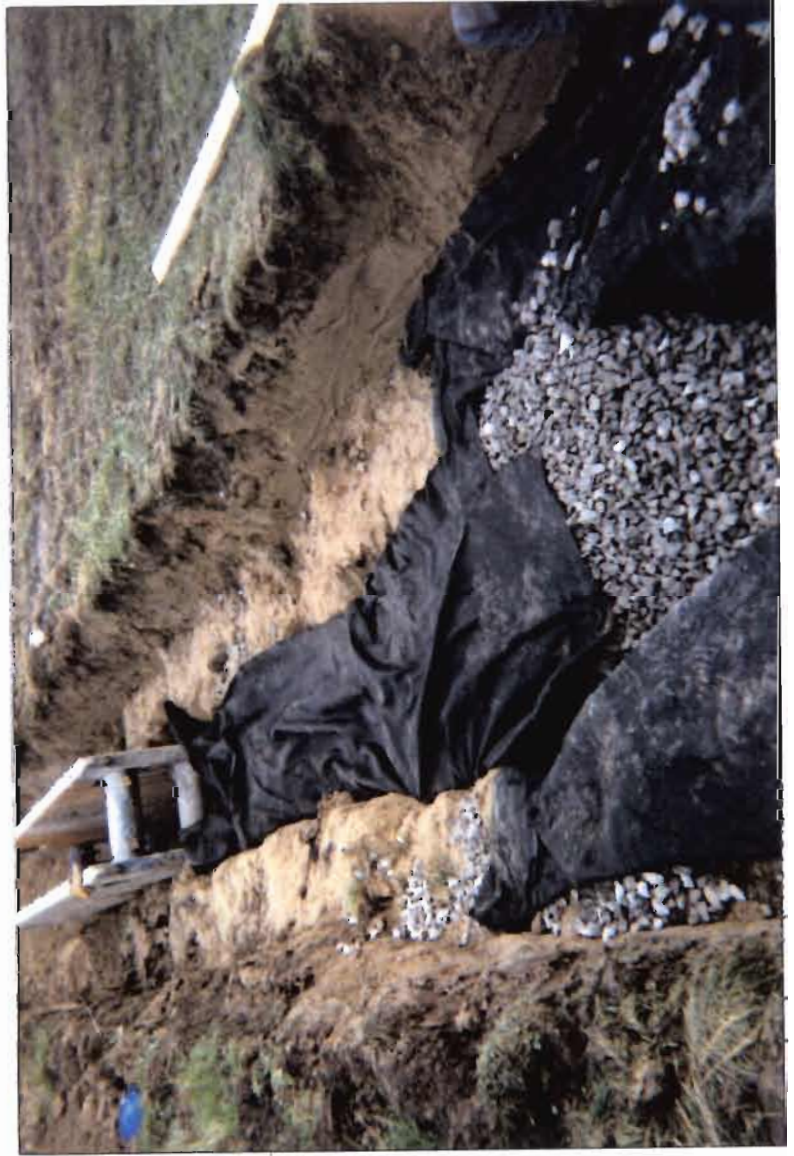
Date:	11/22/94
Description:	Subdrain backfilled with NYSDOT #4 ballast stone wrapped in mirait 140 fabric
Photo By:	DRD—ES
