**PHASE I**

**SITE ASSESSMENT**

April 25, 2003

**Site Identification:** Buffalo Small Boat Harbor and Gallagher Beach  
Fuhrmann Boulevard  
City of Buffalo  
Erie County, New York

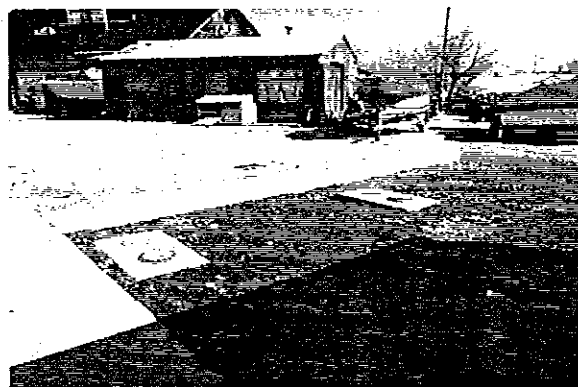
2. Location of (2) 6,000-gallon gasoline USTs, Parcel 1, looking northeast; marine repair shop in background

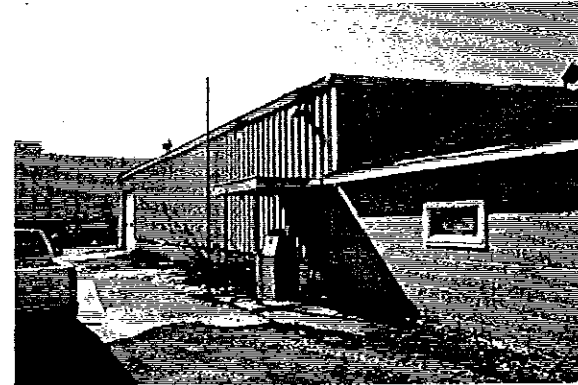
8. Maintenance building and gasoline pump, Parcel 3; UST located beneath truck

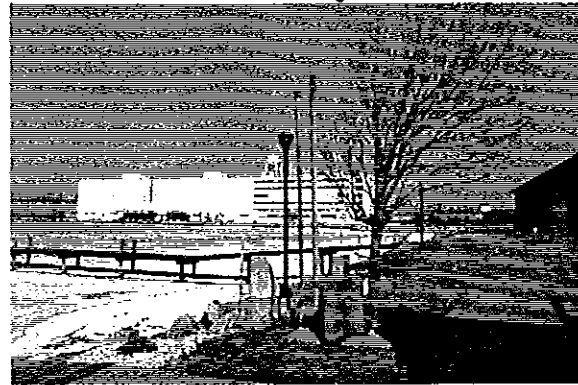
12. Gasoline-sales dock, vent-pipes, and adjoining property to the north

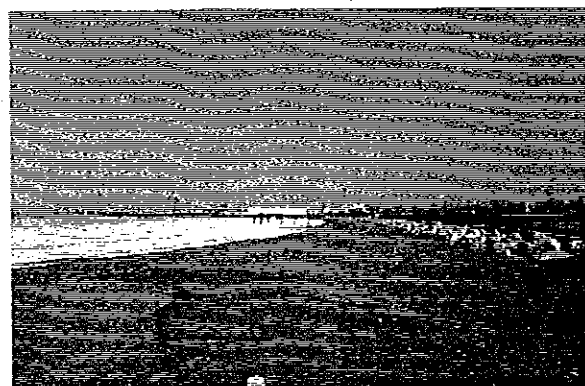
19. View of southern portion of Parcel 1 with former U.S. Army Corps of Engineers CDF in background, looking north
