Re: Ameron Colgate Avenue, Buffalo, Site #915133 Supplemental Investigation

Supplemental Investigation Colgate Avenue Site Ameron International Corporation

SUPPLEMENTAL SOIL BORING LOCATIONS

SUPPLEMENTAL REMEDIAL INVESTIGATION

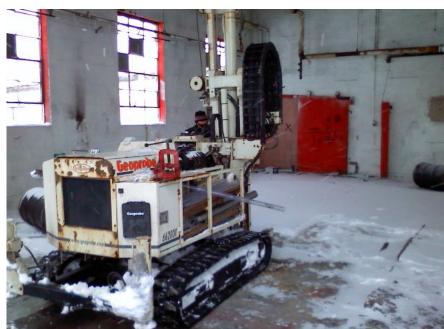
1

Advancing boring b-7.

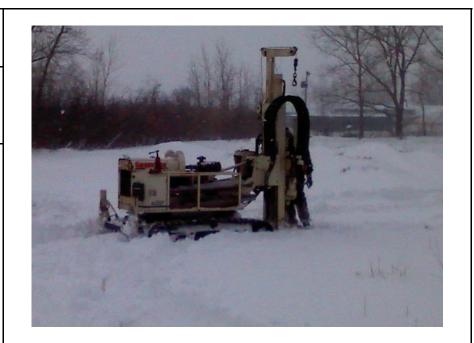
2

Soil boring advancment of B-4/TMW-4.

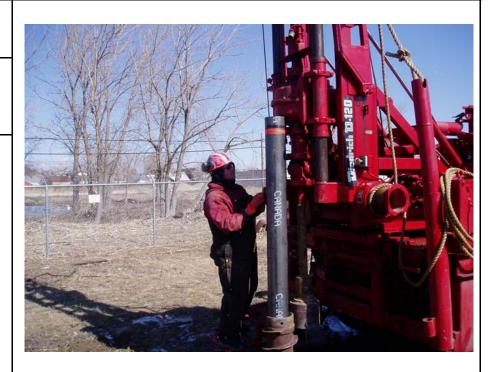
Photo No. Date 3 03/05/09

Installing overburden casing at MW-7b.

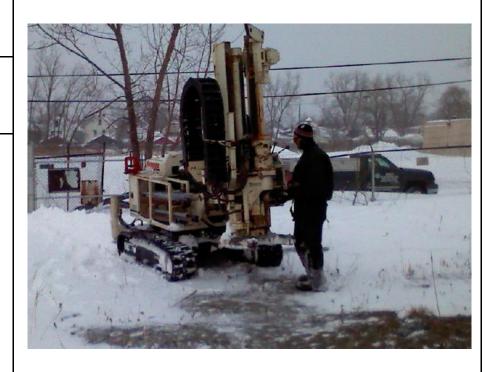
Photo No. Date 4 01/30/09

Soil boring advancment B-6

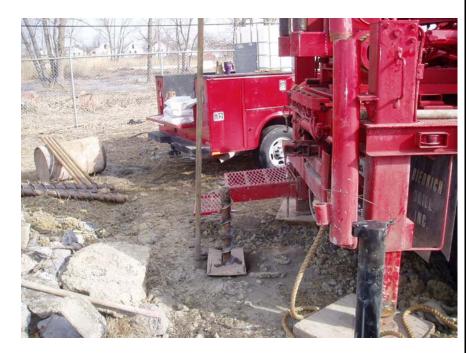
5

Continous split spoon sampling through 6-inch steel casing at MW-7b

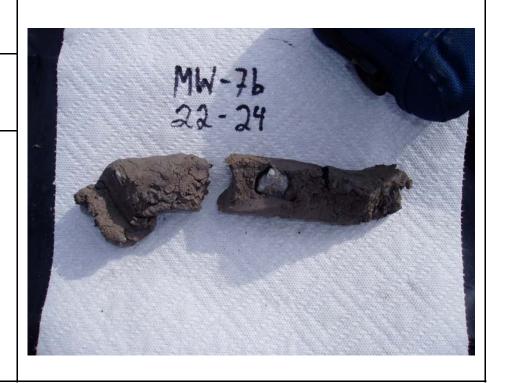
6

Moist glacial till at top of Top of Rock 22.0 - 24.0 feet below ground surface, MW-7b
