# Periodic Review Report

*October 31, 2013–October 31, 2014  
Reporting Period*

*Ameron Site  
113 & 119 Colgate Avenue  
NYSDEC Site No. C915133*

November 2014

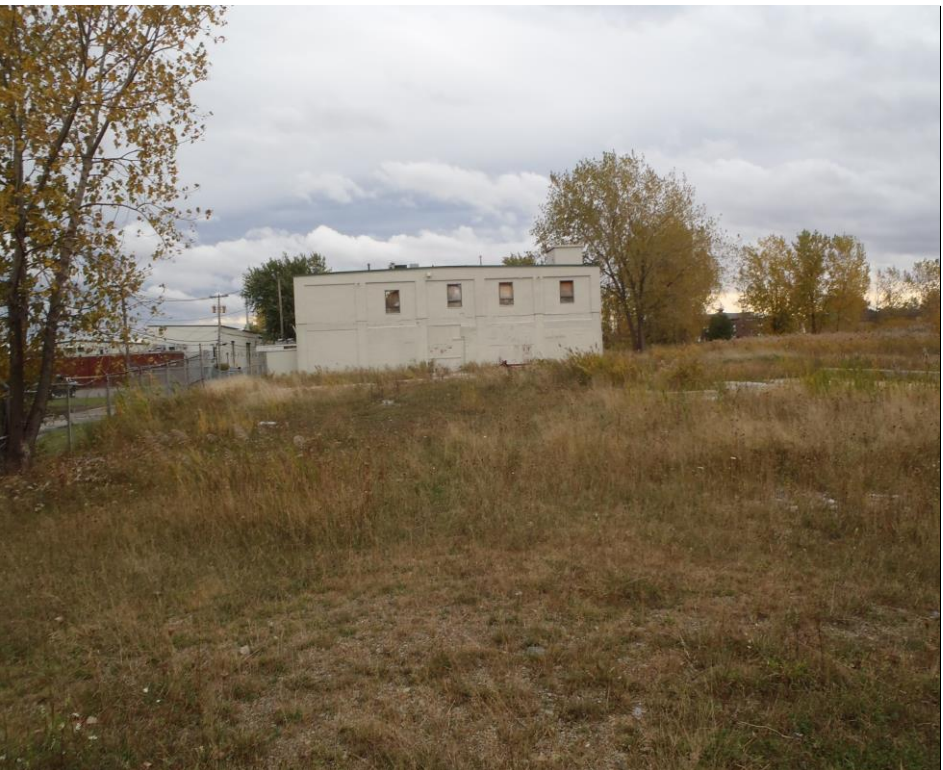
<b>Photo No.</b> 2	<b>Date</b> 10/14/14

<b>Direction Photo Taken:</b> East		
<b>Description:</b> Site Conditions - Existing building looking east from entrance

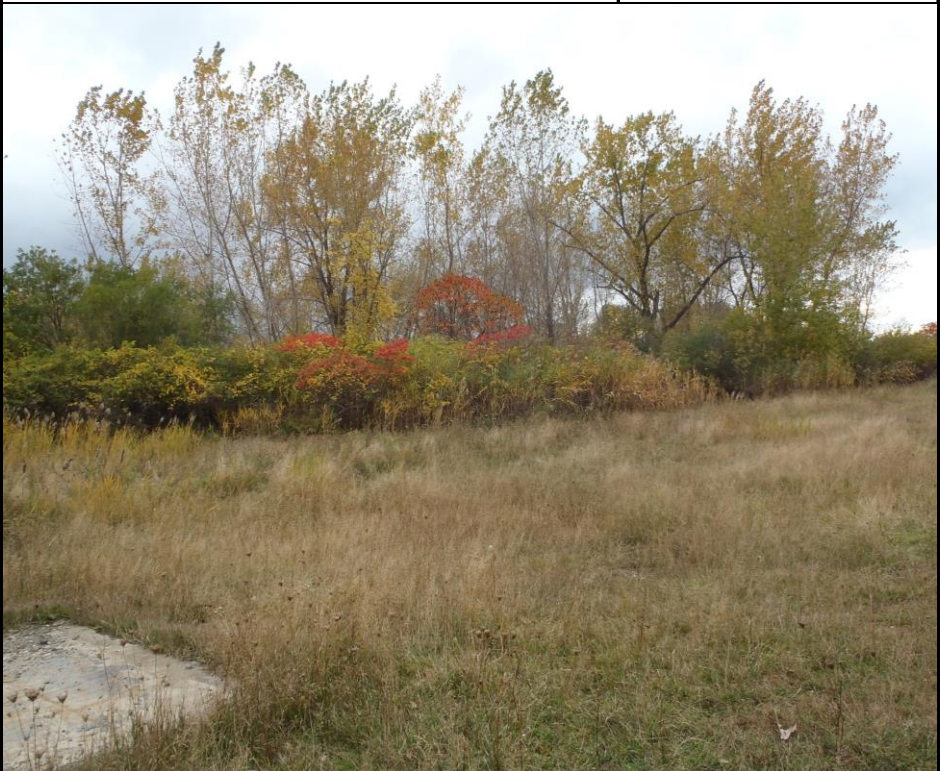
<b>Client Name:</b> Ameron International		<b>Site Location:</b> 113-119 Colgate Avenue Site, Buffalo, NY	<b>Project No.:</b> 0100-014-002
<b>Photo No.</b> 3	<b>Date</b> 10/14/14

<b>Direction Photo Taken:</b> Southeast			
<b>Description:</b> Site Conditions - Southwest corner of site

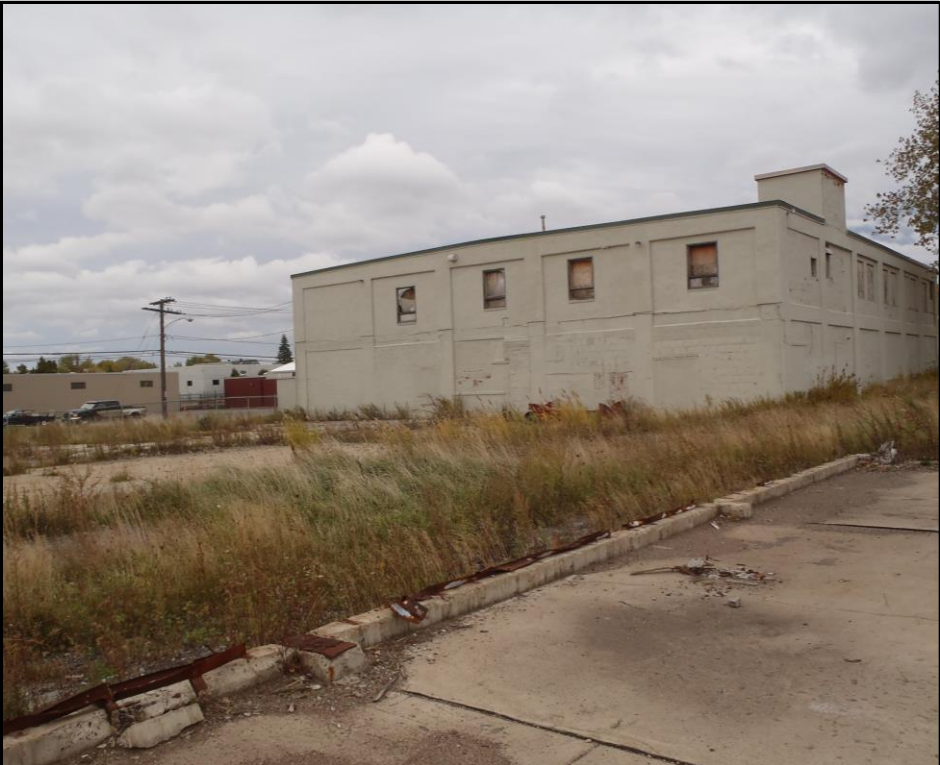
<b>Photo No.</b> 4	<b>Date</b> 10/14/14

<b>Direction Photo Taken:</b> Northeast		
<b>Description:</b> Western side of existing building

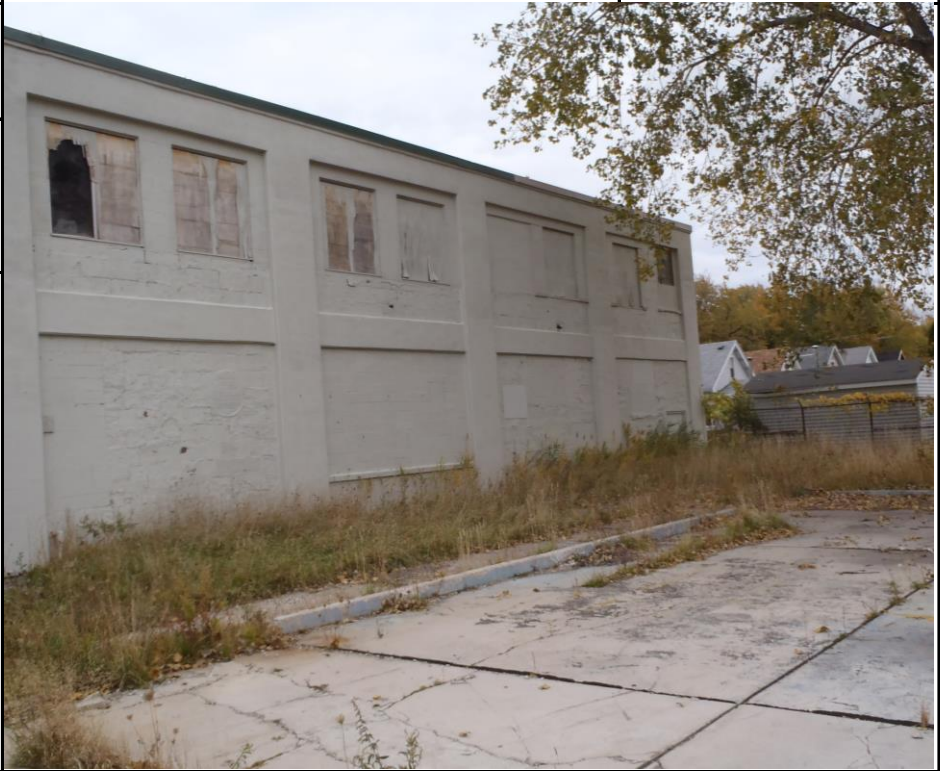
<b>Client Name:</b> Ameron International		<b>Site Location:</b> 113-119 Colgate Avenue Site, Buffalo, NY	<b>Project No.:</b> 0100-014-002
<b>Photo No.</b> 5	<b>Date</b> 10/14/14

<b>Direction Photo Taken:</b> Northeast			
<b>Description:</b> Southern side of existing building and foreground

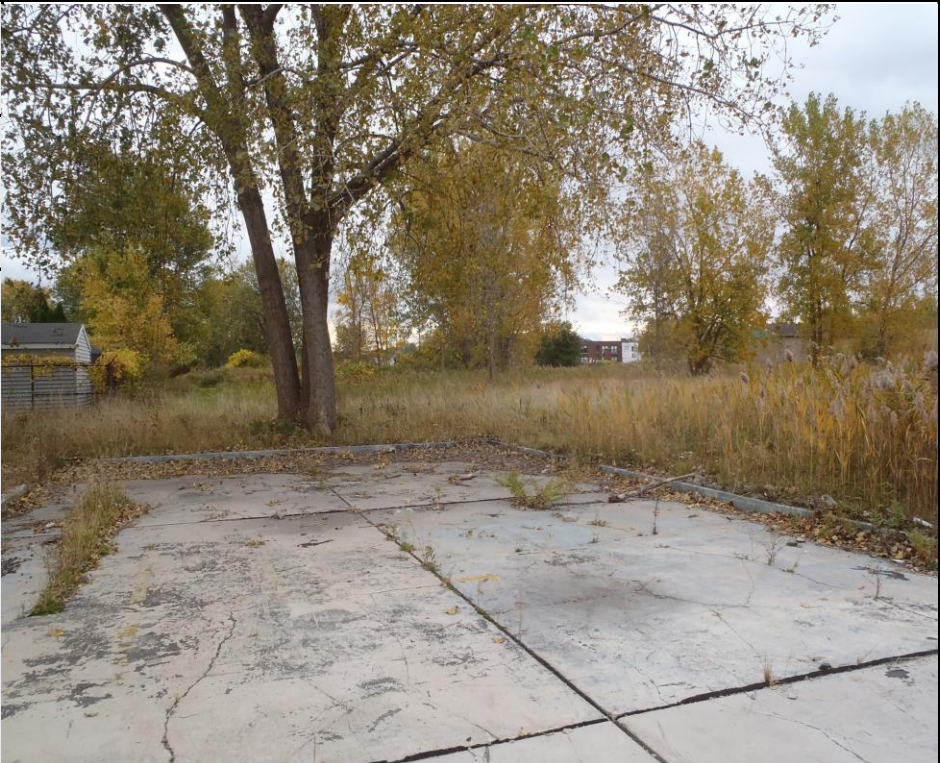
<b>Photo No.</b> 6	<b>Date</b> 10/14/14

<b>Direction Photo Taken:</b> East		
<b>Description:</b> Site Conditions - East side of site
