Periodic Review Report

*October 31, 2014—October 31, 2015
Reporting Period*

*Ameron Site
113 & 119 Colgate Avenue
NYSDEC Site No. C915133*

November 2015

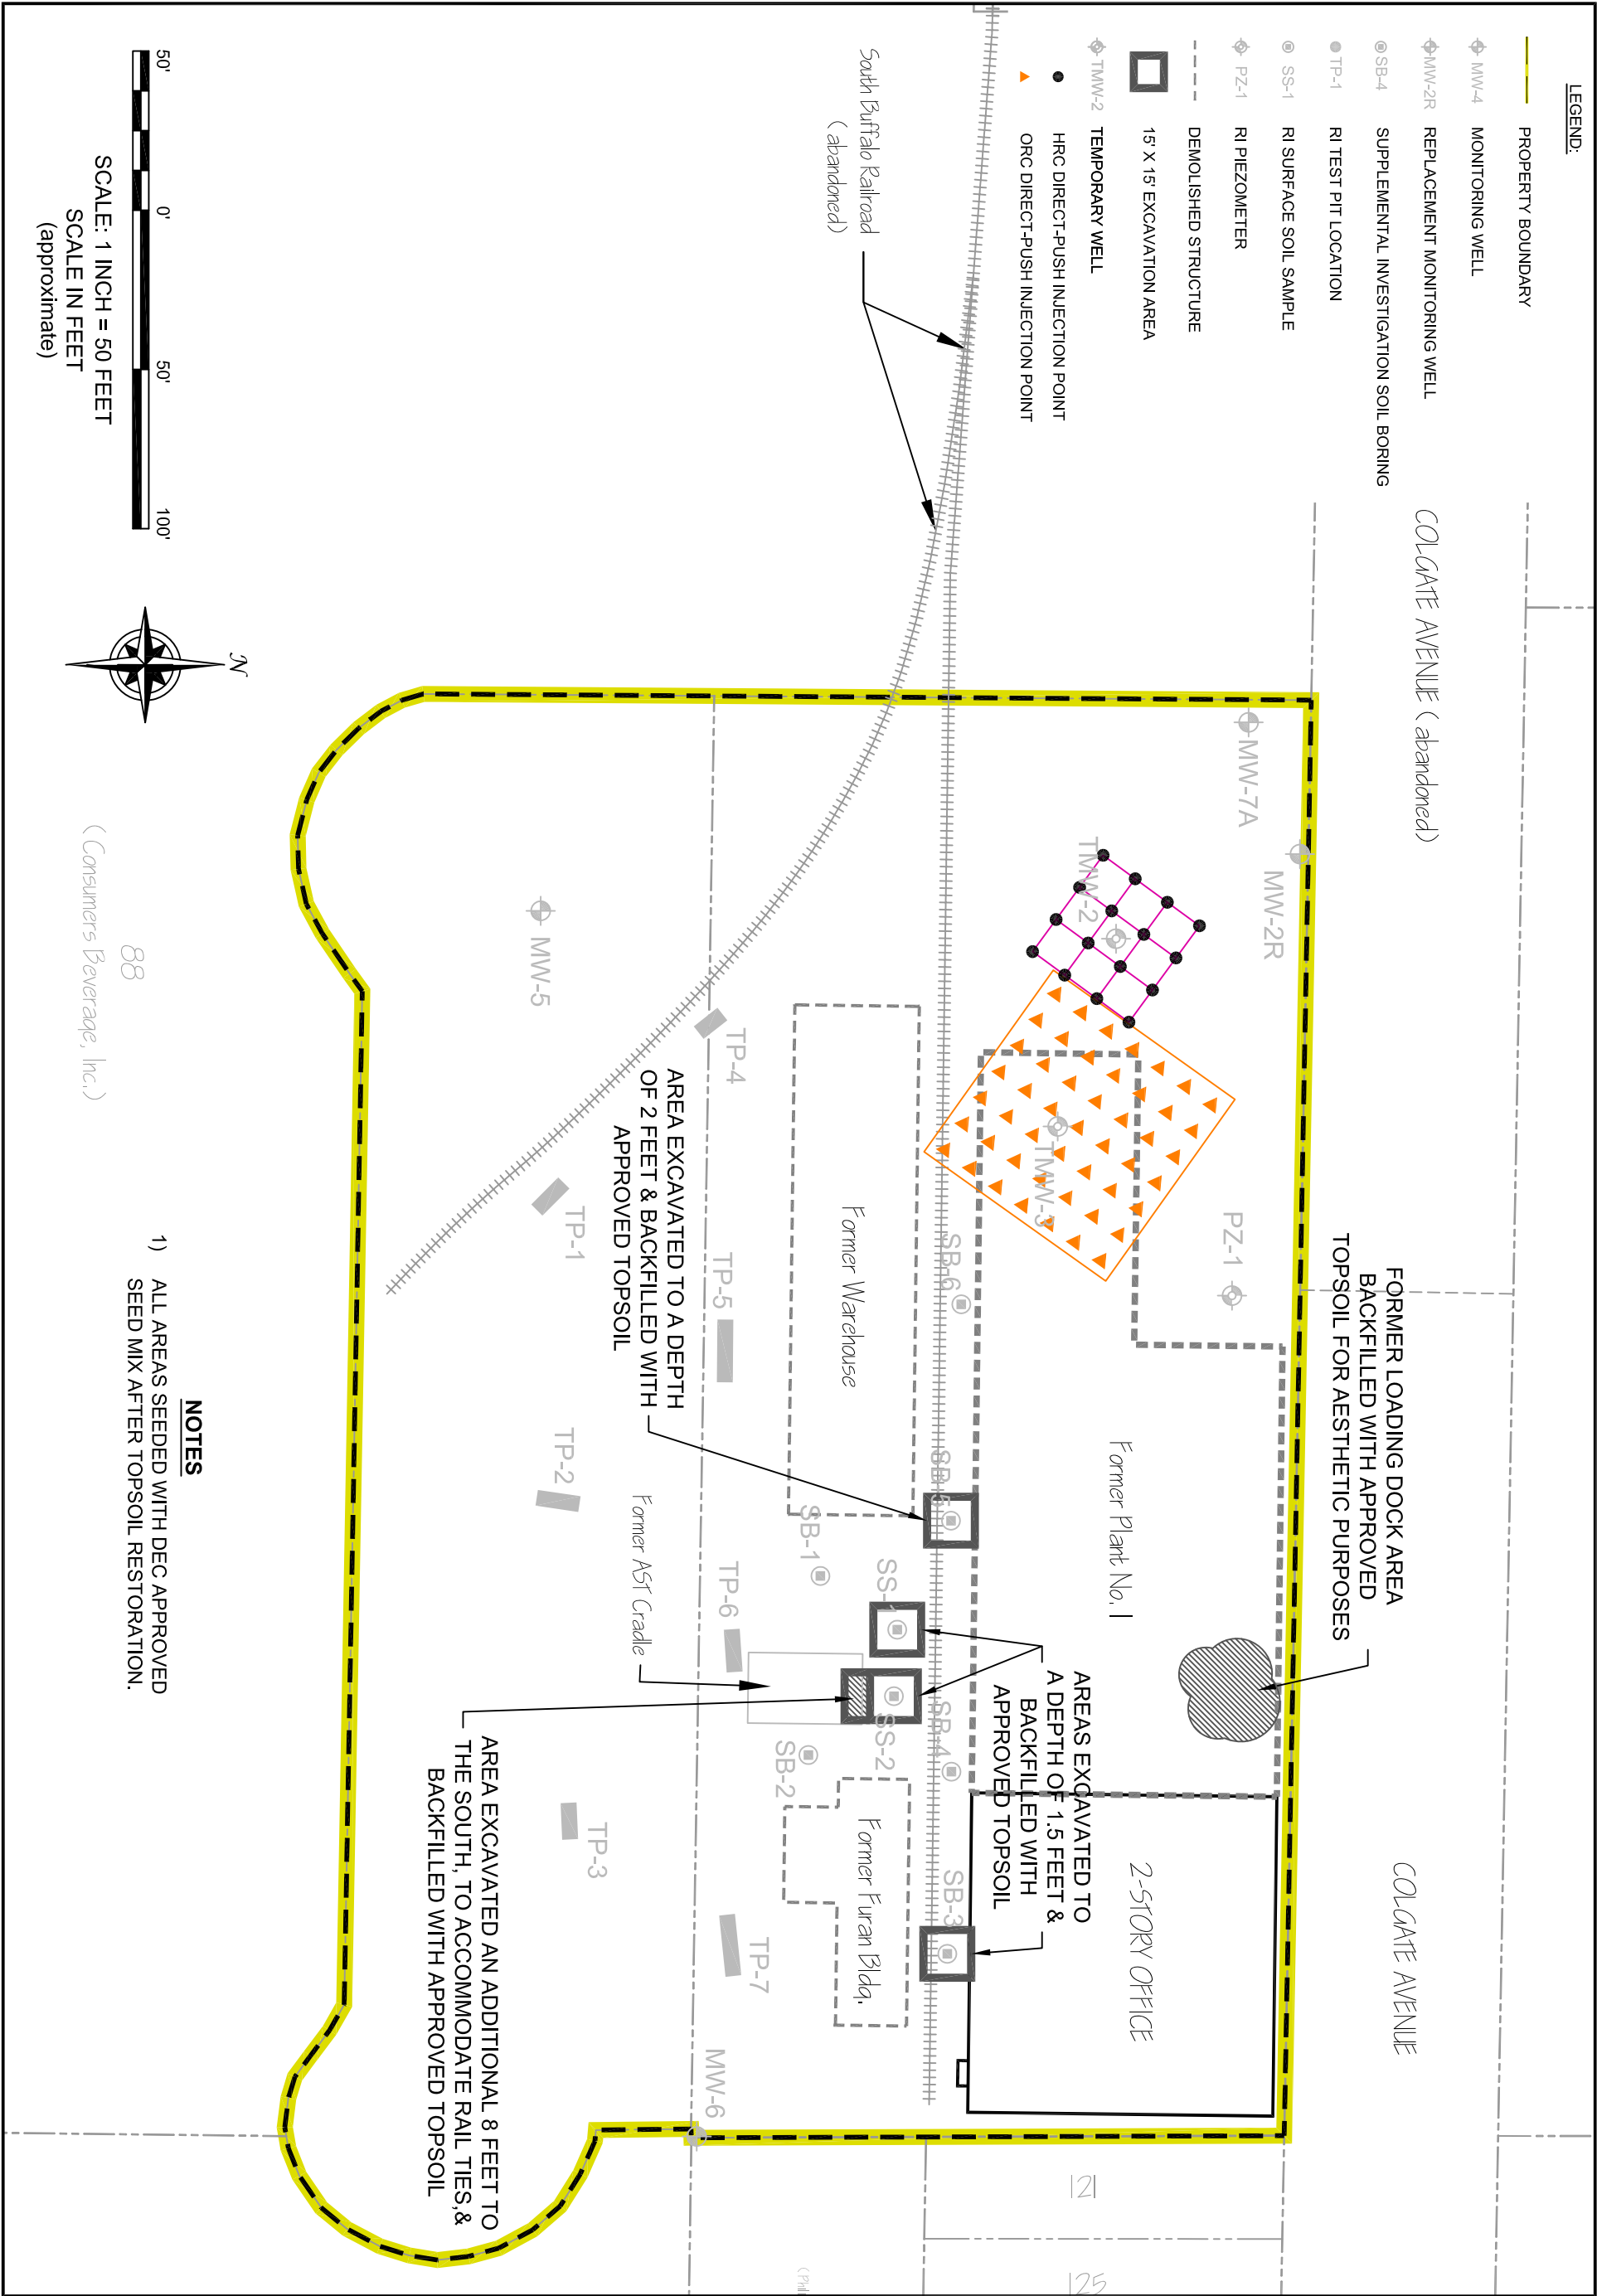
FIGURE 2

In fall 2010, the Site was remediated in accordance with the January 2010 NYSDEC-approved Remedial Action Work Plan (RAWP). The following is a summary of the Remedial Actions performed at the Site (see Figure 2):

1. Excavation of soil/fill exceeding commercial SCO's for lead and PCBs. This required excavation in areas surrounding samples SS-1, SS-2, SB-3, and SB-5. Excavation areas were backfilled with topsoil from an NYSDEC-approved source, as was an area along the north side of the site for aesthetic purposes. Approximately 75 tons of materials were disposed offsite at the Waste Management, Inc. Chaffee Landfill in Chaffee, New York.

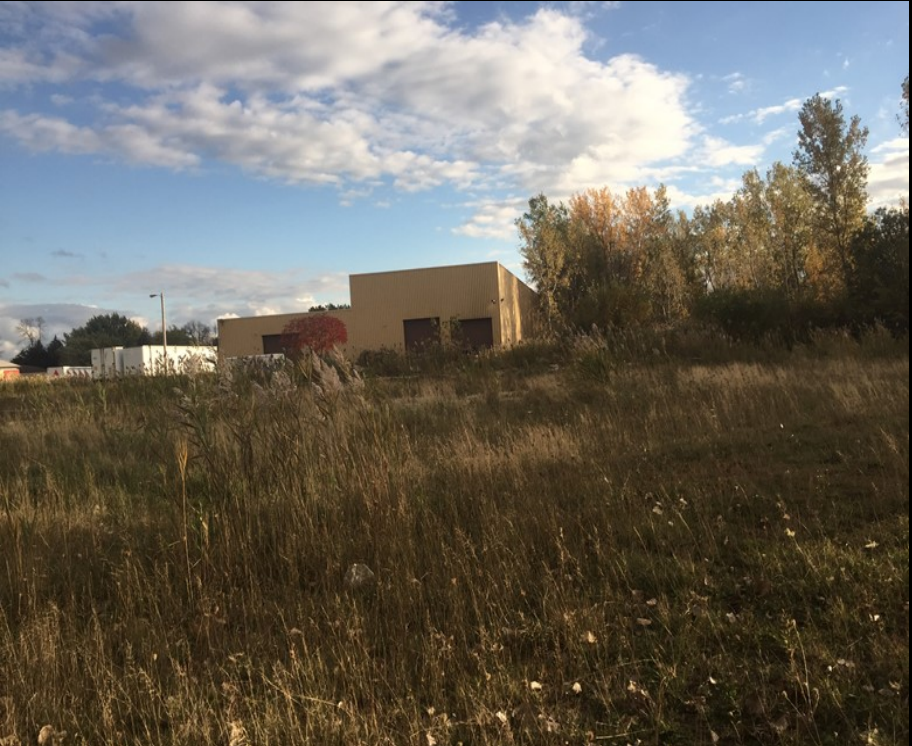
Client Name: National Oilwell Varco		Site Location: Ameron Site: 113-119 Colgate Ave, Buffalo, NY	Project No.: 0100-015-001
Photo No. 1	Date 10/14/15

Direction Photo Taken: South			
Description: Site Conditions - Site entrance looking South toward neighboring beverage distributor

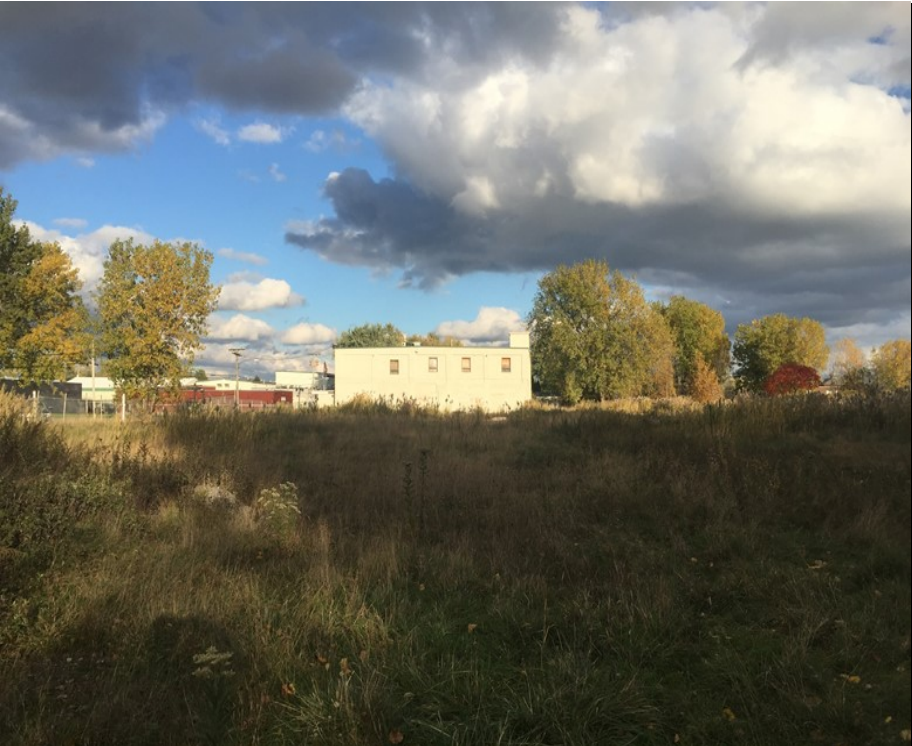
Photo No. 2	Date 10/14/15

Direction Photo Taken: East		
Description: Site Conditions - Existing building

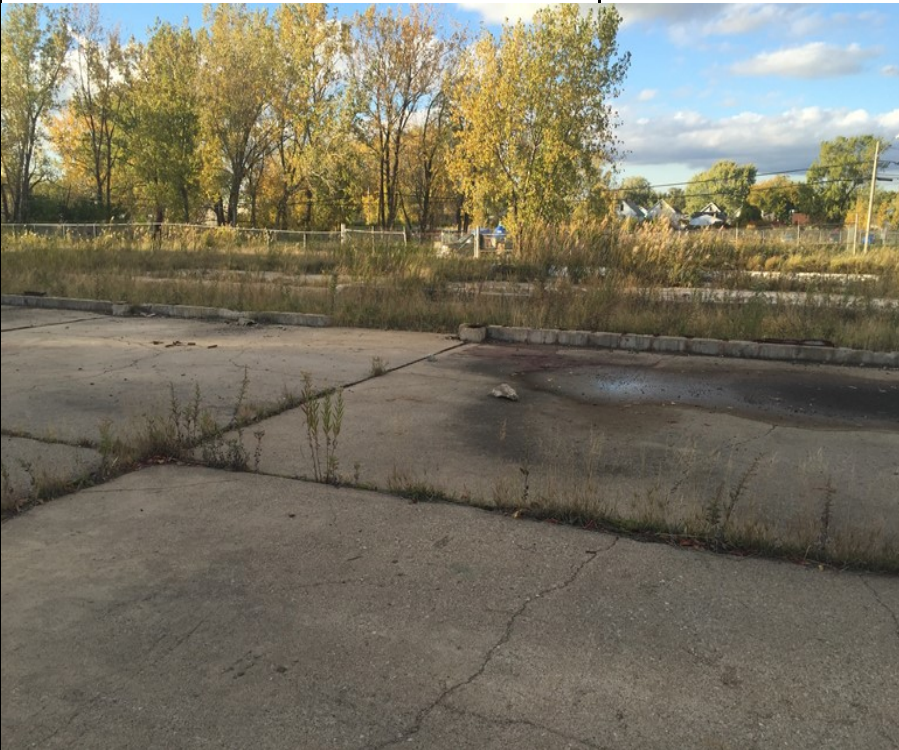
Client Name: National Oilwell Varco		Site Location: Ameron Site: 113-119 Colgate Ave, Buffalo, NY	Project No.: 0100-015-001
Photo No. 3	Date 10/14/15

Direction Photo Taken: North			
Description: Site Conditions - Looking North toward site entrance.

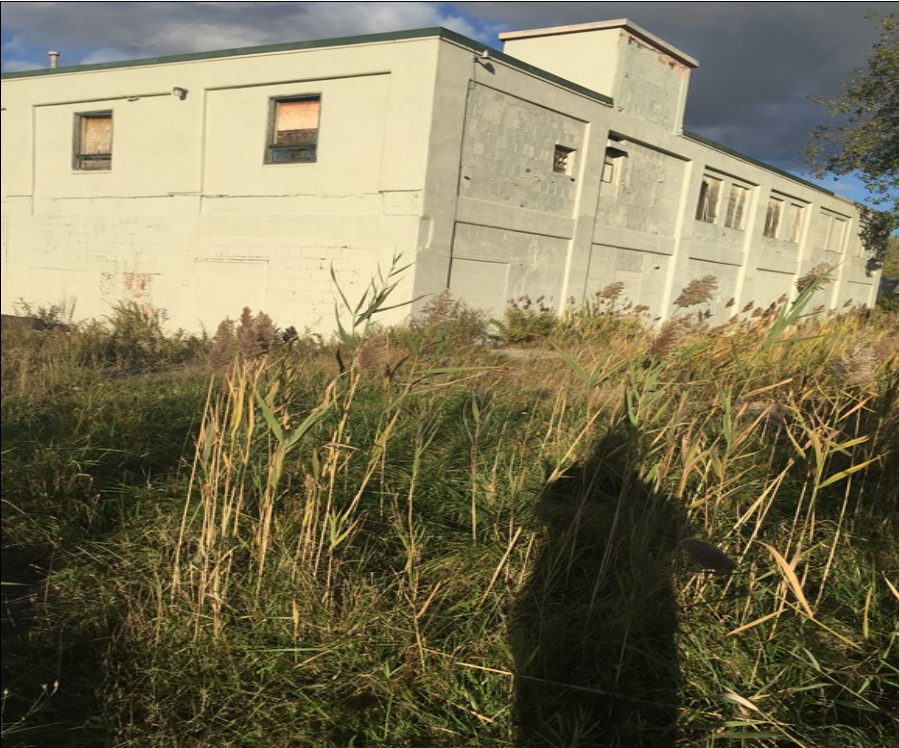
Photo No. 4	Date 10/14/15

Direction Photo Taken: Northeast		
Description: Southwest corner of existing building

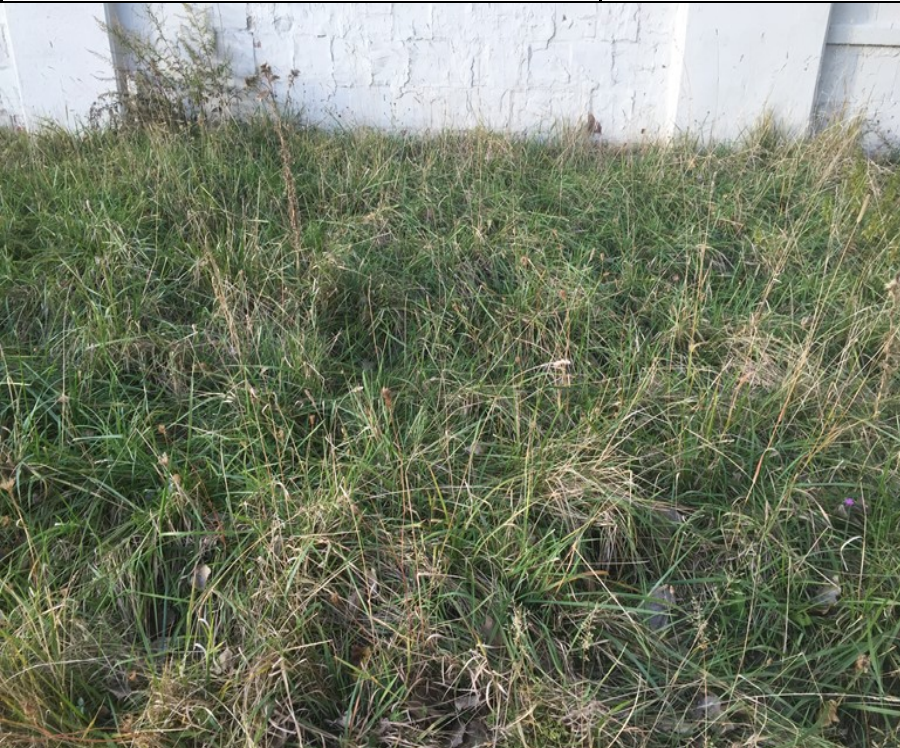
Client Name: National Oilwell Varco		Site Location: Ameron Site: 113-119 Colgate Ave, Buffalo, NY	Project No.: 0100-015-001
Photo No. 5	Date 10/14/15

Direction Photo Taken: North			
Description: Area of prior remedial excavation
