**PERIODIC REVIEW REPORT
PERIOD OCTOBER 31, 2016-OCTOBER 31, 2017
FORMER AMERON SITE
113&119 COLGATE AVENUE
CITY OF BUFFALO, ERIE COUNTY, NEW YORK
NYSDEC SITE NO. C915133**

November 2017

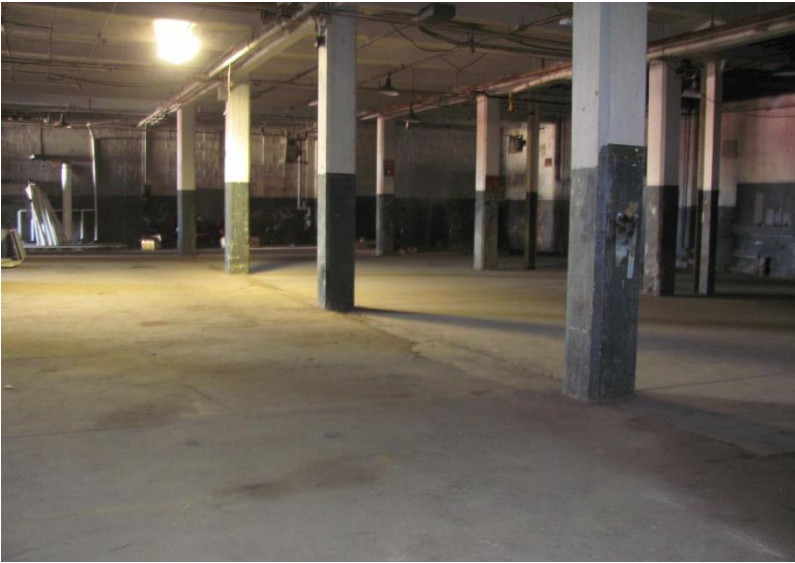
1. View of southcentral area of property facing east -10-2017

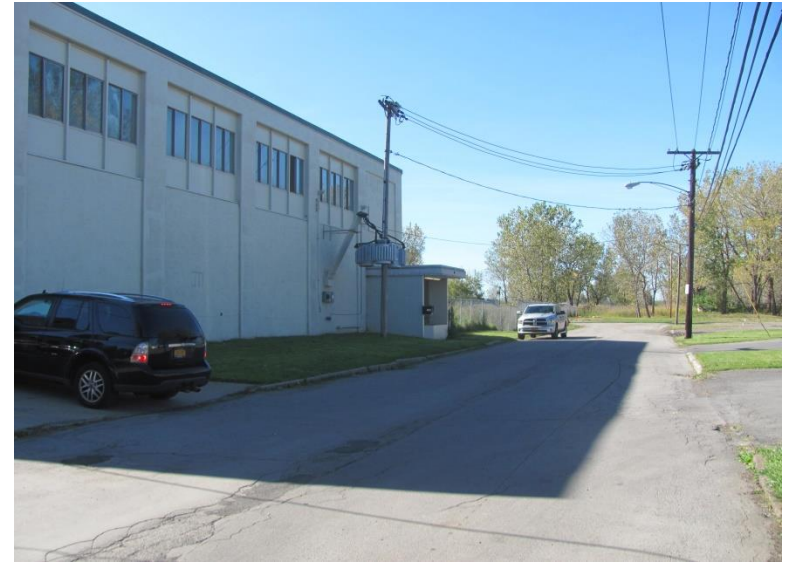
2. View of north side of the subject property along Colgate Avenue facing west- 10-2017

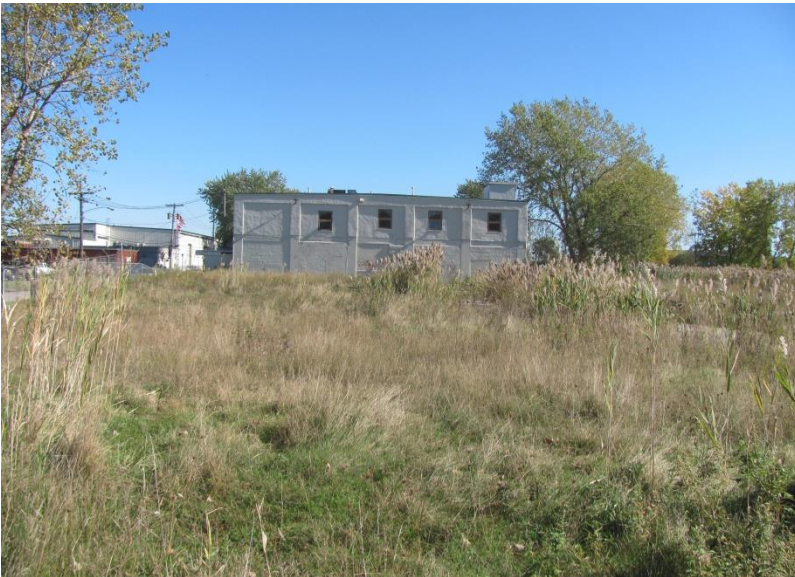
3. View from middle of property facing east - 10-2017

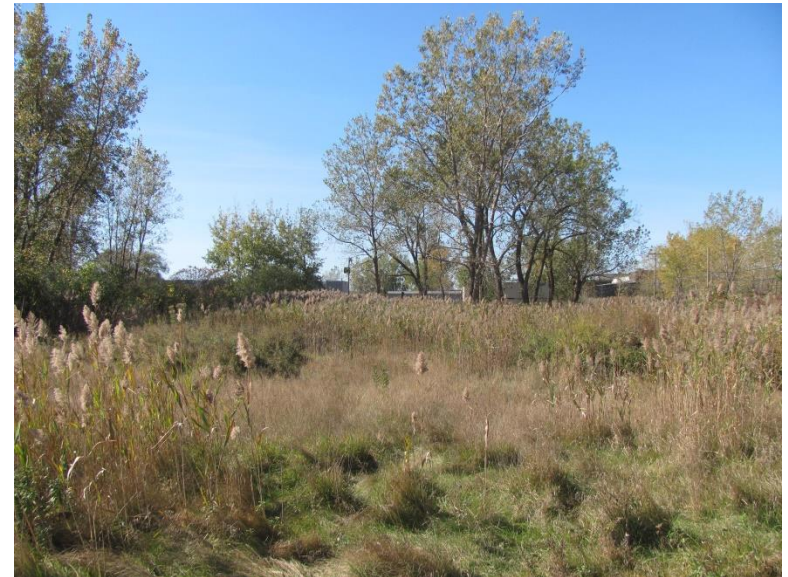
4. View of west end of the property from the middle facing west - 10-2017

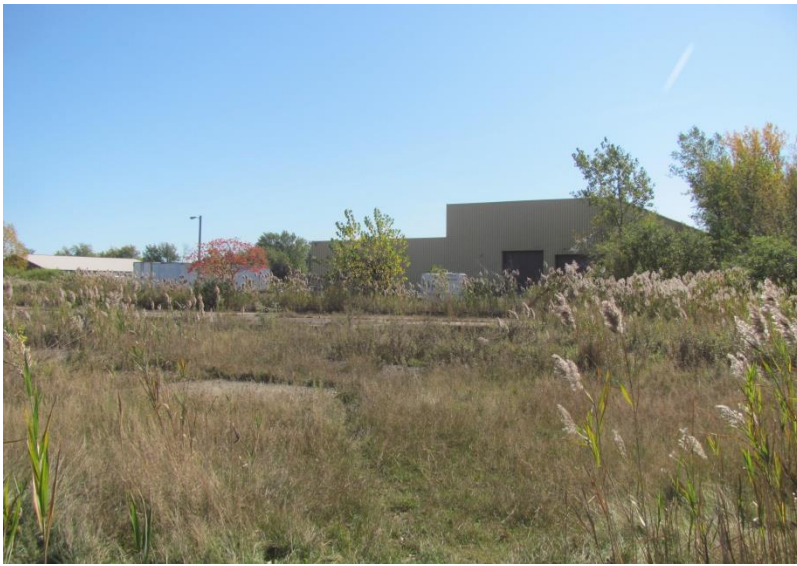
5. View across the subject property at the adjacent southern property from north facing south - 10-217

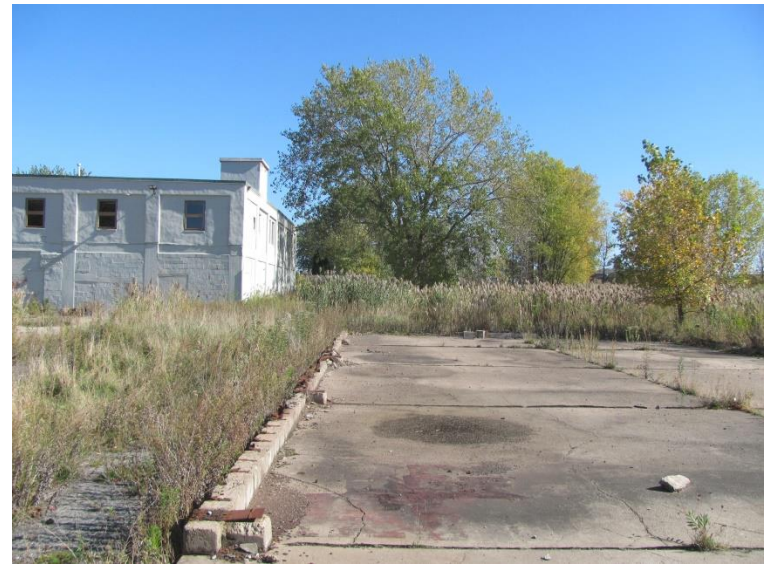
6. South-middle side of property facing east- 10-2017

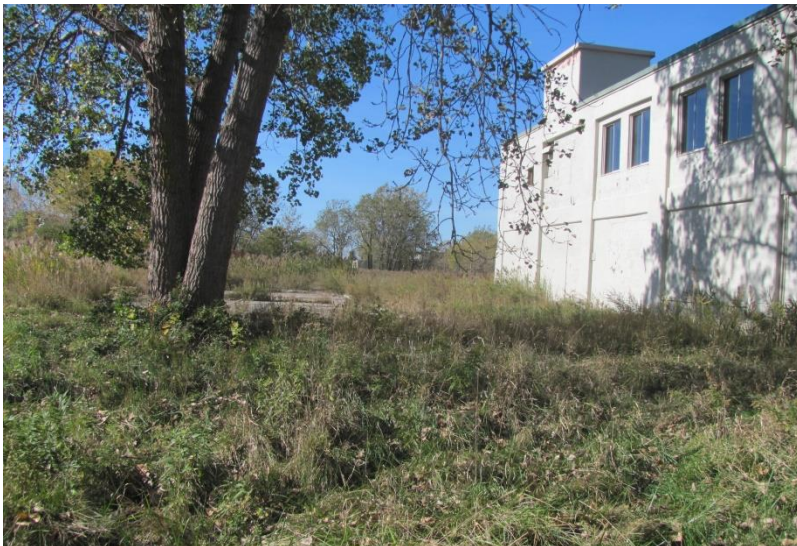
7. View along south side from southeast corner facing northwest 10-2017

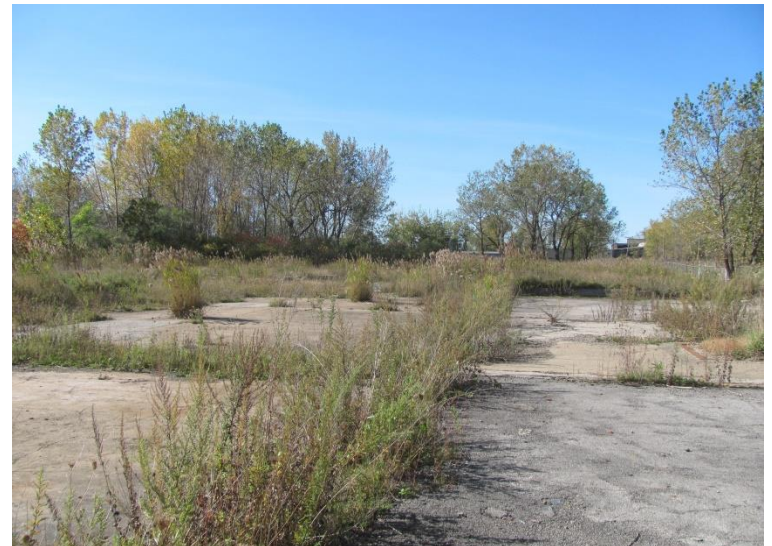
8. View of west side of the property from building facing west - 10-2017

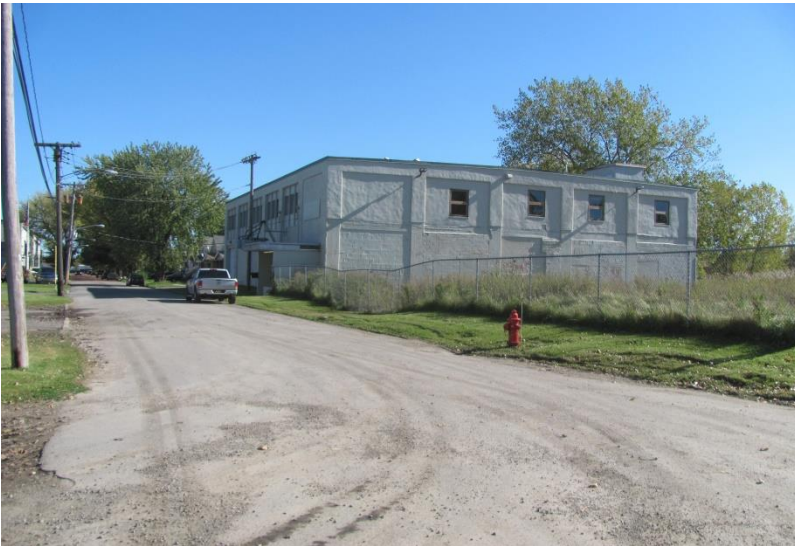
9. View of building from northwest facing southeast 10-2017

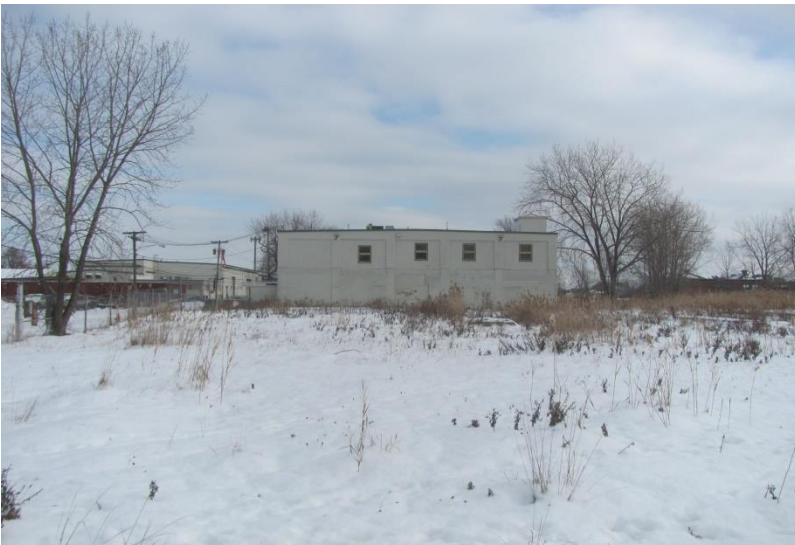
11. View of west side of Colgate property 12-2016

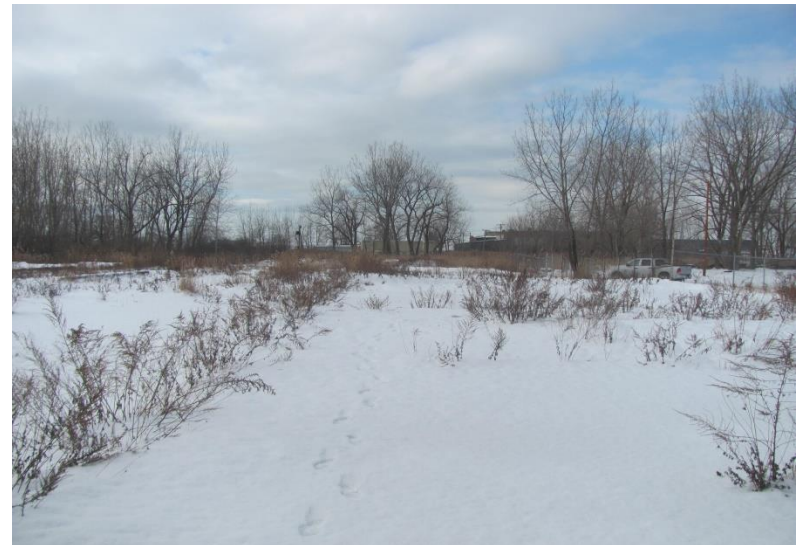
12. View of west side of property facing west 12-2016

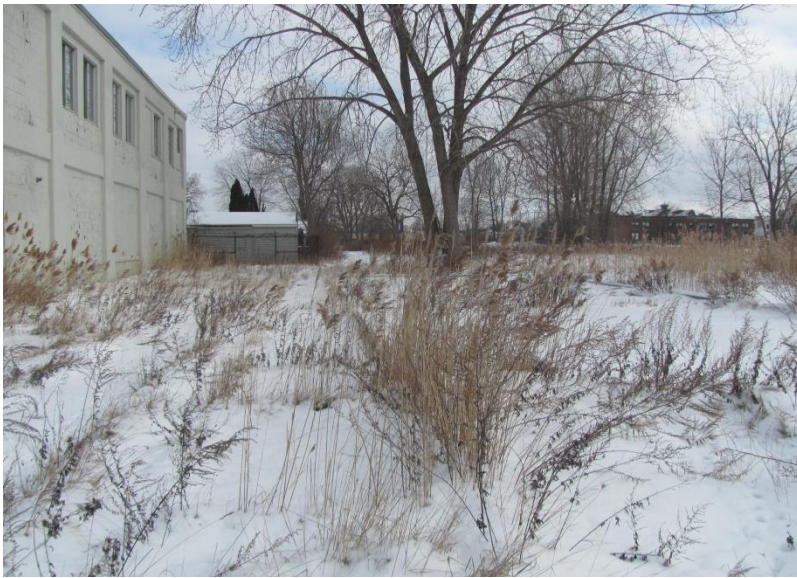
13. View of south side of property facing east 12-2016

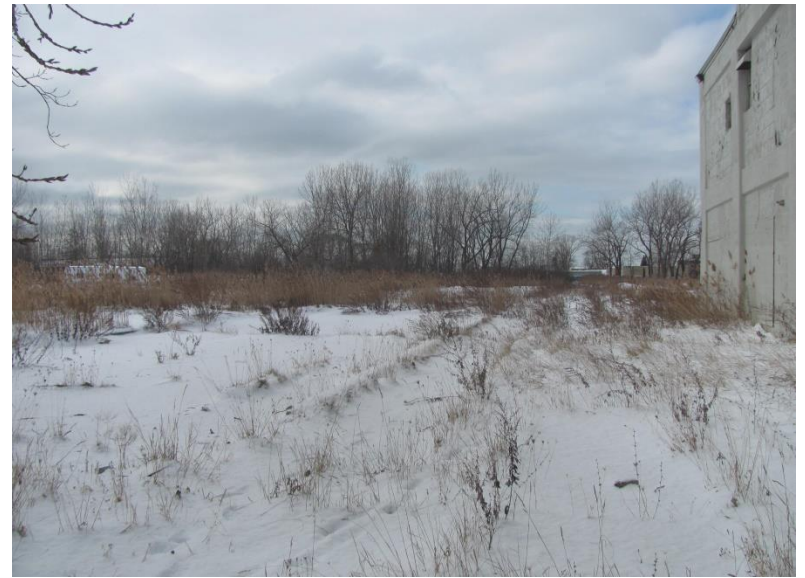
14. View of south side of property facing west 12-2016
