Re: 113-119 Colgate Periodic Review Report (PRR) – 2020-2023

PERIODIC REVIEW REPORT

OCTOBER 31, 2020 – OCTOBER 31, 2023
FORMER AMERON SITE

113 & 119 COLGATE AVENUE
BUFFALO, NEW YORK
NYSDEC SITE NO. 915133

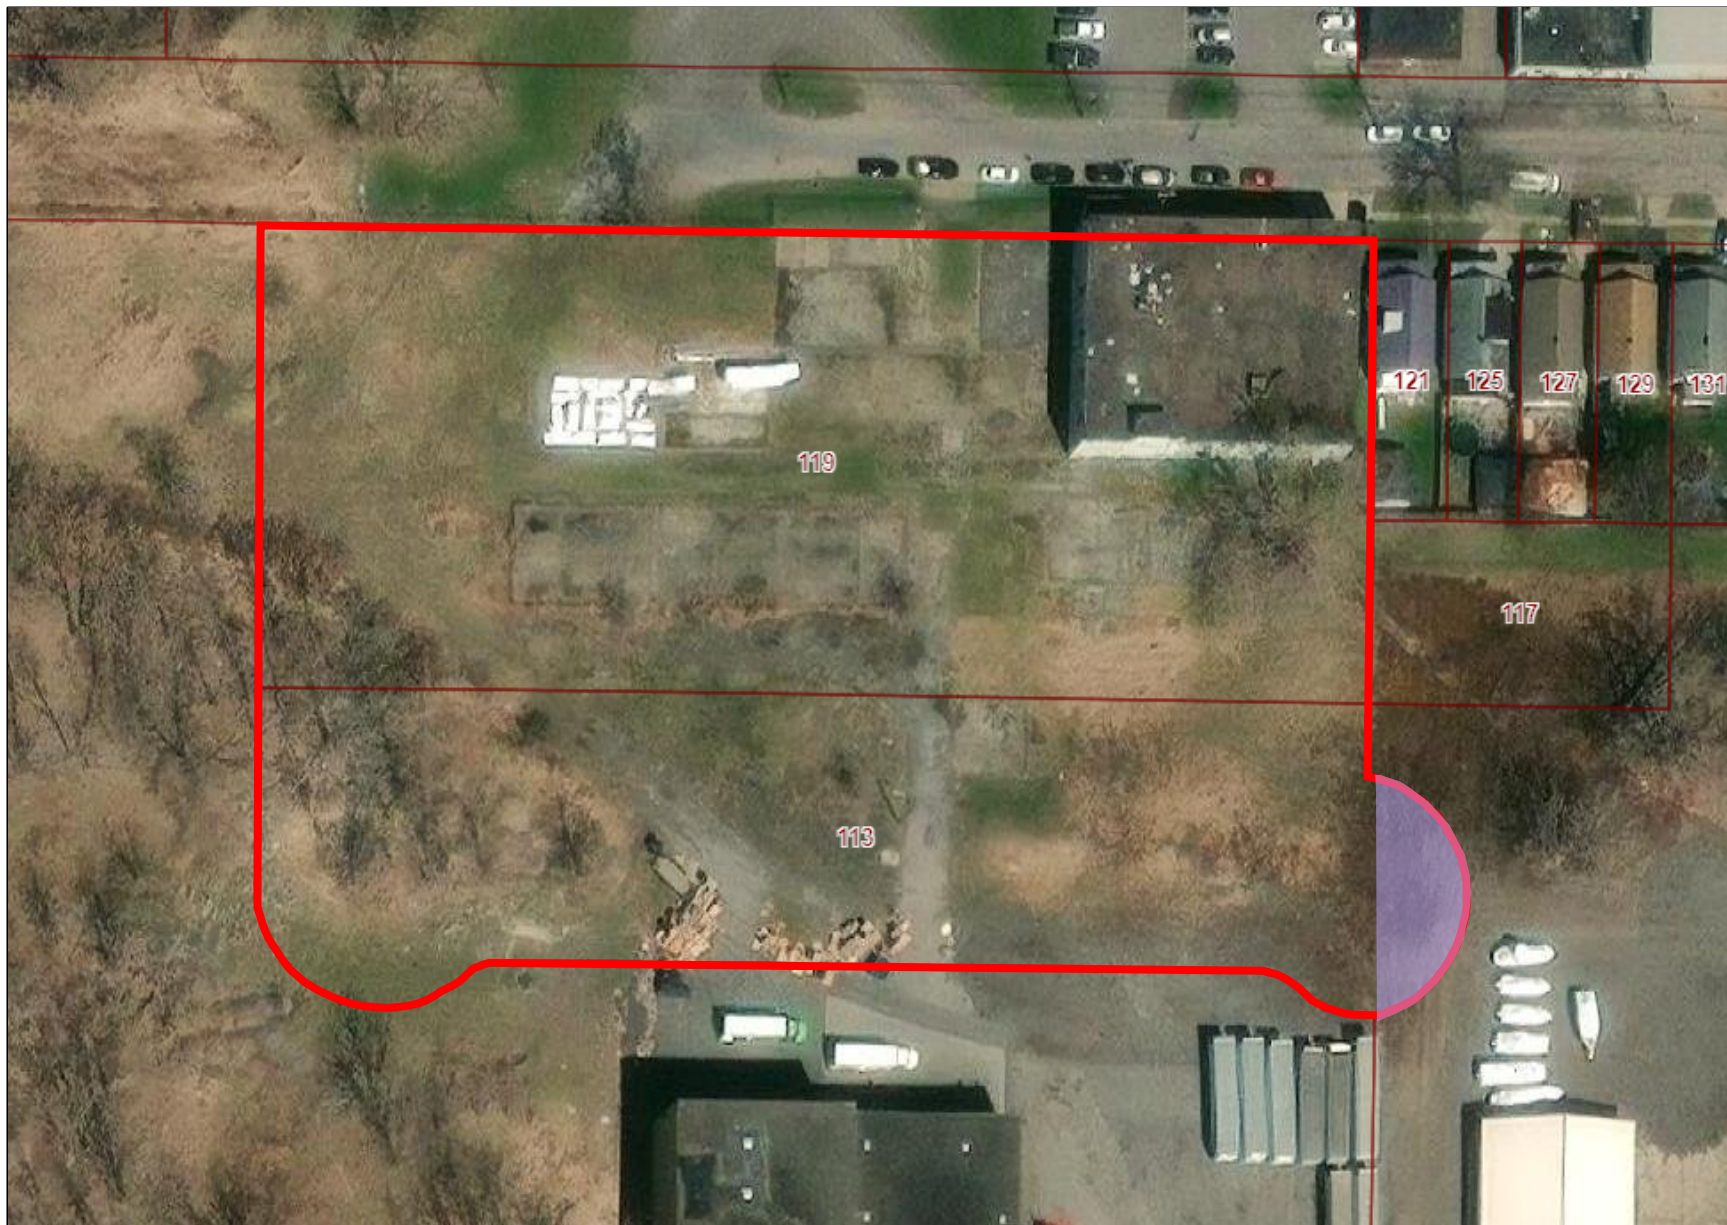
Figure 1 Site Encroachment Location Map

In April 2023, NYSDEC was informed immediately upon discovery by the property owner that ground disturbing activities at the neighboring property had encroached onto the subject Site. Off-site millings were mistakenly deposited by a neighboring property owner on an approximately 0.1-acre area in the southeast portion of the Site. The adjacent property owner was notified, and all millings were subsequently removed. No excavation or on-site removal of soil on the subject property occurred. Seed was placed on the disturbed area to promote vegetation growth and prevent on-site erosion per the SMP requirements. The Department deemed that no further action was required regarding this incident (refer to attached email in **Appendix B**).

The site encroachment comprises approximately 0.05 acres of the BCP Site

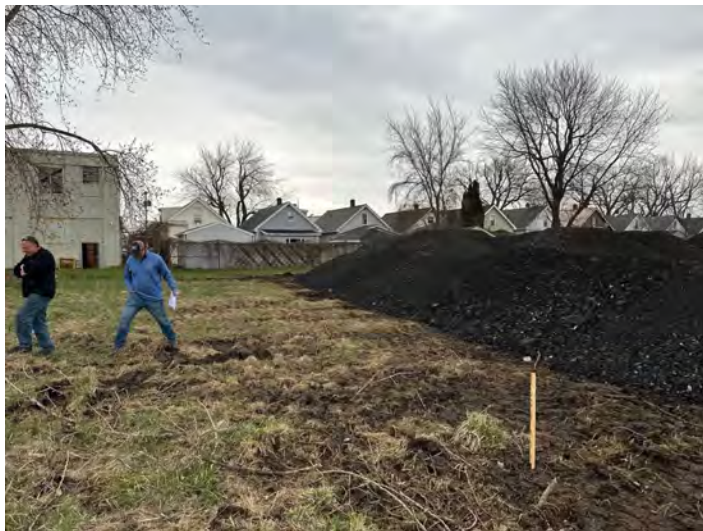
1. Millings unintentionally placed on the Site by a neighboring property owner.

Thanks again for the follow-up and removing the millings from the Ameron Site. Please place seed on the disturbed area to promote vegetation growth and prevent onsite erosion, as the Site Management Plan for this site requires vegetation to stabilize areas not covered by hardscape. I don't expect that any additional action will be required of you at the Ameron Site from the Department related to this incident, once vegetation has been established. In the future, please be cognizant of the restrictions on the Ameron Site and please notify the Department if any hazardous material is uncovered outside the Ameron Site boundaries.

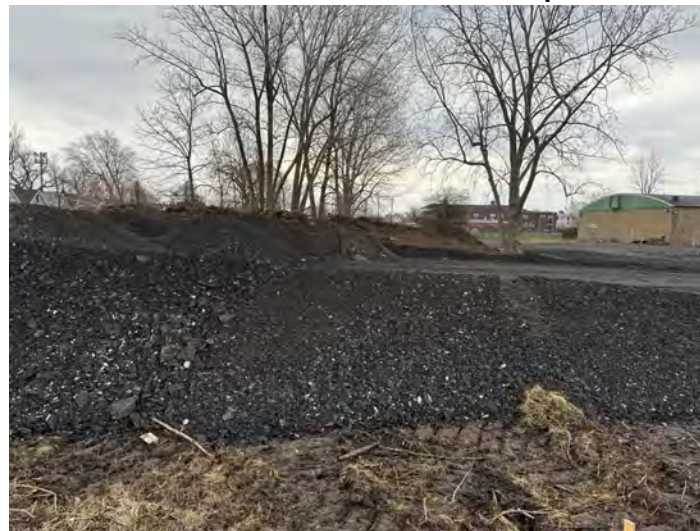
2. Additional view of millings encroaching on the Site.

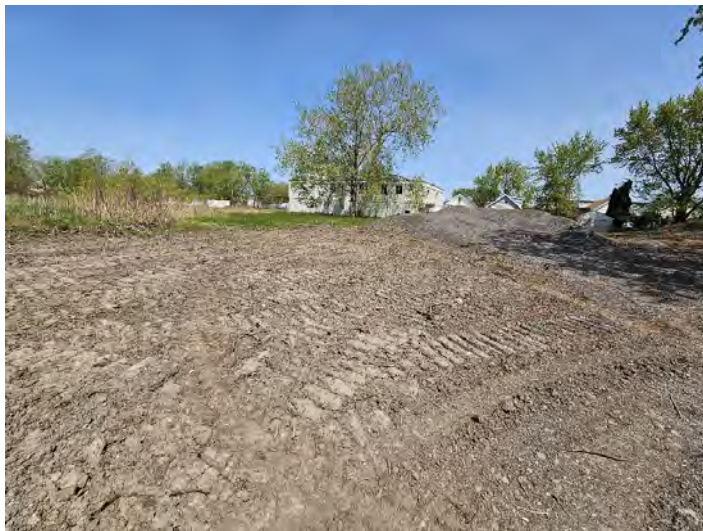
1. View of the Site after millings have been removed, facing north.

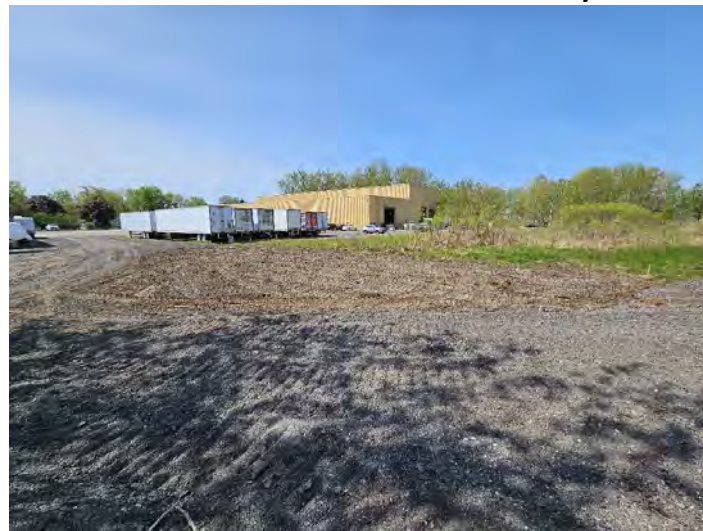
2. View of the Site after millings have been removed, facing south.

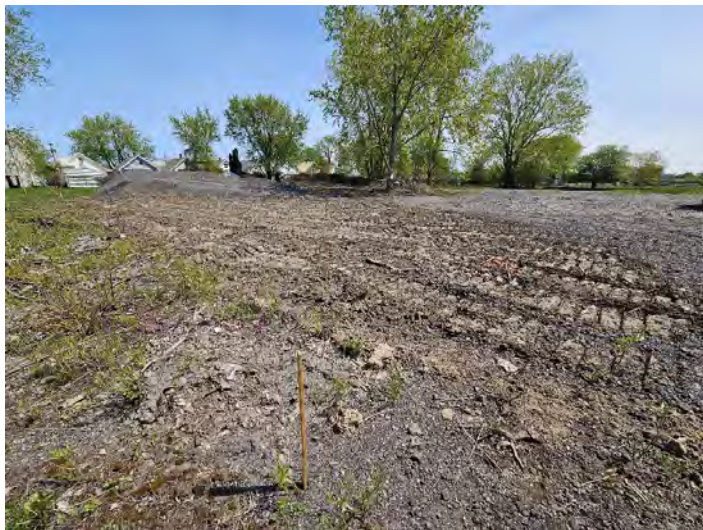
3. View of the Site after millings have been removed, facing northeast.

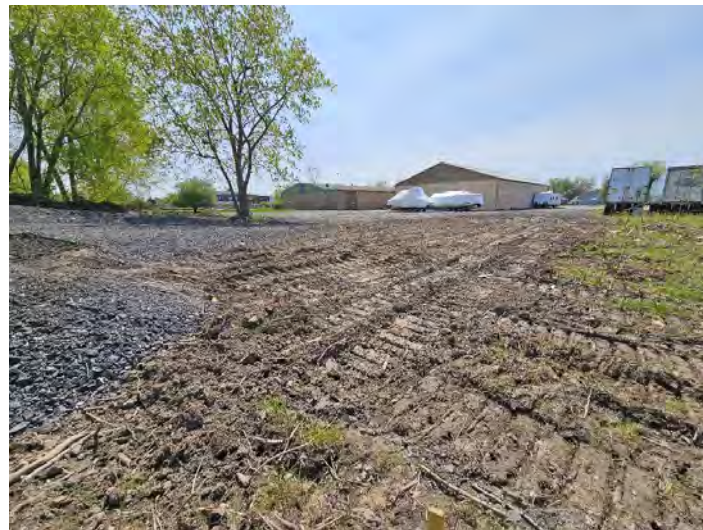
4. View of the Site after millings have been removed, facing southeast.

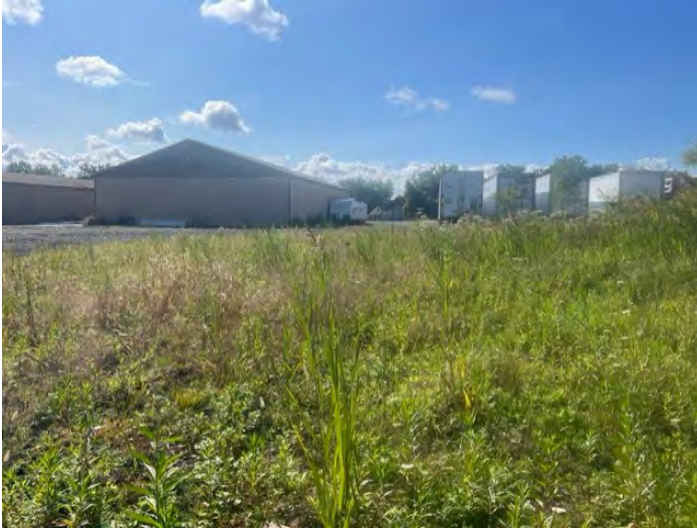
1. Area of encroachment demonstrating vegetative growth, facing south.

General Site Conditions: The Site appears relatively unchanged since the previous 2020 PRR conducted in 2020. Vegetative growth has visibly returned to the area of the site encroachment. Building operations remain consistent.

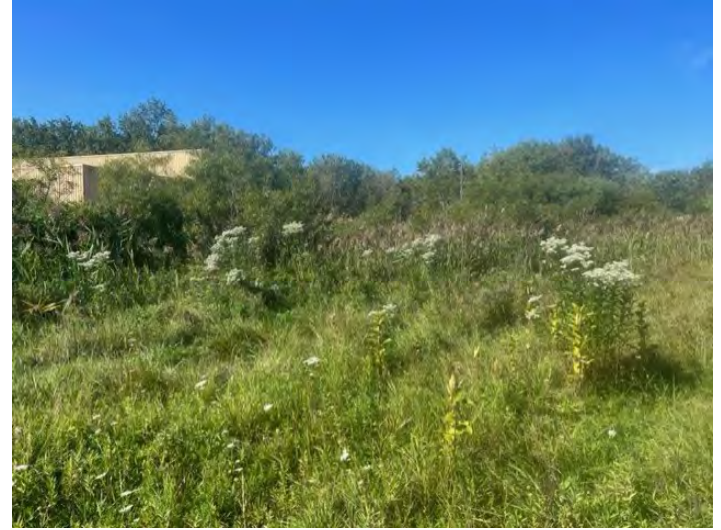
2. Area of encroachment demonstrating vegetative growth, facing southwest.

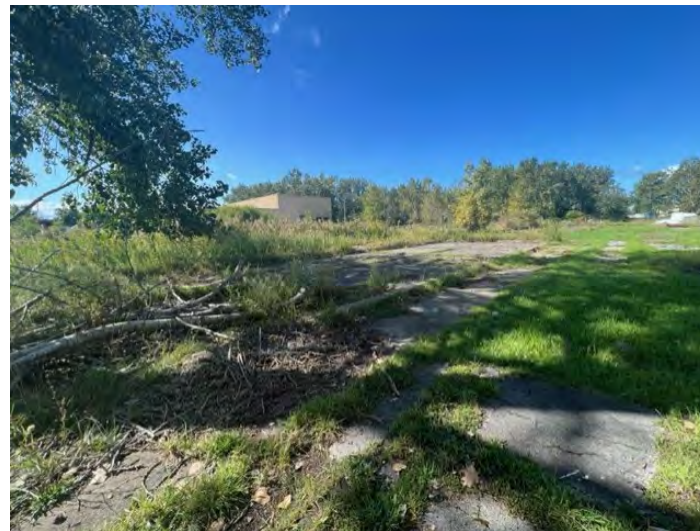
6. Centrally located concrete pads (former building slab), facing west.

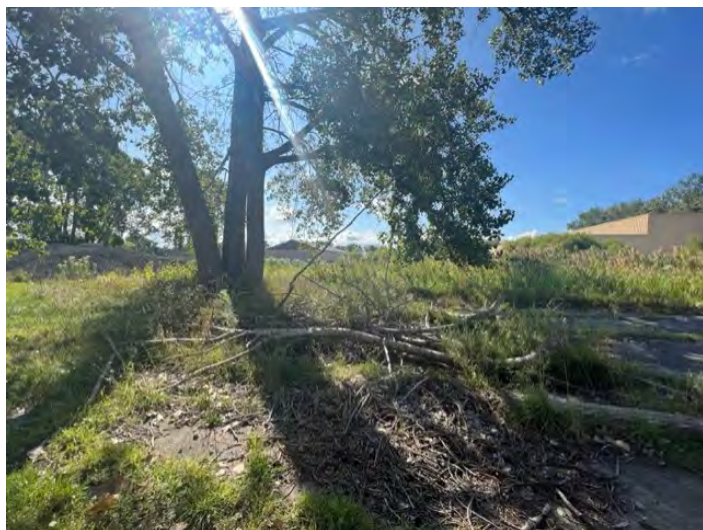
7. Centrally located fallen limbs from 2022 winter storm, facing south.

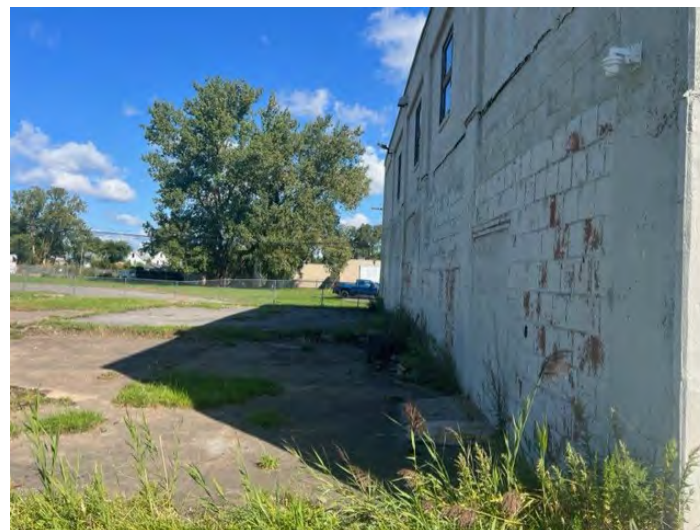
8. Concrete pads (former building slab) immediately south of the on-site building, facing west.
