Re: **Bern Metal Site**

The City of Buffalo has prepared this progress report as part of the inspection and monitoring activities required by the Operations, Maintenance and Monitoring Plan for the Bern Metal/Universal Metal Site in Buffalo, New York.

ACTIVITIES CONDUCTED – June 2008 through May 2009

**Post Closure Inspection Report for Operation, Maintenance and
Monitoring; Inactive Hazardous Waste Site,
Bern Metal/Universal Metal Site
Bender Street, Buffalo, New York**

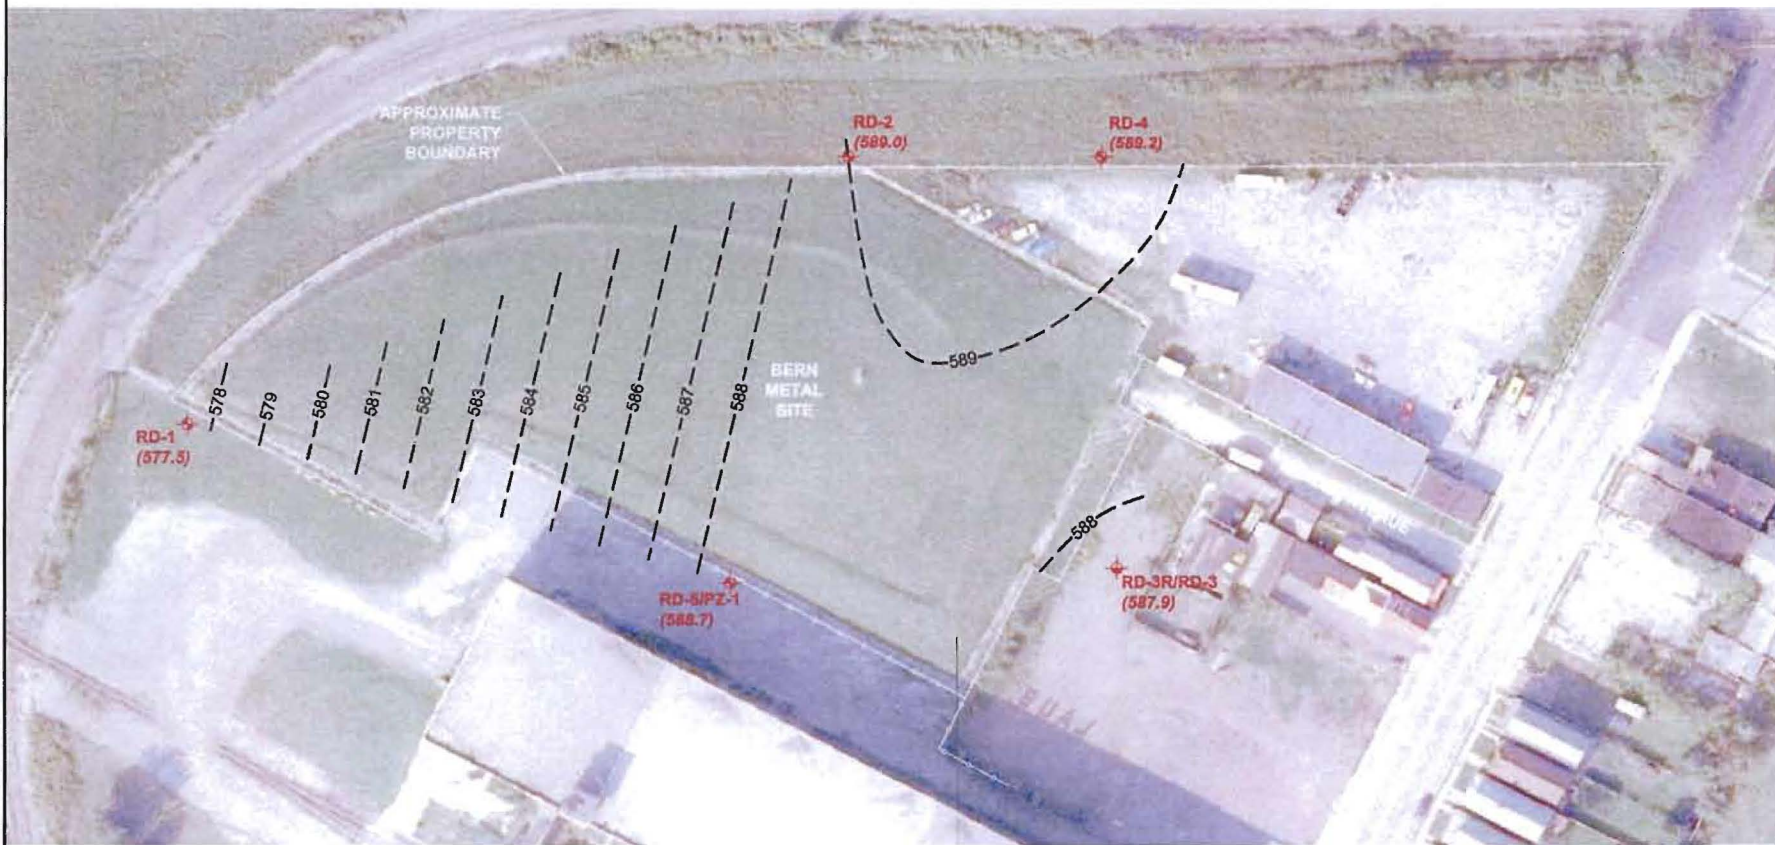
the western portion of the Site in the vicinity of the former Site building, which is no longer present above grade. The groundwater contour shown in Figure 1 is from May 2009. The actual cause of the mounding is unknown (GZA was not present during the demolition and backfilling of the former building) but may be due to portions of the former building remaining in the subsurface or materials used to backfill in the vicinity of the building. The mounding has been observed in a majority of the groundwater elevation measurements collected since 2003.

GZA recommends that the annual groundwater sampling should be discontinued. Lead has been detected at concentrations above method detection limits but below the Class GA criteria in three samples tested in the eight sample rounds completed within the last six years at the Site.
