# 2019 PERIODIC REVIEW REPORT

**Bern Metal Corporation**  
**NYSDEC ID: 915135**

**LiRo Engineers, Inc.**  
690 Delaware Avenue  
Buffalo, New York 14209

February 7, 2020

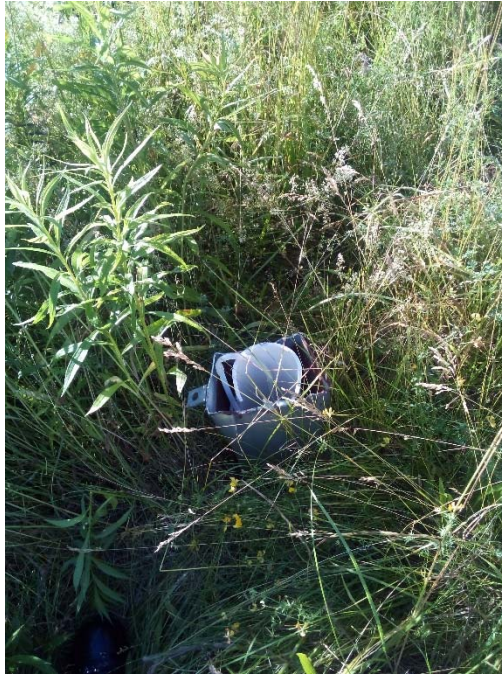
Four of the five site monitoring wells were found to be in good condition, however, one monitoring well, RD-3/RD-3R was found to be damaged. The upper 2 to 3 inches of the steel protective casing and PVC well casing at RD-3/RD-3R appear to have been crushed and the lockable lid on the protective casing was missing.

Photo No. 1 – Monitoring well RD-3/RD-3R with damaged protective casing and damaged PVC riser.

- Site inspections should continue to be performed annually during the spring;
- Groundwater monitoring should be performed during the certifying period ending in May 2022, as approved by NYSDEC;
- The steel protective casing at monitoring well RD-3/RD-3R should be replaced;
- The vegetative cover on the landfill cap should be mowed annually;
- Baiting and trapping for rodent control should be initiated each spring;
- Backfilling of rodent burrows should be completed following removal of rodents; and,
- Continued removal of vegetation from the perimeter drainage ditch to reduce the risk of vegetative spread onto the landfill cap.

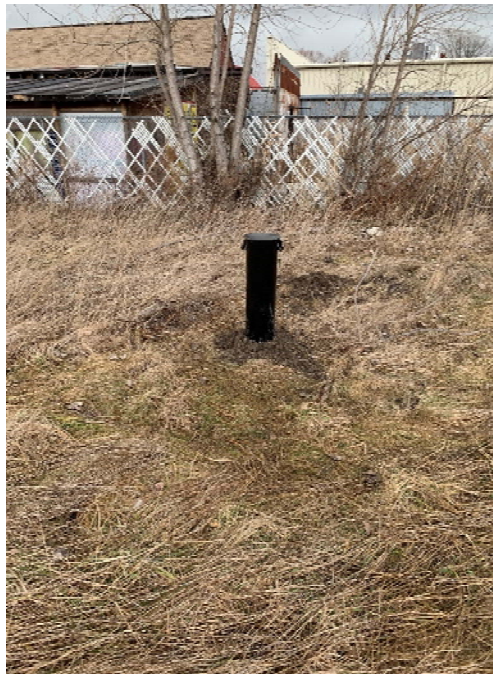
Photo No. 2 – Monitoring well RD-3/RD-3R with new protective casing and repaired PVC riser.

- The steel protective casing at monitoring well RD-3/RD-3R was removed and replaced;

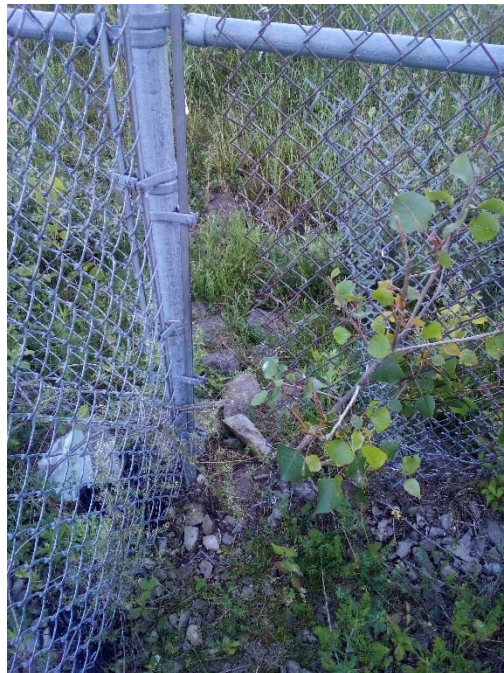
During the inspection of the stormwater drainage system, Japanese Knotweed and other shrubs were observed in areas within the perimeter drainage ditch. Japanese Knotweed growth was particularly heavy in areas of the stormwater drainage system where water is retained.

Photo No. 6 – Japanese Knot wood growing near fence corner.

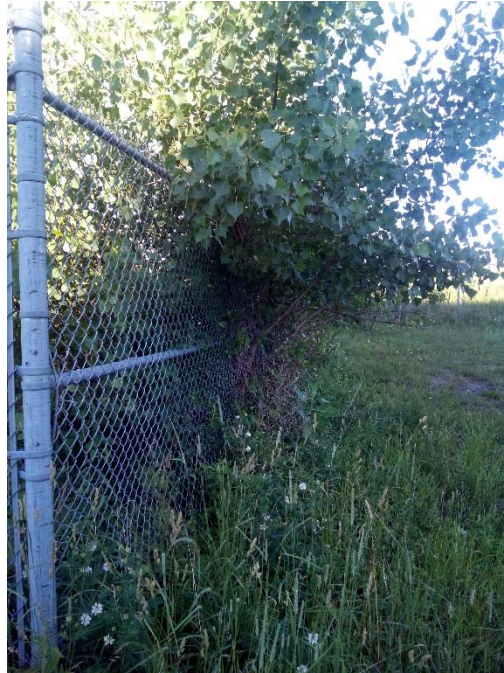
Photo No. 7 – Vegetation growth within drainage swale along fence line.

- Three breeches of the Site perimeter fencing have been repaired; and,
- All excessive vegetative growth within the Site perimeter drainage swale have been cut down to prohibit future growth.

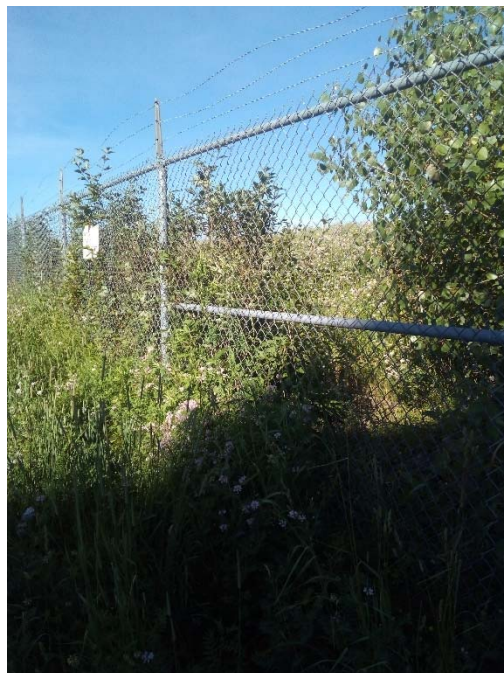
Photo No. 8 – Vegetation growth within drainage swale along fence line.

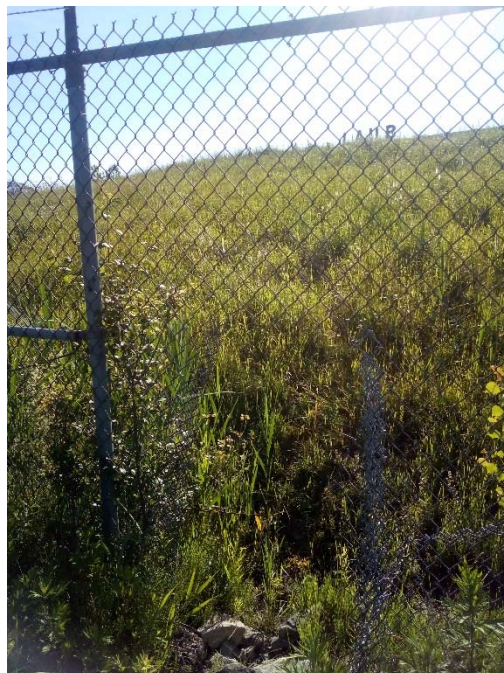
Photo No. 10 – View towards site from the west, hole cut in fence.
