# 2022 Periodic Review Report

(Reporting Period: May 15, 2021 to May 15, 2022)

Bern Metal Corporation  
22 Bender Avenue, City of Buffalo, New York  
NYSDEC Site No. 915135

LaBella Project No. 2223105

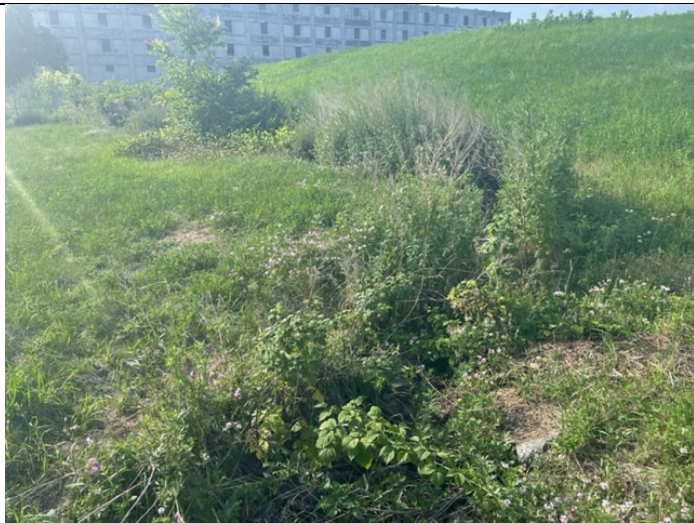
Typical view northern side of the Site

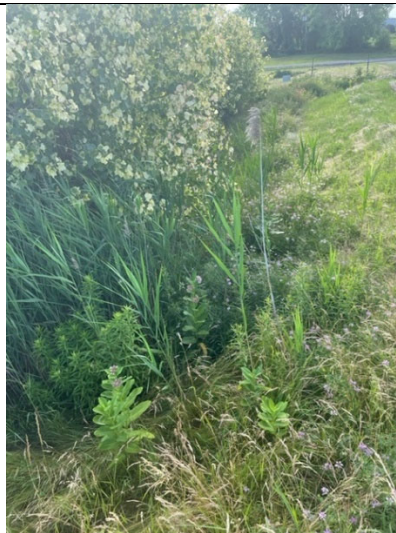
Bush growth in perimeter drainage ditch along east side of the Site

Corrective measures during this reporting period included fence repairs and site mowing, completed in June 2022. The brush growth within the perimeter drainage ditch is scheduled to be cut/removed.

- No changes to the inspection, reporting or certification frequency prescribed for the Site;
- Vegetation from the perimeter drainage ditches should be removed.

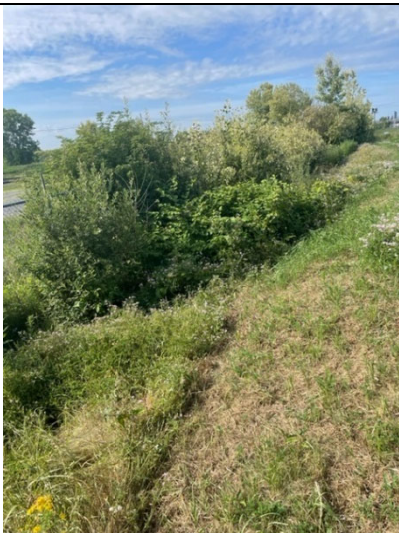
Bush growth in perimeter drainage ditch along south side of the Site

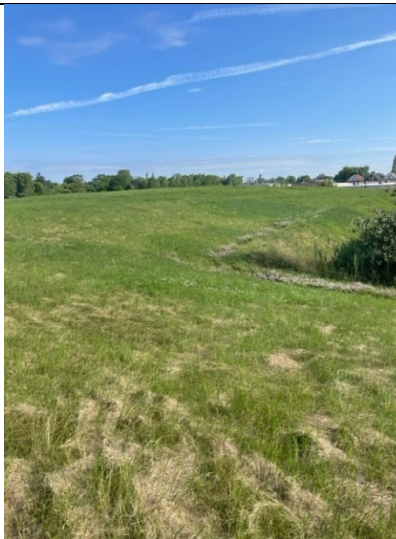
Typical view of the top of the hill at the Site

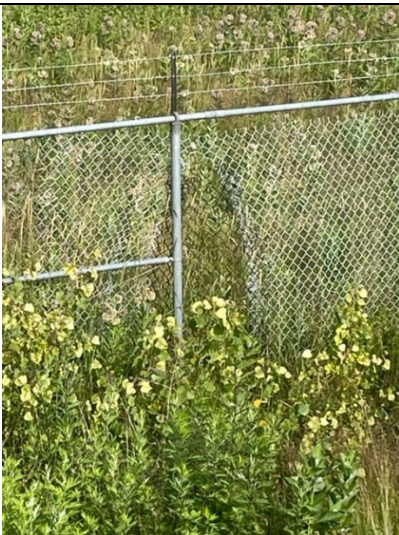
Repaired fencing along western edge of the Site

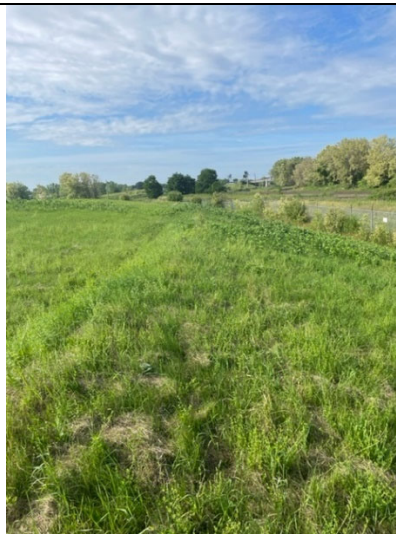
View of hill slope on western side of the Site

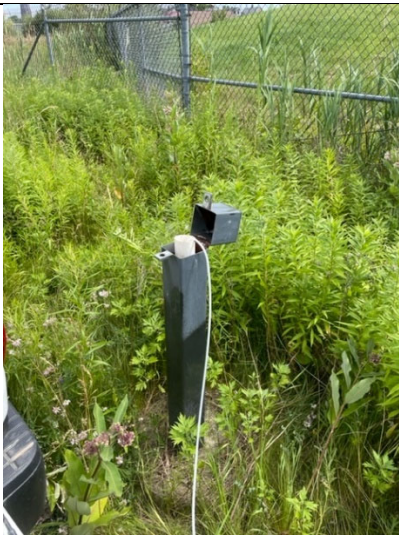
Typical groundwater monitoring well

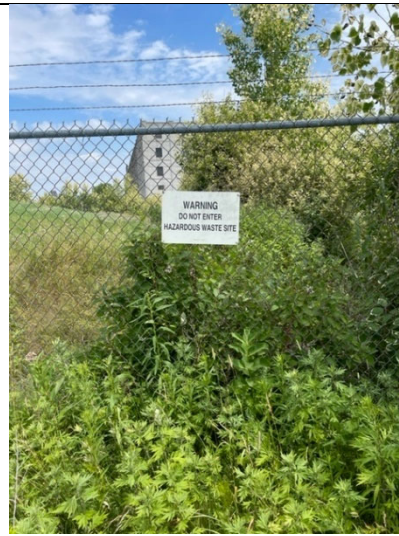
Typical sign on perimeter fencing
