## Construction Complete Report

### Northern DNAPL Recovery System

### Scajaquada Creek Remediation Project Buffalo, New York

November 30, 2001

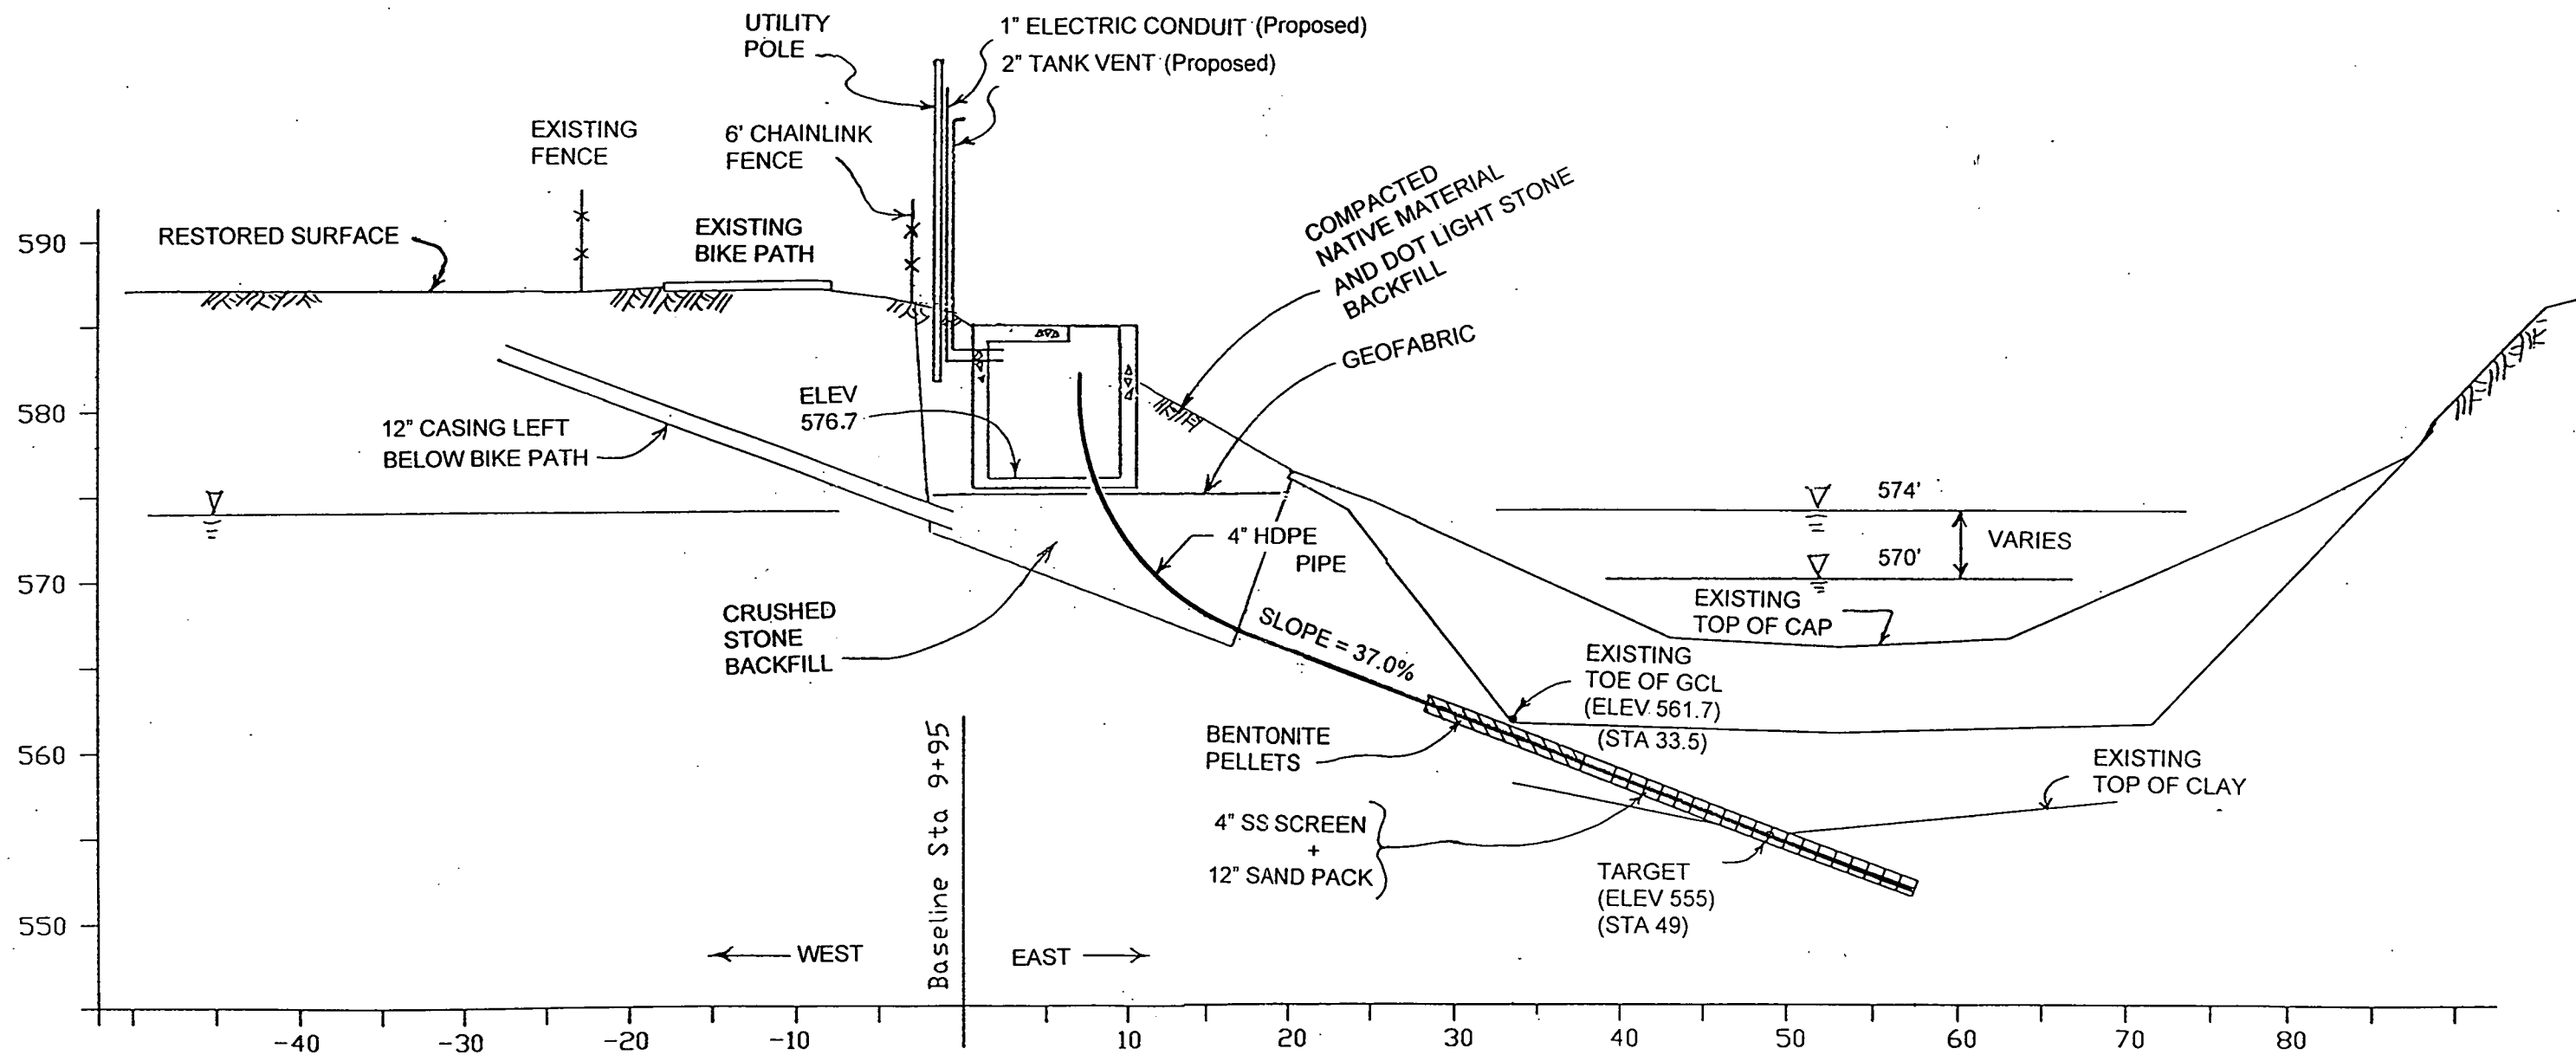
**RETEC**  
RETEC ENGINEERING, P.C.  
Date: 11/30/01 By: mrf  
Figure 2

- Placed drill string, by directional drilling, through the design target location, 12 feet into the lower confining clay layer as shown in the Figures. Deviation of the as-built drilling path from the design, was negligible.
- Installed a 12-inch temporary iron casing, by pneumatic driving, over the full length of the drill string.
- Removed the directional drill string and bored out the 12-inch casing. All drill cuttings were containerized in drums, sampled, analyzed, transferred to a lined rolloff, and disposed offsite as non-hazardous waste. Analytical data is provided in Appendix A.
- Installed the 4-inch diameter well pipe and screen.
- Installed the sandpack by hydraulic recirculation.
- Installed the bentonite collar by hydraulic recirculation.

- Excavated a narrow trench to uncover the 12-inch iron casing below the vault footprint.
- Pulled the 12-inch iron casing back approximately 65 feet to expose the HDPE pipe.
- Cut the HDPE pipe and bent it up as shown in the Figures.
- Backfilled the narrow trench with compacted crushed stone.
- Placed geofabric across the bench, followed by additional compacted crushed stone for vault subbase.

Scajaquada Creek  
Northern DNAPL System  
(As-Built)  
Well and Vault Placement

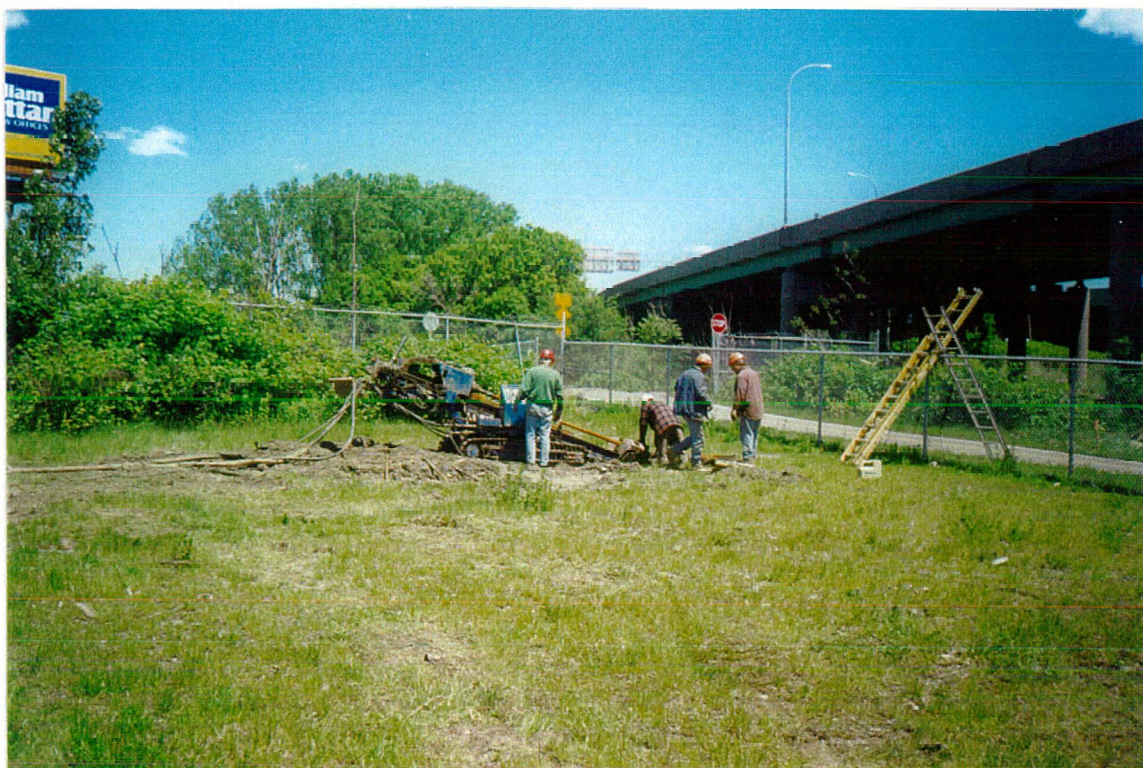
1A. Directional drilling to target area.

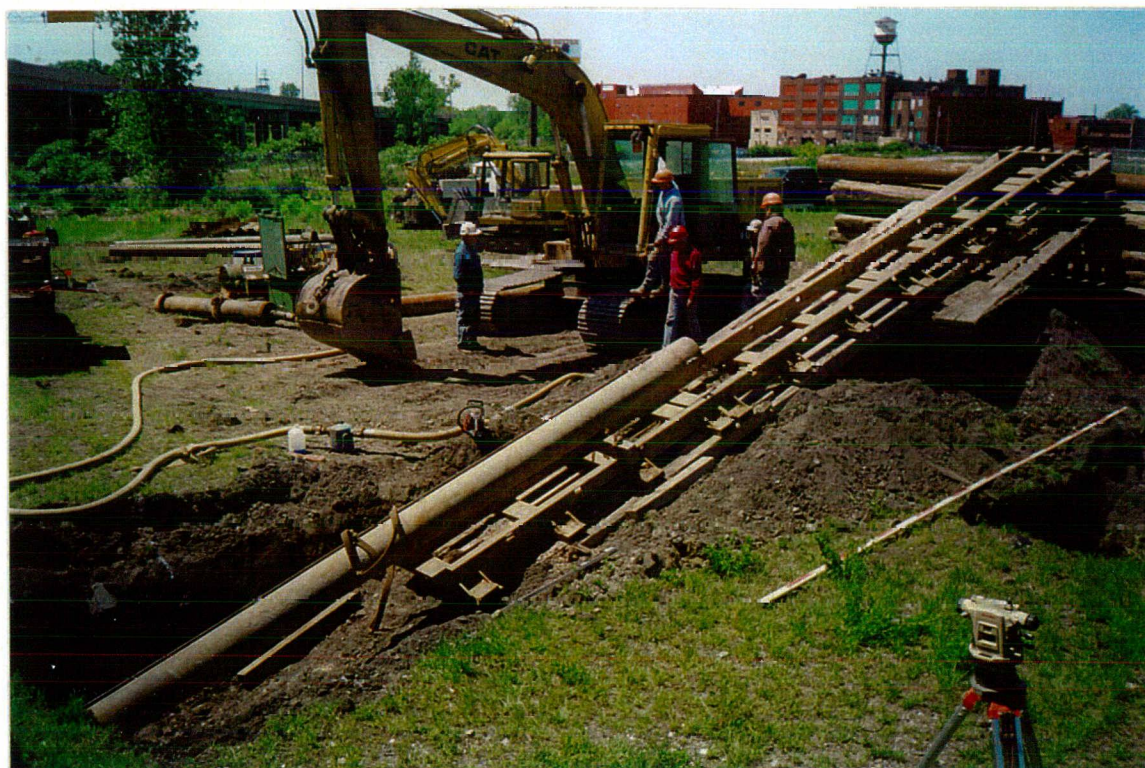
1B. Driving 12-inch casing over directional drill string.

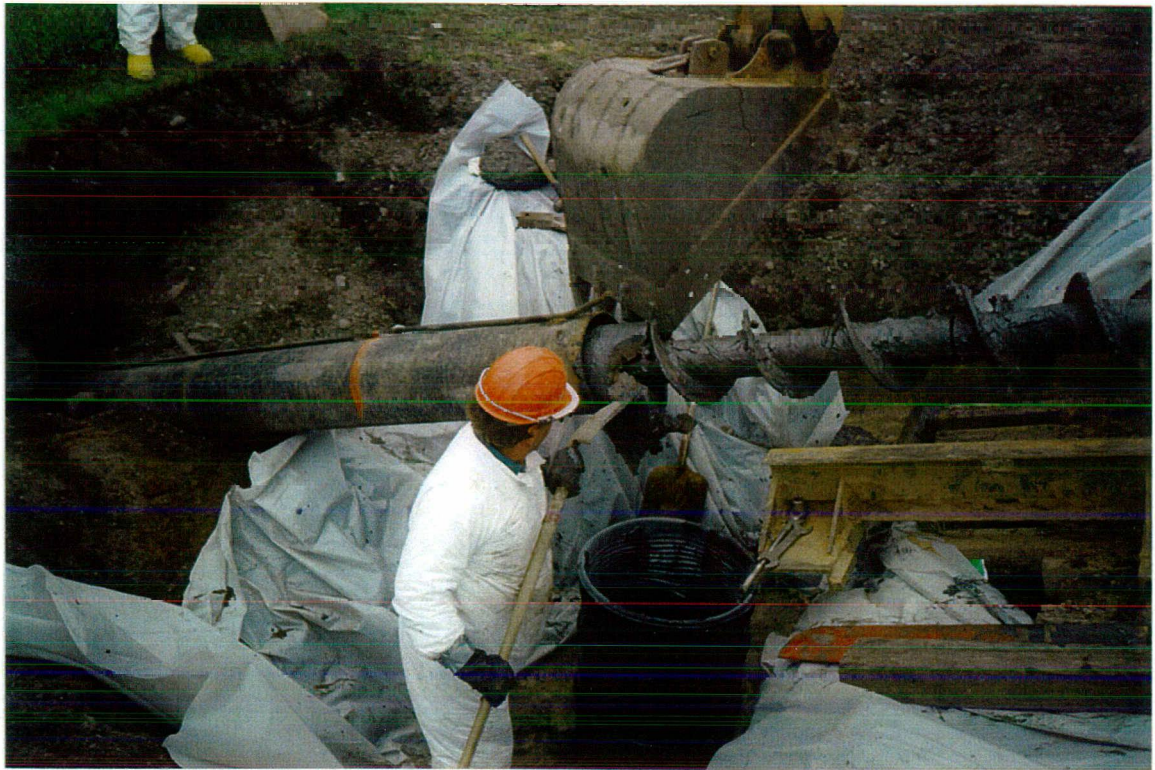
2A. Containerizing drill cuttings.

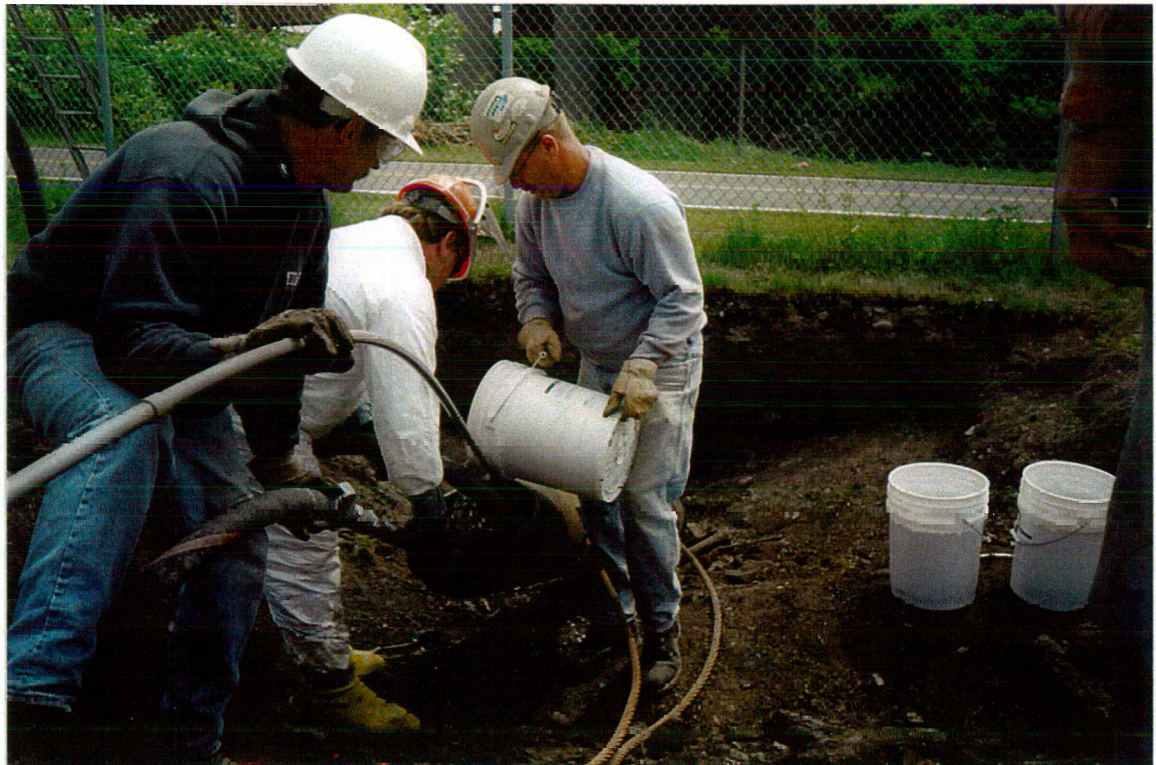
2B. Installing well materials.

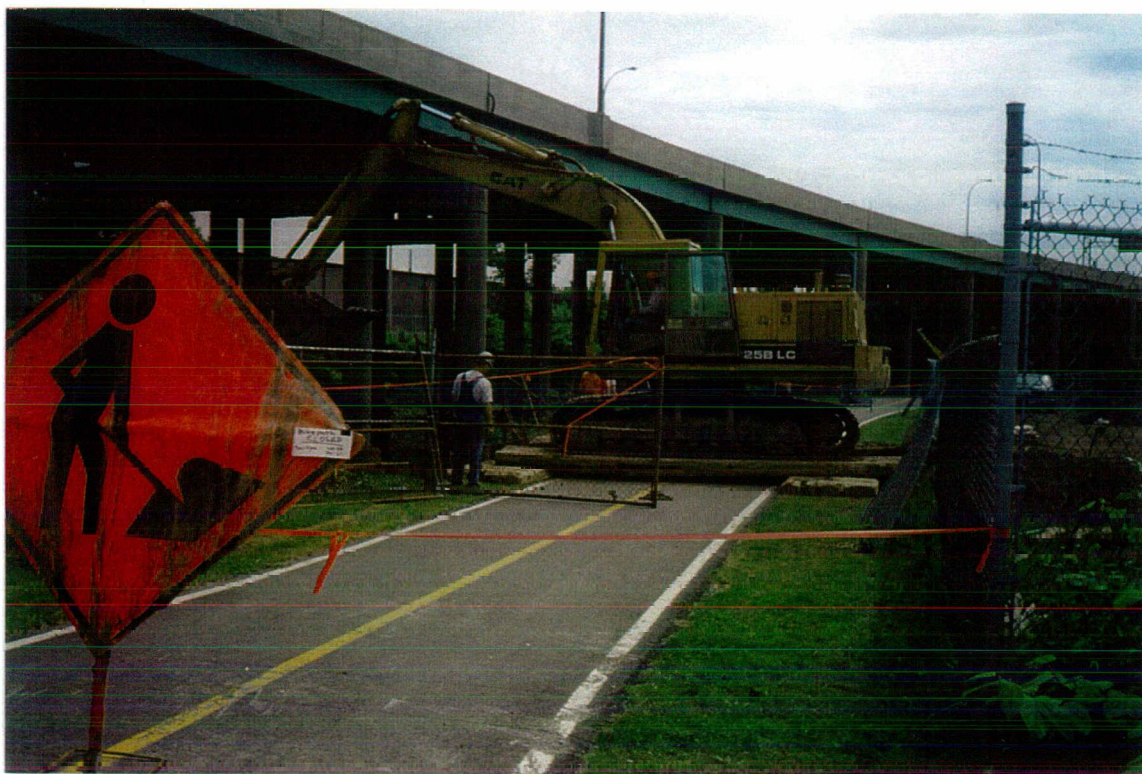
3A. Preparing for vault excavation.

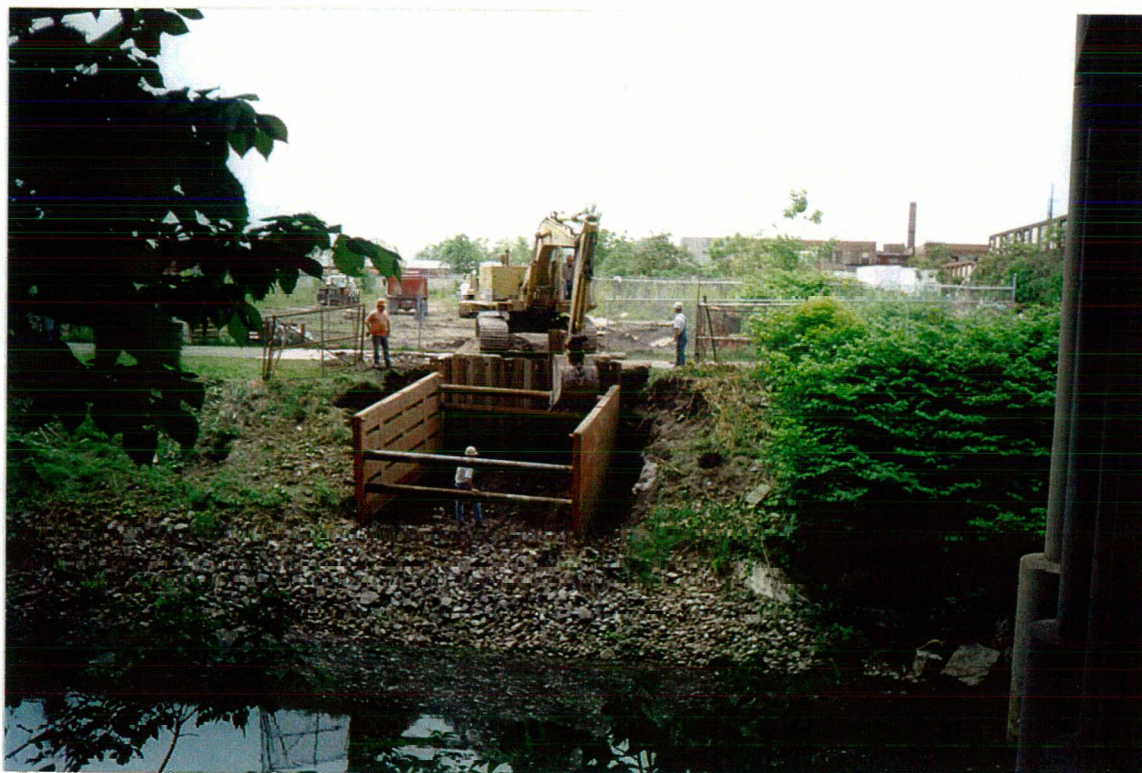
3B. Vault Excavation

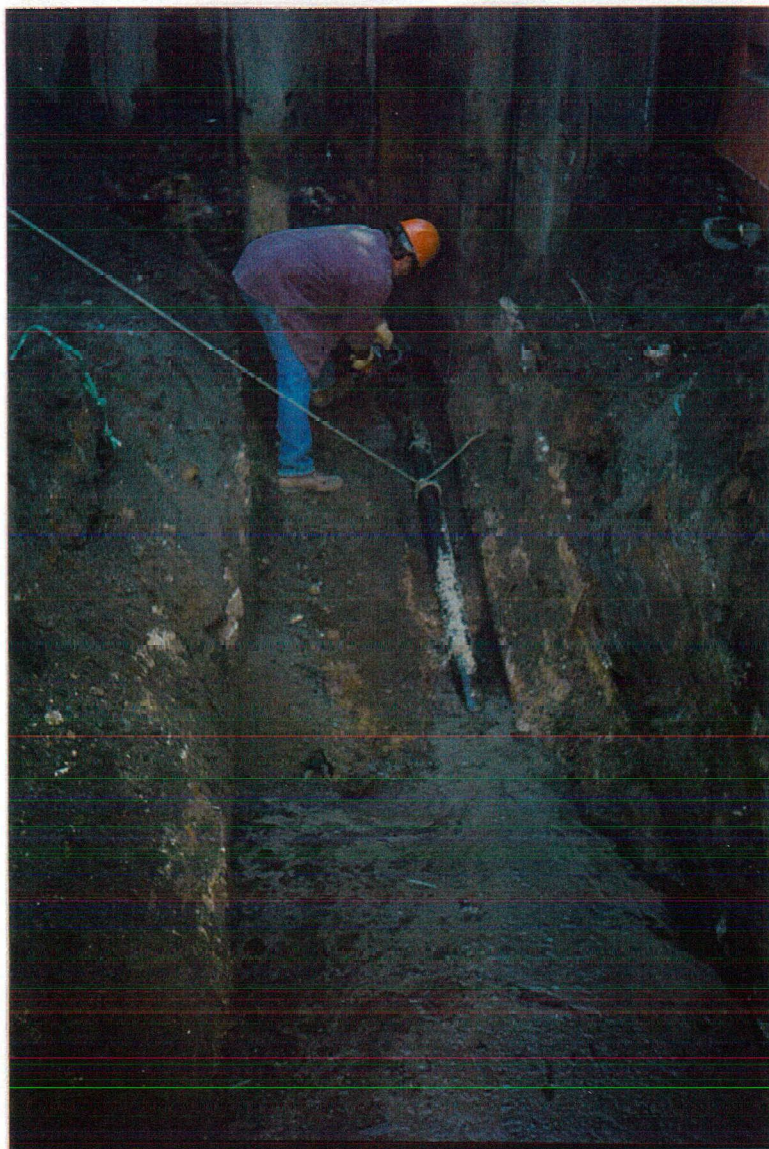
4A. Cutting HDPE pipe.

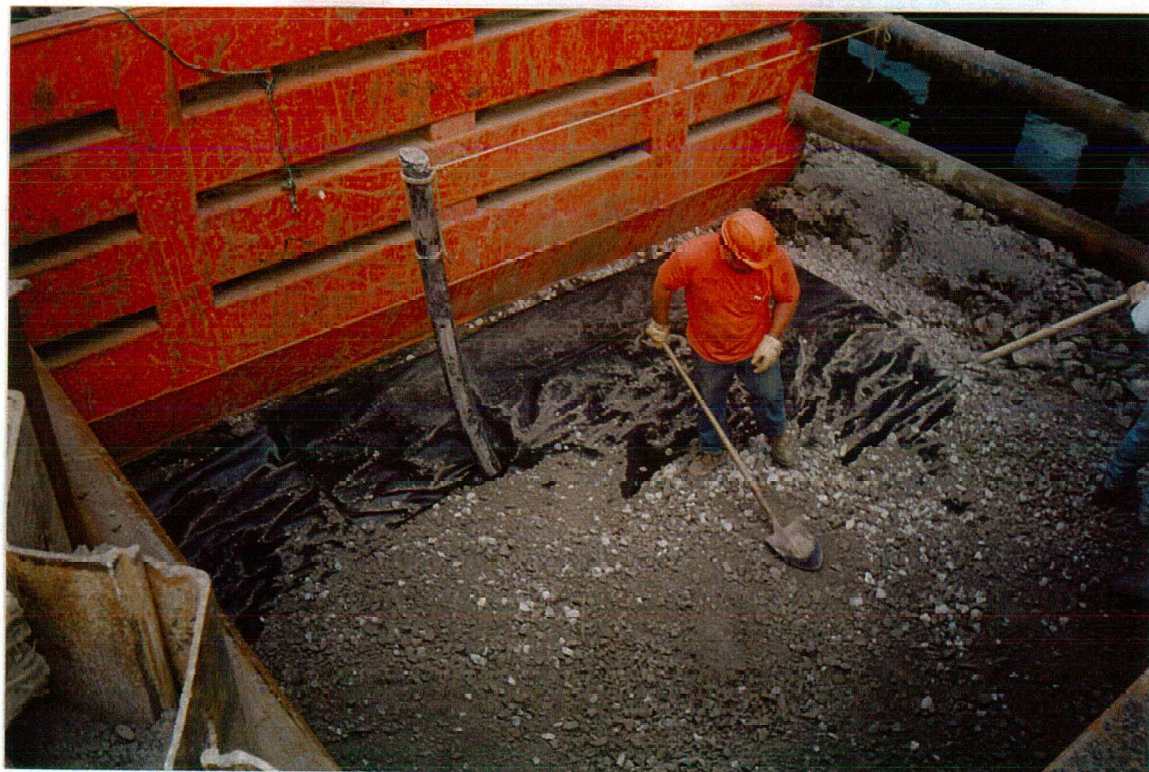
4B. Placing vault sub-base.

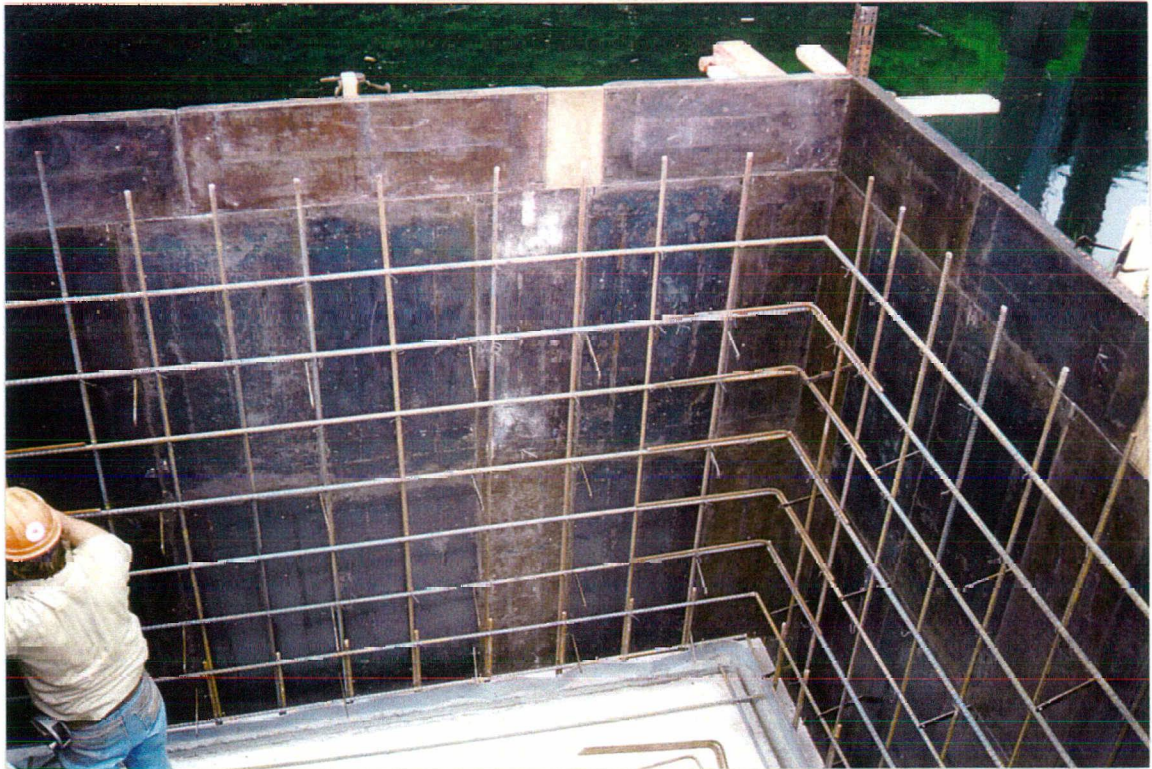
5A. Constructing vault form work.

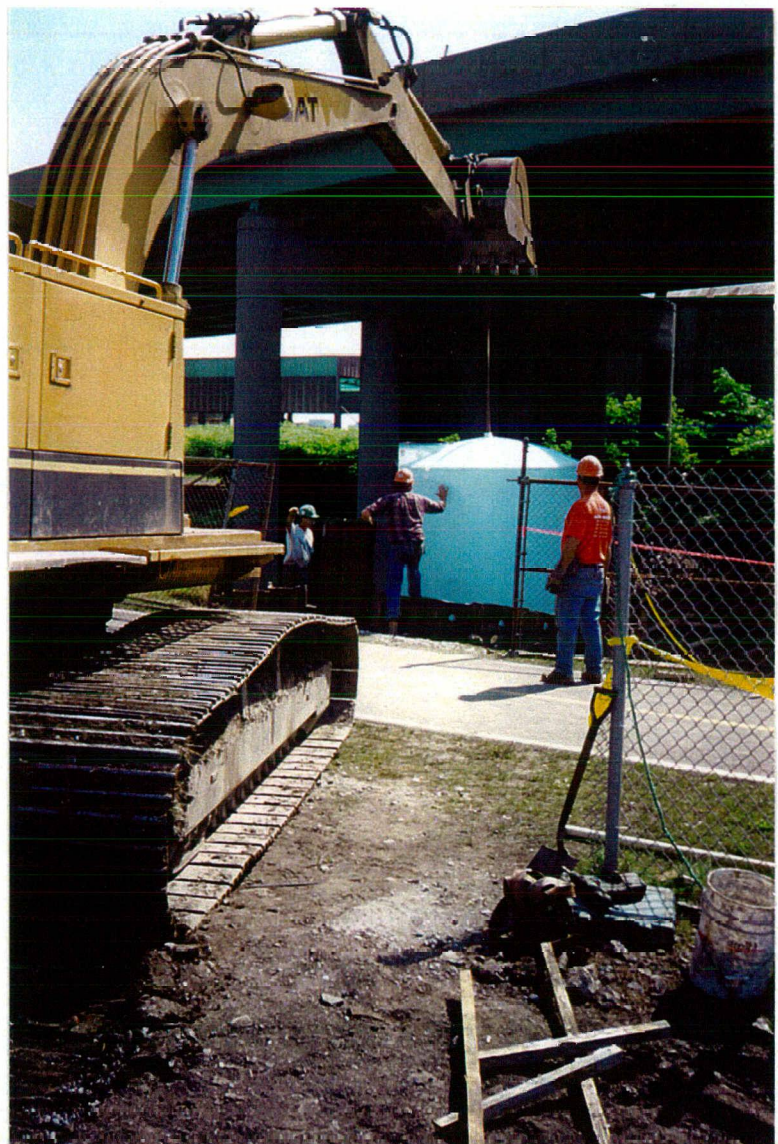
5B. Placing holding tank.

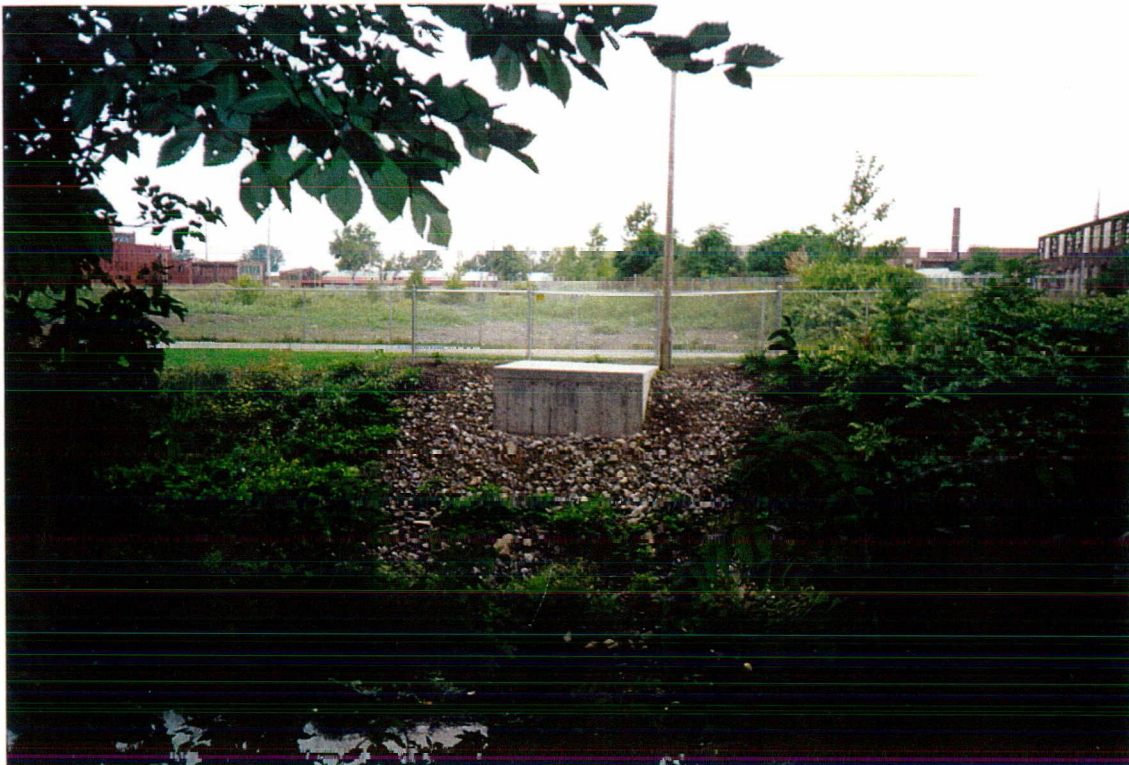
6A. Completed system (from east).

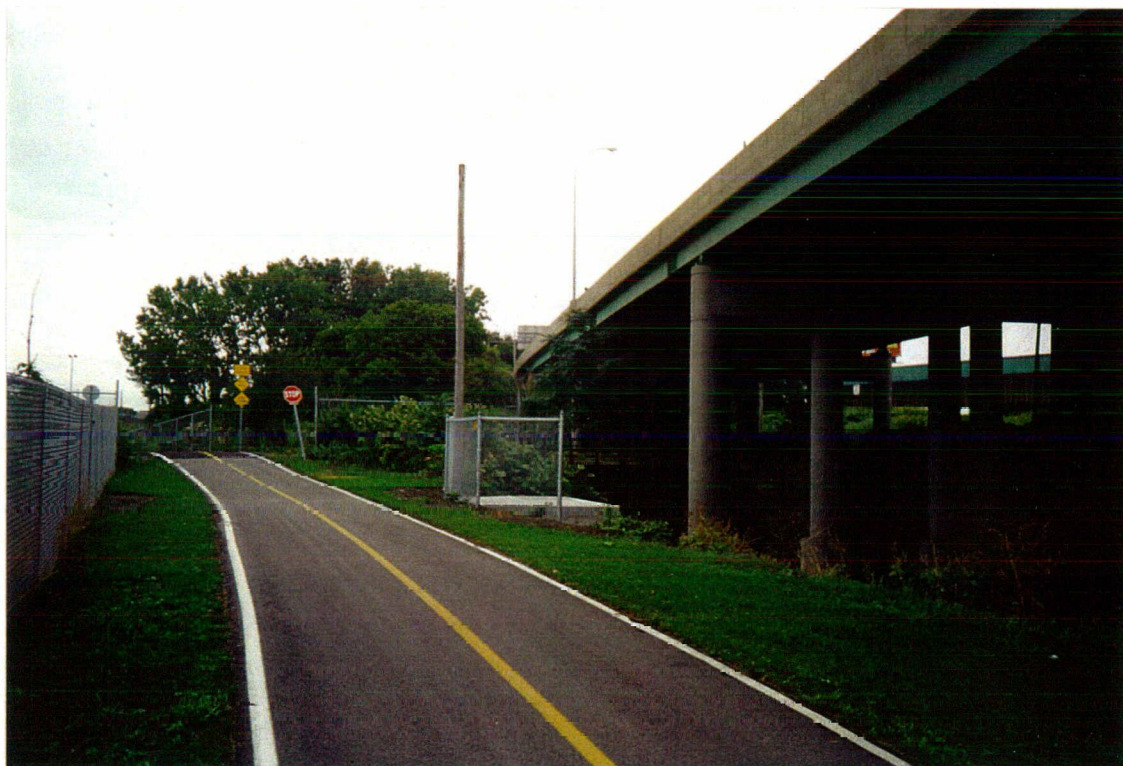
6B. Completed system (from south).
