**Subject: 2010 Periodic Review Report  
Scajaquada Creek Site (#915141B), Buffalo, NY**

Scajaquada Creek Former MGP Site, Buffalo, New York

April 21, 2010

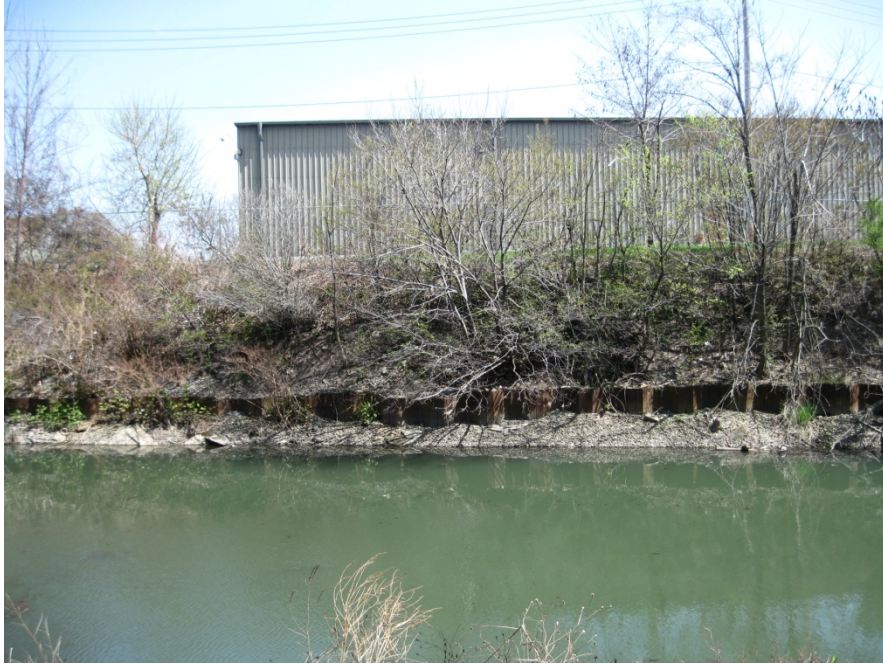
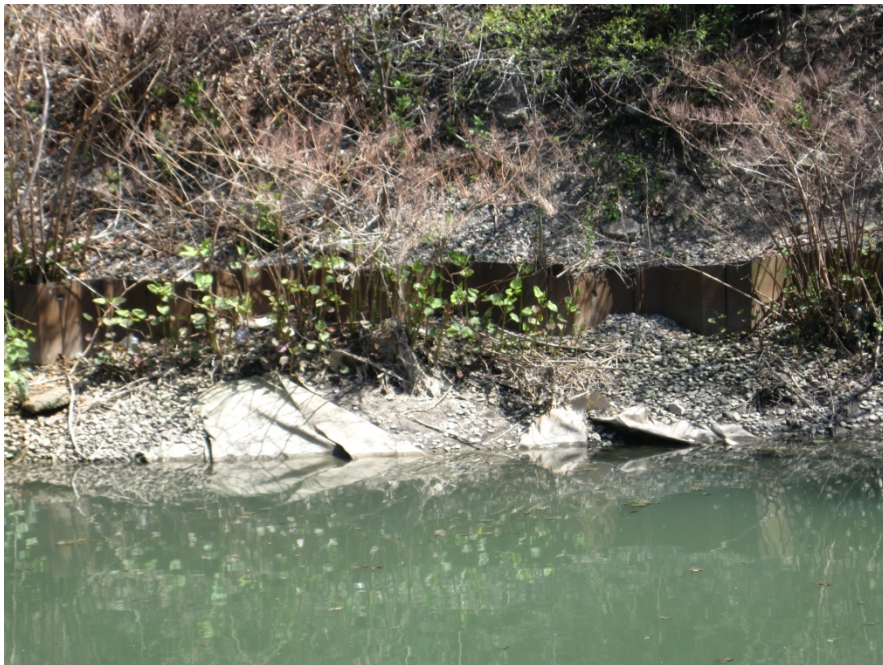
A site inspection was conducted on April 21, 2009 by Thomas Clark, P.E., of AECOM. During the inspection, an area about 250 feet long next to the sheet pile wall was observed where the armor stone layer on the sediment cap was disrupted. Damage included dislocation of geotextile and armor stone in a number of locations and vegetation growing from the cap. The sand cap layer located beneath the armor stone and geotextile does not appear to be damaged or displaced. The photographs included in Attachment 3 show the damaged area. Drawings included in Attachment 4 show the location of the damage. Damage was also identified to armoring at an outfall located near the sheet pile wall. The cause of the damage is not known for certain. It is likely to have been caused by ice or floating debris.

In order to address damage to the sediment cap armor layer described in this report, NFG plans to complete repairs to the cap. NFG is currently pursuing access with the property owners. All work is contingent upon securing an access agreement. Drawings included in Attachment 4 show the location where construction will take place. Approximately 250 linear feet of the creek bank will be repaired during the project. The re-construction of the armored bank will be completed using excavators stationed at the top of the bank. During construction, all machinery will be located landward of the top of the bank. Activities to be completed during the work include the following:

- All debris, trash, and dead wood will be removed from the affected area. Vegetation which is growing in the sediment cap will be removed.
- Existing stone armoring will be removed and redistributed in areas which are damaged using an excavator and by hand.

- The geotextile will then be pulled back in place repaired or replaced as needed and will be secured in place using pins prior to armor stone installation.

- Six inch polyethylene geocell material will be installed to provide support for placement of new armor stone. Geocell is an expandable material in an eggcrate pattern which provides

support. The geocell will be secured to the bank using fiber tendons attached to the sheet pile wall and pins.

- Angular stone up to 4 inches will be placed into the geocell using an excavator stationed at the top of the bank.
- Gabions, wire baskets filled with stone, will be installed at the outfall where damage to the armor stone has been identified.
