March 7, 2012

**Subject: 2011 Periodic Review Report
Scajaquada Creek Site (#915141B), Buffalo, NY**

Attachment 3 Photographs

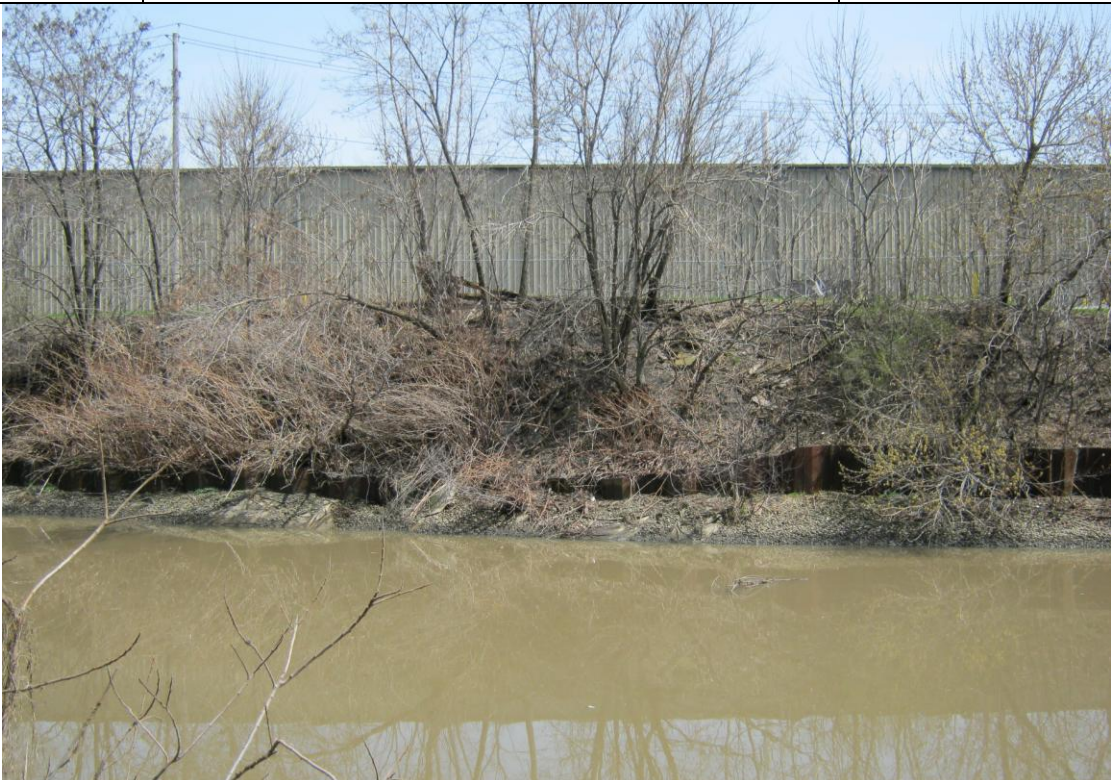
Client Name: National Fuel Gas Distribution Corp.		Site Location: Scajaquada Creek Former MGP Site, Buffalo, New York		Project No. 60137321.750
Photo No. <div style="text-align: center; font-size: 1.2em;">1</div>	Date: 4/26/11

A site inspection was conducted on April 26, 2011 by Thomas Clark, P.E. of AECOM. During the inspection, damage to the armor stone layer along the sheet pile wall on the east side of the river which was observed during the 2010 inspection was still present. The damage did not appear to have changed significantly since the last inspection. The photographs included in Attachment 3 show the damaged area. In addition, disruption of three small areas, two on the east side of the river and one on the west, were observed.

Direction Photo Taken: West to east				
Description: Damage to subaqueous cap armor

In order to address this damage to the sediment cap armor layer, NFG has completed repairs to the cap. The re-construction of the armored bank was completed using excavators stationed at the top of the bank and divers working in the creek. During construction, all machinery was located landward of the top of the bank. Activities completed during the work include the following:

- Existing stone armoring was removed and redistributed in areas which were damaged using an excavator and by hand.
- Geotextile originally placed beneath the armor layer was pulled back in place, repaired or replaced as needed, and secured in place using pins prior to armor stone installation.

- Six inch polyethylene geocell material was installed to provide support for placement of new armor stone. The geocell was secured to the bank using fiber tendons attached to the sheet pile wall and steel pins as recommended by the geocell manufacturer.

- Angular stone up to 3 inches was placed into the geocell using an excavator with a concrete bucket stationed at the top of the bank.
- Two gabions, wire baskets filled with stone, were installed at the outfall where damage to the armor stone has been identified.

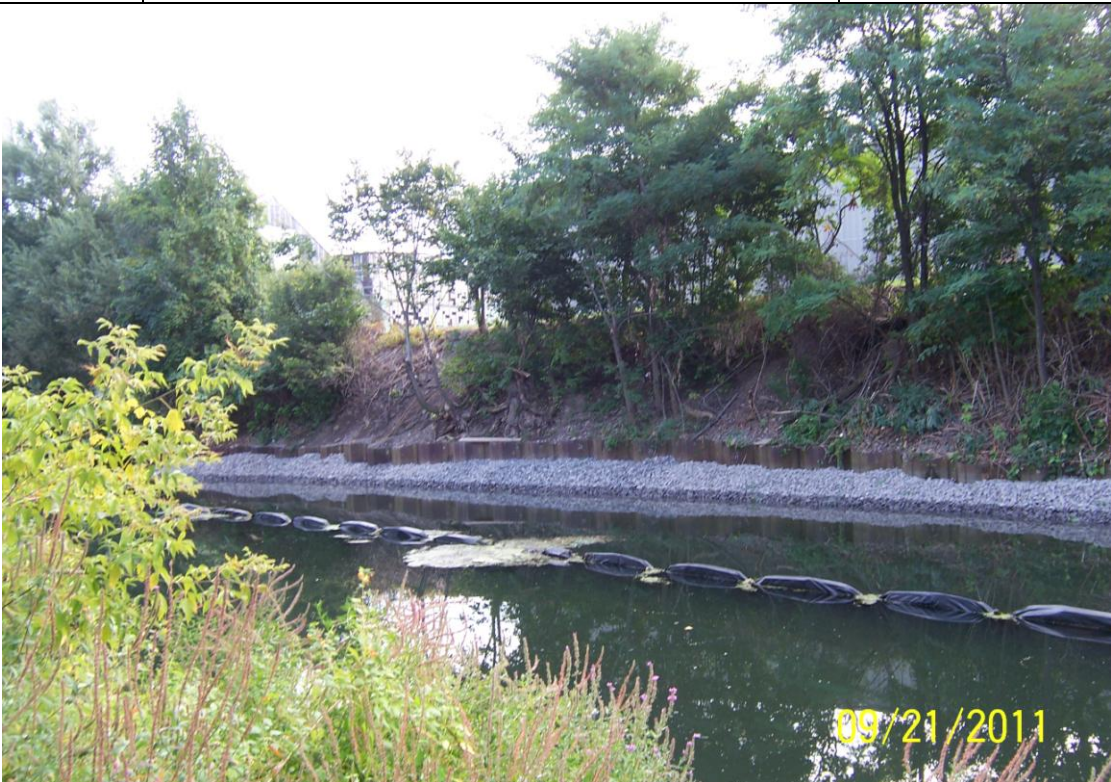
Client Name: National Fuel Gas Distribution Corp.		Site Location: Scajaquada Creek Former MGP Site, Buffalo, New York	Project No. 60137321.750
Photo No. 5	Date: 9/21/11

Direction Photo Taken: West to east			
Description: Completed armor repair
