March 1, 2013

**Subject: 2012 Periodic Review Report
Scajaquada Creek Site (#915141B), Buffalo, NY**

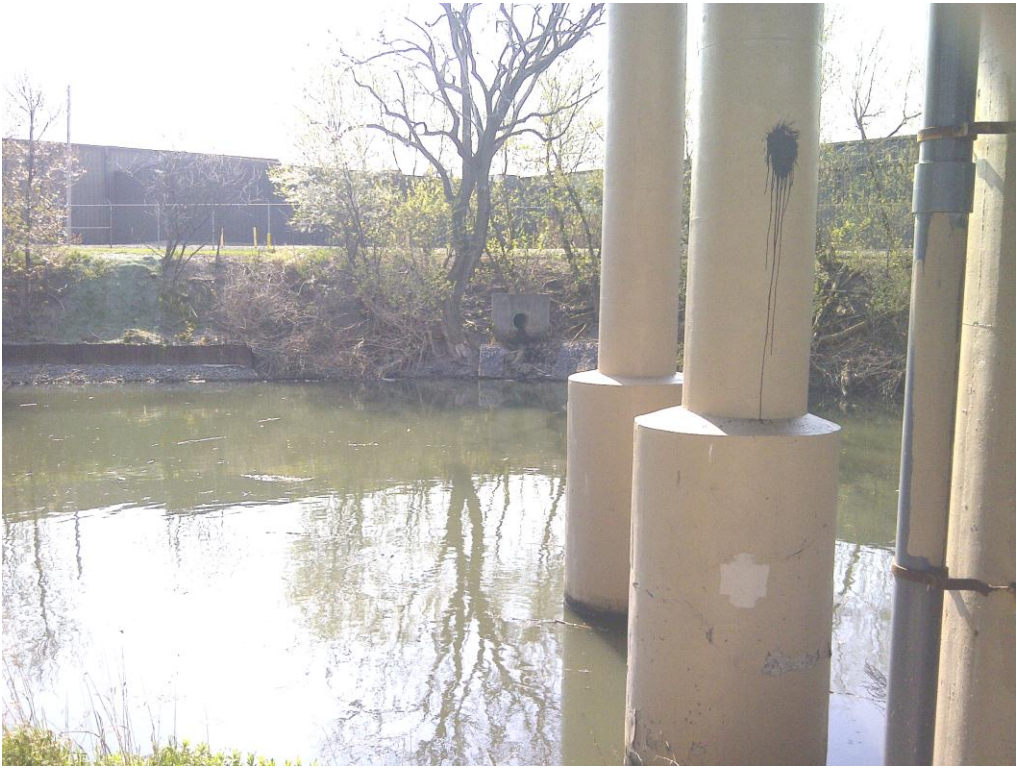
Direction Photo Taken: Looking east from bicycle path			
Description: Gabions at outfall structure and armor stone by sheet pile wall. Note erosion control blankets on bank slope.

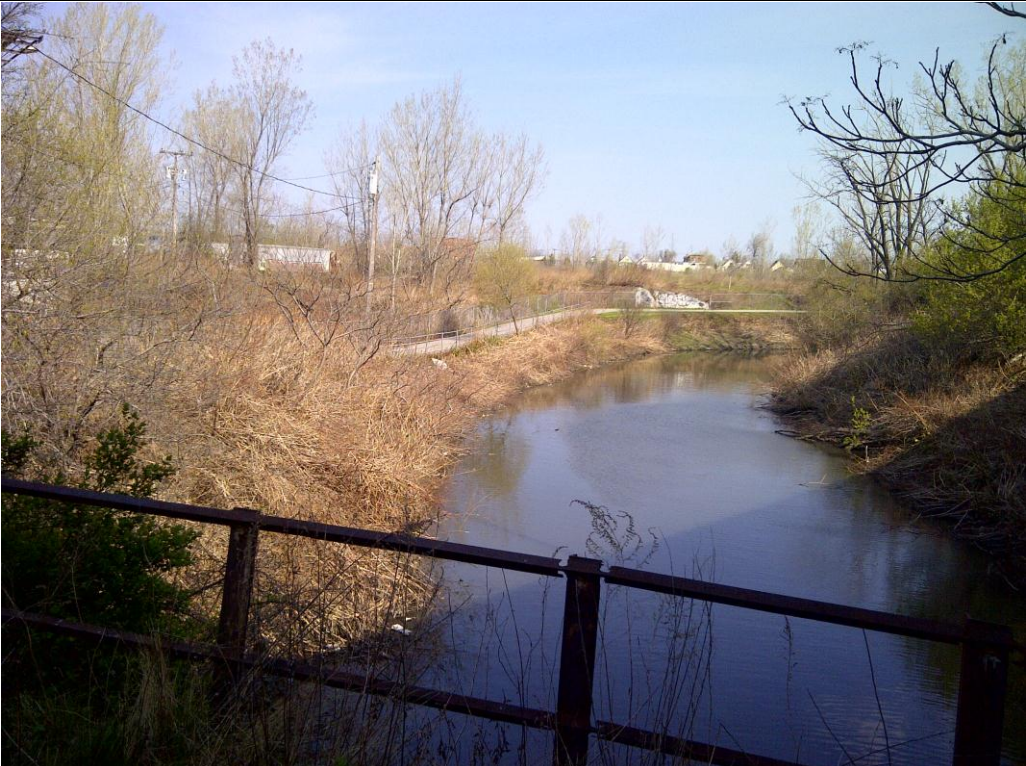
Photo No. 5	Date: 4/19/12

Direction Photo Taken: Looking north					
Description: Subaqueous cap area north of the Conrail Bridge
