March 10, 2014

**Subject: 2014 Periodic Review Report
Scajaquada Creek Site (#915141B), Buffalo, NY**

PHOTOGRAPHIC LOG

Client Name: National Fuel Gas Distribution Corp.	Site Location: Scajaquada Creek Former MGP Site, Buffalo, New York	Project No. 60137321
---	--	--------------------------------

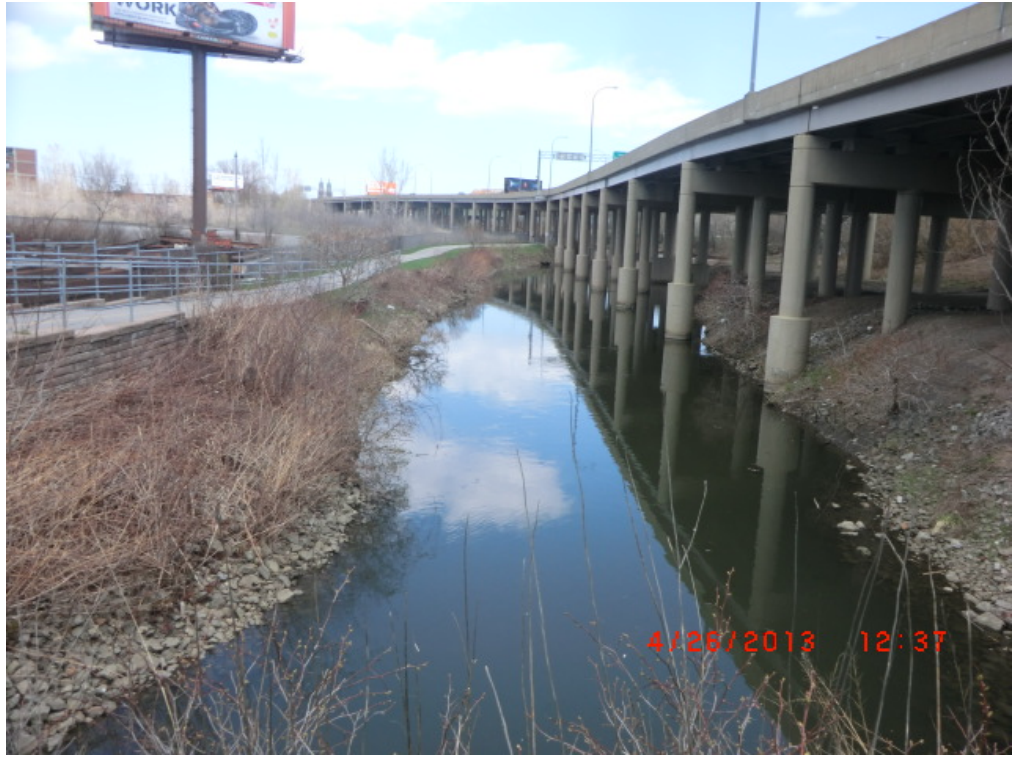
Photo No. 1	Date: 04/26/13
------------------------------	--------------------------

West Street Bridge looking north. East and west banks of Scajaquada Creek.

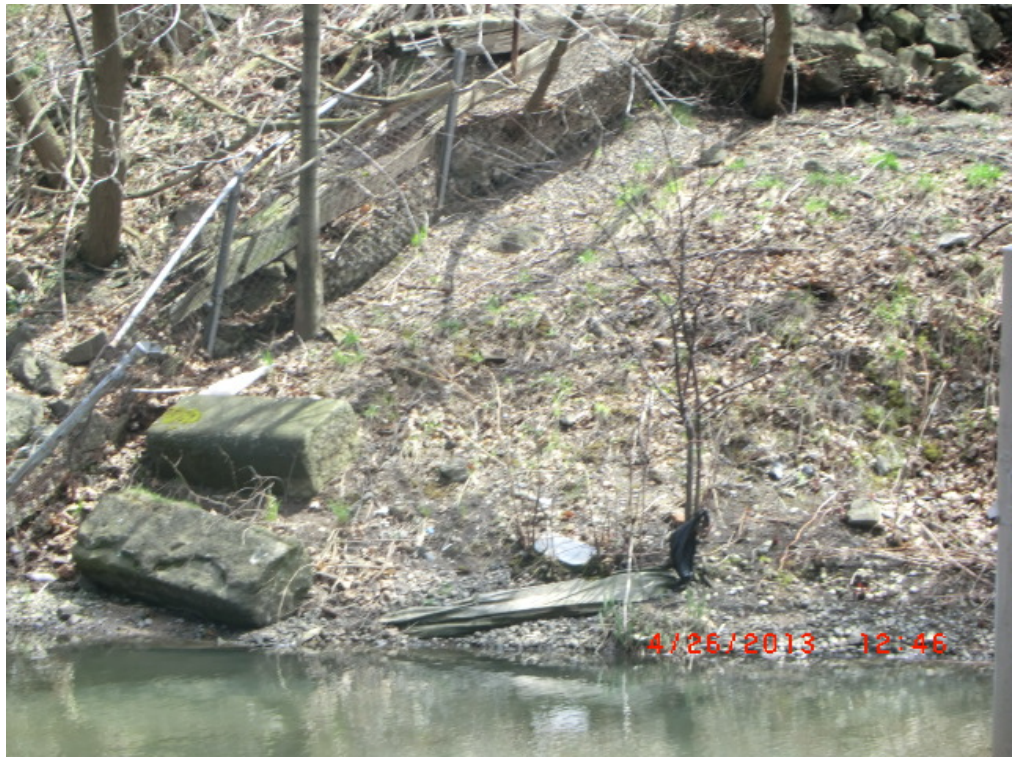
Photo No. 2	Date: 04/25/13
------------------------------	--------------------------

Taken from west bank of creek looking east. Geotextile observed on east bank of creek.

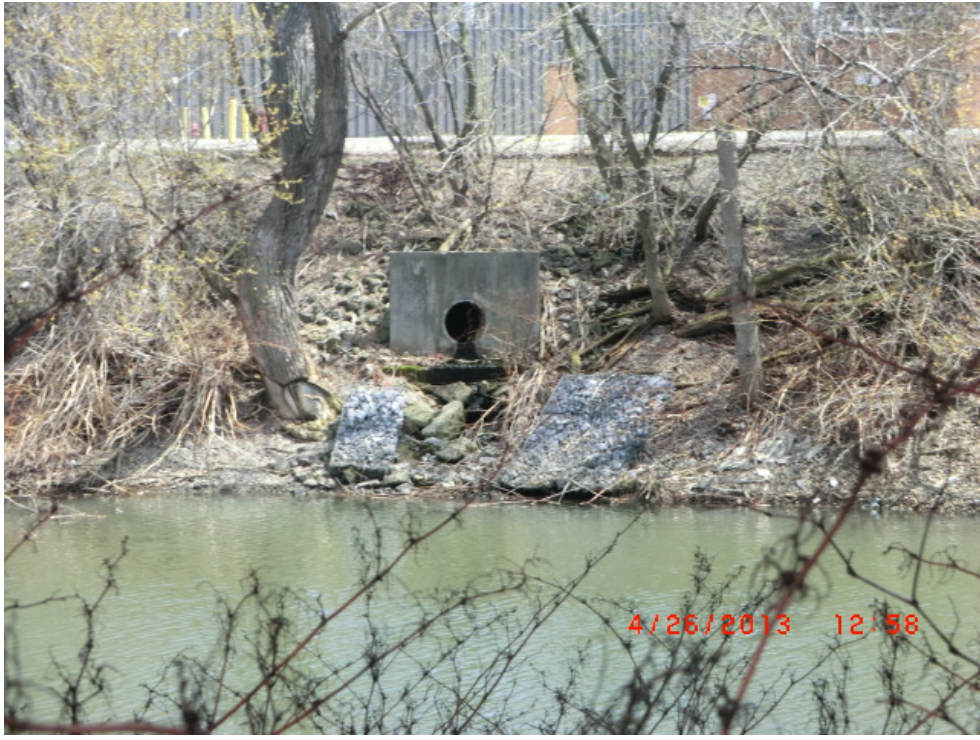
Photo No. 3	Date: 04/26/13
Direction Photo Taken: East

Description:
 Taken from west bank looking east. Gabions installed at outfall in 2011.

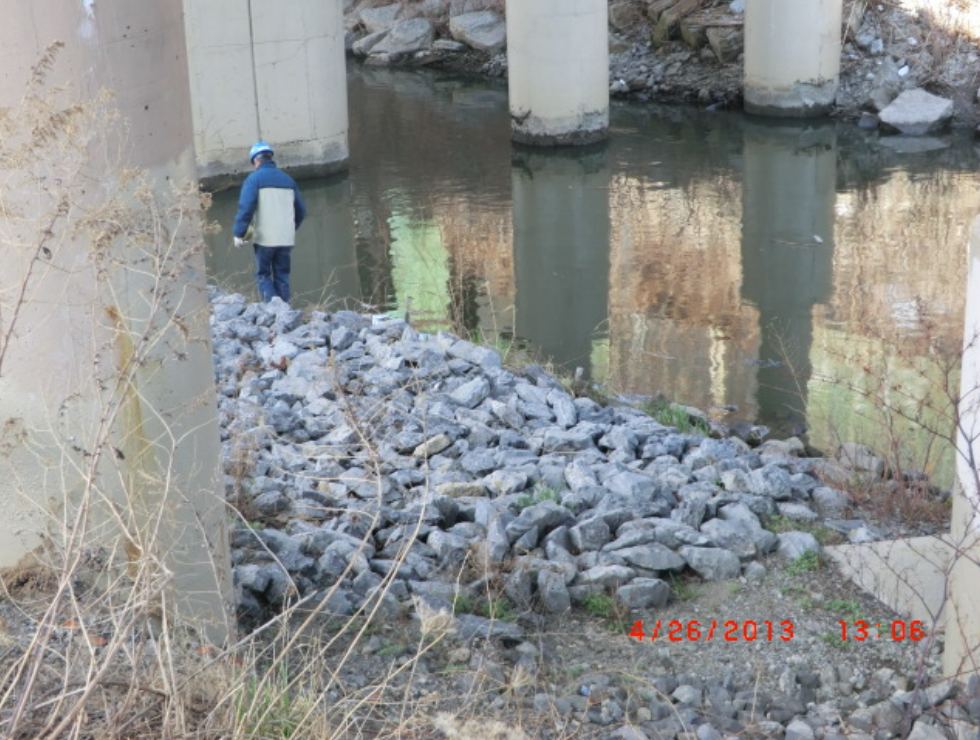
Photo No. 4	Date: 04/26/13
Direction Photo Taken: North

Description:
 Taken from west bank looking north. Repairs on west bank from previous years.

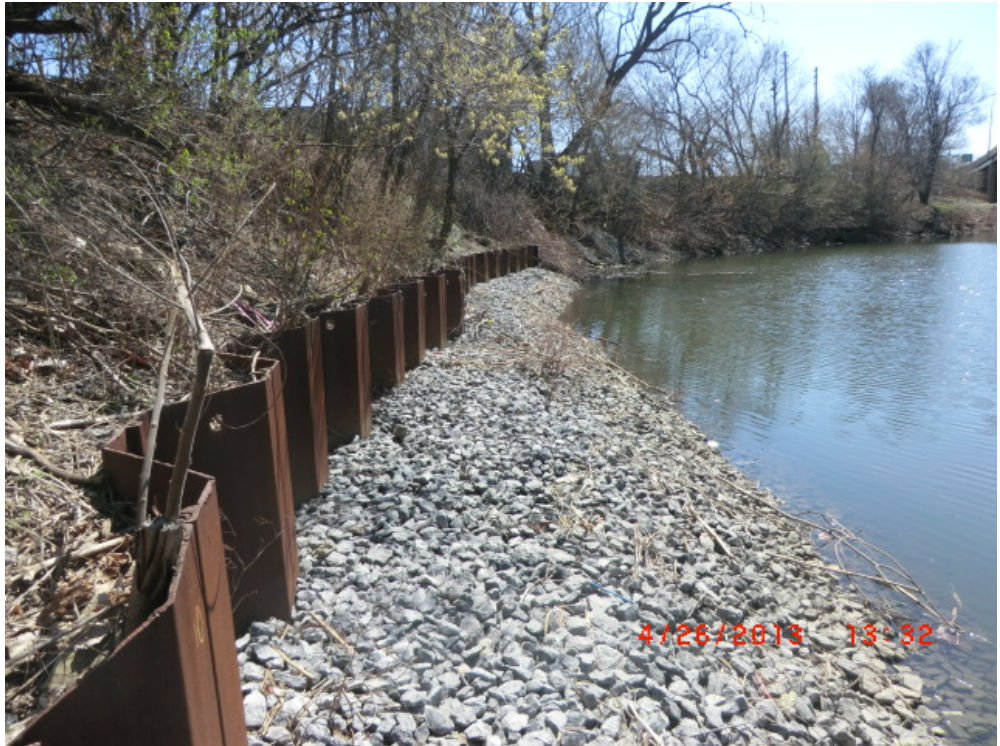
Photo No. 5	Date: 04/26/13
Direction Photo Taken: South	
Description: East side of creek looking south. Bank armor stone repairs implemented in 2011.

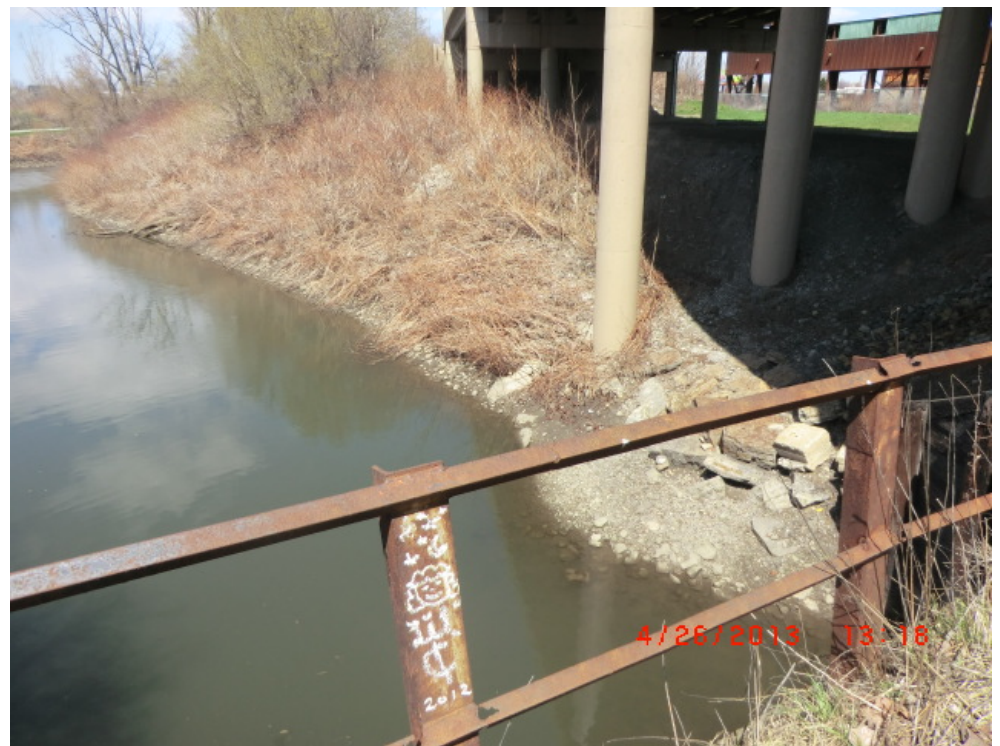
A site inspection was conducted on April 26, 2013 by Thomas P. Clark, P.E. of AECOM. Site photographs are included in Attachment 3. No significant areas of cap disruption or erosion were noted. Repairs to the armor stone on the east side of Scajaquada Creek made in 2011 were intact and effective. It was noted during site visits by National Fuel personnel in 2013 and 2014 that vegetation has started to become established in areas on the bank that were disturbed during armor repairs. Erosion control fabric installed during construction remains in place and has prevented bank erosion. Two small areas of exposed geotextile were identified on the west side of the creek in the previous annual report. The armor stone in one of these areas was repaired in 2014, and the stone in the other area is being monitored. During the February 2014 monthly inspection by National Fuel personnel, two small areas of potentially exposed geotextile were identified. These areas will be investigated further as weather permits.

Photo No. 6	Date: 04/26/13
Direction Photo Taken: North	
Description: Conrail railroad bridge looking north. Geotextile observed on east bank near pile.

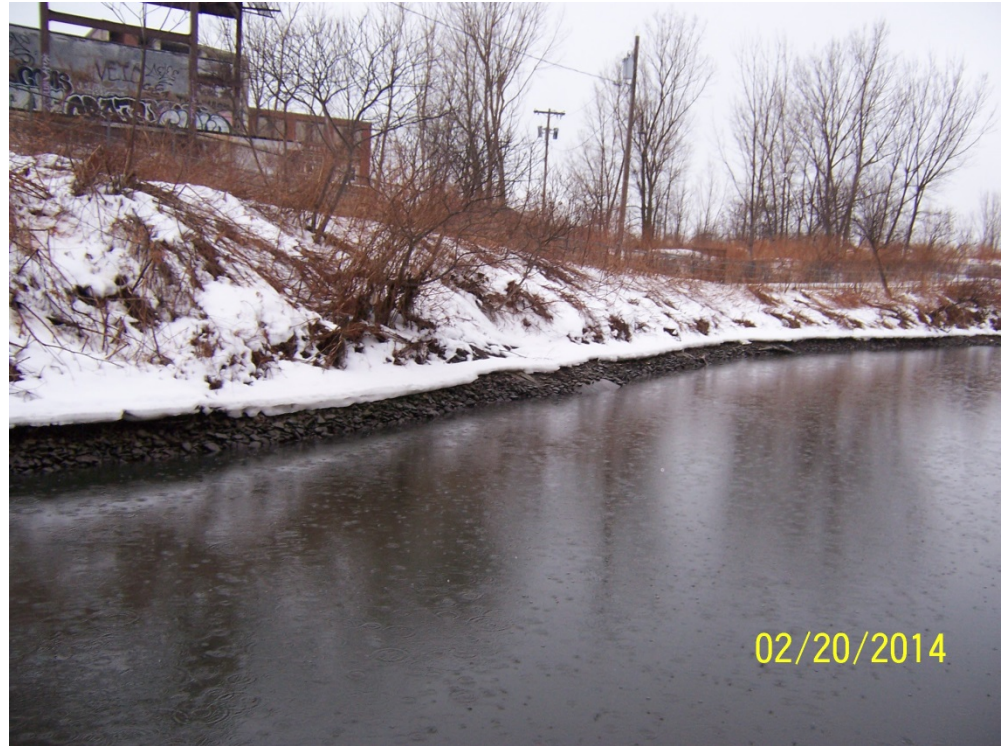
Photo No. 7	Date: 02/20/14
-----------------------	--------------------------

Description:
 East side of creek. Potential exposed areas of geotextile requiring further investigation and monitoring.

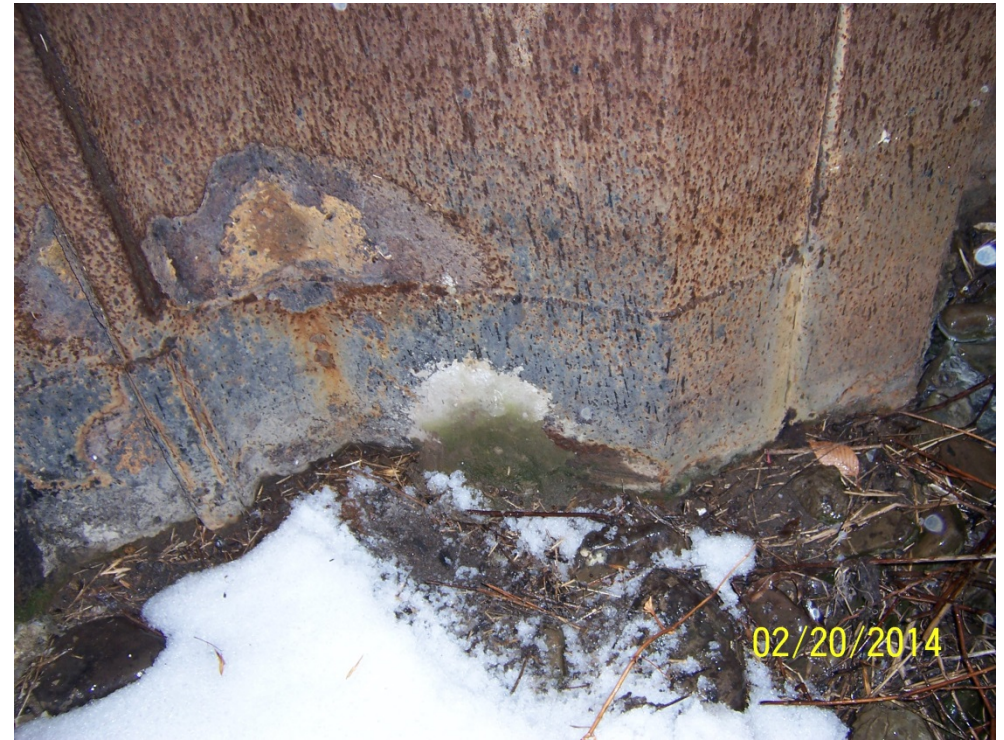
Photo No. 8	Date: 02/20/14
-----------------------	--------------------------

During installation of the geocell in September 2011, NAPL was observed seeping through one of the construction lift holes in the sheeting of the sheeting wall. NYSDEC was notified of the seep on September 8, 2011. The construction lift hole with the NAPL seep along with the adjacent construction lift hole was sealed with hydraulic cement. National Fuel has been monitoring the plugged and unplugged holes for evidence of LNAPL. During the February 2014 monthly inspection, National Fuel noted that the two plugged holes are showing signs of spalling due to freeze-thaw action in the cement. A photograph is provided in Attachment 3. National Fuel anticipates installing steel plates over the construction lift holes in 2014 to control potential future water seepage. Further actions to address groundwater elevation issues are being investigated by Bristol Myers-Squibb (BMS), the upland responsible party. During a meeting with the NYSDEC on July 24, 2012, the BMS contractor, Groundwater Environmental Services, Inc. (GES) discussed completing routine monthly inspections of the sheet pile wall, depending on weather and safety conditions to inspect the wall for NAPL seepage.

Description:
 Construction lift hole in sheet pile on east bank. Hydraulic cement patch is spalling. A steel plate will be installed over the construction lift hole in 2014.
