March 23, 2015

**Subject: 2014 Periodic Review Report  
Scajaquada Creek Site (#915141B), Buffalo, NY**

## PHOTOGRAPHIC LOG

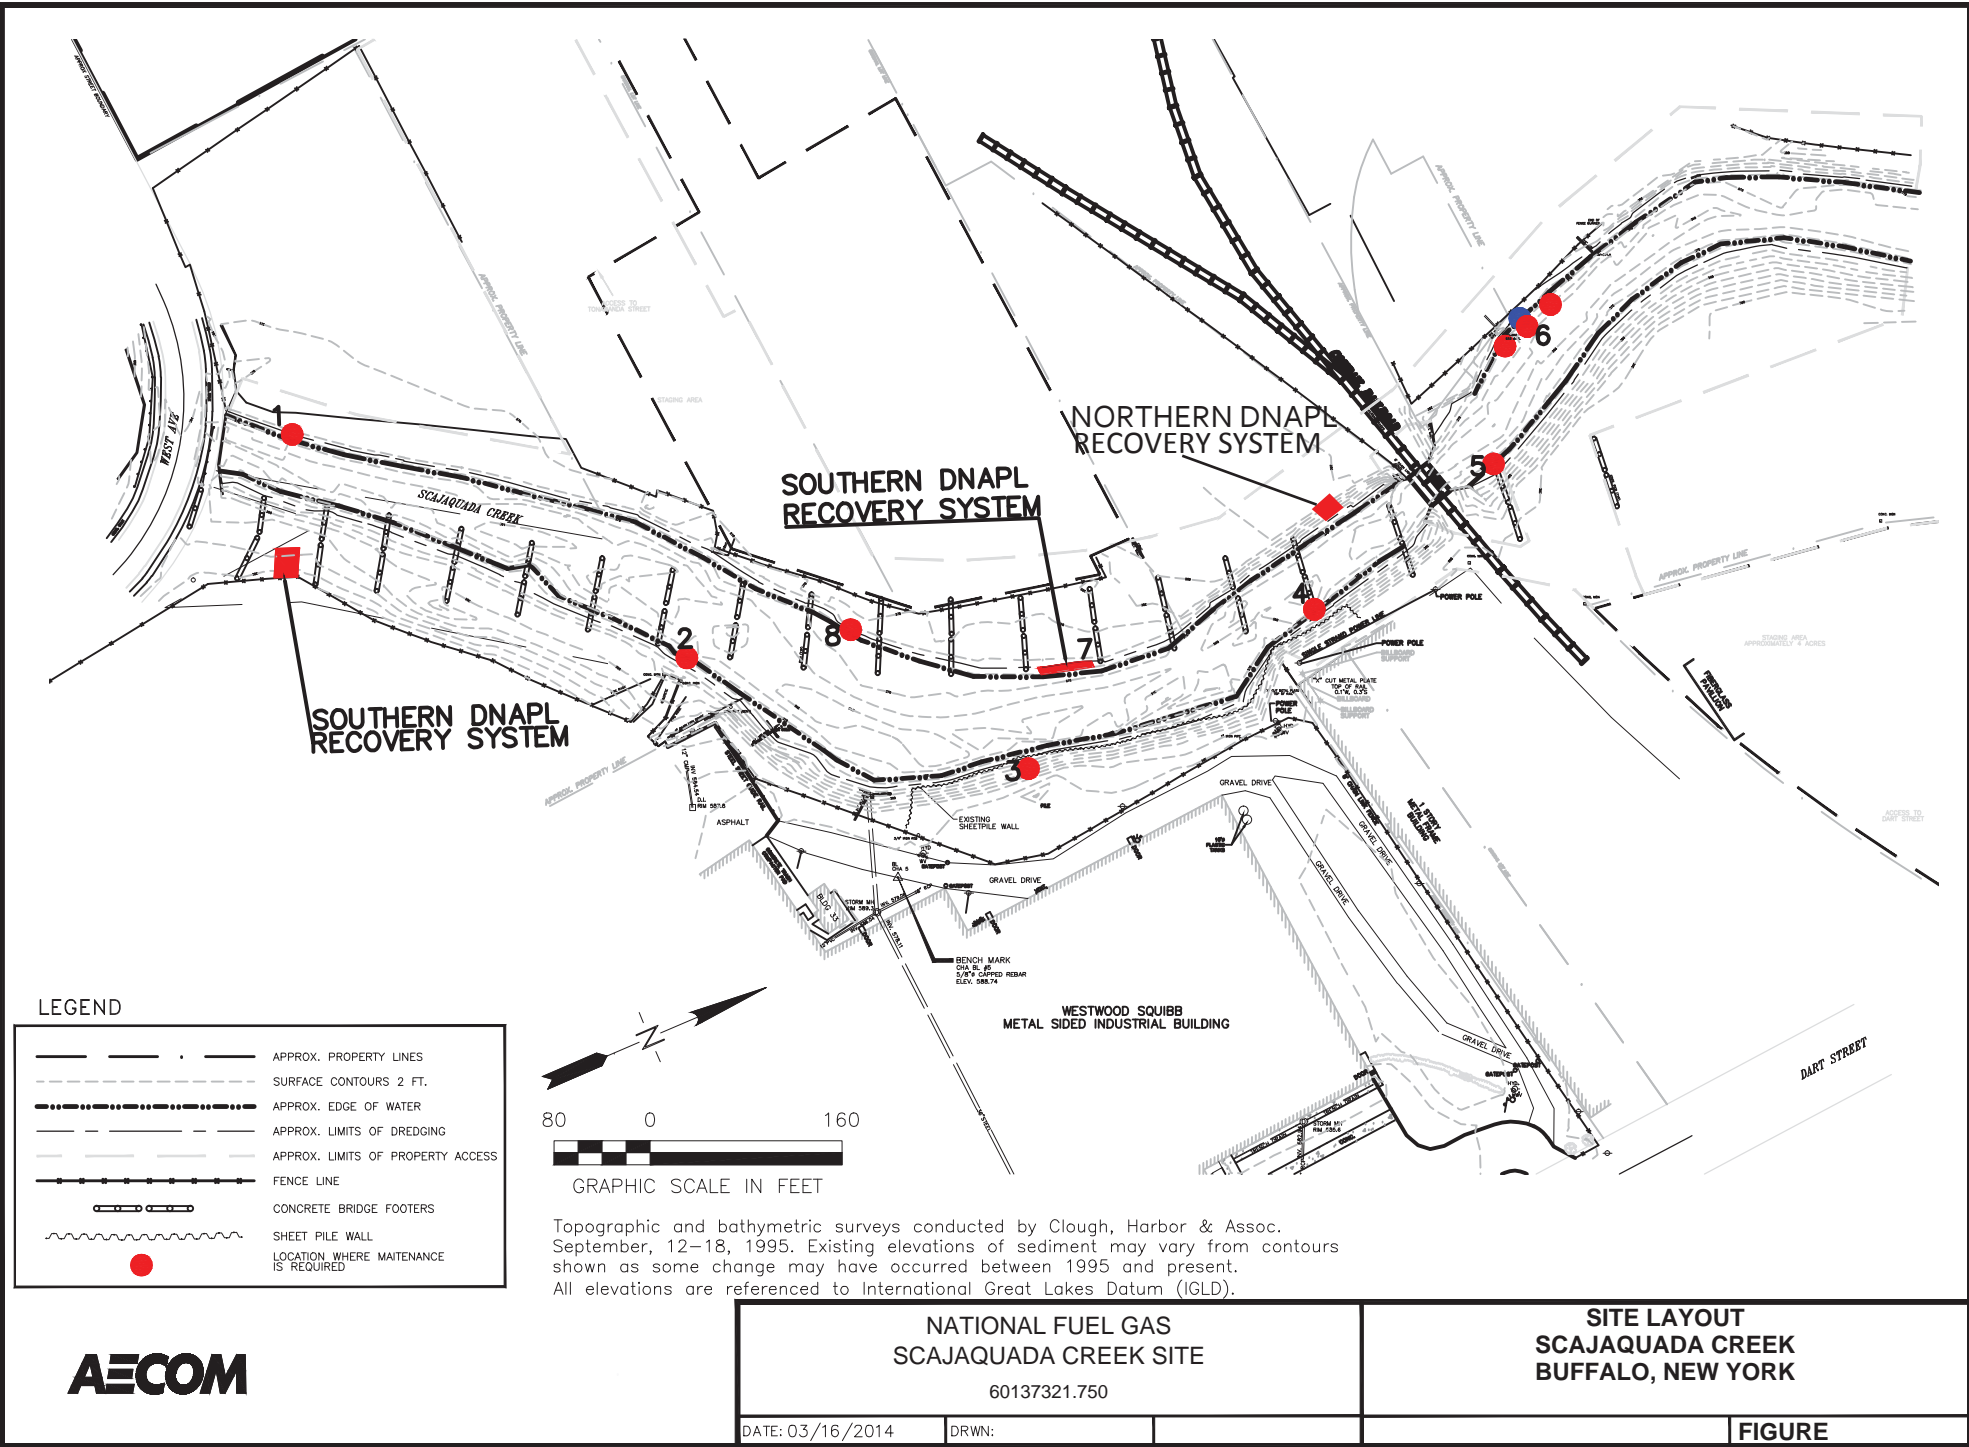
Figure

A site inspection was conducted on April 28, 2014 by Thomas P. Clark, P.E. of AECOM. Site photographs are included in Attachment 3. During the inspection, eight small areas where geotextile fabric was visible or maintenance is required were identified. The locations, designated 1 through 8, are shown on the figure. They include the following:

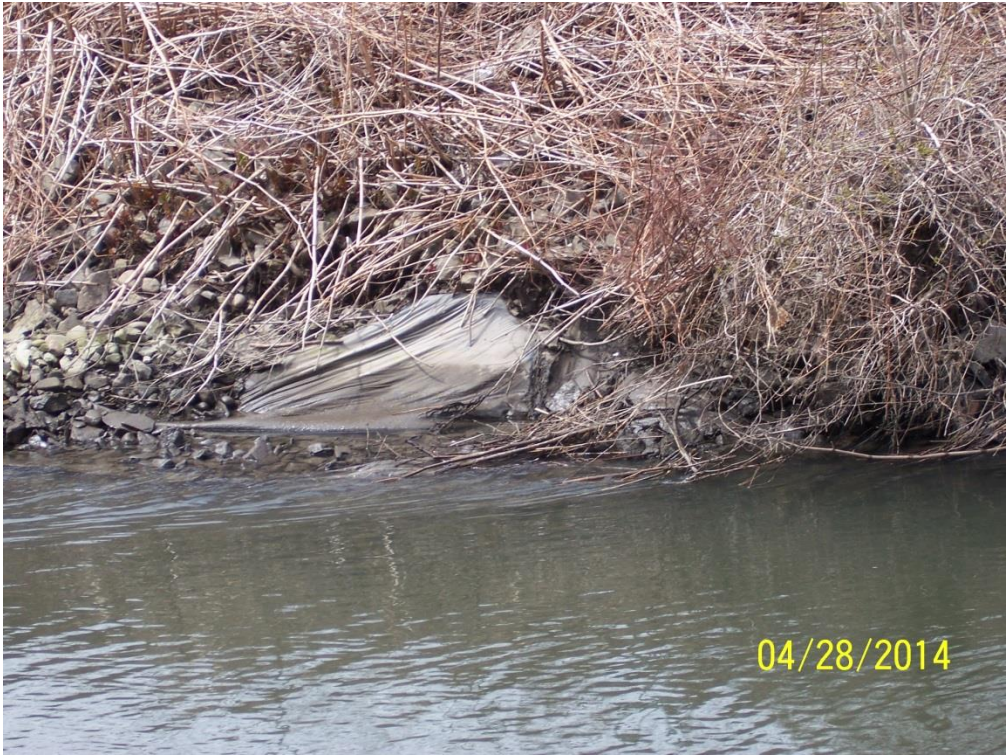
<b>Client Name:</b> National Fuel Gas Distribution Corp.		<b>Site Location:</b> Scajaquada Creek Former MGP Site, Buffalo, New York	<b>Project No.</b> 60137321
<b>Photo No.</b> <b>1</b>	<b>Date:</b> 04/28/14

- Location #1 – Visible geotextile fabric near the entrance to the bike path on the west side of the creek. See Photo 1.
- Location #2 – Visible geotextile fabric near gate in fence. See Photo 2.
- Location #3 – Areas on the east bank which were disturbed during armor repair in 2010 and where vegetation is not fully established. Erosion control blanket installed in 2010 is still in place. No erosion was observed. See Photo 3.
- Location #4 – Exposed geotextile fabric near highway piling. No photo available.
- Location #5 – Exposed geotextile fabric near Conrail bridge. See Photo 4.
- Location #6 – Exposed geotextile fabric in several areas on west bank. See Photo 5.
- Location #7 – Exposed geotextile fabric in location where previous repair was made. See Photo 6.
- Location #8 – Exposed geotextile fabric. No photo available.

<b>Direction Photo Taken:</b>  East bank looking west			
<b>Description:</b>  Location #1 – Disturbed armor and exposed fabric			
<b>Photo No.</b> <b>2</b>	<b>Date:</b> 04/28/14

The O&M program at the Scajaquada Creek Site is being implemented in accordance with the provisions of the O&M Plan. The results of the site inspection indicate that engineering and institutional controls continue to be effective in meeting remedial objectives. Cap repair activities are required in order to ensure that the effectiveness continues. National Fuel will prepare a plan to repair the locations identified in this report. The plan will be submitted to NYSDEC for review before it is implemented. Permitting authorities will be consulted to see if permits are required to complete the work.

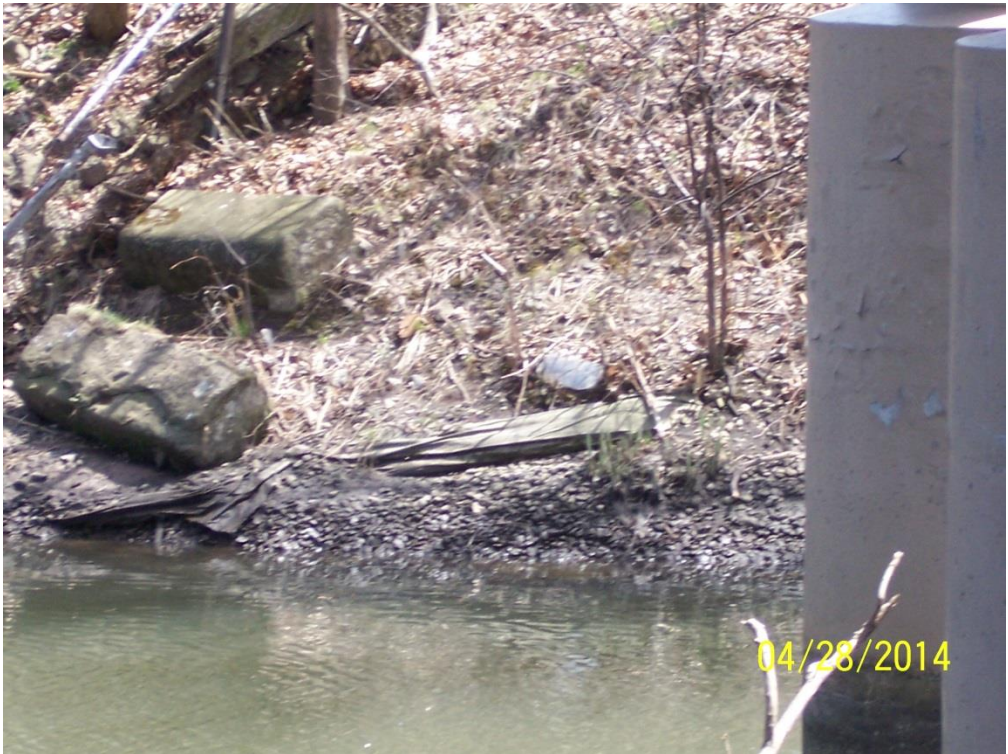
<b>Direction Photo Taken:</b>  West bank looking east			
<b>Description:</b>  Location # 2 – Exposed fabric

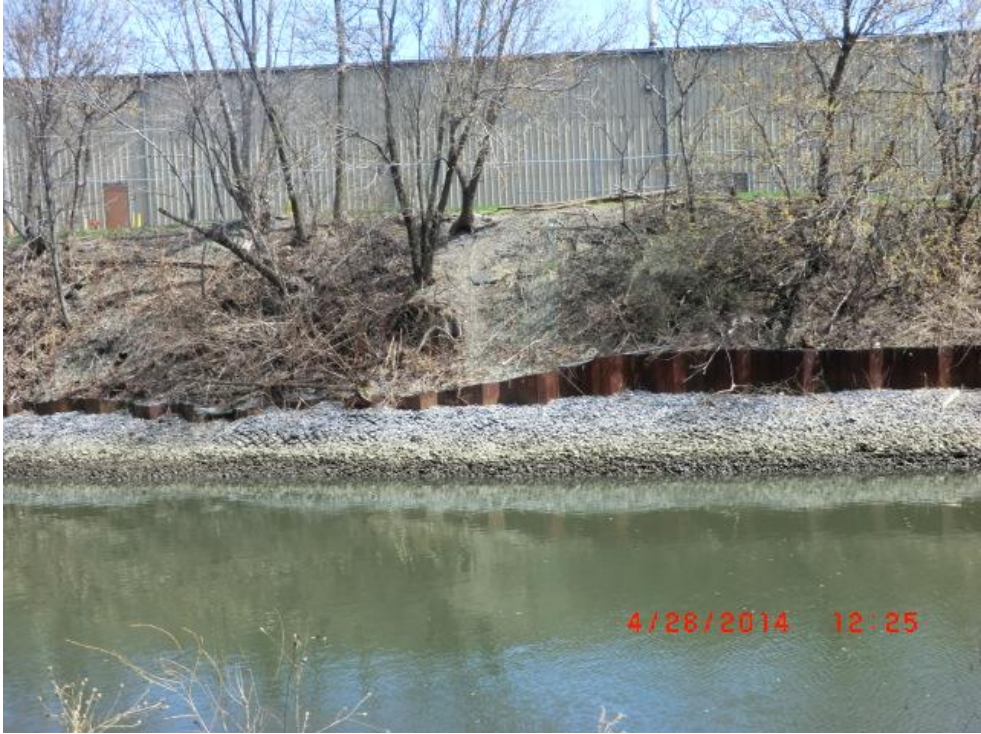
<b>Client Name:</b> National Fuel Gas Distribution Corp.		<b>Site Location:</b> Scajaquada Creek Former MGP Site, Buffalo, New York	<b>Project No.</b> 60137321
<b>Photo No.</b> <b>3</b>	<b>Date:</b> 04/28/14

<b>Direction Photo Taken:</b>  West bank looking east			
<b>Description:</b>  Location #3 – Area where vegetation is not fully established.			
<b>Photo No.</b> <b>4</b>	<b>Date:</b> 04/28/14

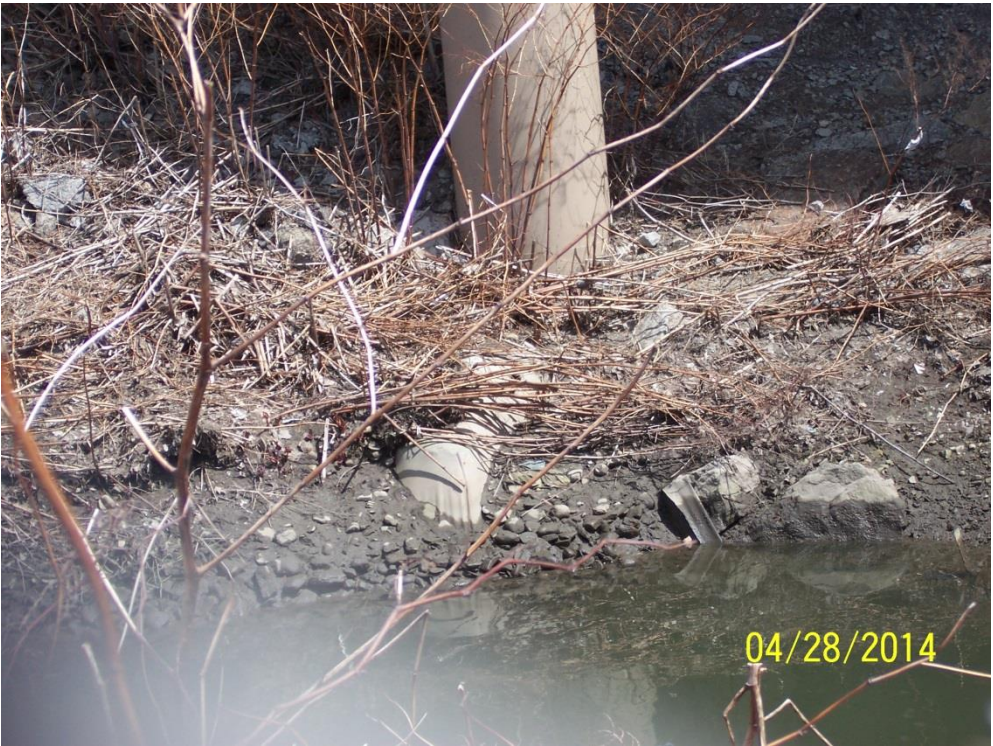
<b>Direction Photo Taken:</b>  West bank looking east			
<b>Description:</b>  Location #5 – Exposed fabric

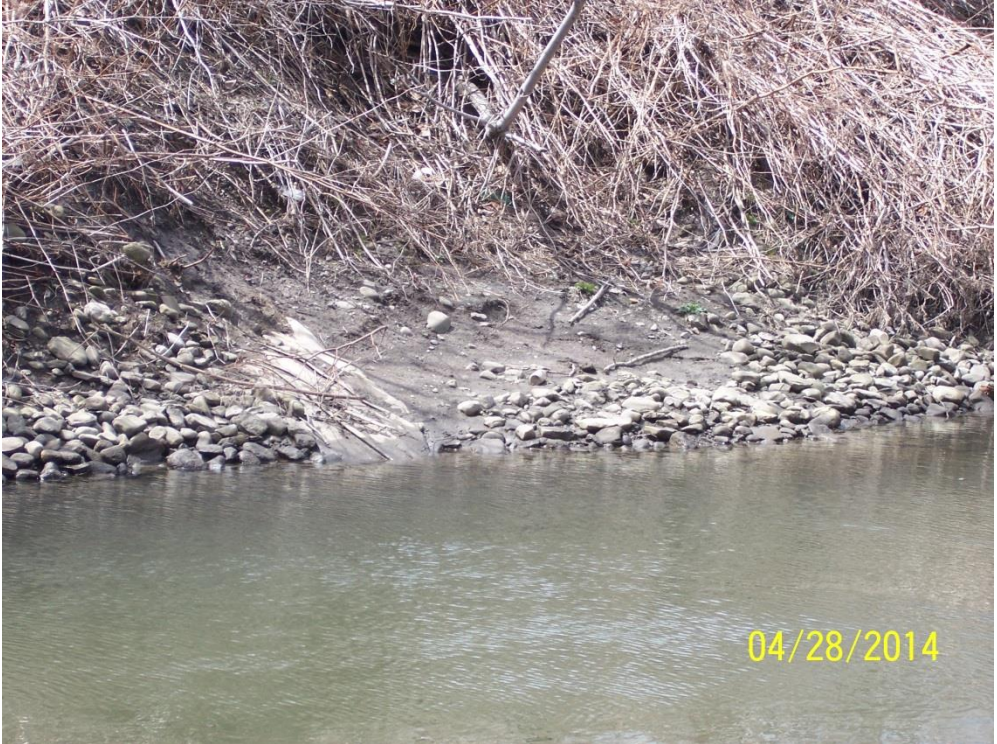
<b>Client Name:</b> National Fuel Gas Distribution Corp.		<b>Site Location:</b> Scajaquada Creek Former MGP Site, Buffalo, New York	<b>Project No.</b> 60137321
<b>Photo No.</b> <b>5</b>	<b>Date:</b> 04/28/14

<b>Direction Photo Taken:</b>  Conrail bridge looking northwest			
<b>Description:</b>  Location #6 – Disturbed armor and exposed fabric			
<b>Photo No.</b> <b>6</b>	<b>Date:</b> 04/28/14

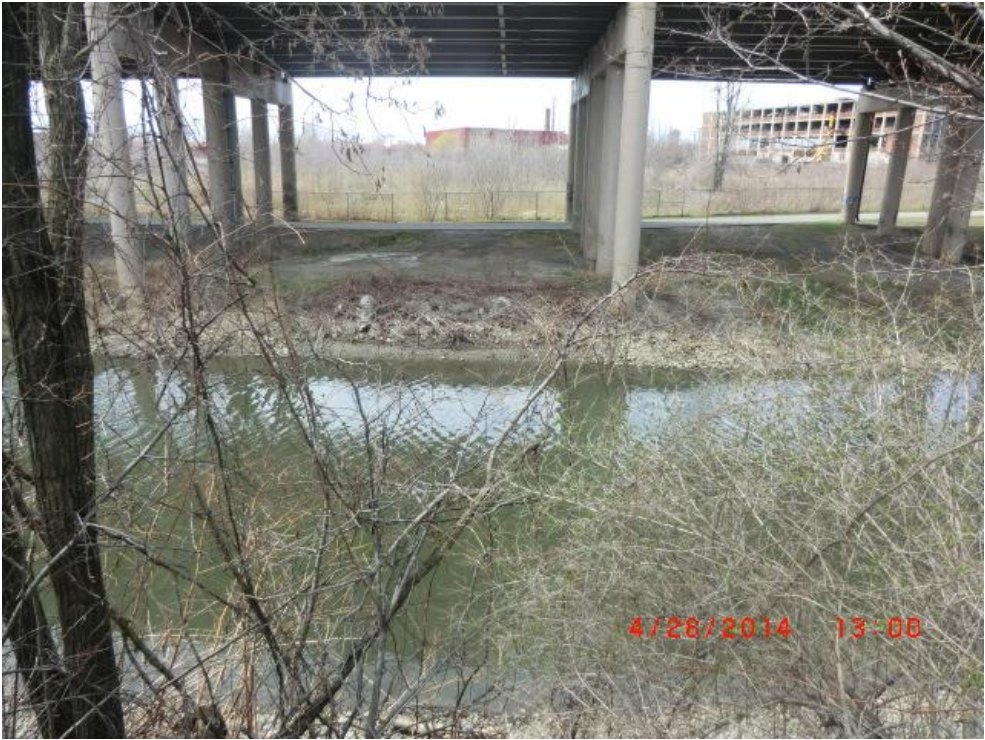
<b>Direction Photo Taken:</b>  East bank looking west			
<b>Description:</b>  Location #7 – Exposed fabric
