February 3, 2016

RE: Summary of Completed 2015 Maintenance Activities
Scajaquada Creek Site (#915141B), Buffalo, NY

Encl: Figure 1
Photo Log

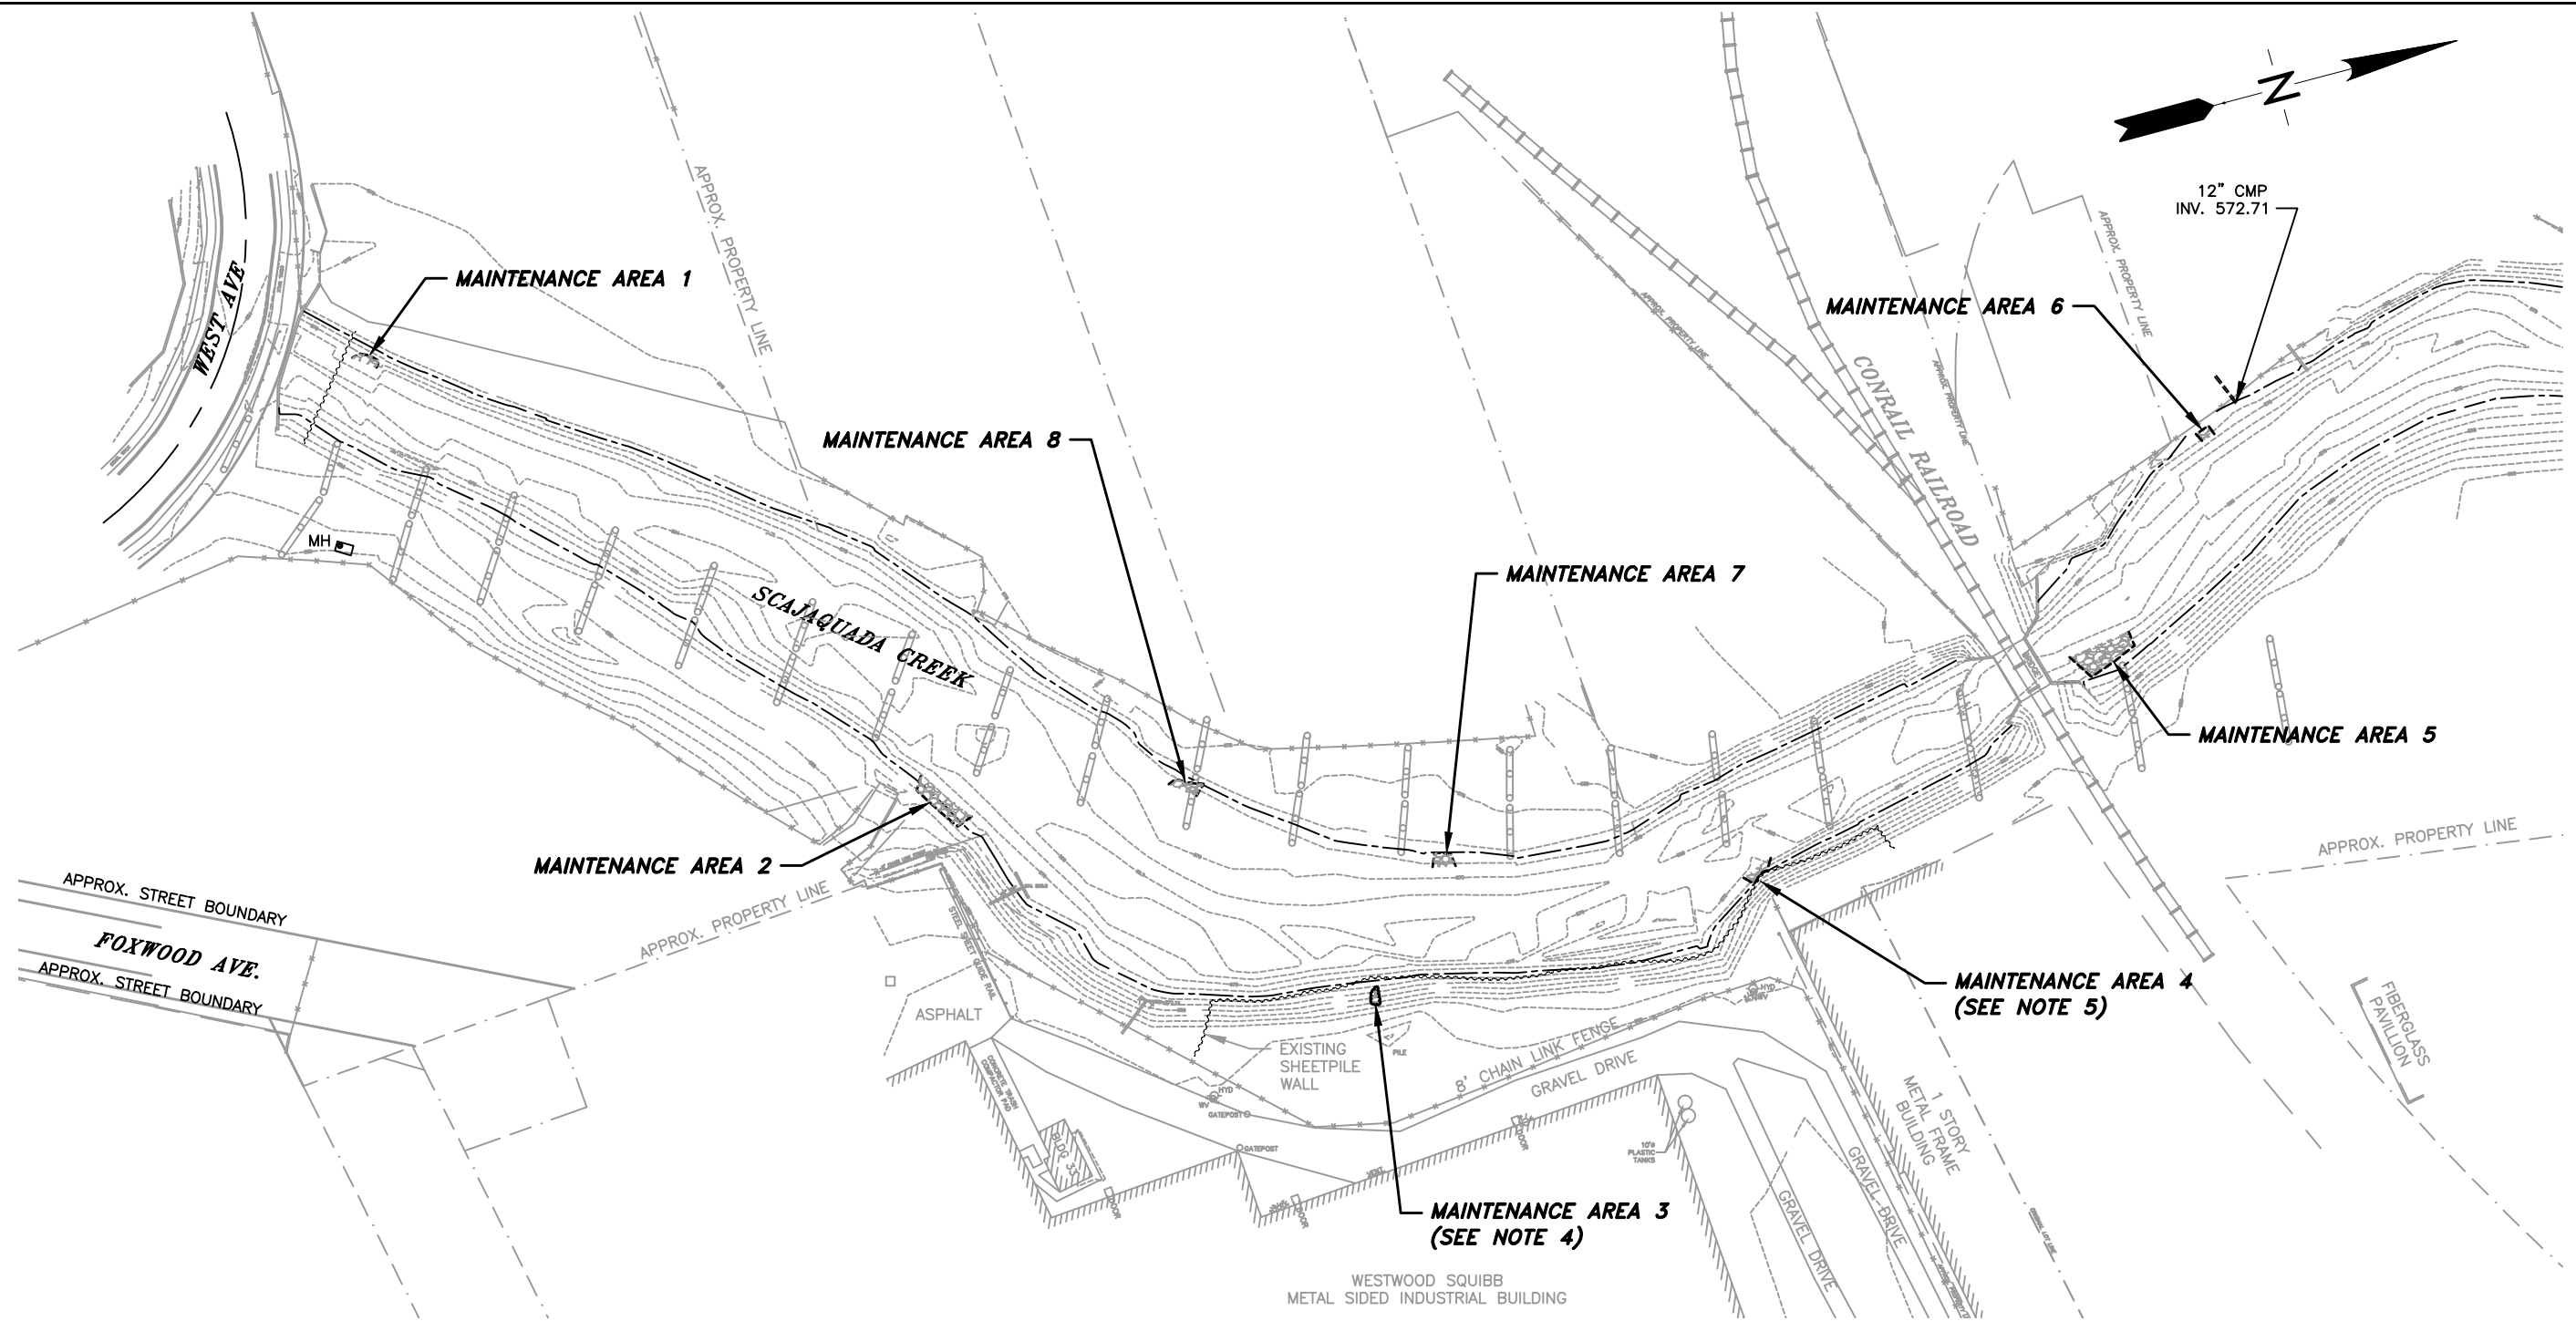
The 2015 inspection report recommended maintenance activities to repair eight areas showing routine loss of soil or cap cover materials. Since, as noted below, Areas 4 and 9 were determined to be the same, the recommended maintenance activities were completed with work at seven locations. That work was performed as summarized below, and is shown in the attached photographs. On December 7, 2015, AECOM surveyed the upland boundaries of the maintenance areas. These boundaries are shown on the attached Figure 1.

APPROXIMATE AREA OF MAINTENANCE ACTIVITIES PERFORMED NOV. 18-20, 2015. (UPLAND BOUNDARY SURVEYED)

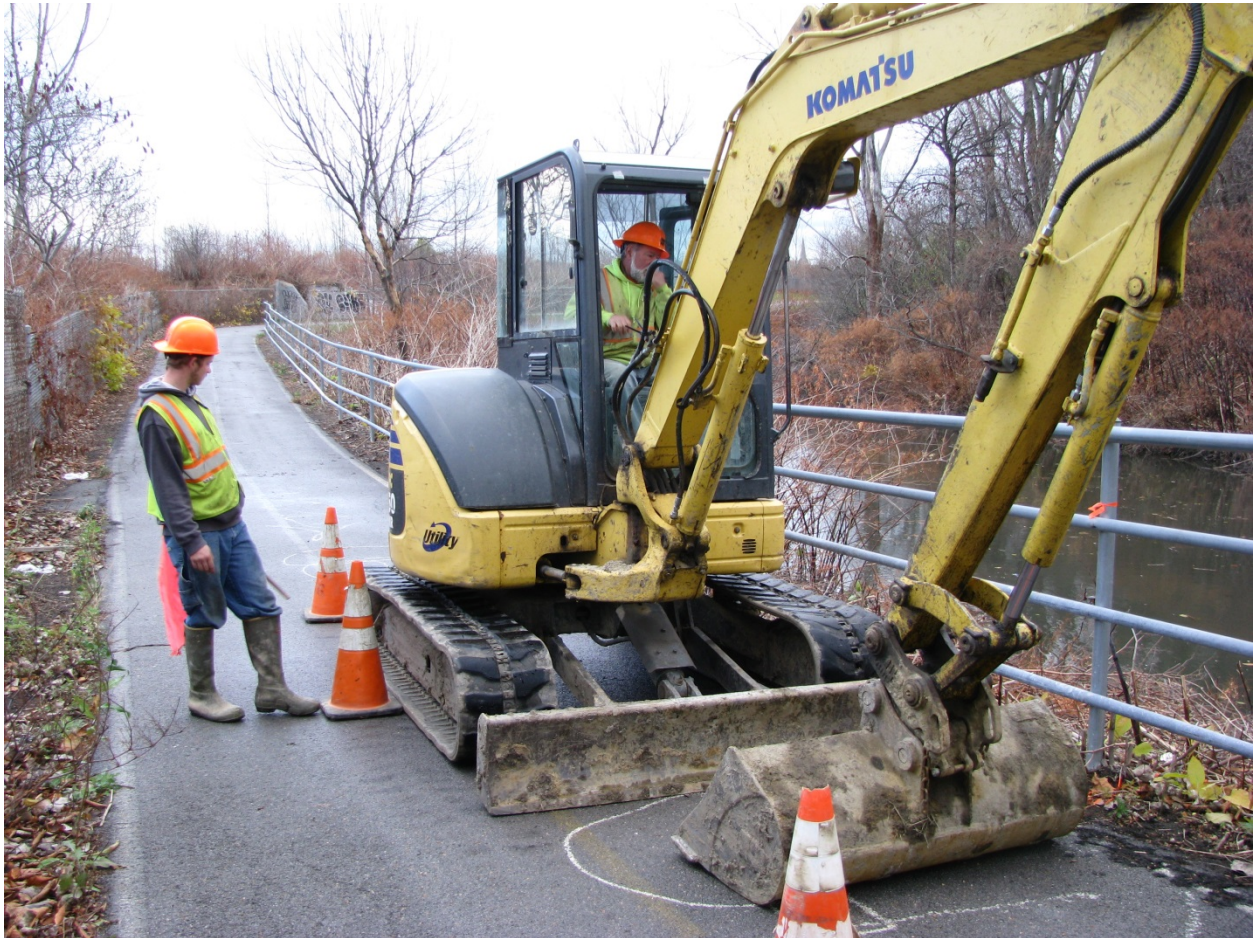
The maintenance materials were brought to the property in a tandem-axle dump truck, and conveyed to the work areas by skid steer equipment. The Contractor used hand-labor and a rubber-tracked excavator (see Photo 1) positioned at the top of the creek bank to clear any remaining standing vegetation from the work areas. This allowed for a clear delineation of areas of sloughed or missing cover materials. AECOM verified in the field the limits of the areas found to require maintenance.

Rubber-tracked equipment used by the Contractor to clear vegetation and place and/or position stone.

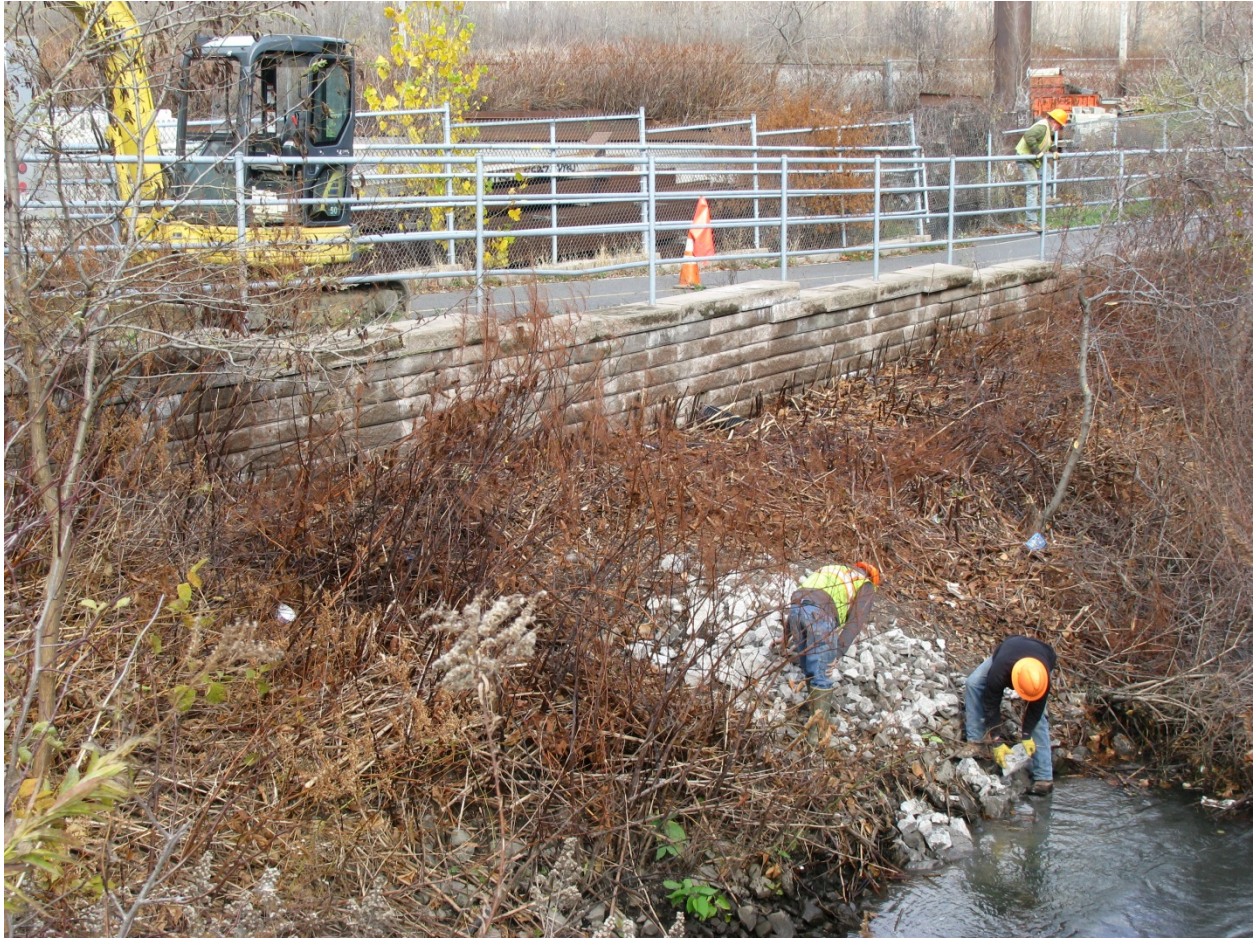
Performing maintenance activity of Area 1.

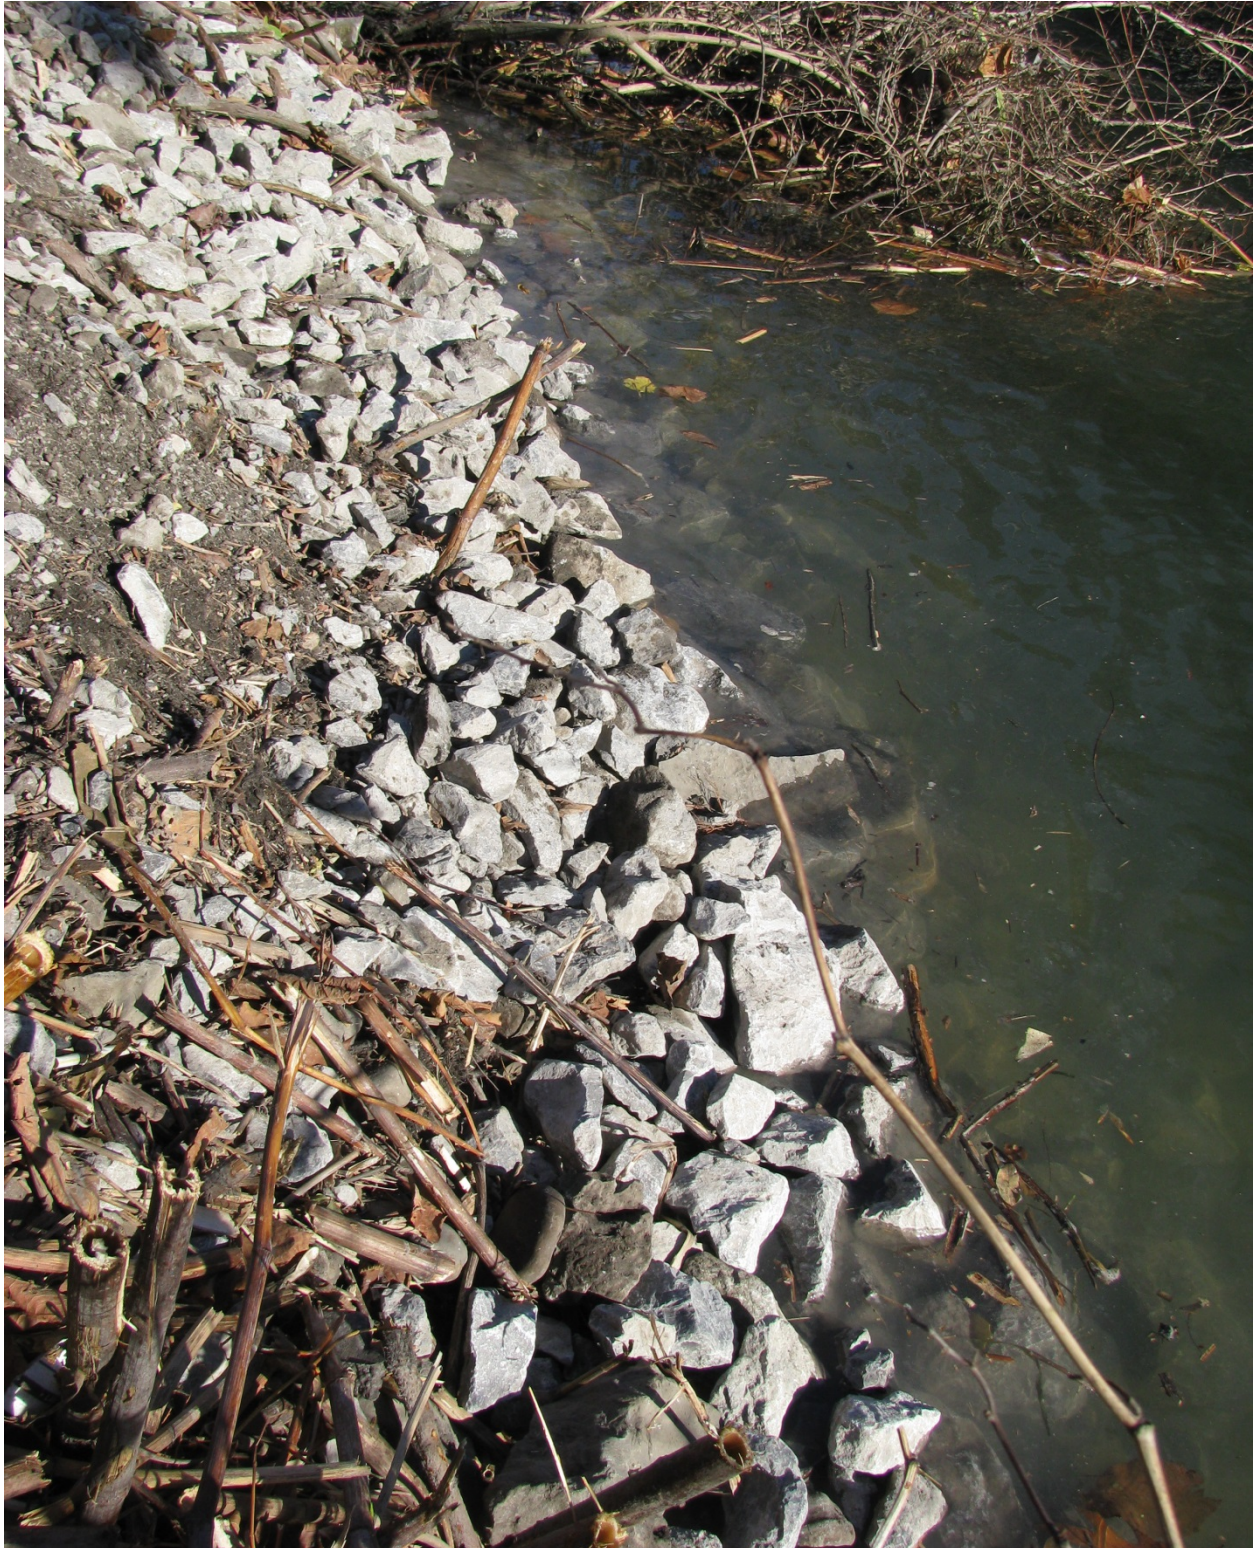
Maintenance stone placed near water's edge at Area 1.

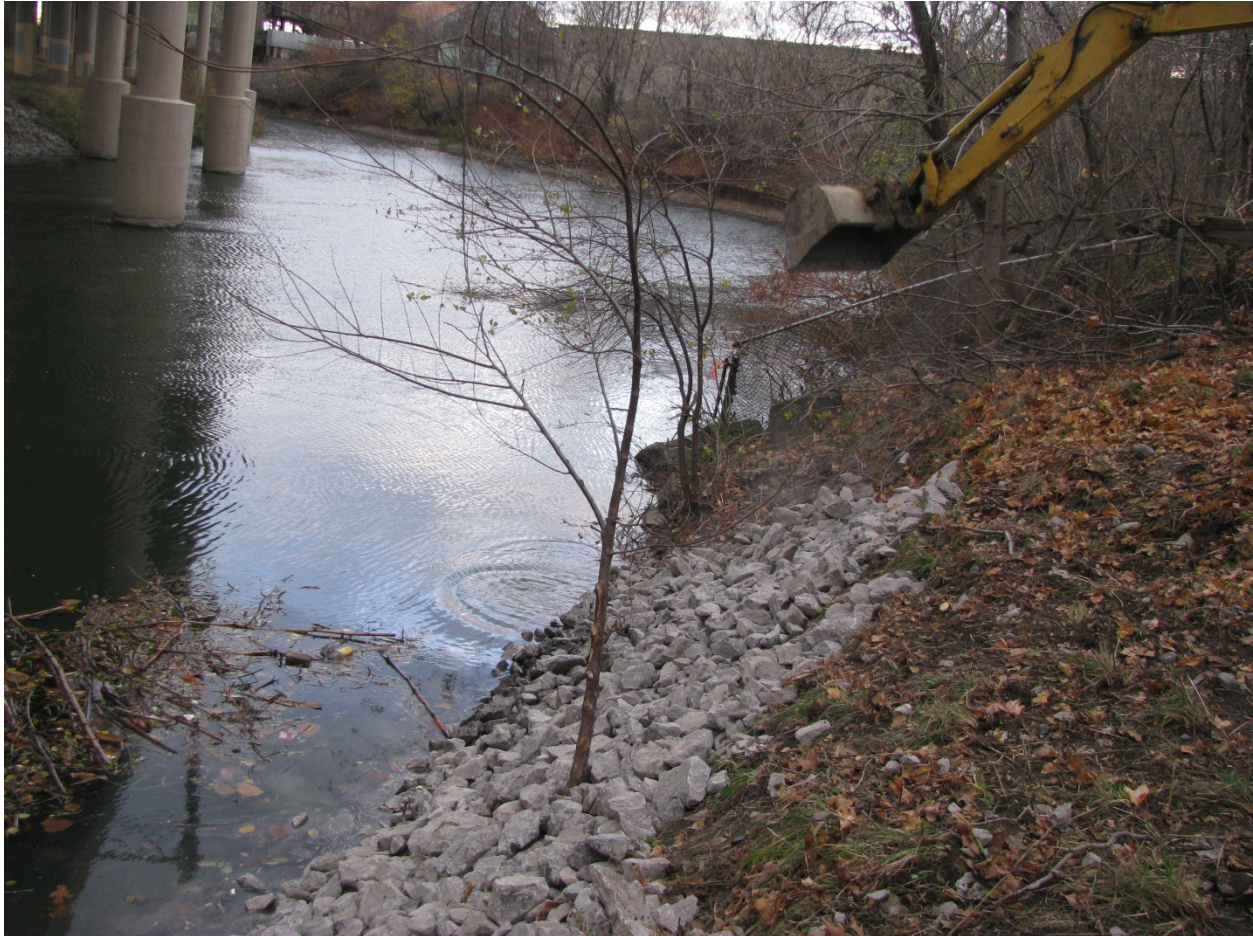
Partially completed maintenance activity at Area 2.

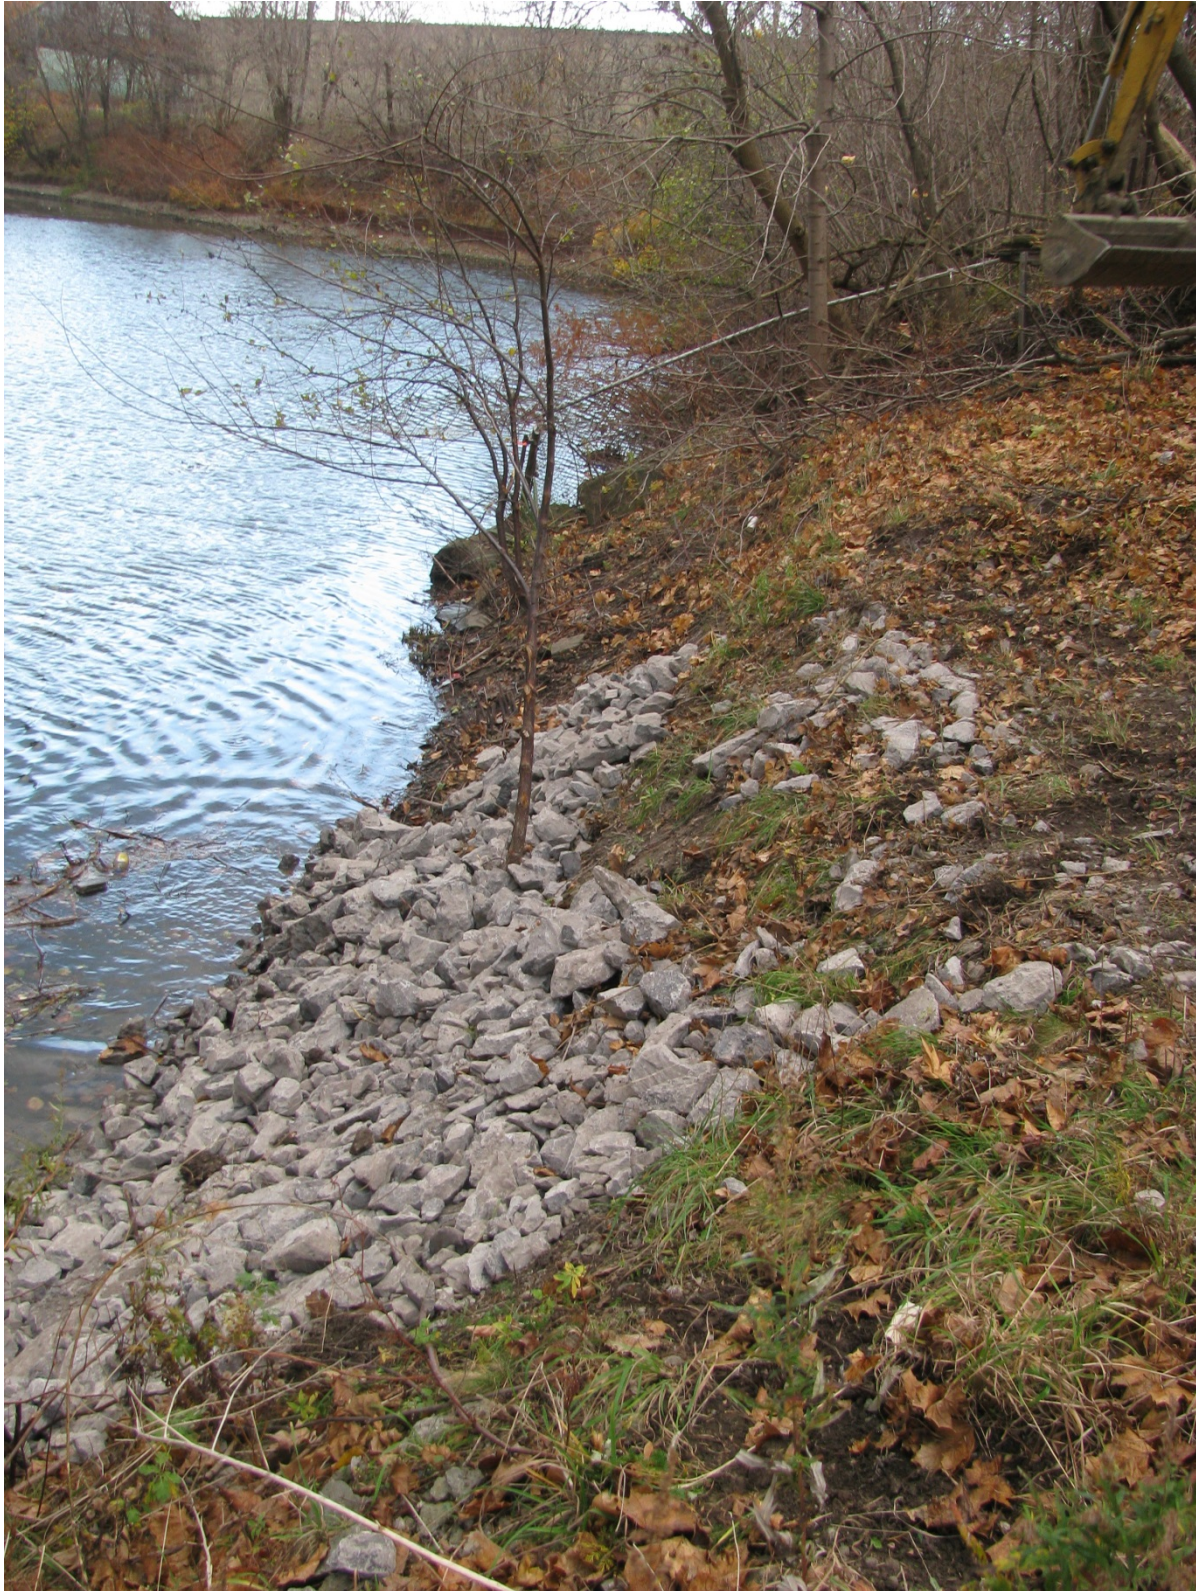
Partially completed maintenance activity at Area 2.

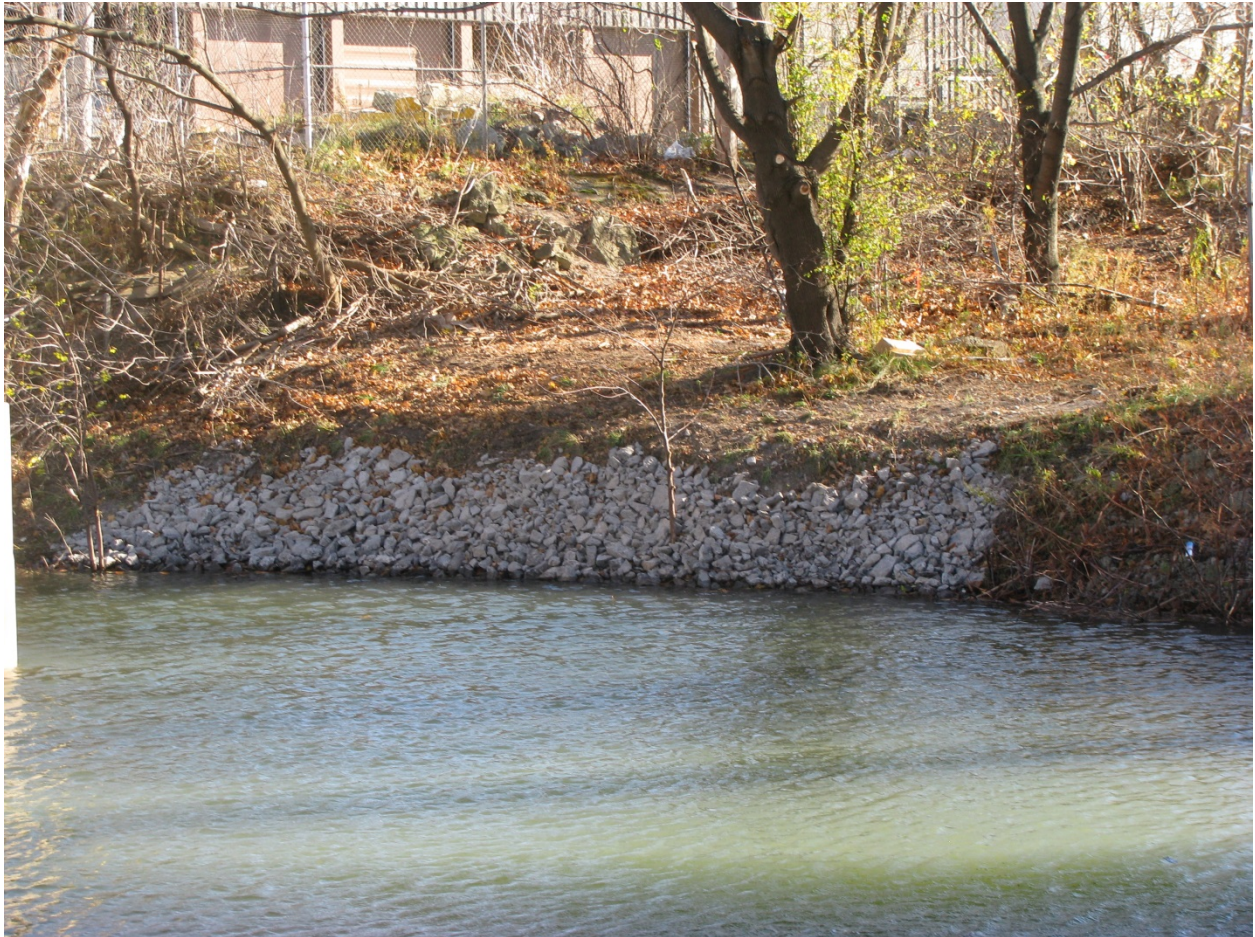
Completed maintenance activity at Area 2.

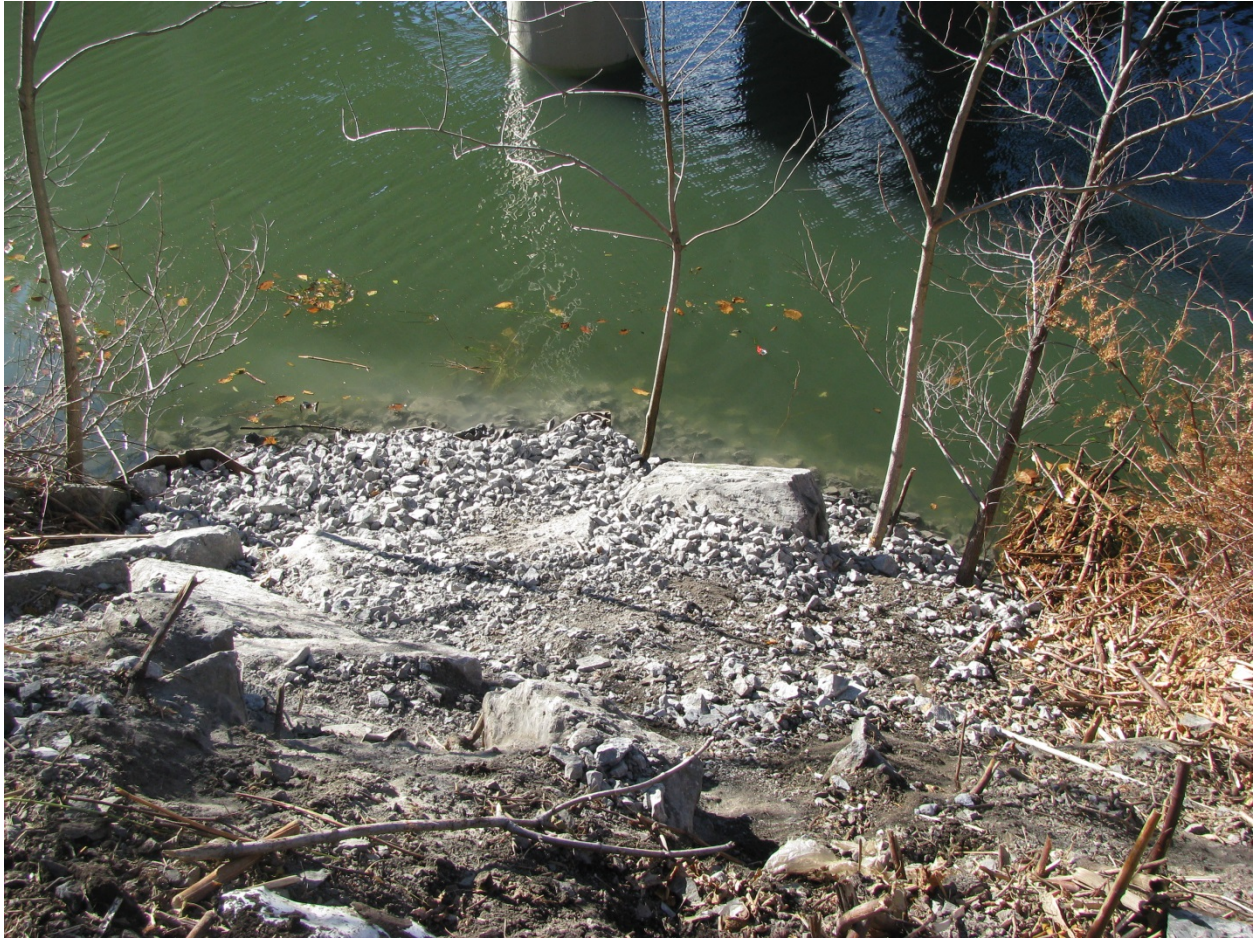
Looking downslope at the portion of the slope above Area 4 that was disturbed by maintenance activities.

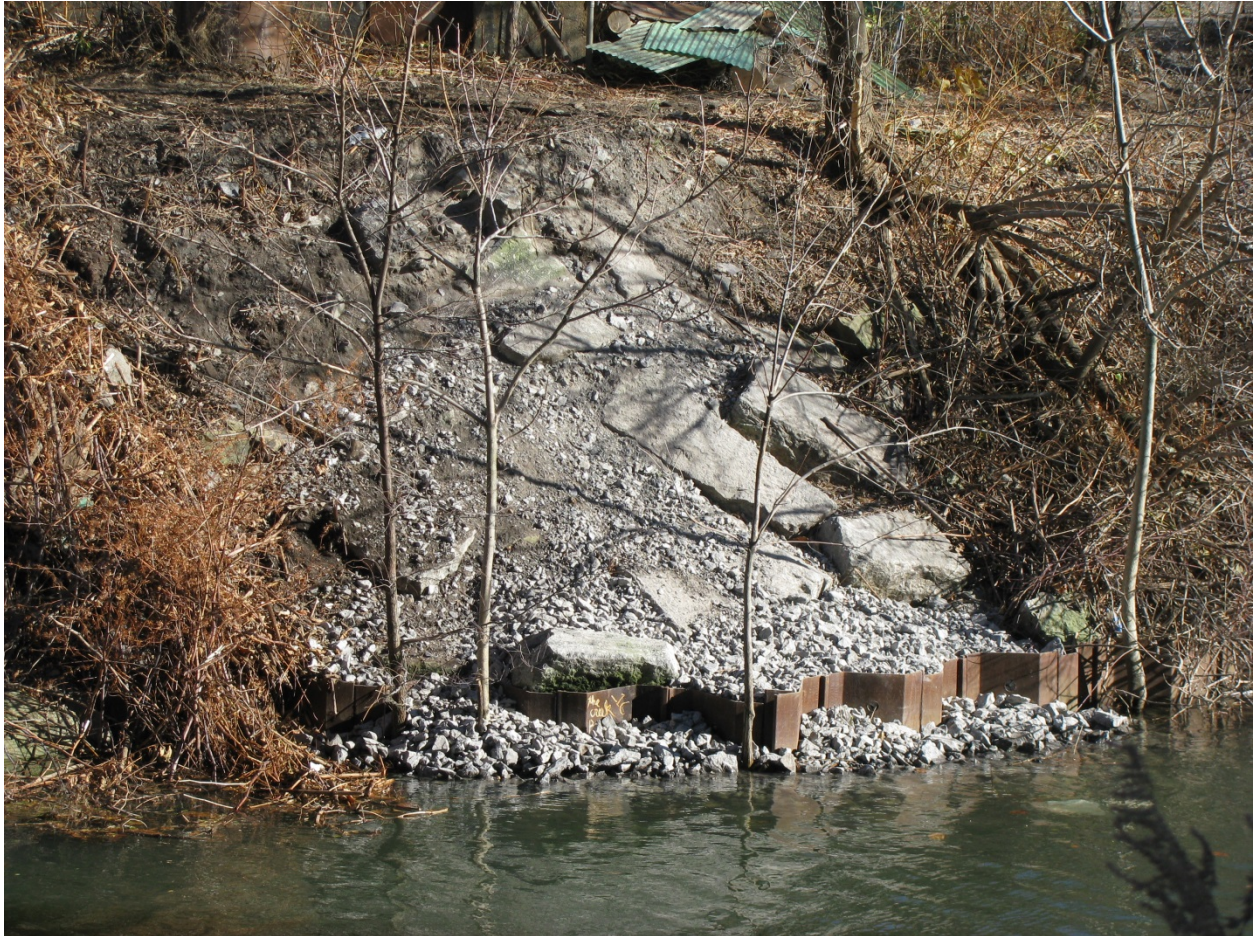
Completed maintenance activity at Area 4 (located in front of sheet pile wall). Apparent bare soils will be monitored for erosion in future site inspections.

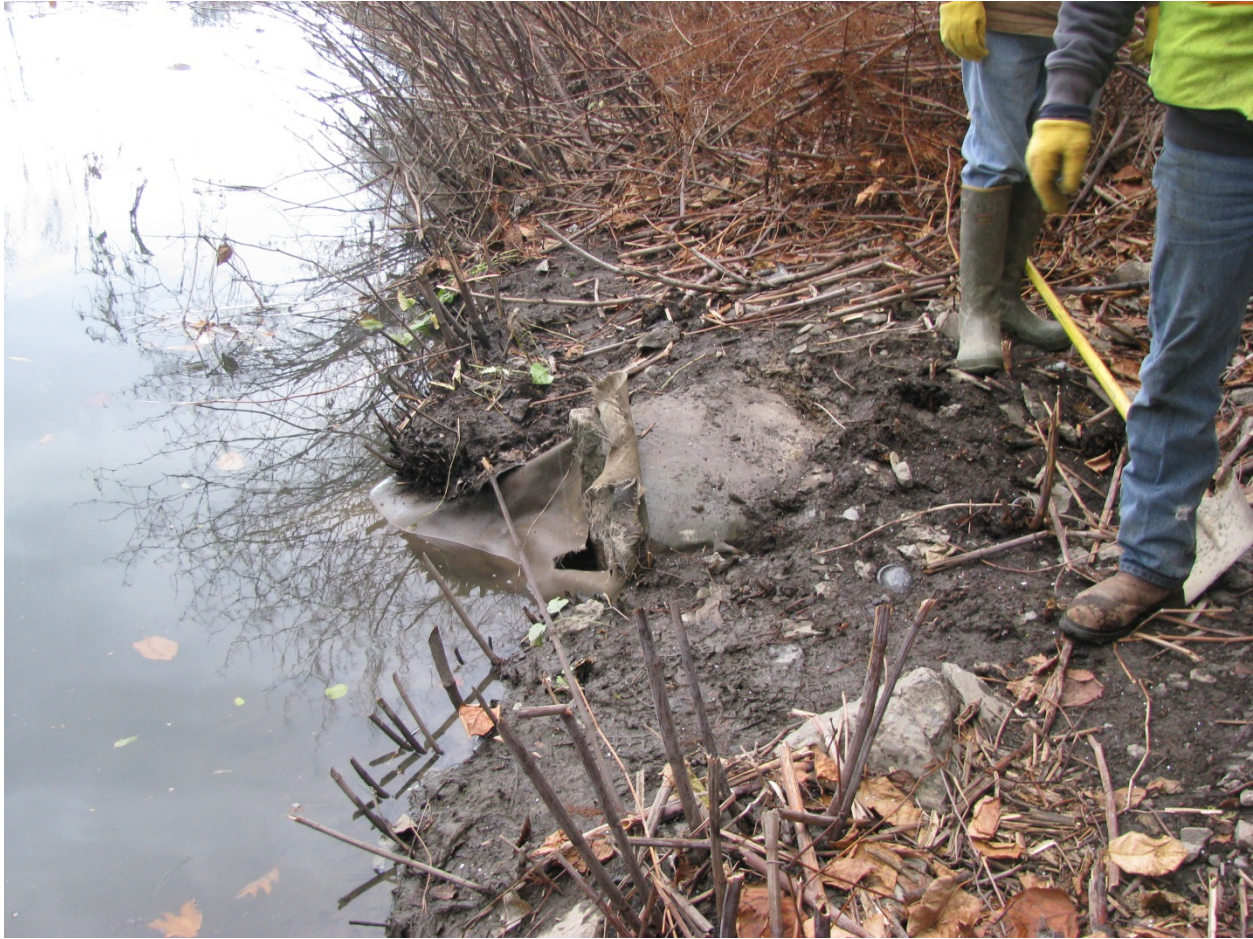
Damaged textile at Area 5. The textile had torn, and was further slit to eliminate bridging over missing stone/soil below, and to allow it to lie flat beneath replaced armor.

- In portions of each maintenance area (extensively in Areas 1, 4, 5, and 6), the stone was not placed by bucket due to difficult access; alternatively, the stone was dumped at the top of slope and then placed in the work areas by hand.
- Area 5: The existing, torn geotextile was further slit to allow it to lie flat against the underlying soils. The resultant hole was overlain with an approximate 5 feet by 5 feet piece of woven polypropylene geotextile that was pinned to the underlying soils rather than being glued or stitched to the existing geotextile. The replacement stone fill was then placed over the pinned textile.
- Area 4, identified in the 2014 PRR, was determined to be the same as Area 9 identified during the 2015 annual site inspection. It is referred to as Area 4 throughout this report.

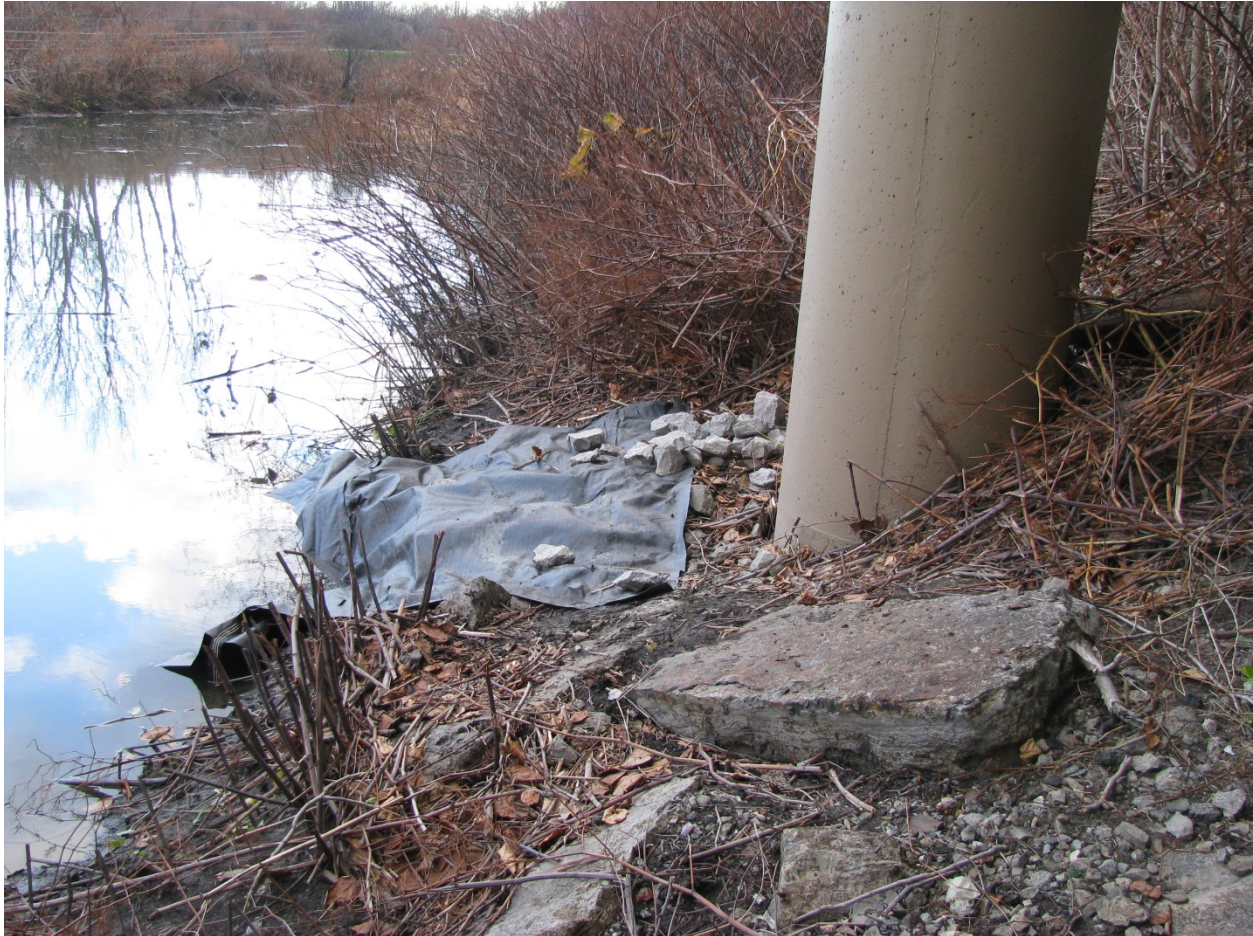
Geotextile patch placed to cover the torn/slit existing textile at Area 5. The replacement textile was affixed to the underlying soil with pins.

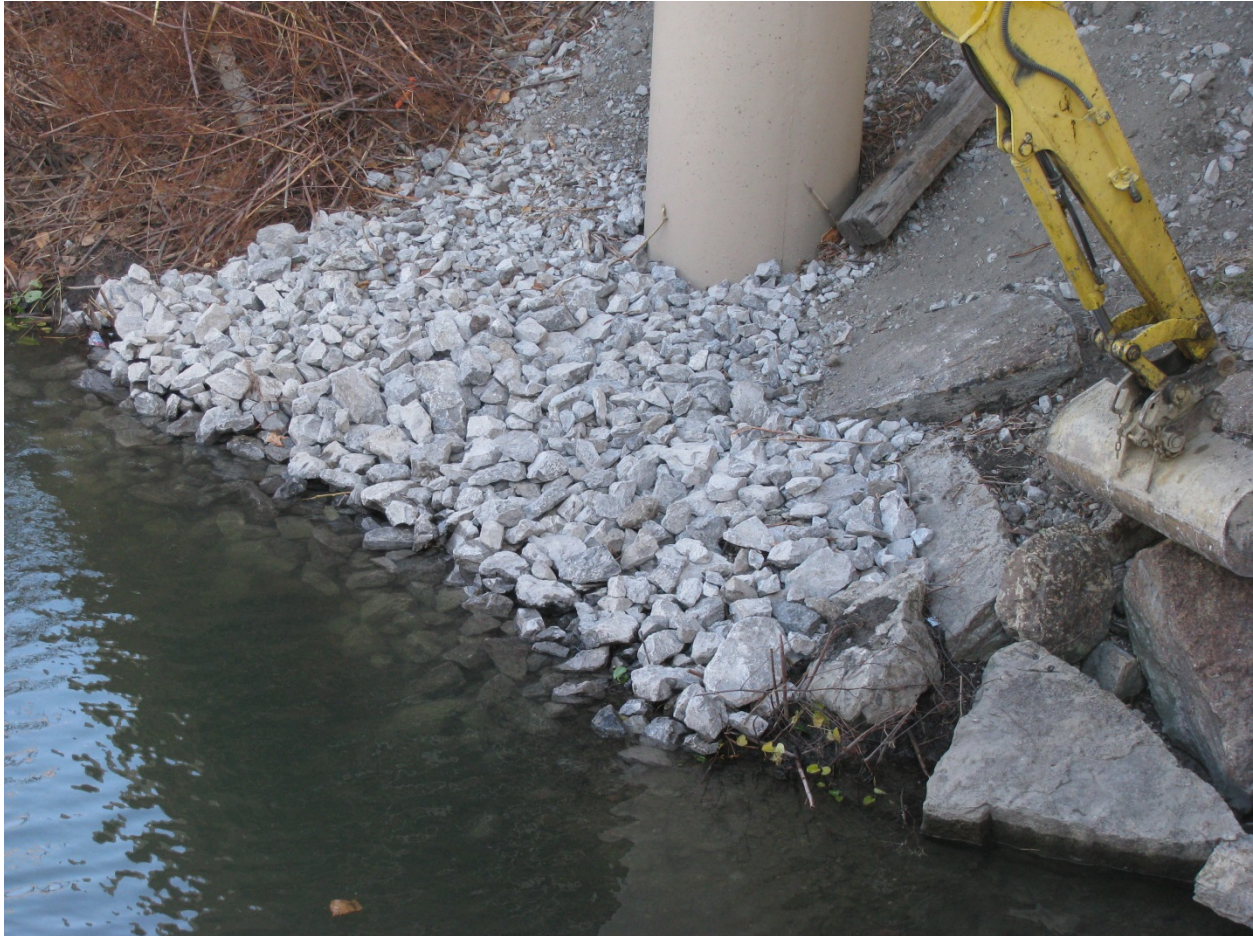
Completed maintenance activity at Area 5.

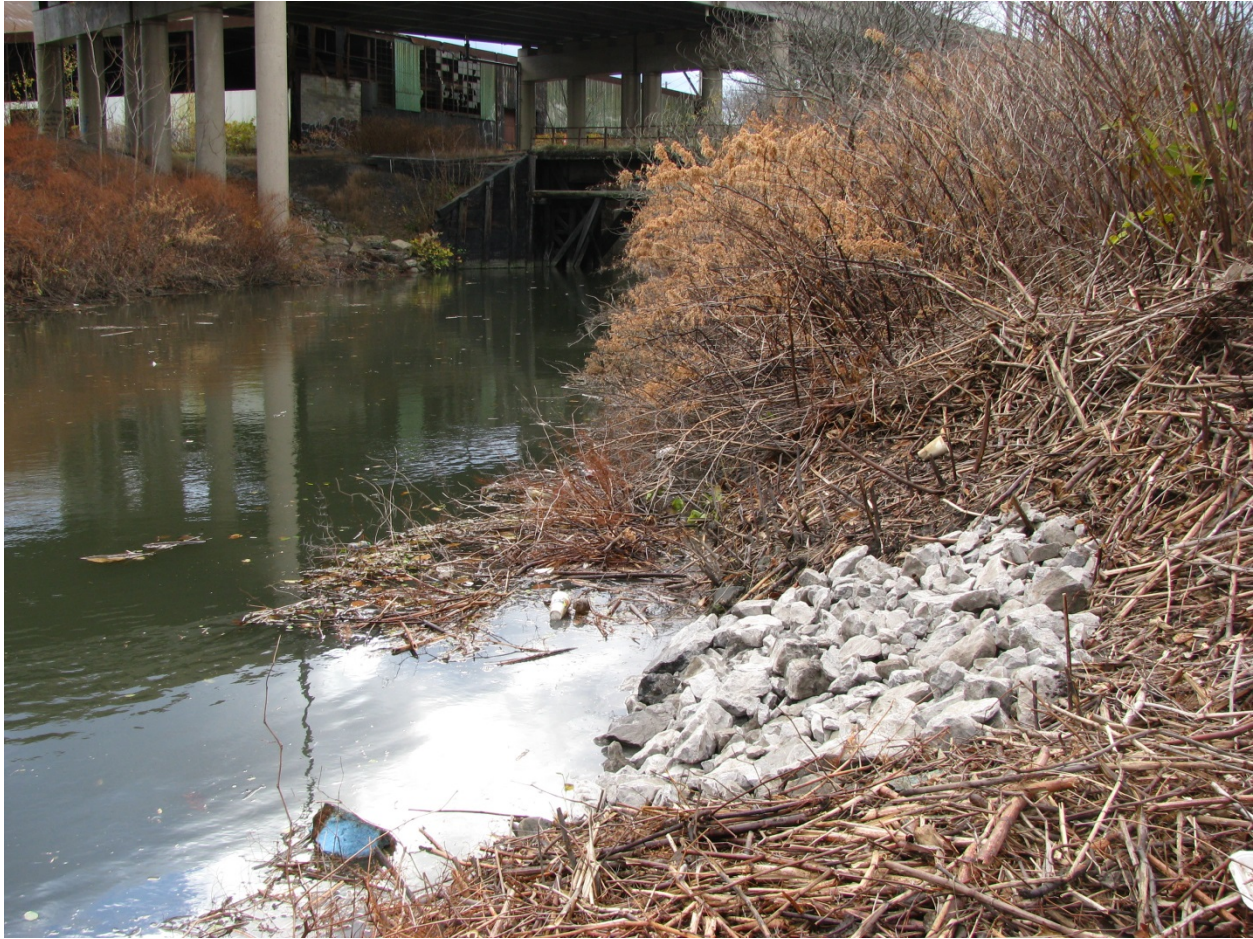
Completed maintenance activity at Area 6.

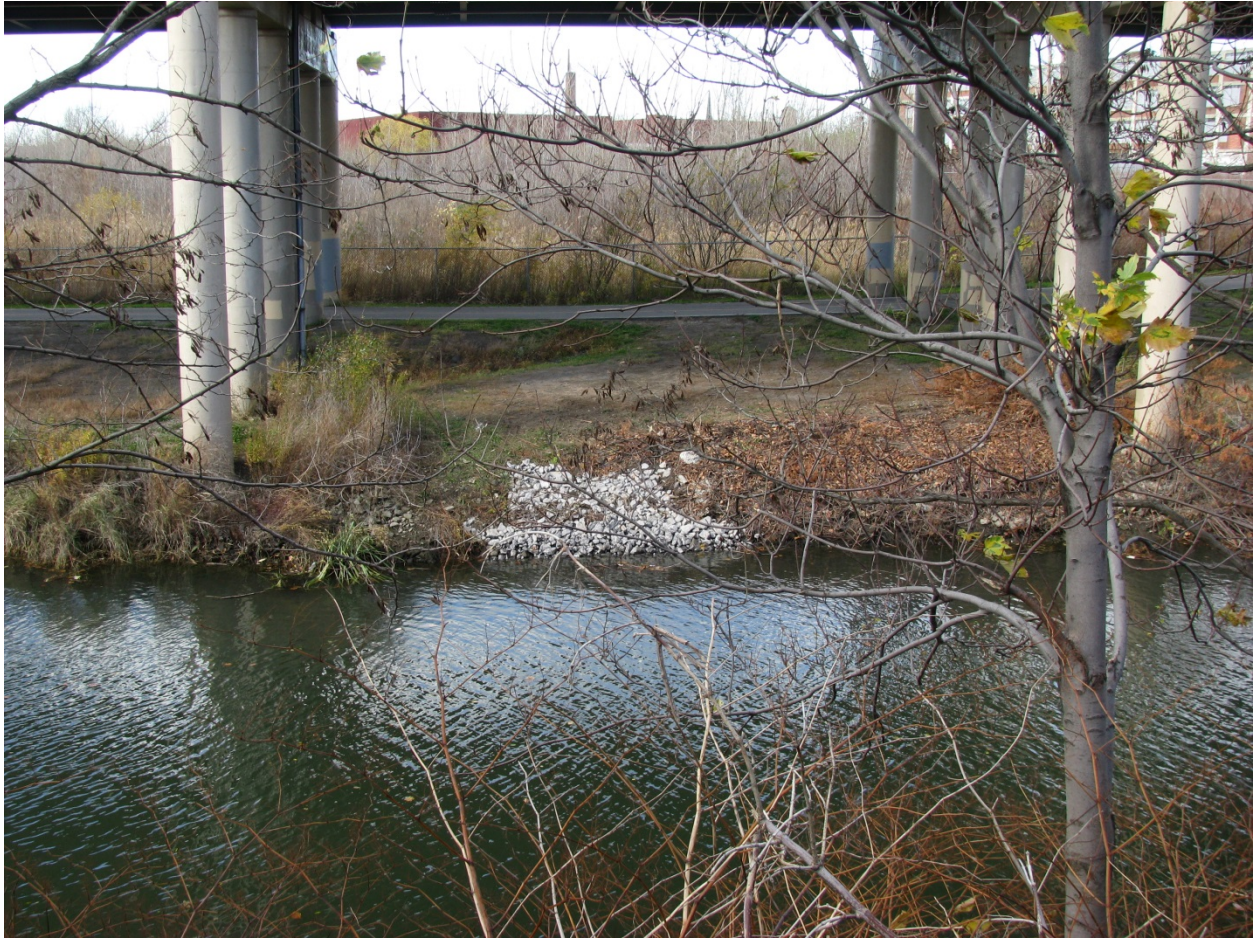
Completed maintenance activity at Area 7.

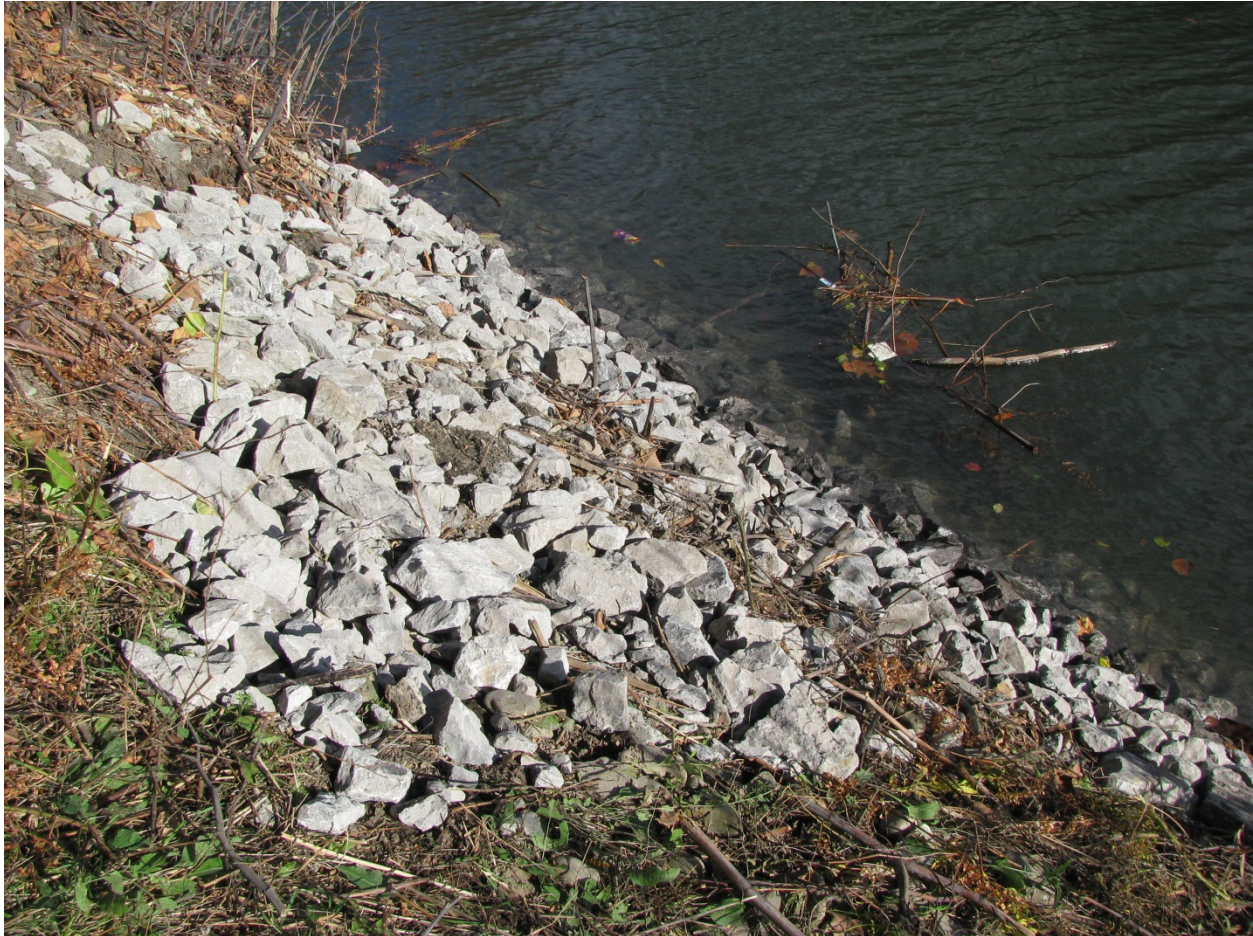
Completed maintenance activity at Area 7.
