February 3, 2016

RE: Summary of Completed 2015 Maintenance Activities
Scajaquada Creek Site (#915141B), Buffalo, NY

Encl: Figure 1
Photo Log

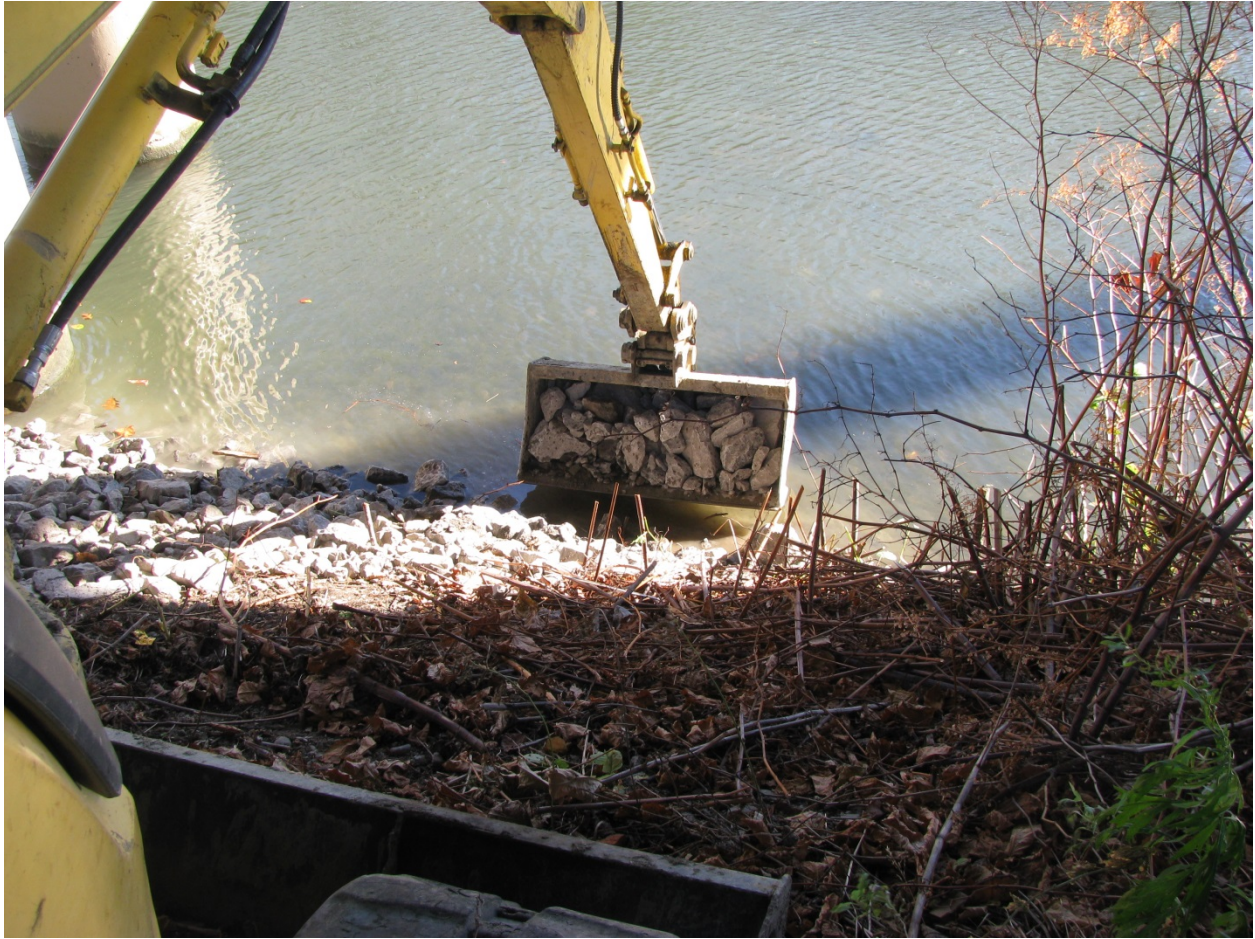
Placement of stone at Area 8.

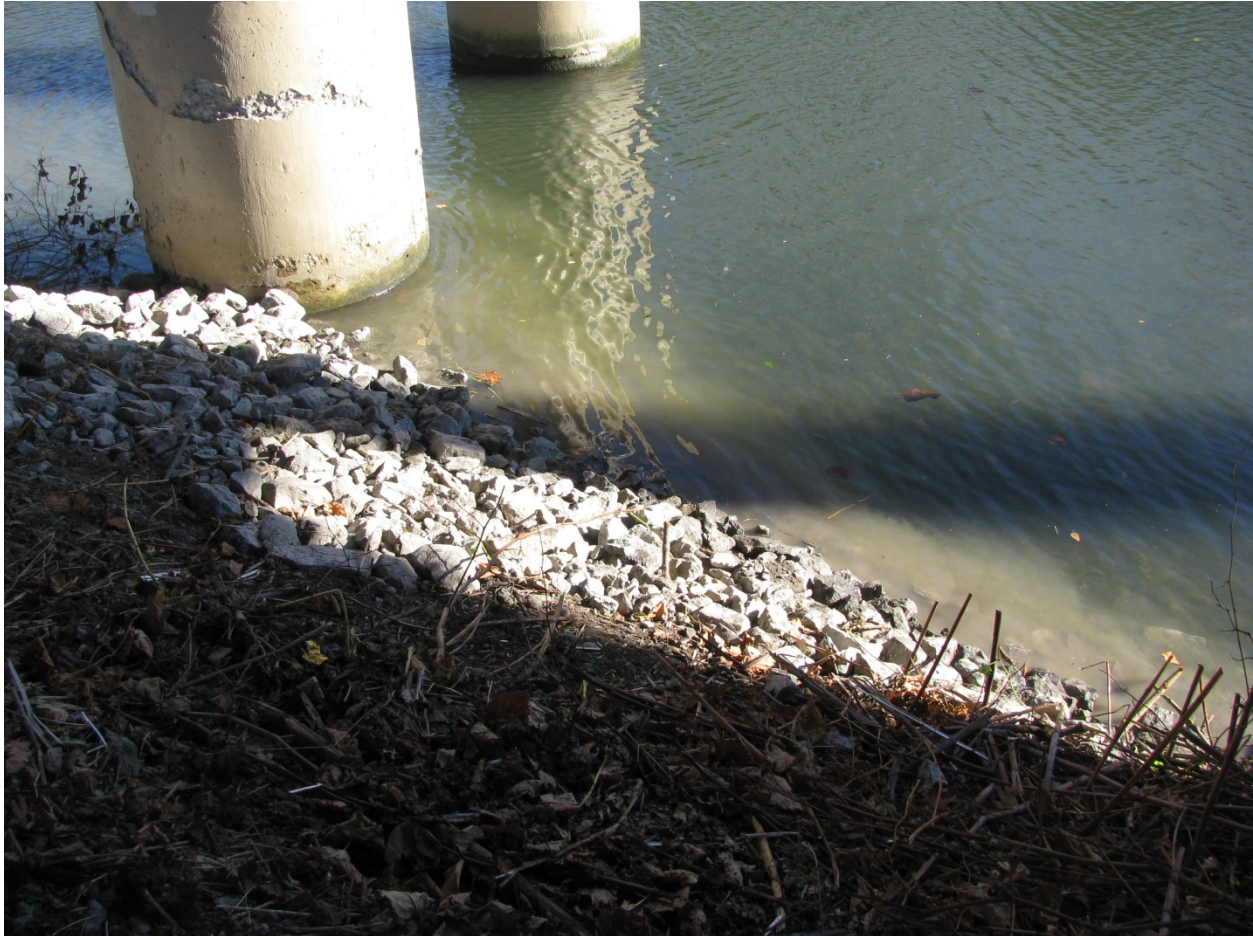
Completed maintenance activity at Area 8.

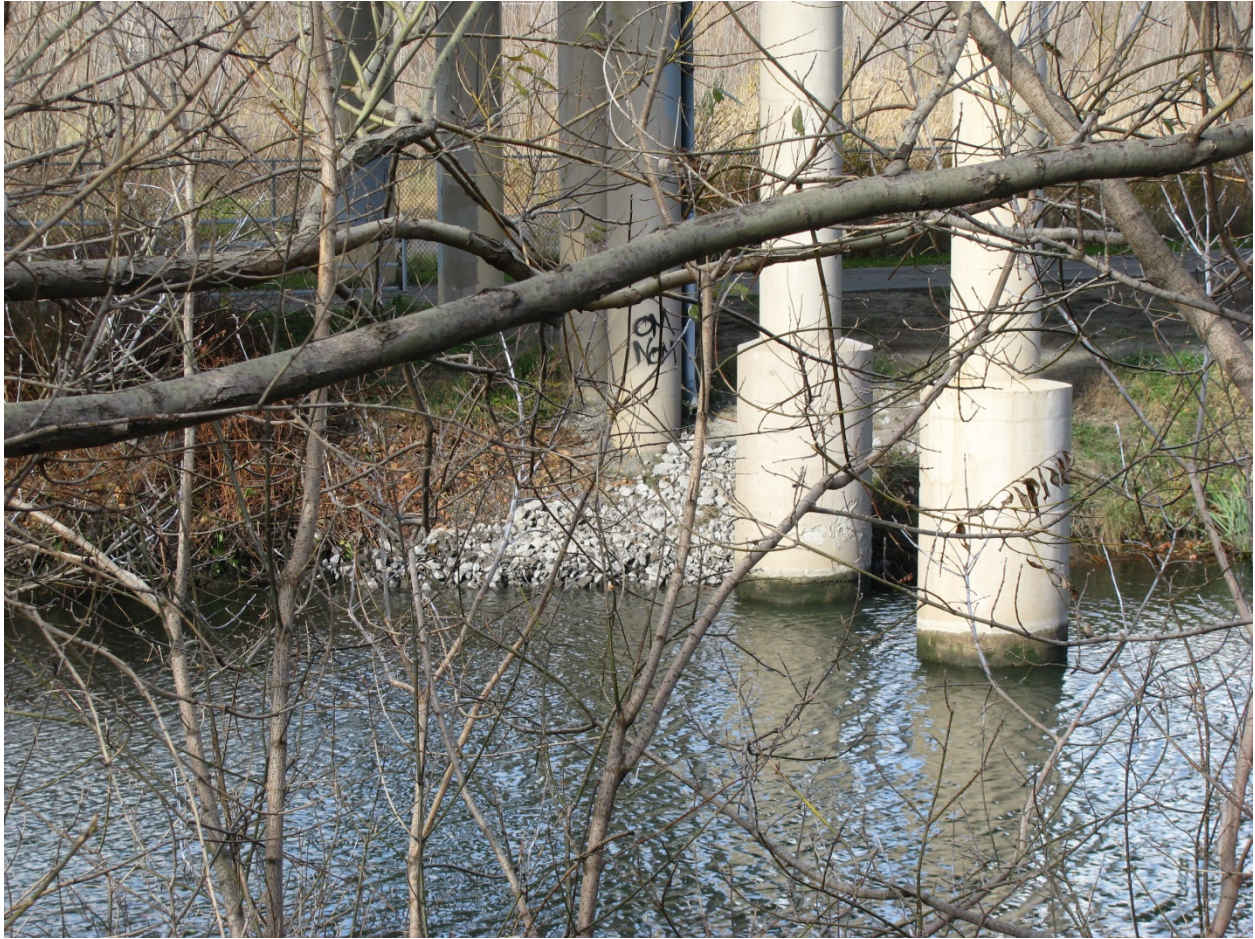
Completed maintenance activity at Area 8.
