## Site Management Periodic Review Report and IC/EC Certification (2016)

Iroquois Gas/Westwood Pharmaceutical Riparian Site No. 915141B  
Buffalo, New York

March 2017

RE: Summary of 2016 Annual Site Inspection  
Scajaquada Creek Site (#915141B), Buffalo, NY

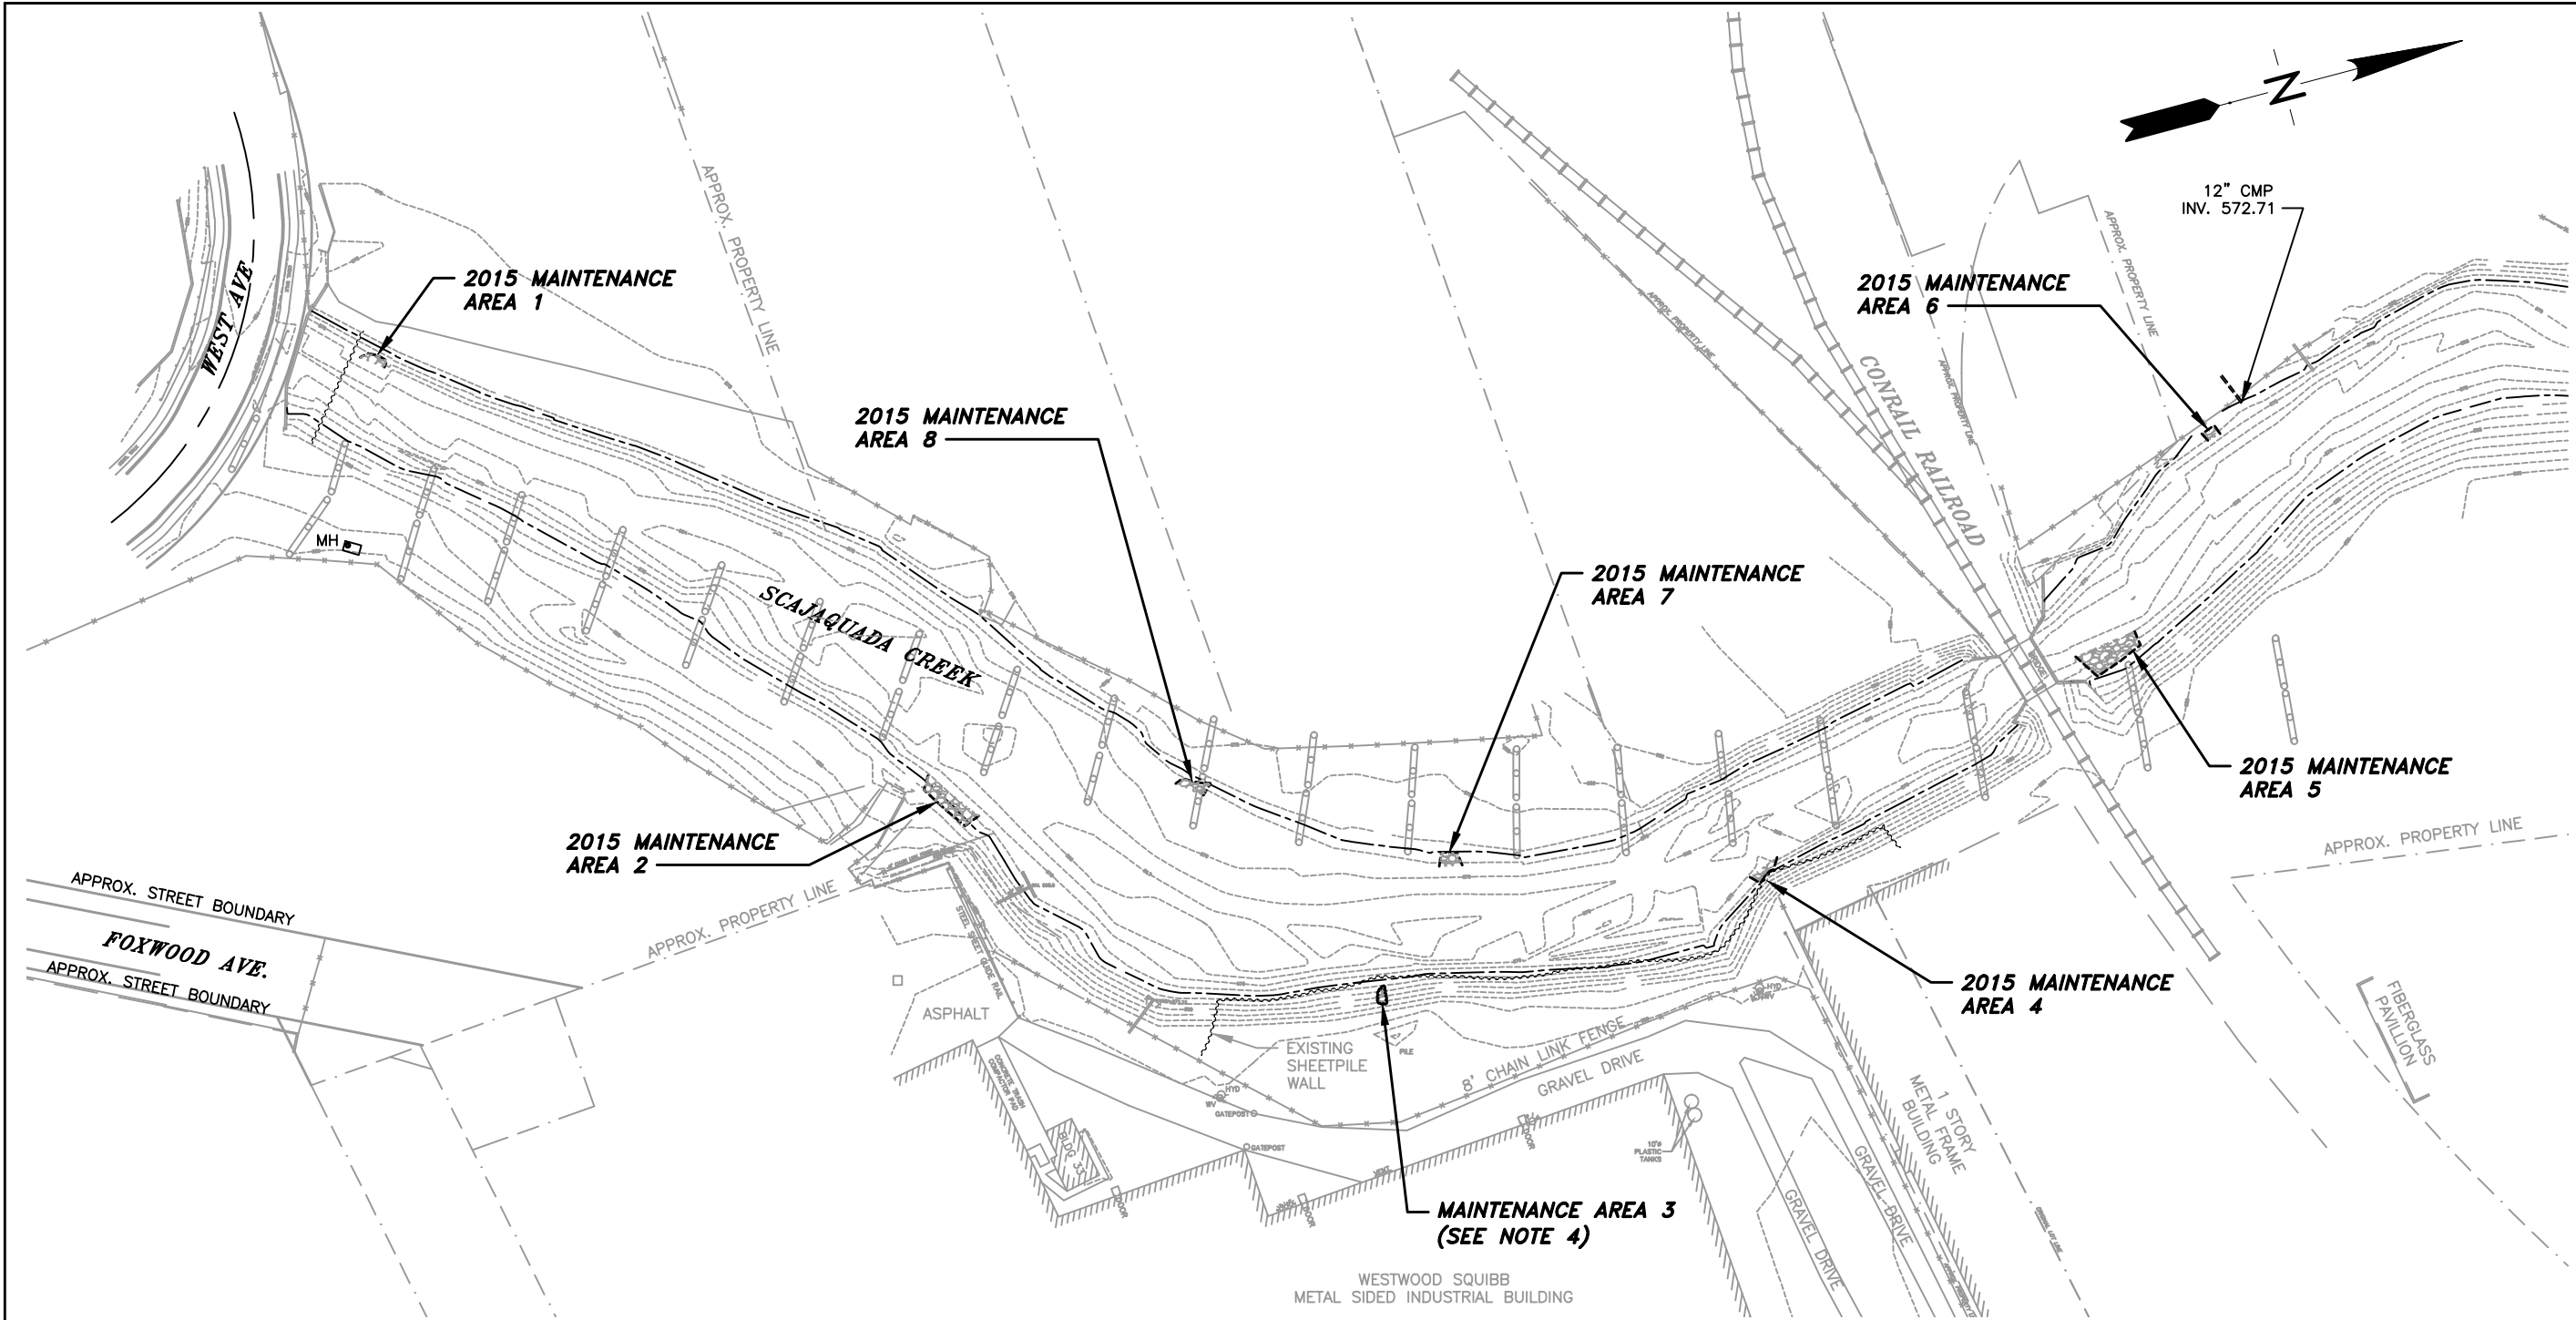
The remedy, including the eight repairs made last year as shown on attached Figure 1 and in the attached photograph log, is functioning as intended. AECOM noted no deficiencies in the capping system, nor any incipient problems meriting additional monitoring or corrective measures.

Based on our inspection, AECOM does not recommend any specific supplemental maintenance activities this year for the capping system at this site.

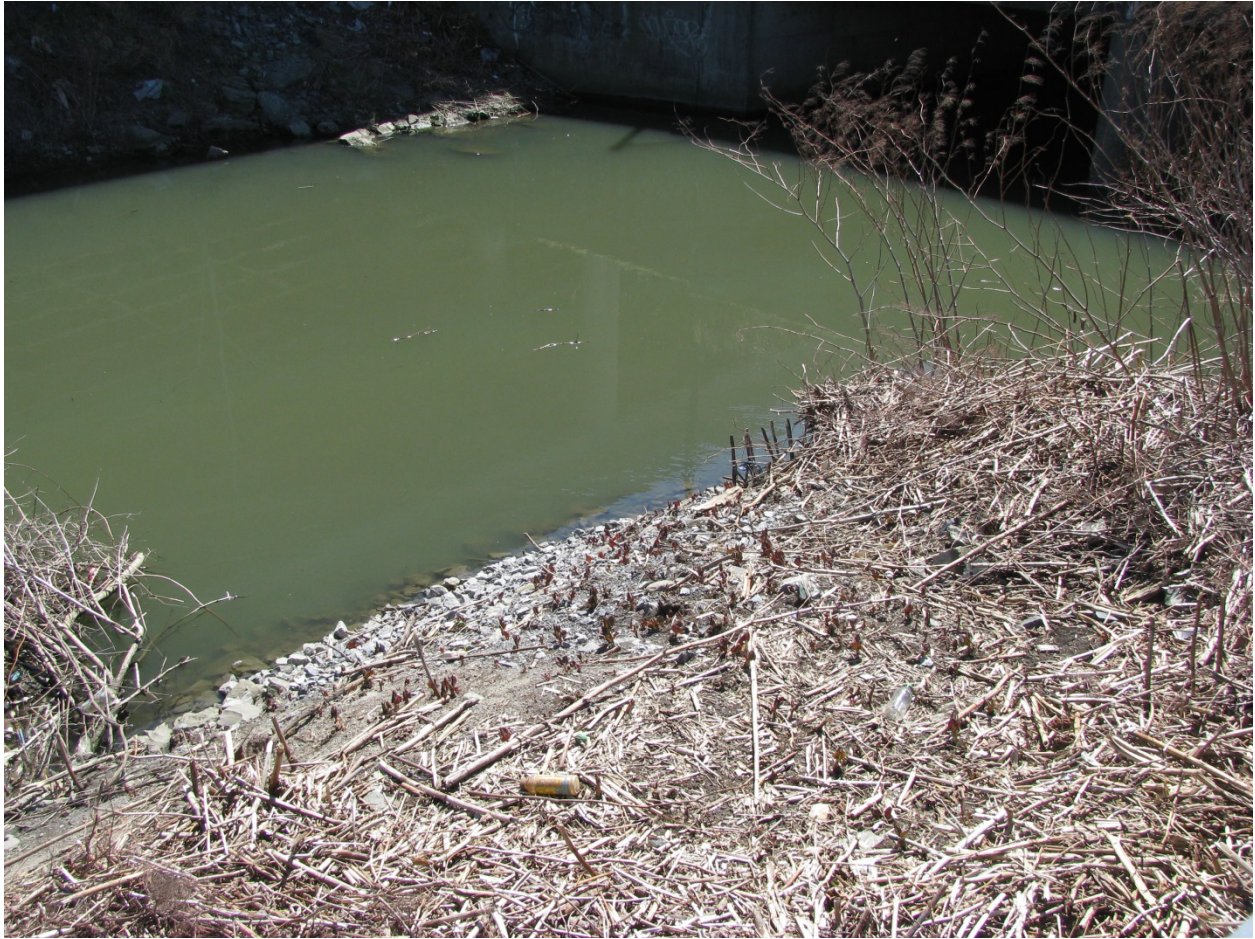
**Looking downslope at 2015 Maintenance Area 1.**

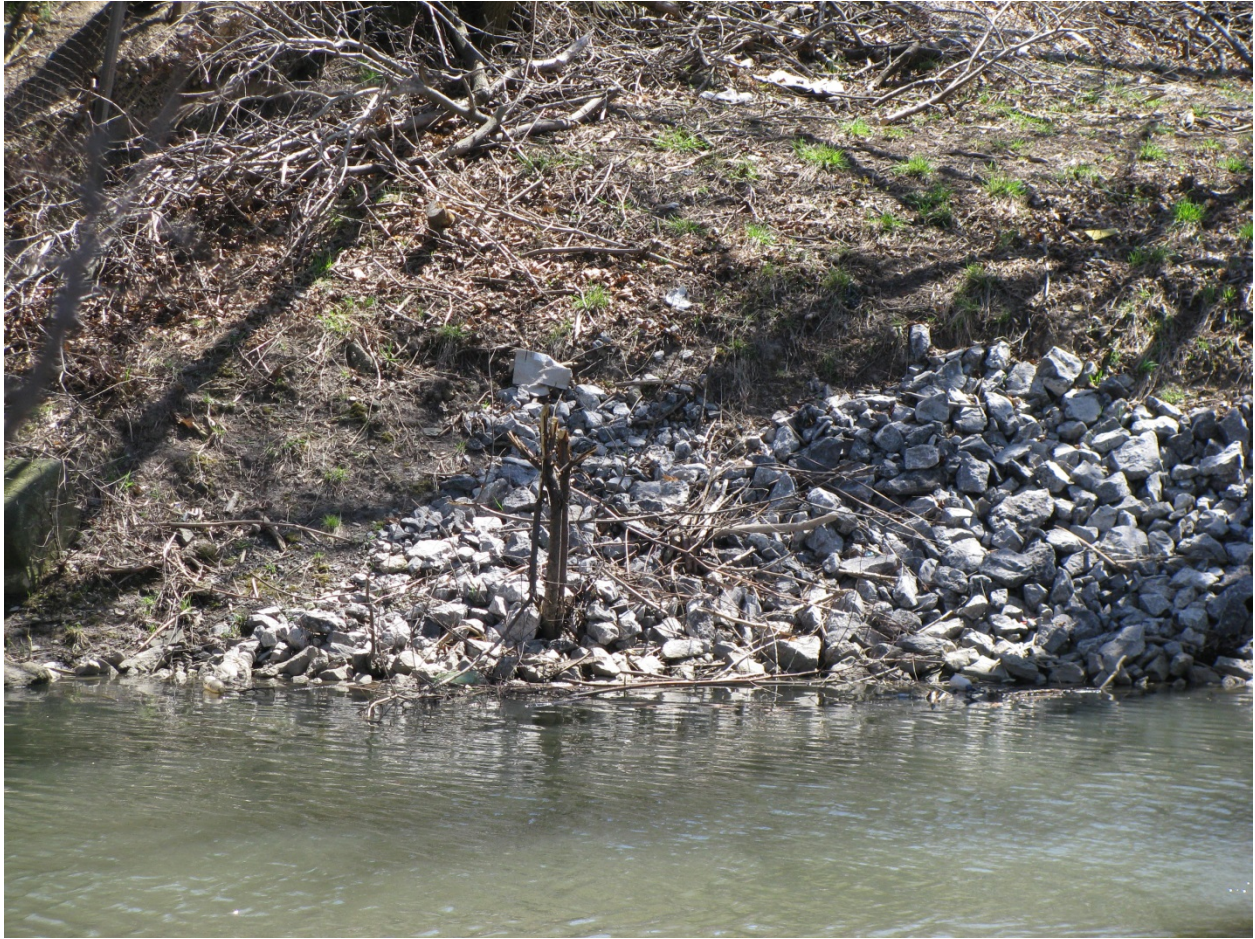
**Looking east (across the Creek) at 2015 Maintenance Area 2.**

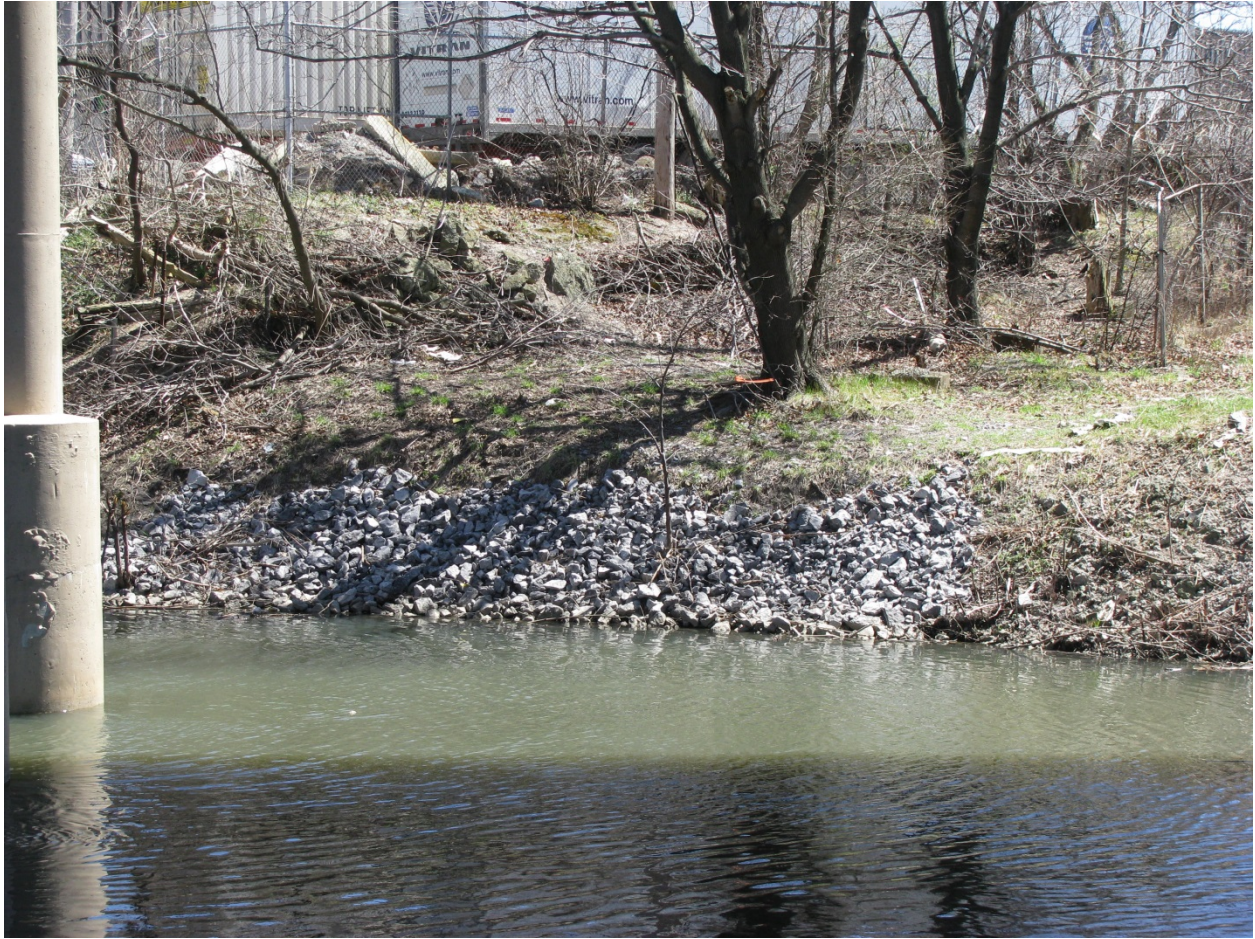
**Looking east (across the Creek) at 2015 Maintenance Area 2.**

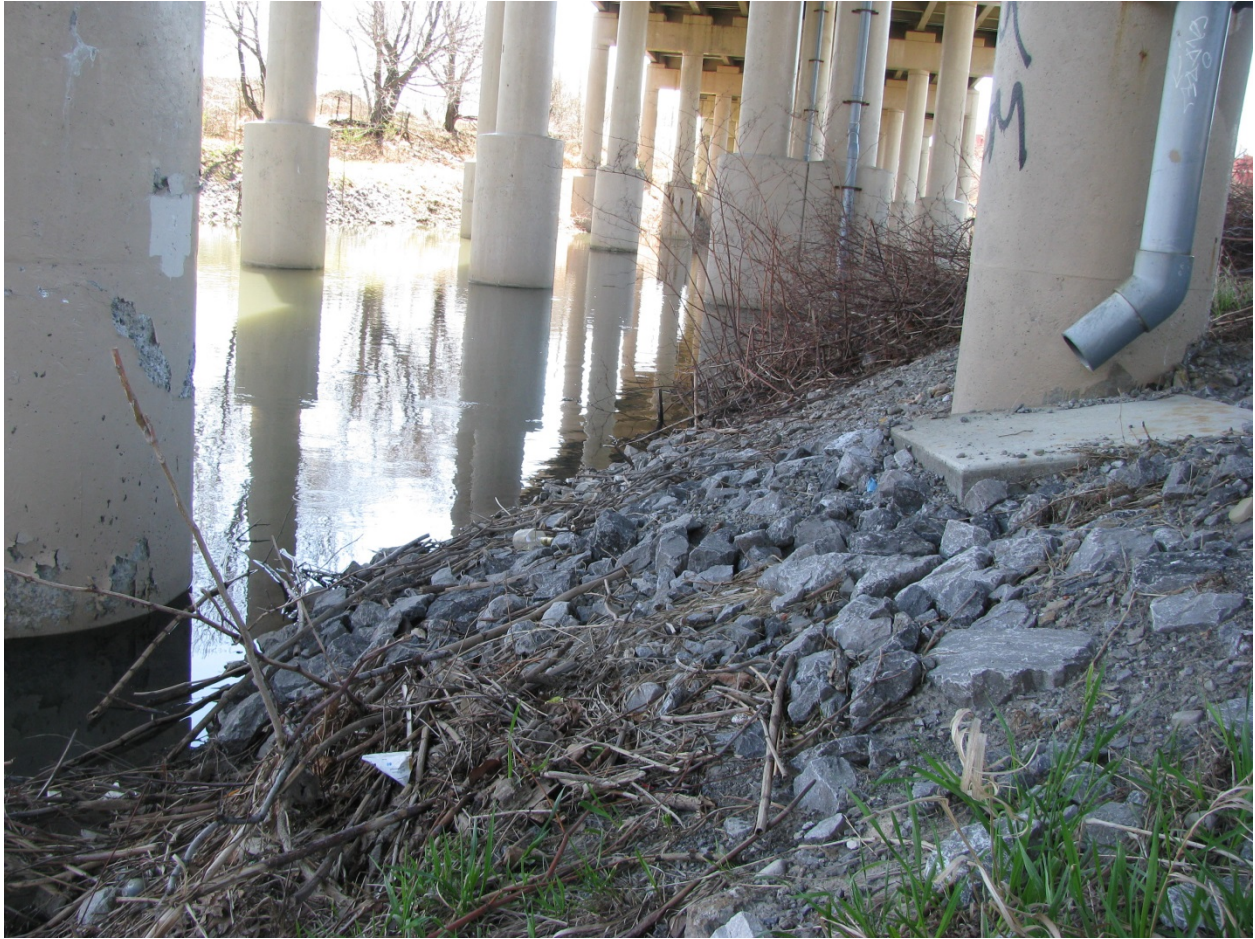
**Looking south at 2015 Maintenance Area 8.**

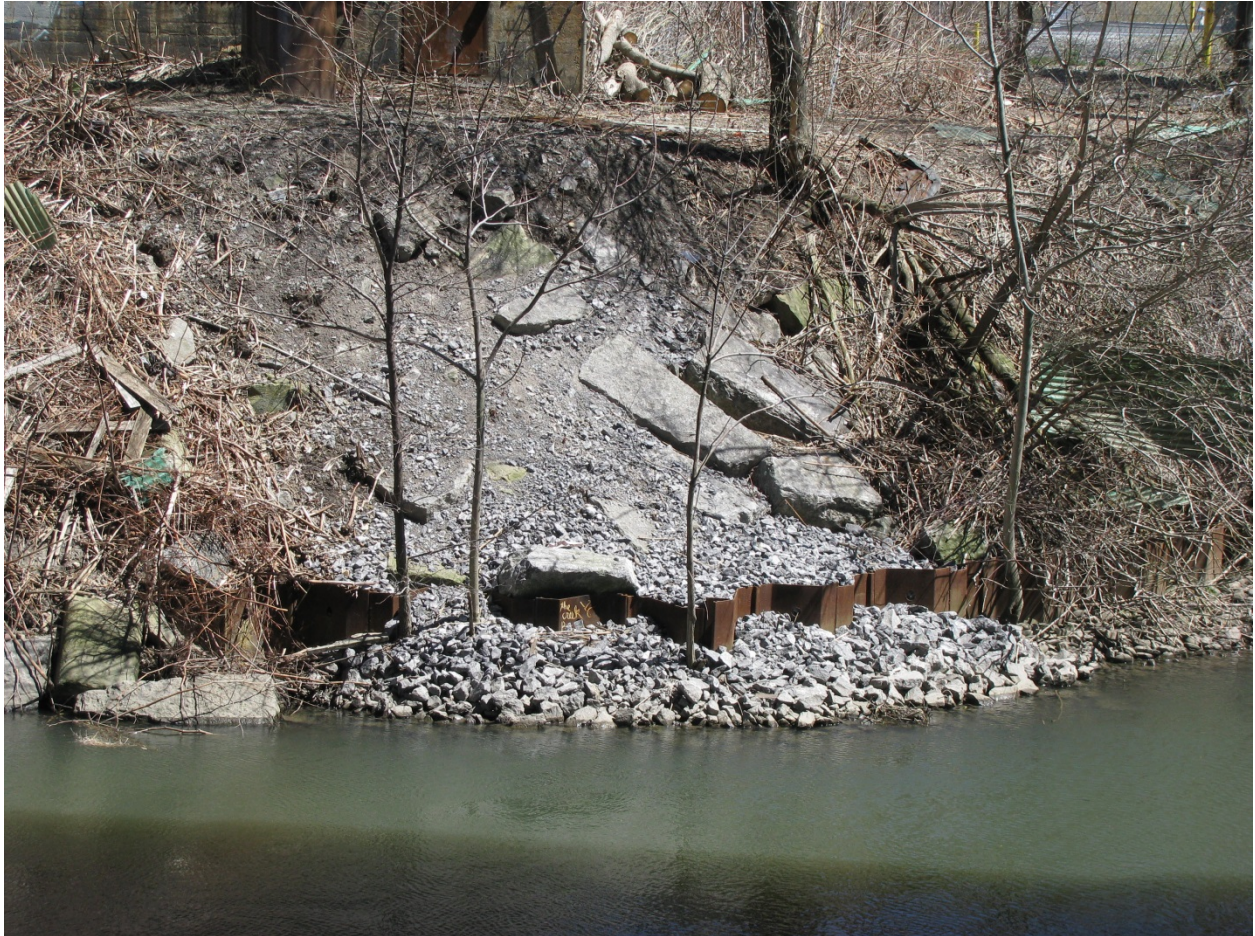
**Looking east (across the Creek) at 2015 Maintenance Area 4. Though no vegetation has yet established itself on the slope above the maintenance area, there are no signs of erosion.**

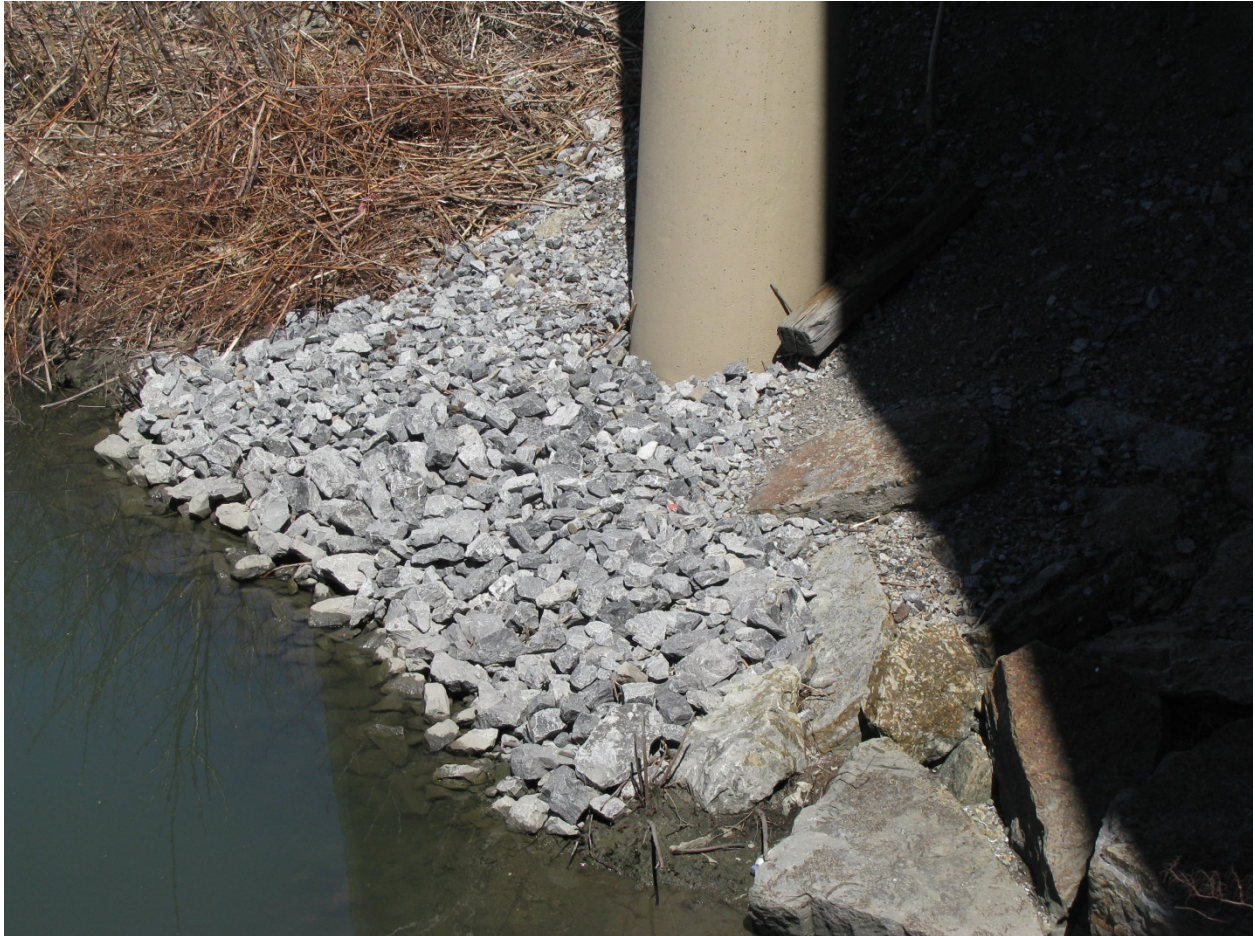
**Looking northeast from the Conrail bridge at 2015 Maintenance Area 5.**

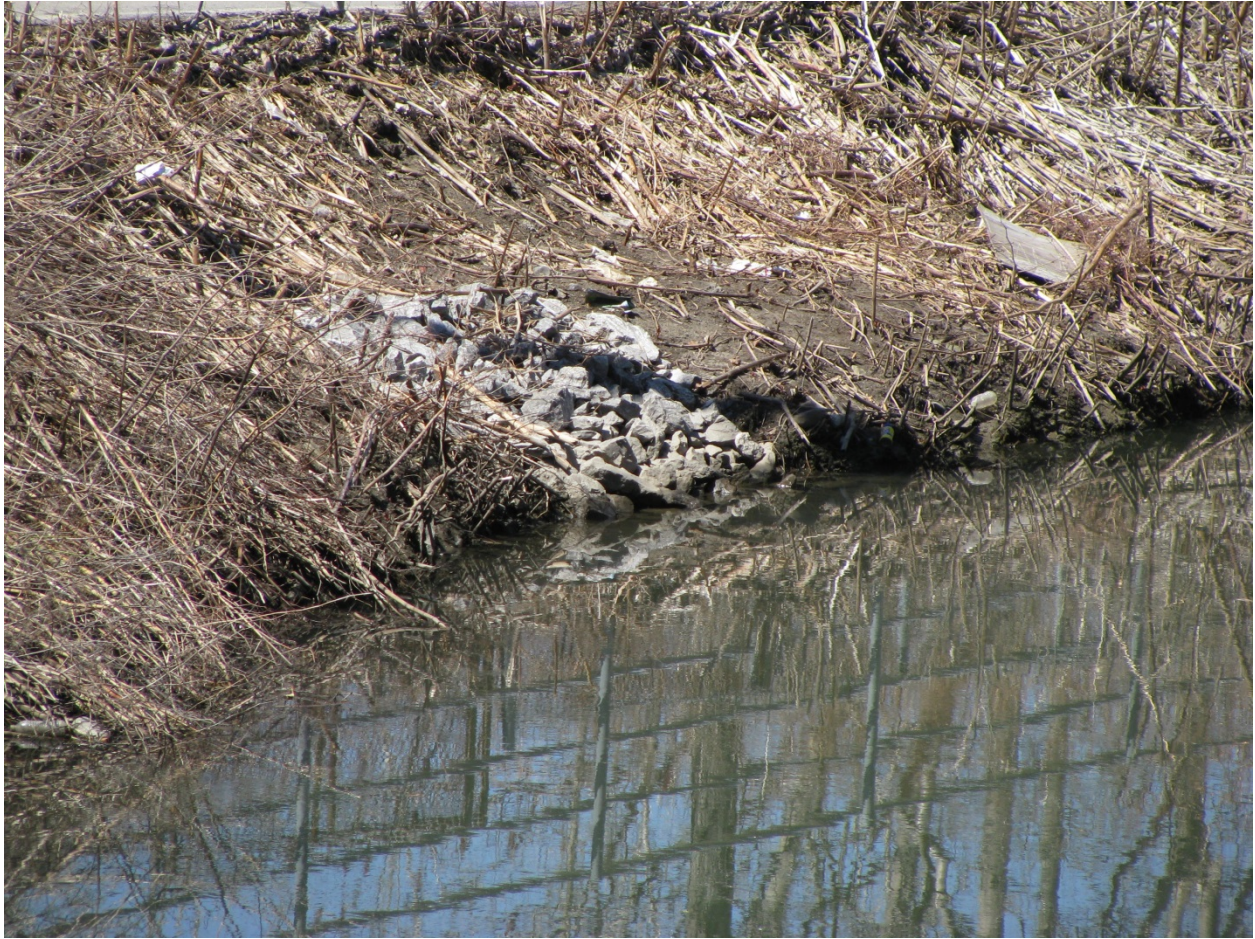
**Looking northwest at 2015 Maintenance Area 6.**

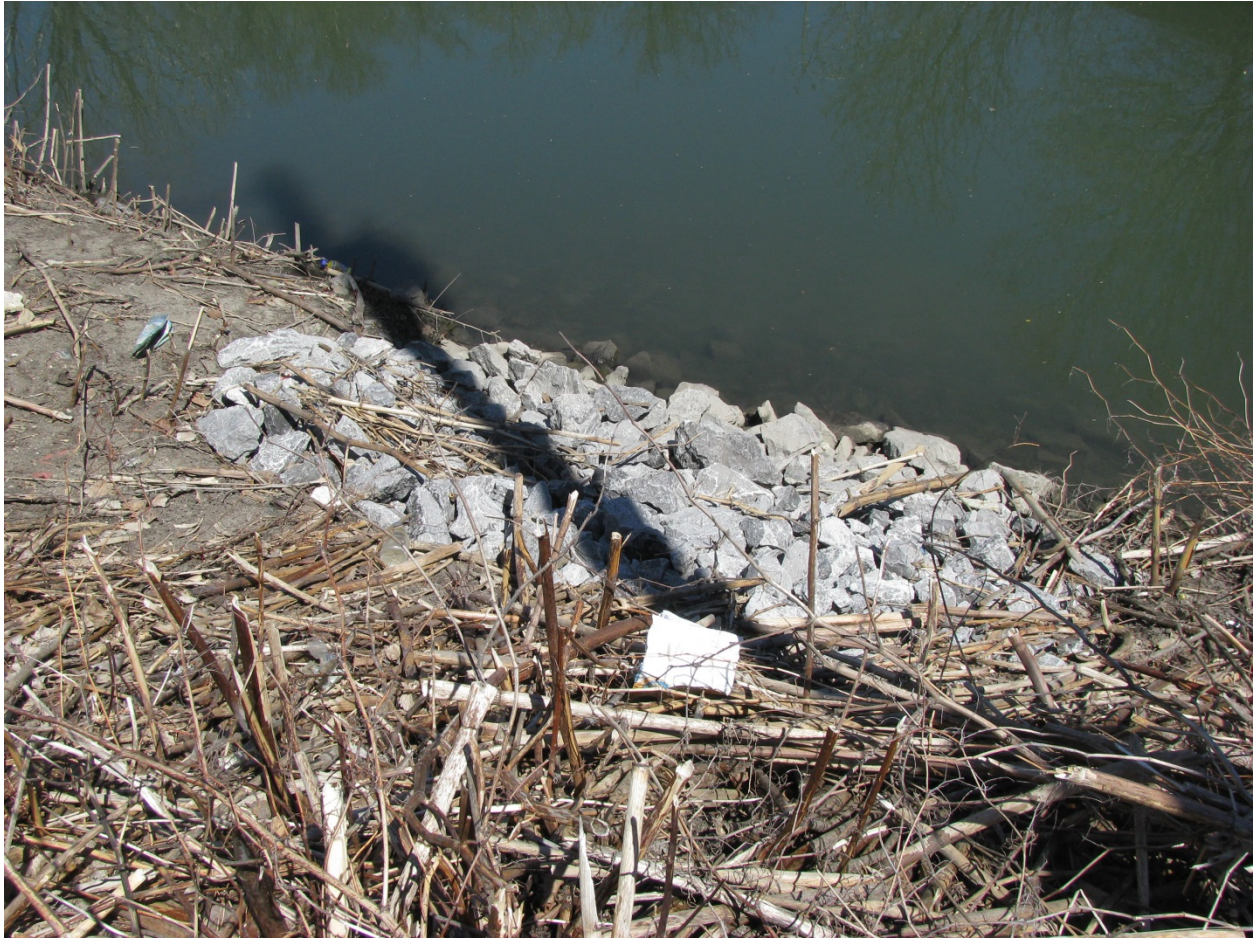
**Looking downslope (southwest) at 2015 Maintenance Area 6.**

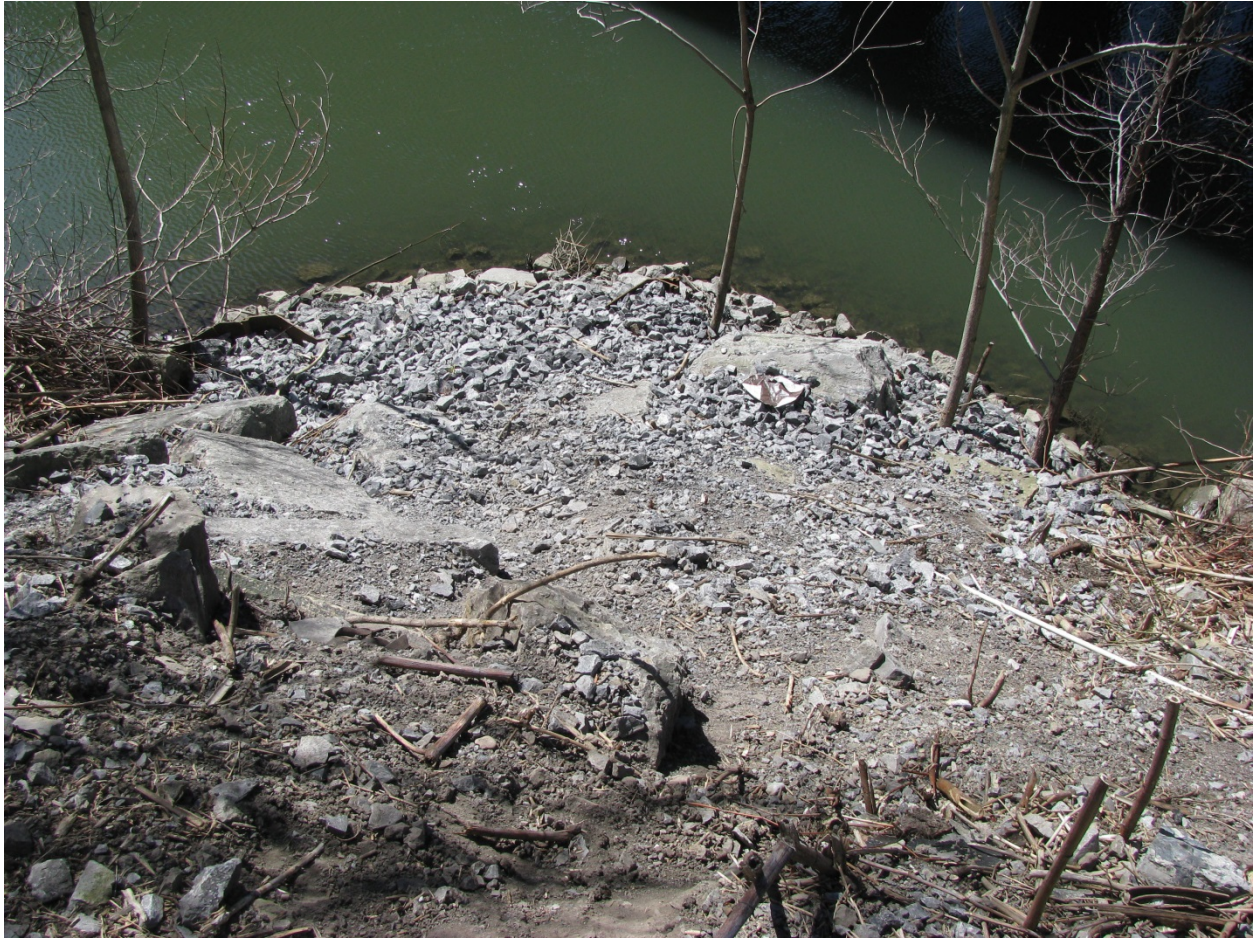
Looking downslope at slope above 2015 Maintenance Area 4. See also the comments on Photo 6.

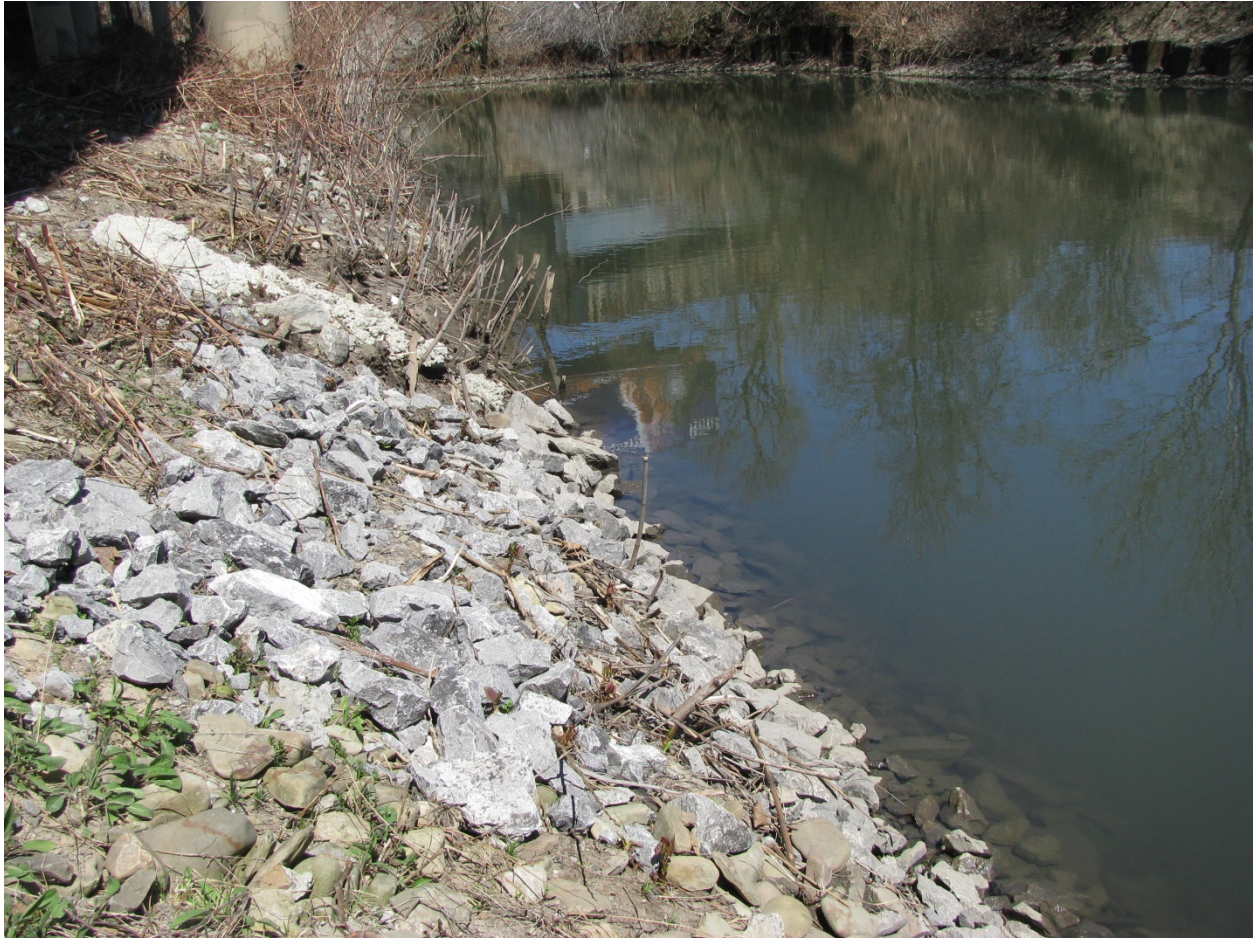
**Looking northeast at 2015 Maintenance Area 7.**

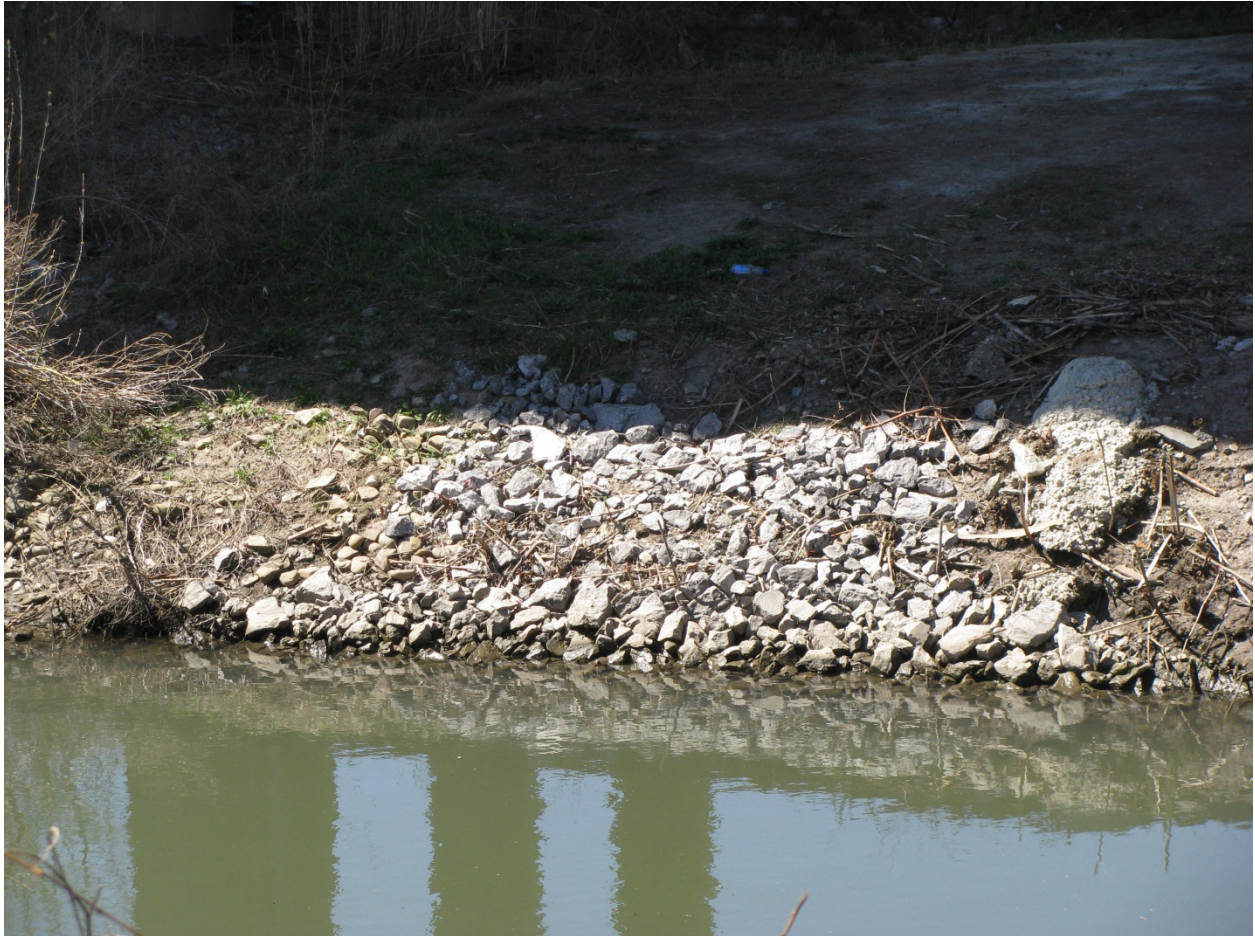
**Looking west at 2015 Maintenance Area 7.**

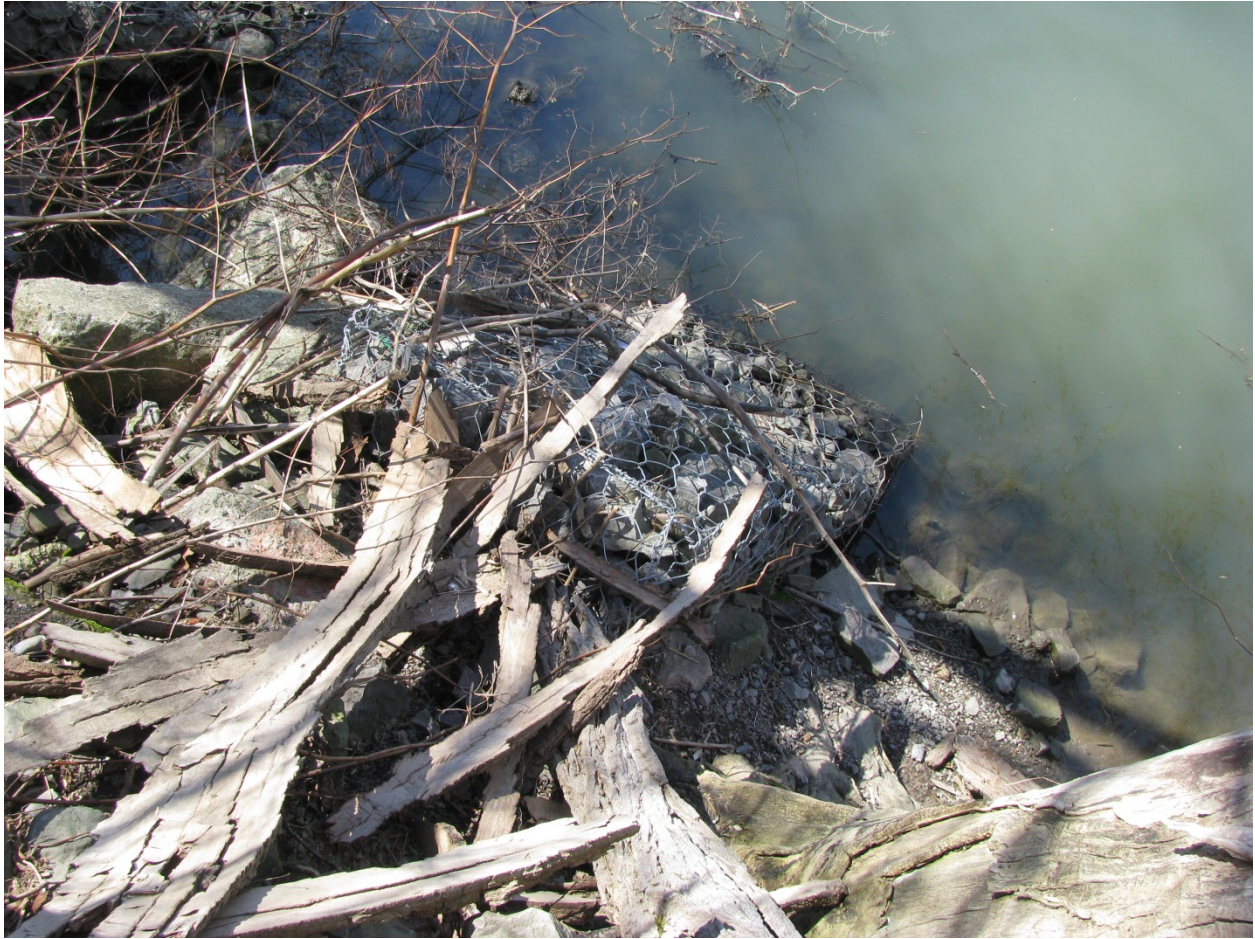
**Looking downslope (west) at the gabion baskets at the outlet to the stormwater discharge pipe from the Westwood property, just south of the existing sheetpile wall. The gabions are in good shape.**

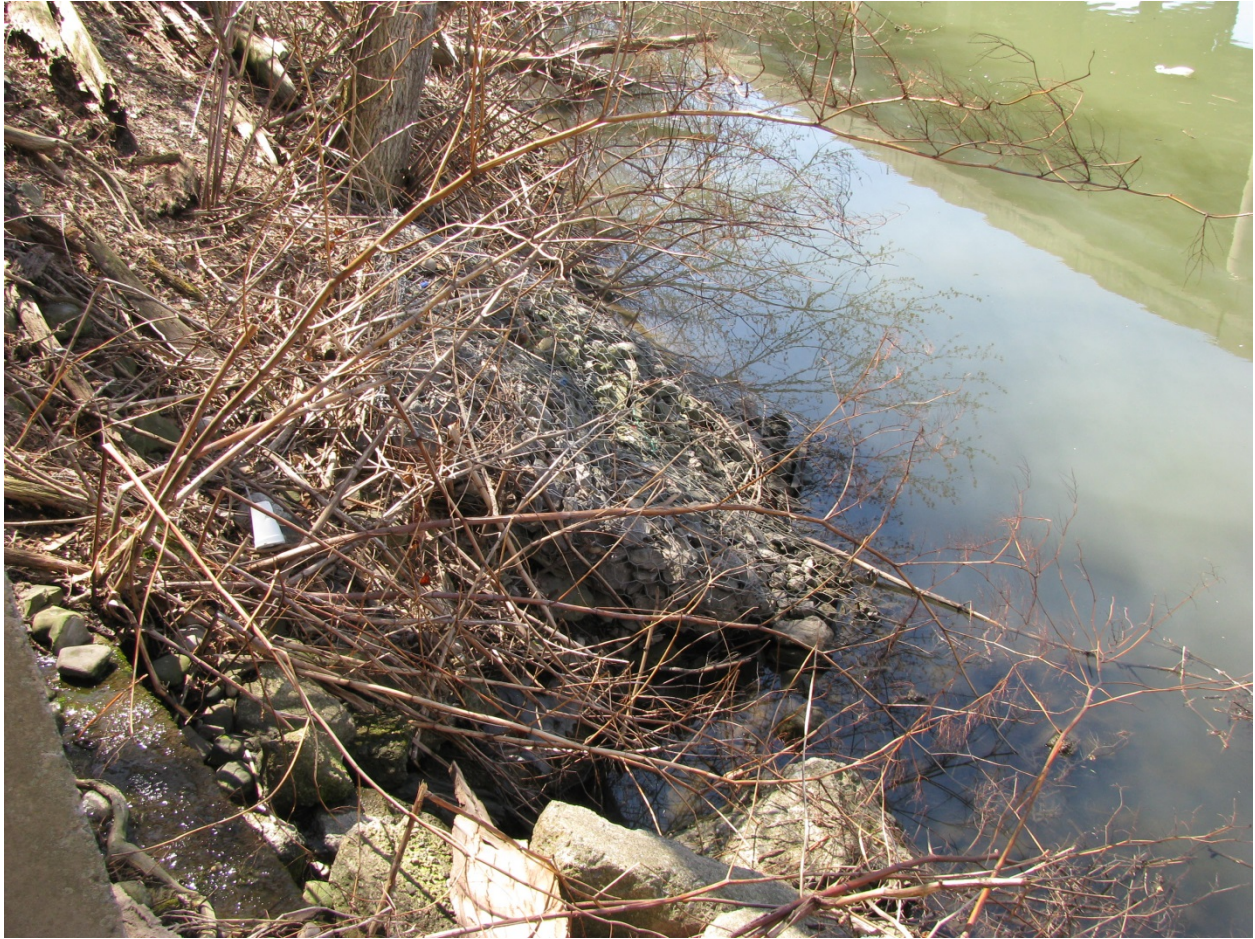
**Looking south at the gabion baskets at the outlet to the stormwater discharge pipe from the Westwood property, just south of the existing sheetpile wall. No damage to the gabions was observed.**

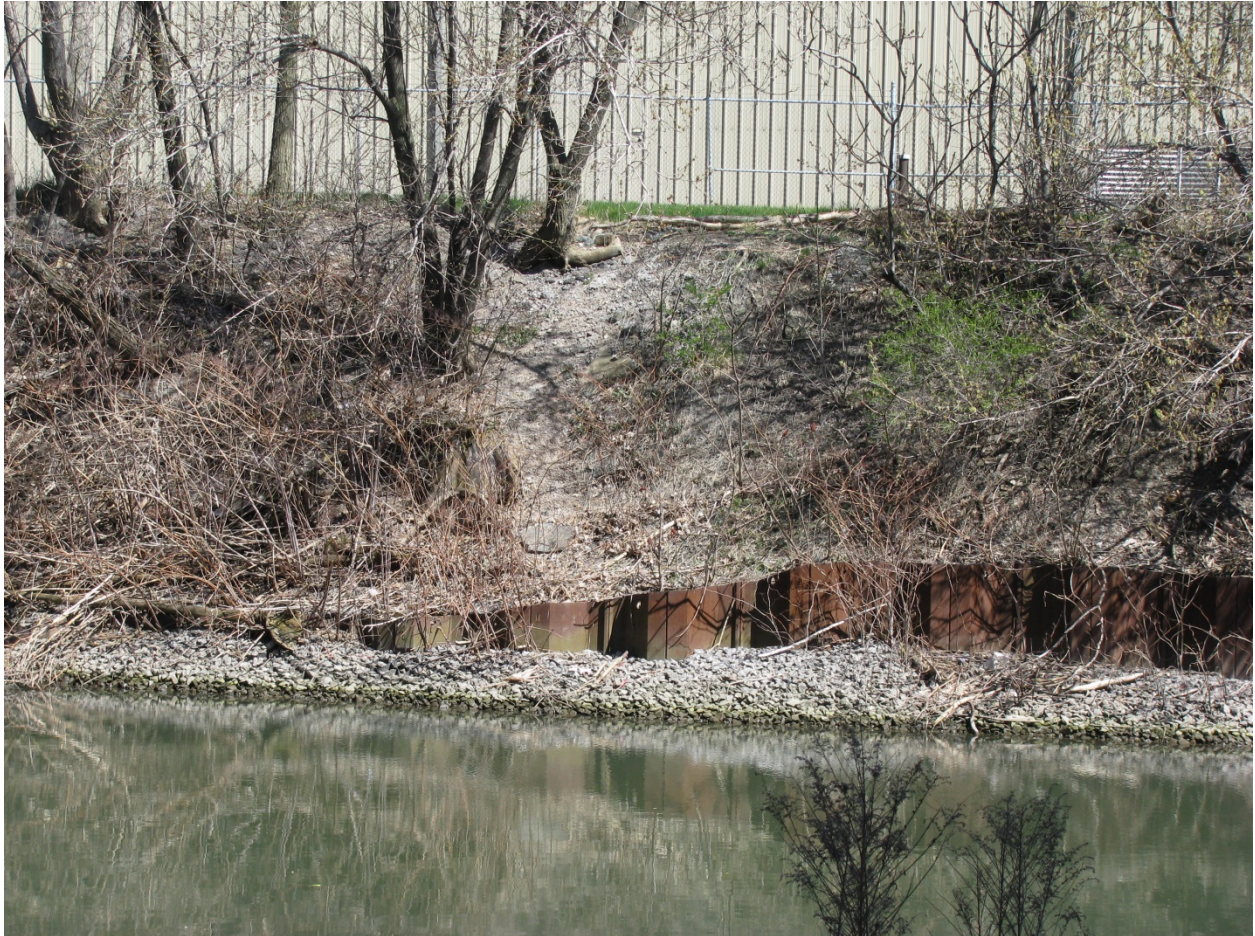
**Looking east at Maintenance Area 3 (inspected but no work performed in 2015), and the stone armor below it (installed in 2010). All appear in good shape.**
