**Re: Site Management Periodic Review Report (PRR) and IC/EC
Certification Submittal (2018)
NFG - Iroquois Gas/Westwood Pharm Riparian Site: Site # 915141B
Scajaquada Creek, Upstream of West Ave. Bridge – Buffalo, NY**

Site Management Periodic Review Report and IC/EC Certification (2018)

Iroquois Gas/Westwood Pharmaceutical Riparian Site No. 915141B
Buffalo, New York

March 2019
Project 1403480

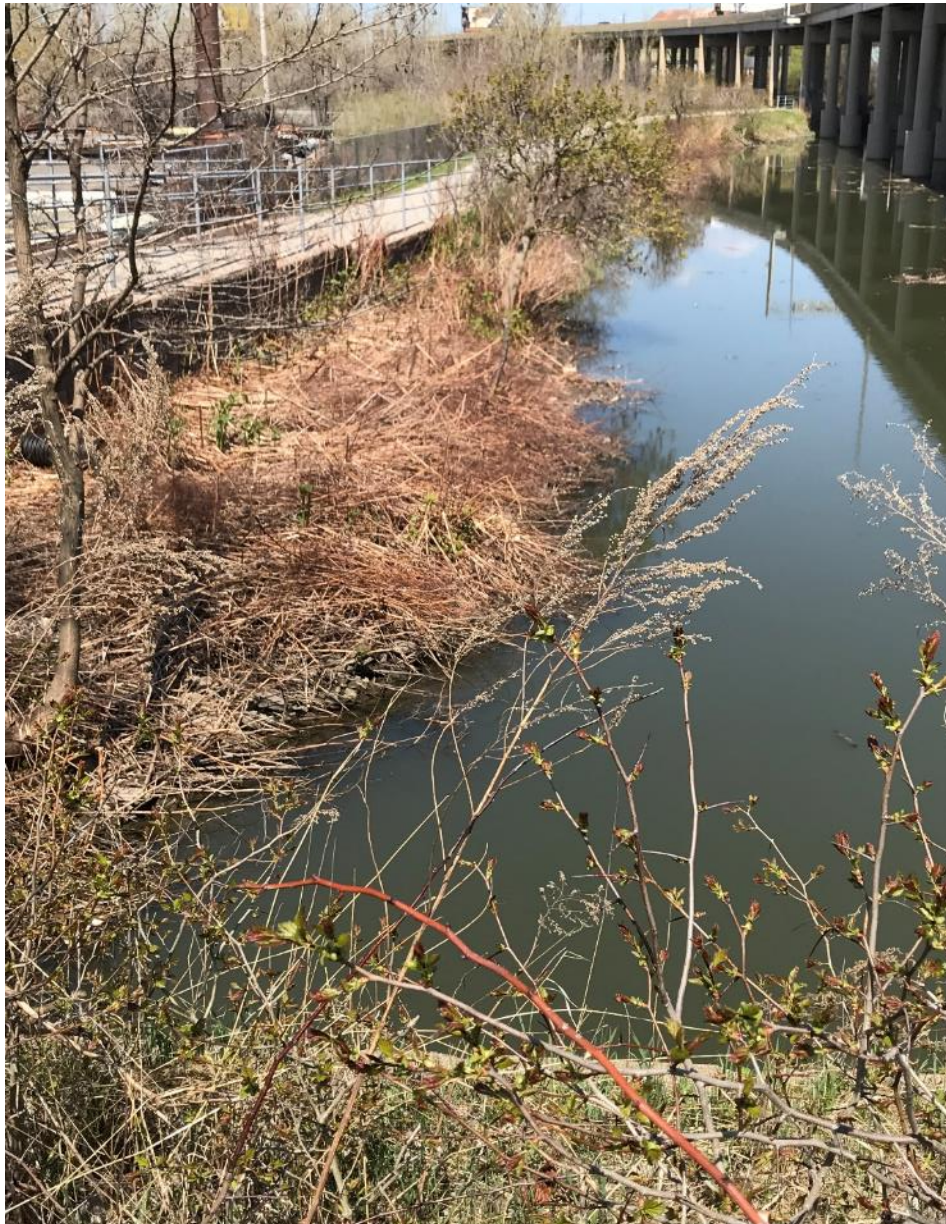
Photo 1. View looking northeast of west bank of creek at 2015 Maintenance Area 1. Vegetation and rip rap remain in place.

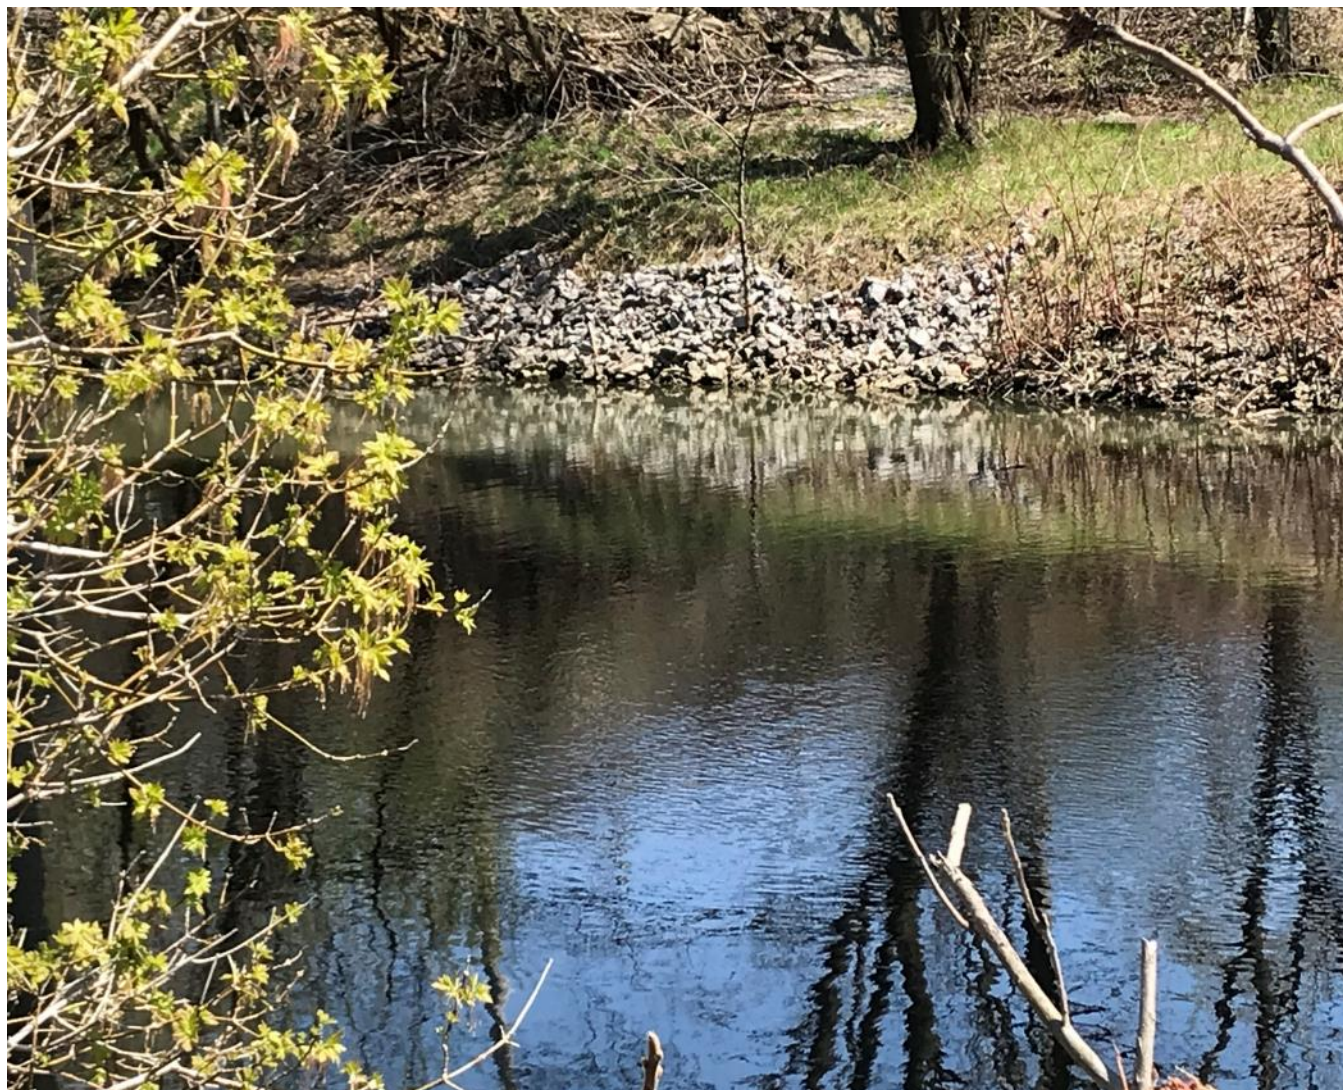
Photo 2. View looking east of east bank of creek at 2015 Maintenance Area 2. Rip rap remains in place.

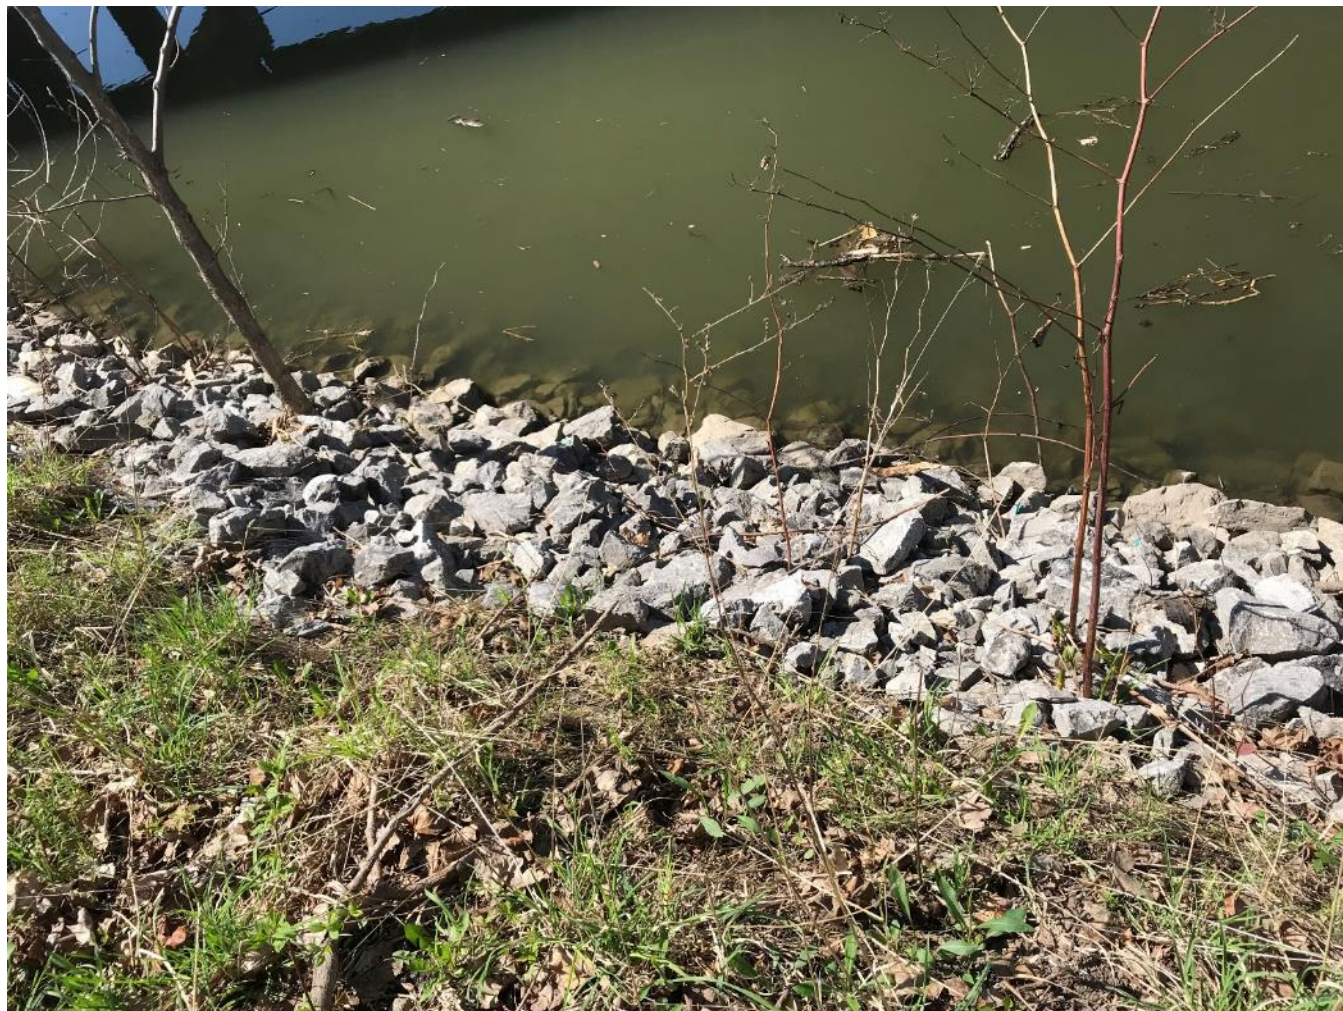
Photo 3. Downslope view on east bank of 2015 Maintenance Area 2. Rip rap in good condition.

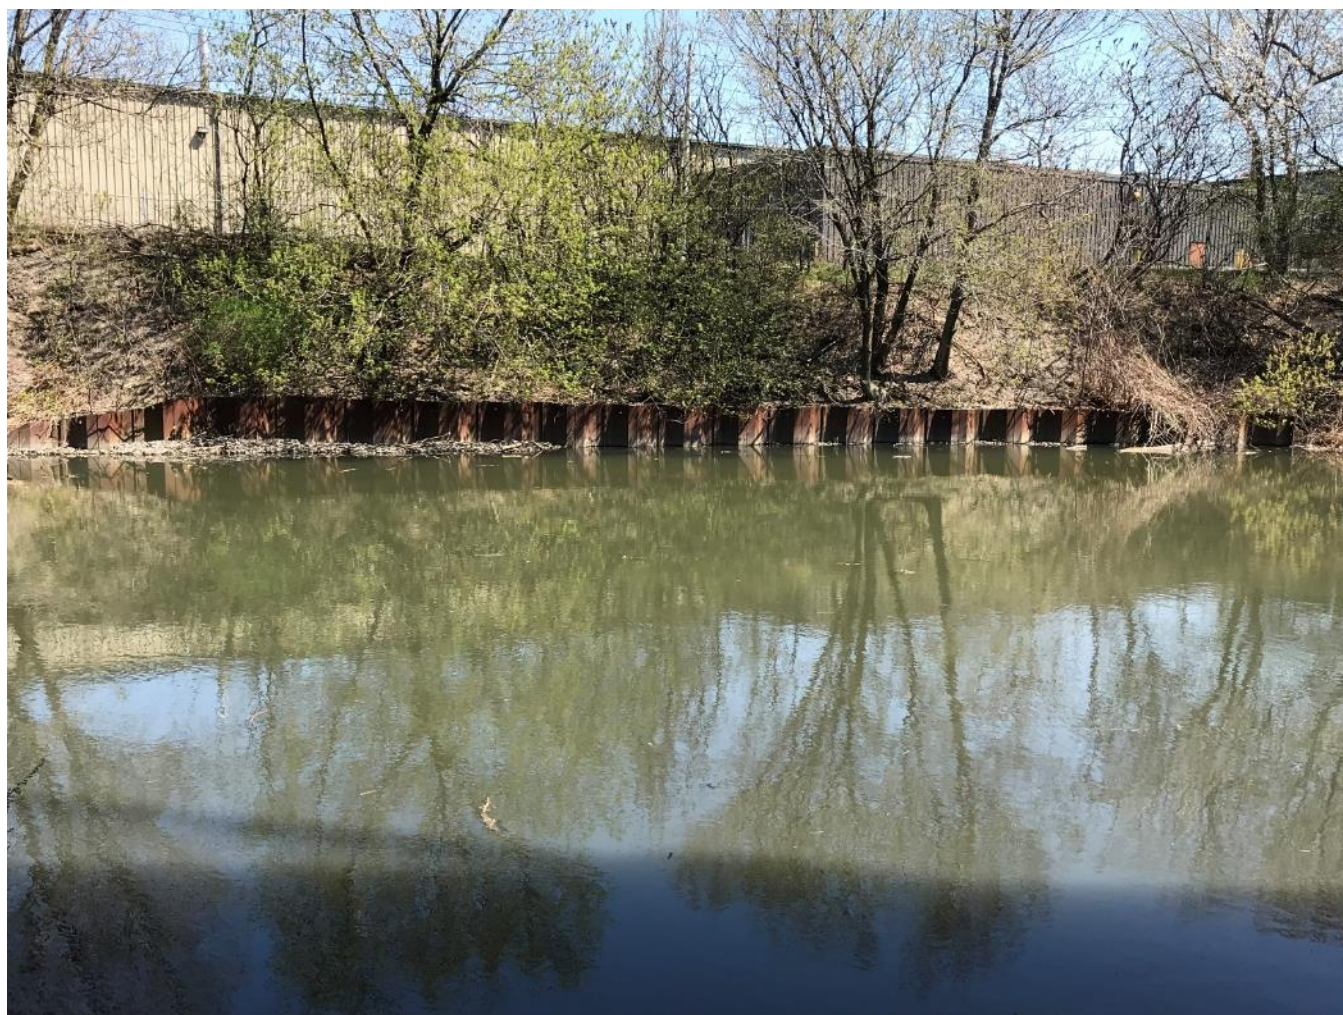
Photo 4. View looking east at east bank of BMS sheet pile near Maintenance Area 4. Sheet pile and rip rap in good condition.

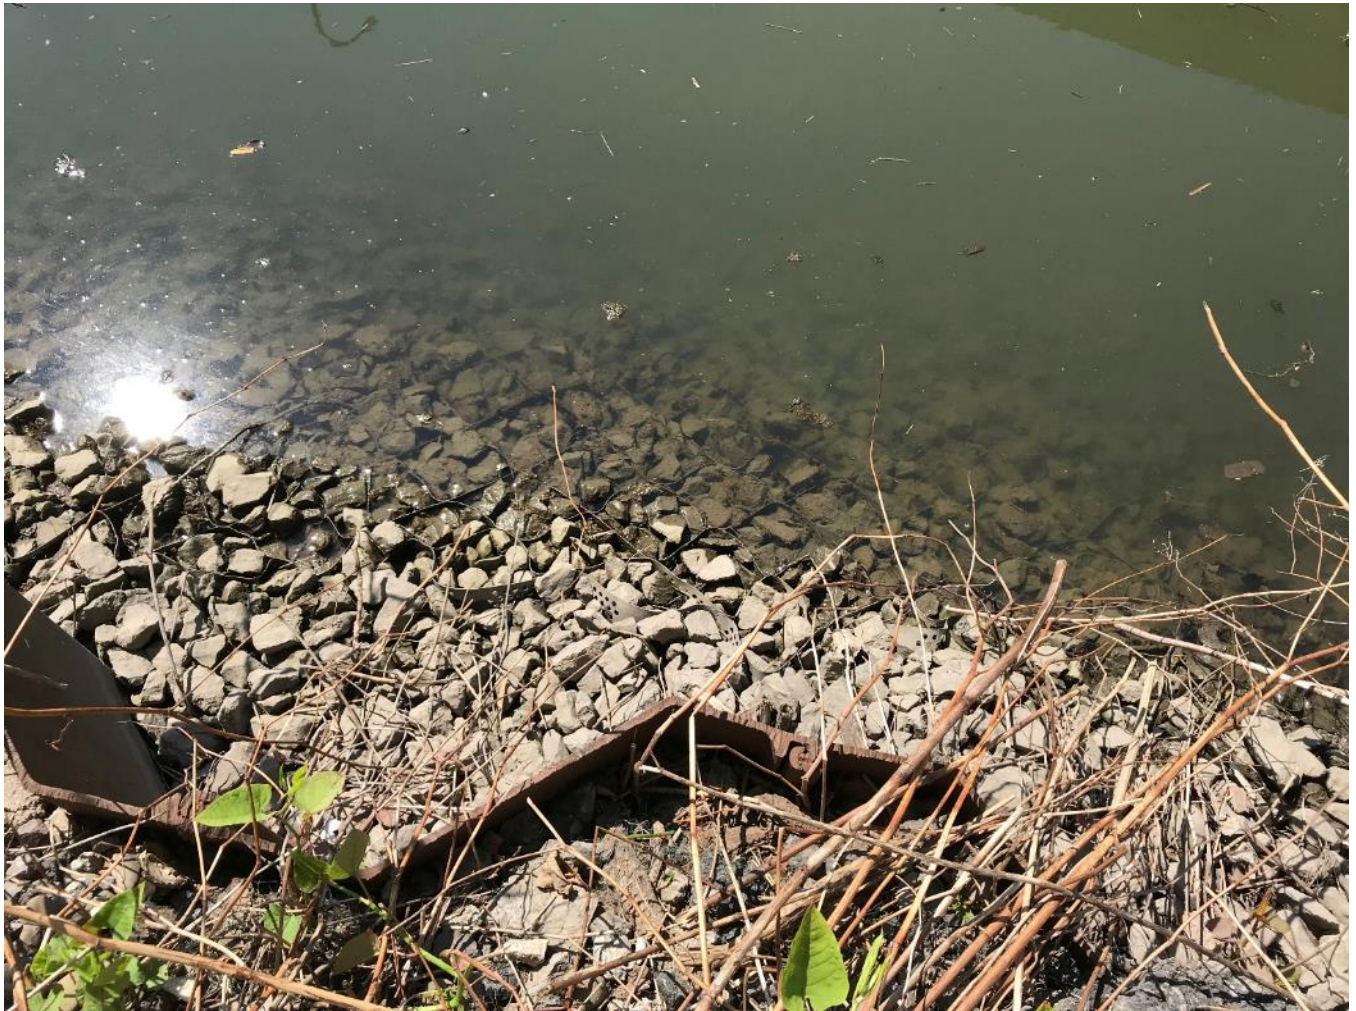
Photo 5. Top down closeup view of Maintenance Area 4 and sheet pile. Rip rap in good condition.

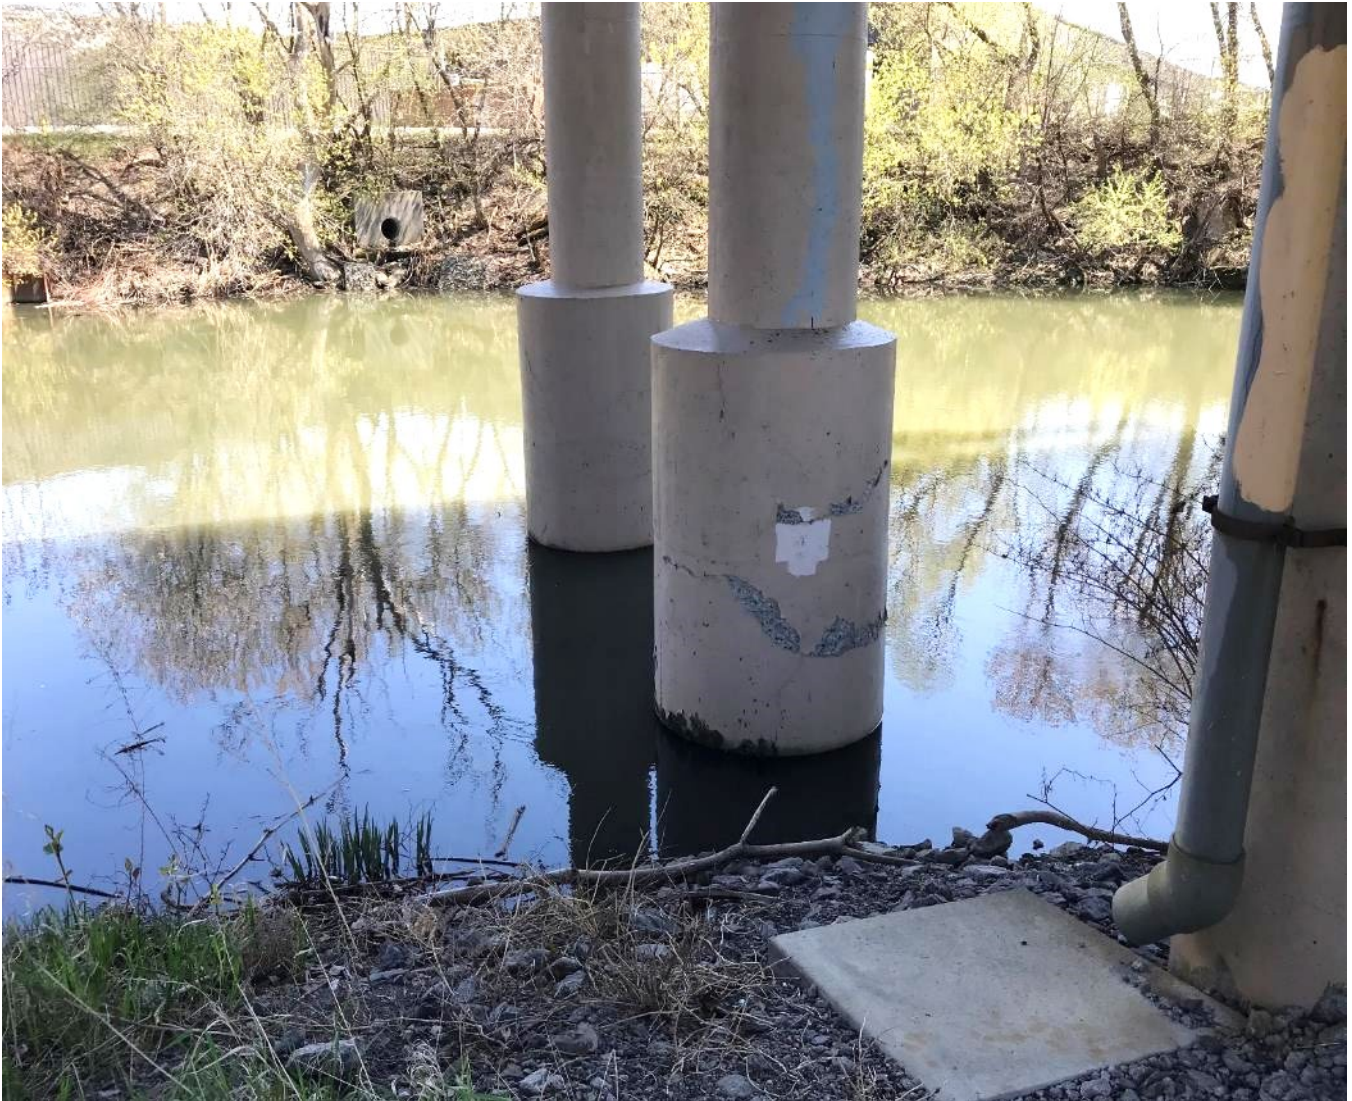
Photo 6. Southeast view of west bank at Maintenance Area 8, rip rap in good condition, no erosion on down slope of drain spout.

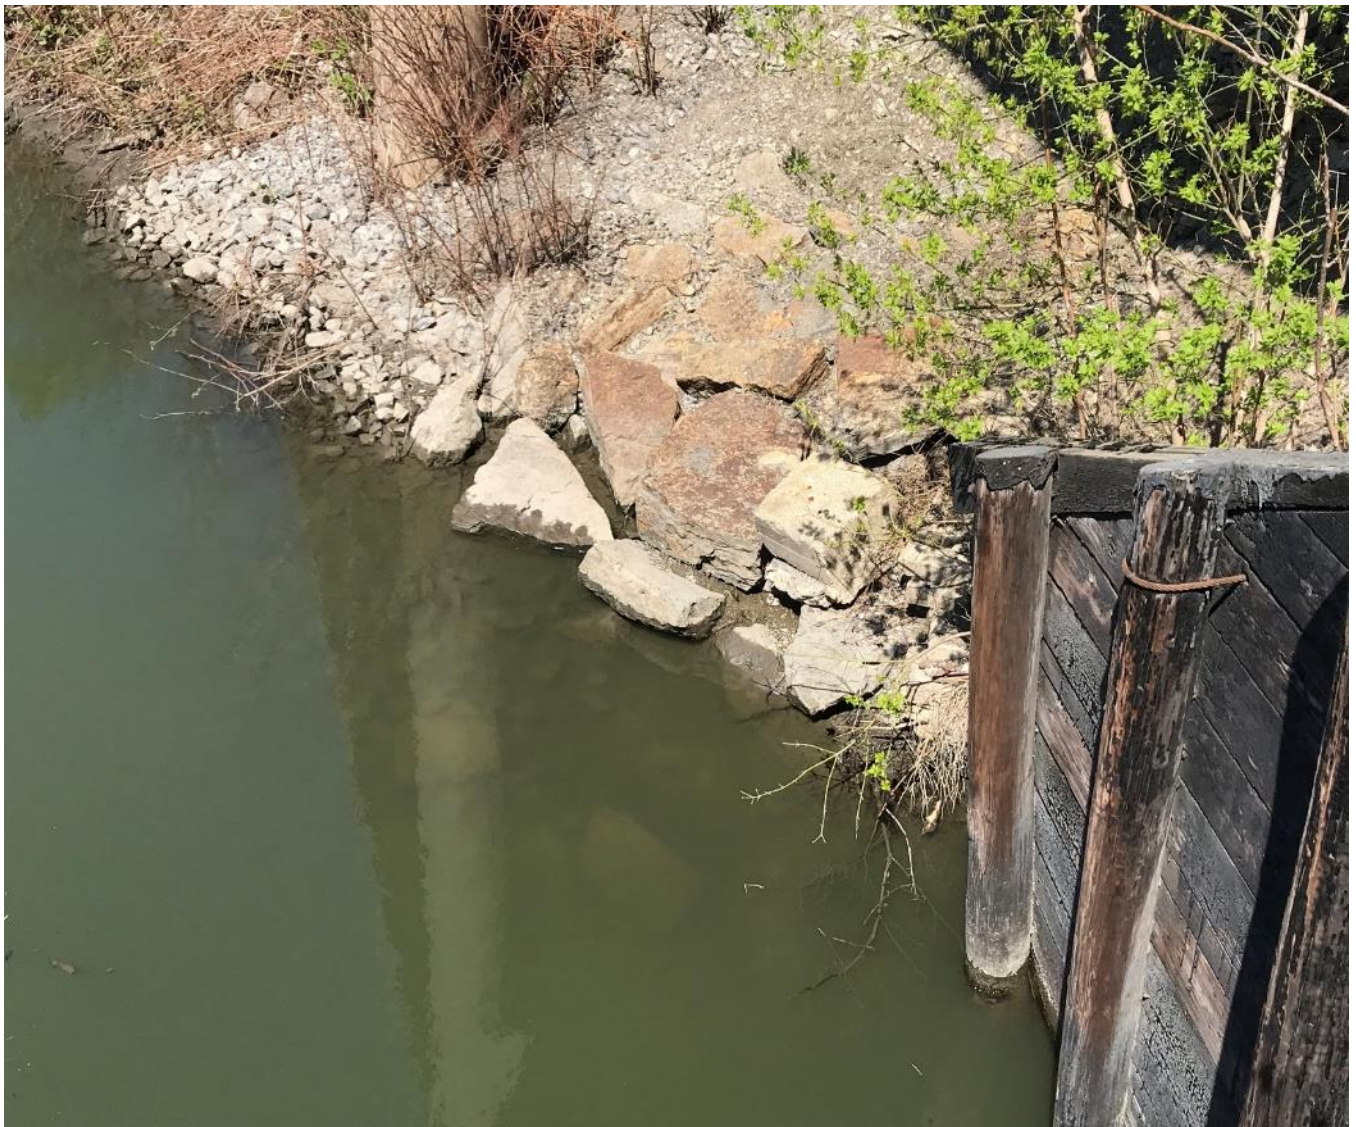
Photo 7. North view of Maintenance Area 5. No visible erosion. Rip rap and stone block in place.

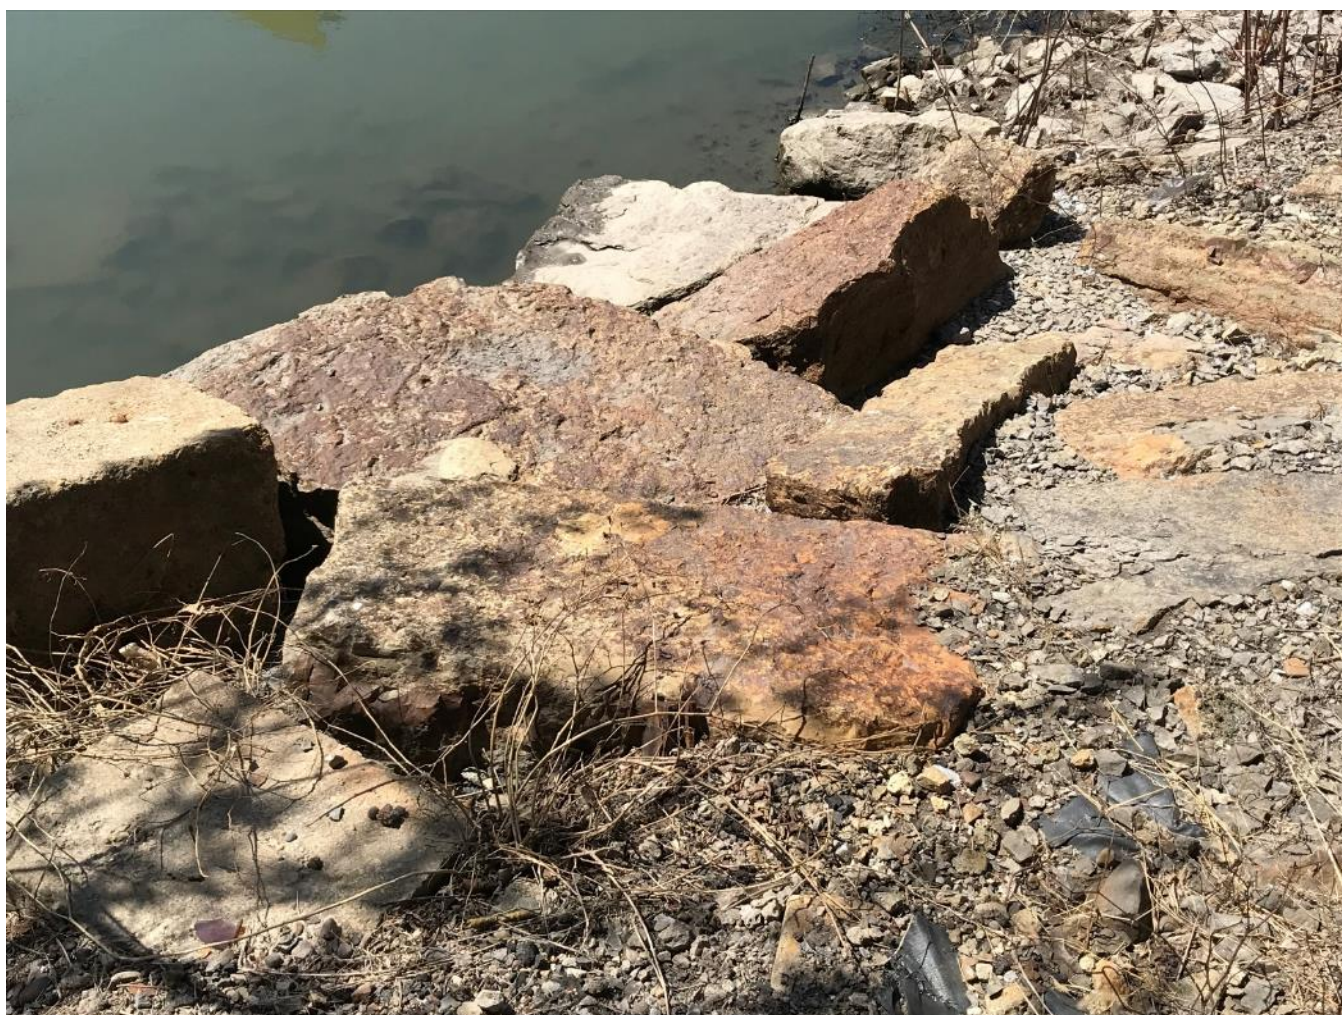
Photo 8. Closeup view east bank at Maintenance Area 5. Some geotextile visible but tightly bound by surrounding block and stone.

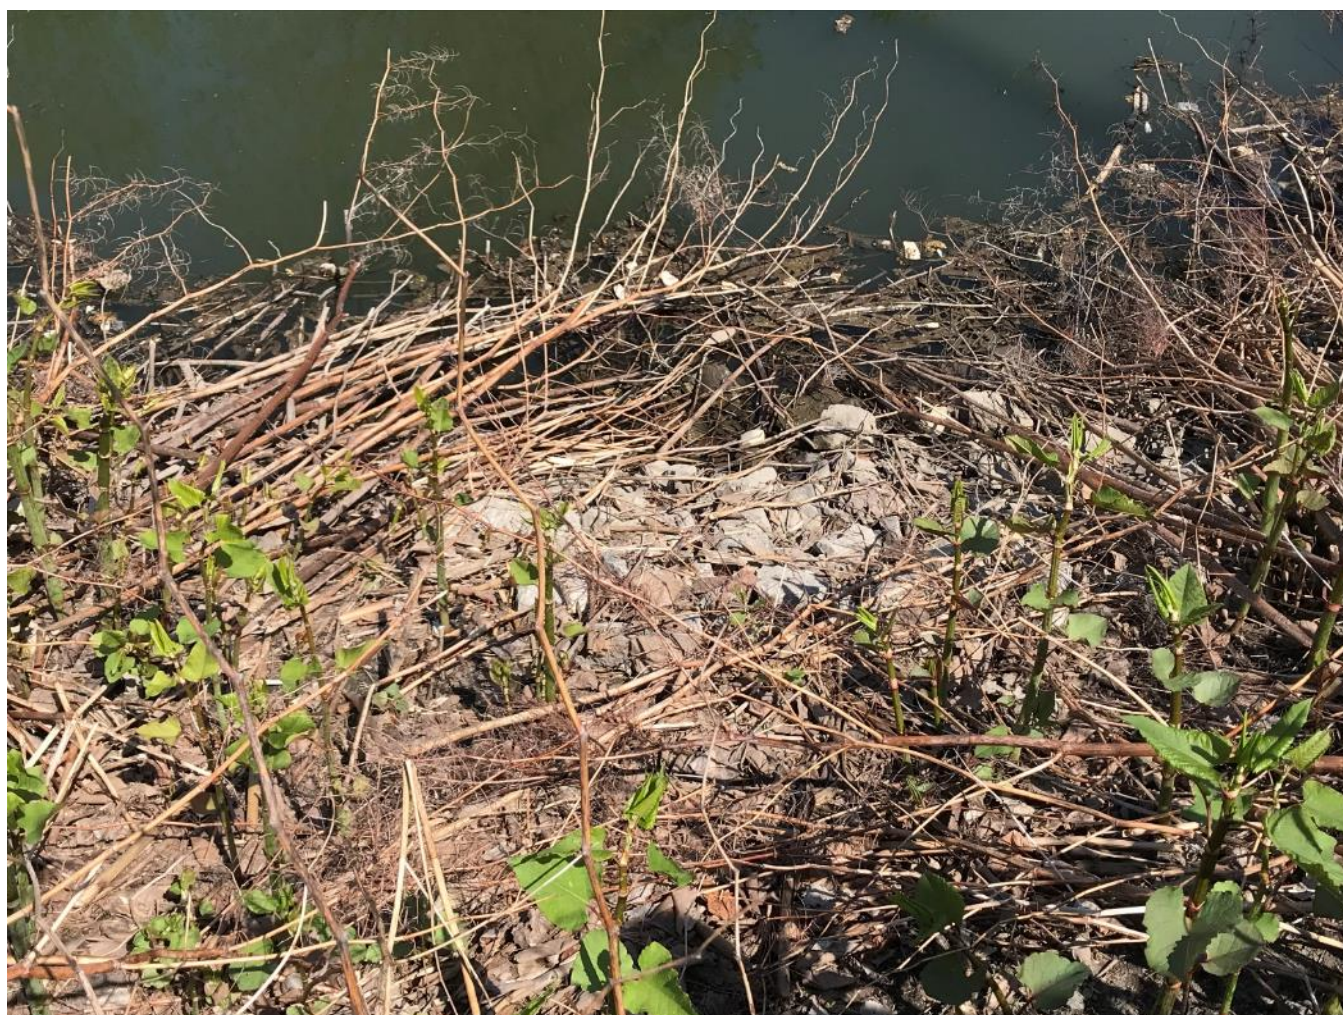
Photo 9. Closeup view of Maintenance Area 6. Rip rap placement intact. No visible erosion.

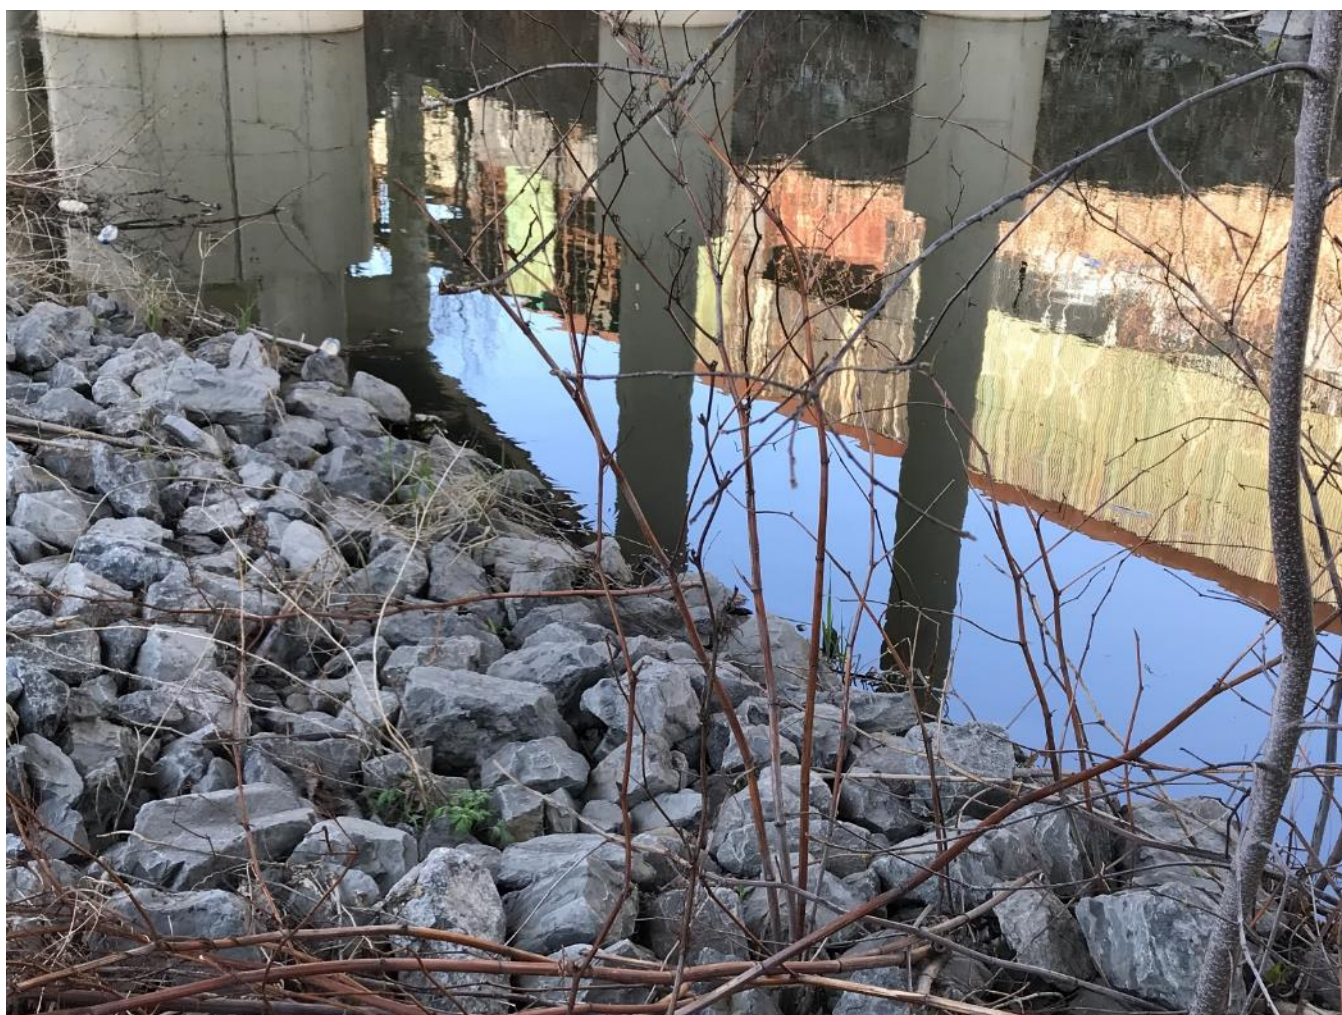
Photo 10. North view of west bank toward Conrail Bridge. No visible erosion.

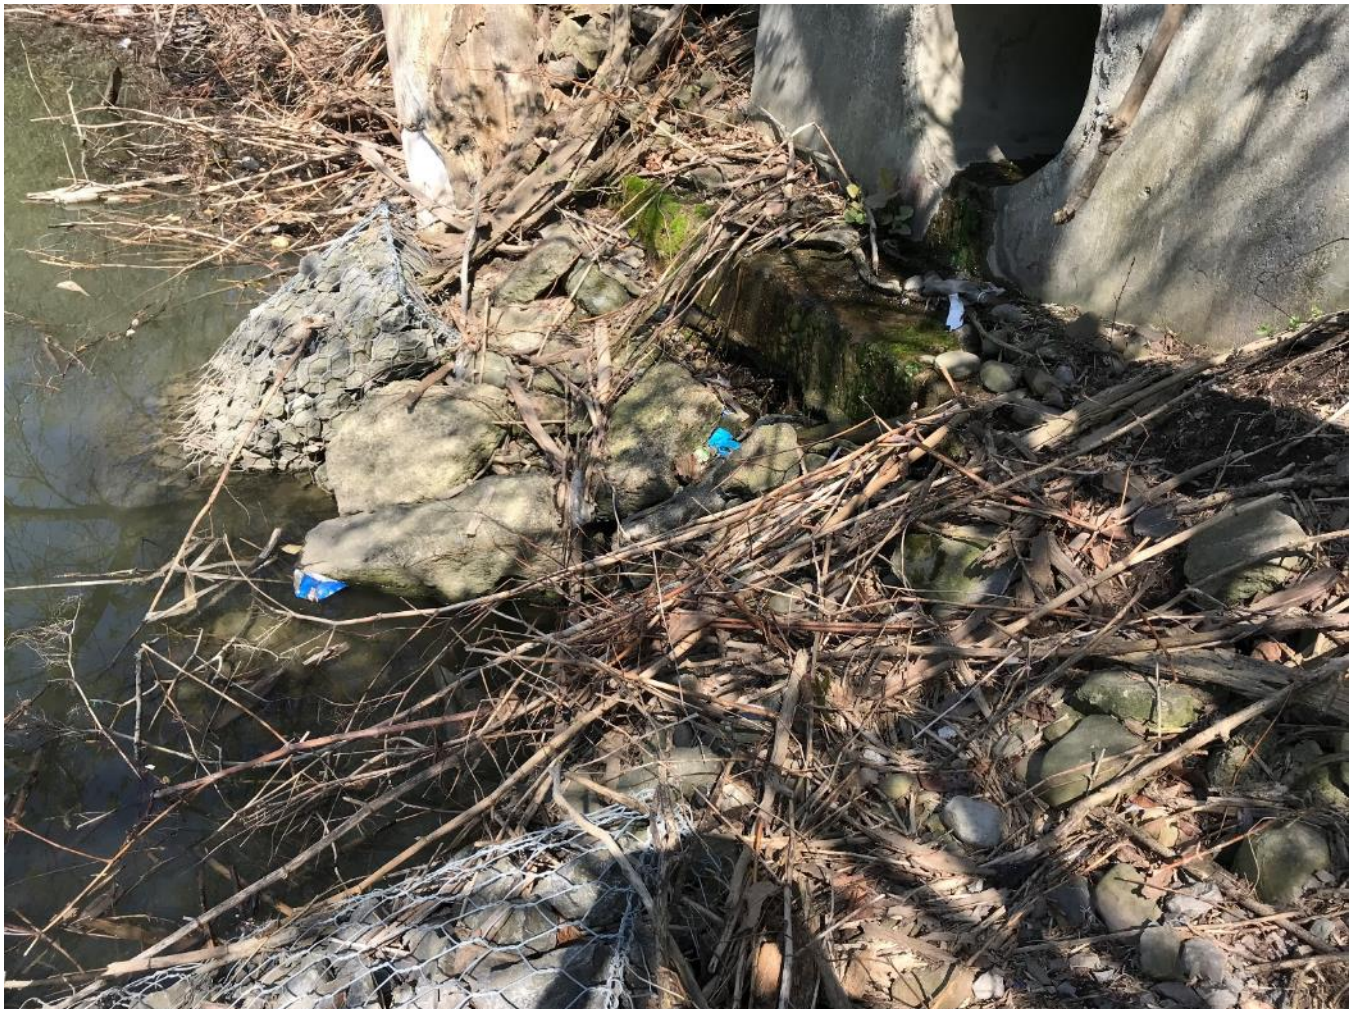
Photo 11. Closeup view of west bank at BMS outfall with gabion baskets. No visible erosion.

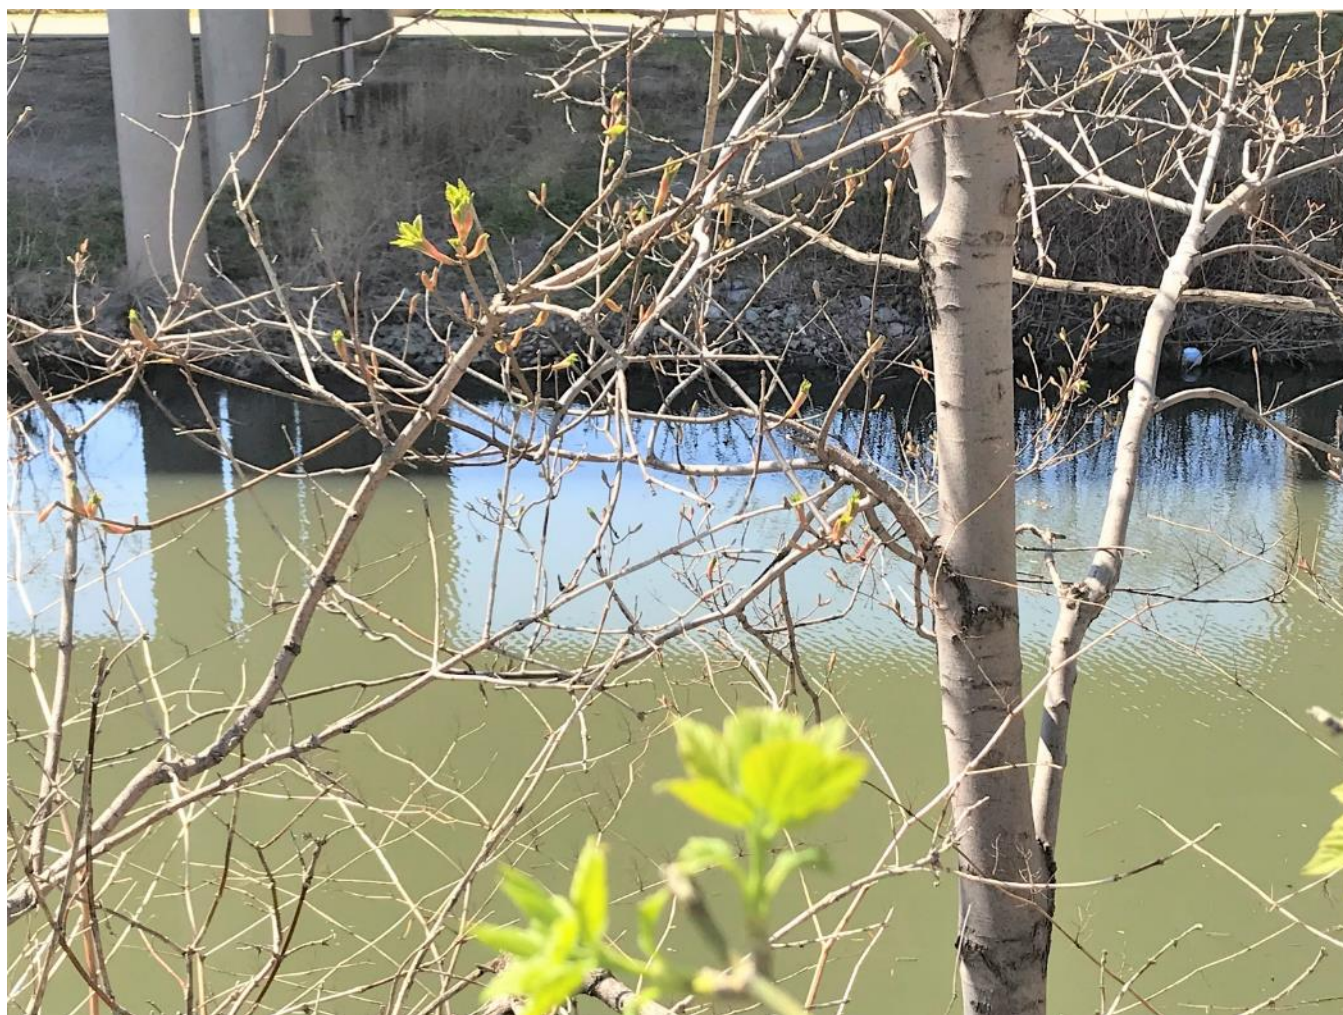
Photo 12. West view of west bank south of Area 7. No visible erosion of creek bank.

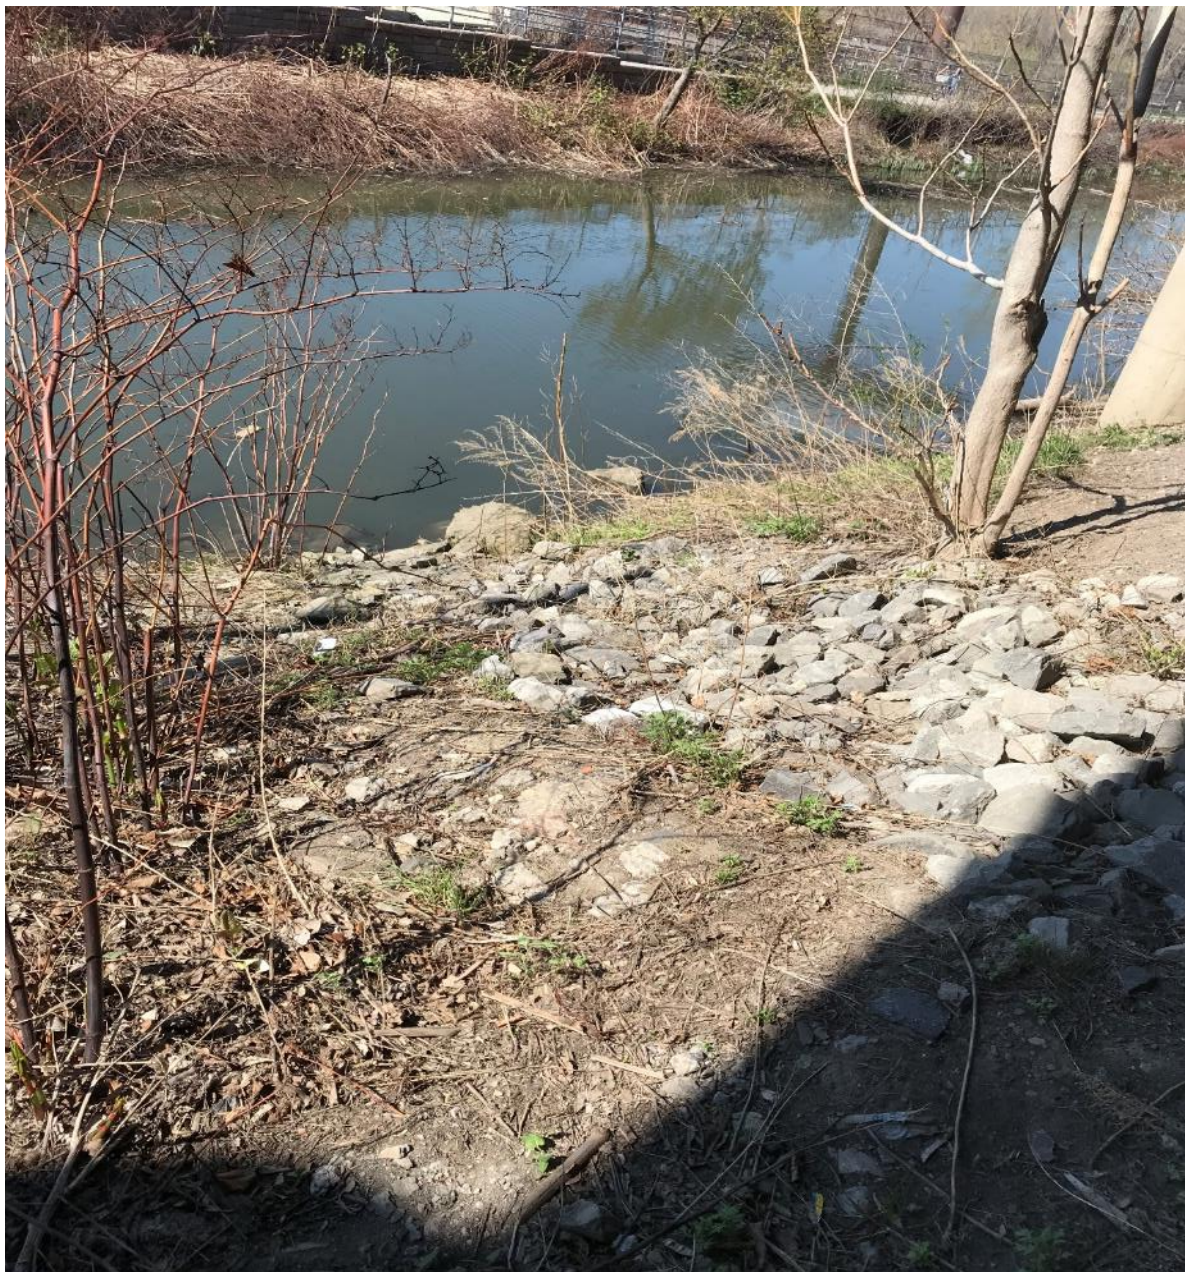
**Photo 13. West view of west bank near South Vault showing rip rap surface water conveyance.
No visible erosion above or at creek bank.**
