**Re: Site Management Periodic Review Report (PRR) and IC/EC
Certification Submittal (2019)
NFG - Iroquois Gas/Westwood Pharm Riparian Site: Site # 915141B
Scajaquada Creek, Upstream of West Ave. Bridge – Buffalo, NY**

Site Management Periodic Review Report and IC/EC Certification (2019)

Iroquois Gas/Westwood Pharmaceutical Riparian Site No. 915141B
Buffalo, New York

March 2020

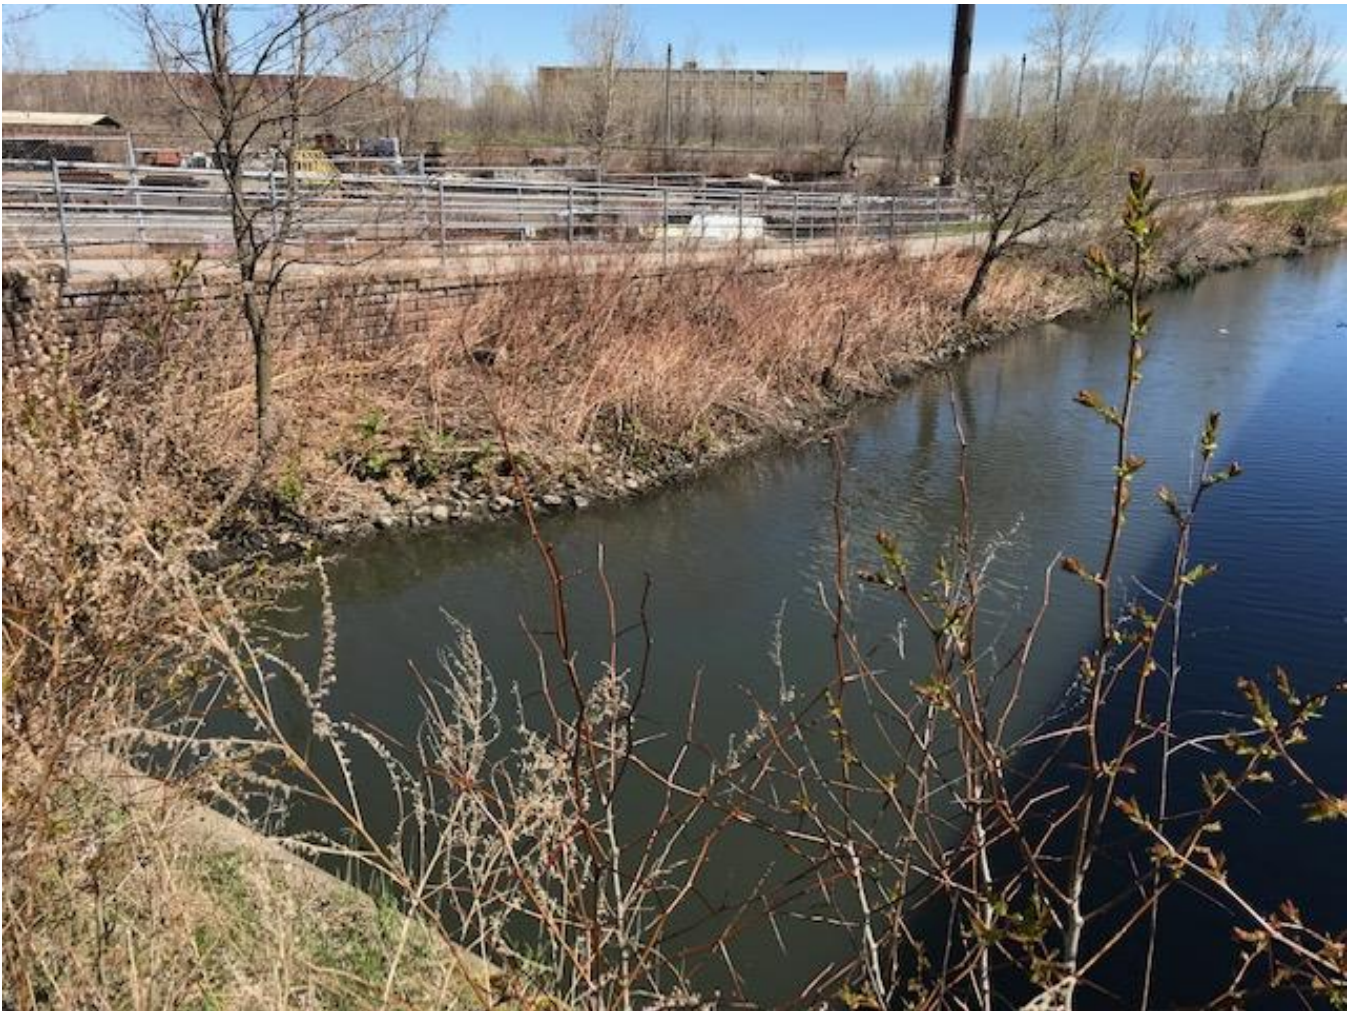
Photo 1. View looking northeast of west bank of creek at 2015 Maintenance Area 1. Vegetation and stone armor remain in place.

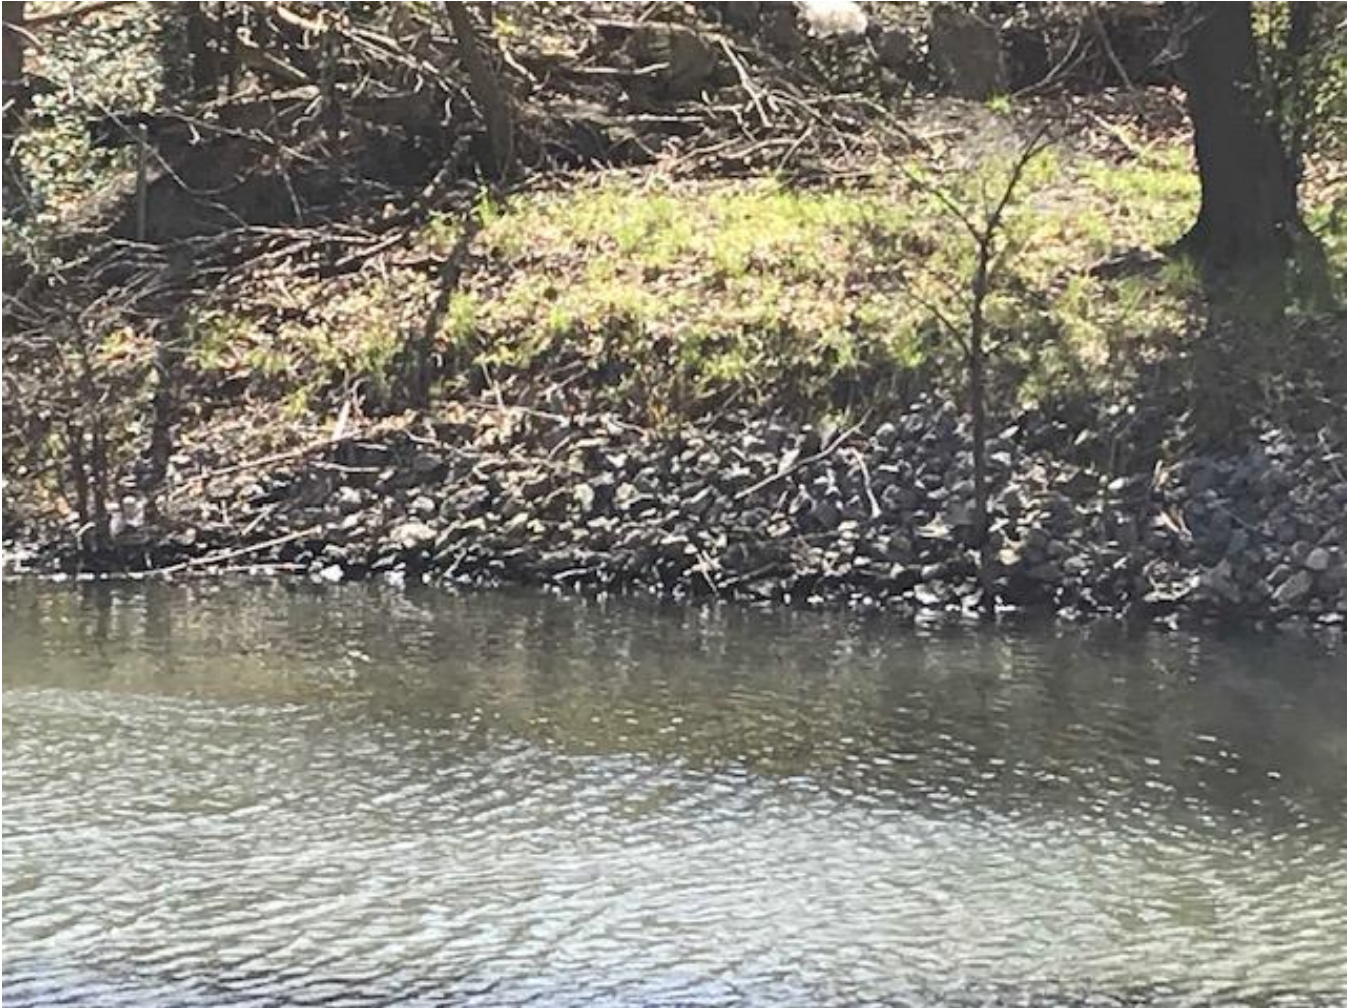
Photo 2. View looking east of east bank of creek at 2015 Maintenance Area 2. Rip rap remains in place.

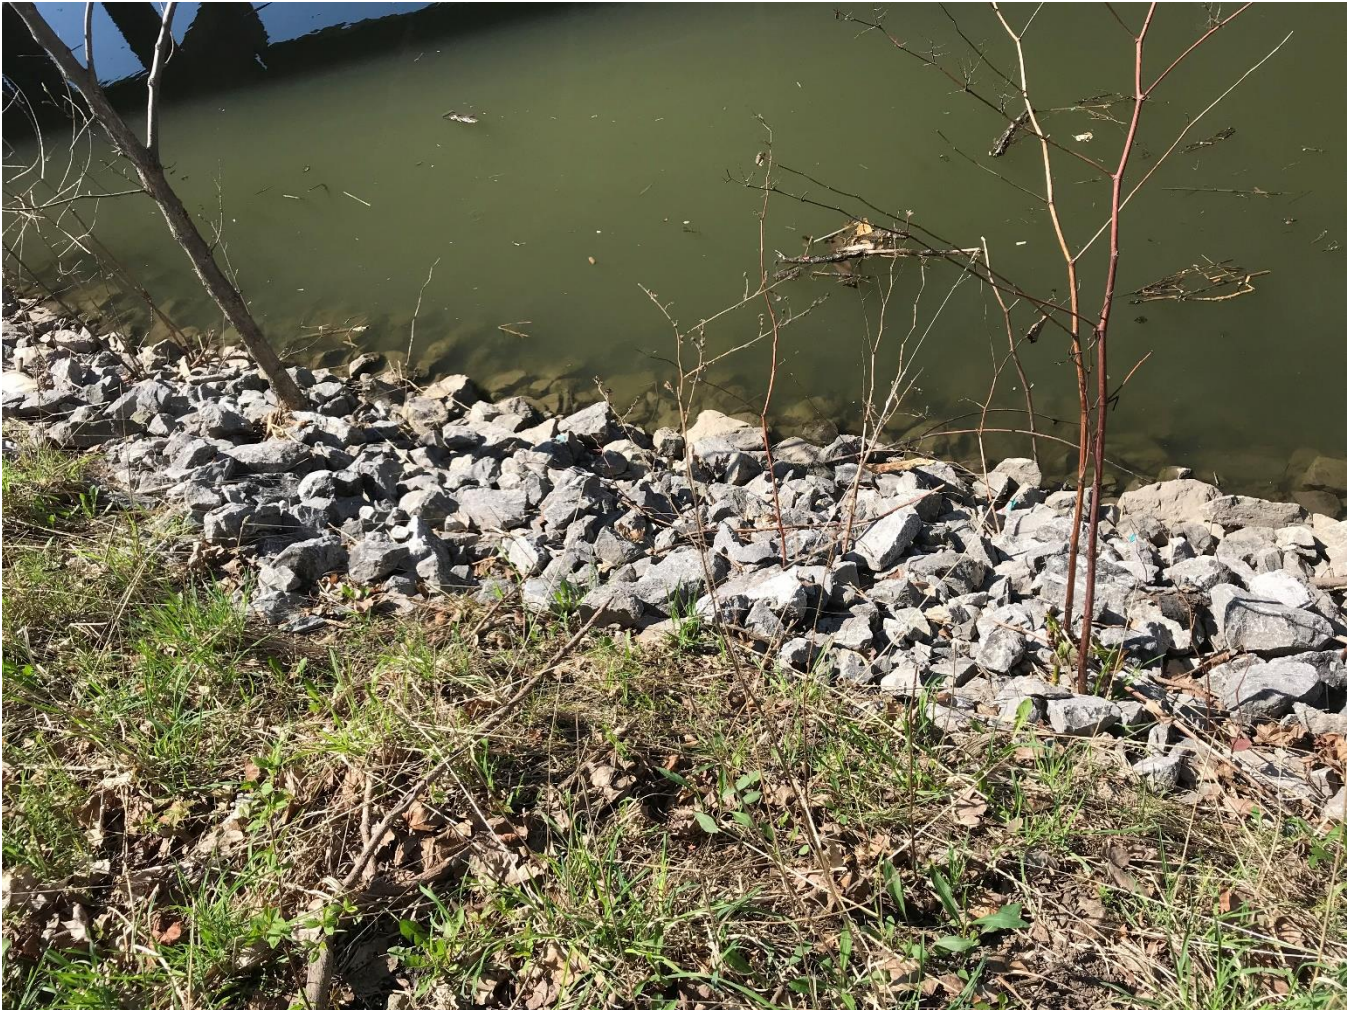
Photo 3. Downslope view on east bank of 2015 Maintenance Area 2.

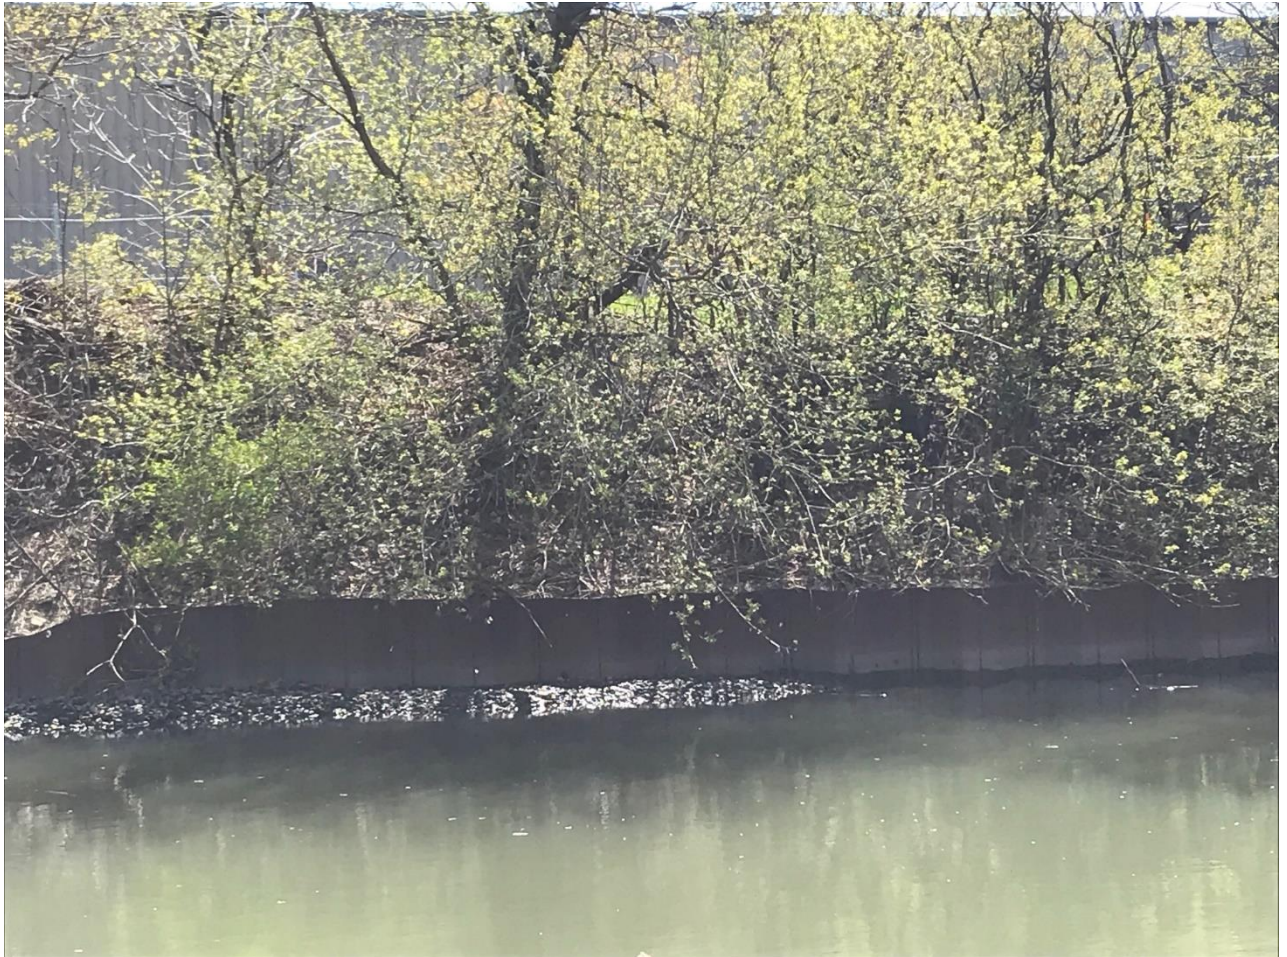
Photo 4. View looking east at east bank of BMS sheet pile near Maintenance Area 4. Sheet pile and rip rap in good condition.

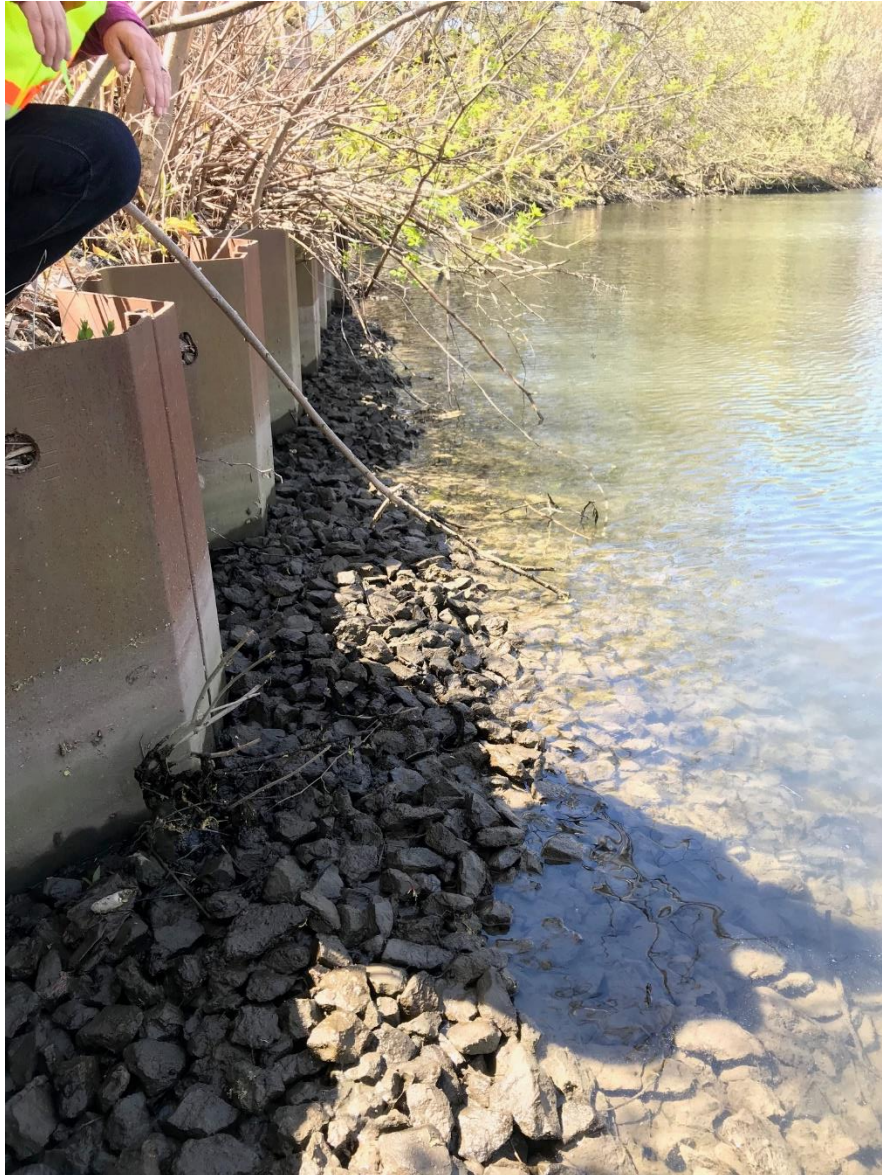
Photo 5. Closeup of east bank of BMS sheet pile near Maintenance Area 4. Sheet pile and rip rap in good condition.

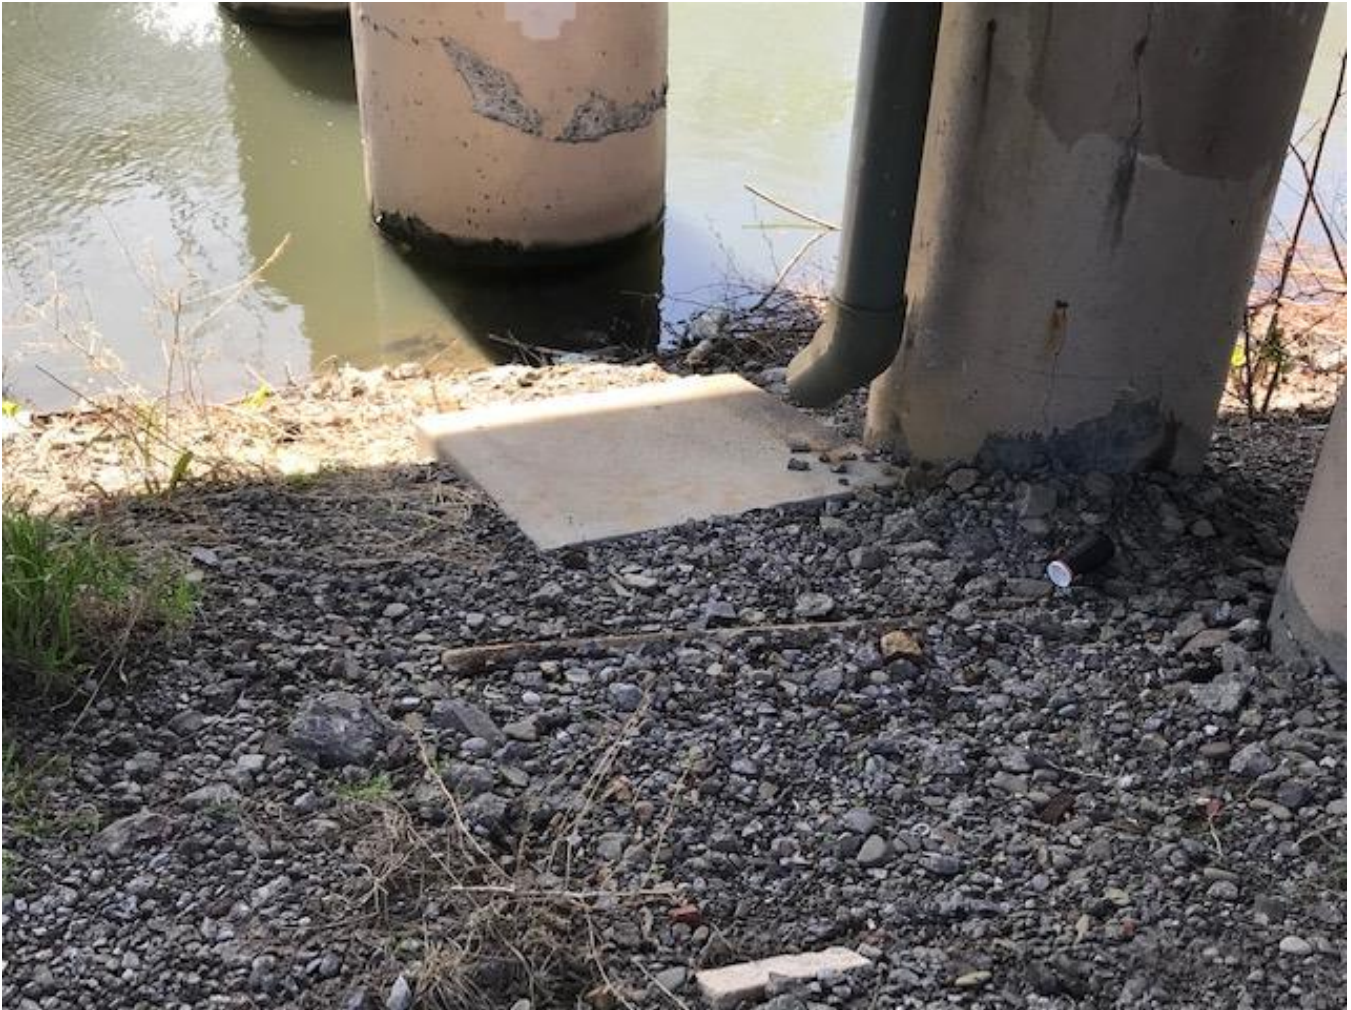
Photo 6. Southeast view of west bank at Maintenance Area 8, rip rap in good condition, no erosion on down slope of drain spout.

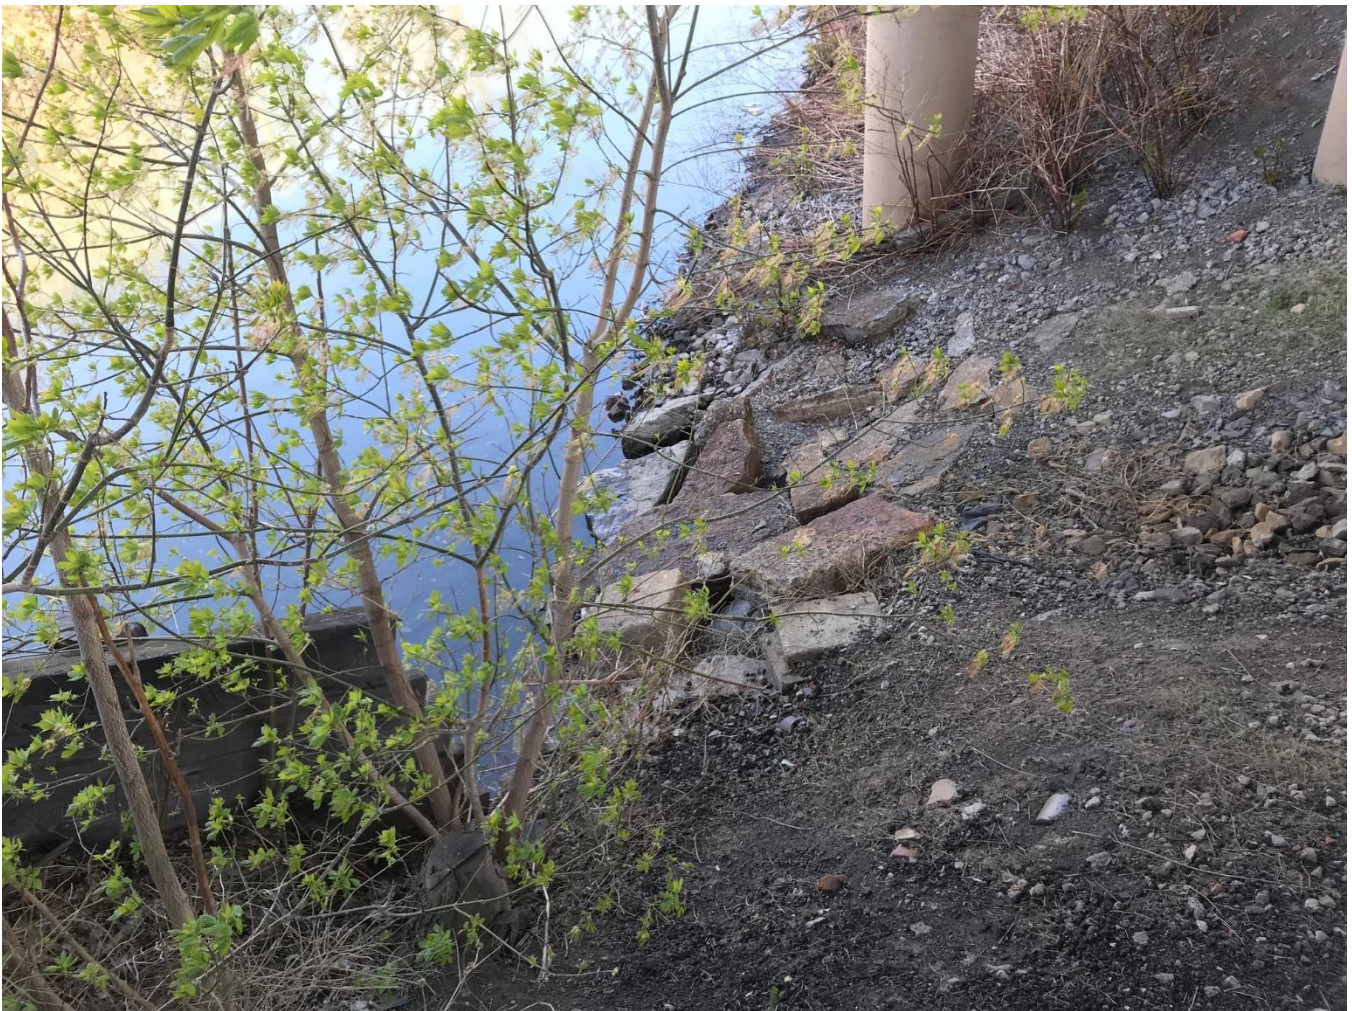
Photo 7. North view of Maintenance Area 5. No visible erosion. Rip rap and stone block in place.

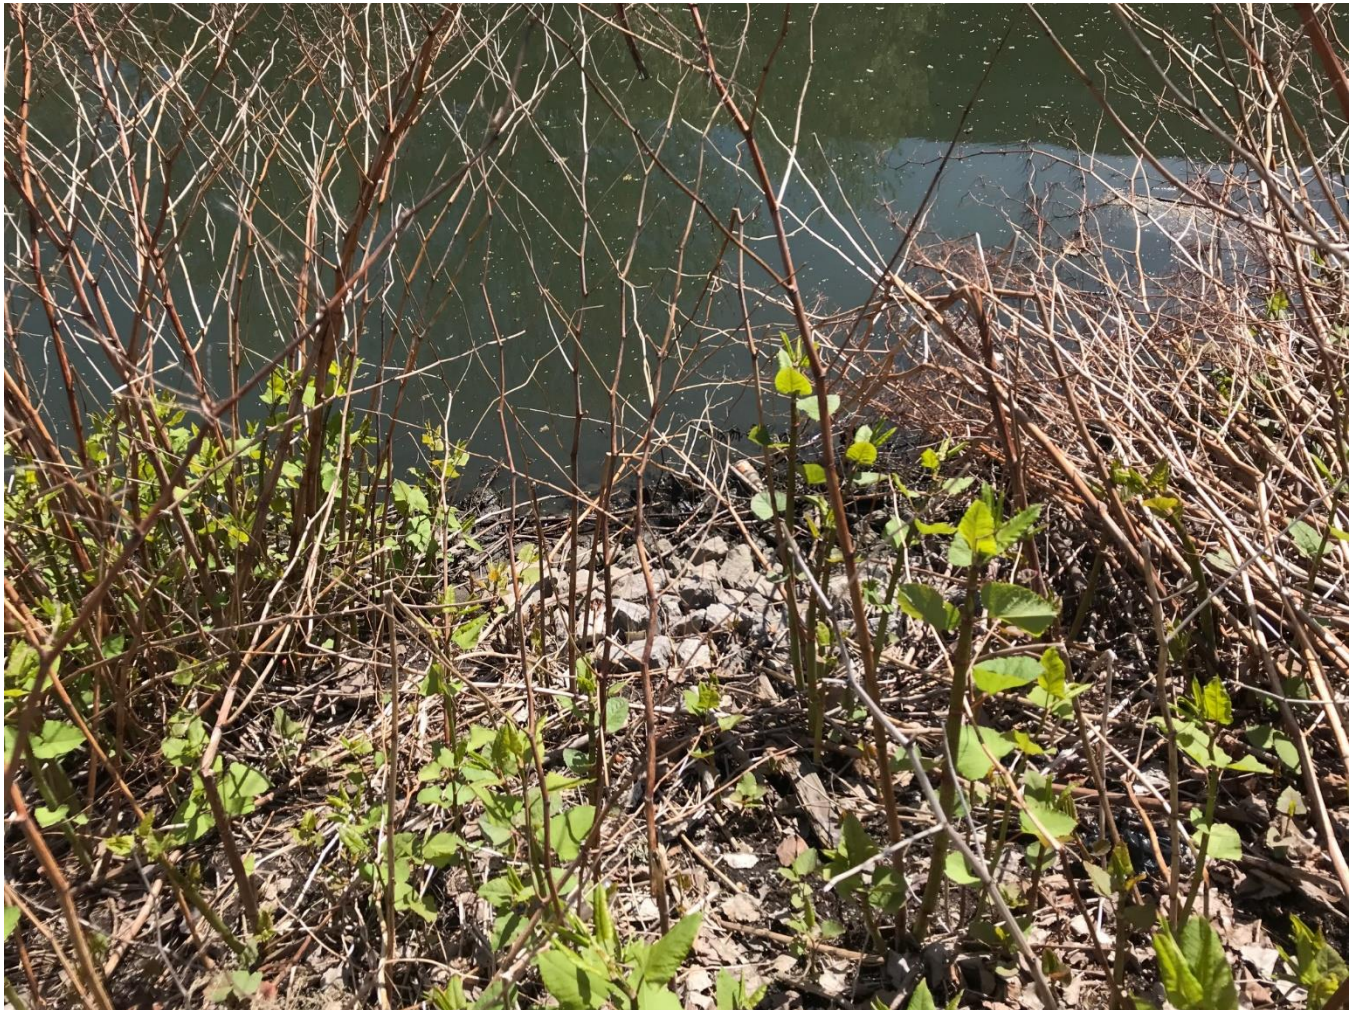
Photo 8. Closeup view of Maintenance Area 6. Rip rap placement intact. No visible erosion.

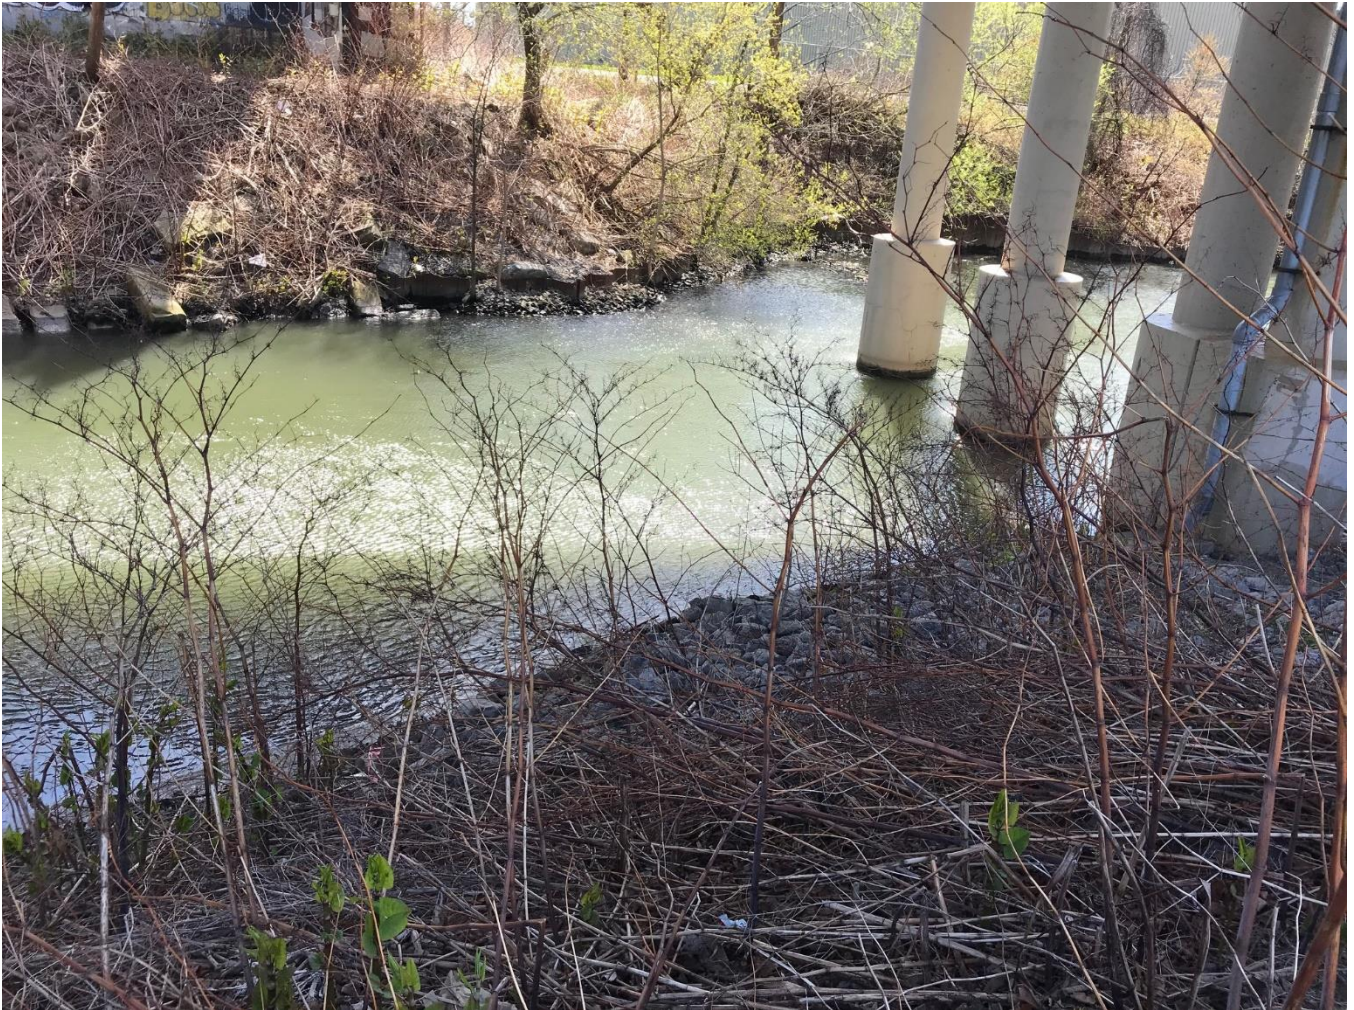
Photo 9. North view of west bank toward Conrail Bridge. No visible erosion.

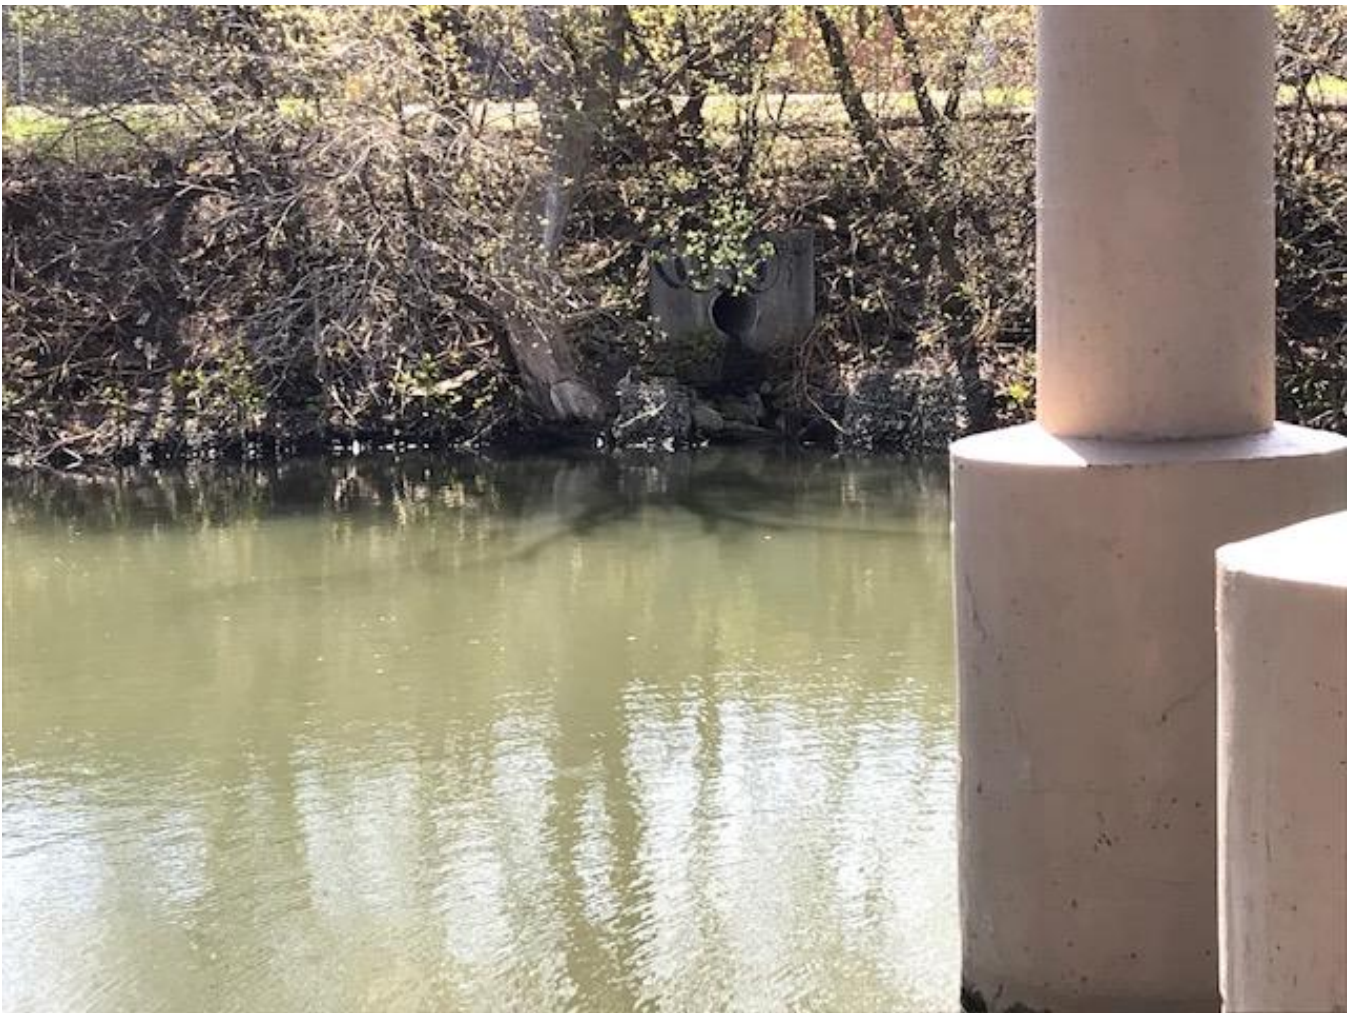
Photo 10. View of west bank at BMS outfall with gabion baskets. No visible erosion.

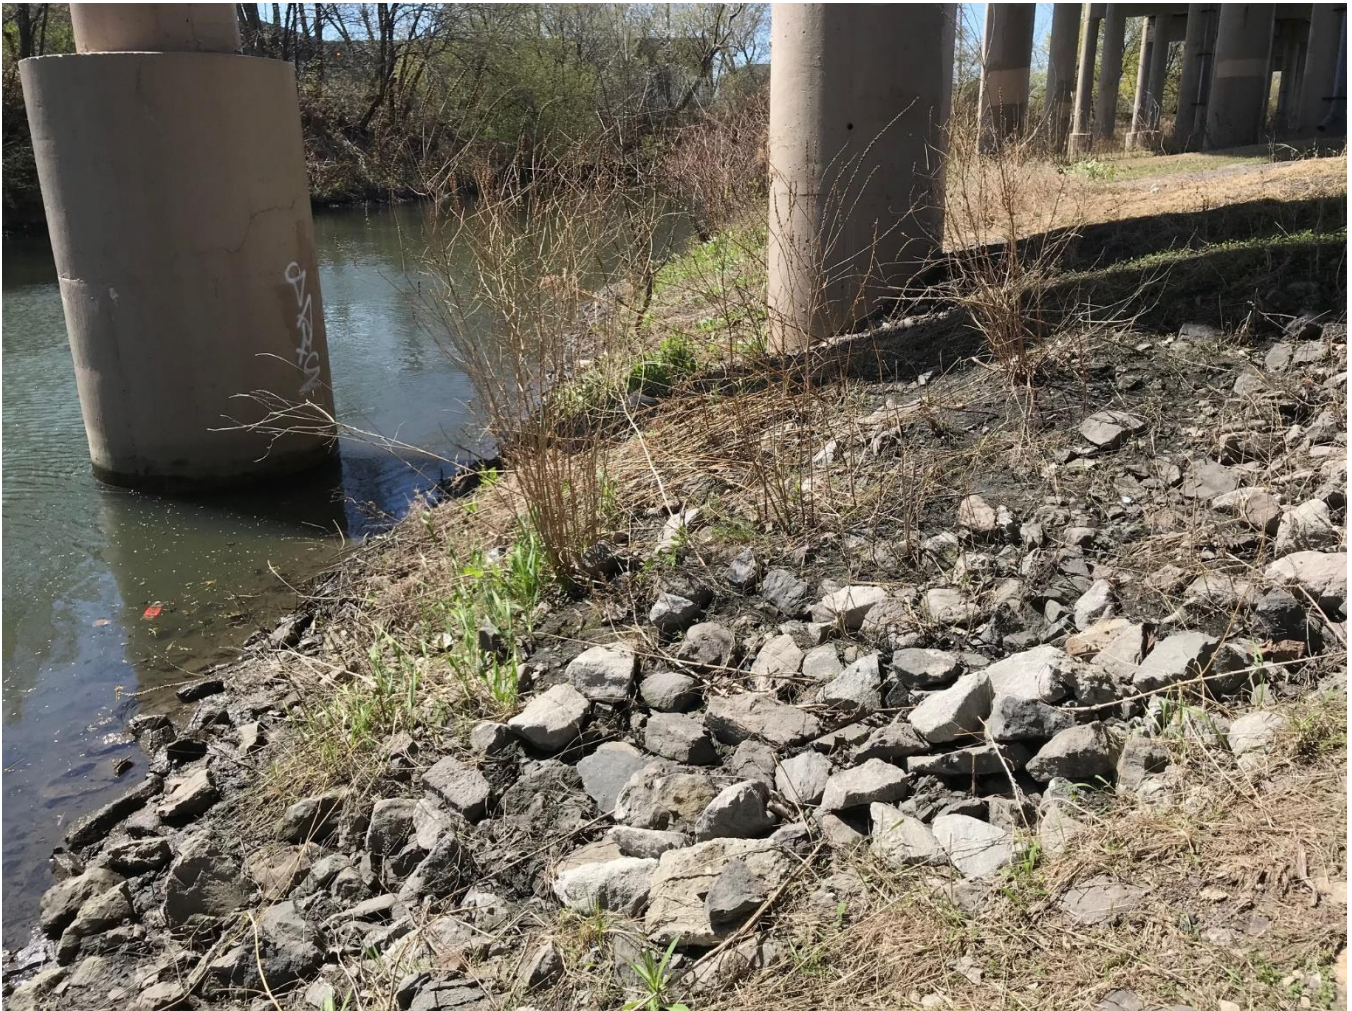
Photo 11. North view of east bank north of South Vault showing rip rap surface water conveyance. No visible erosion above or at creek bank.

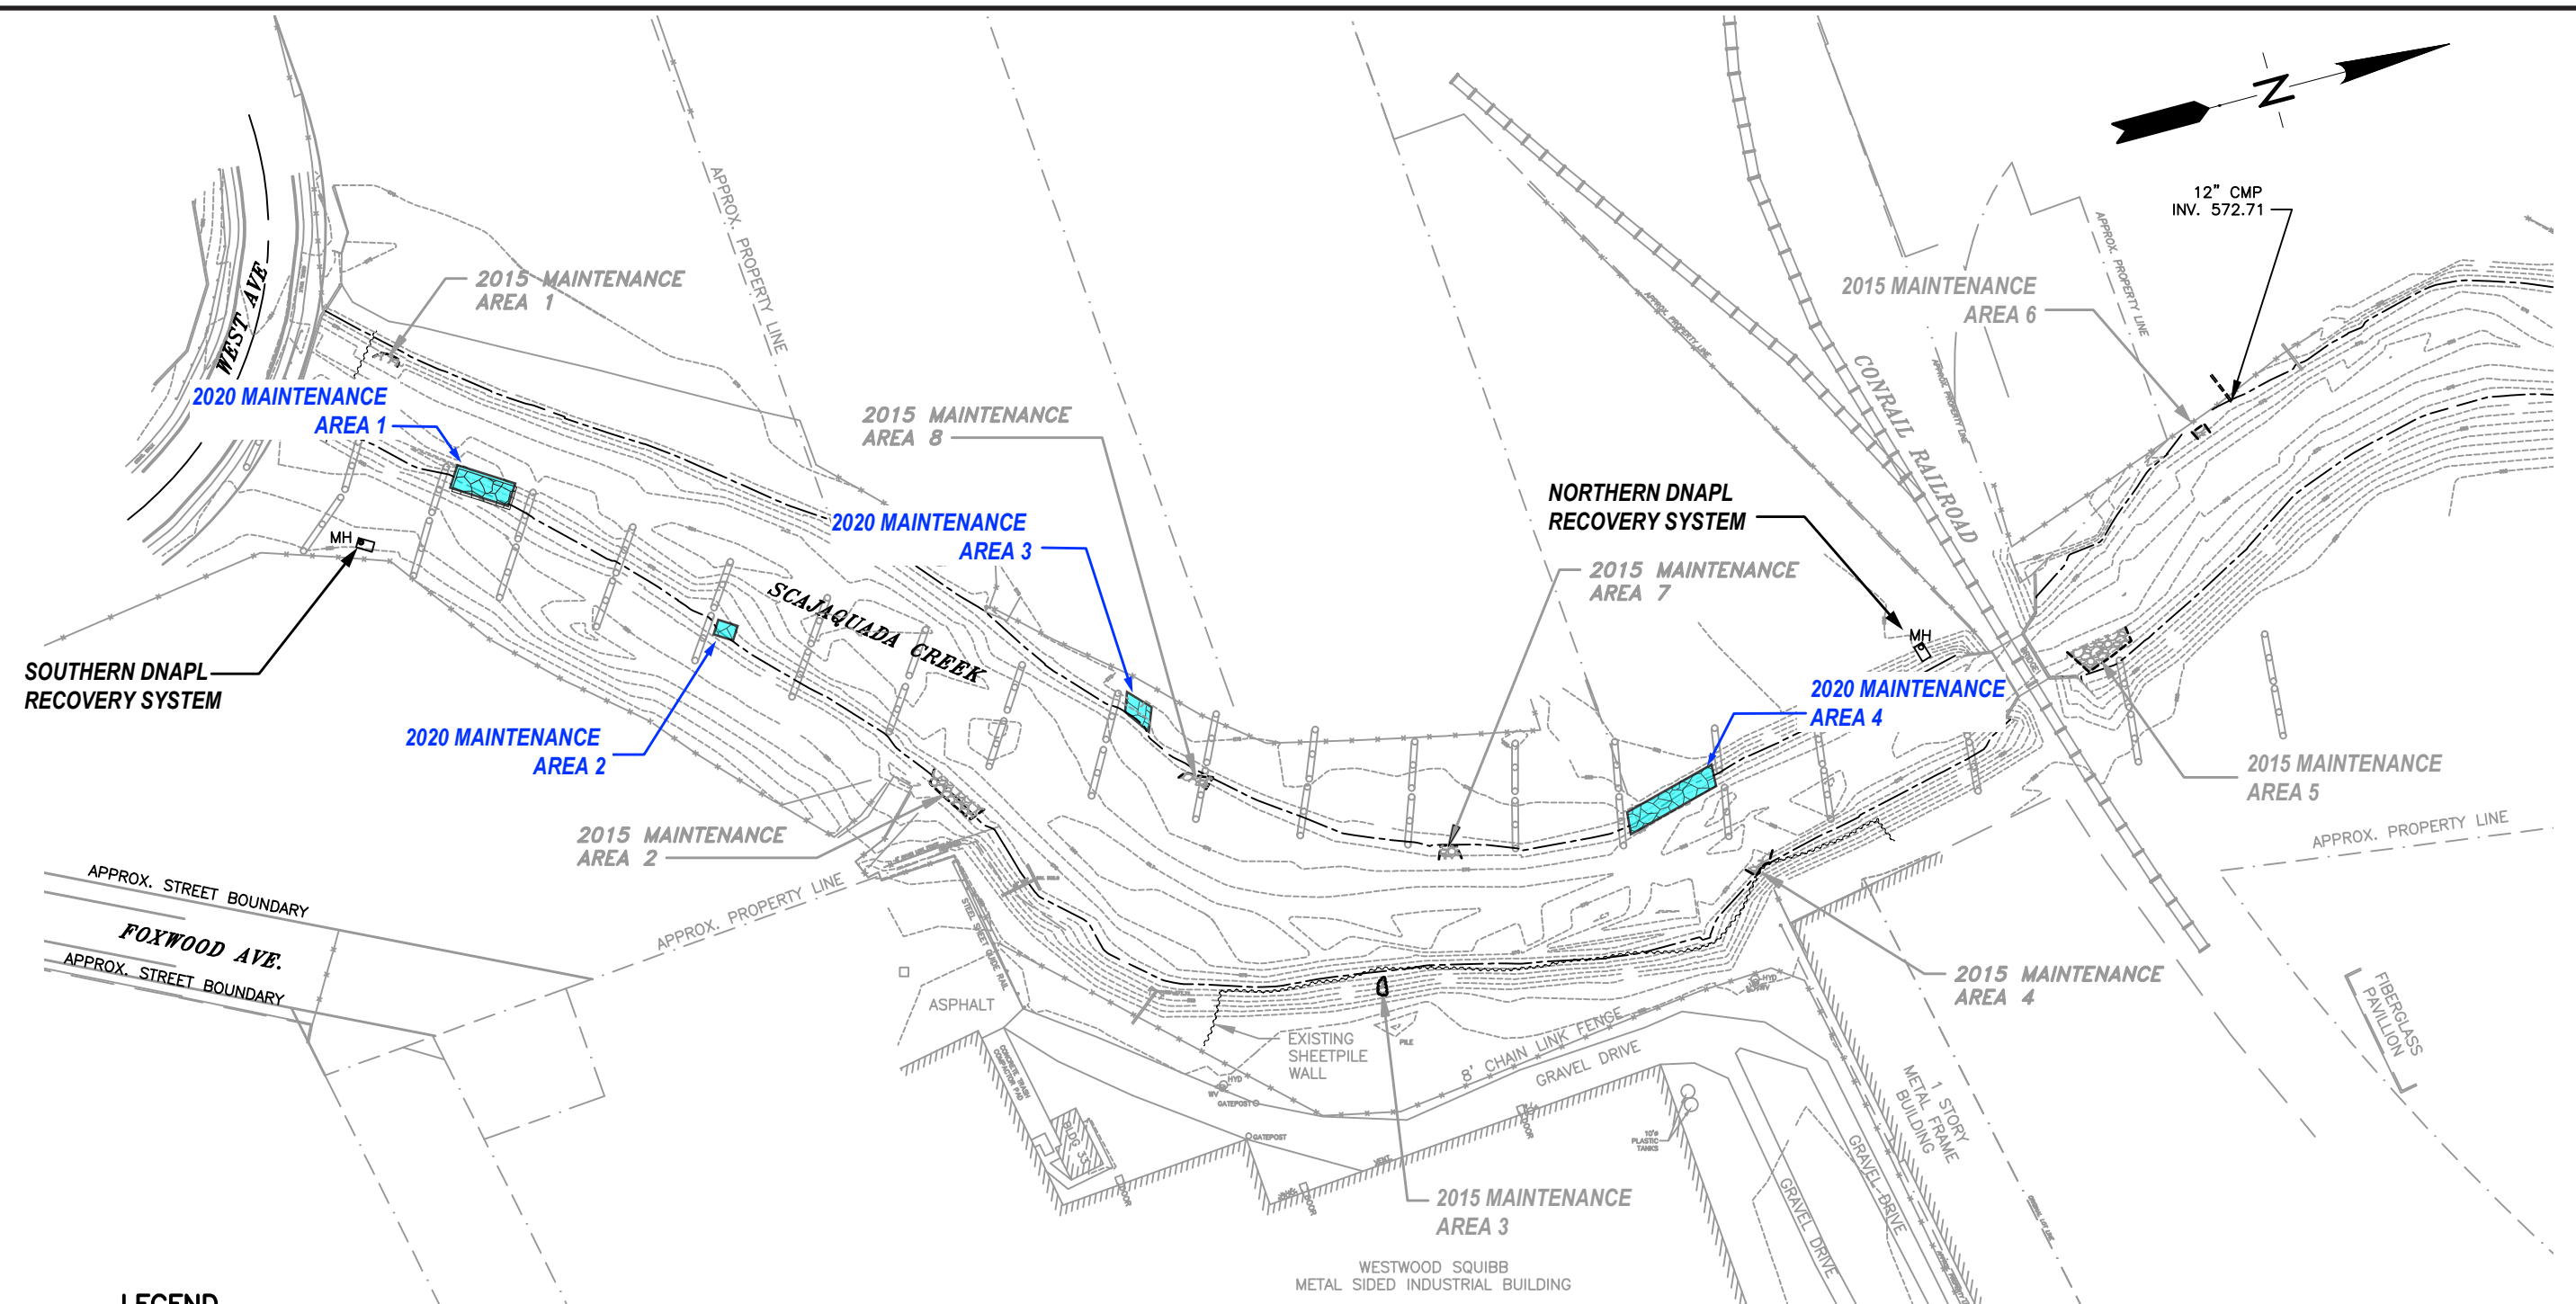
During inspection of the Southern DNAPL Recovery System on January 23, 2020, NFG observed an area of creek bank scour northwest of the Southern DNAPL Recovery System vault. GEI engineering staff accompanied NFG on January 31, 2020 to inspect the scoured area. An area approximately 15 x 10 feet had approximately 6-inches of the gravel/cobble armor layer scoured from the slope of the creek bank. The remaining armor layer thickness was adequate to prevent exposure of the geotextile present above the sand layer and GCL which comprises the cap. Based on the bank height of erosion, ice and surface water likely scoured the surface during an abnormally high creek water level condition. Subsequently, GEI and NFG inspected the east and west sides of the creek bank to the north and identified three other areas where recent scouring occurred. Each of the four areas requiring cap maintenance are shown on Figure 3 and are identified as follows: 2020 Maintenance Area 1; 2020 Maintenance Area 2; 2020 Maintenance Area 3; and 2020 Maintenance Area 4.

GEI notified the NYSDEC in correspondence dated February 3, 2020 and developed specifications for creek bank cap repairs consistent with those undertaken in 2015.

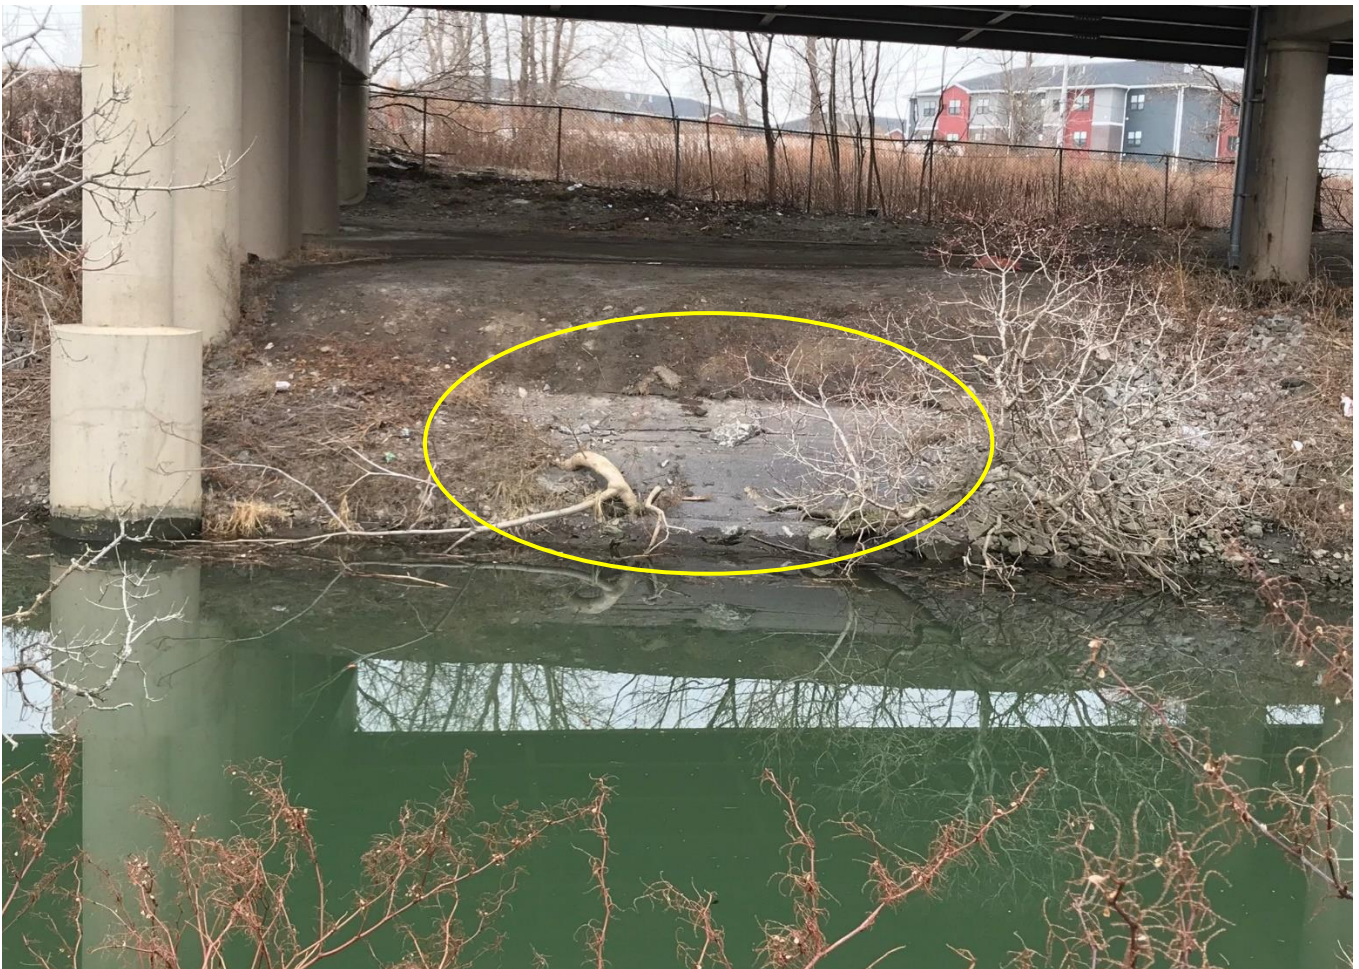
Photo 1. View looking east of east creek bank at 2020 Maintenance Area 1 taken on January 31, 2020. Vegetation and stone armor scoured away in January during high water/ice level in creek. Scoured area is identified on the photo.

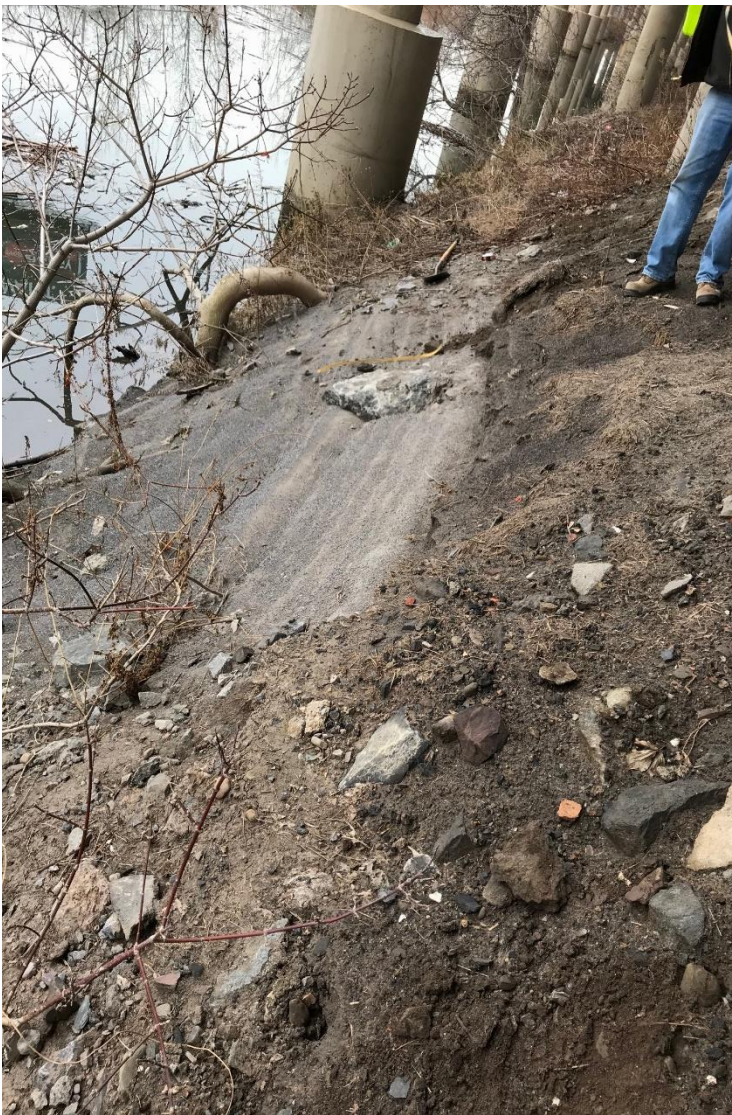
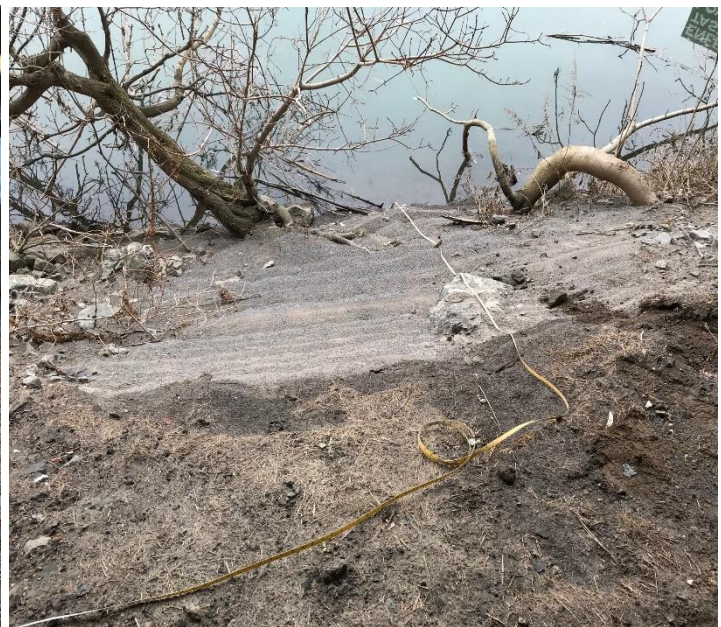
Photo 2a and 2b. Close-up views of the scoured area. Coarse armor stone missing, compact sand and fine gravel remain in place with no visible geotextile fabric.

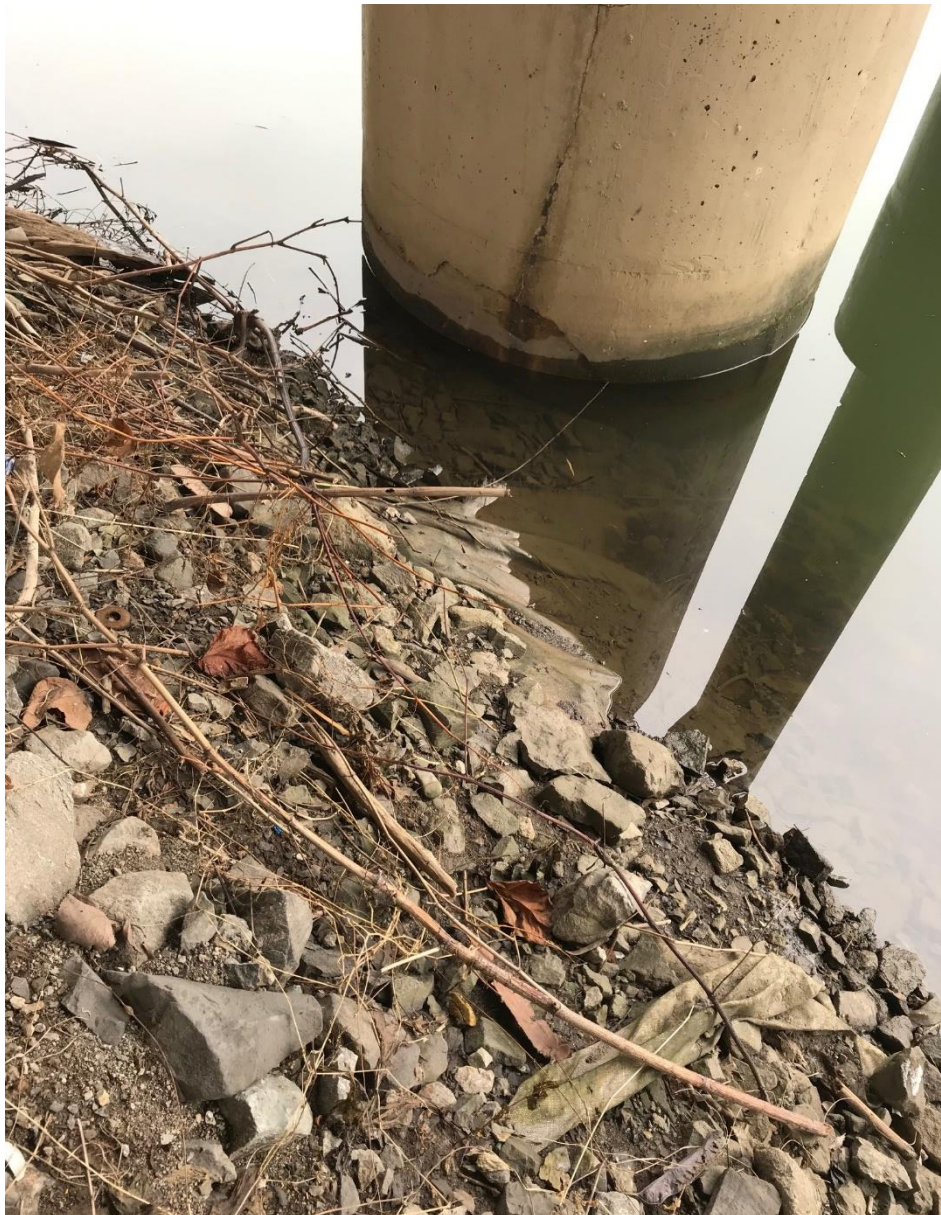
Photo 1. Close-up view of east creek bank at 2020 Maintenance Area 2 taken on January 31, 2020. Some vegetation and stone armor scoured away in January during high water/ice level in creek exposing a 2 X 3 foot area of geotextile fabric. Sand bedding and geosynthetic clay liner (GCL) remain below geotextile fabric and are not visible.
