**Re: Site Management Periodic Review Report (PRR) and IC/EC
Certification Submittal (2019)
NFG - Iroquois Gas/Westwood Pharm Riparian Site: Site # 915141B
Scajaquada Creek, Upstream of West Ave. Bridge – Buffalo, NY**

Site Management Periodic Review Report and IC/EC Certification (2019)

Iroquois Gas/Westwood Pharmaceutical Riparian Site No. 915141B
Buffalo, New York

March 2020

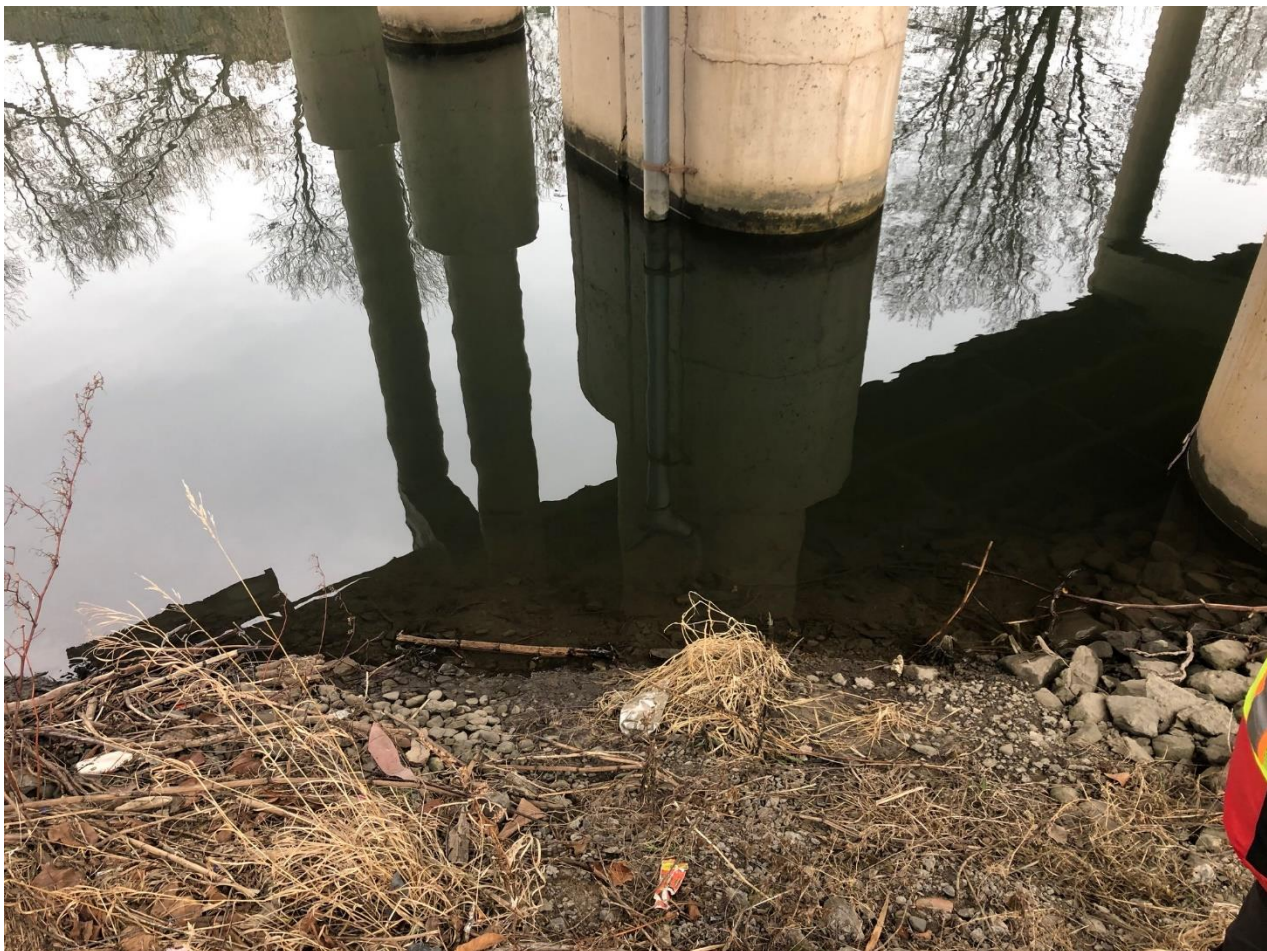
Photo 1. Close-up view of west creek bank at 2020 Maintenance Area 3 taken on January 31, 2020. Some vegetation and stone armor scoured away in January during high water/ice level in creek. No geotextile fabric was exposed and sand bedding and geosynthetic clay liner (GCL) remain intact below remaining armor sand and stone.

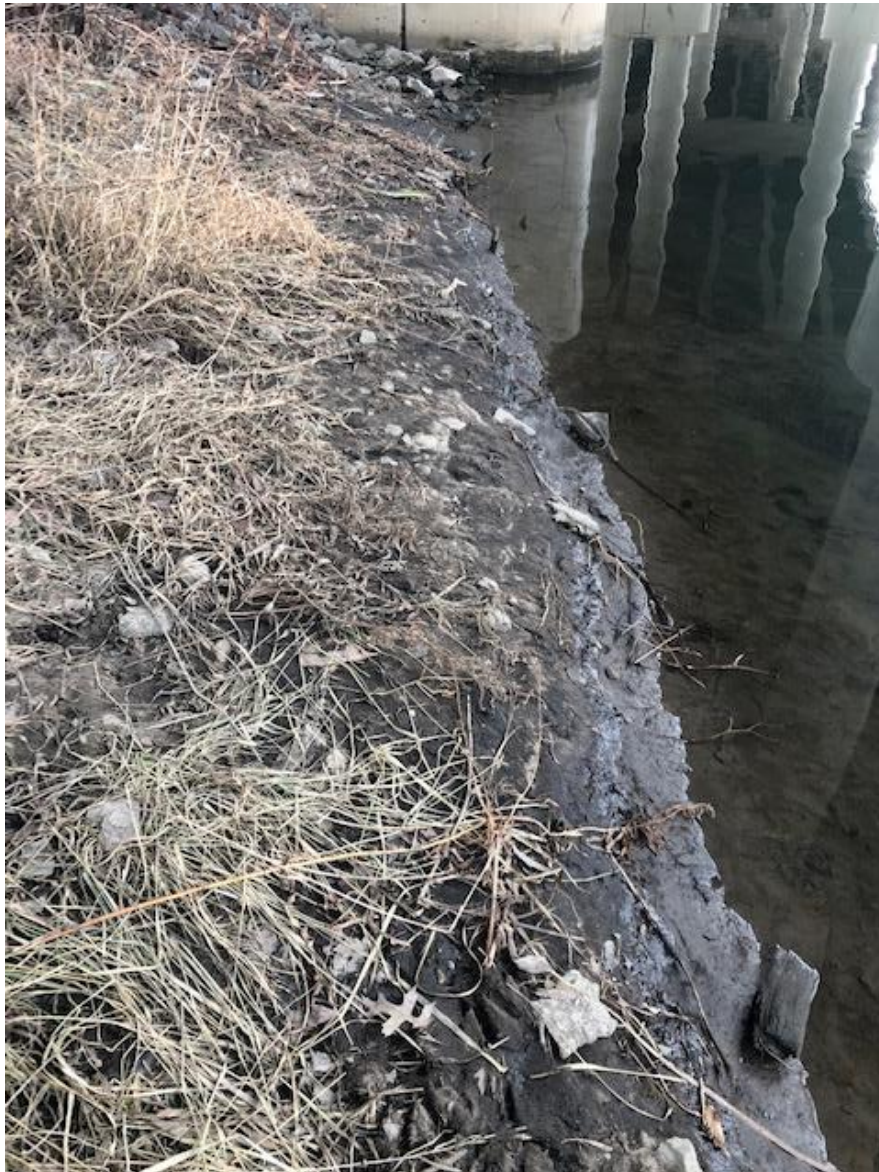
Photo 1. Close-up view looking north of west creek bank at 2020 Maintenance Area 4 taken on January 31, 2020. Some vegetation and stone armor scoured away in January during high water/ice level in creek. No geotextile fabric was exposed and sand bedding and geosynthetic clay liner (GCL) remain intact below remaining armor sand and stone.
