**Re: Site Management Periodic Review Report (PRR) and IC/EC  
Certification Submittal (2020)  
NFG - Iroquois Gas/Westwood Pharm Riparian Site: Site # 915141B  
Scajaquada Creek, Upstream of West Ave. Bridge – Buffalo, NY**

## Site Management Periodic Review Report and IC/EC Certification (2020)

Iroquois Gas/Westwood Pharmaceutical Riparian Site No. 915141B  
Buffalo, New York

March 2021  
Project 1403480

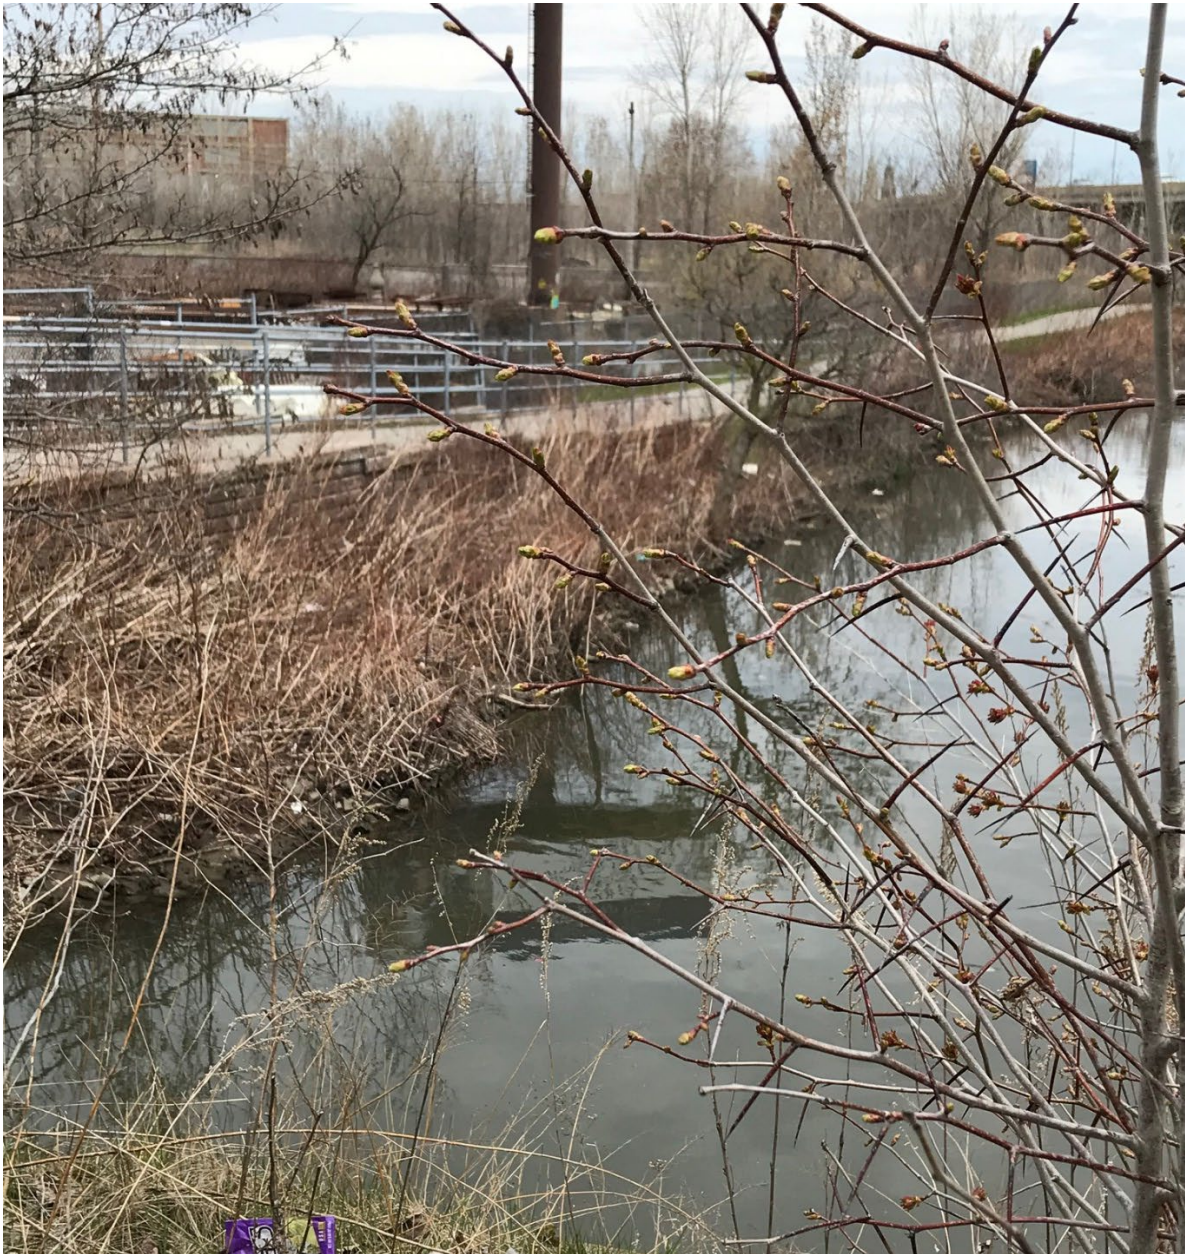
**Photo 1. View looking northeast of west bank of creek at 2015 Maintenance Area 1. Vegetation and stone armor remain in place.**

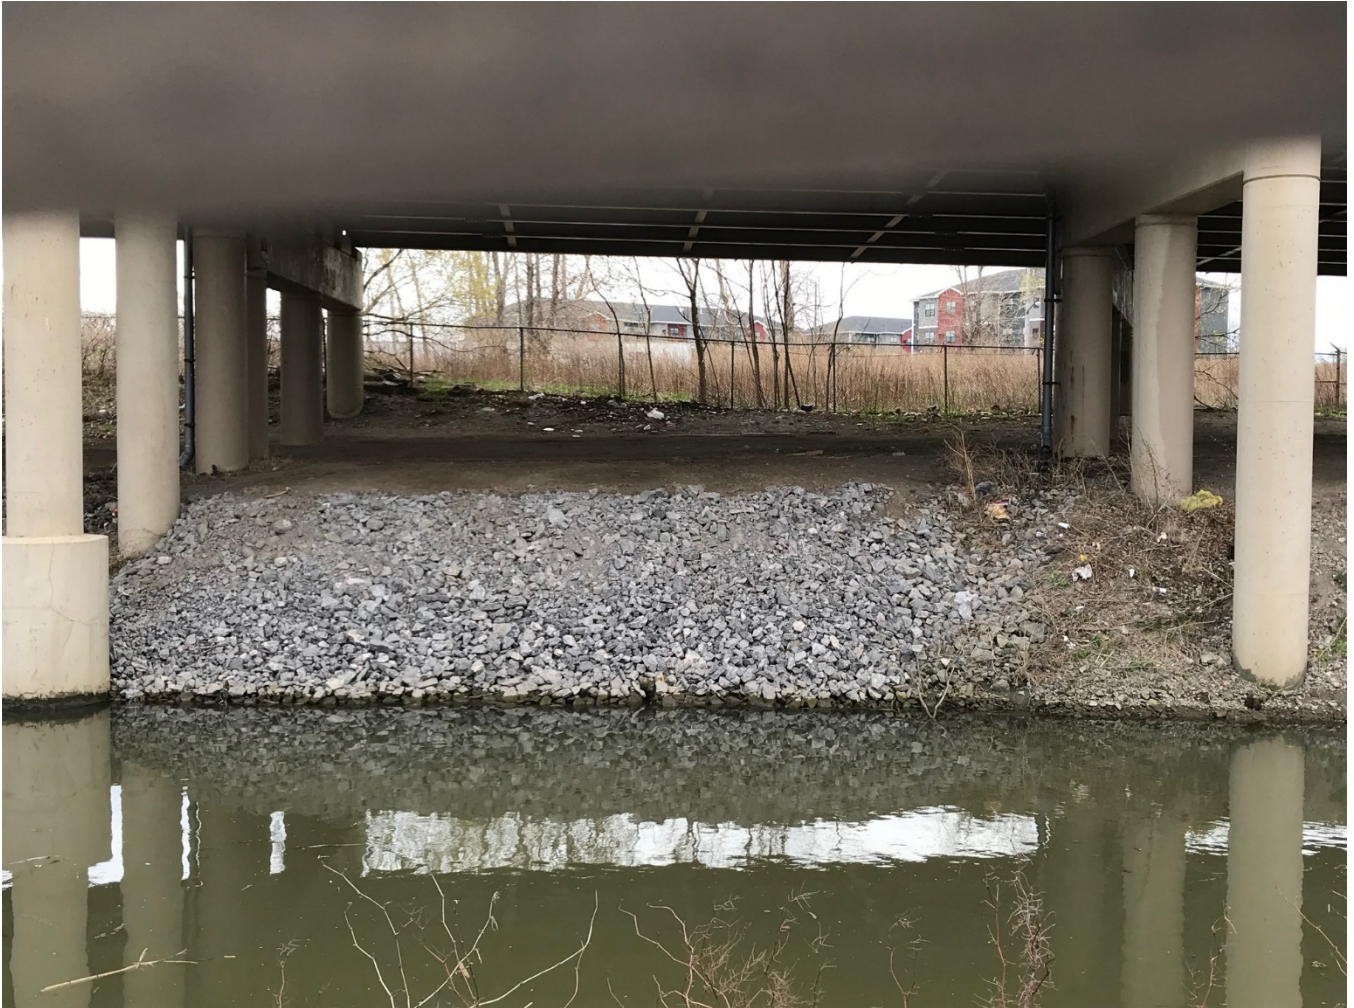
**Photo 2. View looking east of east bank of creek at 2020 Maintenance Area 1. Rip rap remains in place.**

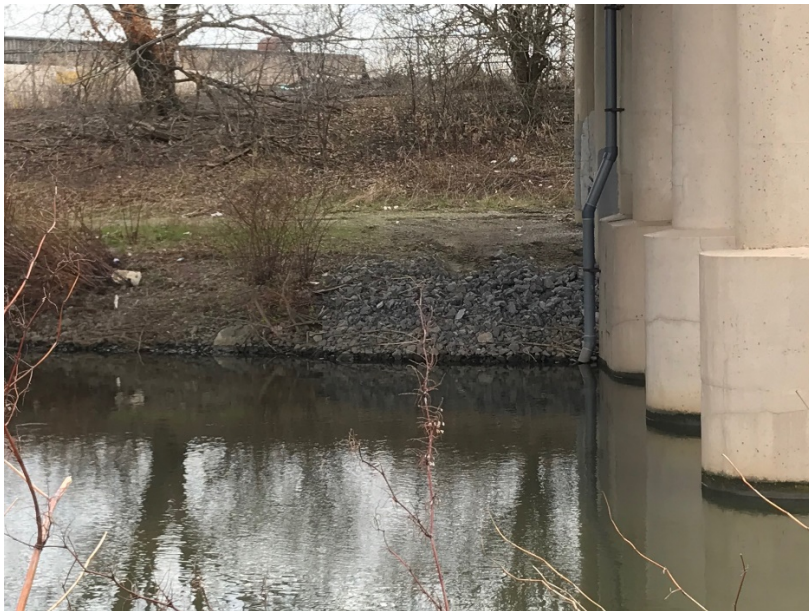
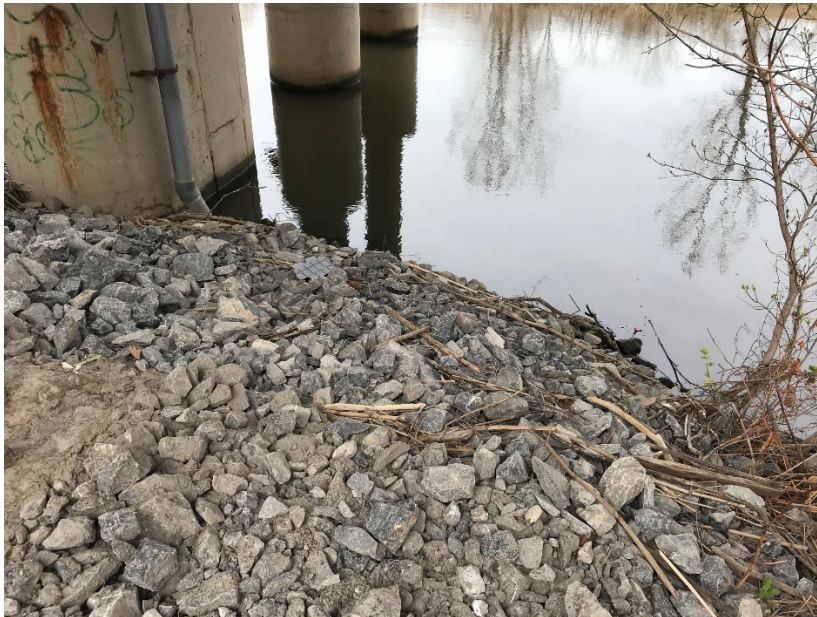
Photo 3A

**Photo 3. East view and downslope view (Photo 3A) on east bank of 2020 Maintenance Area 2.  
Stone armor remains in place.**

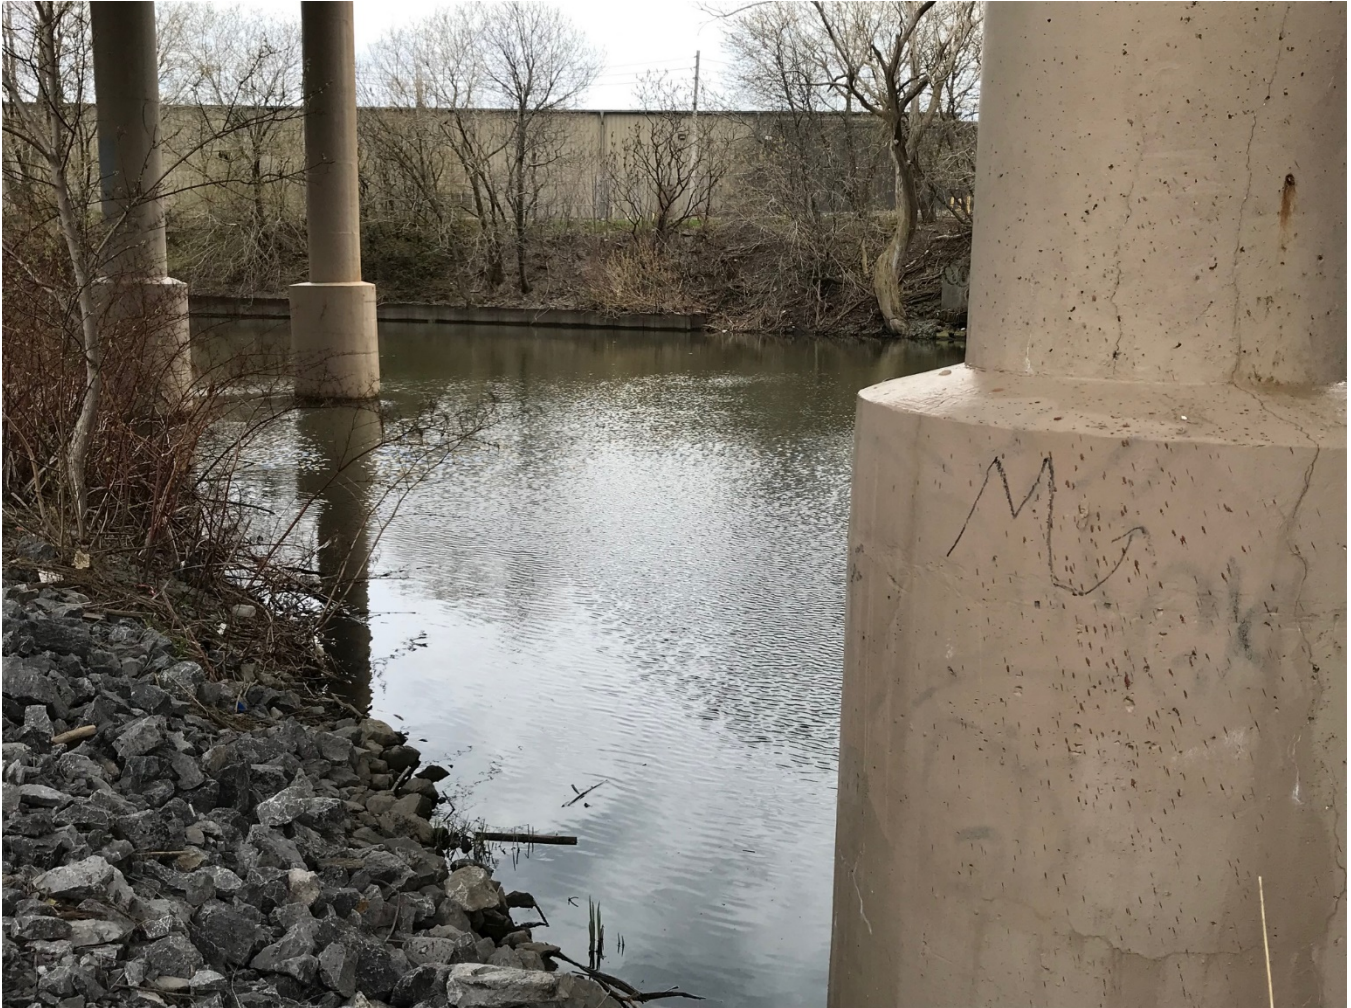
**Photo 4. View looking at west bank at 2020 Maintenance Area 3. Stone armor remains in place. BMS Sheet Pile on east bank in far view of photo.**

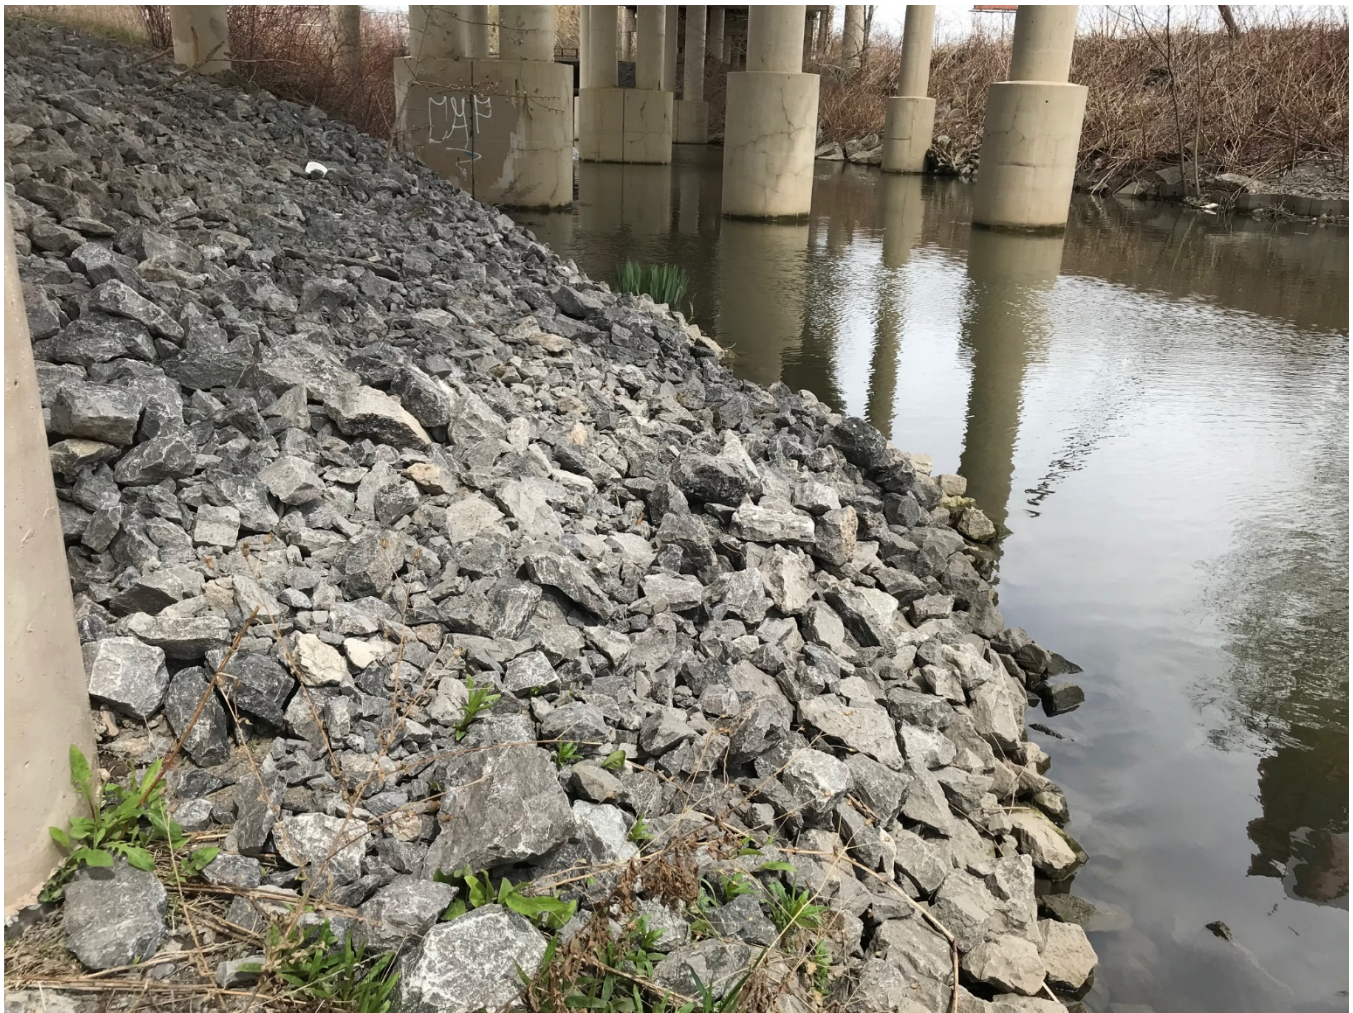
**Photo 5. Closeup of west bank of 2020 Maintenance Area 4. Rip rap in good condition.**

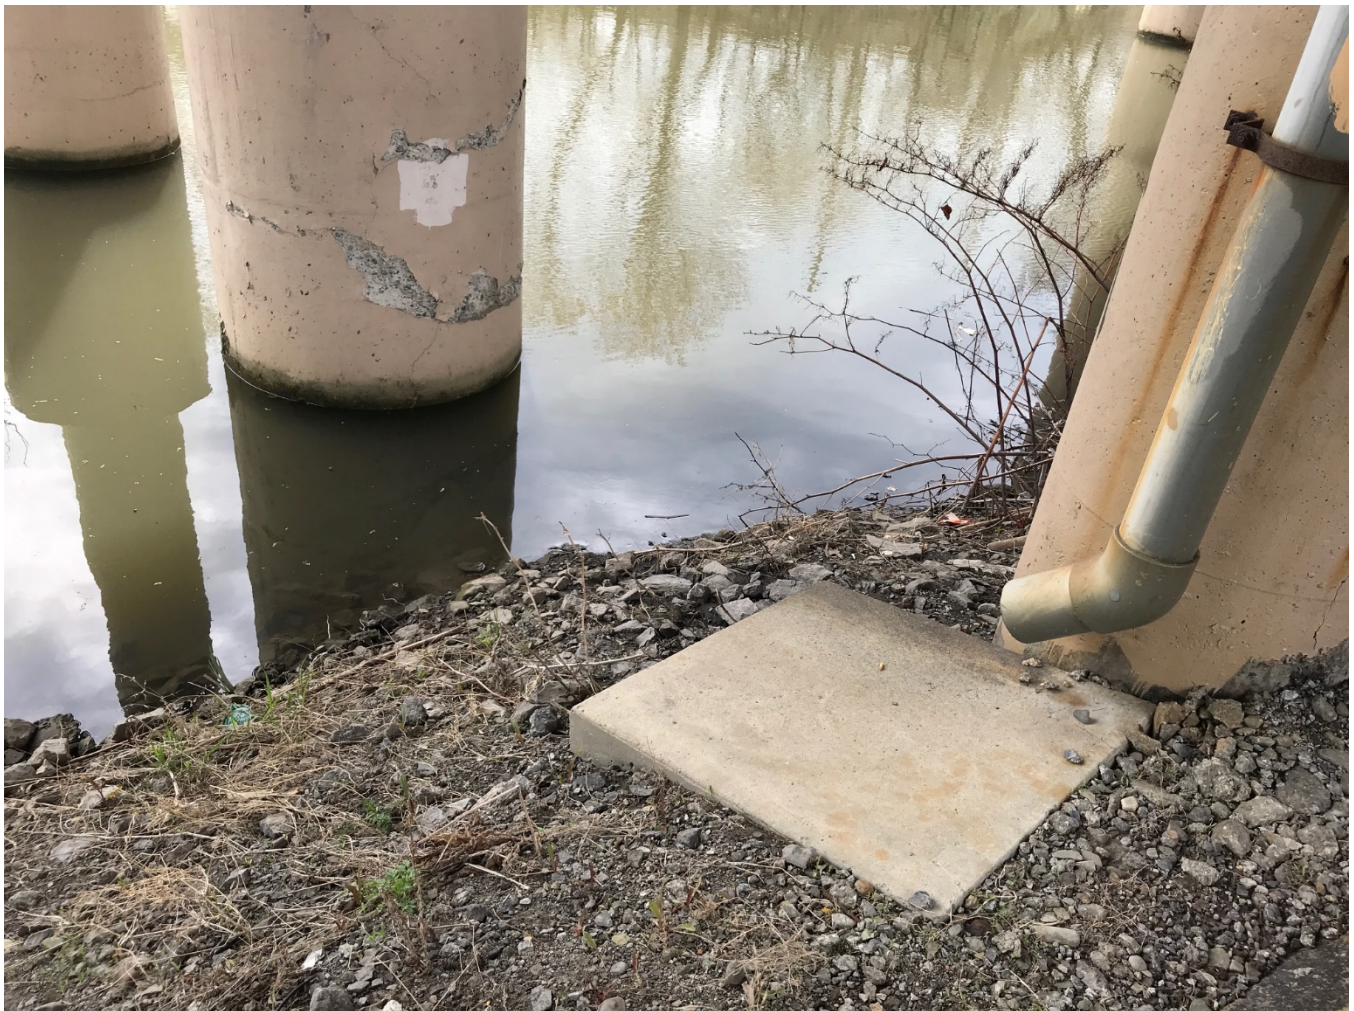
**Photo 6. Southeast view of west bank at Maintenance Area 8, rip rap in good condition, no erosion on down slope of drain spout.**

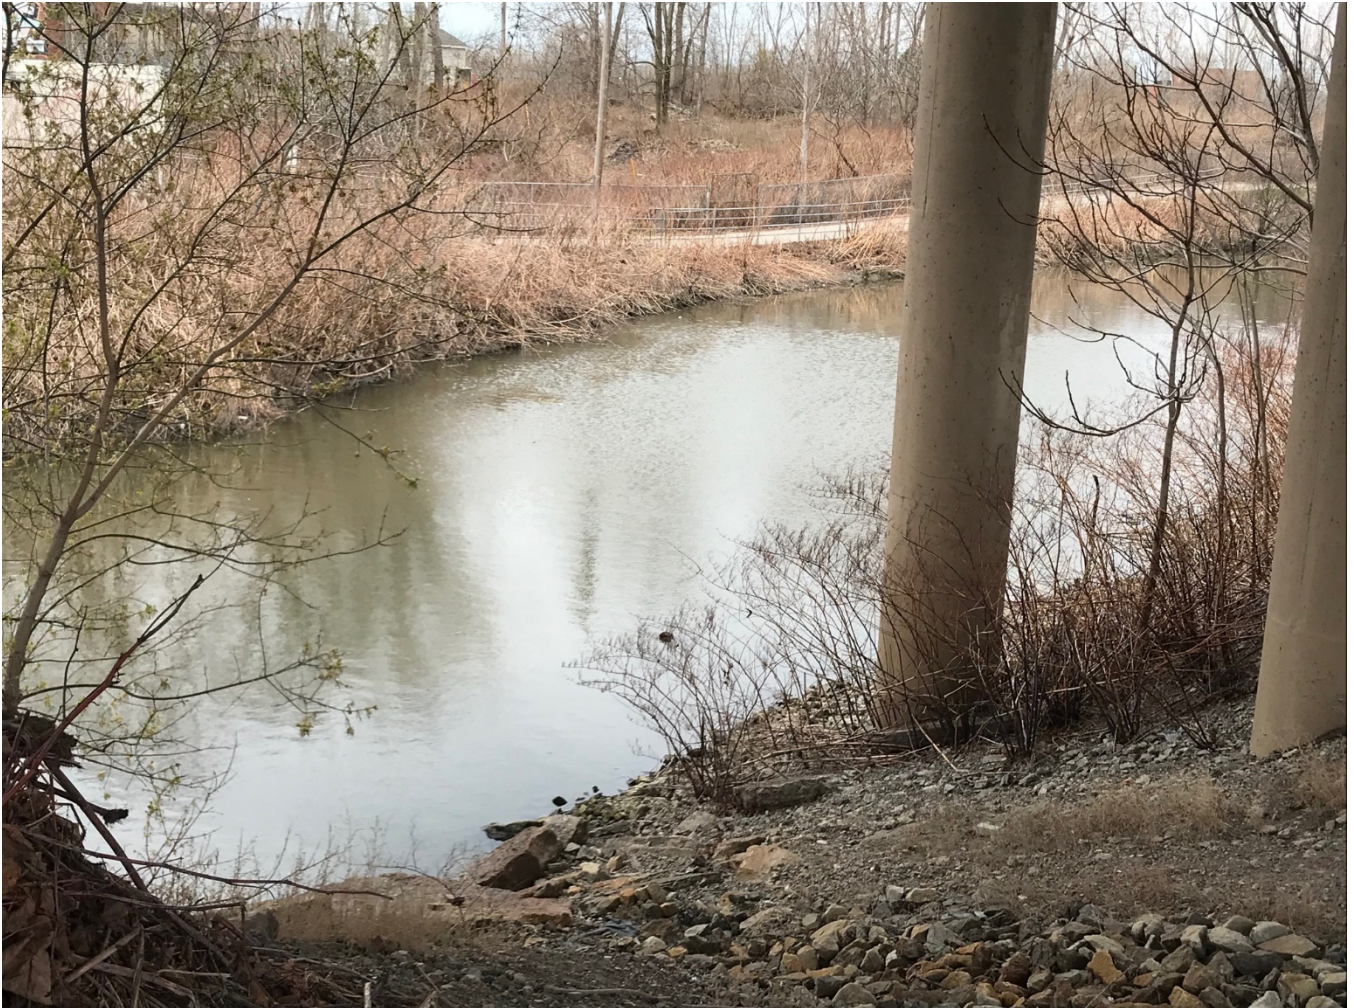
**Photo 7. North view of Maintenance Area 5. No visible erosion. Rip rap and stone block in place.**

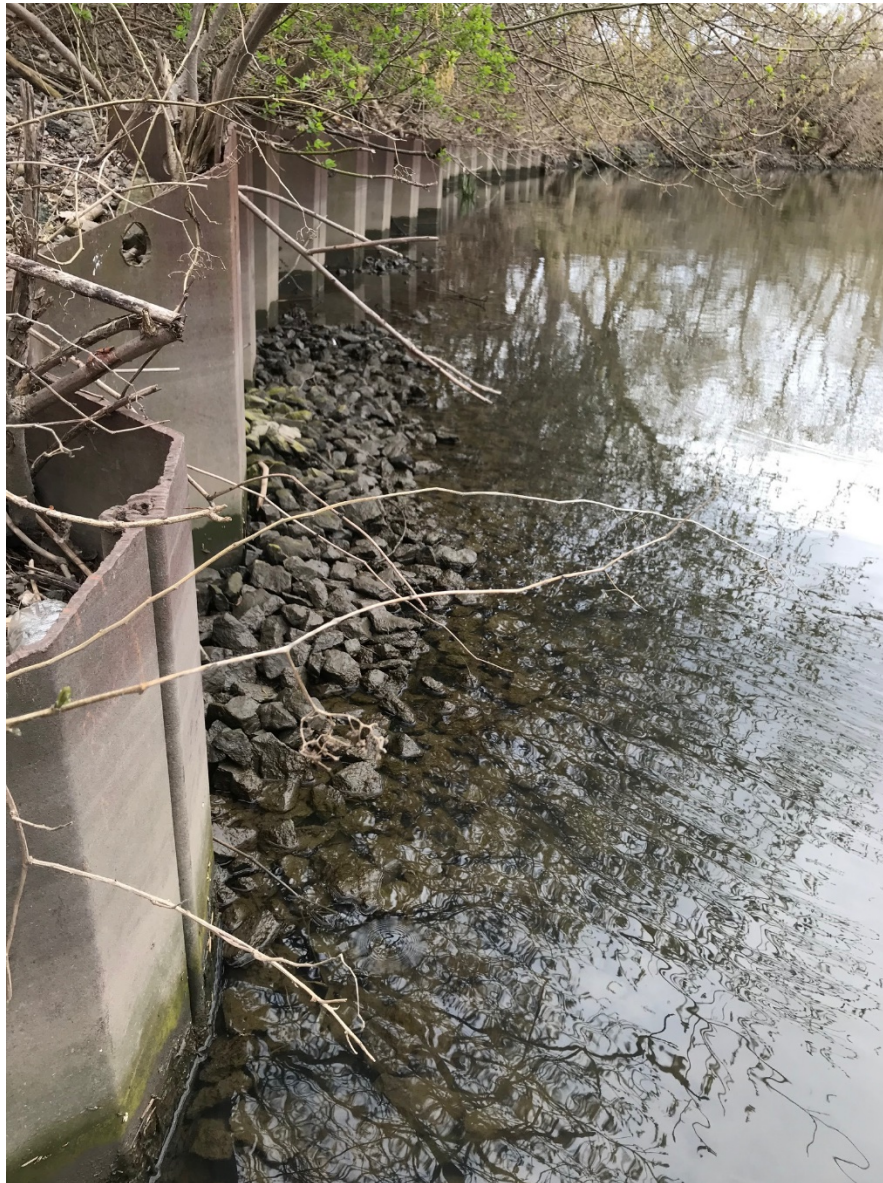
**Photo 8. Closeup view of Steel Sheet Pile along BMS Terrestrial Site. No visual NAPL seepage along entire length of sheet pile.**

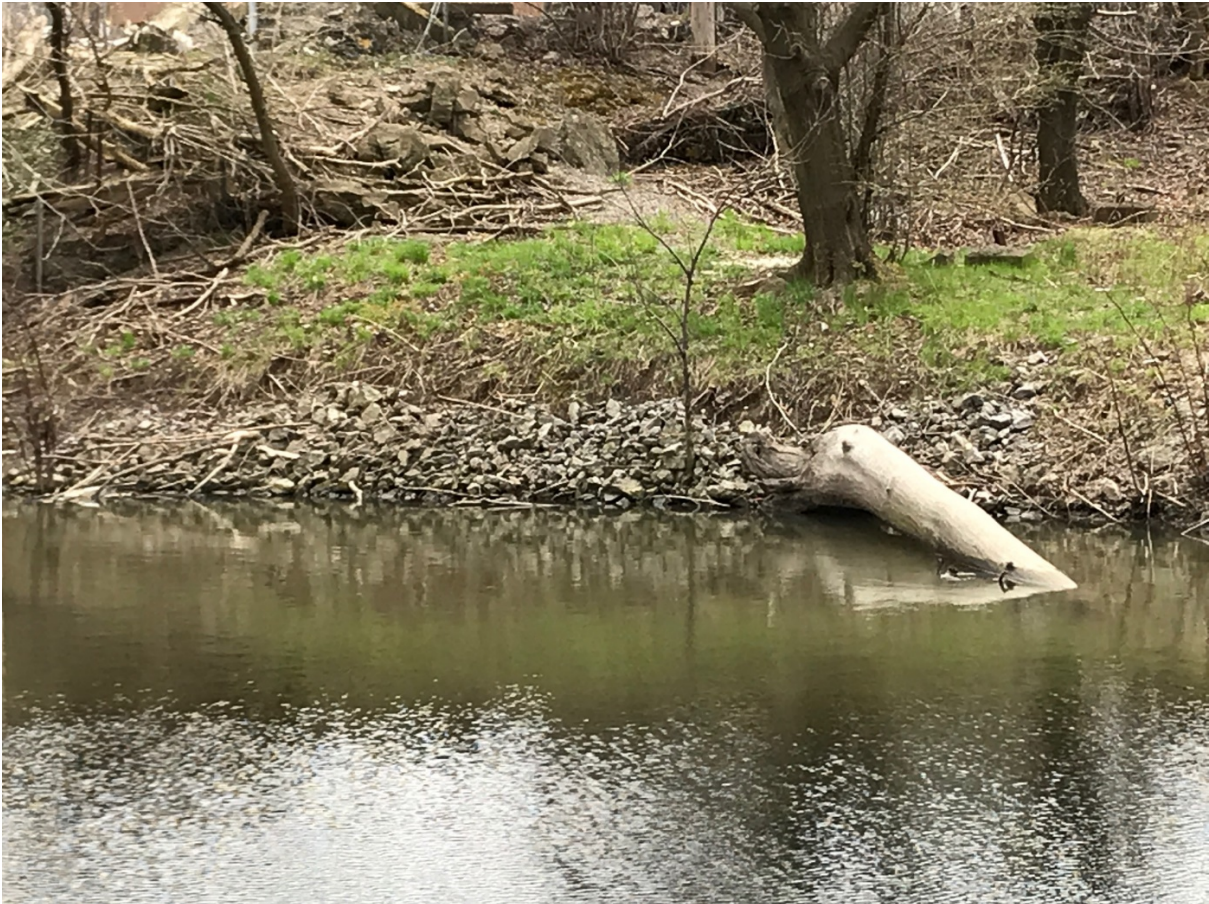
**Photo 9. East bank view of 2015 Maintenance Area 2. No visible erosion.**

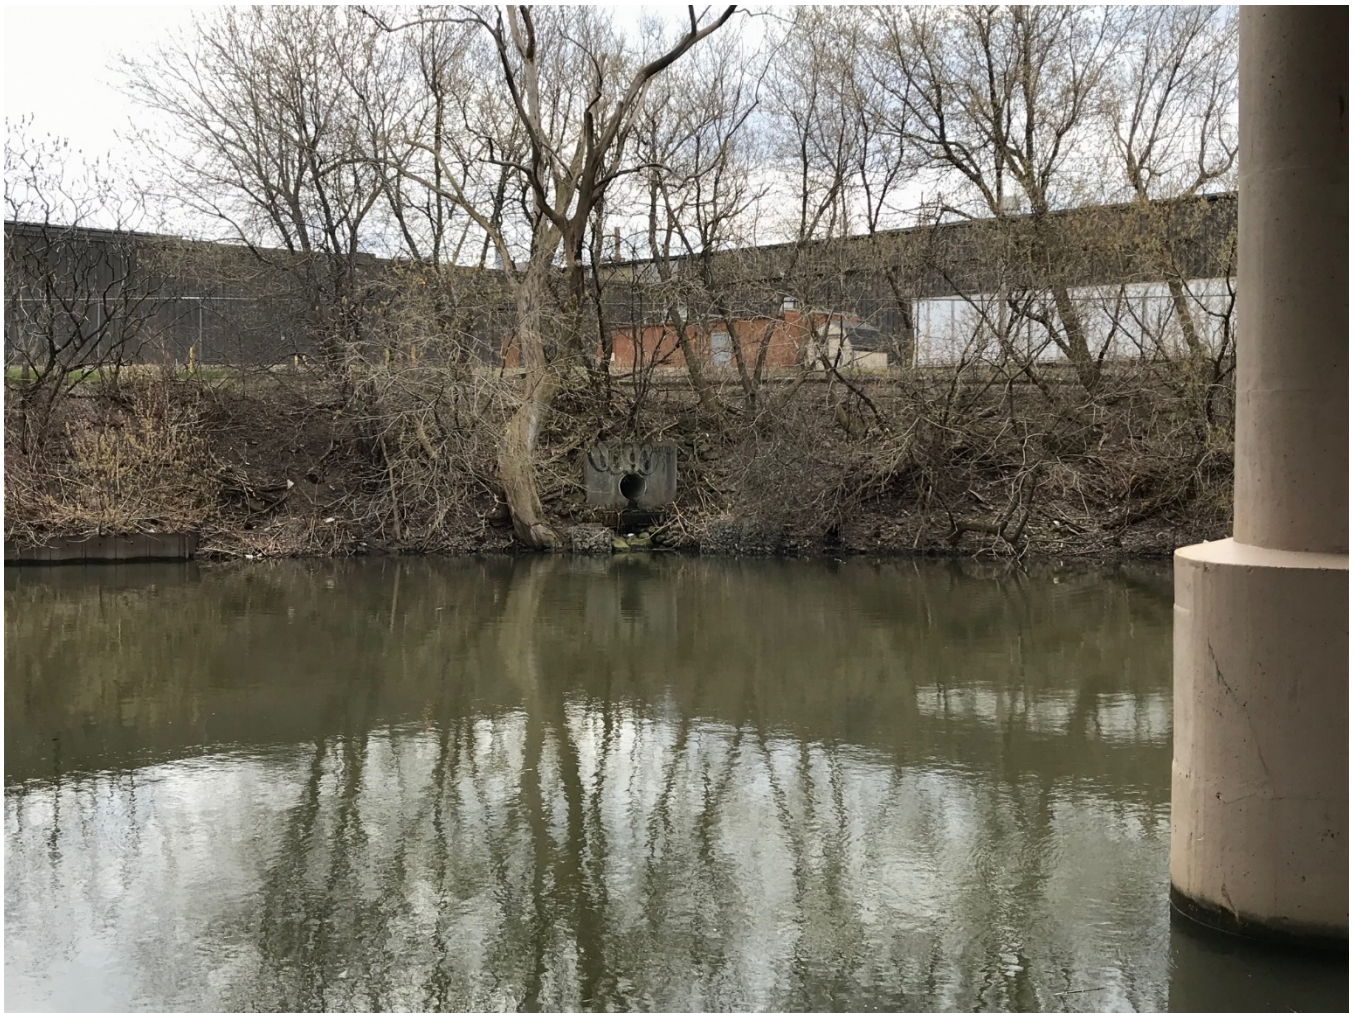
**Photo 10. View of west bank at BMS outfall with gabion baskets. No visible erosion or NAPL seepage.**

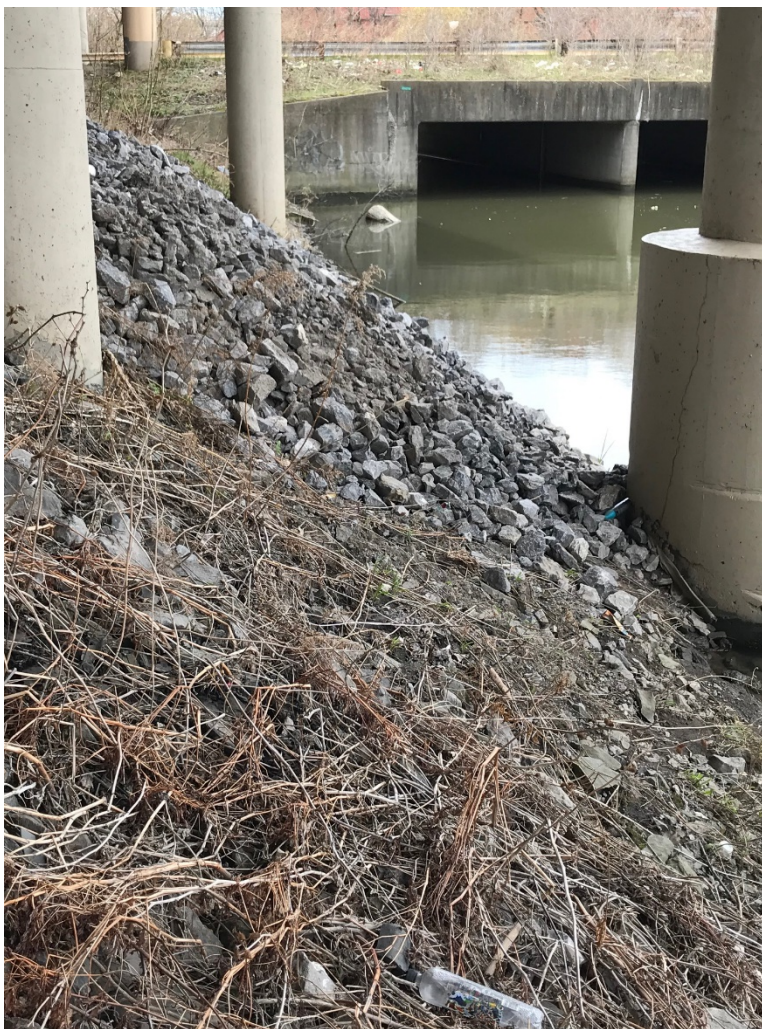
**Photo 11. South view of east bank north of South Vault showing rip rap and West Avenue Bridge. No visible erosion above or at creek bank.**

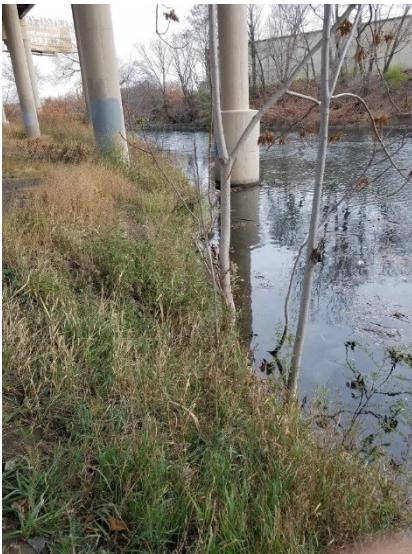
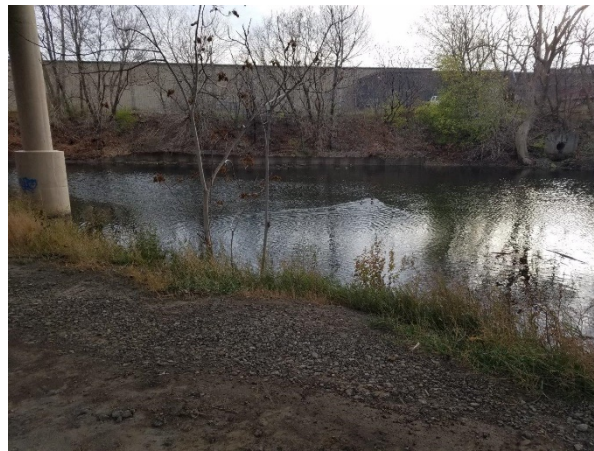
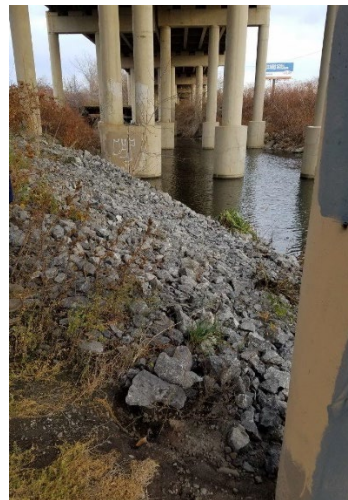
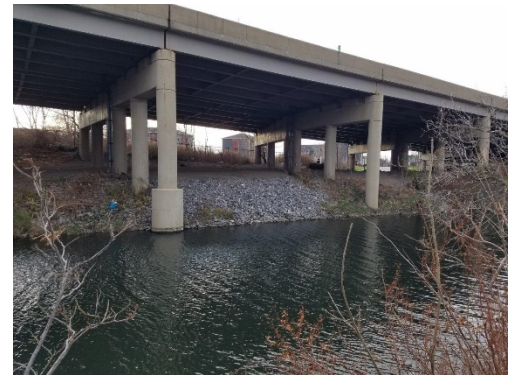
**Supplemental periodic inspection on November 19, 2020 following high westerly wind event causing seiche conditions on Lake Erie causing high water backflow condition in Creek. No damage to cap observed.**

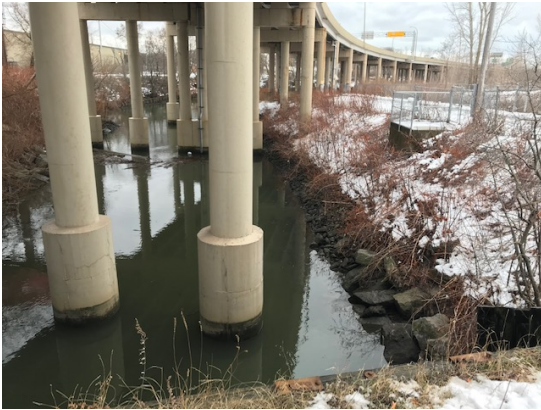
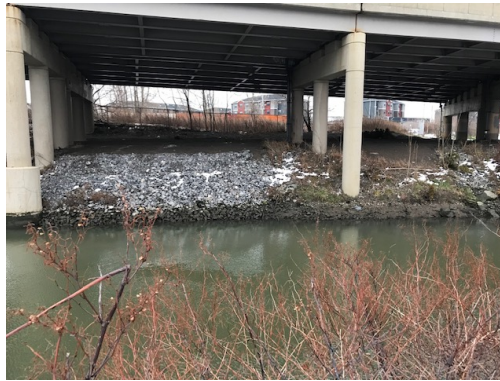
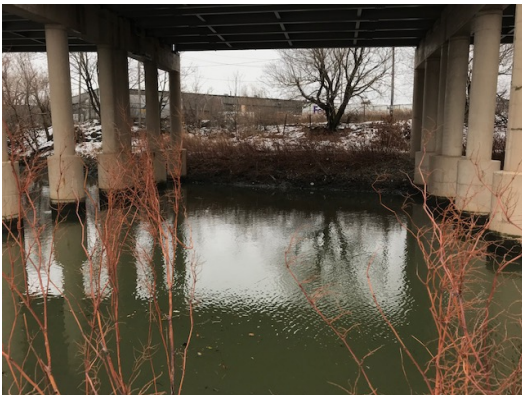
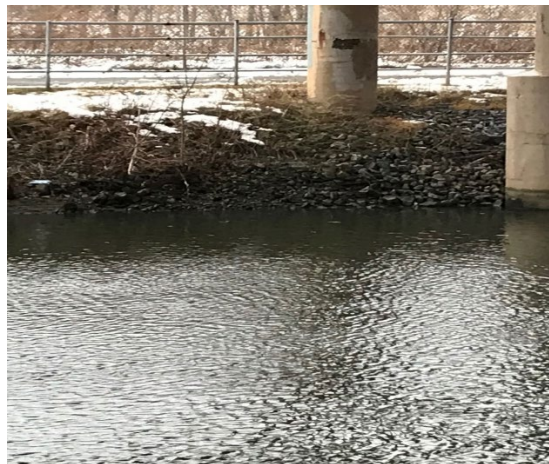
**Supplemental periodic inspection on December 28, 2020 following high westerly wind event causing seiche conditions on Lake Erie causing high water backflow condition in Creek. No damage to cap observed.**
