Site Management Periodic Review Report (2024) Site No. 915141B

NFG - Iroquois Gas/Westwood Pharmaceutical Riparian Site,
Buffalo, New York

January 2025, Rev. September 2025
Project No. 1403480-1000

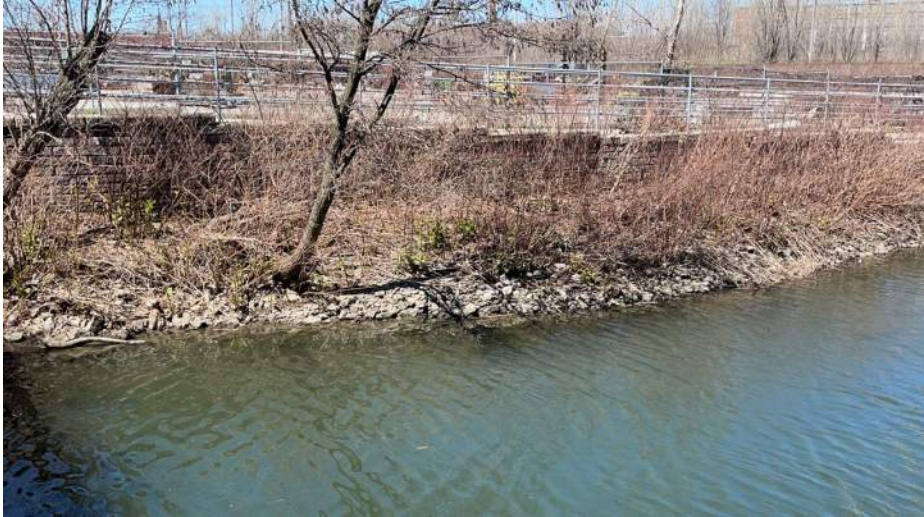
PHOTO BY: RICK FRAPPA, P.G.			
PHOTOGRAPH No: 02	DATE: April 22, 2024	LATITUDE: 42.9305595019027	LONGITUDE: -78.8953575501922
DIRECTION: Southwest	SITE LOCATION: SCAJAQUADA CREEK SITE - BUFFALO, NEW YORK		
DESCRIPTION: 2020 Maintenance Area 1. Armor stone in good condition.

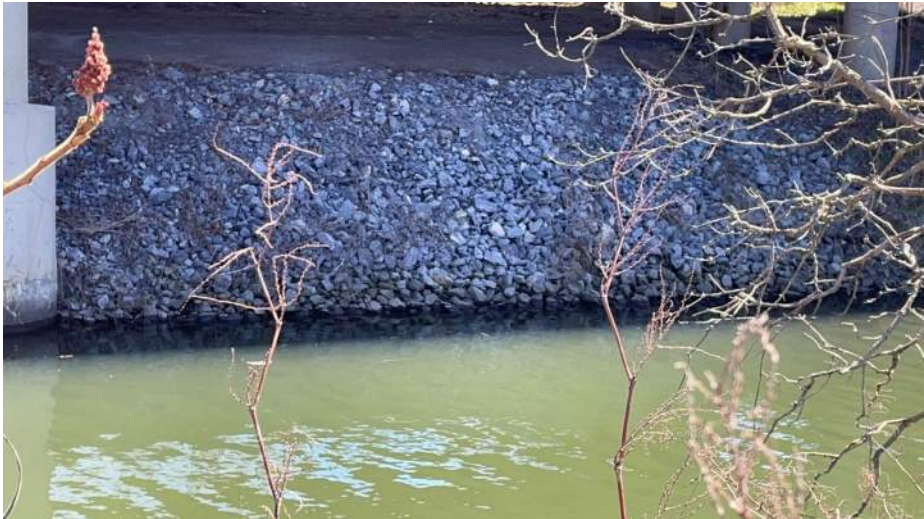
PHOTOGRAPH No: 03	DATE: April 22, 2024	LATITUDE: 42.9306861993883	LONGITUDE: -78.8951808417912
DIRECTION: West	SITE LOCATION: SCAJAQUADA CREEK SITE - BUFFALO, NEW YORK		
DESCRIPTION: 2020 Maintenance Area 2. Note visible geotextile to the left (north) of the 2020 Maintenance Area. The area north of the recently repaired area requires additional armoring stone.

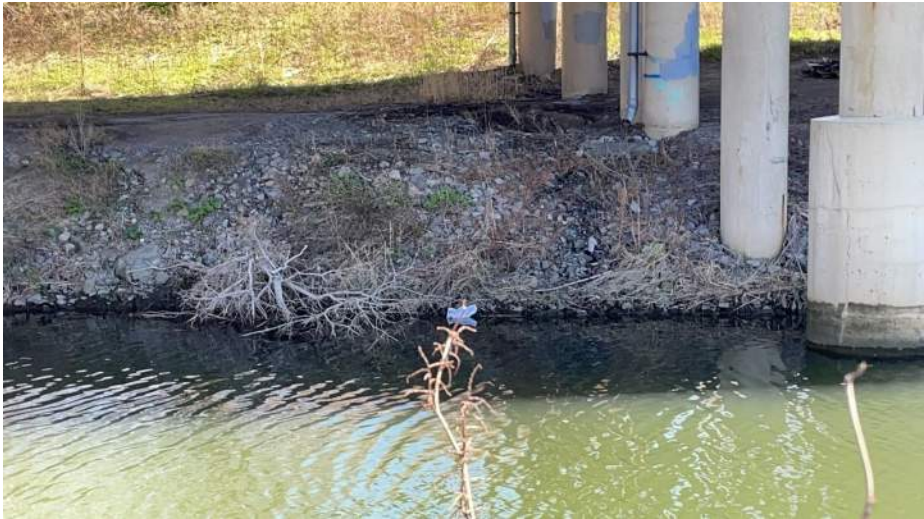
PHOTO BY: RICK FRAPPA, P.G.			
PHOTOGRAPH No: 04	DATE: April 22, 2024	LATITUDE: 42.9308448450195	LONGITUDE: -78.8948847452311
DIRECTION: North	SITE LOCATION: SCAJAQUADA CREEK SITE - BUFFALO, NEW YORK		
DESCRIPTION: Exposed geotextile along the shoreline of the west bank about 15ft in length. Area requires additional armor stone.

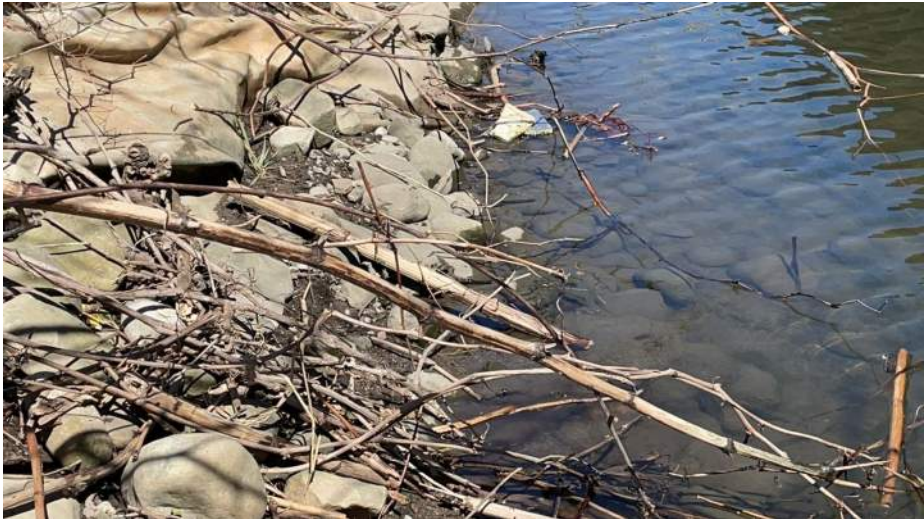
PHOTOGRAPH No: 05	DATE: April 22, 2024	LATITUDE: 42.9309044336563	LONGITUDE: -78.8948549153884
DIRECTION: West	SITE LOCATION: SCAJAQUADA CREEK SITE - BUFFALO, NEW YORK		
DESCRIPTION: Additional exposure of geotextile on western shoreline visible through the weeds.

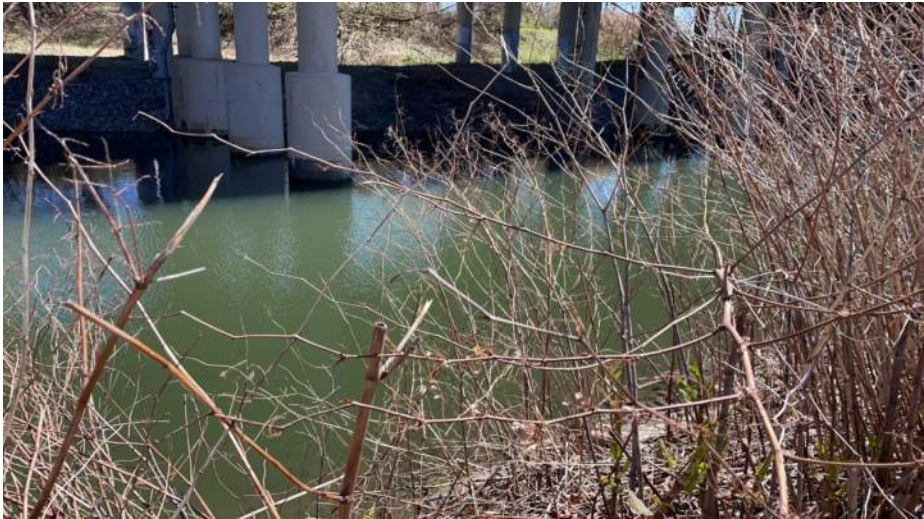
PHOTO BY: RICK FRAPPA, P.G.			
PHOTOGRAPH No: 06	DATE: April 22, 2024	LATITUDE: 42.9310030423532	LONGITUDE: -78.8946990990309
DIRECTION: Southwest	SITE LOCATION: SCAJAQUADA CREEK SITE - BUFFALO, NEW YORK		
DESCRIPTION: Exposed area of geotextile about 30 ft north of the prior area approximately 12 ft in length.

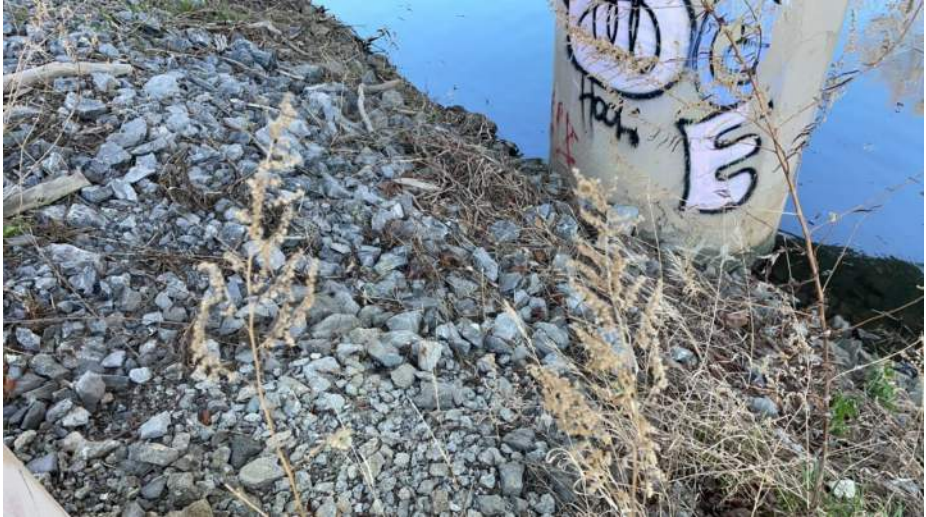
PHOTO BY: RICK FRAPPA, P.G.			
PHOTOGRAPH No: 08	DATE: April 22, 2024	LATITUDE: 42.9312210920381	LONGITUDE: -78.8937536910005
DIRECTION: Southeast	SITE LOCATION: SCAJAQUADA CREEK SITE - BUFFALO, NEW YORK		
DESCRIPTION: 2015 Maintenance Area 8. Portions of the geotextile are visible below the Expressway concrete splash pad. Additional armor stone is recommended.

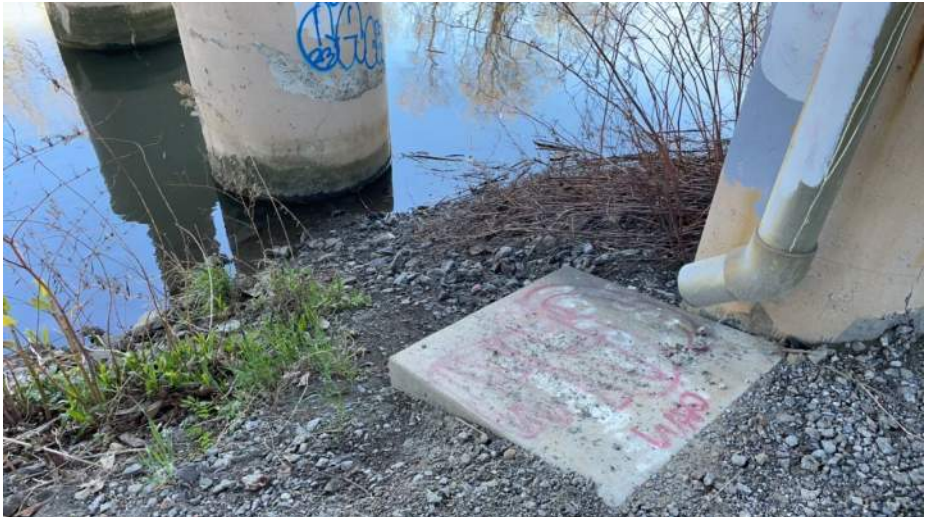
PHOTOGRAPH No: 09	DATE: April 22, 2024	LATITUDE: 42.9314242603717	LONGITUDE: -78.8937007491115
DIRECTION: Southwest	SITE LOCATION: SCAJAQUADA CREEK SITE - BUFFALO, NEW YORK		
DESCRIPTION: 2015 Maintenance Area 7 requires additional armor stone to cover visible geotextile.

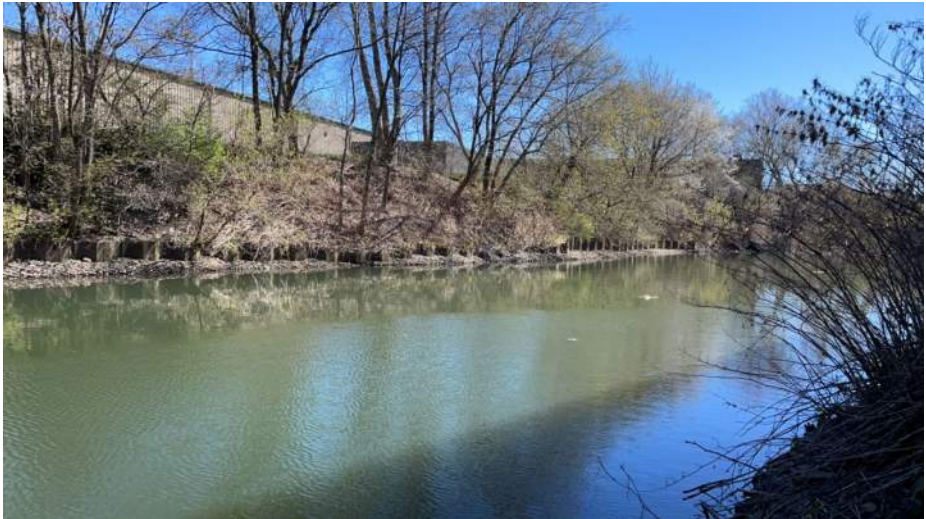
PHOTOGRAPH No: 11	DATE: April 22, 2024	LATITUDE: 42.9319082921896	LONGITUDE: -78.8933754266153
DIRECTION: East	SITE LOCATION: SCAJAQUADA CREEK SITE - BUFFALO, NEW YORK		
DESCRIPTION: 2020 Maintenance Area 4 requires additional stone prevent erosion into creek bank soil below downspout splash pad.

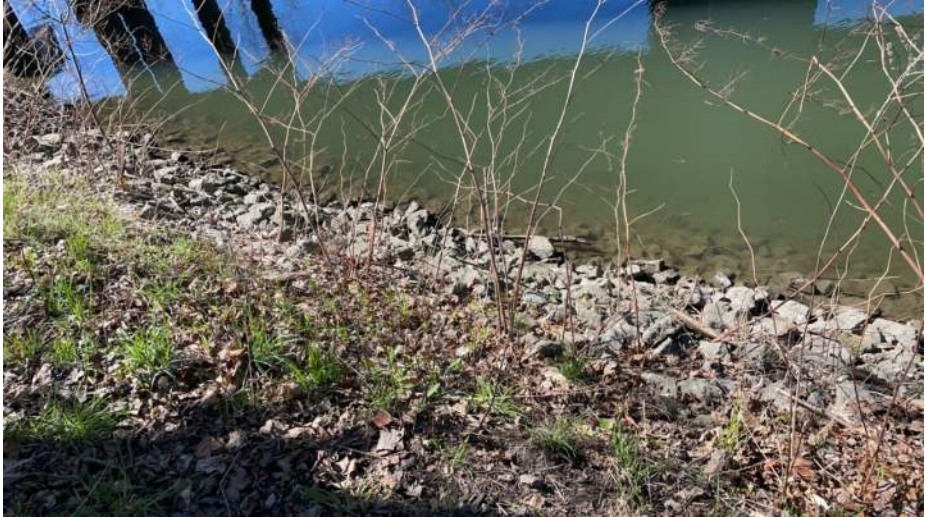
PHOTO BY: RICK FRAPPA, P.G.			
PHOTOGRAPH No: 16	DATE: April 22, 2024	LATITUDE: 42.9306309750423	LONGITUDE: -78.8945798075594
DIRECTION: South	SITE LOCATION: SCAJAQUADA CREEK SITE - BUFFALO, NEW YORK		
DESCRIPTION: Exposed geotextile in fore ground of photo on west bank 30 ft length a few feet north of 2020 Maintenance Area 2.

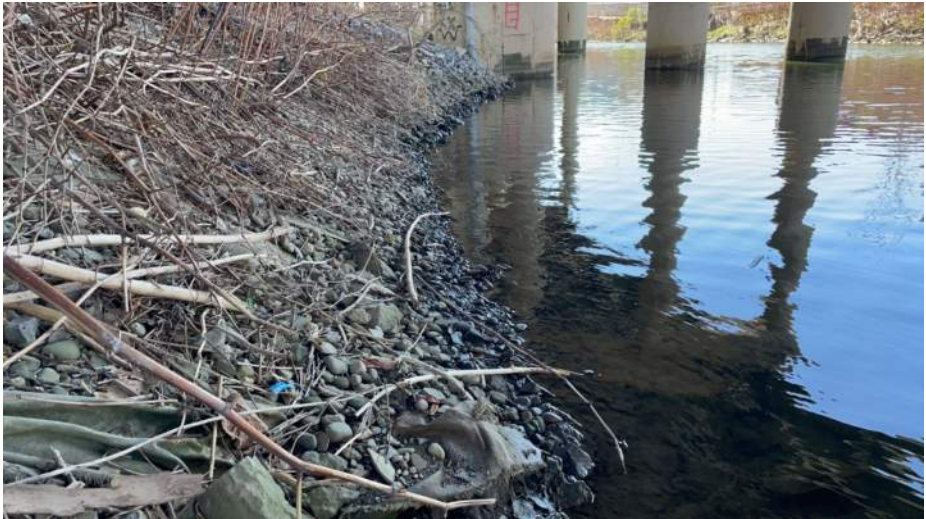
PHOTOGRAPH No: 17	DATE: April 22, 2024	LATITUDE: 42.9307807114997	LONGITUDE: -78.8946192388288
DIRECTION: West	SITE LOCATION: SCAJAQUADA CREEK SITE - BUFFALO, NEW YORK		
DESCRIPTION: View of west bank showing geotextile exposure from photographs 4 and 5.

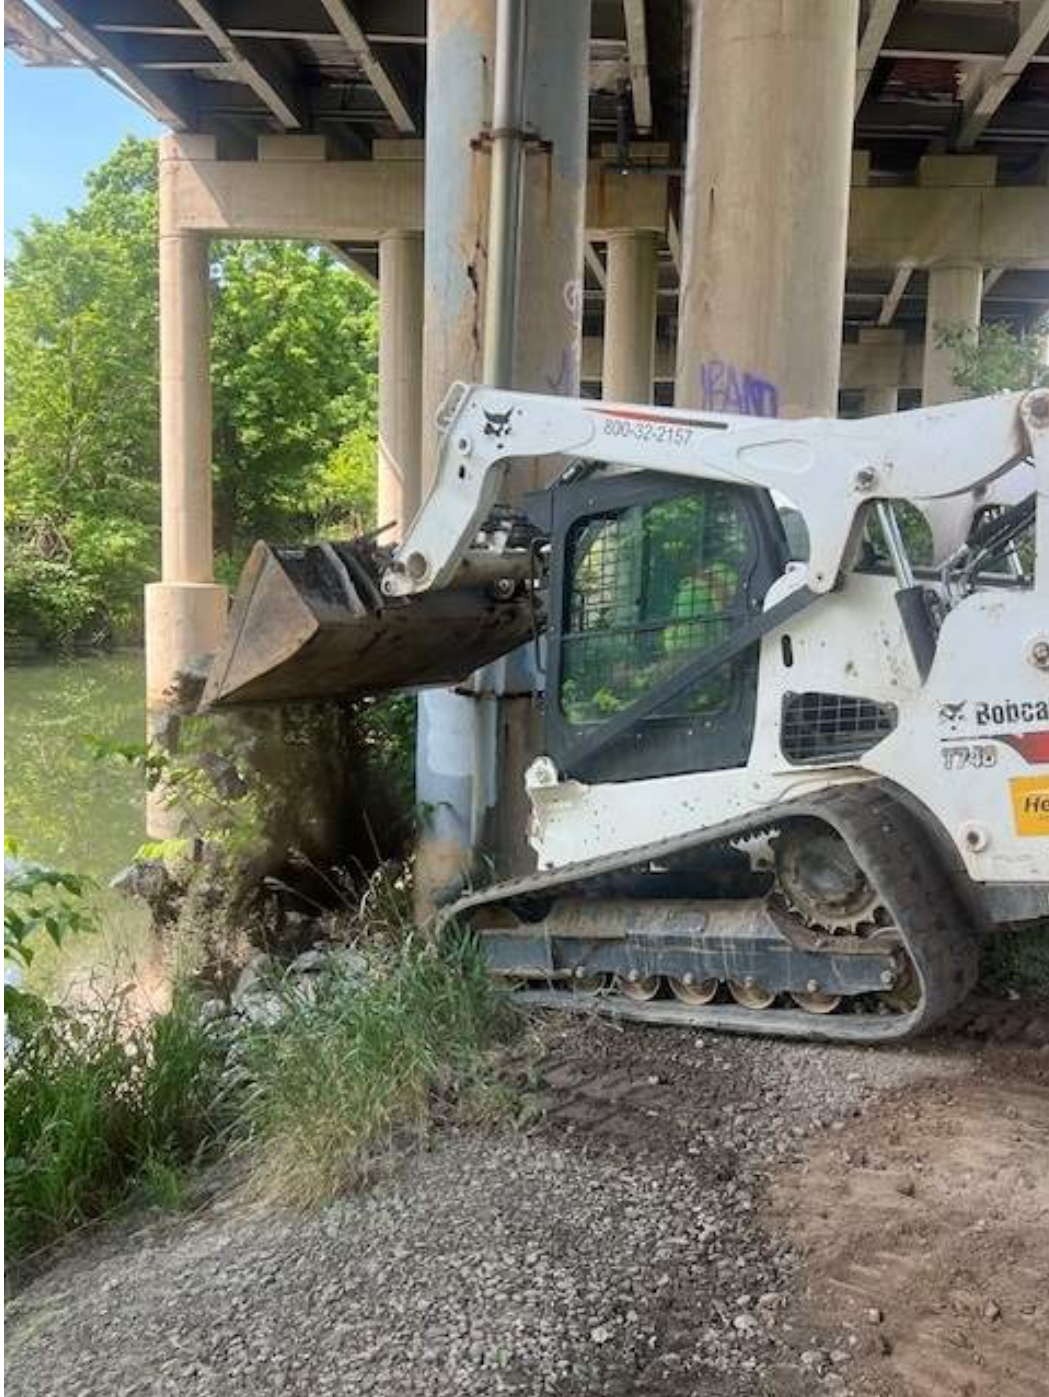
Photograph 2: Sun placing Light Stone Fill over Maintenance Area No. 7 (Looking south).

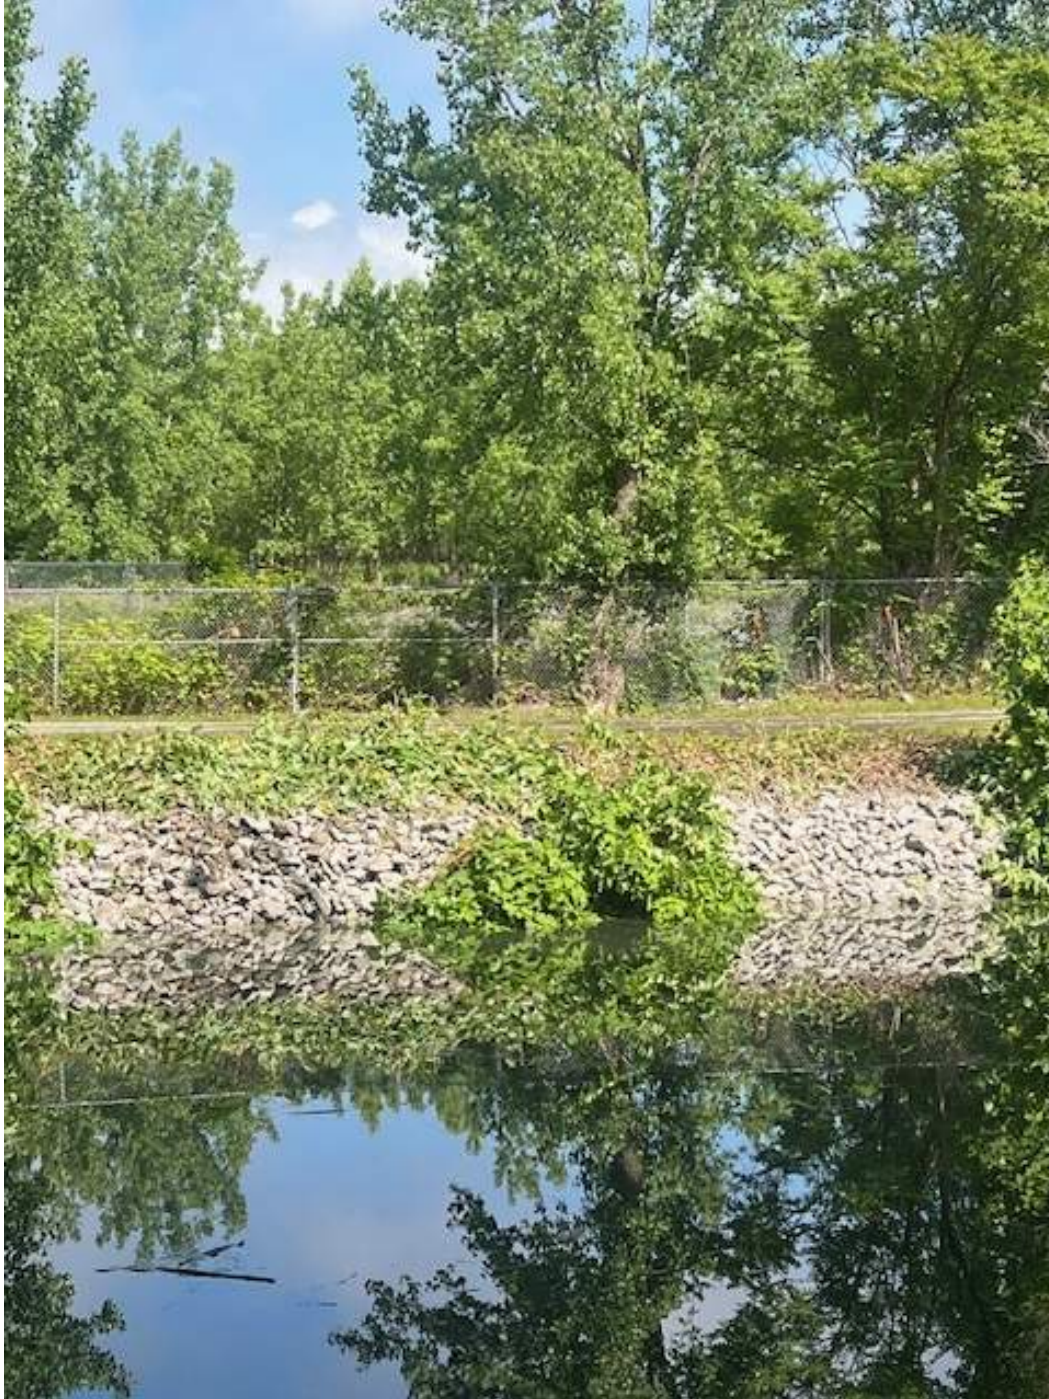
Photograph 3: Planned maintenance areas No. 3 and 4 completed (Looking northwest).

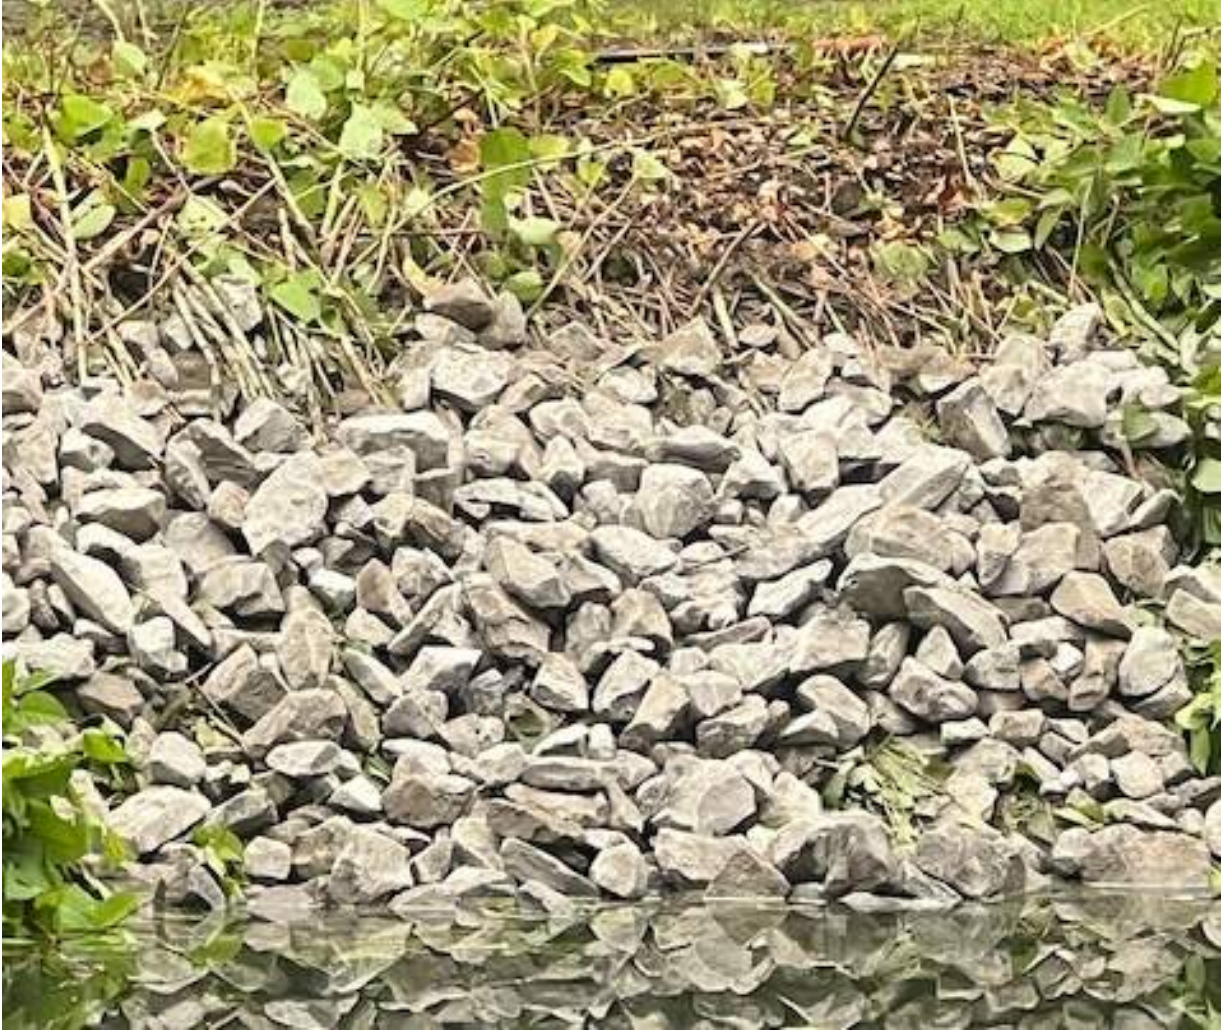
Photograph 4: Planned maintenance areas No. 5 completed (Looking northwest).

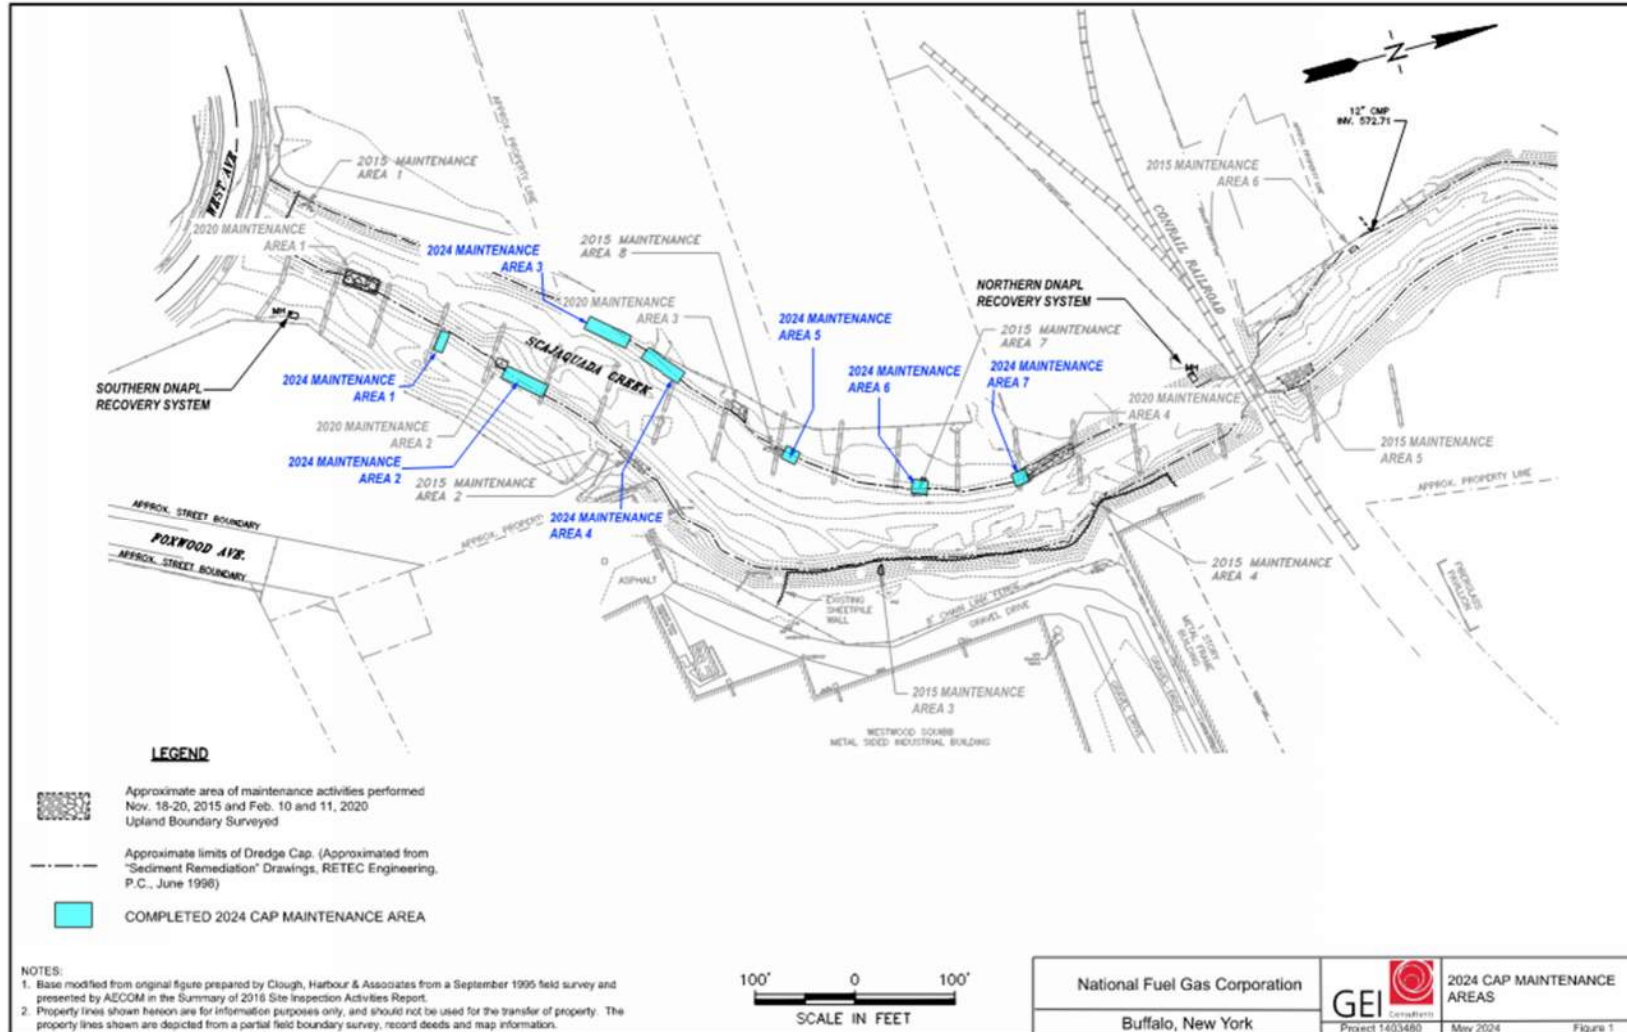
Figure 1: 2024 Maintenance Areas

- Sun placed Light Stone Fill (Item #620.03) material on the 2024 Cap Maintenance Areas identified during a 2024 site inspection (see Figure 1). The material was placed using a tracked skid steer machine (see Photographs 1 through 4). Approximately 40-tons of material was used to complete the Cap repairs.
