## **Site Management Periodic Review Report (2025) Site No. 915141B**

NFG - Iroquois Gas/Westwood Pharmaceutical Riparian Site,  
Buffalo, New York

January 2026

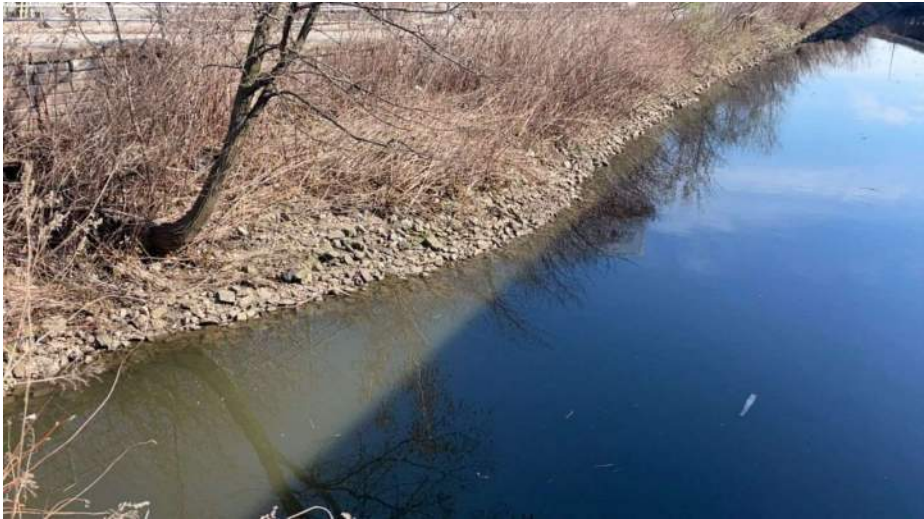
| <b>PHOTOGRAPH NO: 1</b> | <b>DATE:</b><br>April 24, 2025 | <b>LATITUDE:</b><br>42.93033263091523 | <b>LONGITUDE:</b><br>-78.89572056620851 |

| <b>DESCRIPTION:</b><br><br>Northwest bank | | | |

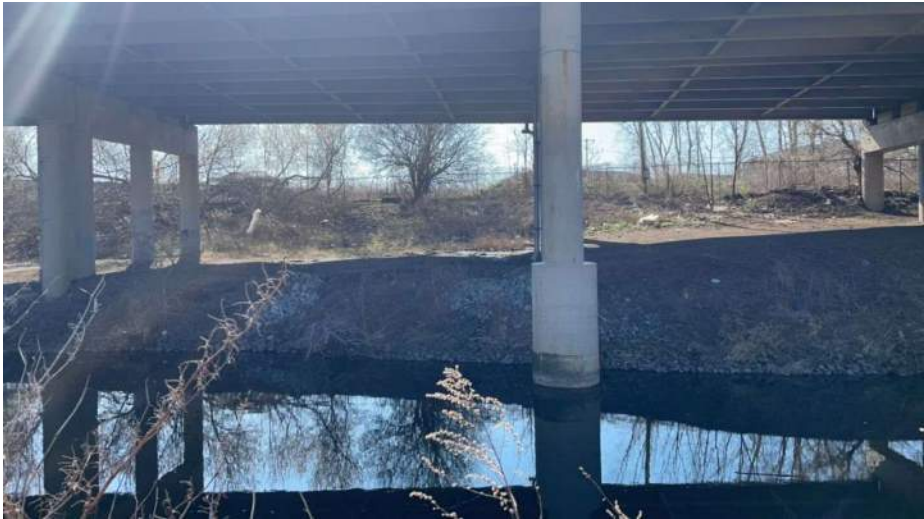
| <b>PHOTOGRAPH NO: 3</b> | <b>DATE:</b><br>April 24, 2025 | <b>LATITUDE:</b><br>42.93057436609936 | <b>LONGITUDE:</b><br>-78.89534171037705 |

| <b>DESCRIPTION:</b><br><br>East bank | | | |

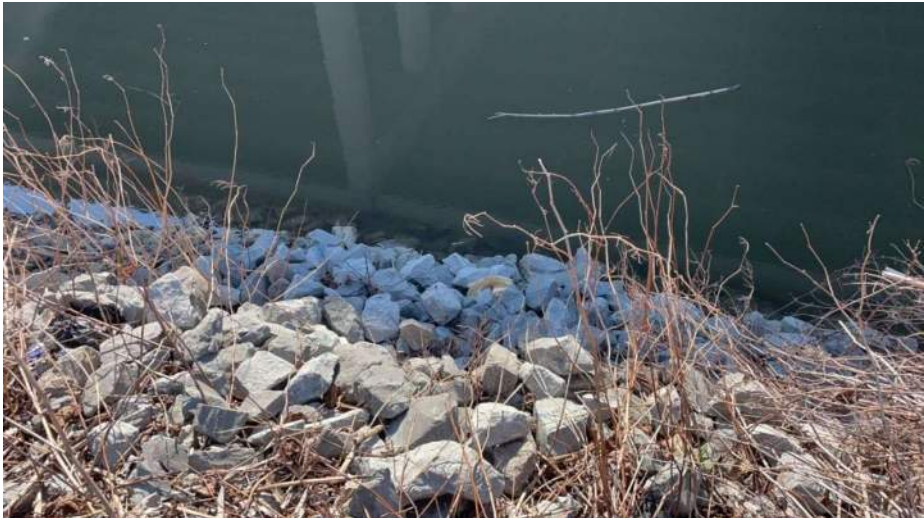
| <b>PHOTOGRAPH NO: 4</b> | <b>DATE:</b><br>April 24, 2025 | <b>LATITUDE:</b><br>42.93081425998168 | <b>LONGITUDE:</b><br>-78.89495964769989 |

| <b>DESCRIPTION:</b><br><br>West bang repair area 6 | | | |

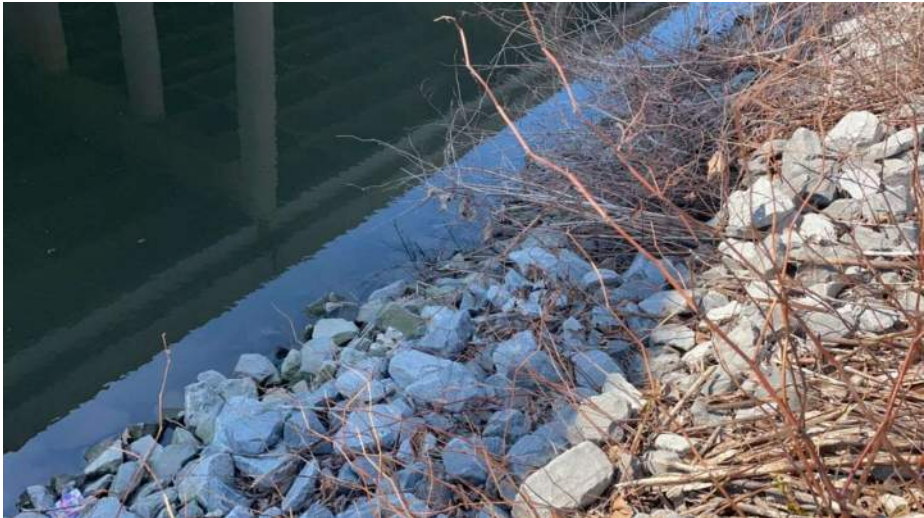
| <b>PHOTOGRAPH NO: 6</b> | <b>DATE:</b><br>April 24, 2025 | <b>LATITUDE:</b><br>42.93092261487518 | <b>LONGITUDE:</b><br>-78.89474755049012 |

| <b>DESCRIPTION:</b><br><br>West Bank repair 4 | | | |

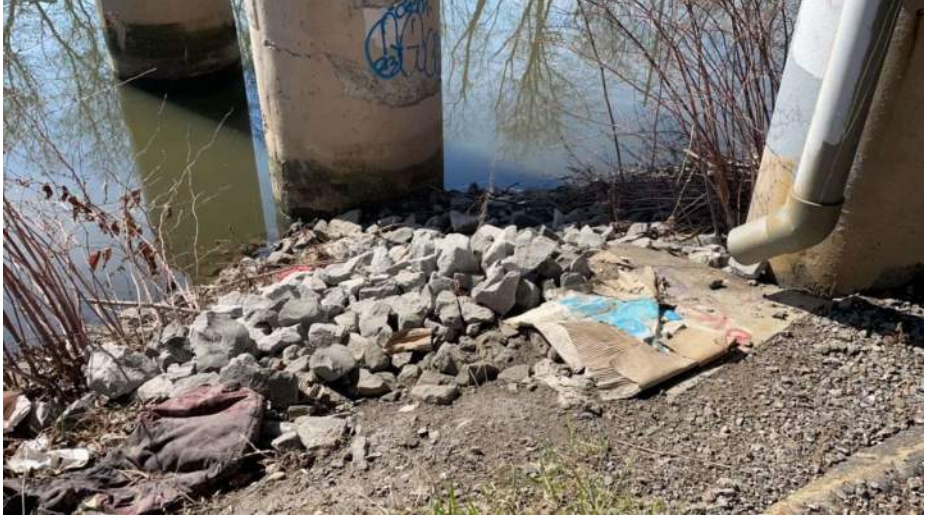
| <b>PHOTOGRAPH No: 9</b> | <b>DATE:</b><br>April 24, 2025 | <b>LATITUDE:</b><br>42.93135311194023 | <b>LONGITUDE:</b><br>-78.89432307011549 |

| <b>DESCRIPTION:</b><br><br>West Bank downspout | | | |

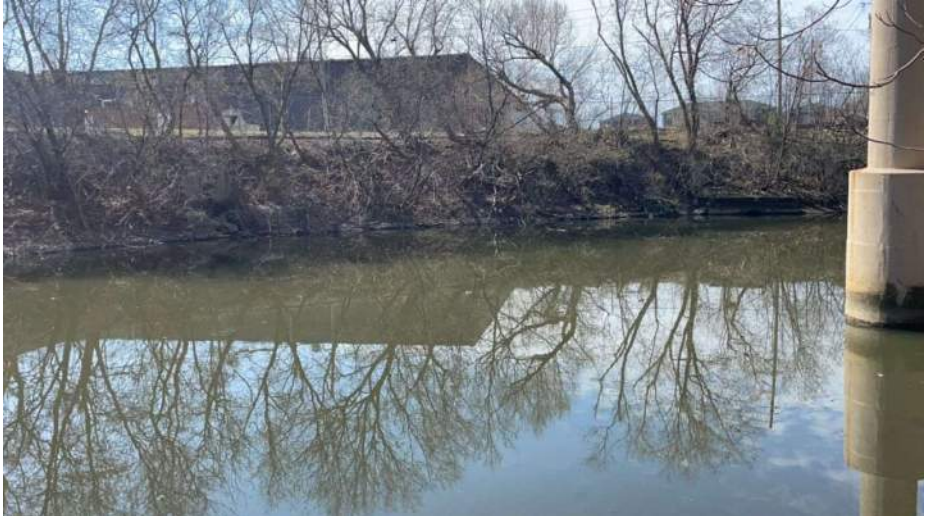
| <b>PHOTOGRAPH No: 10</b> | <b>DATE:</b><br>April 24, 2025 | <b>LATITUDE:</b><br>42.9313099024708 | <b>LONGITUDE:</b><br>-78.89395576671666 |

| <b>DESCRIPTION:</b><br><br>Outfalls | | | |

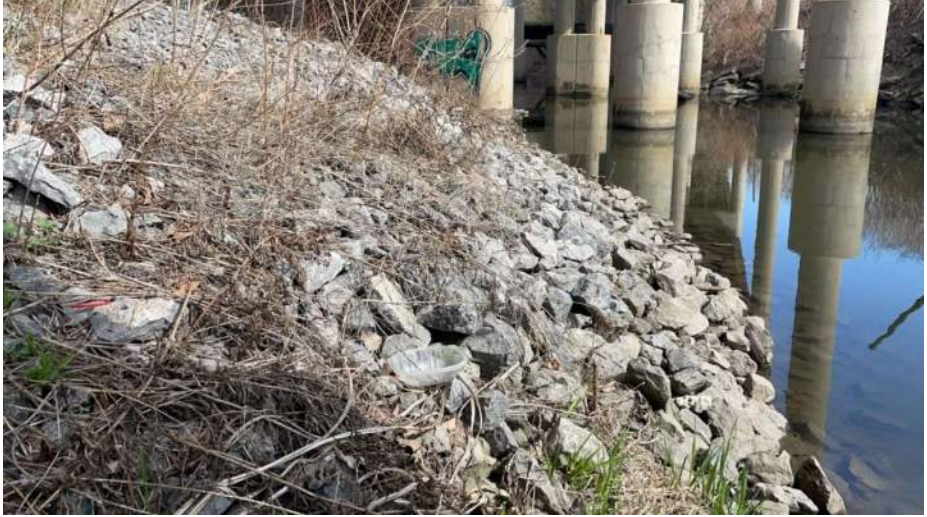
| <b>PHOTOGRAPH No: 13</b> | <b>DATE:</b><br>April 24, 2025 | <b>LATITUDE:</b><br>42.93182713734564 | <b>LONGITUDE:</b><br>-78.8931671571217 |

| <b>DESCRIPTION:</b><br><br>Repair area 2024 area 7 | | | |

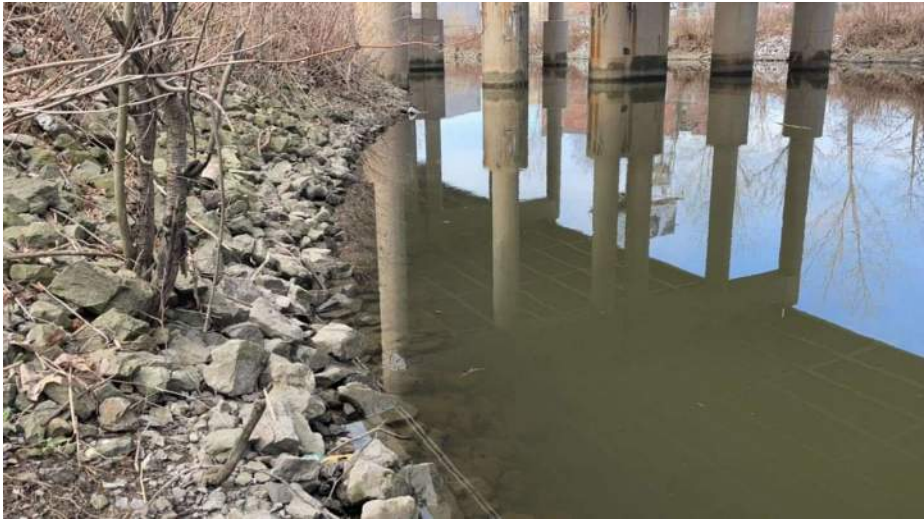
| <b>DESCRIPTION:</b><br><br>2015 Maintenance Area 2 | A photograph showing a creek with several concrete pillars or pilings in the water. The water is calm, reflecting the sky and the pillars. The left bank is rocky and has some bare trees and shrubs. The right bank is also visible, with more water and a distant shoreline. | | |

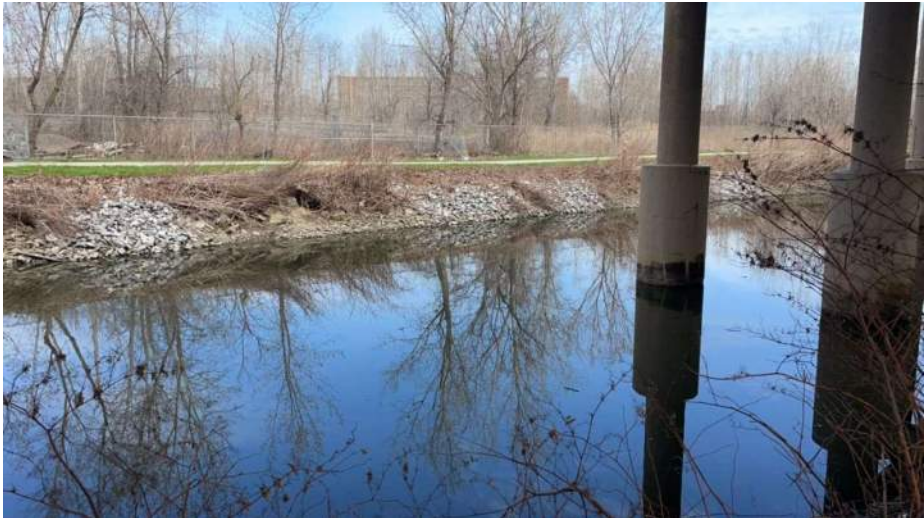
| <b>DESCRIPTION:</b><br><br>2024 Area 3 | A photograph showing a creek with several concrete pillars or pilings in the water. The water is calm, reflecting the sky and the pillars. The left bank is grassy and has some bare trees and shrubs. The right bank is also visible, with more water and a distant shoreline. | | |

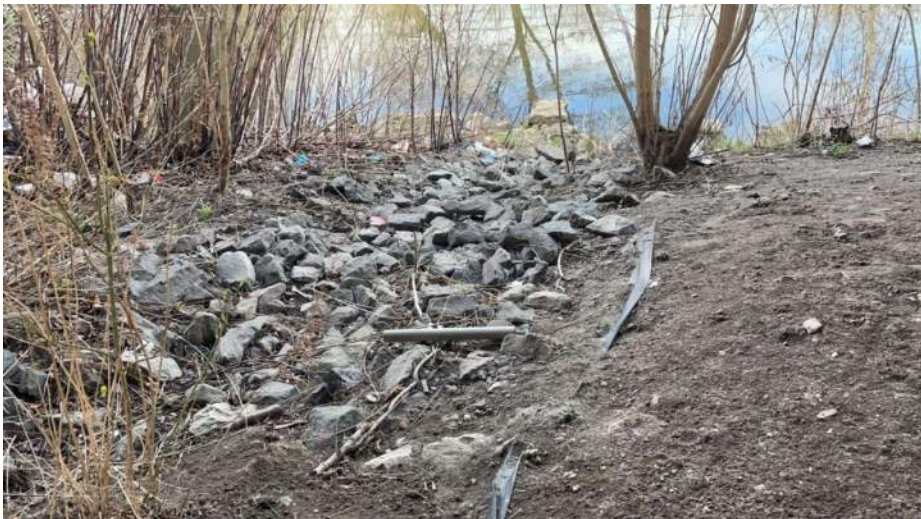
| <b>PHOTOGRAPH No: 21</b> | <b>DATE:</b><br>April 24, 2025 | <b>LATITUDE:</b><br>42.9302024302363 | <b>LONGITUDE:</b><br>-78.89556078681984 |

| <b>DESCRIPTION:</b><br><br>Downspout flow area<br>near bridge | | | |

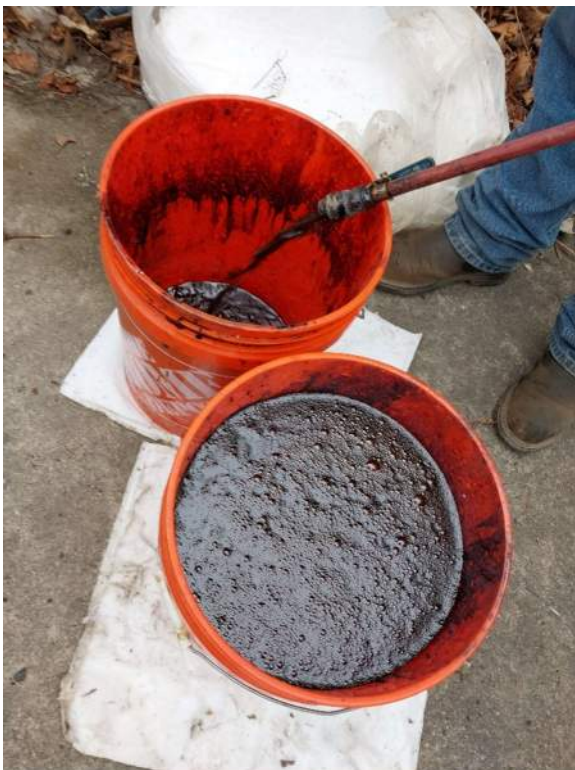
| <p>1015</p> | <p>Begin Enhanced Recovery pumping at the North Vault. Initial water quality is very silty black with 10-20% coal tar like material, strong coal tar like odor, separate NAPL phase.</p> <p>This water quality observations persist for approximately the first 15 gallons of discharge.</p> <p>Flow rate is 3.0 gpm.</p> | <p>Photograph 2: Initial discharge at North Vault</p> |

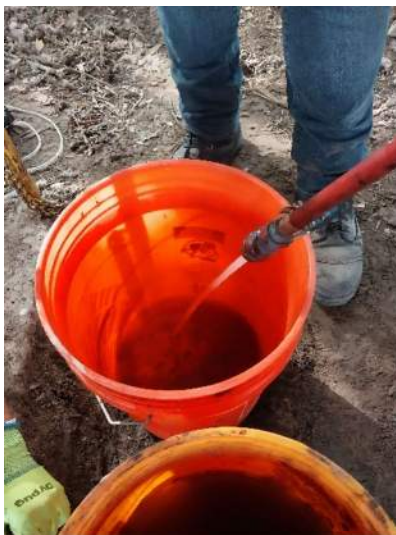
| Time | Notes | Photographs |
|---|---|---|
| 0830 AM<br><br>(beginning of high rate extraction) | <p>All personnel on Site-begin High Rate Extraction at 8:30 AM Peristaltic pump in the south vault malfunctioned in May 2025 and will be replaced. No measurements of water quantity in the tank were taken.</p> <p>Water quality is lightly silty brown with light H2S odor. No other odors or sheens noted.</p> <p>Initial flow rate is 3.0 gpm.</p> | <p>Photograph 1: Initial water quality in south vault.</p> |

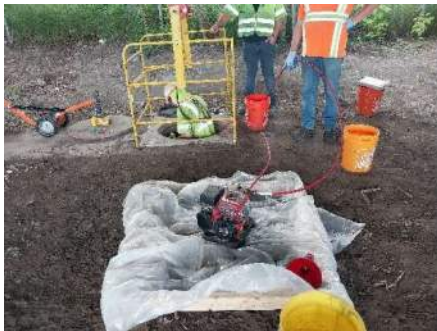
| 0840 | Discharge water is silty black with strong H <sub>2</sub> S odor. Flow rate is 2.5 gpm. No other odors or sheens noted. | <p>Photograph 2:<br/>Pumping at<br/>South Vault</p> |

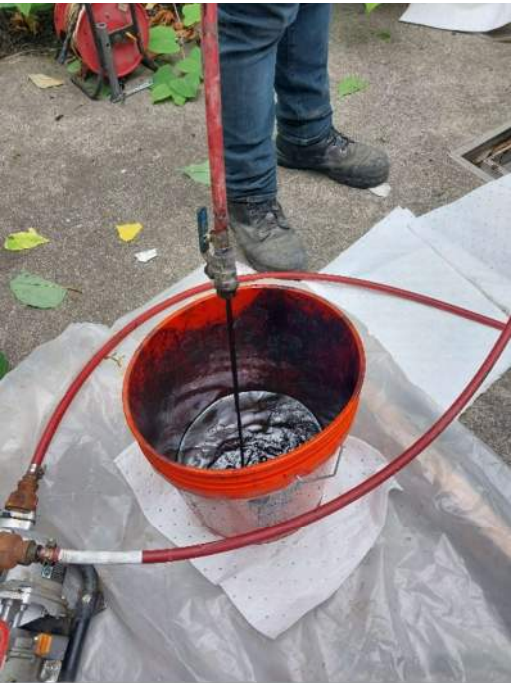
| <p>1005</p> | <p>Begin Enhanced Recovery pumping at the North Vault. Initial water quality is very silty black with 10-20% coal tar like material, strong coal tar like odor.</p> <p>This water quality observations persist for approximately the first 20 gallons of discharge.</p> <p>Flow rate is 3.5 gpm.</p> | <p>Photograph 2: Discharge at North Vault</p> |

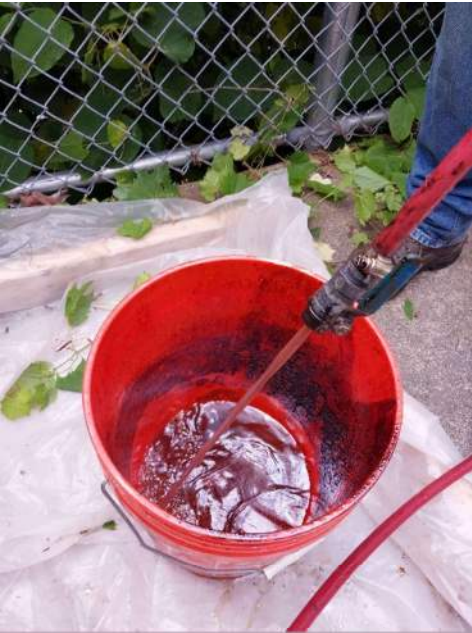
| <p>1020</p> | <p>Water quality becoming clear to slightly silty with moderate to strong sheen and moderate coal tar like odor.</p> <p>Flow rate is 3.5 gpm.</p> | <p>Photograph 3: Discharge at North Vault after 15 minutes of pumping.</p> |

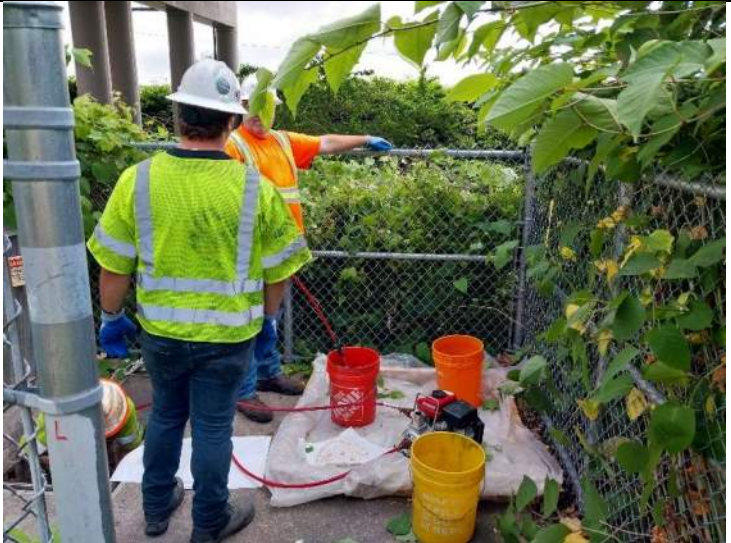
| 1040 | Discharge water quality is clear with slight sheen and coal tar like odor. | <p>Photograph 4: Pumping at North Vault.</p> |

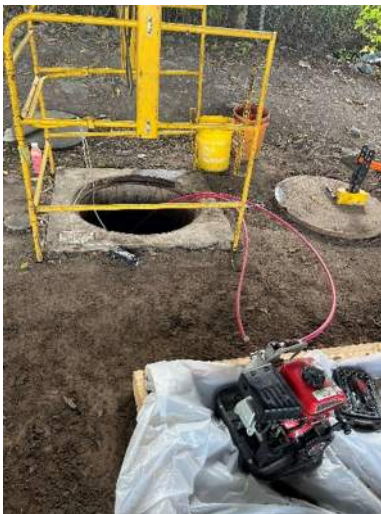
| Time | Notes | Photographs |
|---|---|---|
| 0835 | Discharge water is silty black with strong H <sub>2</sub> S odor. Flow rate is 2.75 gal/min. No other odors or sheens noted. | <p>Photograph 1: Pumping at South Vault</p> |

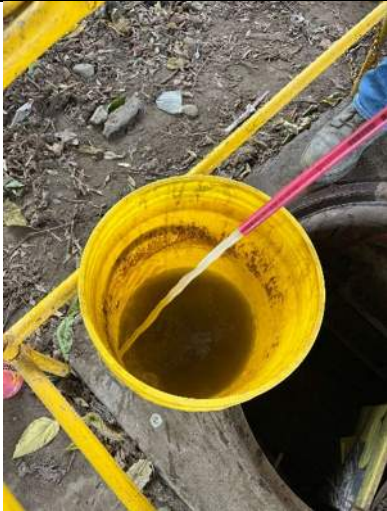
| 0900 | <p>Discharge water is clear with a strong H<sub>2</sub>S odor. Flow rate is 2.5 gal/min.</p> | <p>Photograph 2: Discharge at South Vault.</p> |

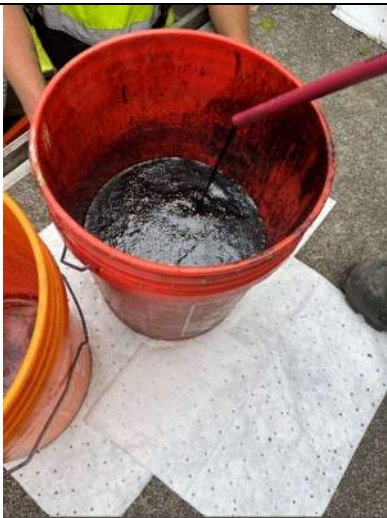
| 1005 | <p>Begin Enhanced Recovery pumping at the North Vault. Initial water quality is very silty black with 20% separate phase coal tar like material, strong coal tar like odor, heavy staining for the first 10-15 gallons. Initial depth to water is 7.0 feet.</p> | <p>Photograph 3: Initial water quality at North Vault</p> |

| 1010 | Test stopped due to low/no flow. This was discovered to be the result of tubing that was poorly sealed. | |

| 1015 | Tubing resealed and Enhanced Recovery pumping restarted at the North Vault. | |

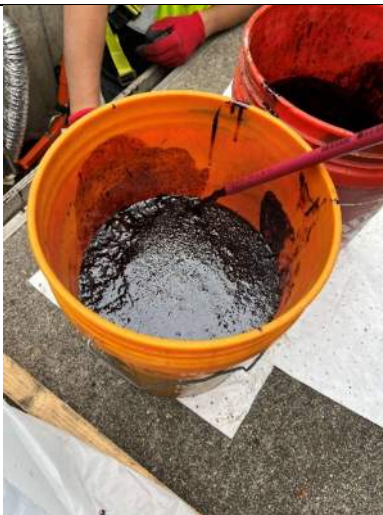
| 1020 | Discharge water is very silty black with 25% separate phase coal tar like material, strong coal tar like odor, heavy NAPL sheen. Flow rate is 2.5 gal/min. | <p>Photograph 4: Discharge at North Vault</p> |

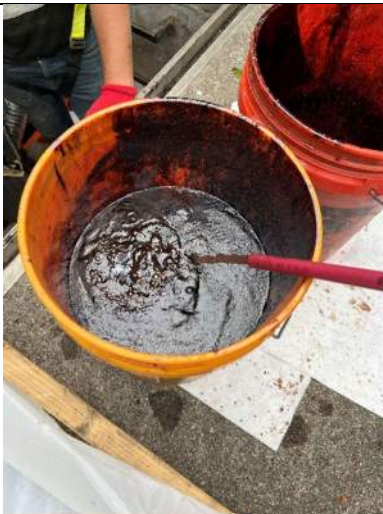
| 1025 | Discharge water is medium brown, lightly silty with <10% coal tar like material, strong coal tar like odor, heavy NAPL sheen. | <p>Photograph 5: Discharge at North Vault after 10 minutes of pumping.</p> |

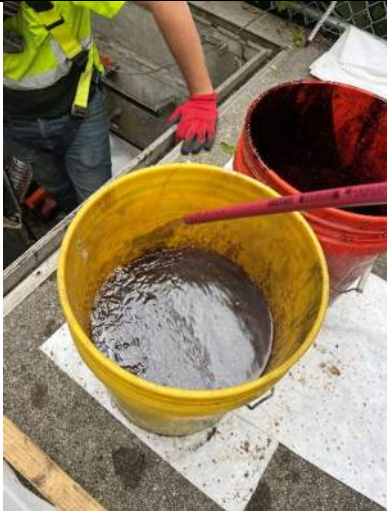
| 1030 | Discharge water is lightly silty with 1% coal tar like material, strong coal tar like odor, heavy NAPL sheen. Flow rate is 2.5 gal/min. | <p>Photograph 6: Discharge at North Vault after 15 minutes of pumping</p> |

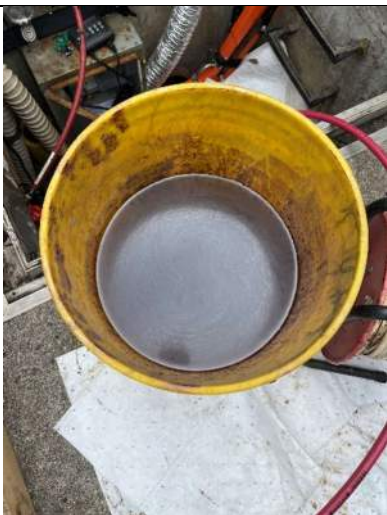
| 1045 | Discharge water is clear, heavy NAPL sheen. Flow rate is 2.75 gal/min. | <p>Photograph 7: Discharge water at North Vault after 30 minutes of pumping</p> |

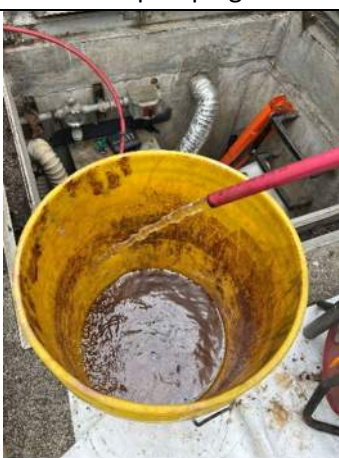
| 1115 | <p>Enhanced Recovery pumping complete at North Vault. Final water quality is clear with slight sheen and coal tar like odor. Flow rate is 2.75 gal/min. Final depth to water is 6.53 feet.</p> <p>Approximately 165 gallons pumped into north vault storage tank.</p> | <p>Photograph 8: Final water quality at North Vault</p> |
