NYSDEC

Division of Environmental Remediation

Site: Osmose Wood Preserving

Site No.: 915143

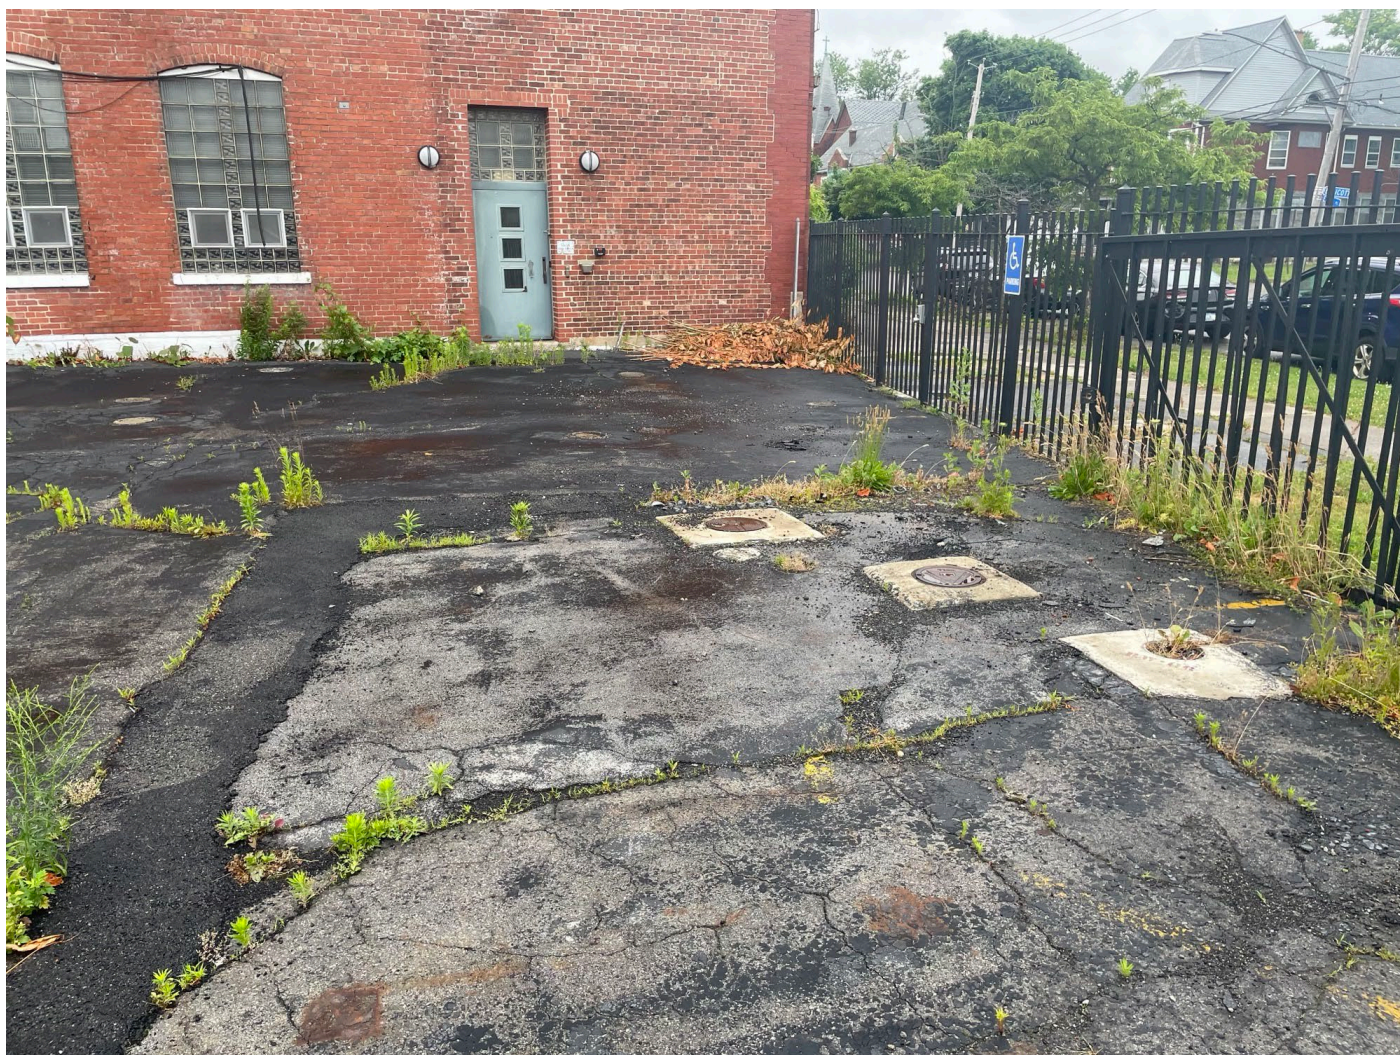
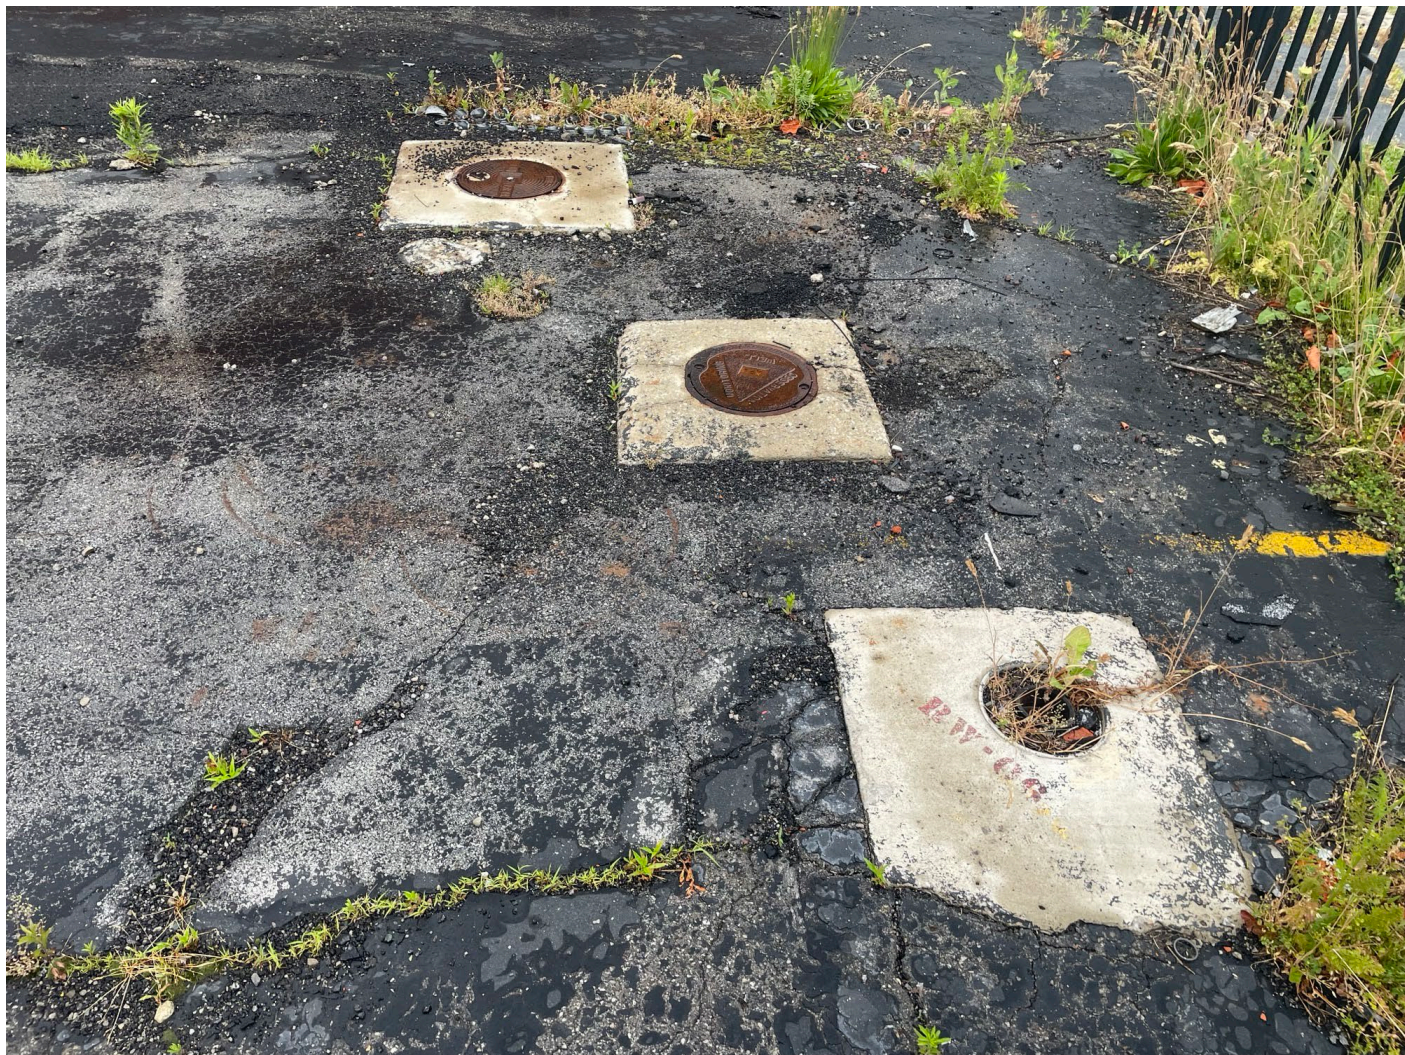
3 well cluster onsite RW-1 is furthest away, followed by MW-5 and then the exposed well labeled "RW-06" that needs to be decommissioned.

Same as above.

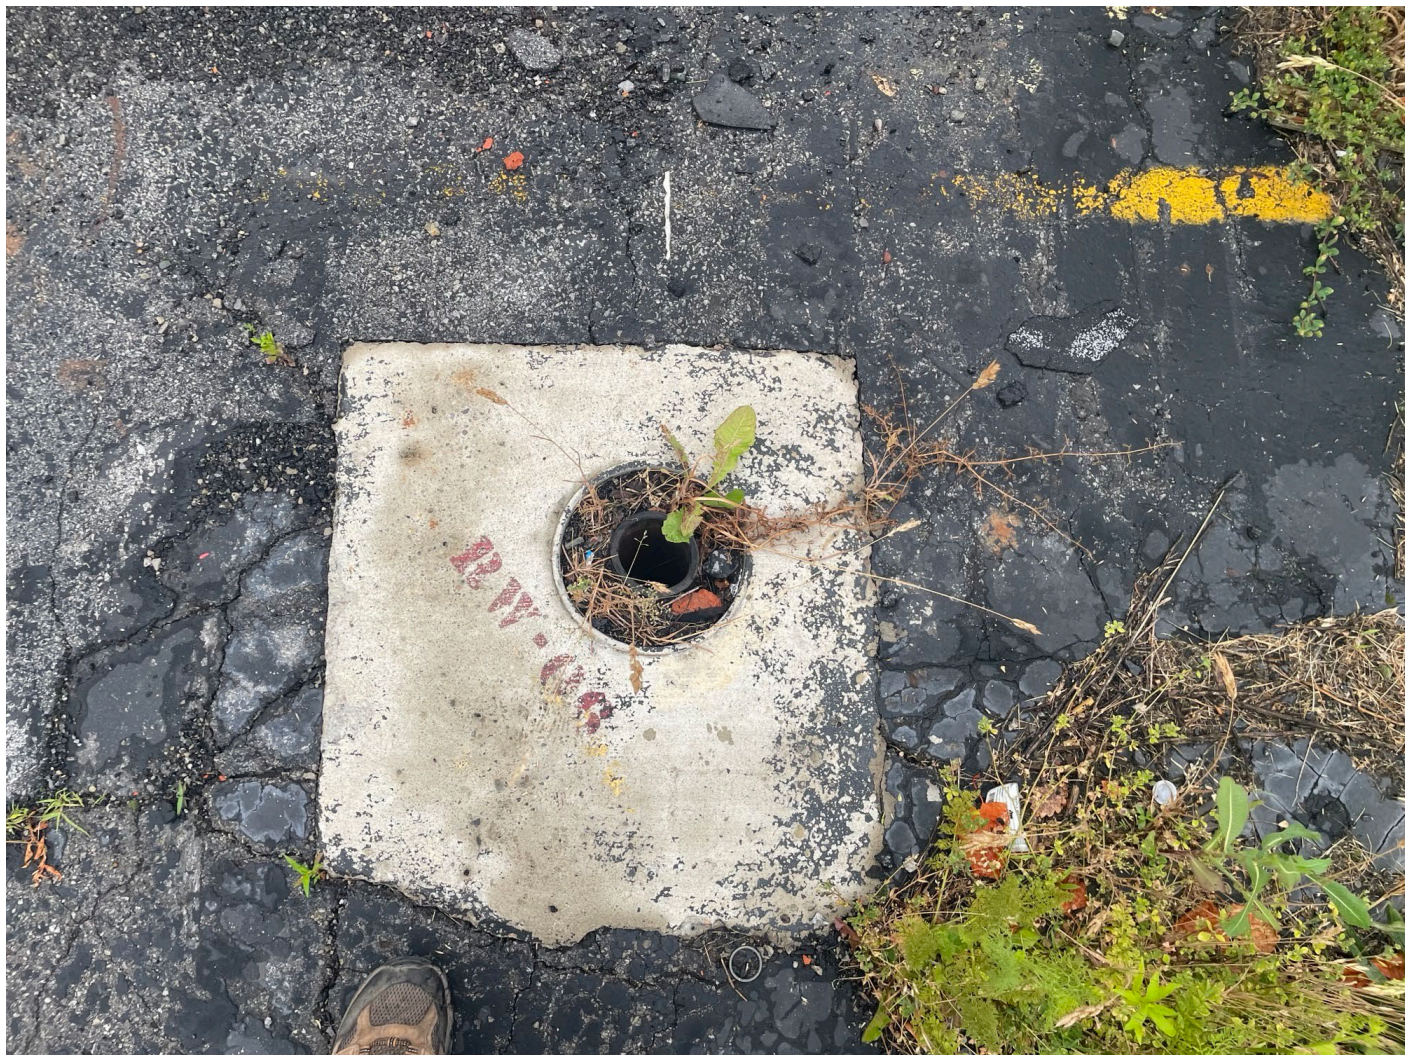
Aerial view of previously unknown well labeled "RW-06" with no cover and vegetation growing out of the side.

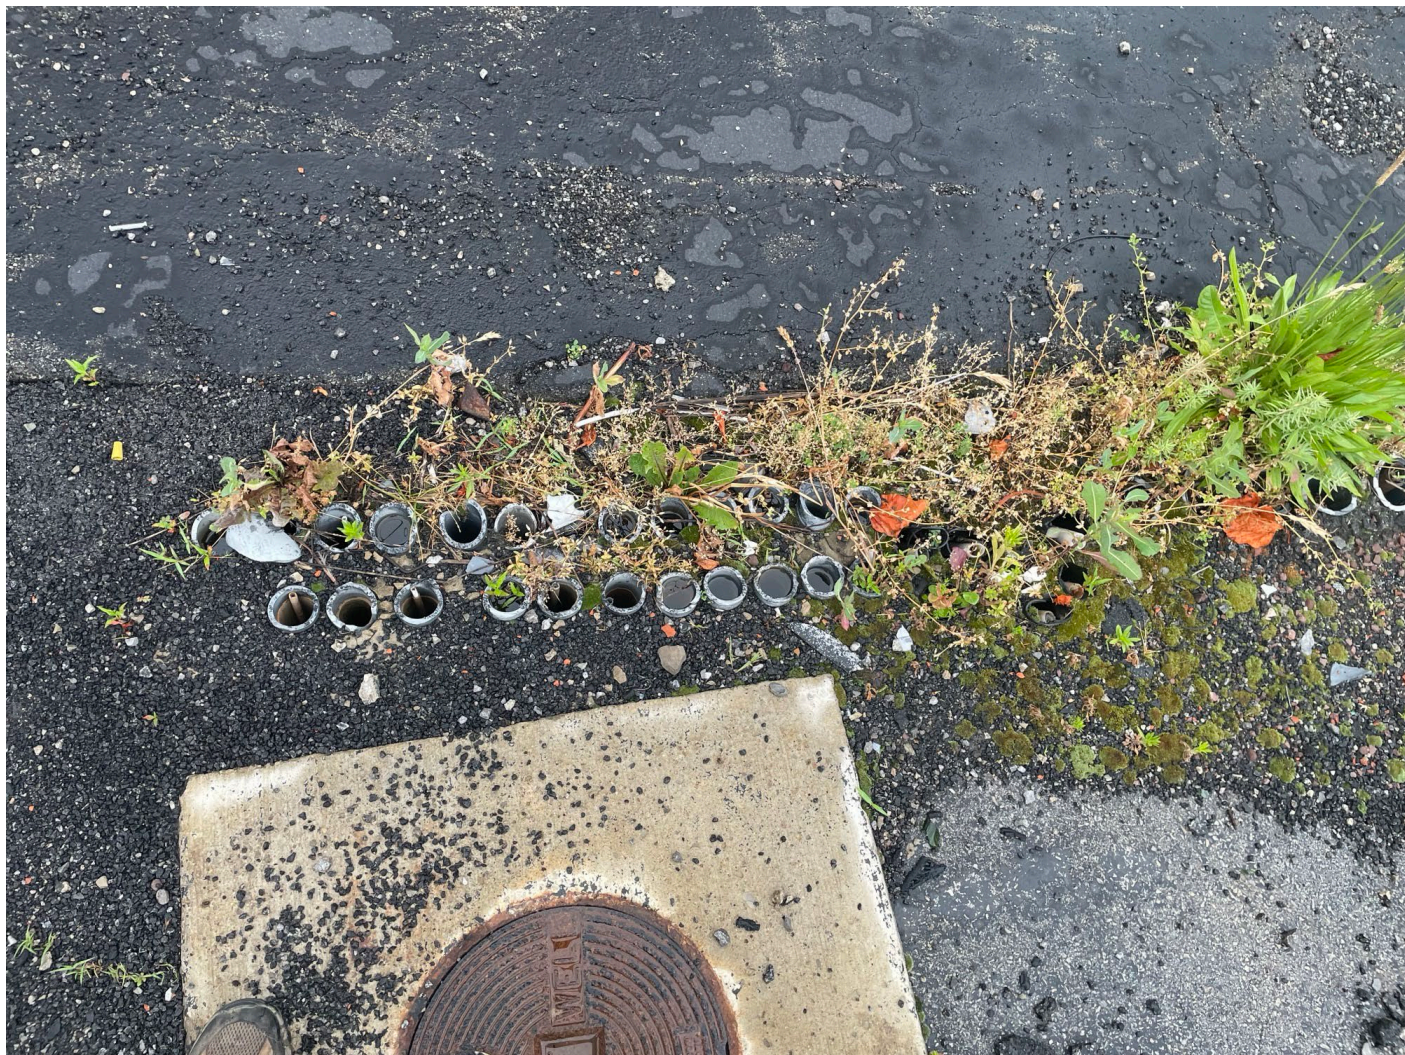
- NYSDEC onsite 7:30 am to 8:00 am with Inventum for site inspection. Monitoring well gauging and sampling took place the previous week per Inventum.
- Site cover in fair condition, one small hole in the asphalt was observed.
- Monitoring well proposed for decommissioning in last periodic review report was misidentified per Inventum. Another 2 inch well, previously unidentified, was observed to be filled with grit and debris. A well next to RW-1 and MW-5, painted RW-06 was exposed and uncovered and not in the gauging or sampling program per Inventum. This is also a candidate for decommissioning and will be assessed. All other wells in fair to good condition.
- Possible soil vapor extraction wells remaining onsite. Their remaining purpose needs to be reassessed.

Possible soil vapor extraction wells to be decommissioned.

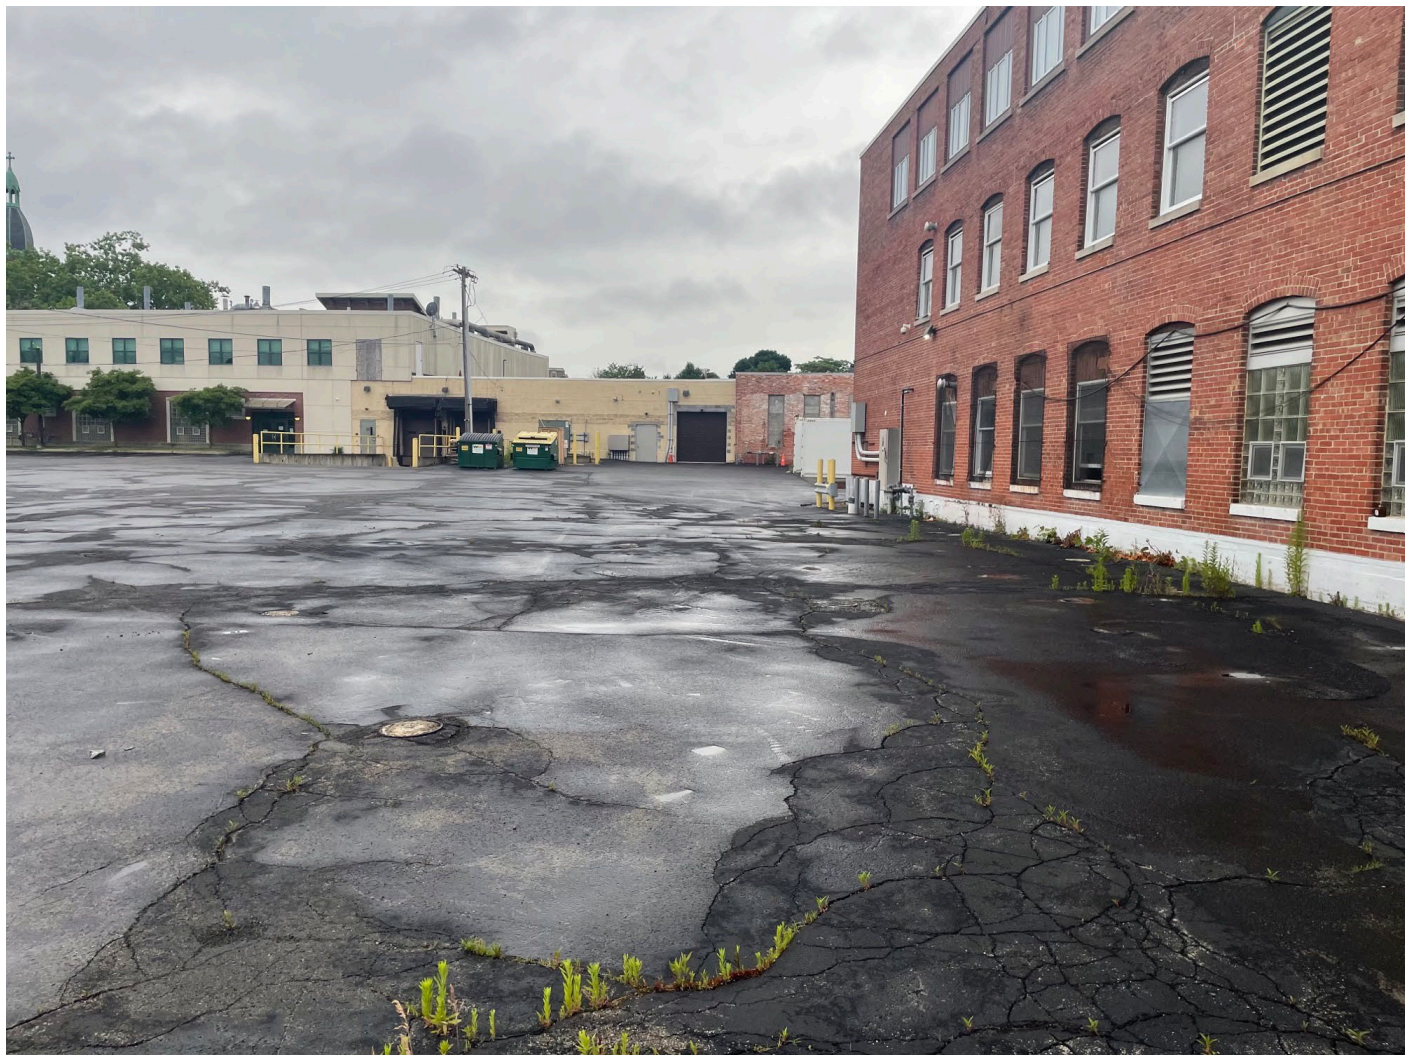
Asphalt cover conditions.

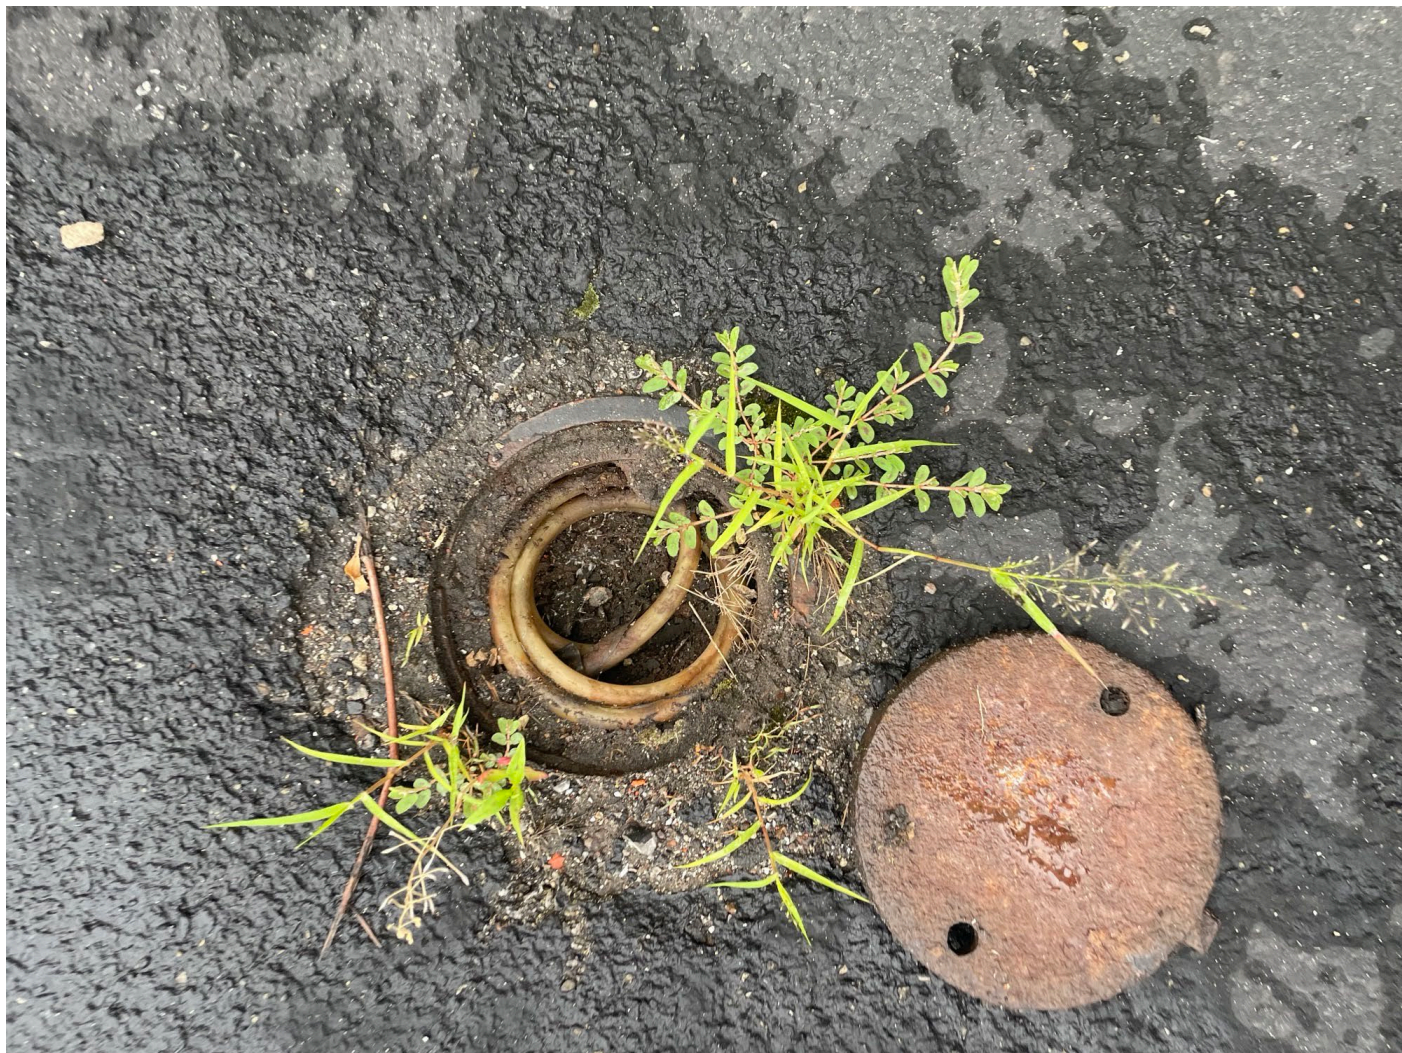
Previously misidentified well suggested for decommissioning in 2025 PRR. Appears to be completely blocked with debris and is not in the gauging or sampling program.

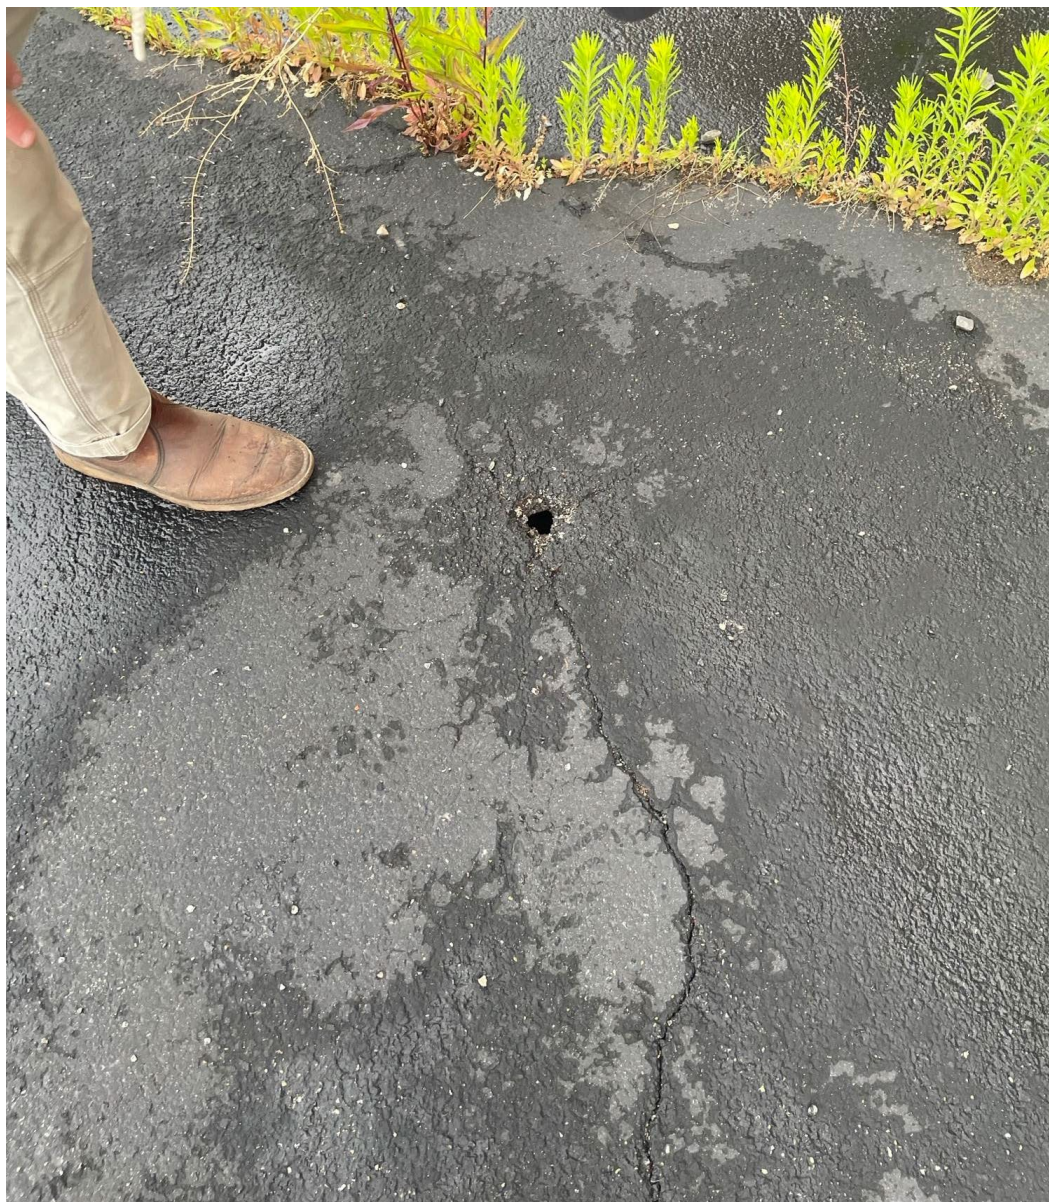
Small hole in asphalt near previously misidentified well.

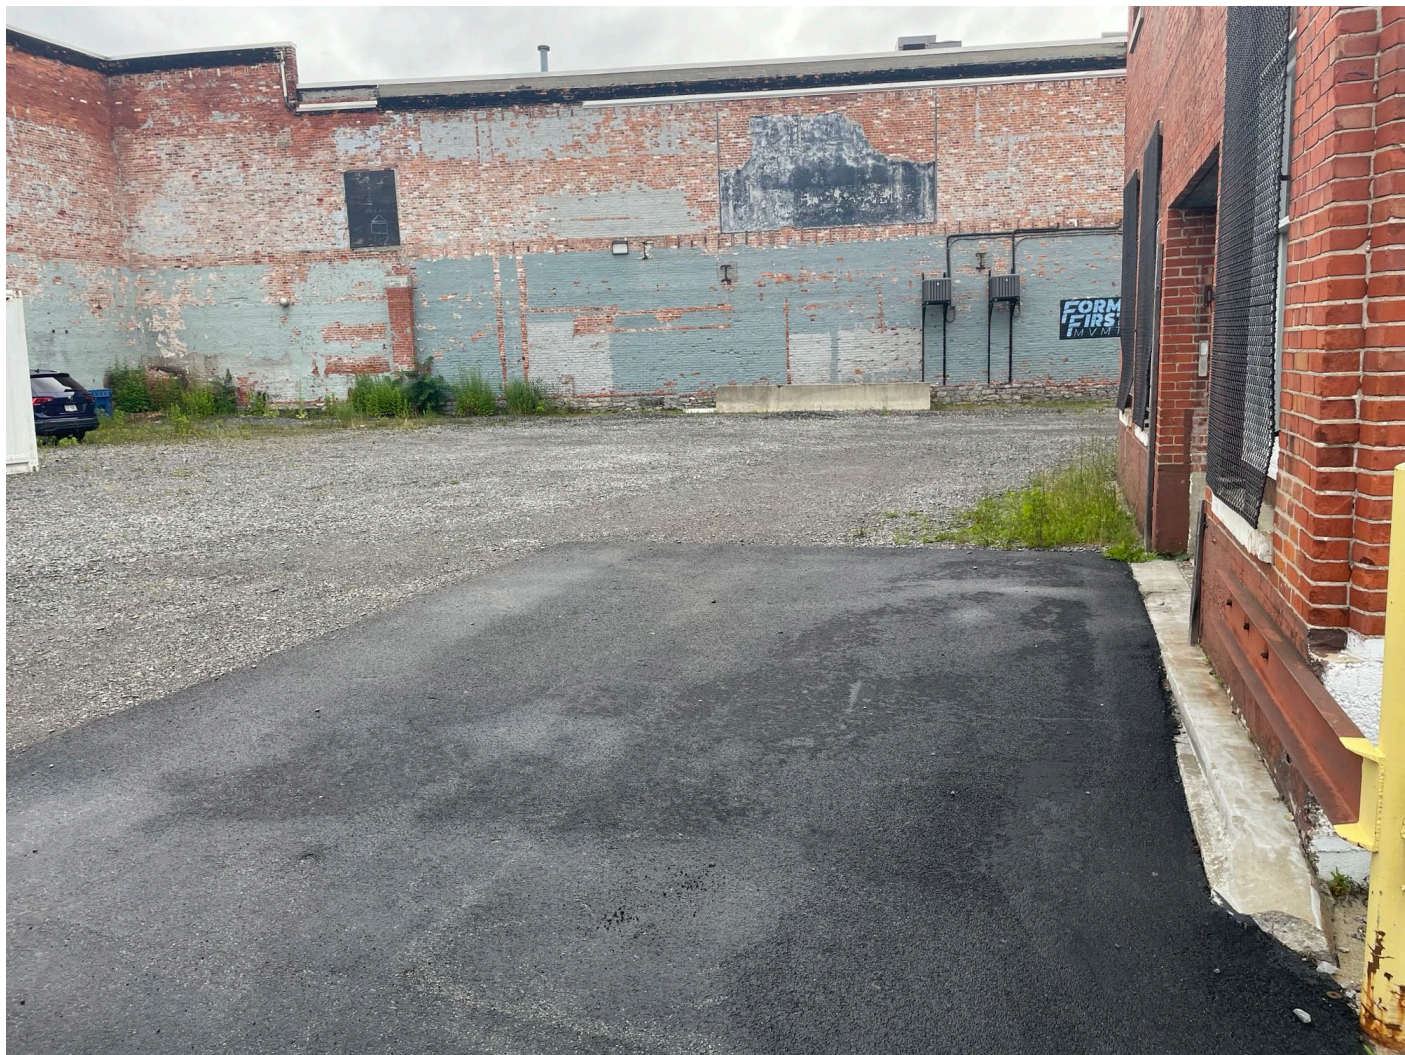
Asphalt cover condition.

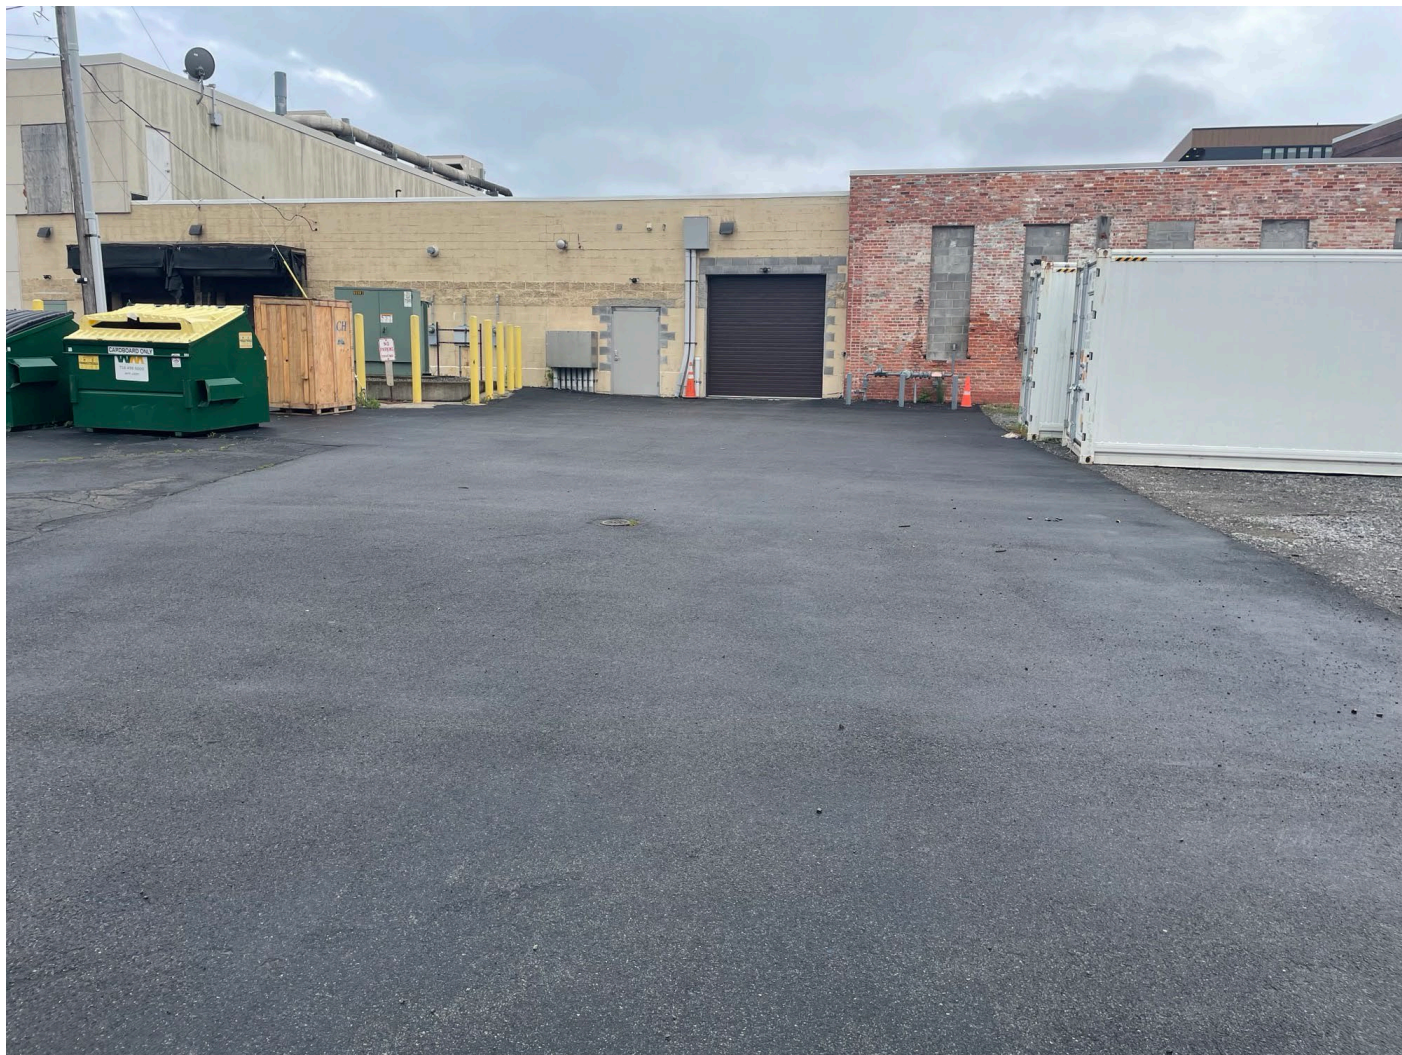
Asphalt cover conditions.

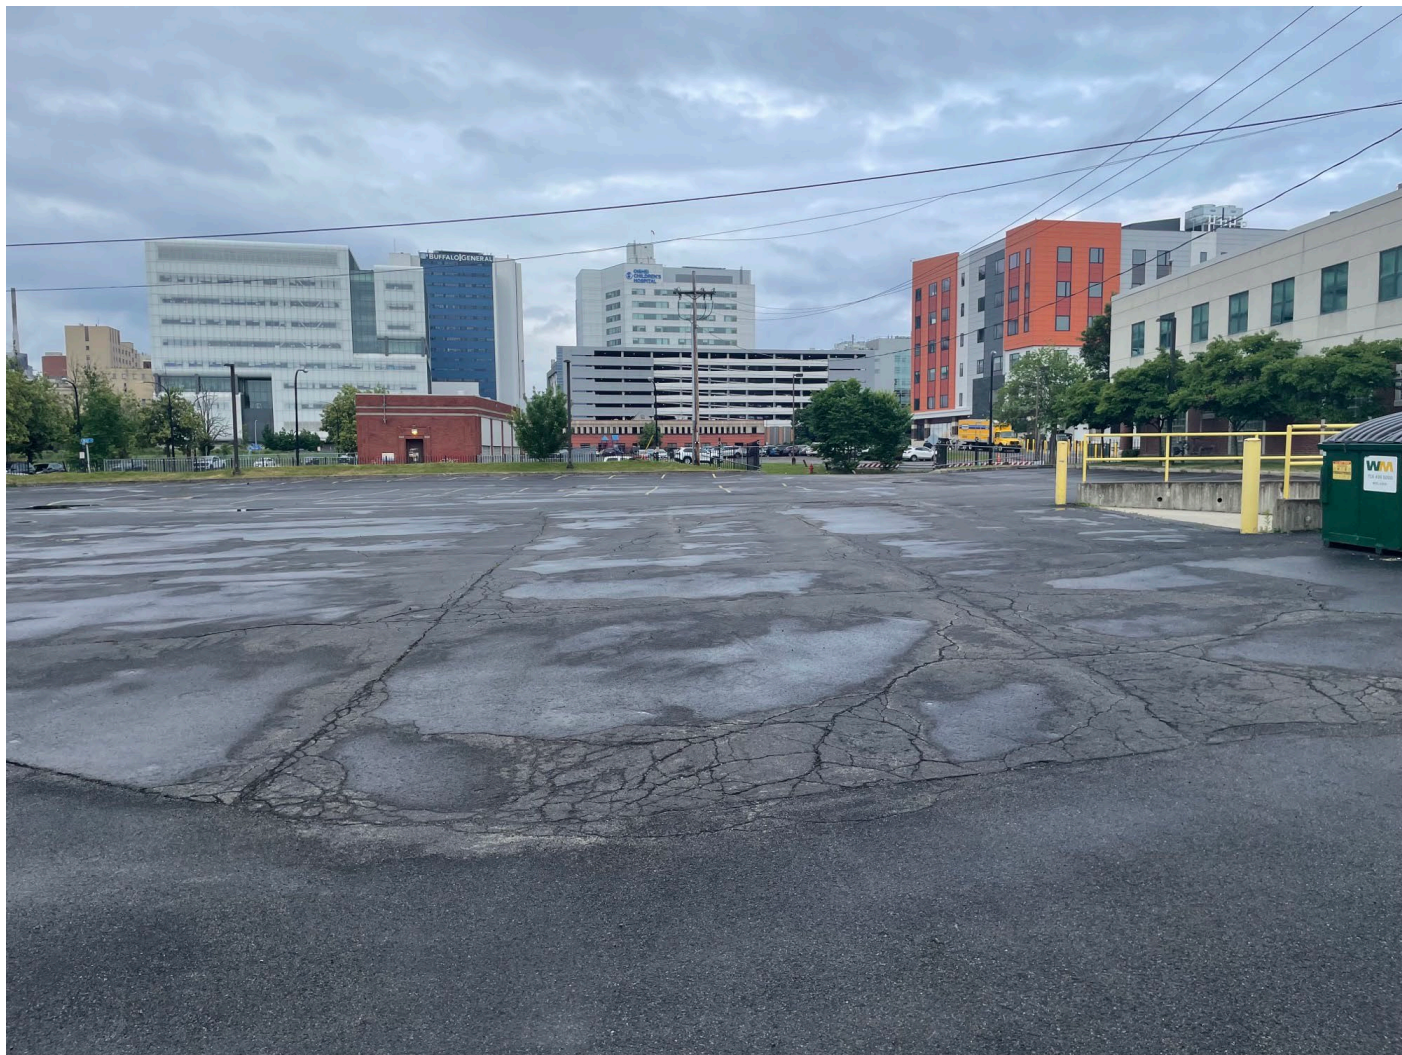
Asphalt cover conditions.
