NYSDEC SITE NUMBER: 9-15-151
FORMER GE APPARATUS SERVICE CENTER
318 URBAN STREET
BUFFALO, NEW YORK

FINAL CONSTRUCTION CERTIFICATION REPORT

MAY 2012

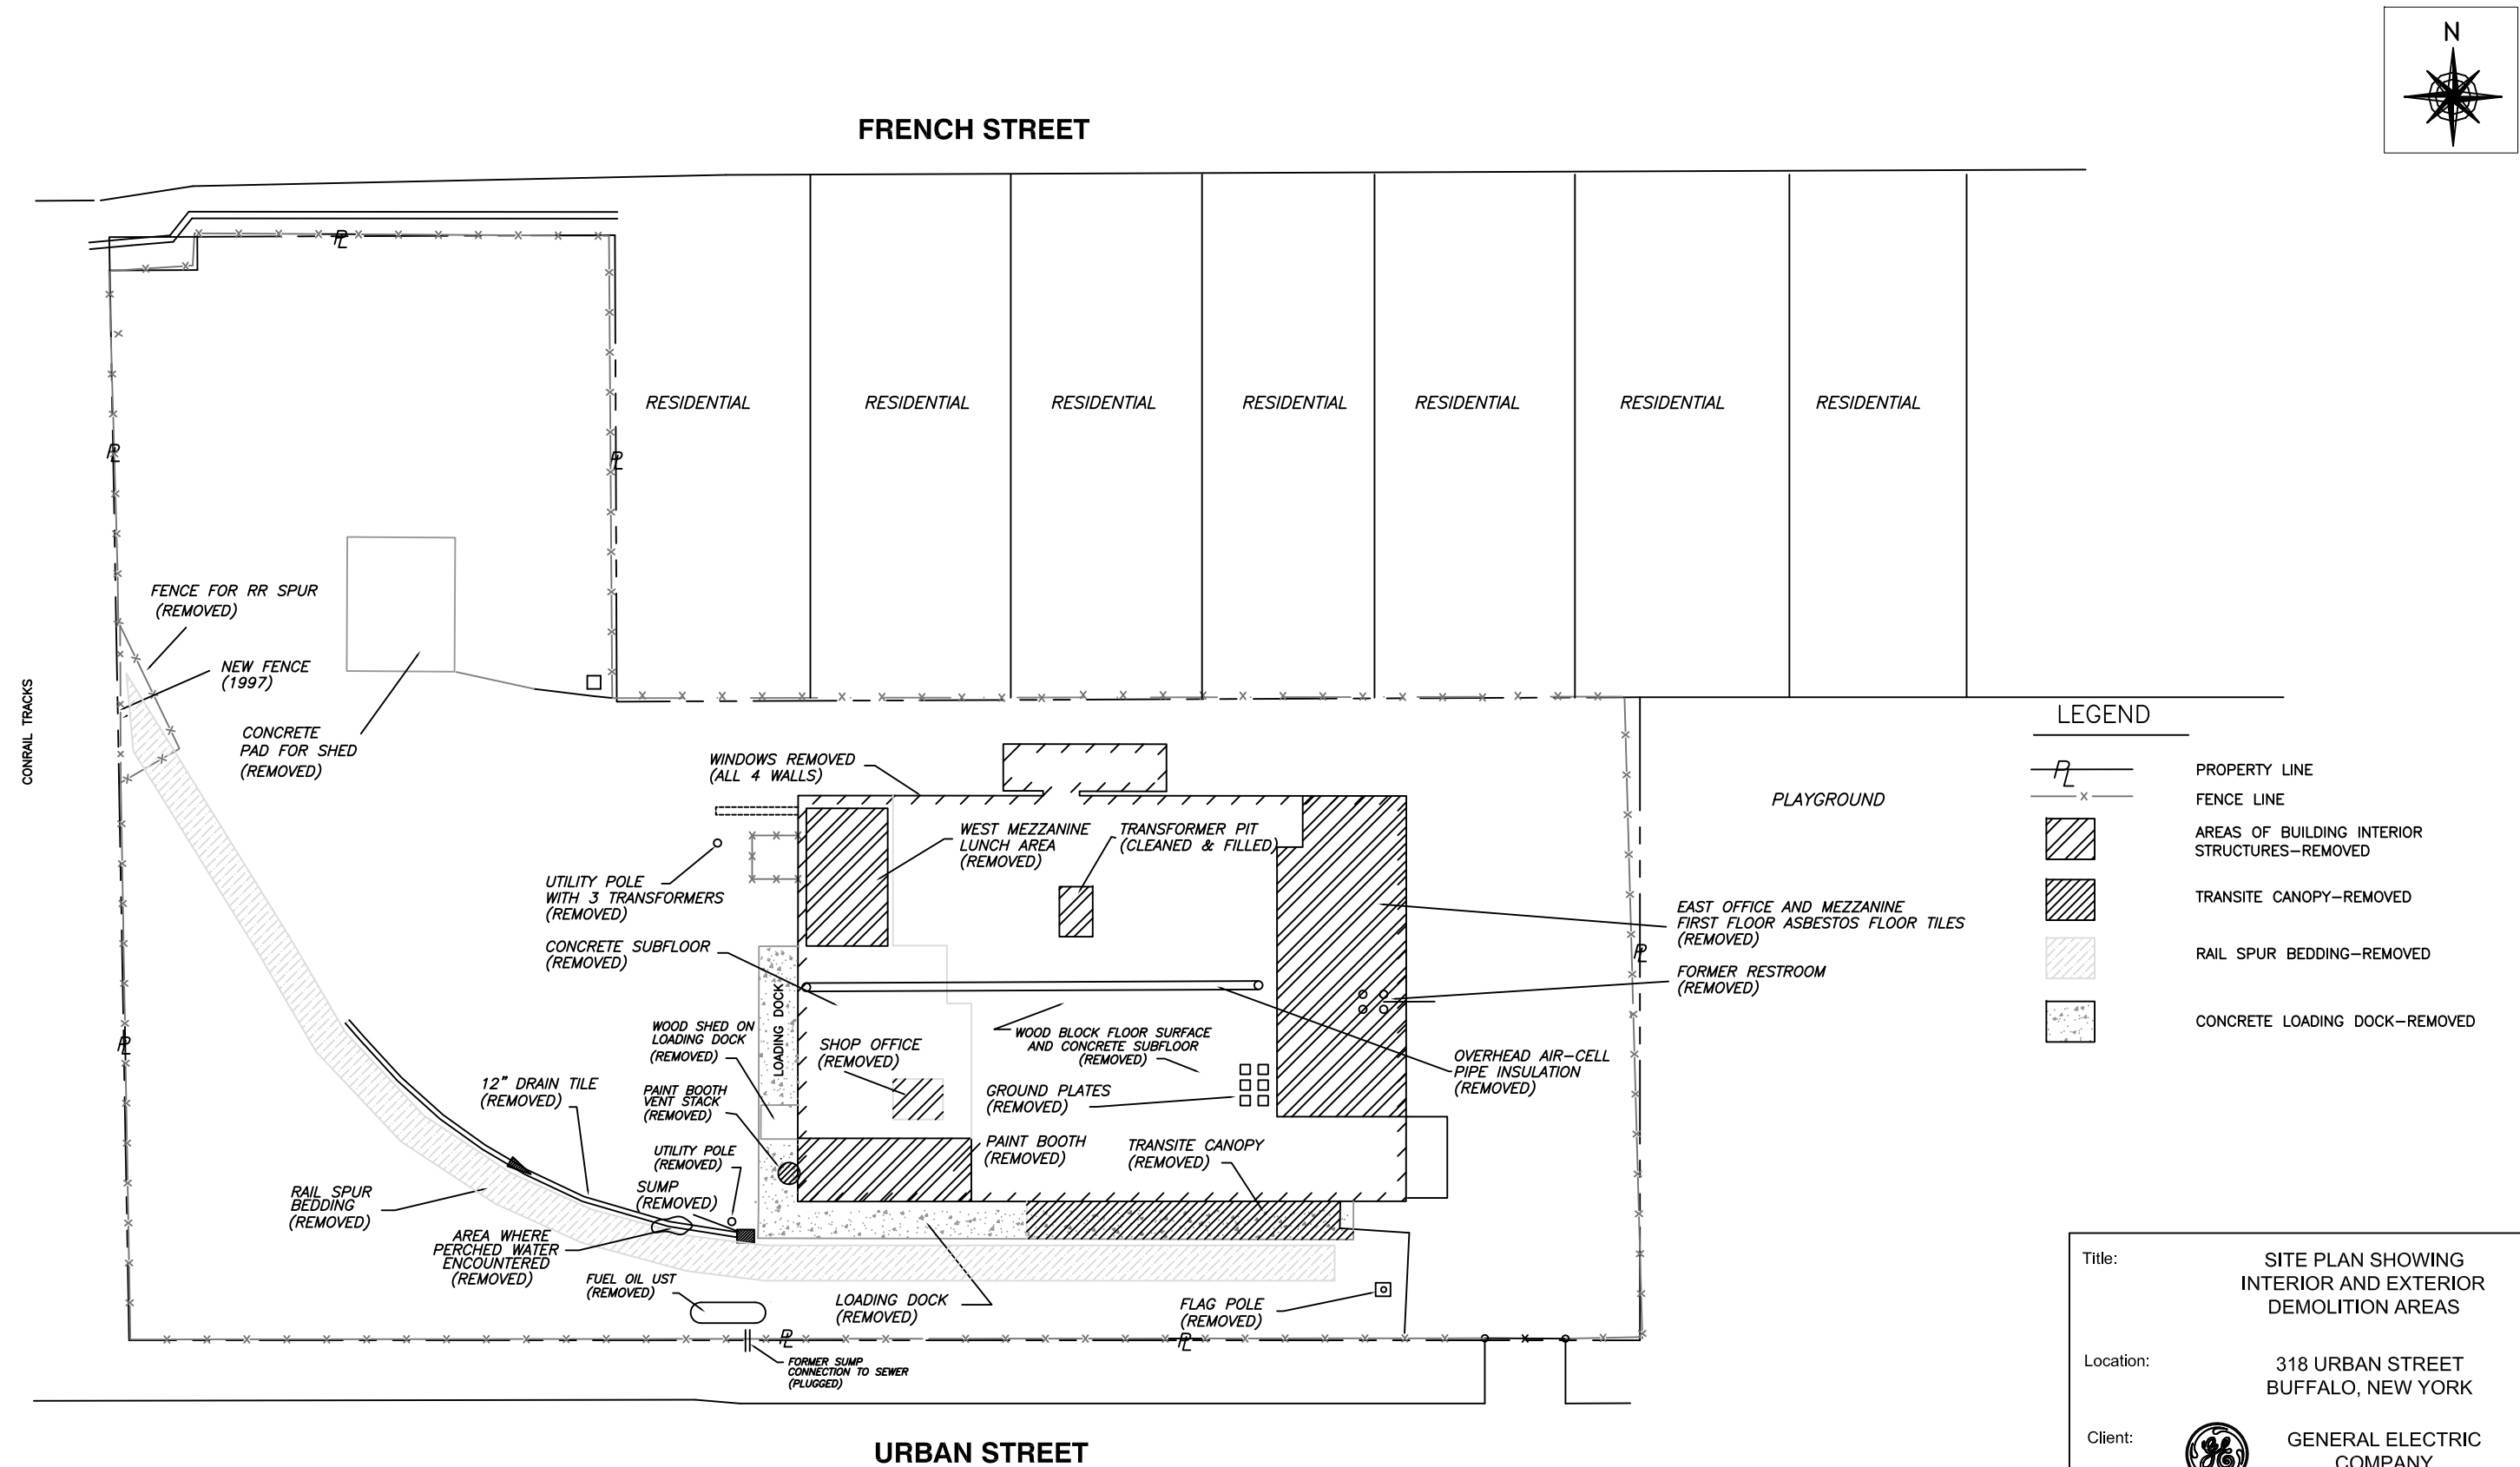
Title: SITE PLAN SHOWING INTERIOR AND EXTERIOR DEMOLITION AREAS	
Location: 318 URBAN STREET BUFFALO, NEW YORK	
Client:

The interior and exterior demolition areas are shown in Figure 3. The areas where the concrete floor was removed and replaced are shown in Figure 4.

The demolition and removal work was completed in accordance with the *Project Manual*, except where noted. The portions of the building that were demolished and removed are indicated in Figure 3. The demolished portions of the building comprised approximately 1,700 cubic yards of debris.

The transformer pit near the center of the northern end of the main building floor, which is shown in Figure 3, was also demolished. The pit, which had concrete walls and floor, was approximately 10 feet deep and was covered by a wooden lid. In 1997, the lid over the pit was removed and loose brown sand was encountered in the pit. The sandy material was dry and showed no visible signs of chemical impact. Following removal of the fill from the former transformer pit, the pit was dry. There were no obvious cracks in the walls or floor of the concrete pit. Two random samples of the fill material were analyzed for PCBs using the immunoassay field test kits. The results, which are summarized in Table 4, indicated that the

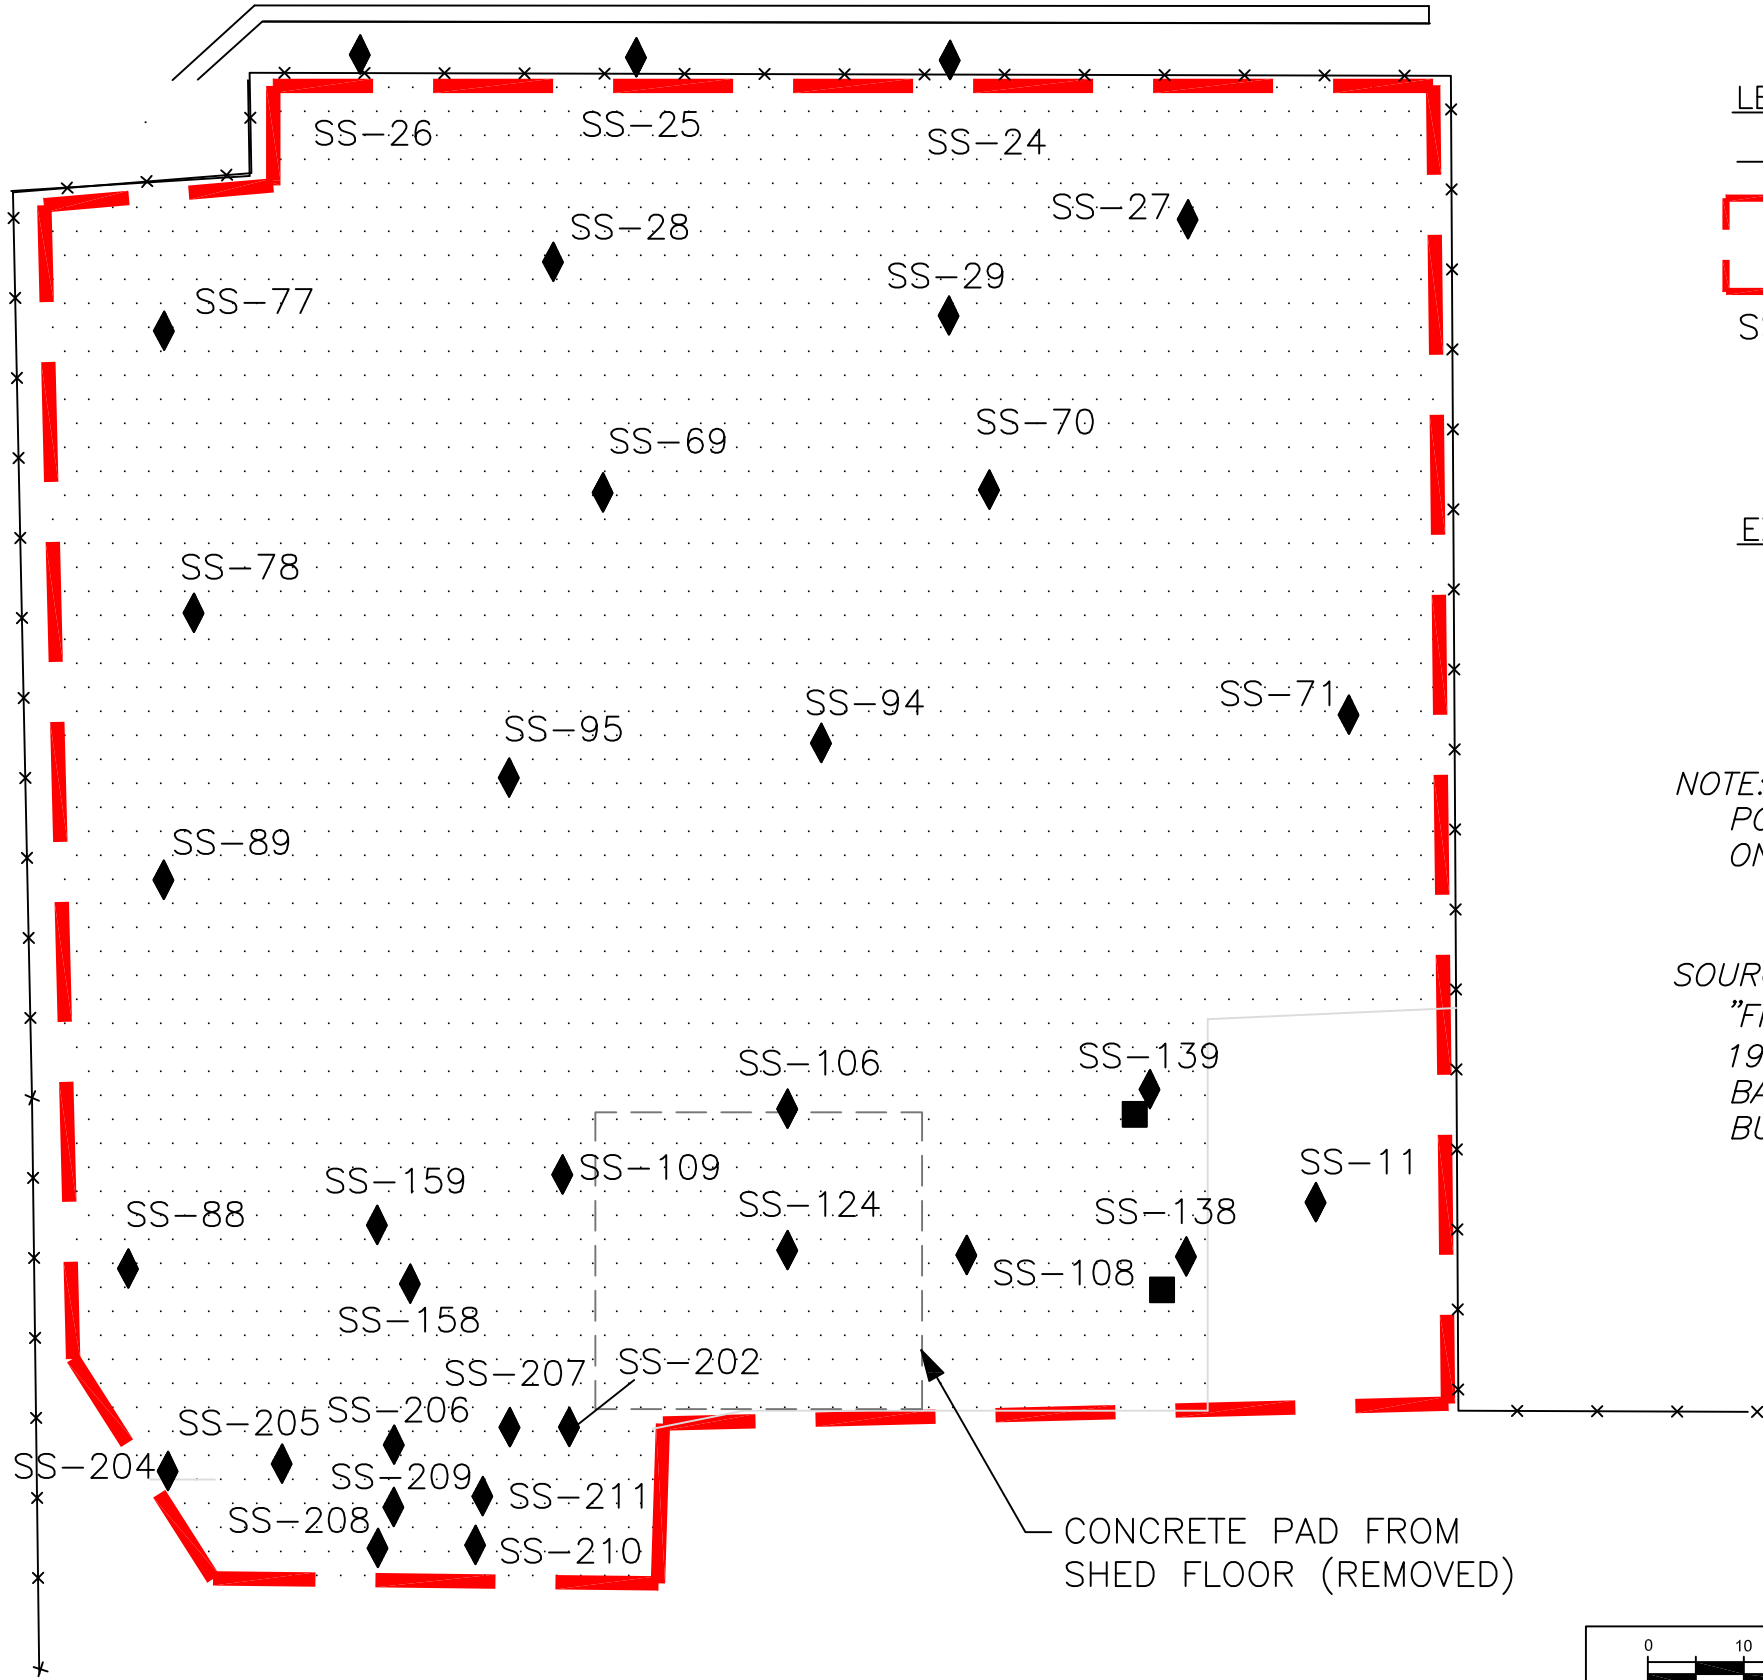
Title: AREA 1 PLAN - FINAL PCB CONFIRMATION SAMPLES	
Location: 318 URBAN STREET BUFFALO, NEW YORK	
Client: 	GENERAL ELECTRIC COMPANY
	Drafter: KP
URS Corporation 3 Corporate Drive, Suite 203 Clifton Park, New York 12065	Date: April 2012
Drg. Size: 11 x 17	Job No.: 38394784.30000
FIGURE 8

The excavated soil was disposed as hazardous waste at CWM's Model City Landfill. Following the completion of the excavation, soil samples were analyzed for PCBs and VOCs. As shown in Tables 14 and 12 (respectively), VOCs were not detected in the confirmatory soil sample from the bottom of the excavation, and PCB concentrations were below the remediation goal of 10 mg/kg. The VOC sample locations are shown on Figure 9, and the locations of samples documenting that remediation goals for PCBs were achieved are shown on Figure 8. The excavated area was backfilled with clean soil.

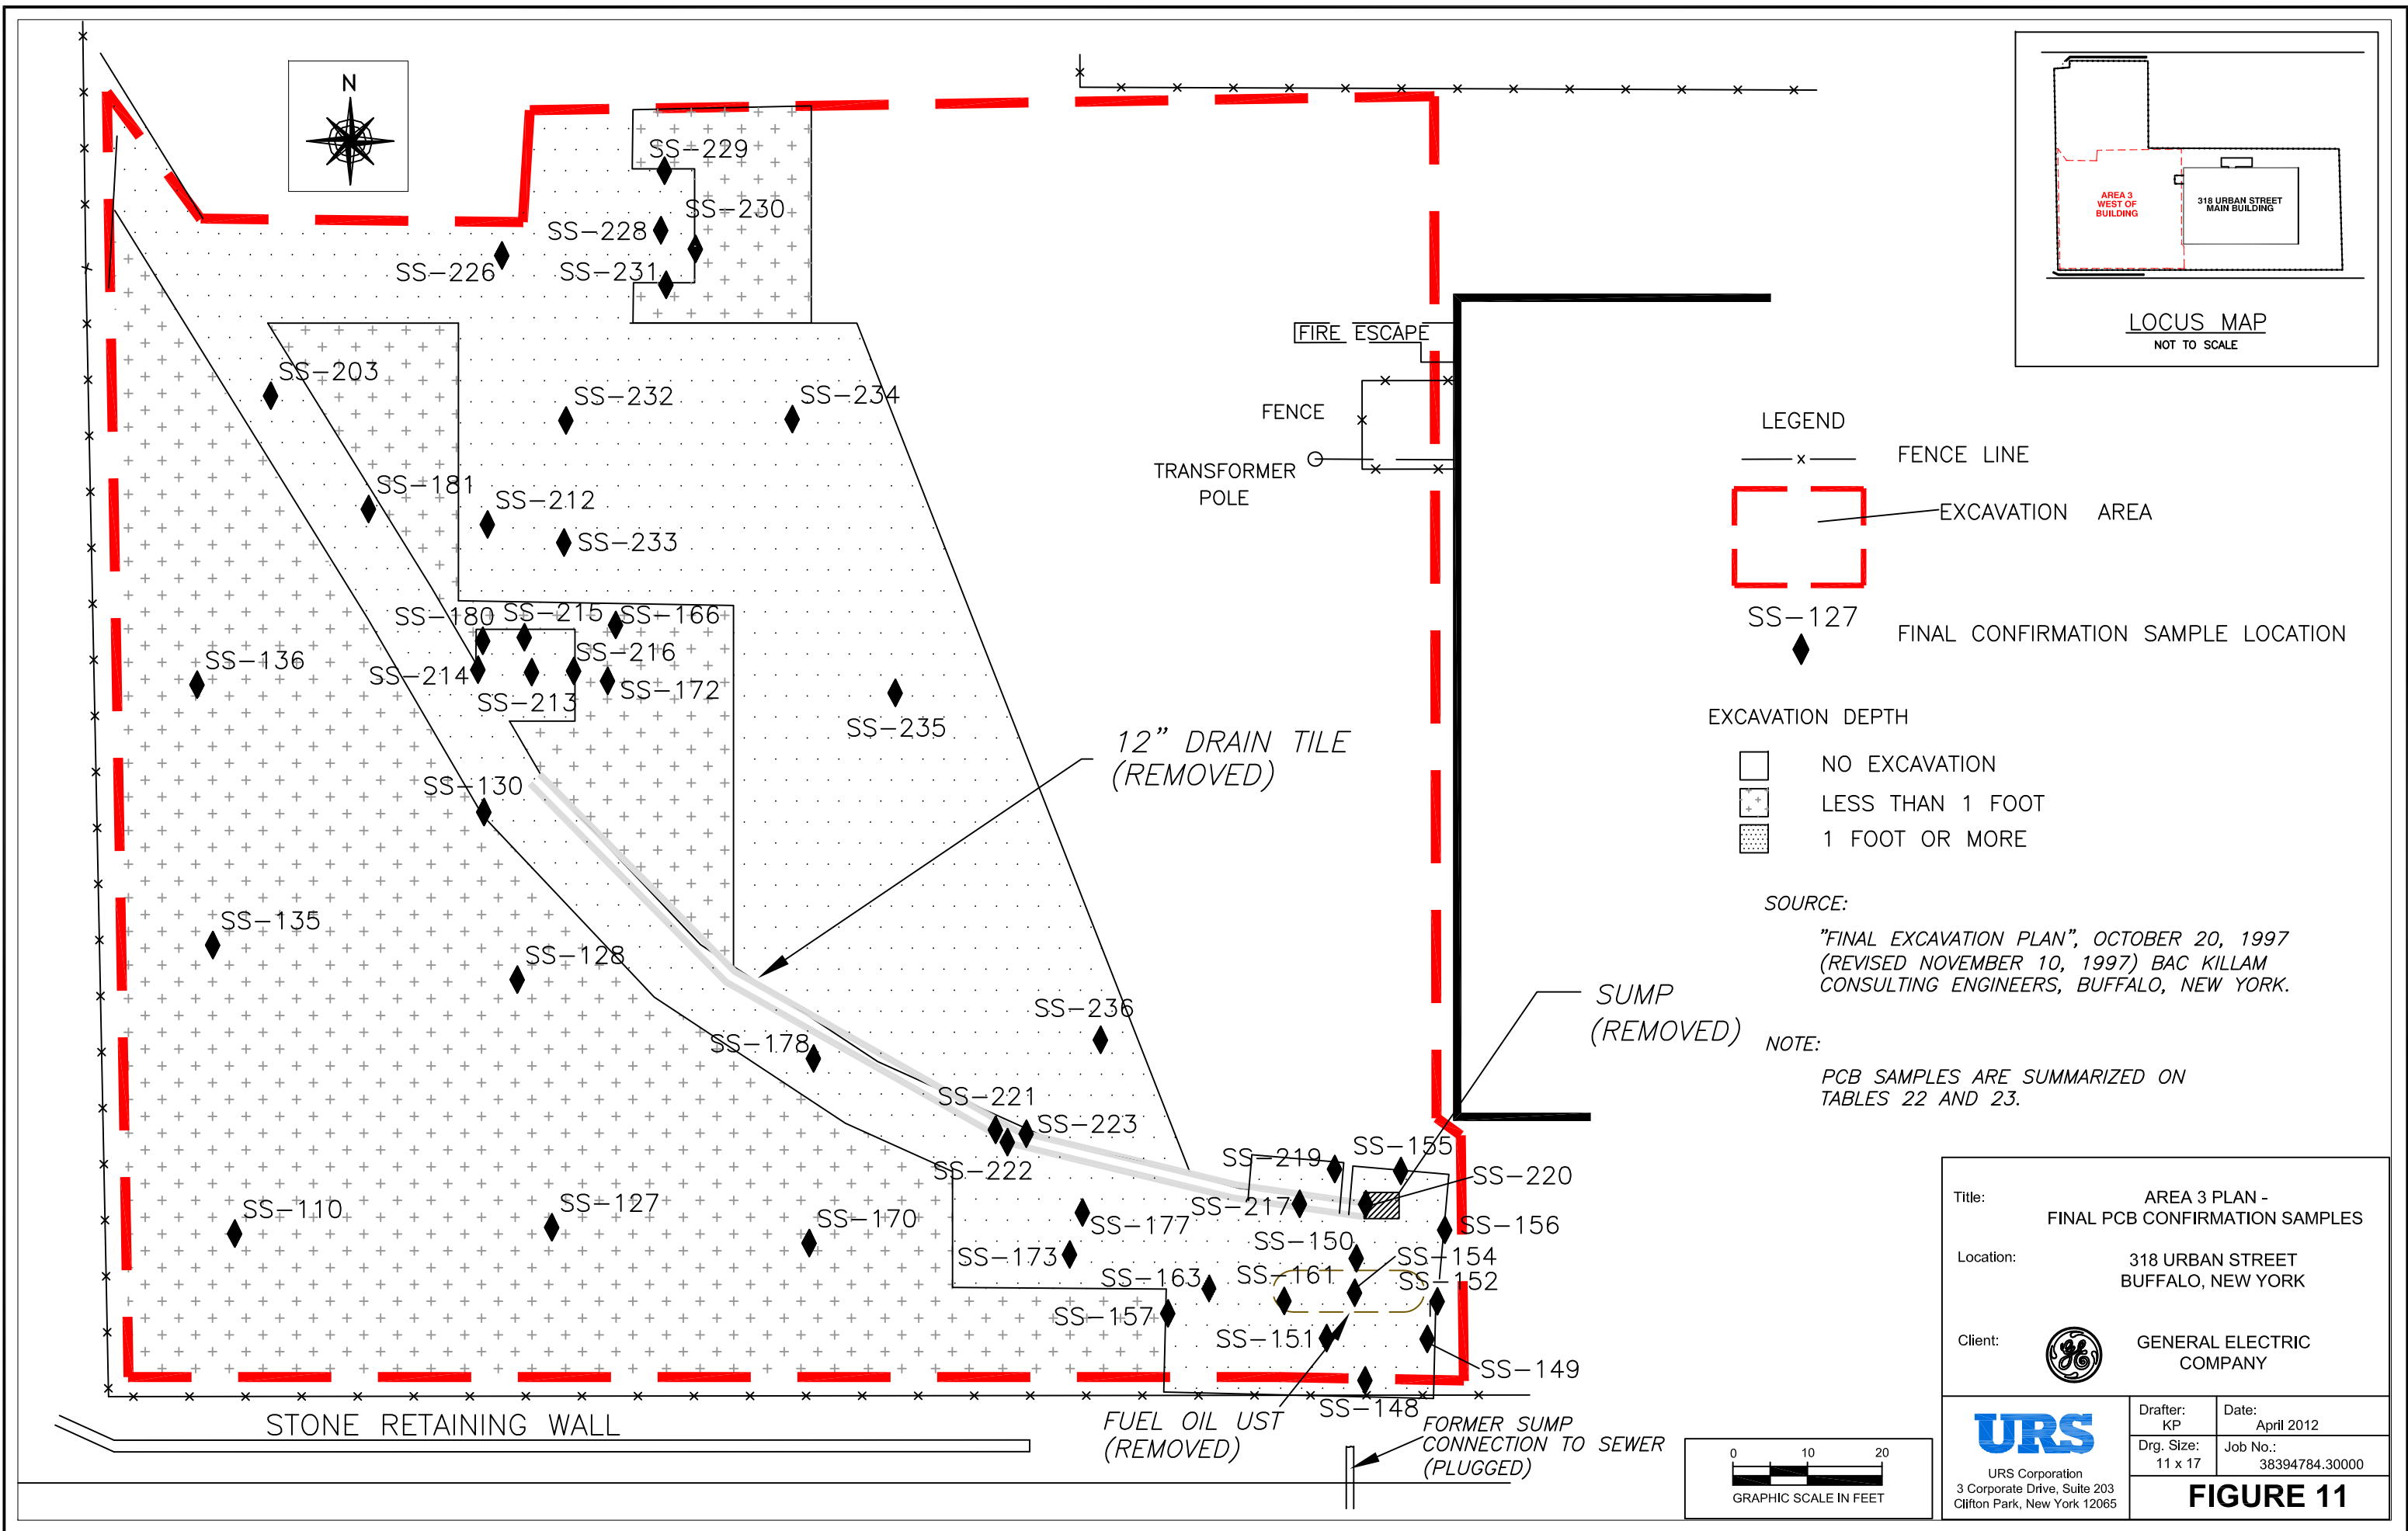
A 12-inch diameter steel drain pipe was encountered along the north side of the bed of the former rail spur. The pipe appeared to drain eastward to a concrete sump beneath the southwest corner of the former loading dock. Figure 11 shows the location of the drain tile and sump. The pipe and the sump contained a black, oily sludge. As shown in Table 27, laboratory analyses indicated that the sludge contained PCBs at a concentration of 330 mg/kg. As shown in Table 13, VOC and SVOC concentrations in the TCLP extract were less than the regulatory criteria for characteristic hazardous waste.

The sludge from the pipe was removed and shipped to CWM's Model City Landfill. CWM then shipped the sludge to its Port Arthur, Texas facility to be incinerated as a hazardous waste. The pipe, pipe bedding material, concrete sump, and associated steel pipe were removed and disposed as hazardous waste at CWM's Model City Landfill. Confirmatory soil samples were collected following removal of the pipe, sump, and surrounding soil. After the receipt of analytical results that met the remediation goals, the area was backfilled.
