Re: Periodic Review Report and IC/EC Certification Submittal
318 Urban Street Site
Buffalo, New York
NYSDEC Site Number: 915151

318 Urban Street Site

Periodic Review Report For November 2013 through October 2015

NYSDEC Site Number: 9-15-151

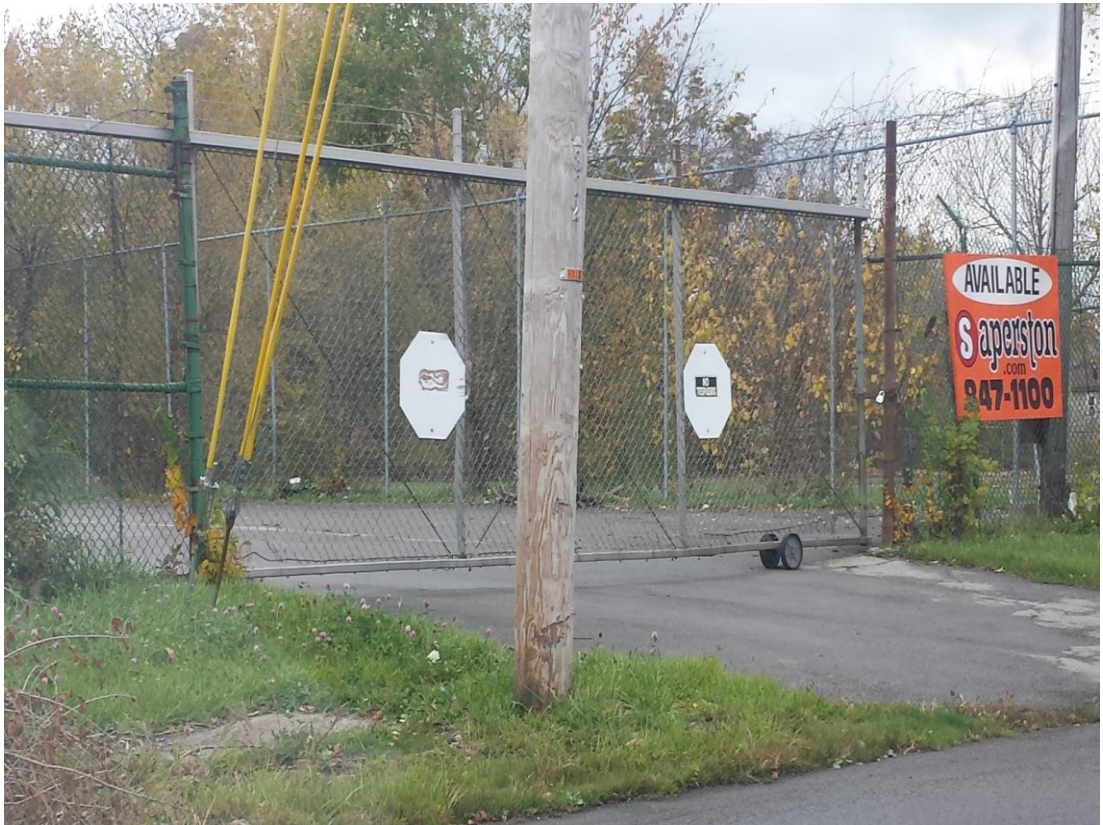
PHOTO NO: 1 Date: 10/31/14 Direction: Northeast Description: Site entrance with secured gate. Note some damage to the gate in the lower-left corner.

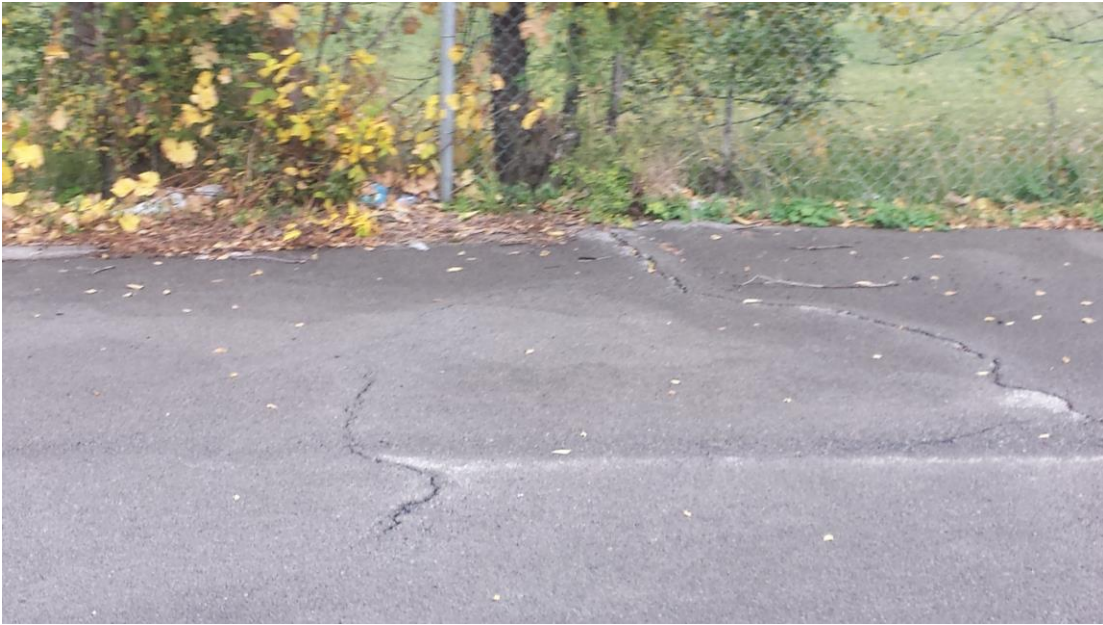
PHOTO NO: 2 Date: 10/31/14 Direction: East Description: Pavement cracks observed in asphalt lot to the east of the building.

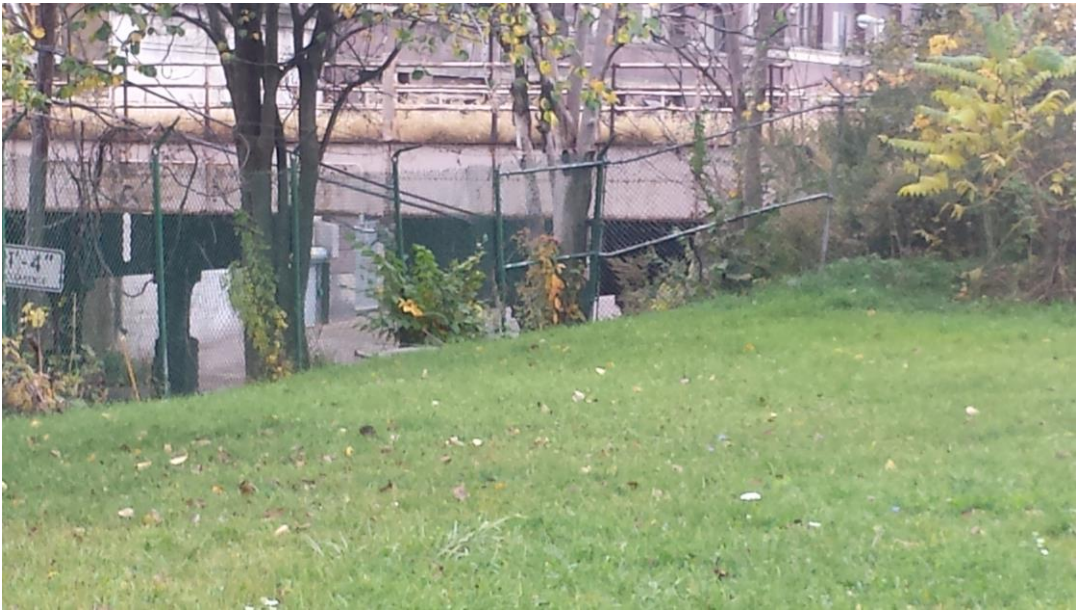
PHOTO NO: 7 Date: 10/31/14 Direction: Southwest Description: Fencing at the southwest corner of the property. The fence is intact and stable despite being a bit uneven.

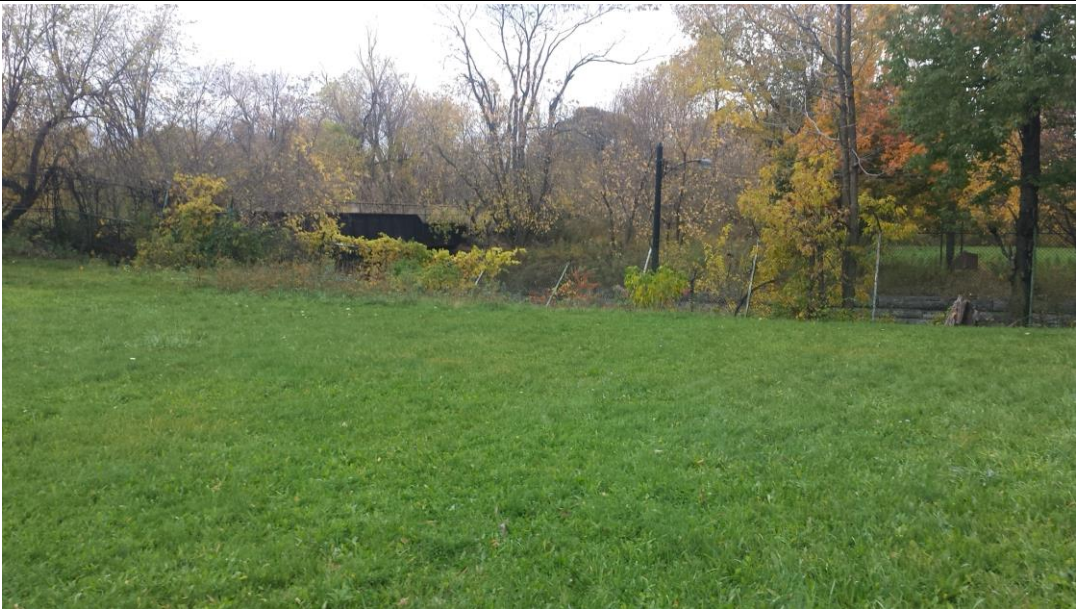
PHOTO NO: 8 Date: 10/31/14 Direction: Northwest Description: Fence at the northwest corner of the site that is at risk of falling over.

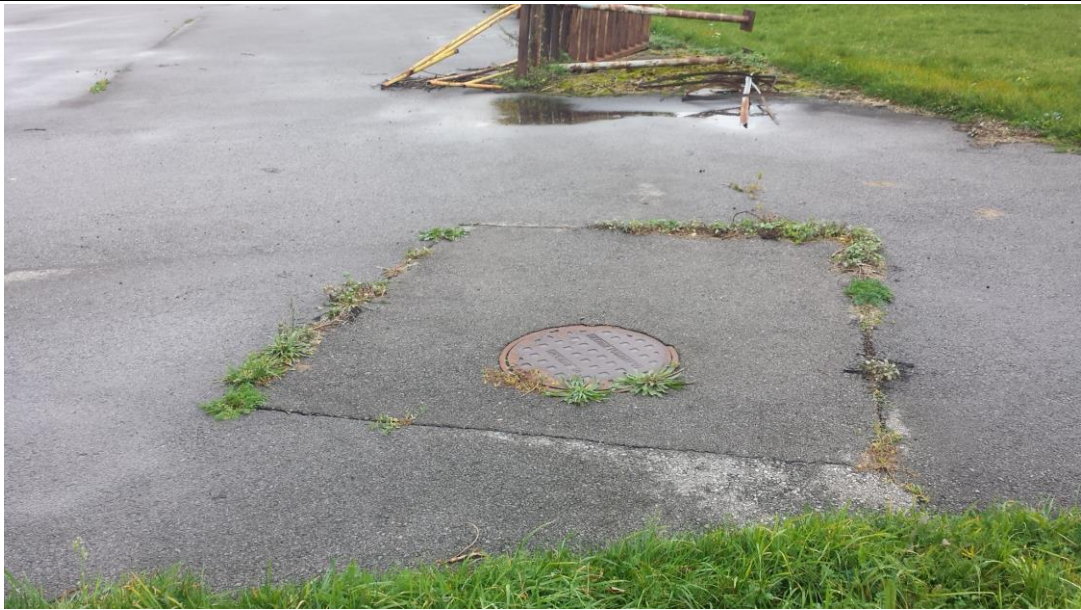
PHOTO NO: 11 Date: 10/31/14 Direction: South Description: A manhole with an apparent asphalt replacement around it.

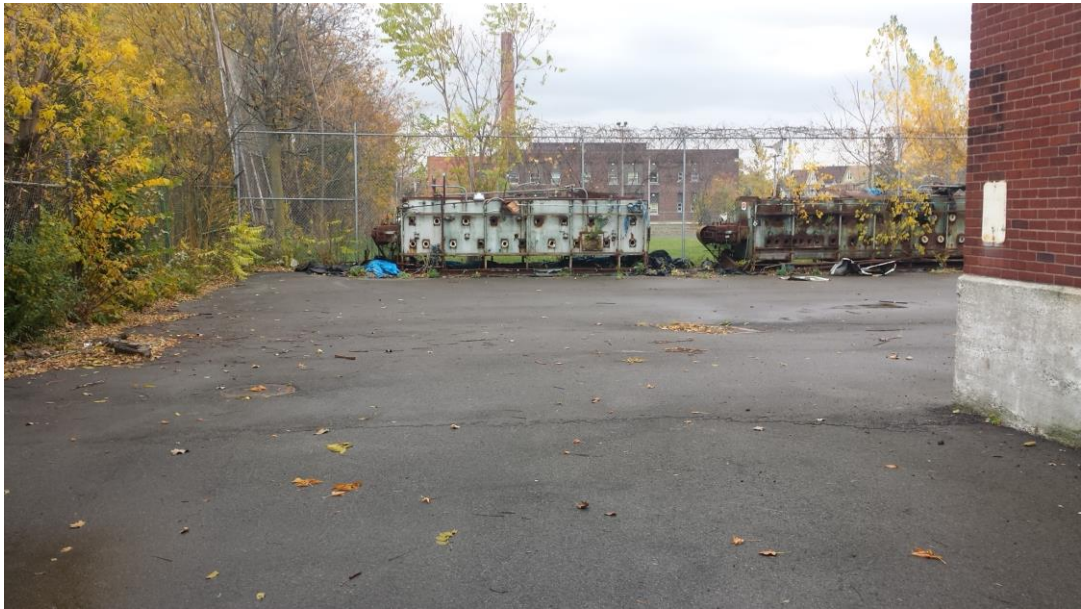
PHOTO NO: 12 Date: 10/31/14 Direction: East Description: Asphalt pavement at the northeast corner of the building in good shape, with only some minor cracking.

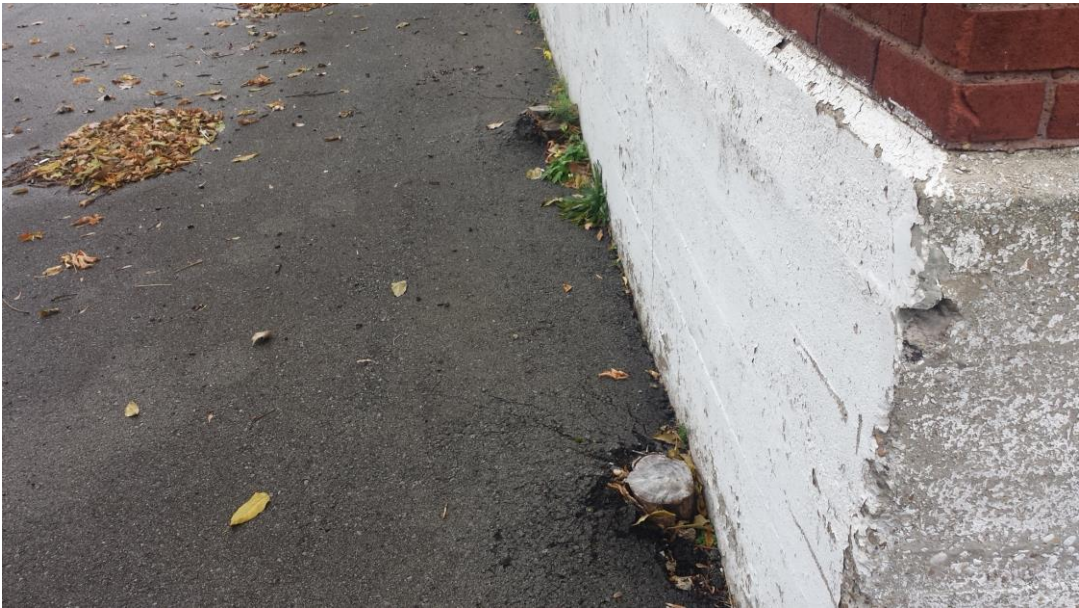
PHOTO NO: 13 Date: 10/31/14 Direction: South Description: Some breaches in the asphalt pavement, resulting from tree growth, along the northeastern corner of the building.

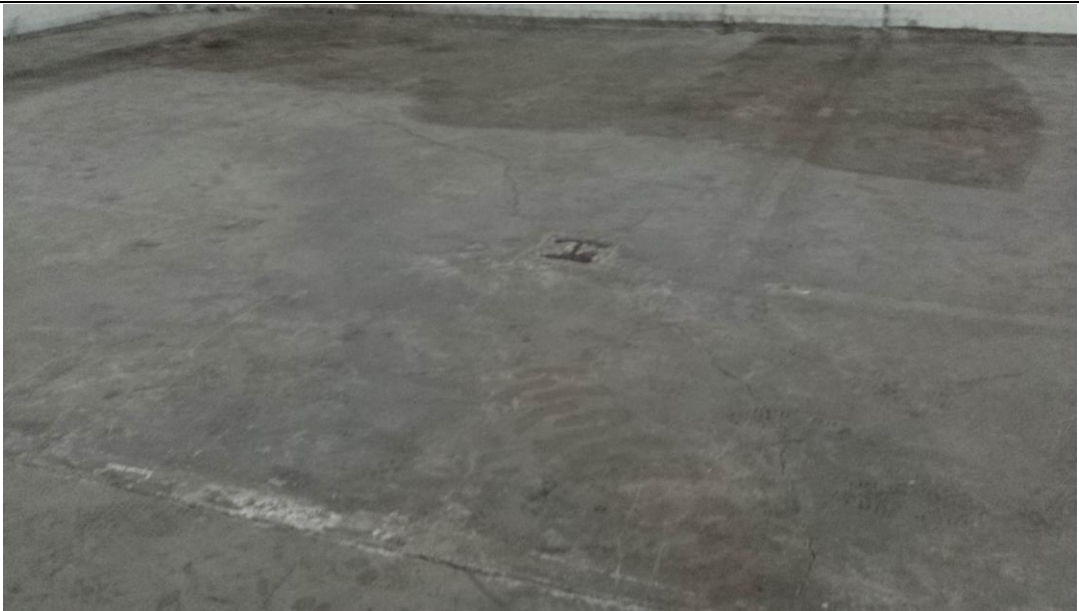
PHOTO NO: 14 Date: 10/31/14 Direction: Northeast Description: Concrete floor inside the building is in generally very good condition, despite some minor cracking as shown here.

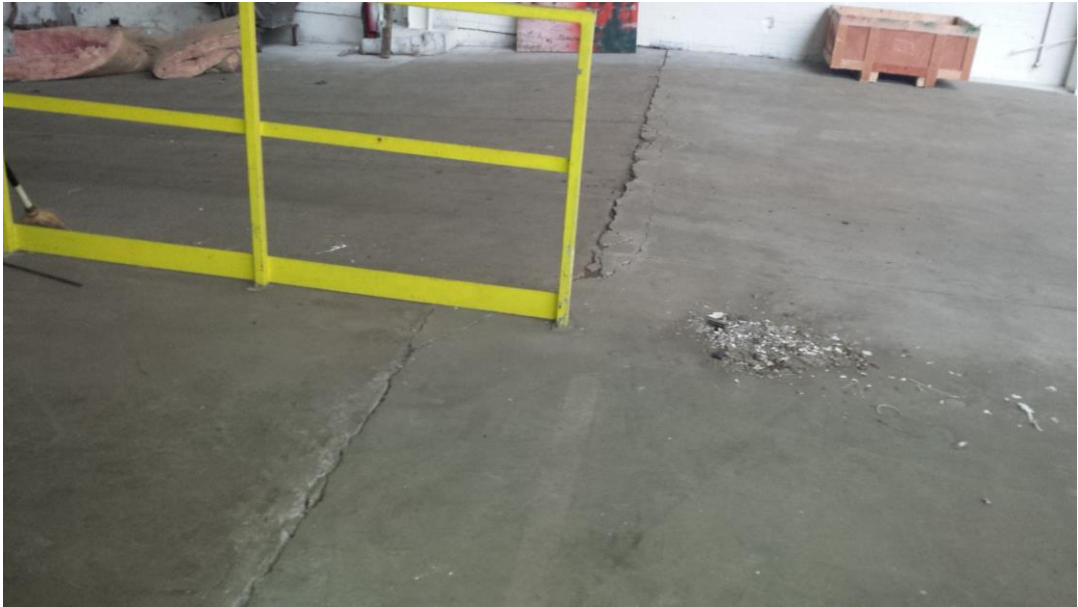
PHOTO NO: 19	 
Date: 10/31/14	
Direction: East Description: A crack in the floor next to a southern building entrance. This photo was taken from a staircase at the southwest corner of the building.	
PHOTO NO: 20

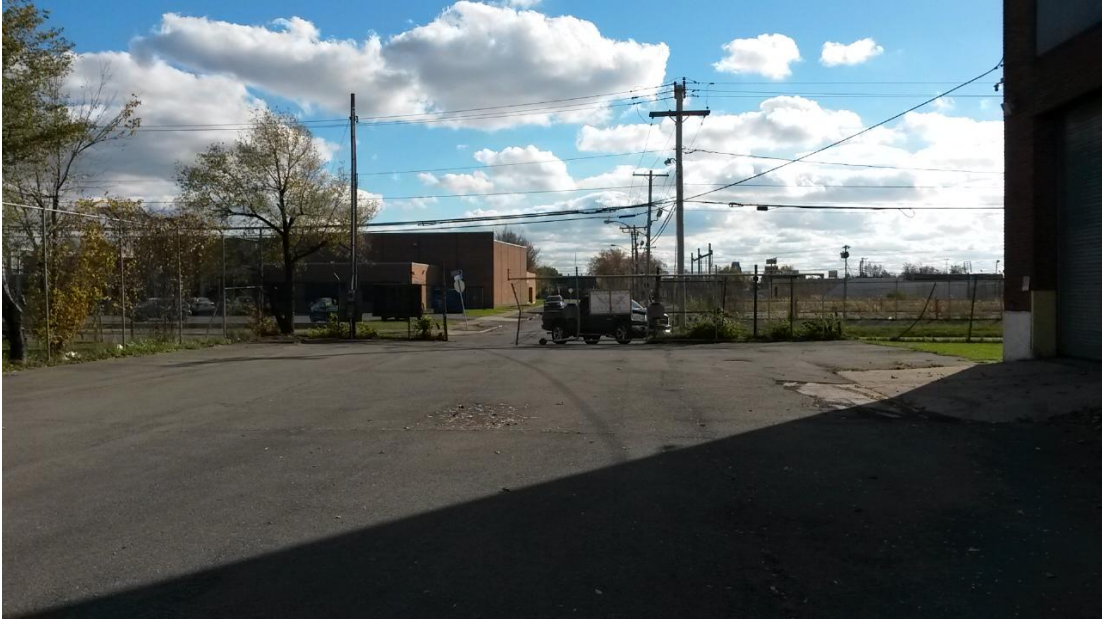
PHOTO NO: 1	
Date: 10/30/15	
Direction: South Description: Overview of pavement on eastern side of building with view of damage to entrance gate. Gate is still functional. On right is junction of asphalt and concrete pad. No soil is exposed.

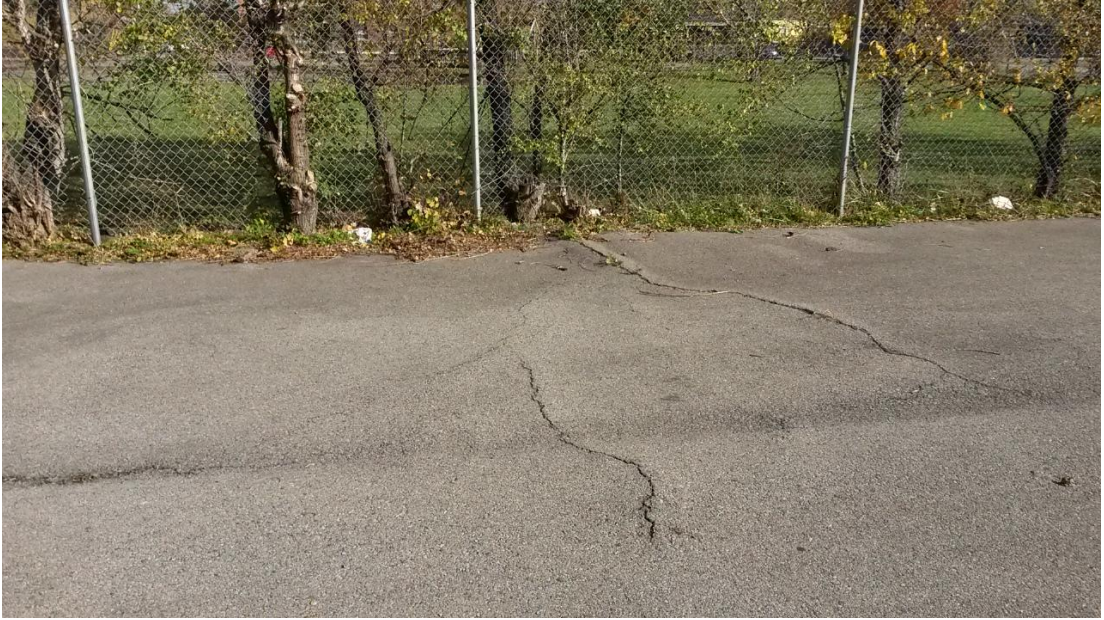
PHOTO NO: 2	
Date: 10/30/15	
Direction: East Description: View of eastern edge of property. Cracked and heaving pavement likely due to frost and/or roots.

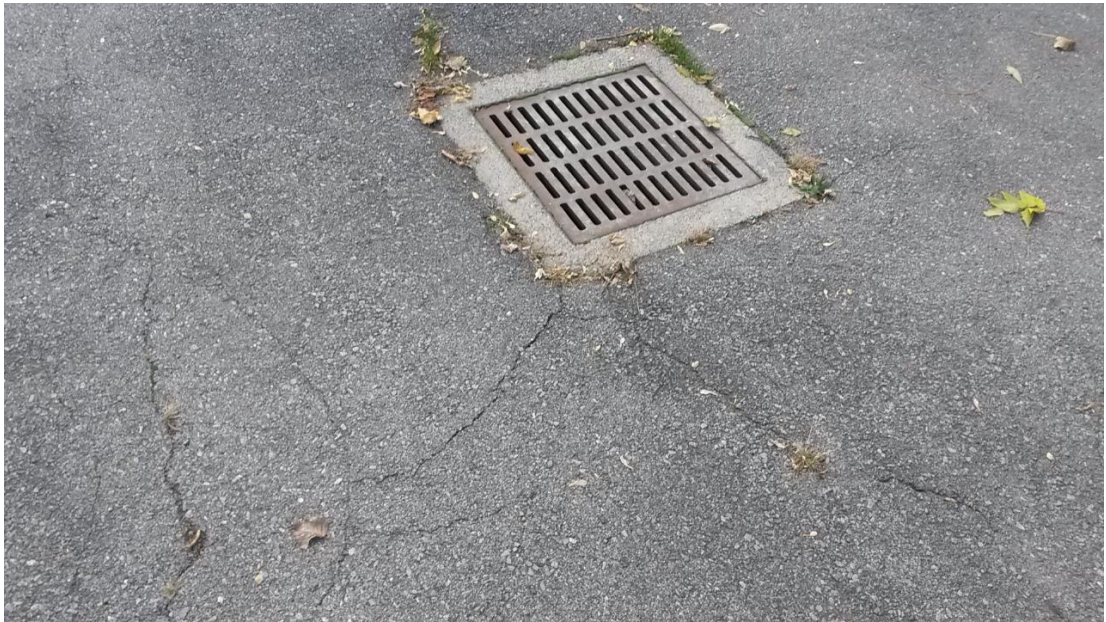
PHOTO NO: 3

Date: 10/30/15	
Direction: -- Description: Catch basin near northeast property corner. Minor cracking and vegetation growth.	
PHOTO NO: 4

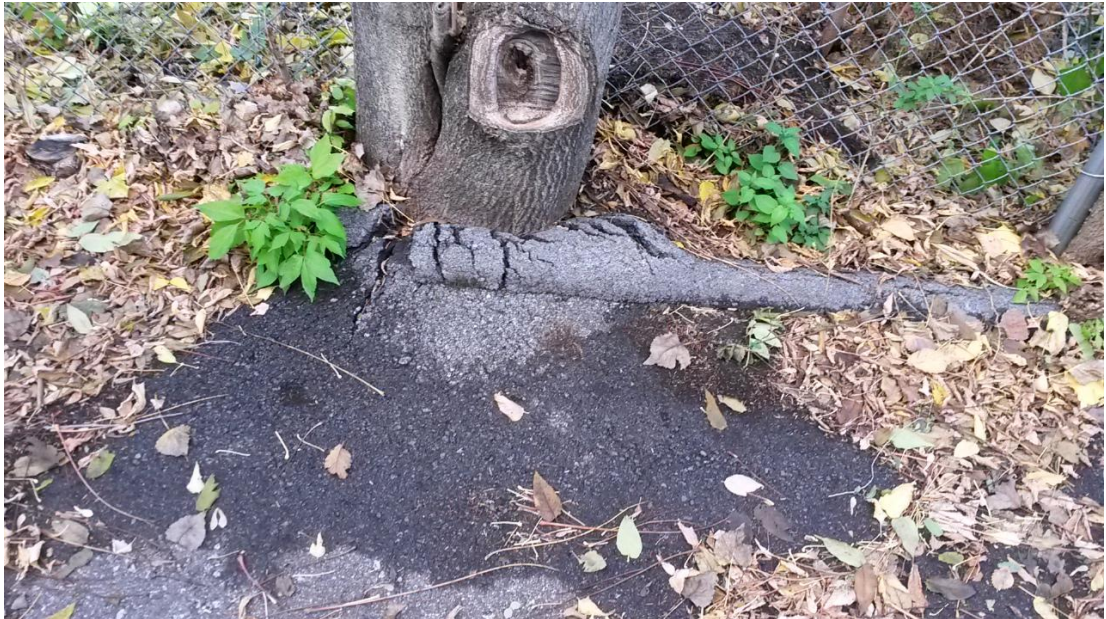
Date: 10/30/15	
Direction: North Description: Heaving of pavement due to tree growth.

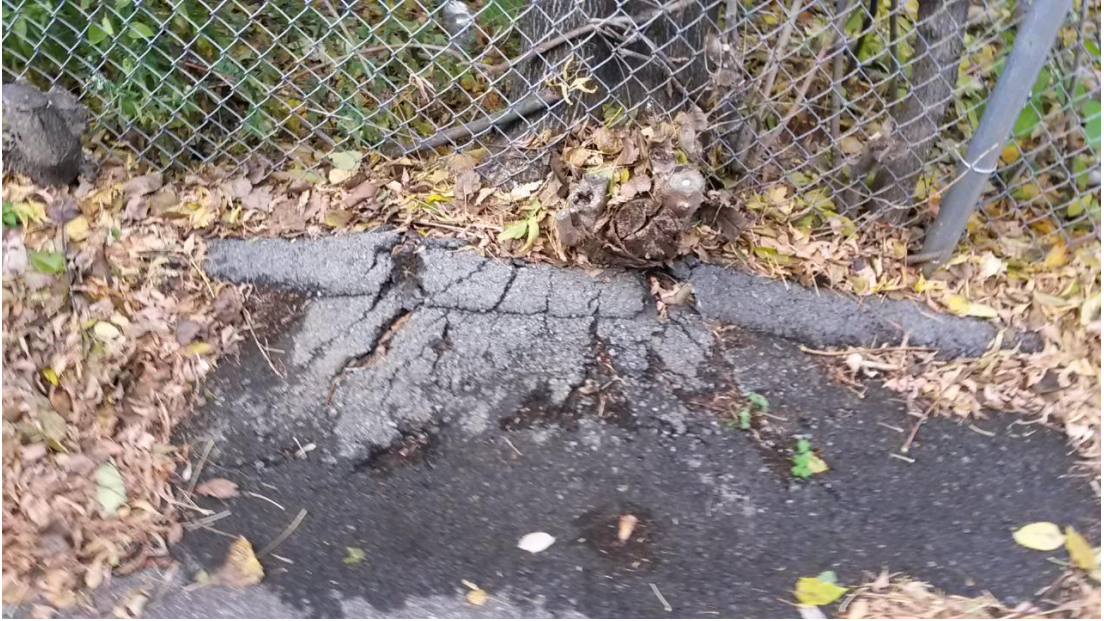
PHOTO NO: 5	
Date: 10/30/15	
<p>Direction: North</p> <p>Description: Cracking and heaving of pavement due to tree growth on neighboring property.</p>

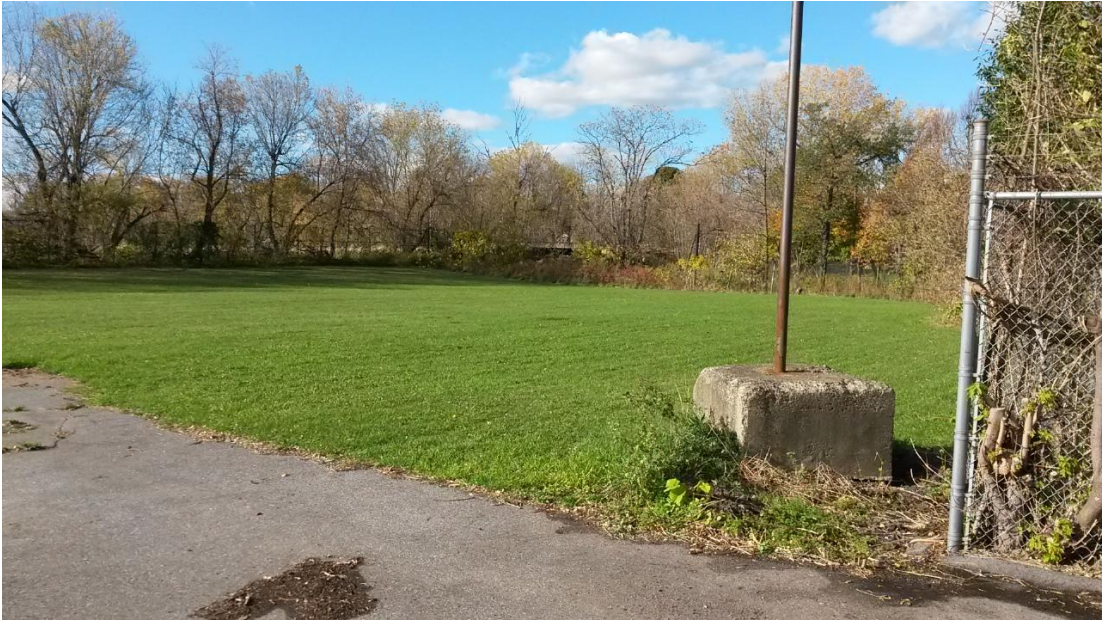
PHOTO NO: 6	
Date: 10/30/15	
<p>Direction: Northwest</p> <p>Description: Overview of grass covered northern panhandle of site. Area is vegetated and maintained.</p>

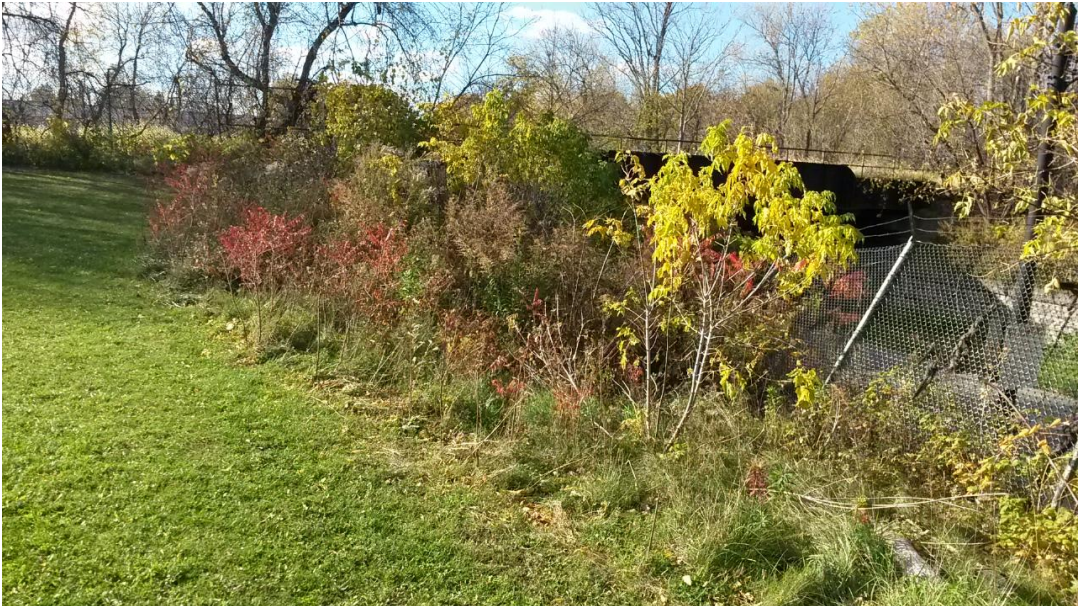
- The fence and gate are present and currently functioning as intended. It appears that the fence fabric has been reattached. Several of the fence posts are damaged (bent). A section of fence in the northwest part of the property is leaning, although it is functional. The gate has sustained additional damage since the 2014 site visit, but is functional. The fence condition should continue to be monitored.

PHOTO NO: 7 Date: 10/30/15 Direction: West northwest Description: View of leaning fence along French Street. Condition appears to be unchanged from 2014 site visit.

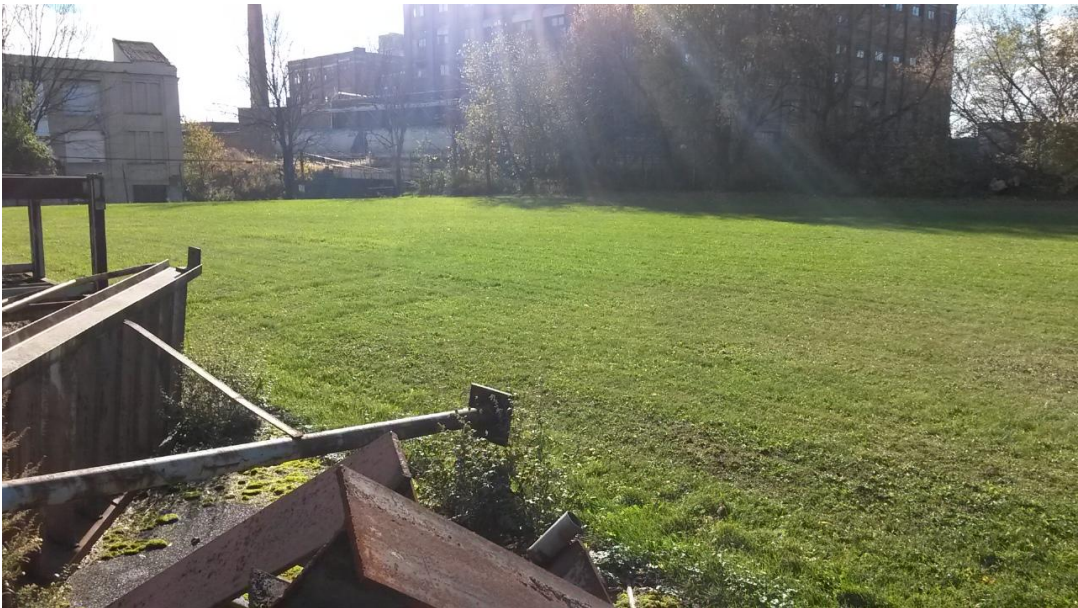
PHOTO NO: 8 Date: 10/30/15 Direction: Southwest Description: View of western grassy area. Area is vegetated and maintained. Equipment is still stored along western edge of pavement.

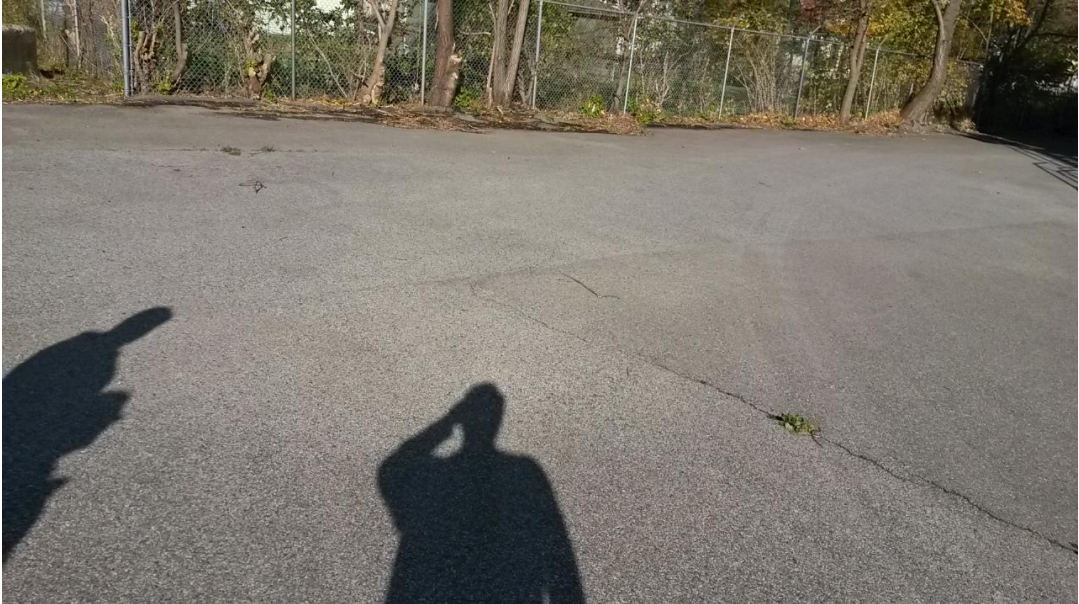
PHOTO NO: 13

Date: 10/30/15	
Direction: North Description: View of trees along the property line north and west of the building. Minor cracks in pavement.	
PHOTO NO: 14

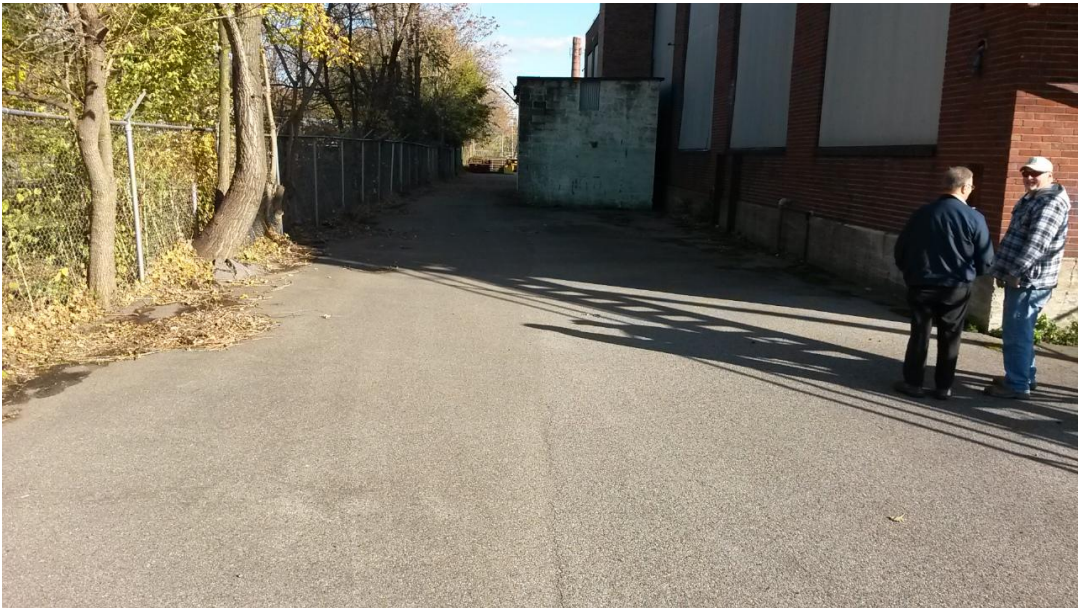
Date: 10/30/15	
Direction: East Description: Condition of pavement on north side of building.
