**Re: Periodic Review Report and IC/EC Certification**  
**318 Urban Street**  
**Buffalo, New York**  
**NYSDEC Site No. 915151**

# **PERIODIC REVIEW REPORT FOR AUGUST 2015 THROUGH AUGUST 2017**

318 Urban Street Site

NYSDEC Site Number: 9-15-151

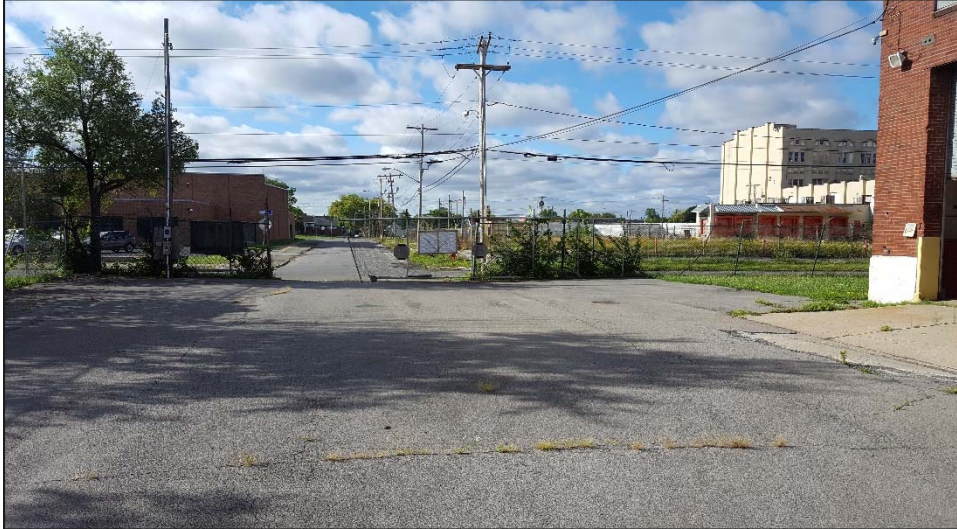
**Photo: #1**

Overview of pavement on eastern side of building with view of damage to entrance gate. Gate is still functional.

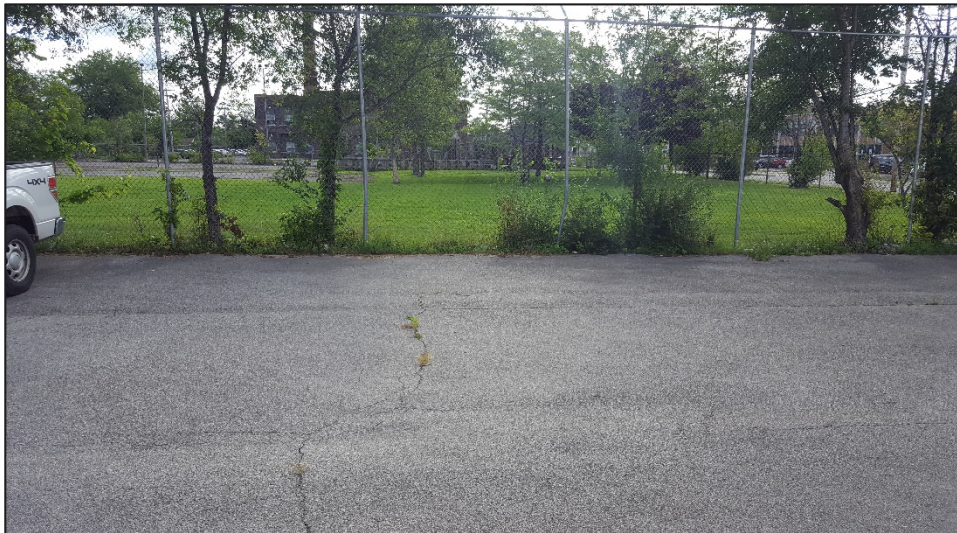
**Photo: #2**

View of eastern edge of property. Minor cracking observed.

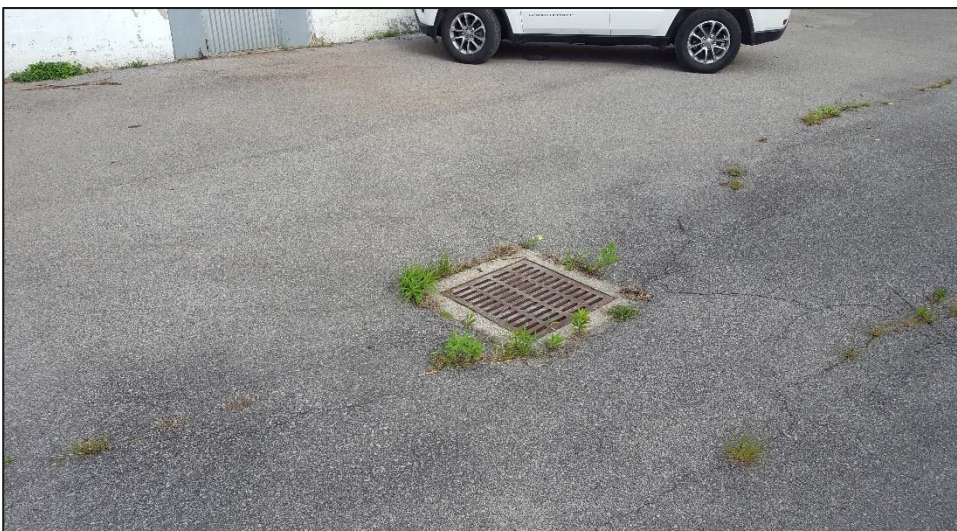
**Photo: #3**

Catch basin near northeast property corner. Minor cracking and vegetation growth.

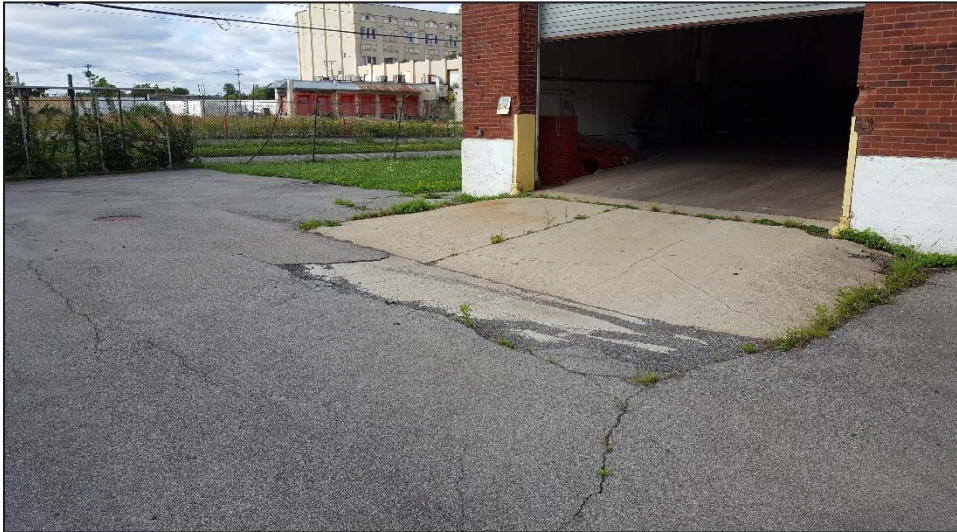
**Photo: #4**

Entrance to building and  
minor pavement cracking.

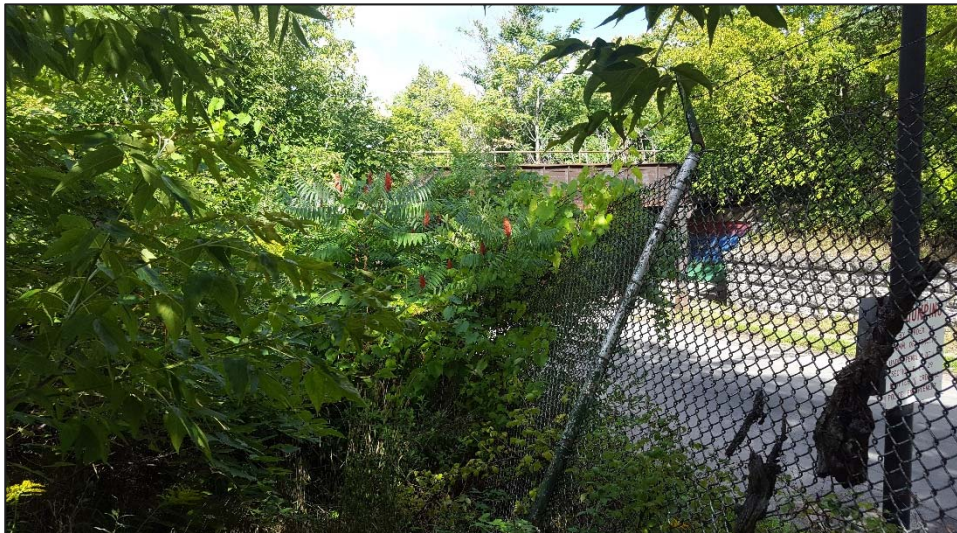
**Photo: #8**

View of leaning fence along French St. Condition appears unchanged from 2015 visit.

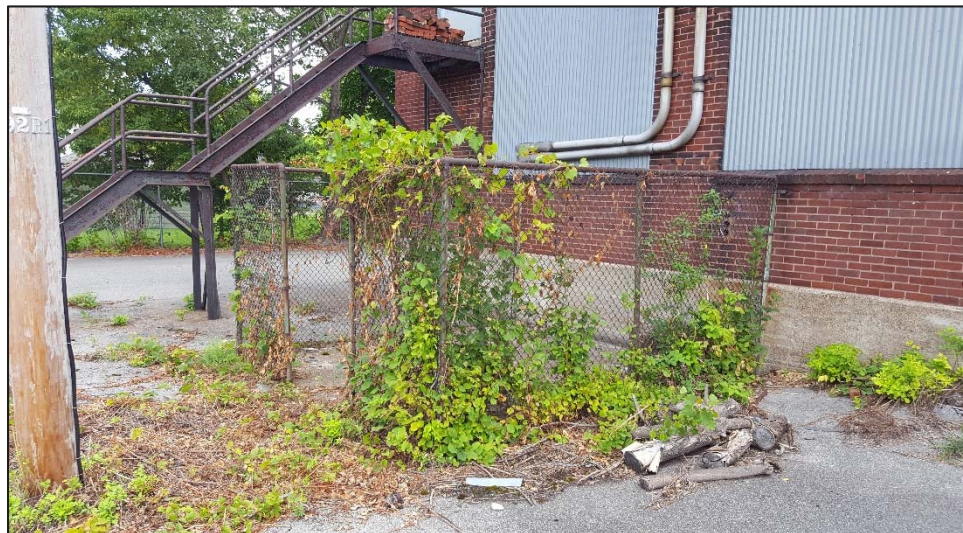
**Photo: #13**

**Description:**  
Pavement and vegetation near the northwest side of the building.

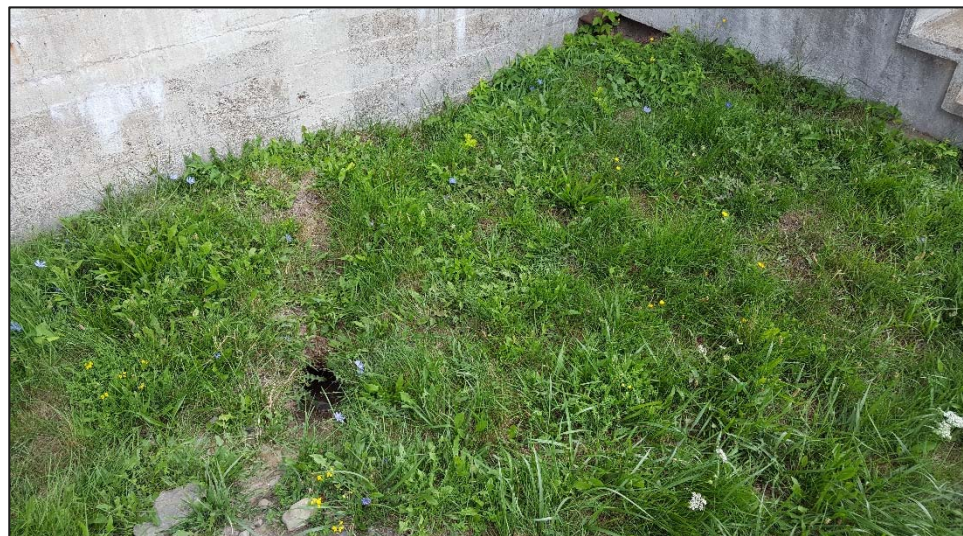
**Photo: #14**

**Description:**  
Animal burrow observed on the south side of the building, adjacent to the stairs.

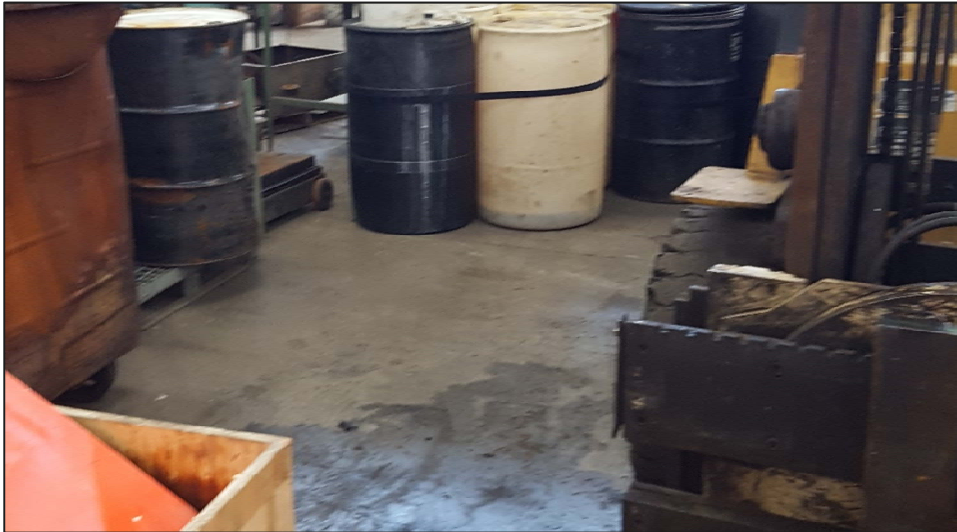
**Photo: #16**

Wet spot on the floor adjacent to machinery. No adjacent cracks or holes in floor.

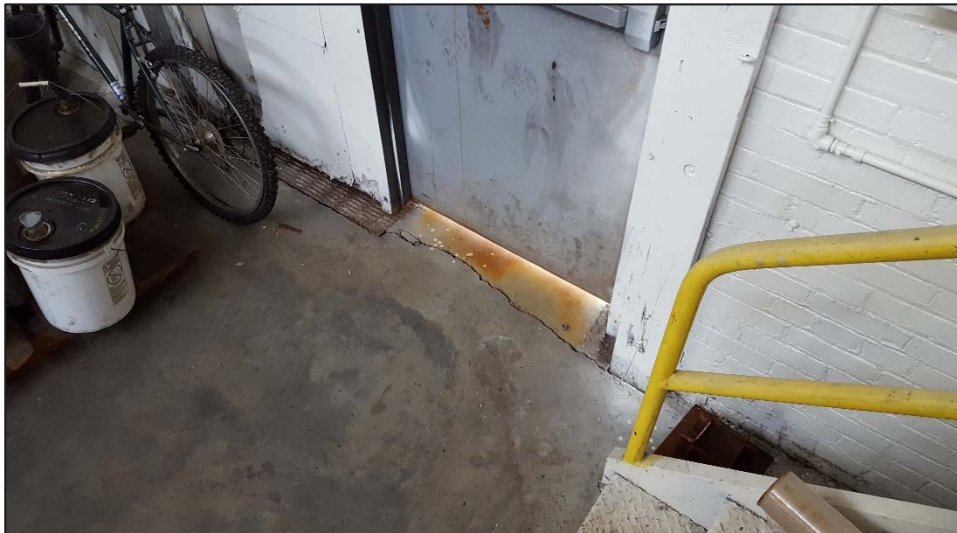
**Photo: #17**

Crack in concrete floor near door on southern side of the building.

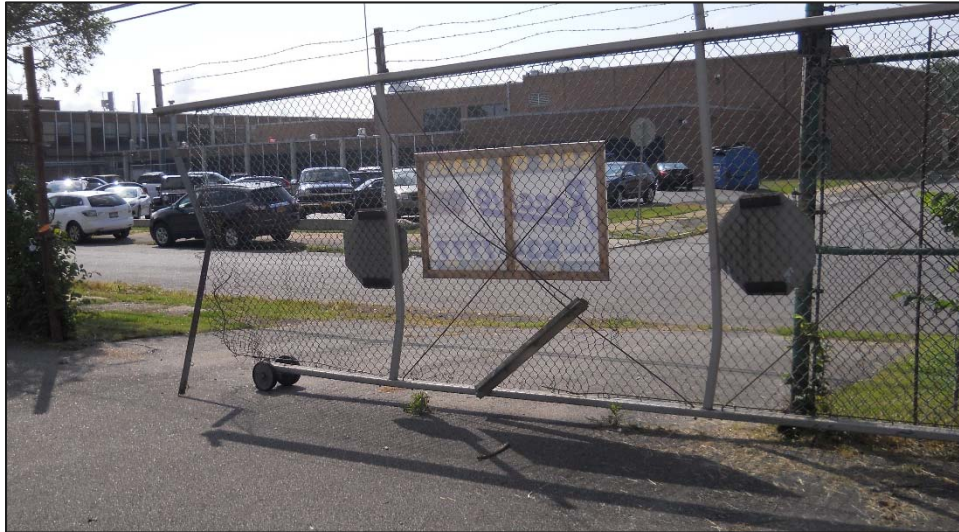
**Photo: #1**

- The fence and gate are present and currently functioning as intended. Several of the fence posts are damaged (bent). A section of fence in the northwest part of the property is leaning, although it is functional. The gate has sustained damage, but is functional. The fence condition should continue to be monitored.

View of damage to entrance gate. Gate is still functional.

| <b>Inspection Form</b><br>318 Urban Street, Buffalo, New York<br>NYSDEC Site Number: 9-15-151 | | | |
|---|--|---|--|
| <b>Recommendations for maintenance:</b><br><u>Fence posts adjacent to French St. should continue to be monitored. Fence gate is functional, but may require maintenance.</u> | | | |

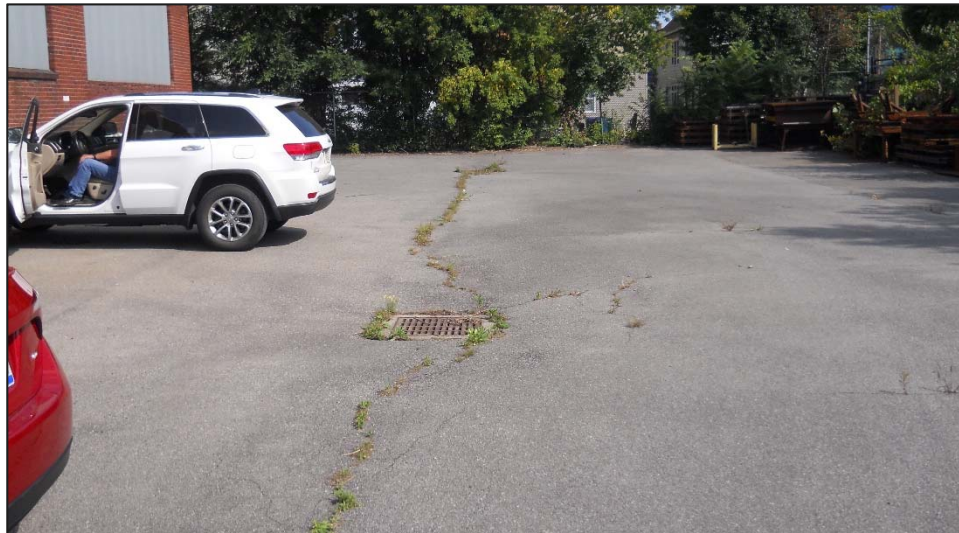
**Photo: #2**

View of pavement east of the building (minor cracking and vegetation growth observed).

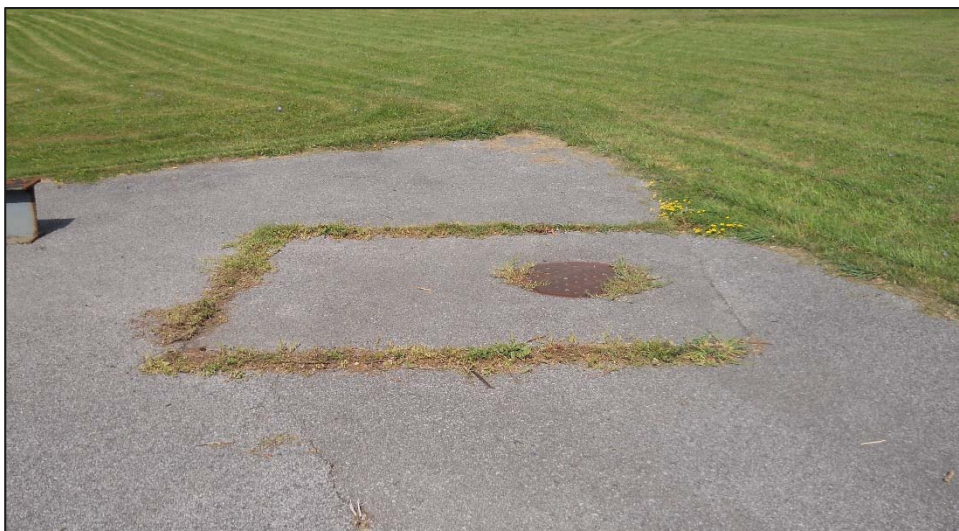
**Photo: #3**

Minor cracking and vegetation grown in western pavement.

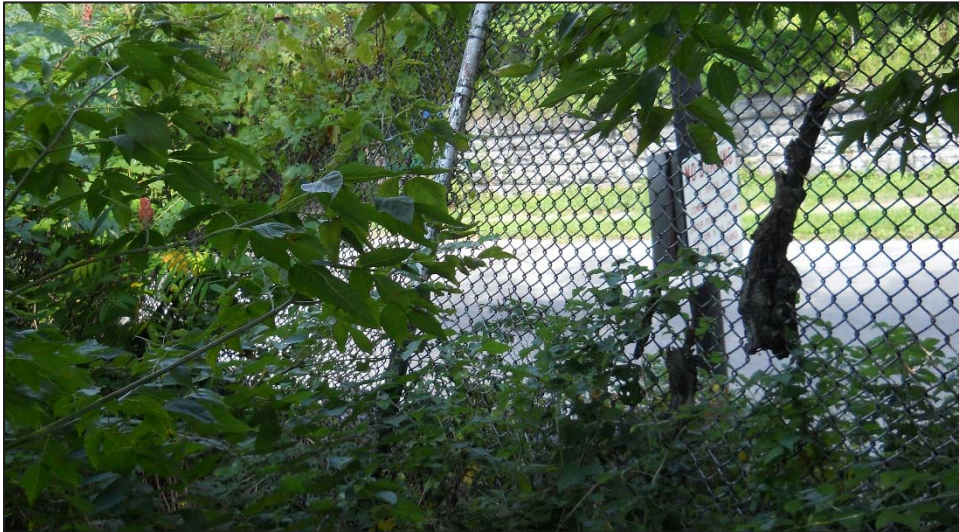
**Photo: #7**

View of leaning fence along French St. Condition appears unchanged from 2016 visit.

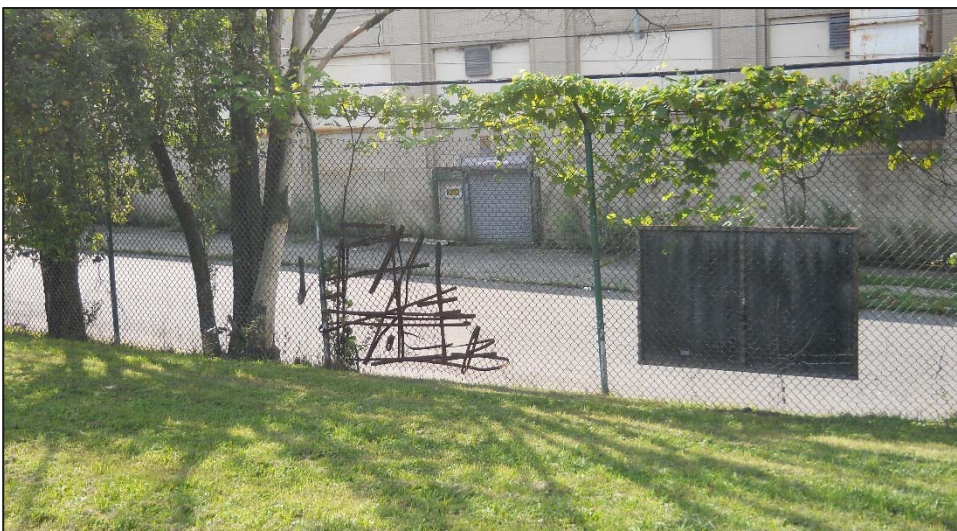
**Photo: #12**

Fence repair in perimeter fencing adjacent to Urban Street.

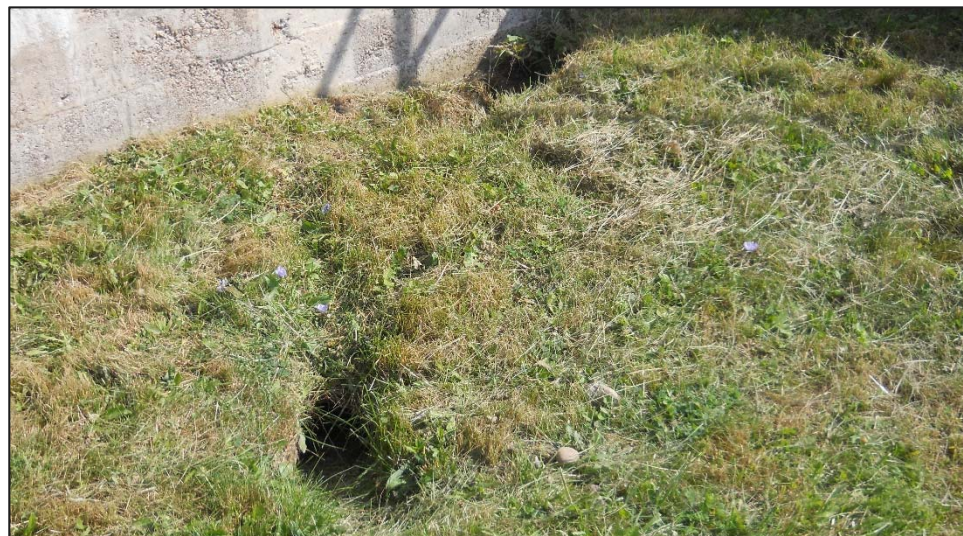
**Photo: #14**

- The grass on the southern and western portions of the site is intact and maintained. There were minor tire ruts observed near the southwest edge of the pavement that were less than an inch deep. Additionally, an animal burrow was observed on the south side of the building, adjacent to the stairs.

Animal burrow observed on the south side of the building, adjacent to the stairs.

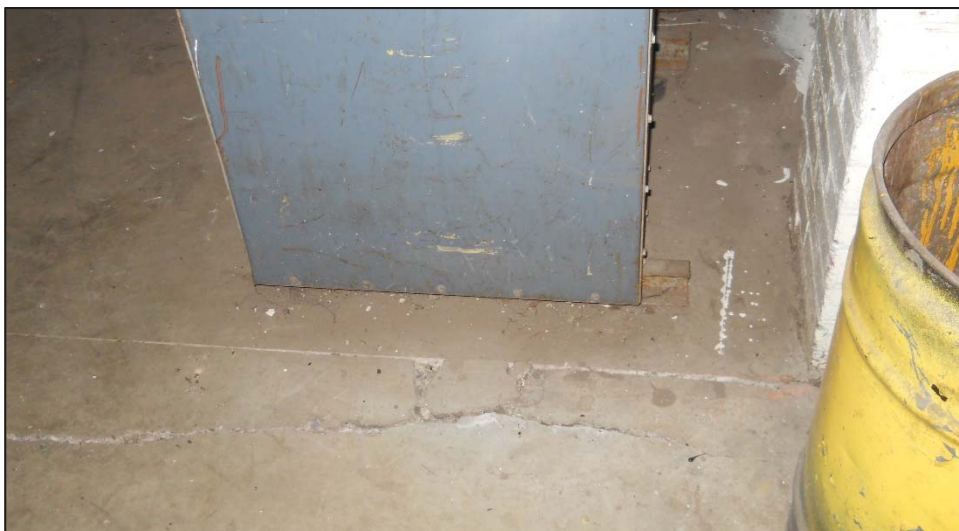
**Photo: #18**

Minor cracking in concrete flooring.
