# Periodic Review Report for August 2019 through August 2022

**318 Urban Street Site  
Erie County, New York  
NYSDEC Site Number: 9-15-151**

September 2022;  
Revised February 2023

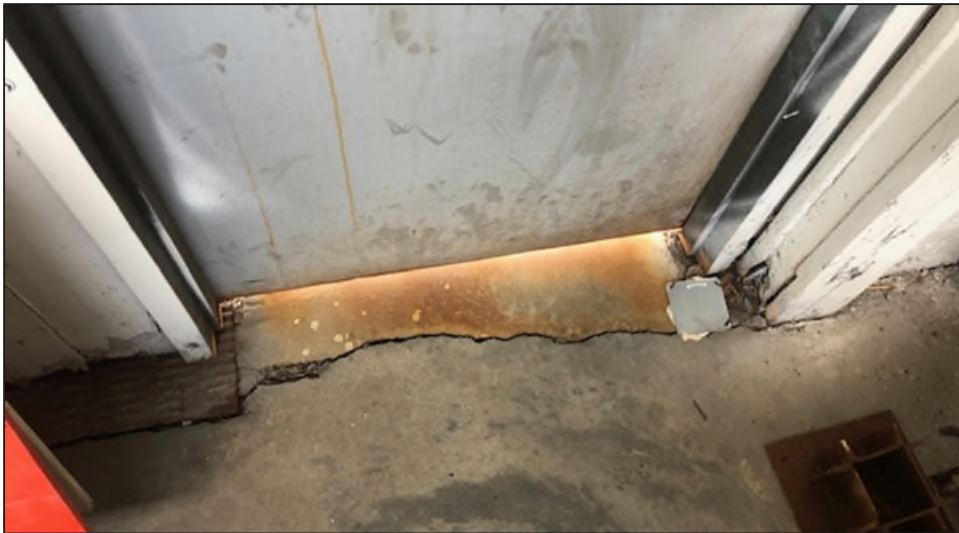
**Photo: #4**

Minor concrete cracking near entry door; condition unchanged from 2019 inspection.

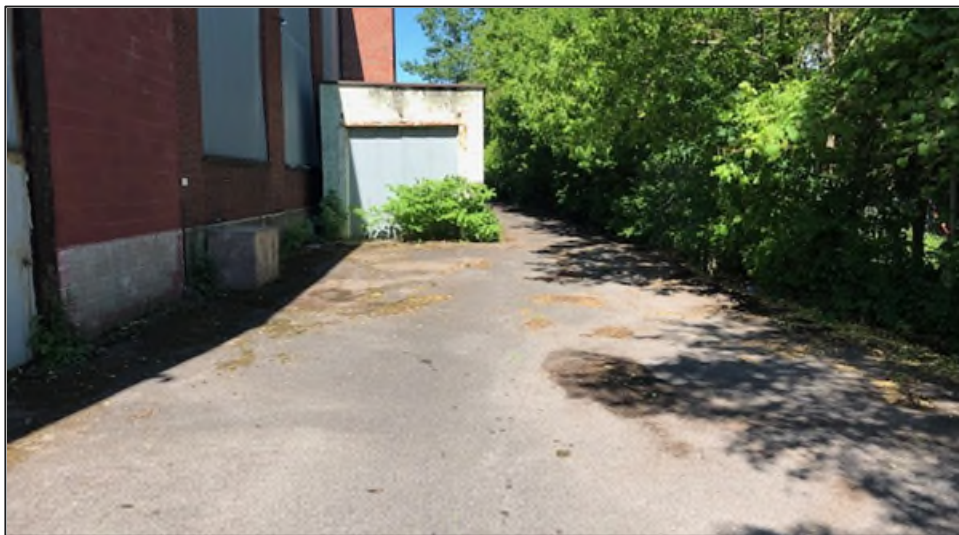
**Photo: #5**

North side of building facing west; note dense vegetation along fence line.

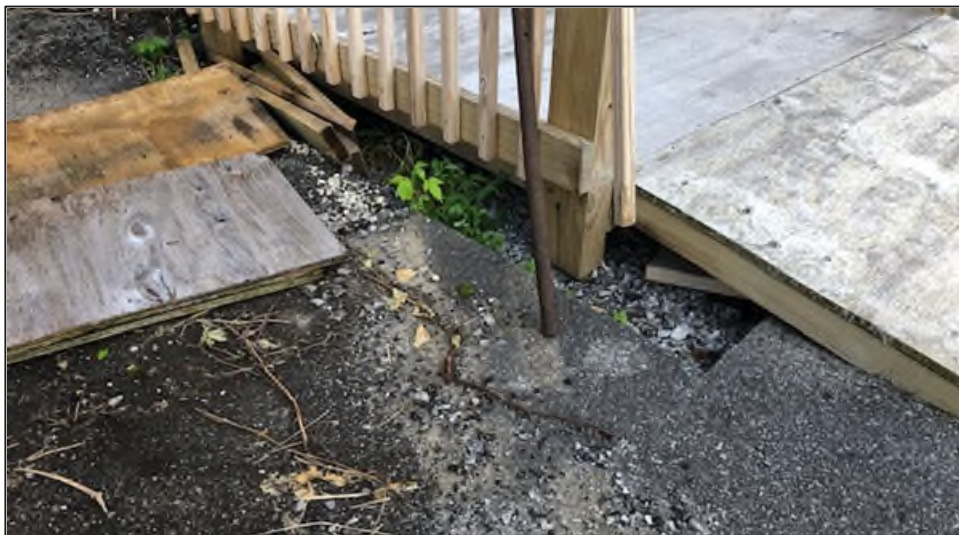
**Photo: #8**

During the June 2020 inspection Arcadis observed that a small area of asphalt adjacent to the west side of the building appeared to have been saw cut and removed to facilitate construction of an access ramp sometime between the 2018 and 2019 site inspections.<sup>1</sup> The soils in the area where the asphalt was removed were not

**Description:**  
Area where pavement was saw cut by others in constructing a handicap access ramp.

disturbed and the site cover system in this area was restored in November 2022 with the placement of concrete around and beneath the access ramp.

- As stated previously, a small area of the asphalt cover adjacent to the west side of the building was removed in constructing a new handicap access ramp sometime in 2019. Soils beneath the asphalt were not disturbed in constructing the ramp. The area where the asphalt was removed was repaired by the property owner in November 2022 with the placement of concrete beneath and around the ramp area (see photographs of repairs in Appendix B).

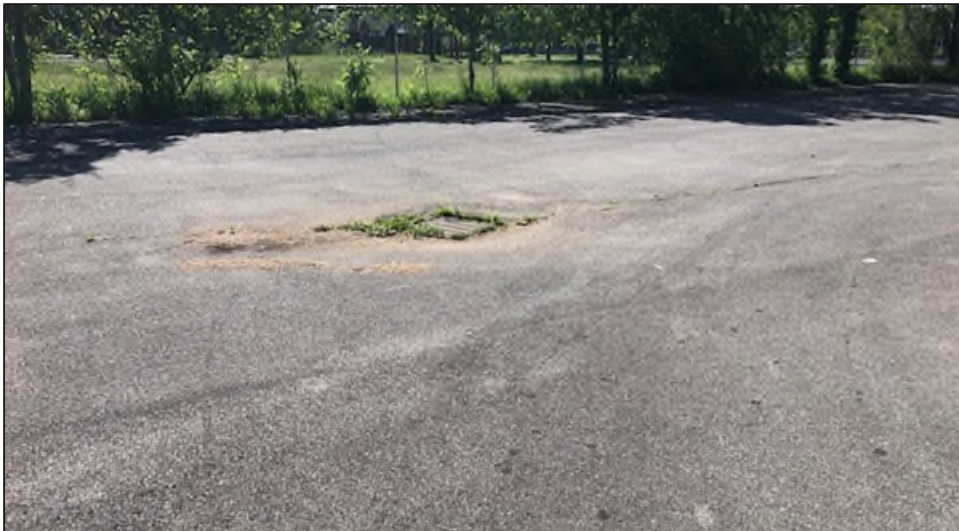
**Photo:** #10

Parking area on east side of building - minor cracking of the pavement was observed (condition generally unchanged from 2019 inspection).

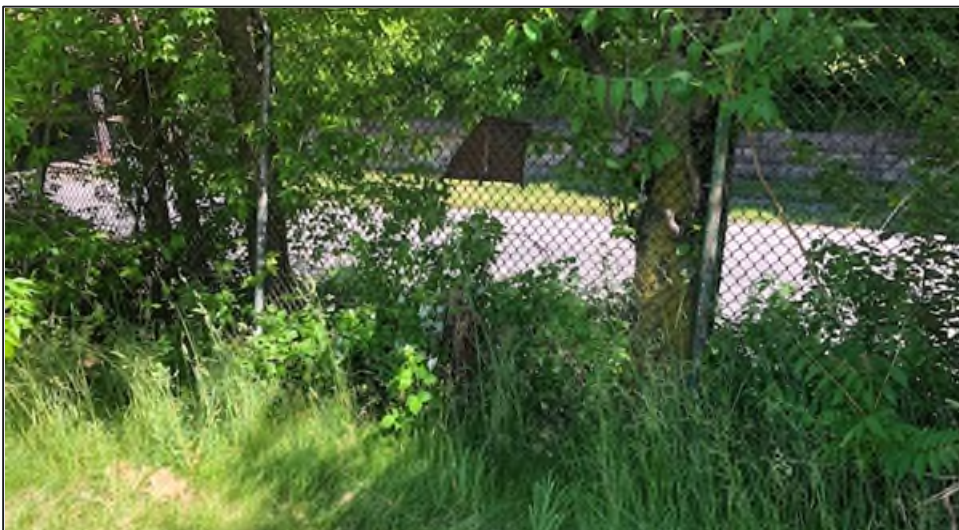
**Photo:** #12

Fence along French St. Condition appears unchanged from 2019 inspection.

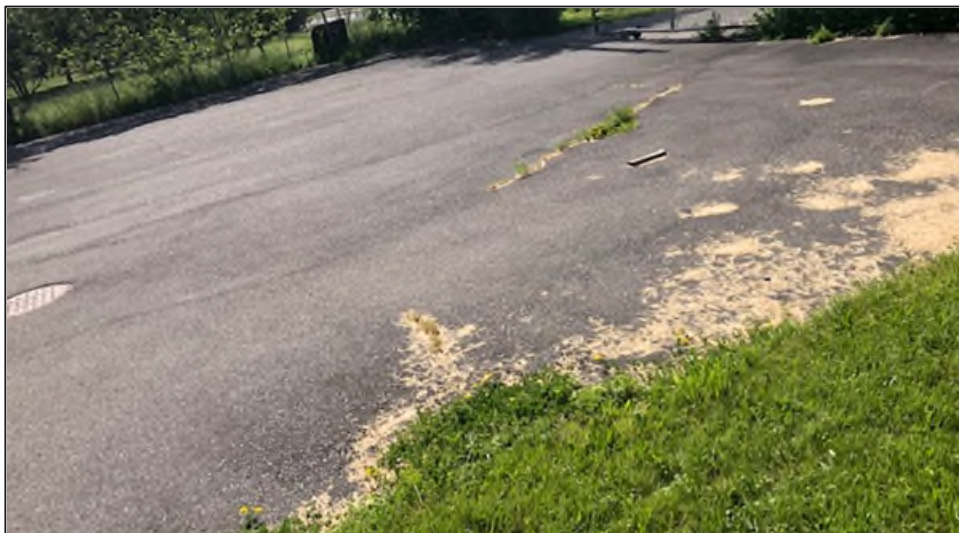
**Photo: #14**

**Description:**  
East parking area by front gate where minor cracking was observed; condition appears unchanged from 2019.

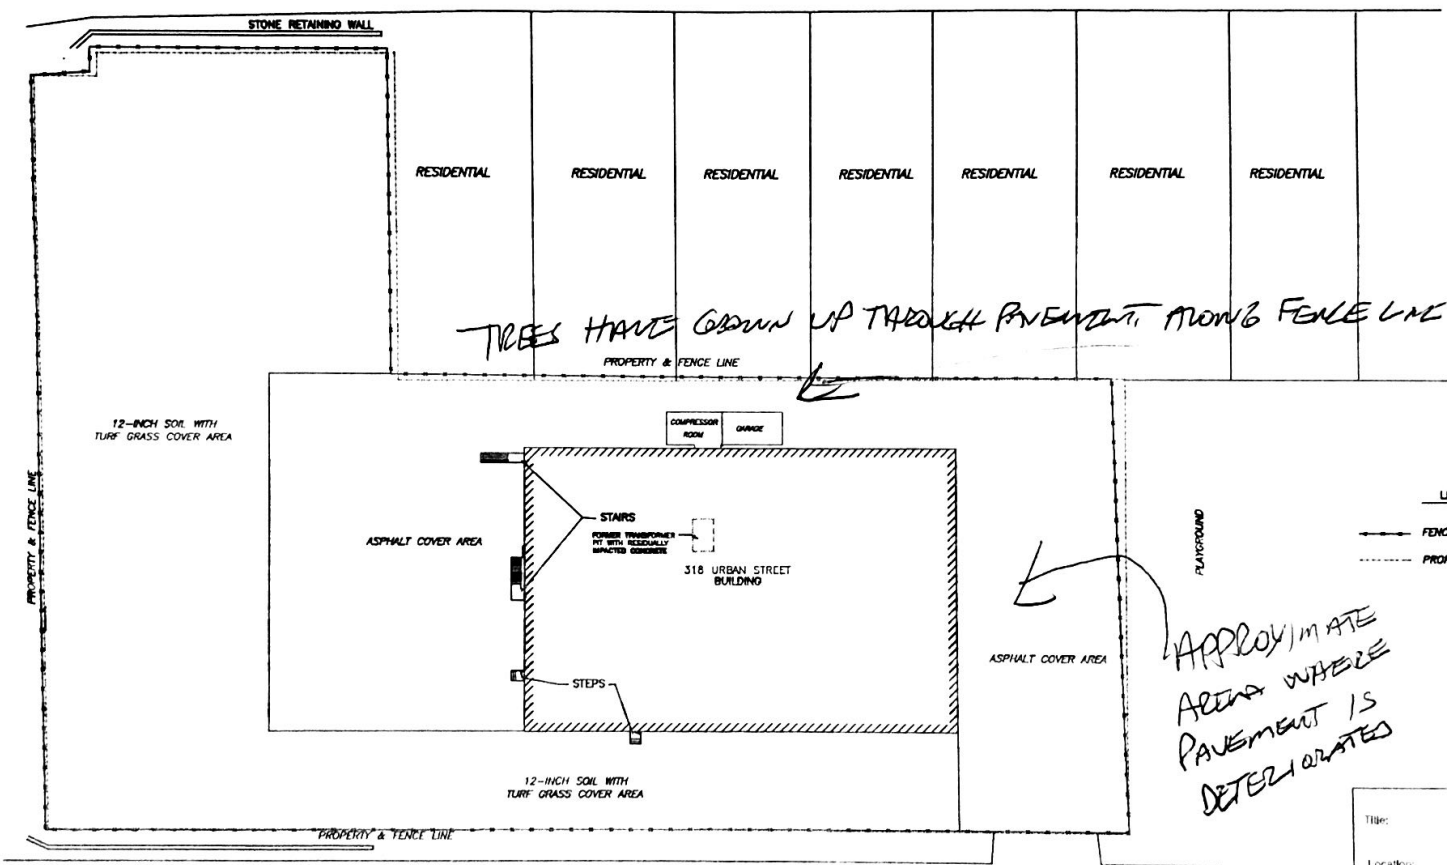
TREES HAVE GROWN UP THROUGH PAVEMENT ALONG FENCE LINE

APPROXIMATE AREAS WHERE PAVEMENT IS DETERIORATED

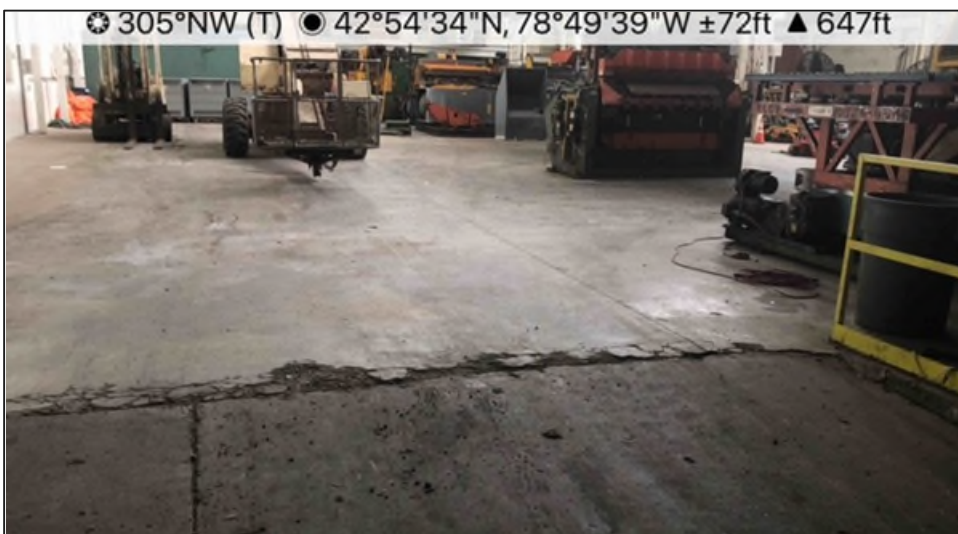
**Photo: #3**

Loading ramp with minor cracking of the concrete.

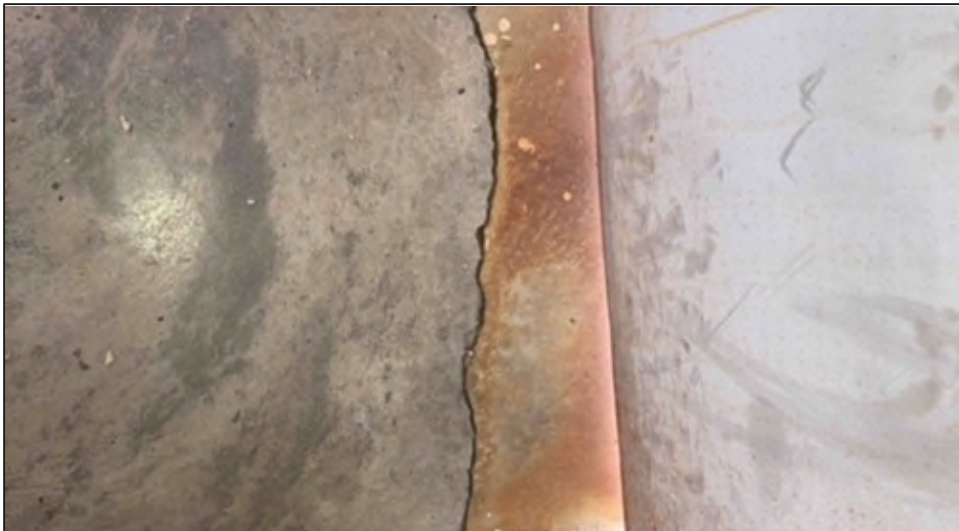
**Photo: #4**

**Description:**  
Some minor concrete cracking near entry door; condition appears unchanged from 2020 inspection.

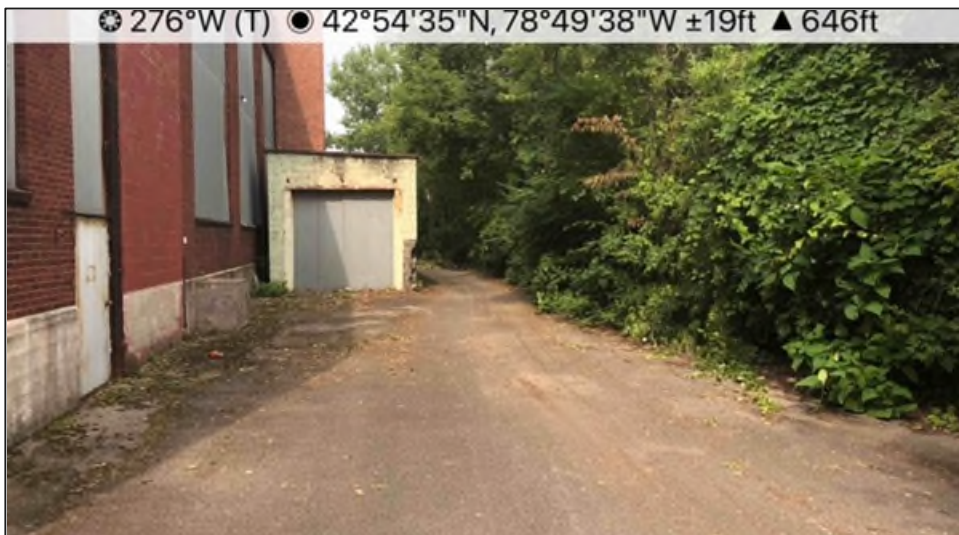
**Photo: #5**

**Description:**  
North side of building; note dense vegetation along fence line..

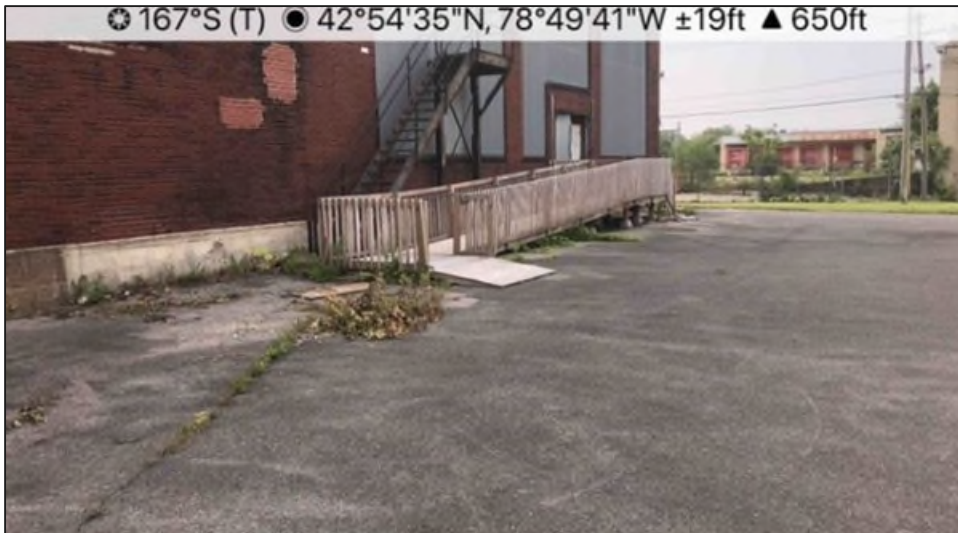
**Photo: #7**

West side of building. Minor cracking in pavement observed that appears unchanged from previous years.

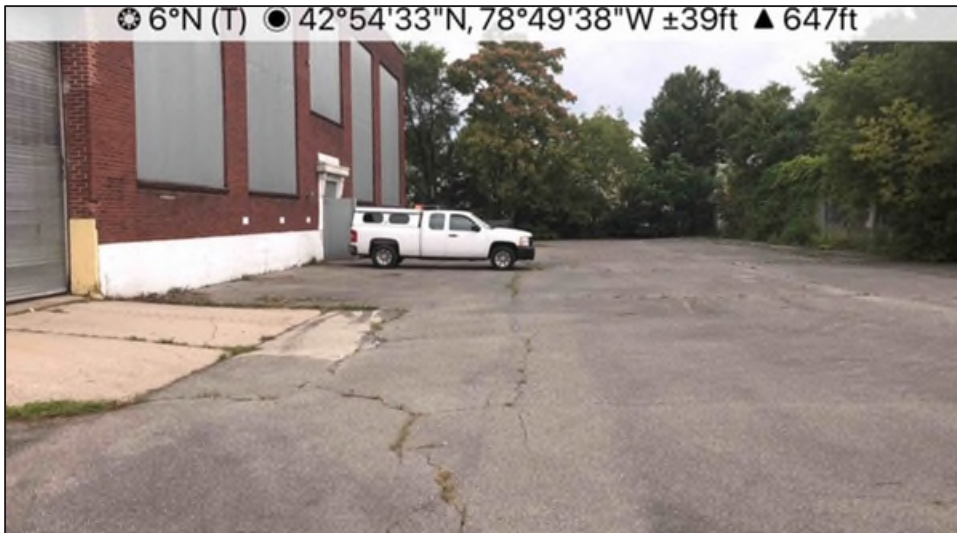
**Photo:** #10

**Description:**  
Parking area on east side of building - minor cracking of pavement observed; appears generally unchanged from 2020 inspection.

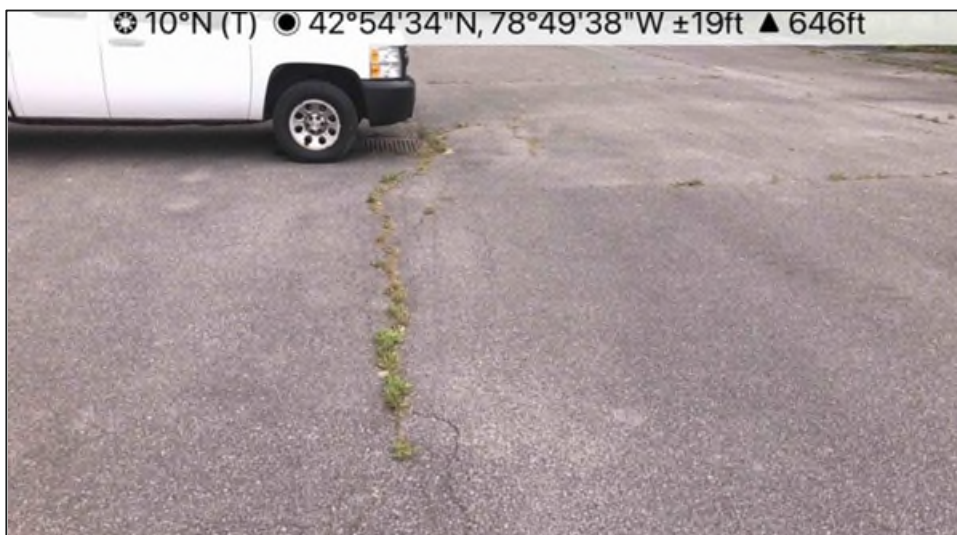
**Photo:** #11

**Description:**  
Minor cracking of pavement on east side of building; appears unchanged from 2020 inspection.

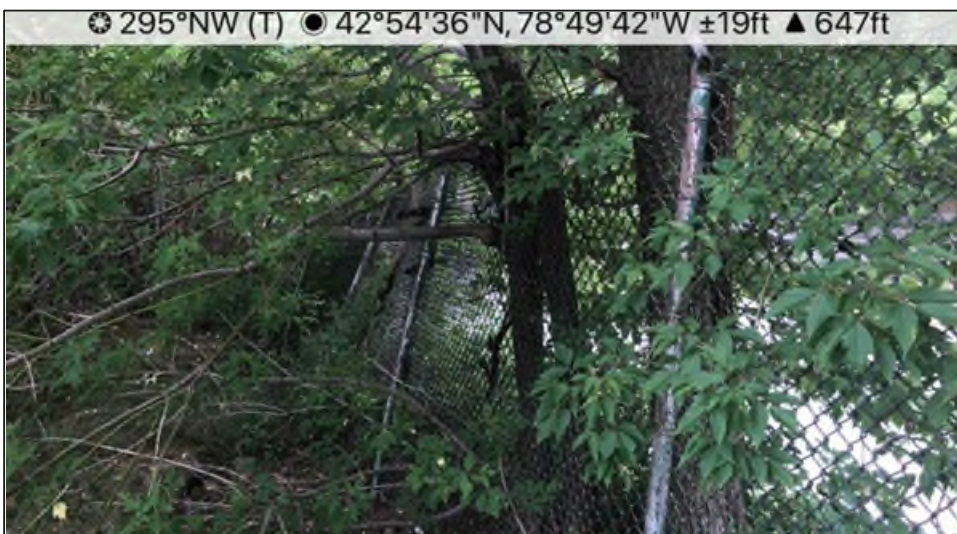
**Photo:** #12

**Description:**  
Fence along French St. Condition appears unchanged from 2020 inspection.

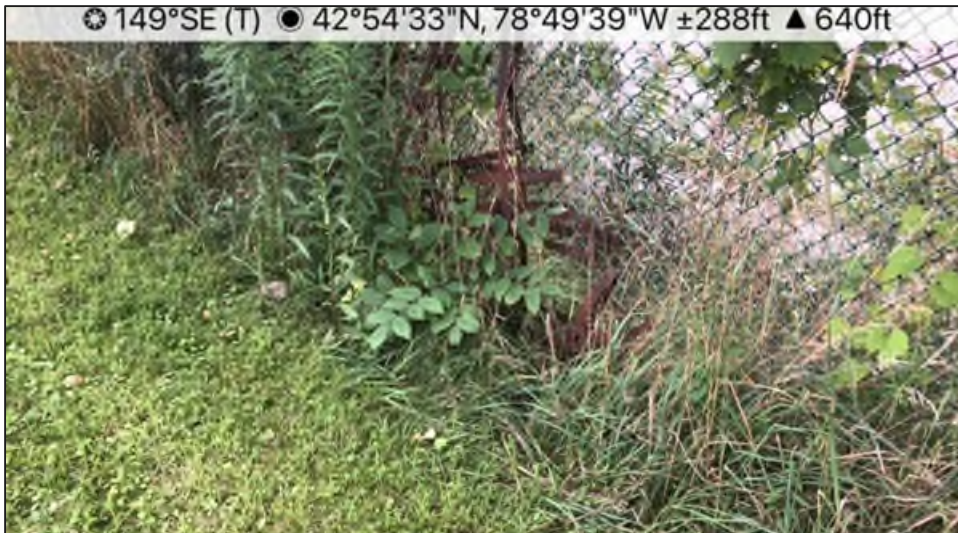
**Photo:** #13

**Description:**  
South fence line where fence was repaired. Appears unchanged from previous years.

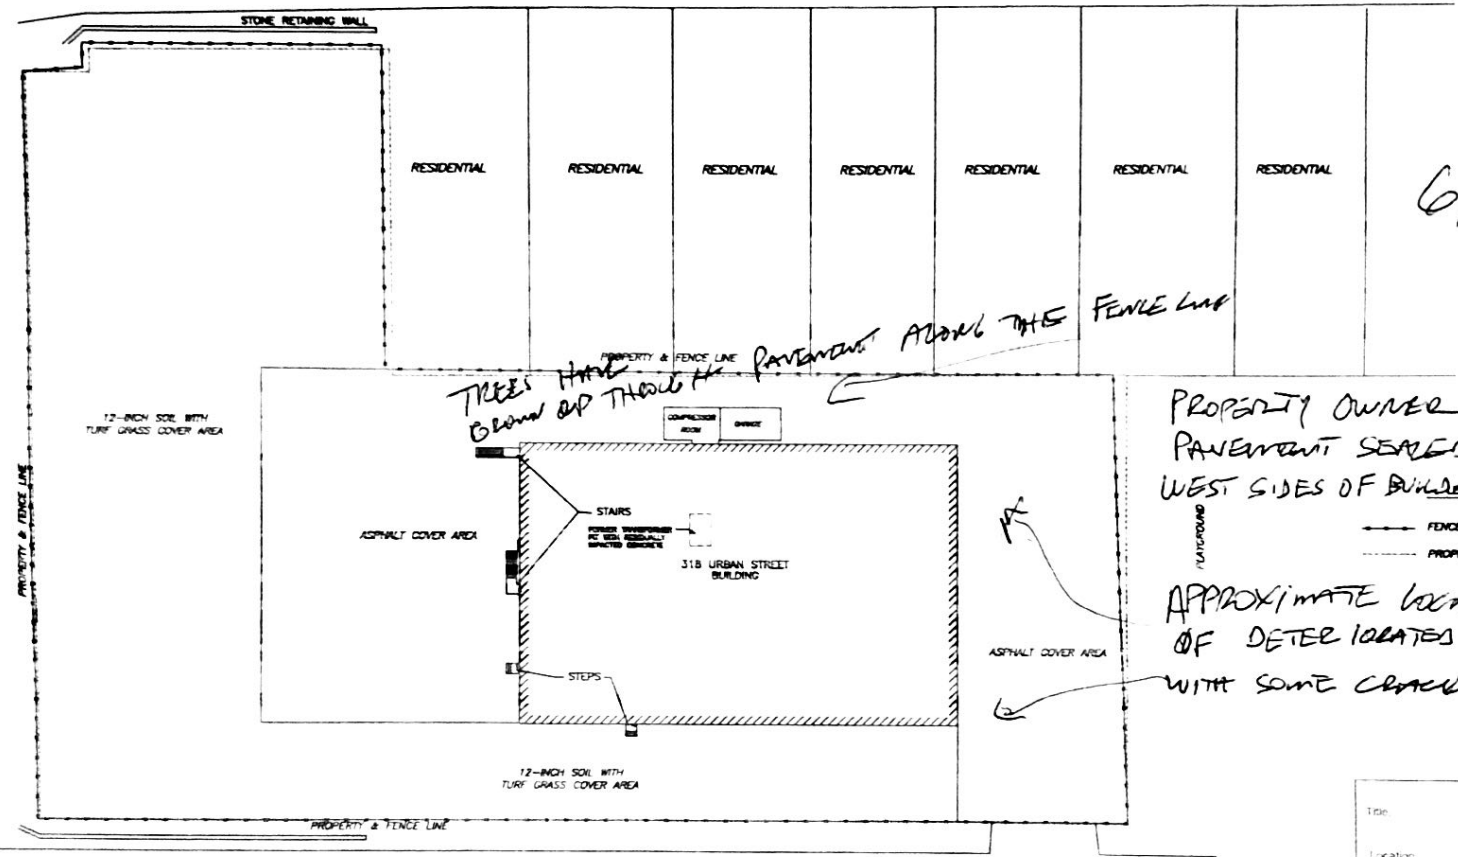
TREES HAVE  
Blown UP THROUGH THE  
PROPERTY & FENCE LINE

PAVEMENT ALONG THE FENCE LINE

APPROXIMATE LOCATION  
OF DETEER LOCATED PAVEMENT  
WITH SOME CRACKING

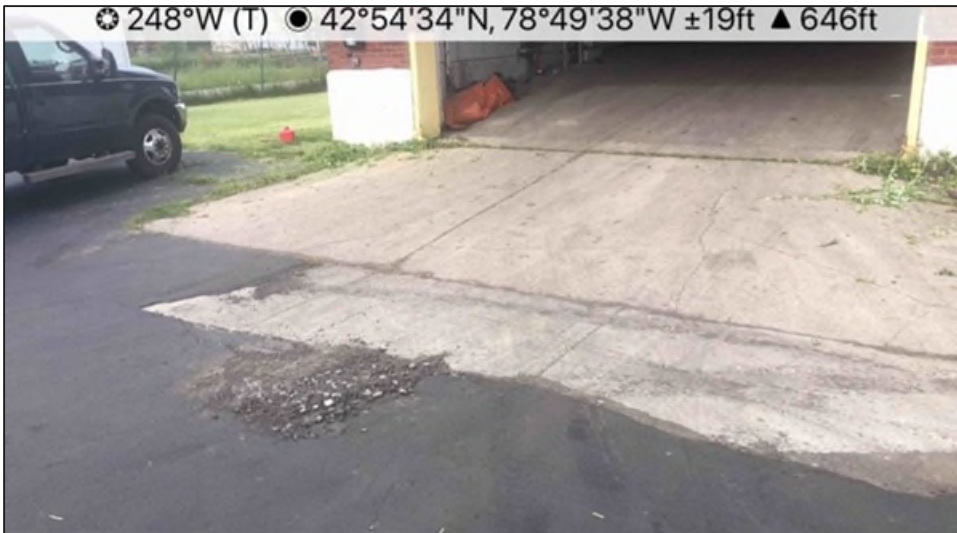
**Photo:** #4

- A small area of deteriorated asphalt was observed on east side of the building at the base of the entrance ramp to the building. This area of deteriorated asphalt was repaired by GE with asphalt cold patch on October 25, 2022 (See photographs in Appendix B)<sup>2</sup>.

**Description:**  
Area at bottom of ramp where pavement has deteriorated.

<sup>2</sup> In preparation for placement of asphalt cold patch the deteriorated asphalt and debris were cleared from the targeted repair area, revealing that a layer of concrete was present beneath the asphalt. As a conservative measure, the area was patched with asphalt nonetheless.

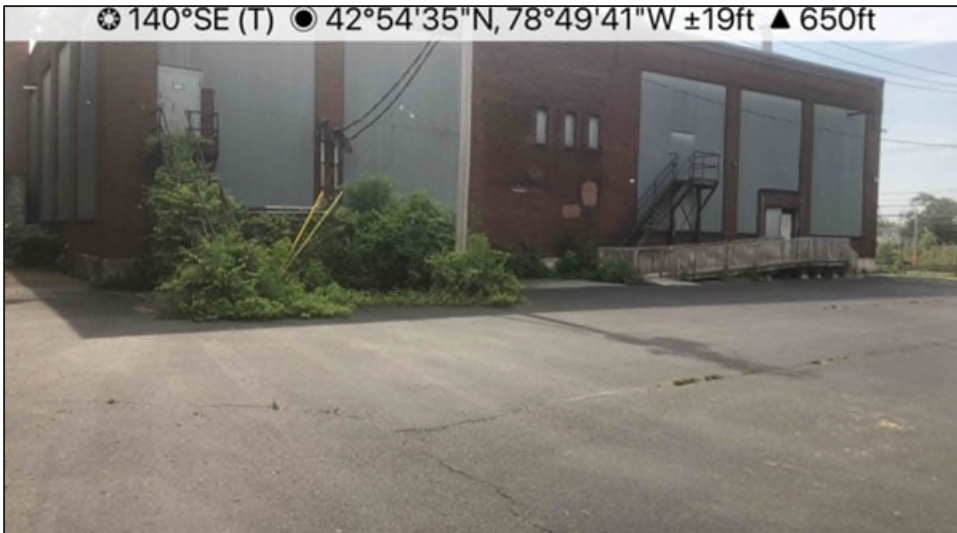
**Photo: #7**

West side of building. Minor cracking in pavement observed.

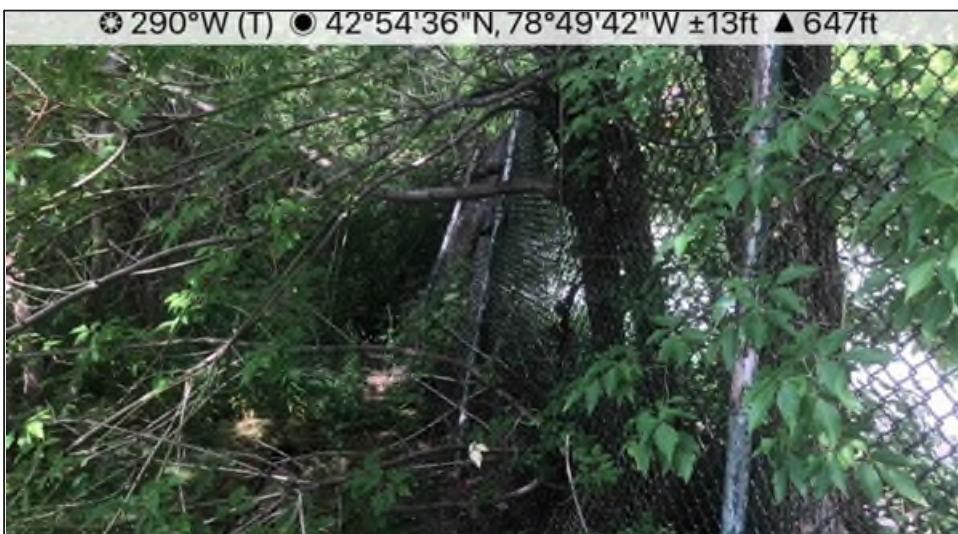
**Photo:** #12

- The fence and gate are present and functioning as intended. A section of fence in the north part of the property along French St. was leaning but the fence remains functional (condition appears unchanged from previous inspections).

Fence along French St. Condition appears unchanged from 2021 inspection.

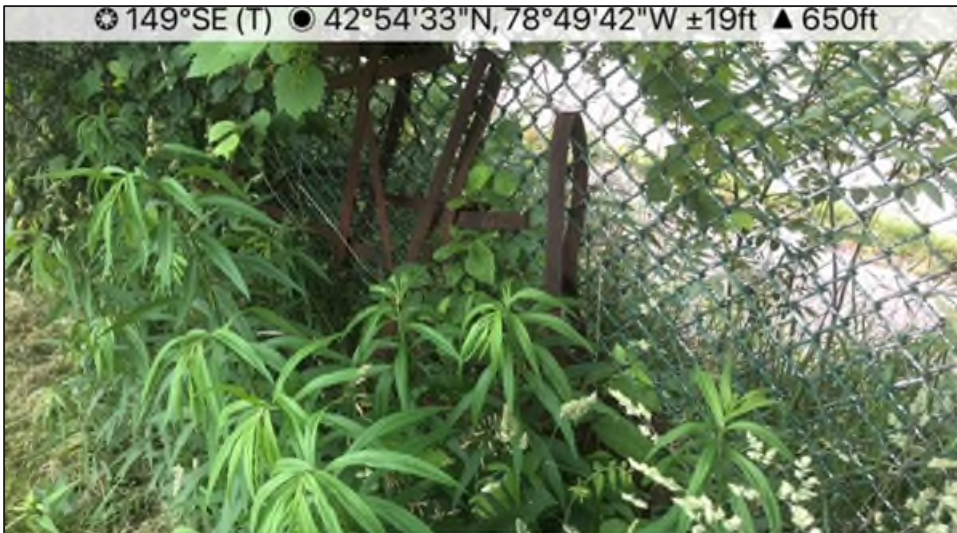
**Photo:** #13

**Description:**  
South fence line where fence was repaired. Condition appears unchanged from previous years.
