**Re: Revised Periodic Review Report and IC/EC Certification  
318 Urban Street  
Buffalo, New York  
NYSDEC Site No. 915151**

# Periodic Review Report – August 2022 to August 2025

**318 Urban Street Site  
Erie County, New York  
NYSDEC Site Number: 9-15-151**

September 2025  
Revised October 2025

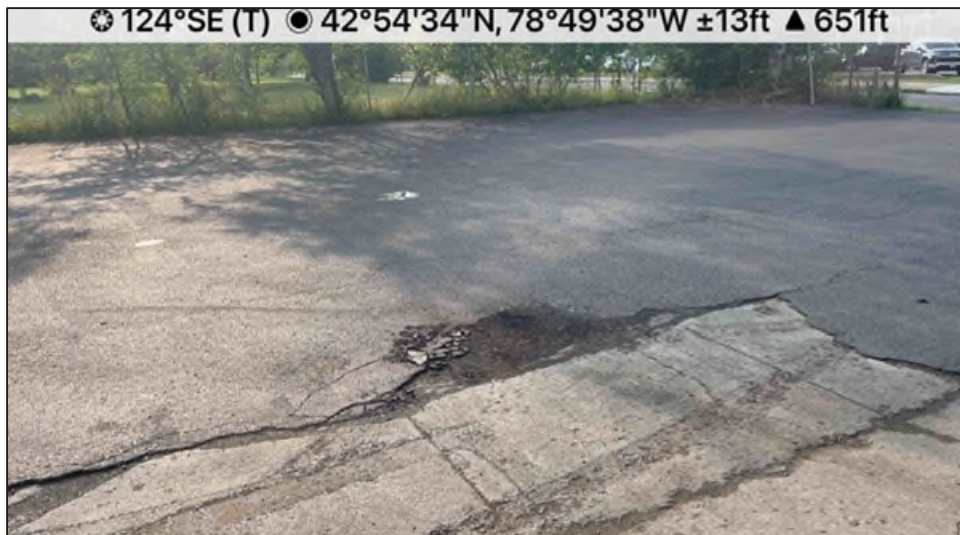
**Photo: #4**

Area at bottom of ramp where pavement has deteriorated.

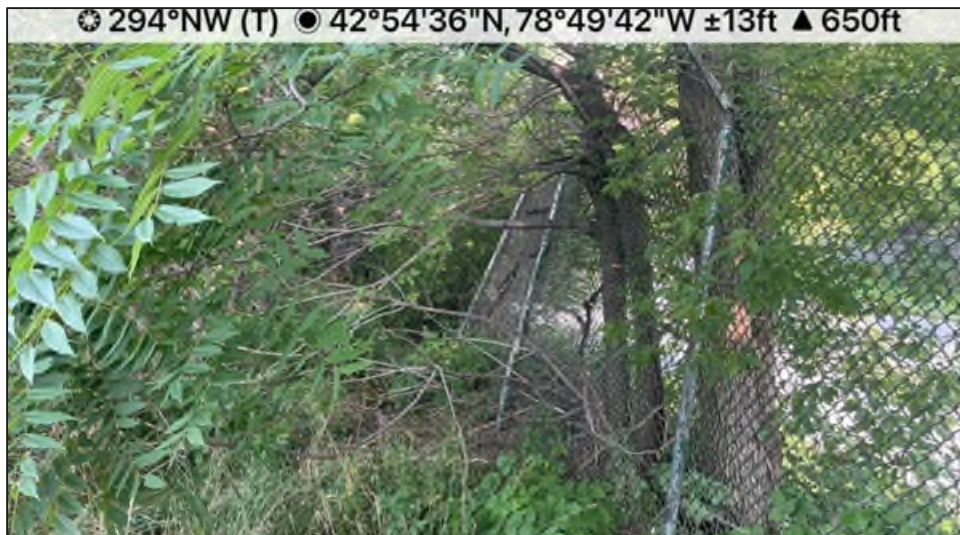
**Photo: #7**

Fence along French St.  
Condition appears unchanged  
from 2022 inspection.

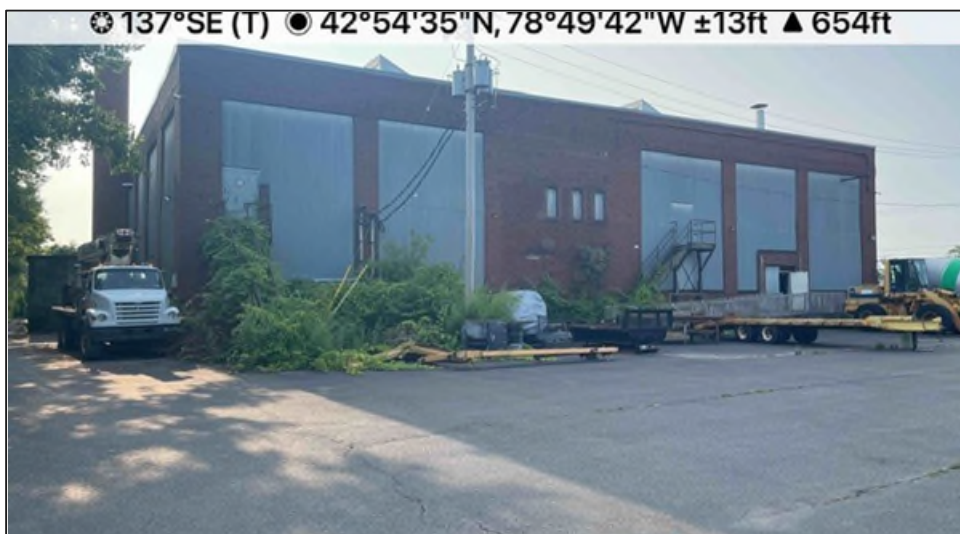
**Photo: #9**

West side of building; minor  
cracking in pavement  
observed.

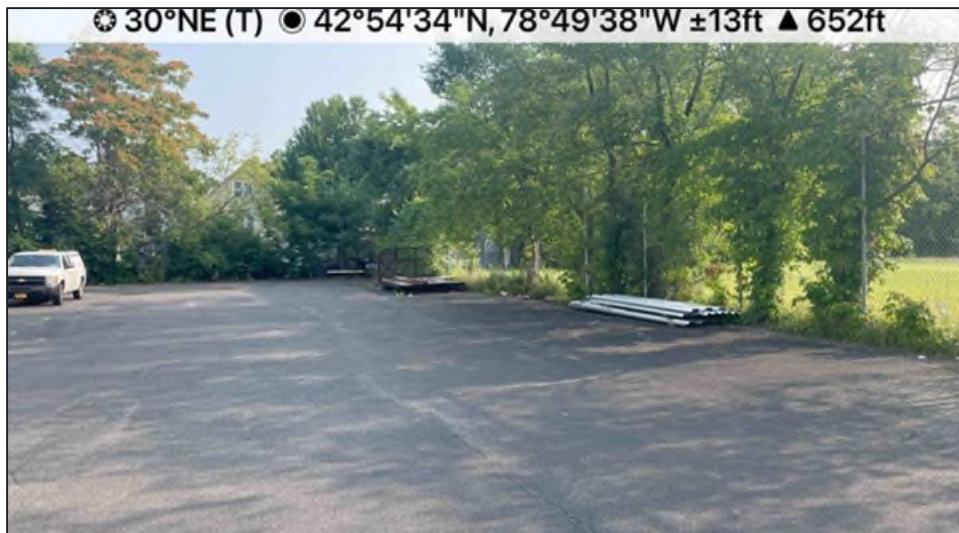
**Photo: #13**

Parking area on east side of building; minor cracking in pavement observed.

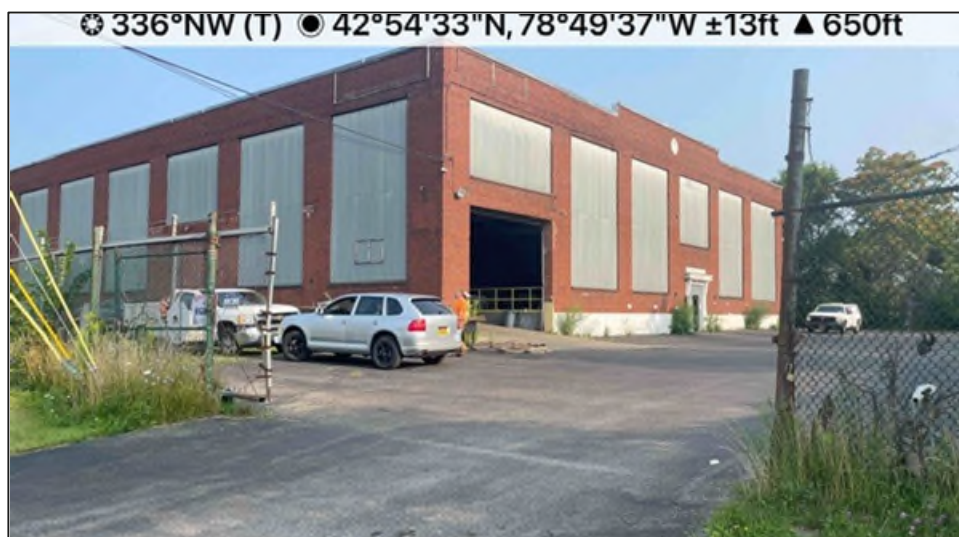
**Photo: #14**

East side of building; minor cracking in pavement observed.

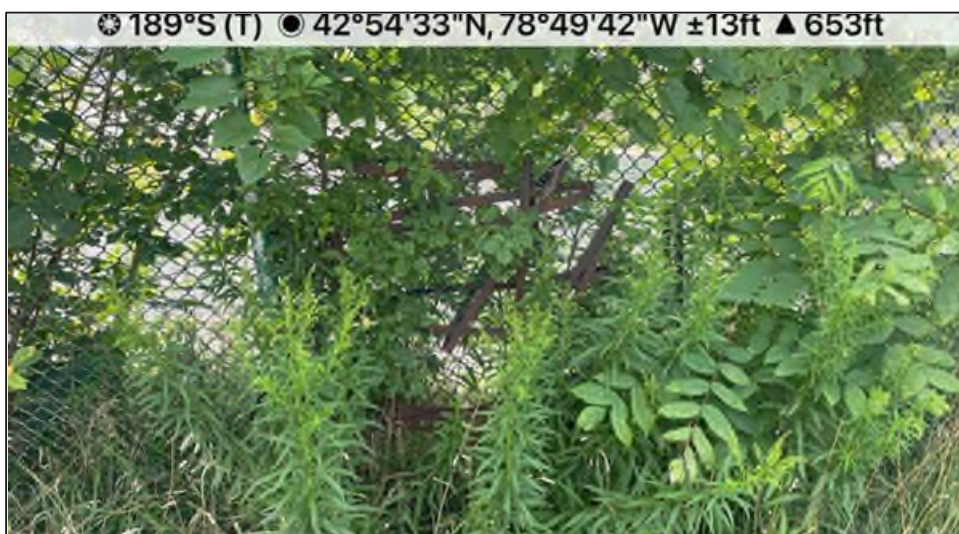
**Photo: #15**

South fence line where fence was repaired; condition appears unchanged from previous years.

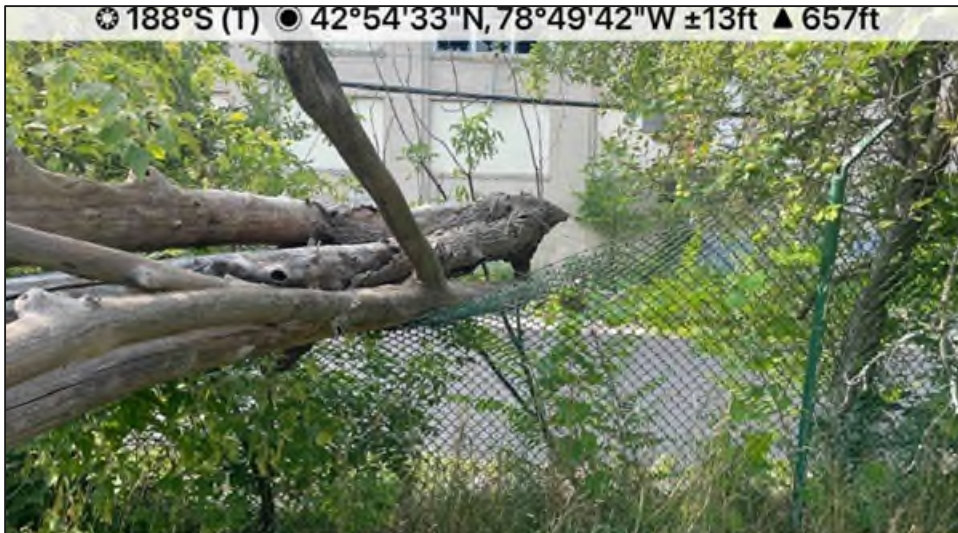
Photo: #16

South fence line; fallen tree lying on fence.

FOUND HOLE CUT IN FENCE ON WEST SIDE OF SITE, ADJACENT TO CSX TRACKS. RECOMMEND REPAIR  
LARGE DEAD TREE LYING ON SOUTH SIDE FENCE ALONG URBAN ST

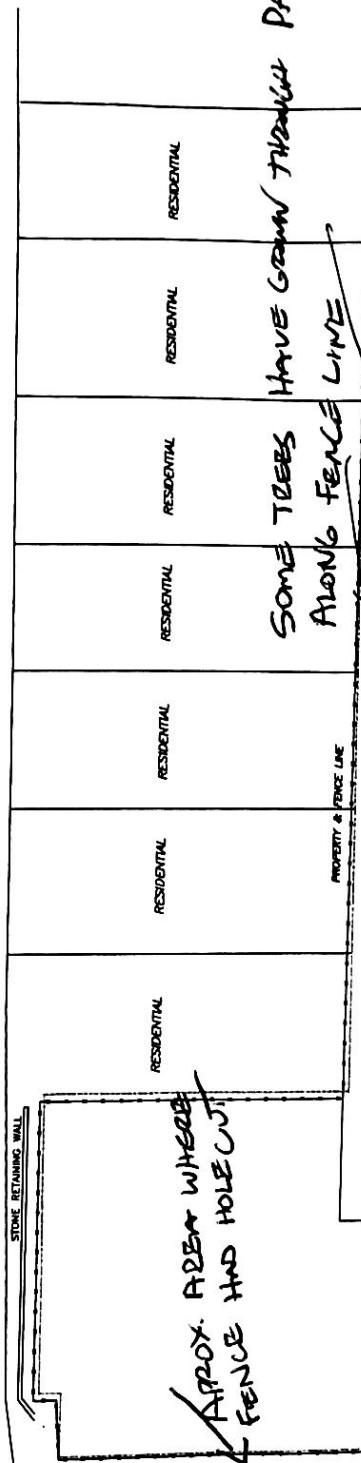
APPROX. AREA WHERE FENCE HAD HOLE CUT

SOME TREES HAVE GROWN THICKER ALONG FENCE LINE

SOME CRACKING IN PAVEMENT

APPROXIMATE LOCATION OF DETERIORATED PAVEMENT WITH SOME CRACKING

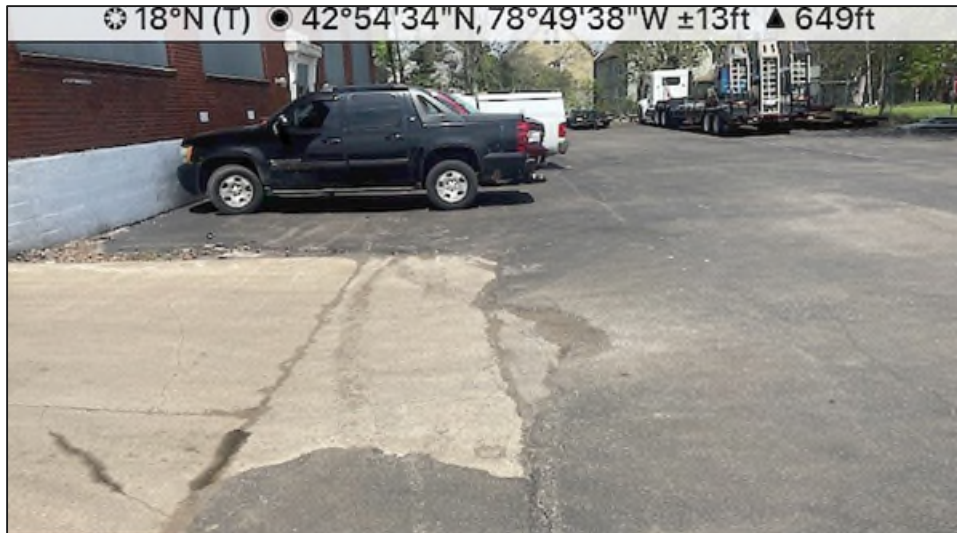
**Photo: #4**

**Description:**  
Area at bottom of ramp  
where pavement has been  
patched.

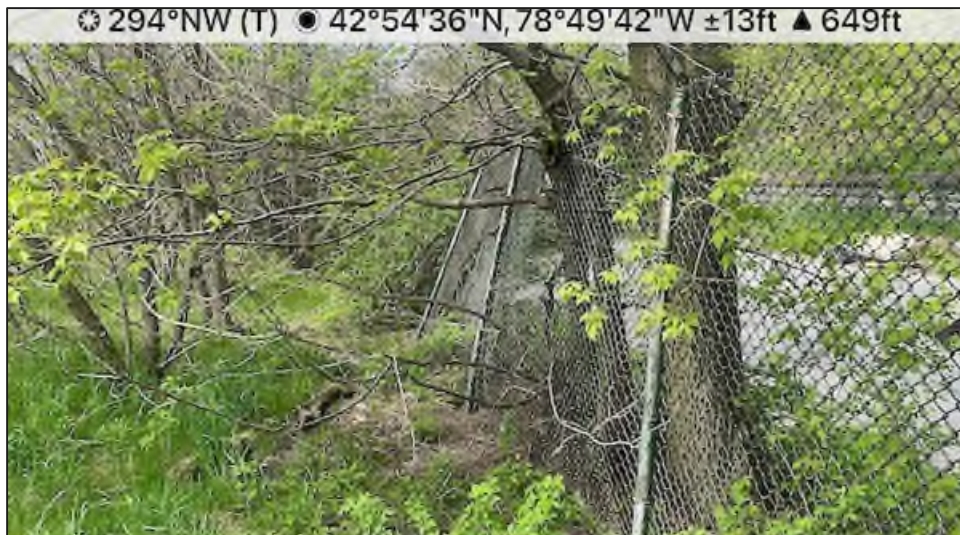
**Photo: #7**

Fence along French St.  
Condition appears unchanged  
from 2023 inspection.

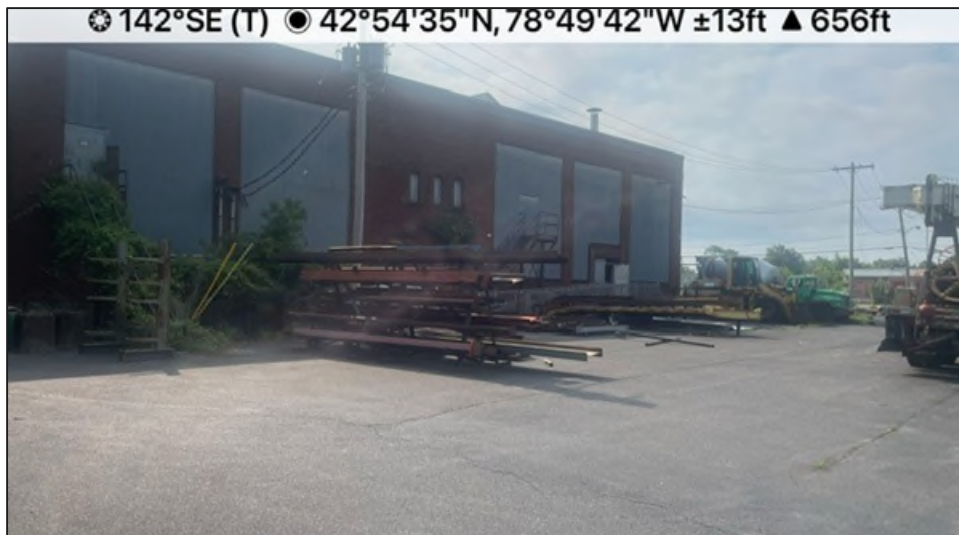
**Photo: #10**

West side of building; minor cracking in pavement observed.

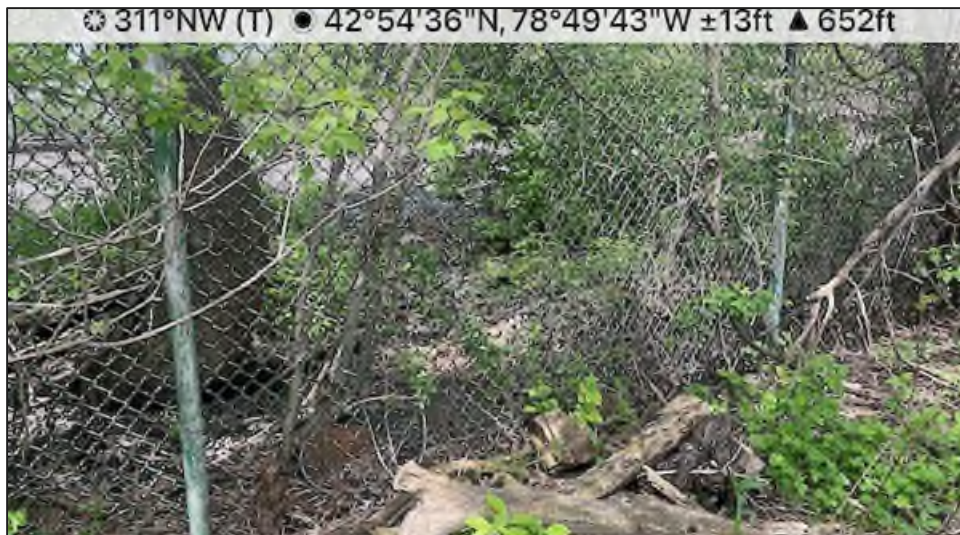
**Photo: #13**

Fence along CSX railway; hole cut in fence.

| <b>Inspection Form</b><br>318 Urban Street, Buffalo, New York<br>NYSDEC Site Number: 9-15-151 | | | |
|---|--|---|--|
| <u>- HOLE IN WEST FENCE LINE ADJACENT TO CSX TRACKS. REPAIRS RECOMMEND REPAIR.</u> | | | |

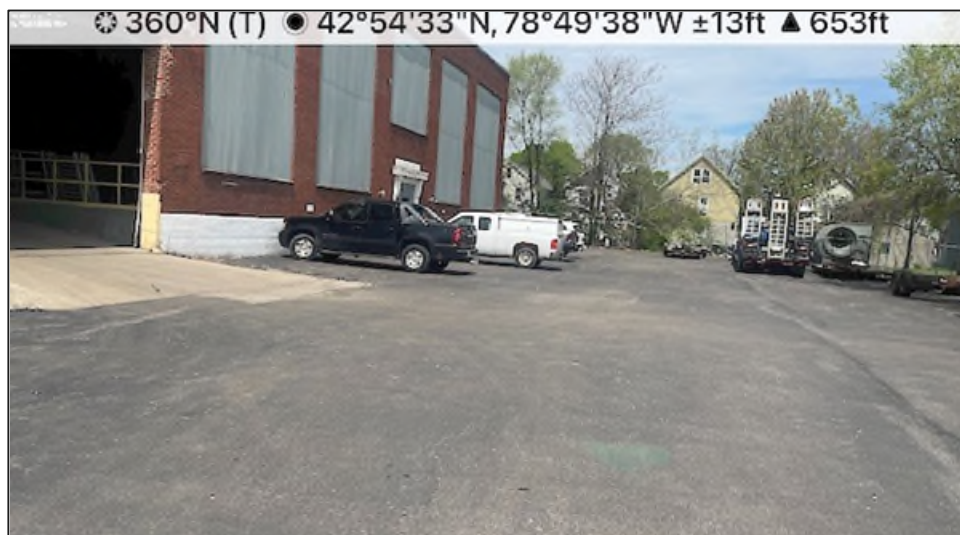
**Photo: #14**

Parking area on east side of building; minor cracking in pavement observed.

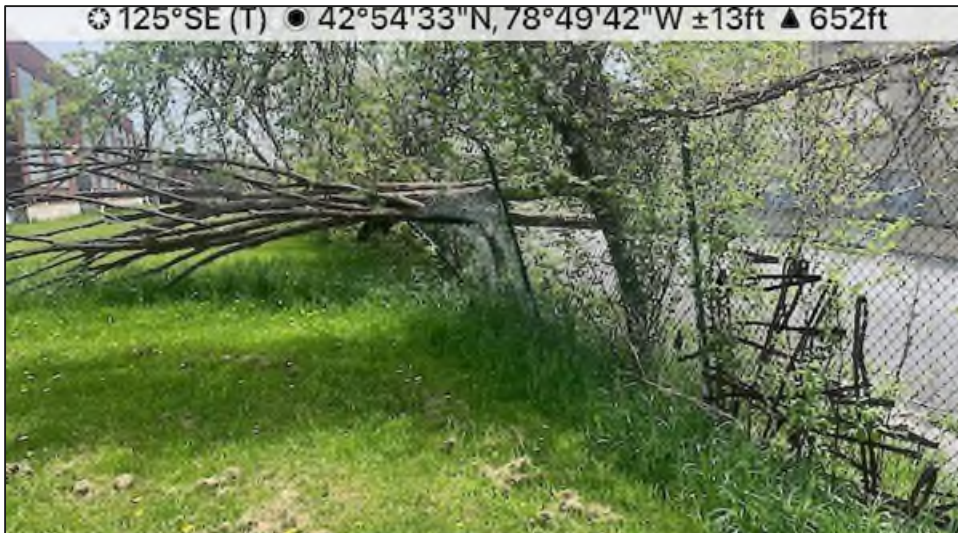
**Photo: #16**

South fence line where fence was repaired; fallen tree lying on fence.

- HOLE IN WEST FENCE LINE ADJACENT TO C&D TRAILS, RECOMMENDED REPAIR
- LARGE DEAD TREE LAYING ON SOUTH SIDE OF FENCE ALONG URBAN ST.

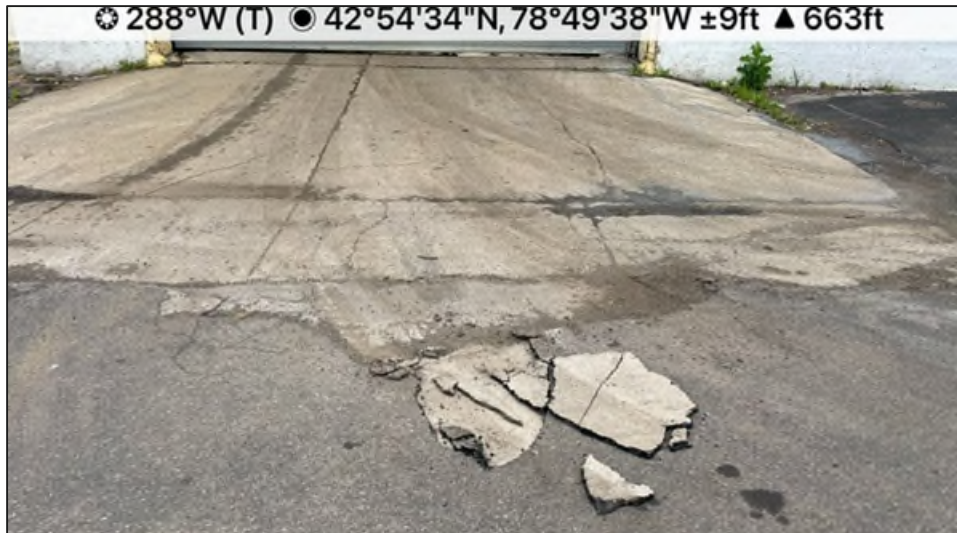
**Photo: #4**

Area at bottom of ramp where pavement has deteriorated.

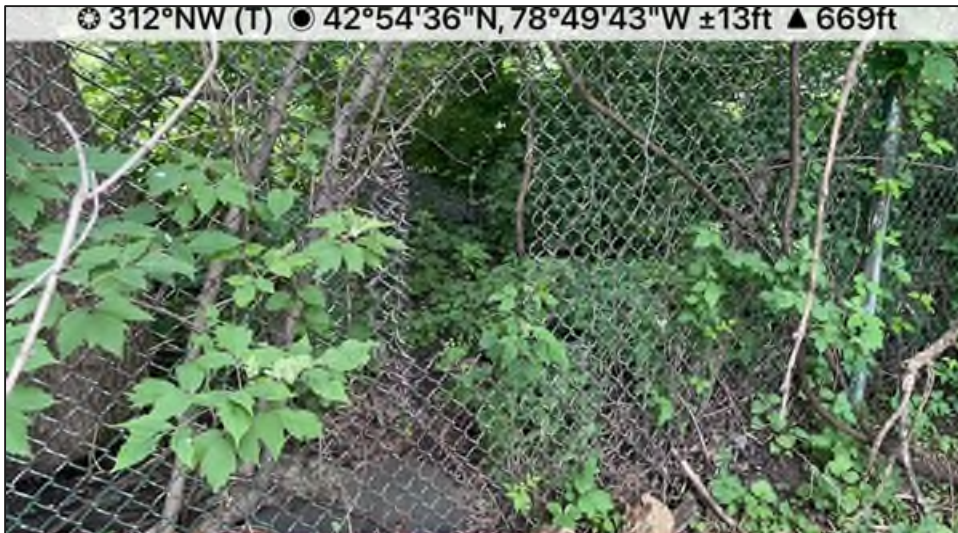
**Photo: #13**

Fence along CSX railway; hole cut in fence.

Based on the inspections, the soil/asphalt/concrete cover system continues to remain effective in preventing exposure to residually impacted soil. Site use remains industrial, in compliance with the ICs. Therefore, the Site remedy (including the IC/ECs) continues to be protective of public health and the environment. GE has recommended to the property owner that a fallen tree in contact with the south fence line be removed, and that the hole in the fence on the western side of the property be repaired as soon as practicable.

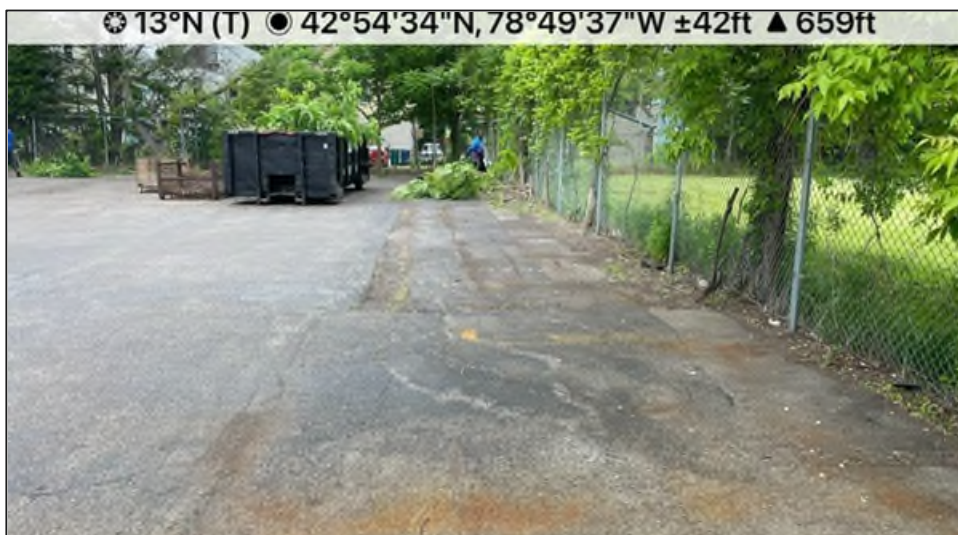
**Photo: #14**

Parking area on east side of building; minor cracking in pavement observed.

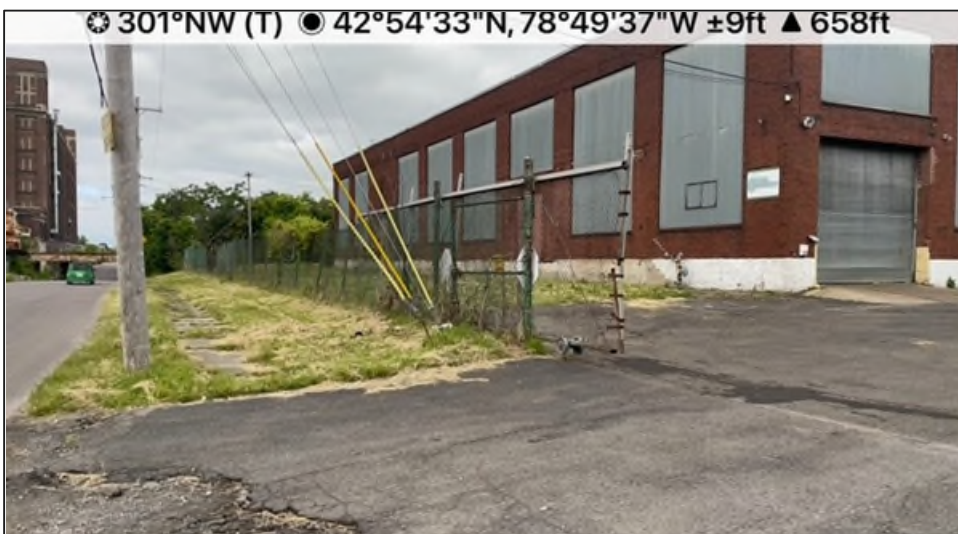
**Photo: #15**

Site entrance; pavement deterioration observed.

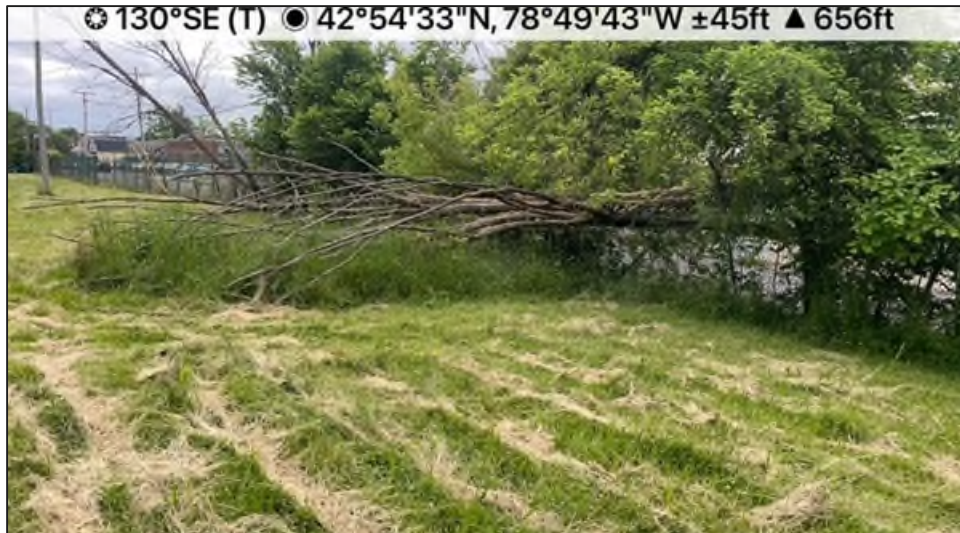
**Photo: #16**

South fence line where fence was repaired; fallen tree lying on fence.
