**Evaluation of the Former GM – Saginaw Facility Investigations**

**Niagara Mohawk Power Corporation  
300 Erie Boulevard West  
Syracuse, New York 13202  
Kensington Terminal Station, Buffalo, New York**

**Geomatrix Consultants Inc.  
336 Harris Hill Road, Ste. 100  
Williamsville, NY 14221  
(716) 565-0624**

**Project B4295  
December 22, 1997**

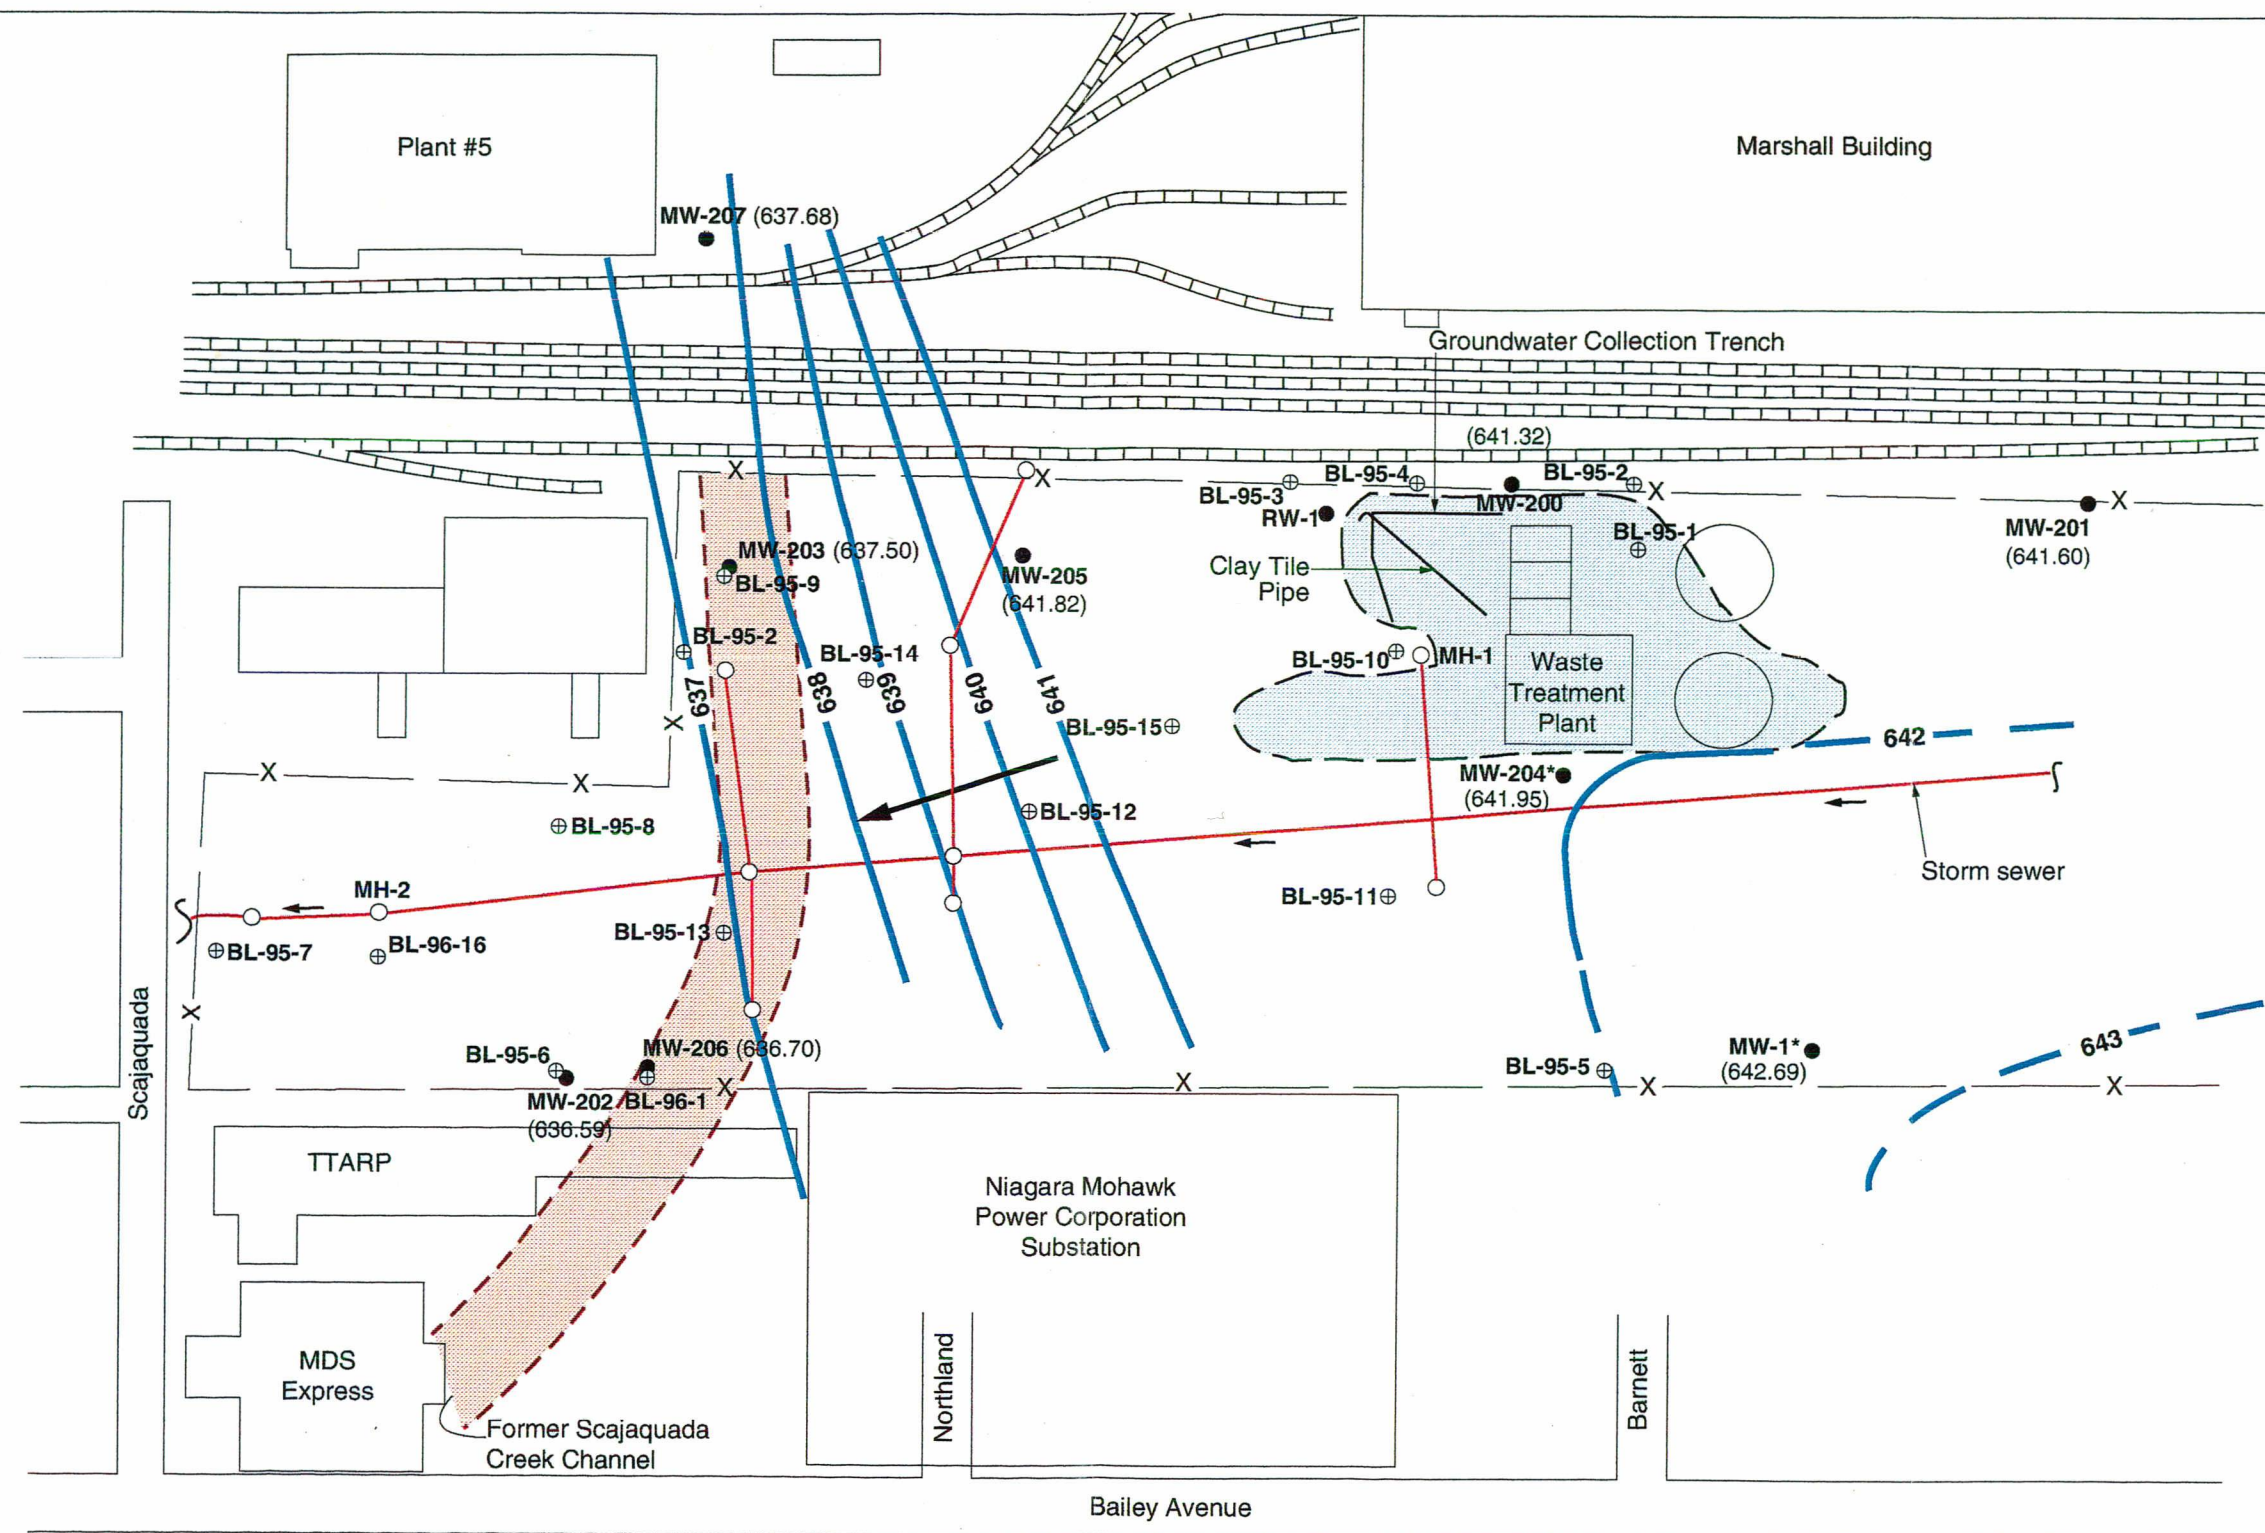
Figure  
7

The distribution of oil-stained soil samples collected from soil borings in the vicinity of the source area is shown in Figures 6 and 7. The extent of oil shown on the figures was established by Geomatrix from a review of borehole logs indicating the presence of oil-laden soil or sheens present in split spoon soil samples. Analytical test results of these oily soils indicate that PCBs are constituents present in the free-phase oil and can potentially migrate with the movement of oil and groundwater. Laboratory analysis identified Aroclor 1242, 1248, and 1260 in soil and groundwater samples collected from the source area. As shown in the figures, oily soils were not present in the vicinity of MH-1. This was confirmed by excavation and repair of a portion of the sewer lateral in 1995 which extended 5 to 10 feet to the east of MH-1. However, borings located east of MH-1 in the vicinity of the sewer lateral (i.e., BL-12) identified the presence of oily soils. Oily soils in this area indicate a strong potential for sewer bedding contamination east of MH-1; beyond the area of sewer lateral repair. Investigation of sewer bedding beyond the sewer lateral repair was not documented in the Site Investigation Report or reports provided to the NYSDEC for NMPC review. Sewer bedding materials often act as migratory pathways for contamination from source areas.

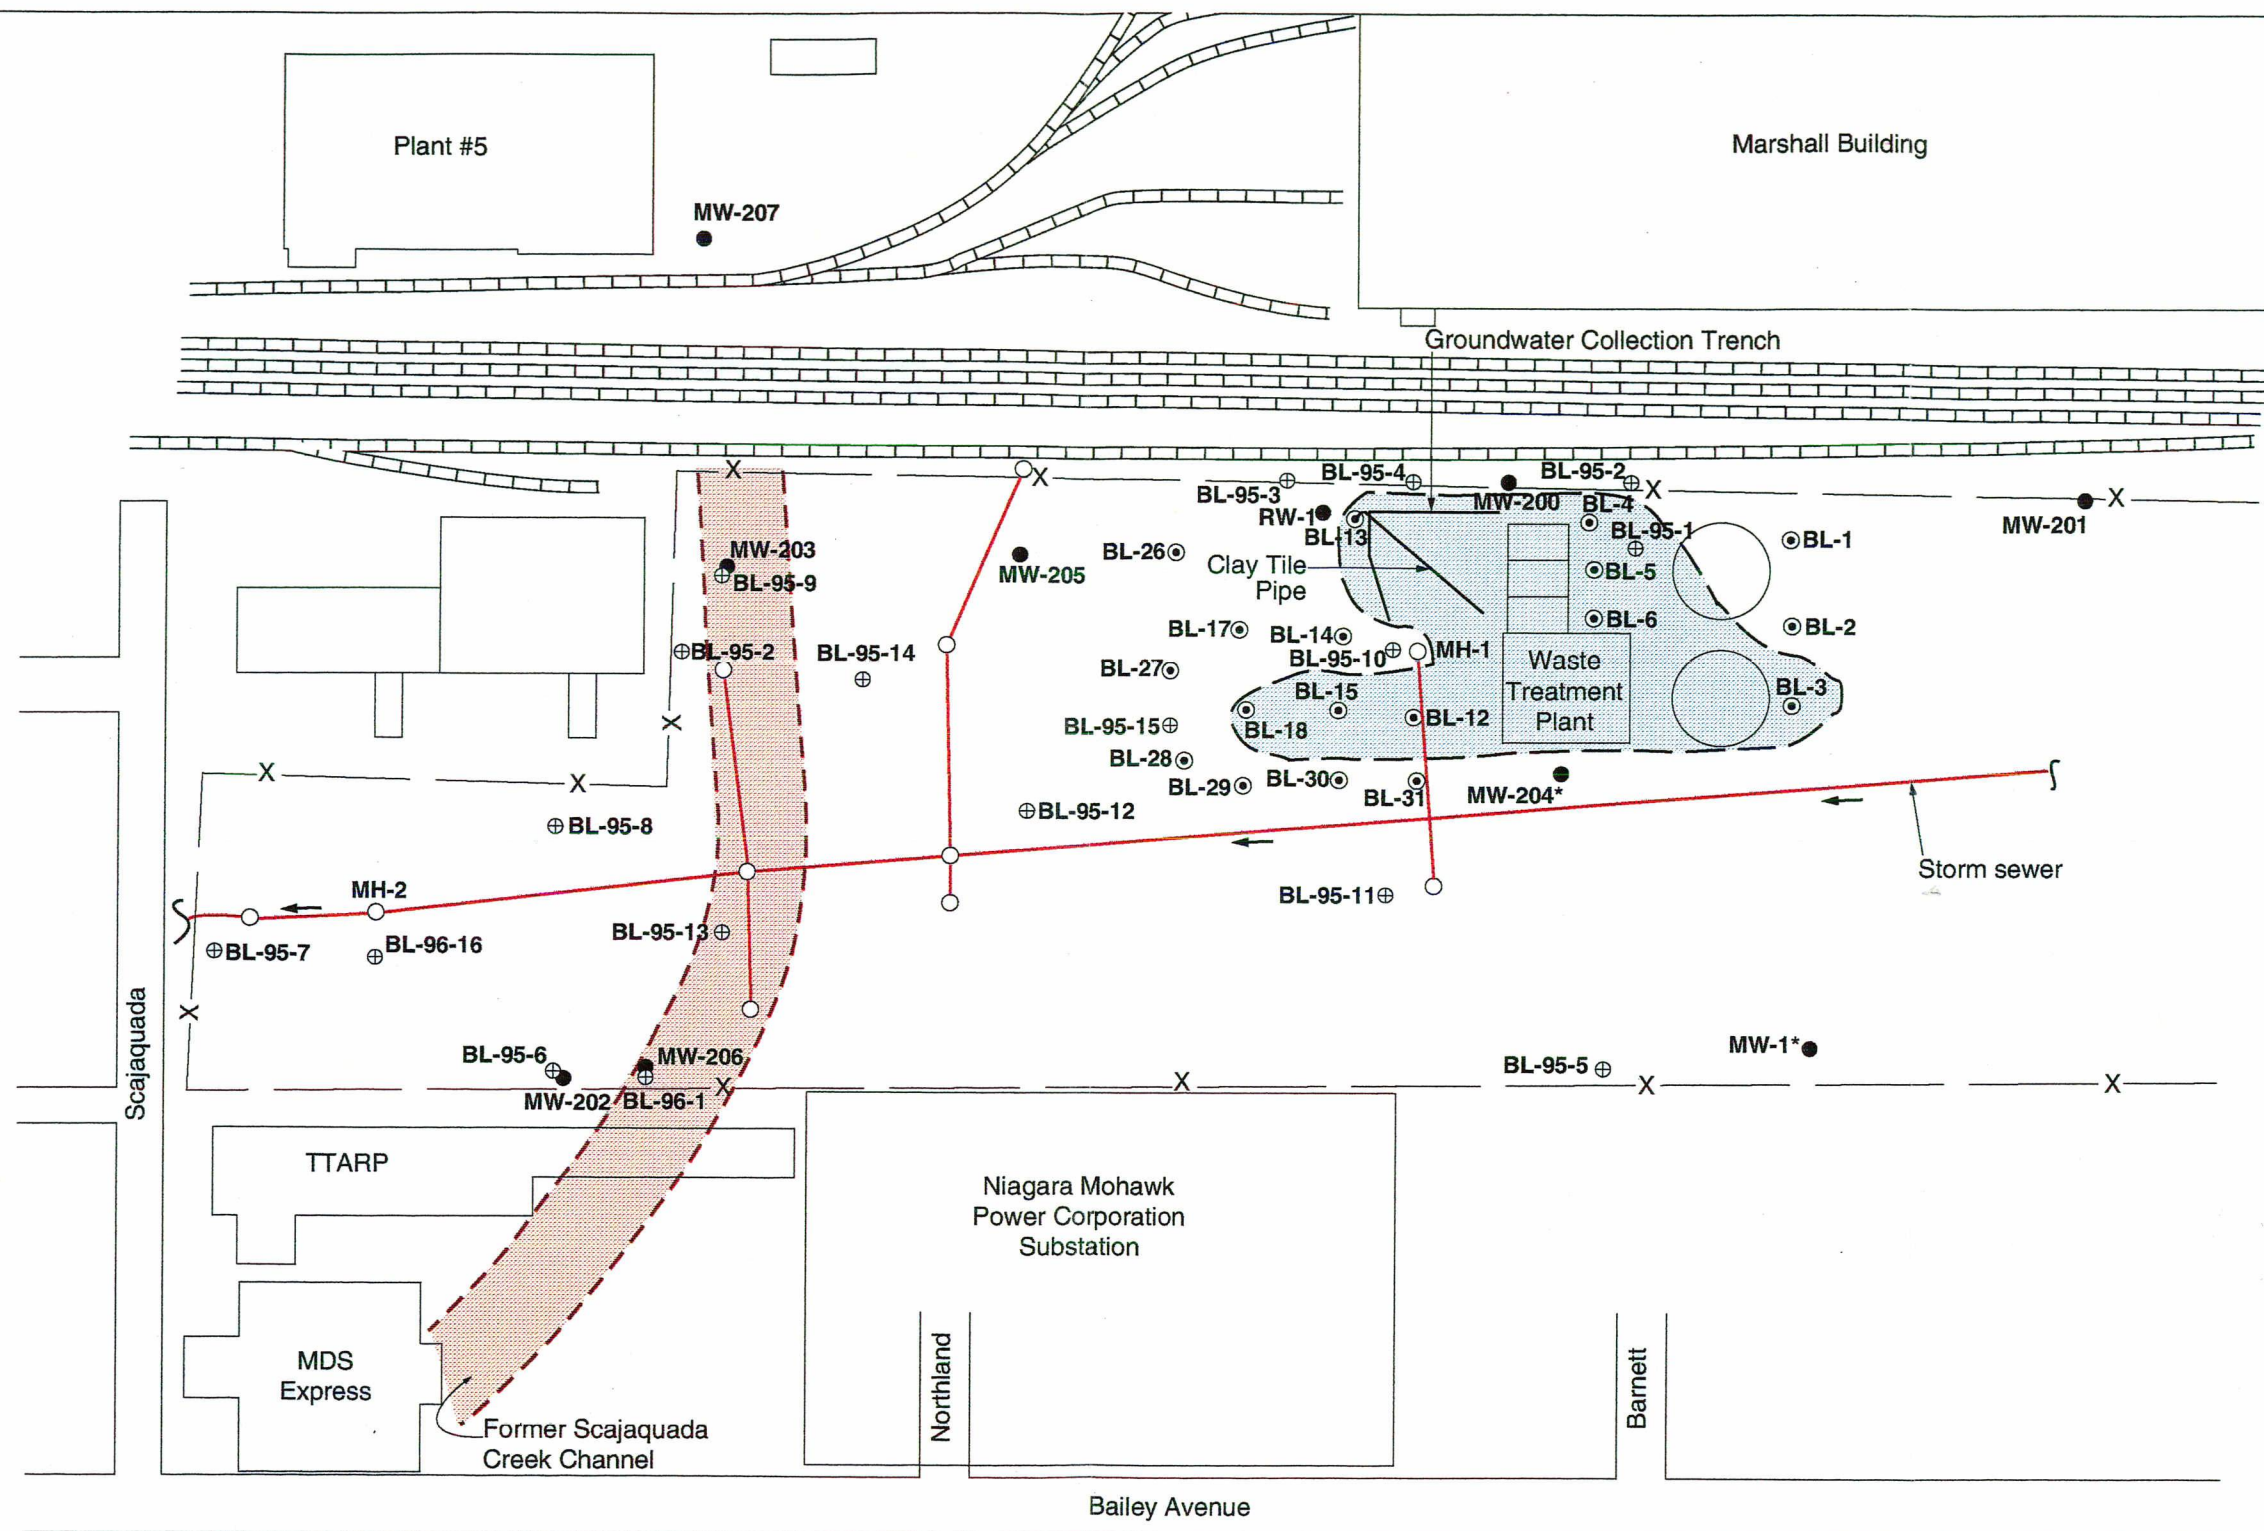
Figure  
6

No data exist in reports presented to NMPC (as part of this review) that describes any detailed investigation of the sewer bedding along the storm sewer. The only documented investigation of the sewer bedding materials was presented in Section 2.0 of the SI Report that described limited soil excavation to repair a short length of sewer lateral (5 to 10 feet in length) located in the immediate vicinity of manhole MH-1 (see Figure 6).

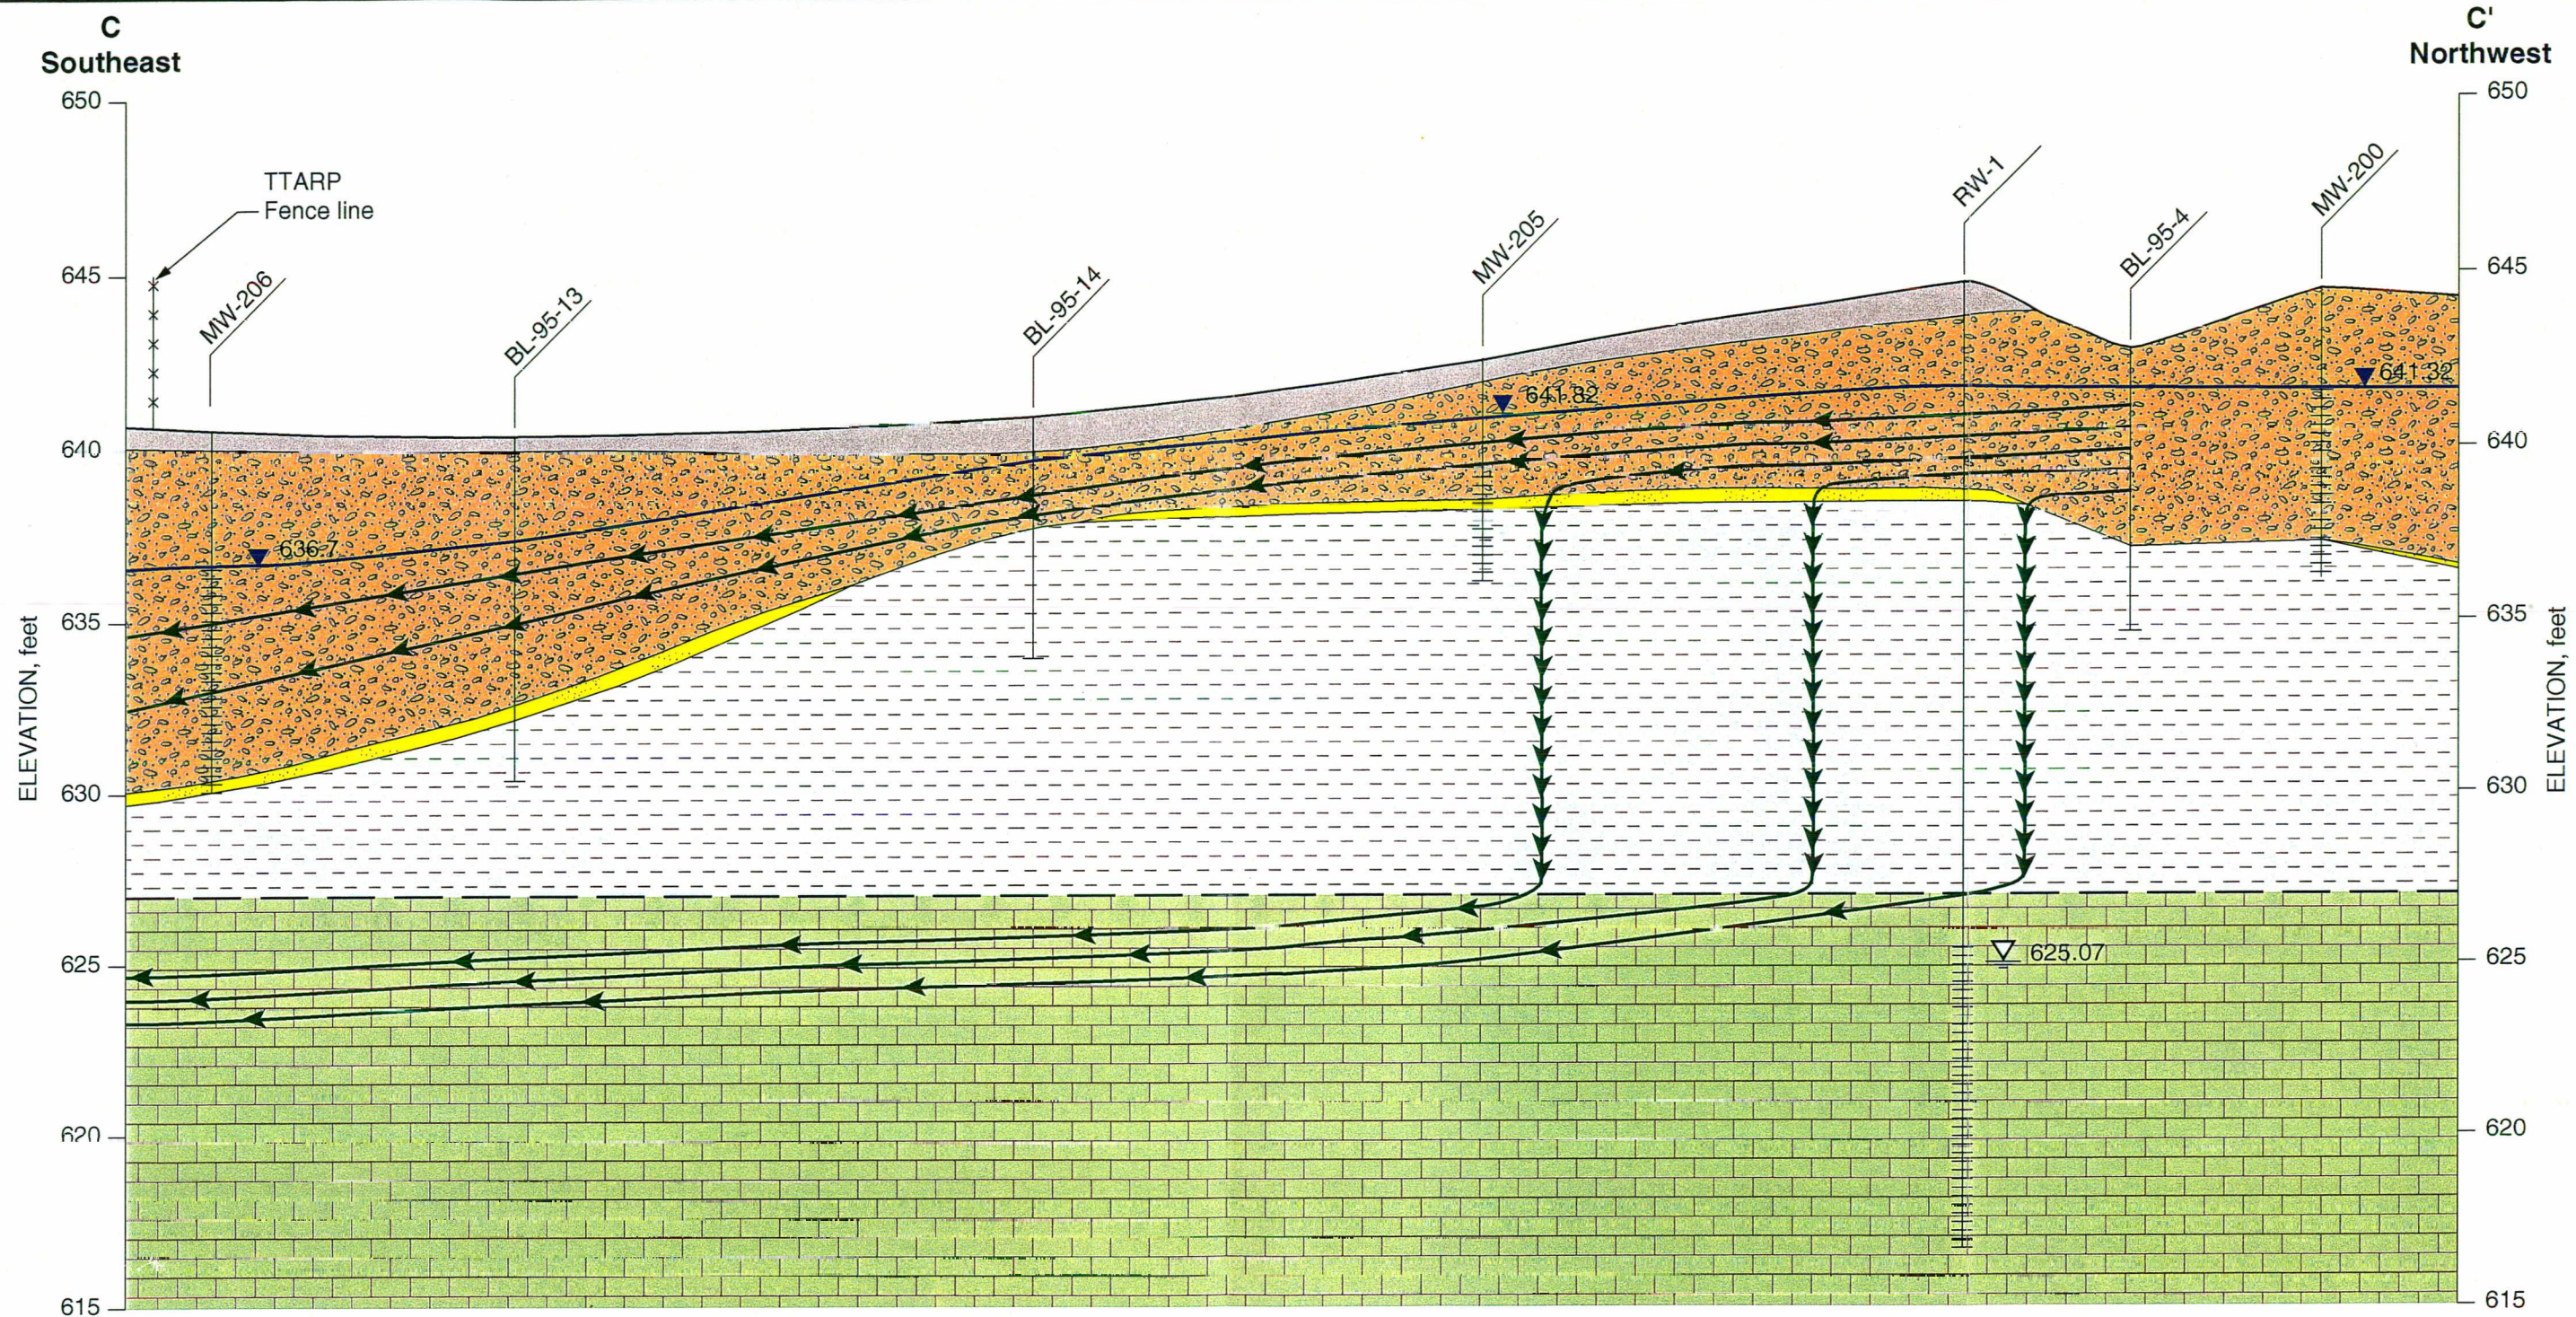
Cross-sectional groundwater flow modeling is presented in Figure 5 along section line C-C' (from the source area to the southeast in the direction of NMPC property). The cross-sectional flow model presents groundwater flow directions and time of travel estimates in saturated soil and bedrock. As shown in Figure 5, groundwater flow velocities (approximately 50 to 60 ft/yr) are moderate through the fill in the direction of the Niagara Mohawk Property. Groundwater from the PCB source area could have reached the vicinity of the Niagara Mohawk property in less than 10 years. Spillage of PCBs occurred during the early 1970's (EMCON Site Investigation Report, 1997), more than 25 years ago.

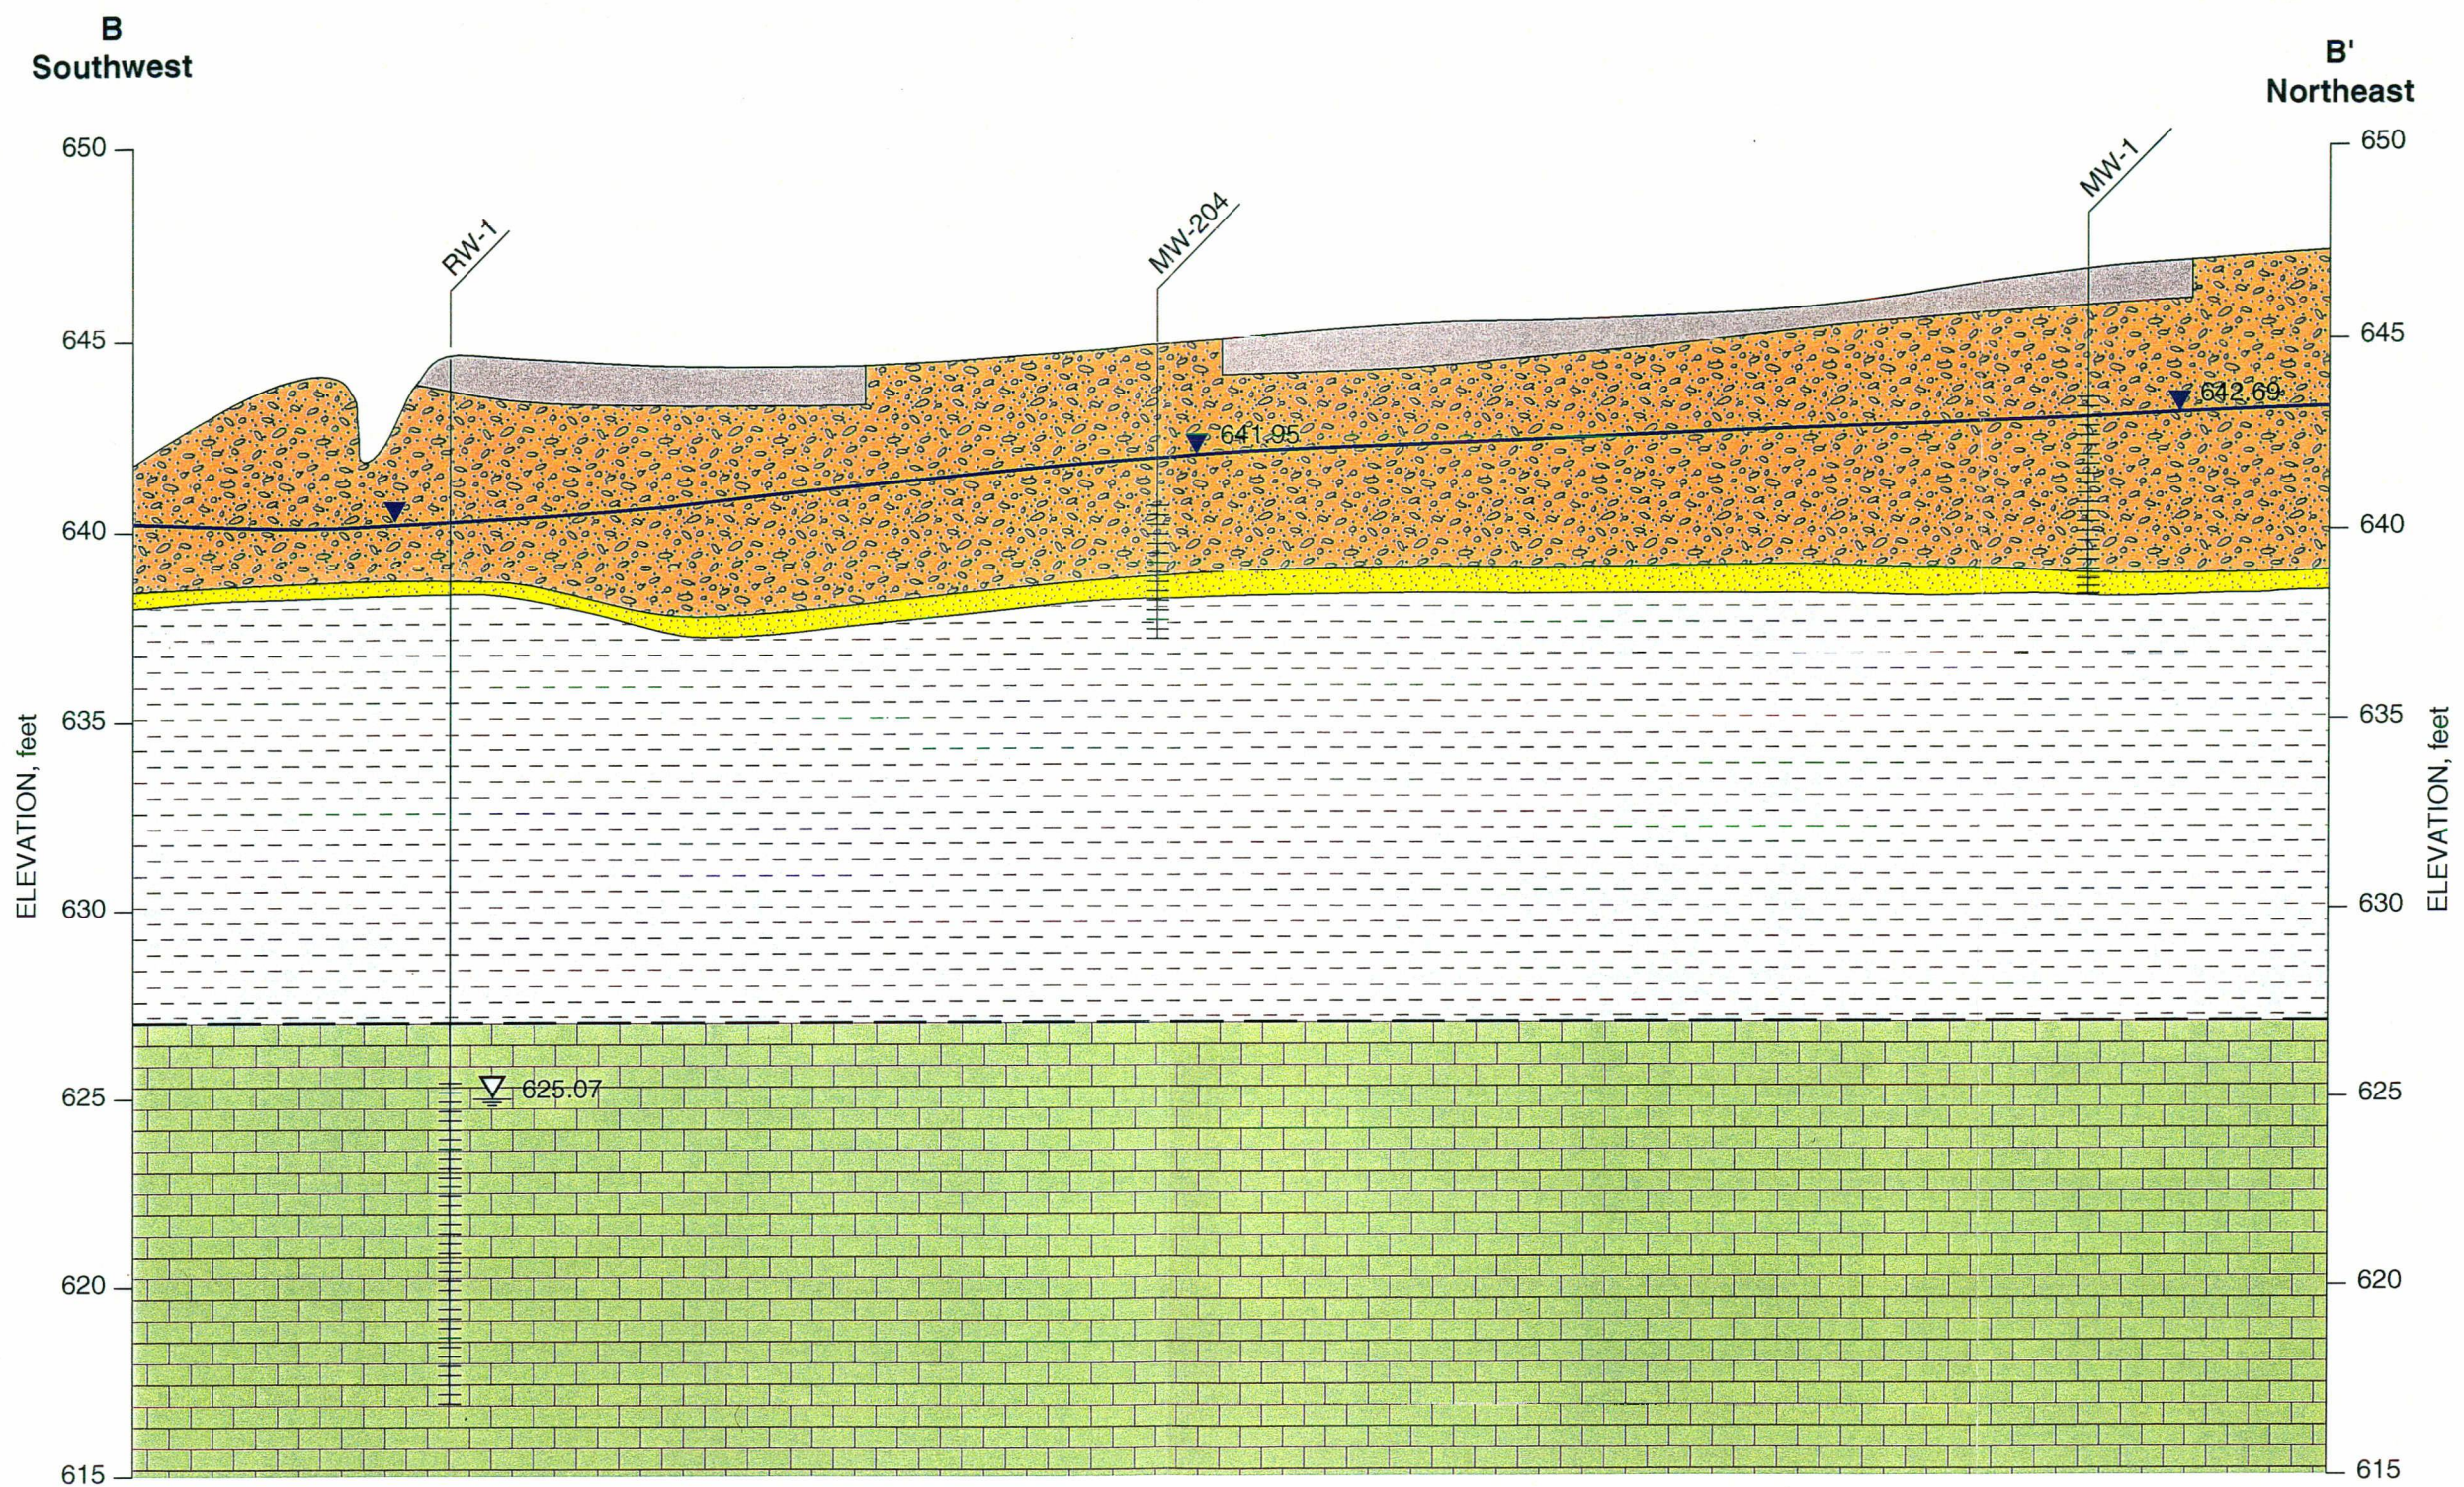
Figure  
3

These stratigraphic units are presented in cross-section using the same section lines drawn by EMCON (Drawings 4 and 5 of the Site Investigation Report) on Figures 2 and 3. However, several corrections to the EMCON-prepared cross-sections were necessary to match monitoring well construction diagrams (i.e. well screen positions) and location of geologic contacts to depths reported in the borehole logs. An additional cross-section was prepared using EMCON data along section line C-C', oriented with the general direction of groundwater flow (see Figure 4). Since storm sewer depths are not presented in the EMCON report, sewers are not shown on the cross-sections. The cross-section in Figure 4 shows a clay confining unit sloping from the source area to the southeast toward the southwest corner of NMPC property.
