Re: Remedial Construction Certification Report
Saginaw-Buffalo Site, Buffalo, NY
NYSDEC Site No. 915152

**REMEDIAL CONSTRUCTION CERTIFICATION
REPORT**

SAGINAW-BUFFALO SITE

NYSDEC SITE NO. 915152

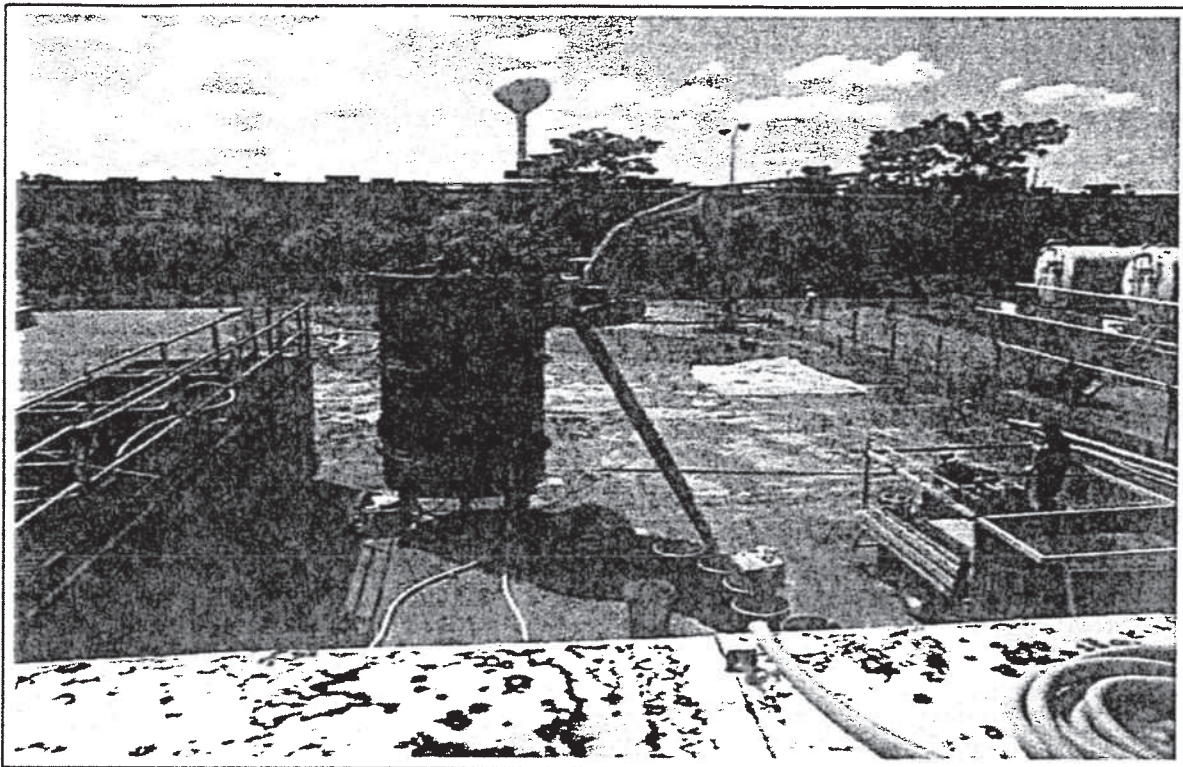
Photograph 1: Looking west over excavation area during setup of water treatment system.

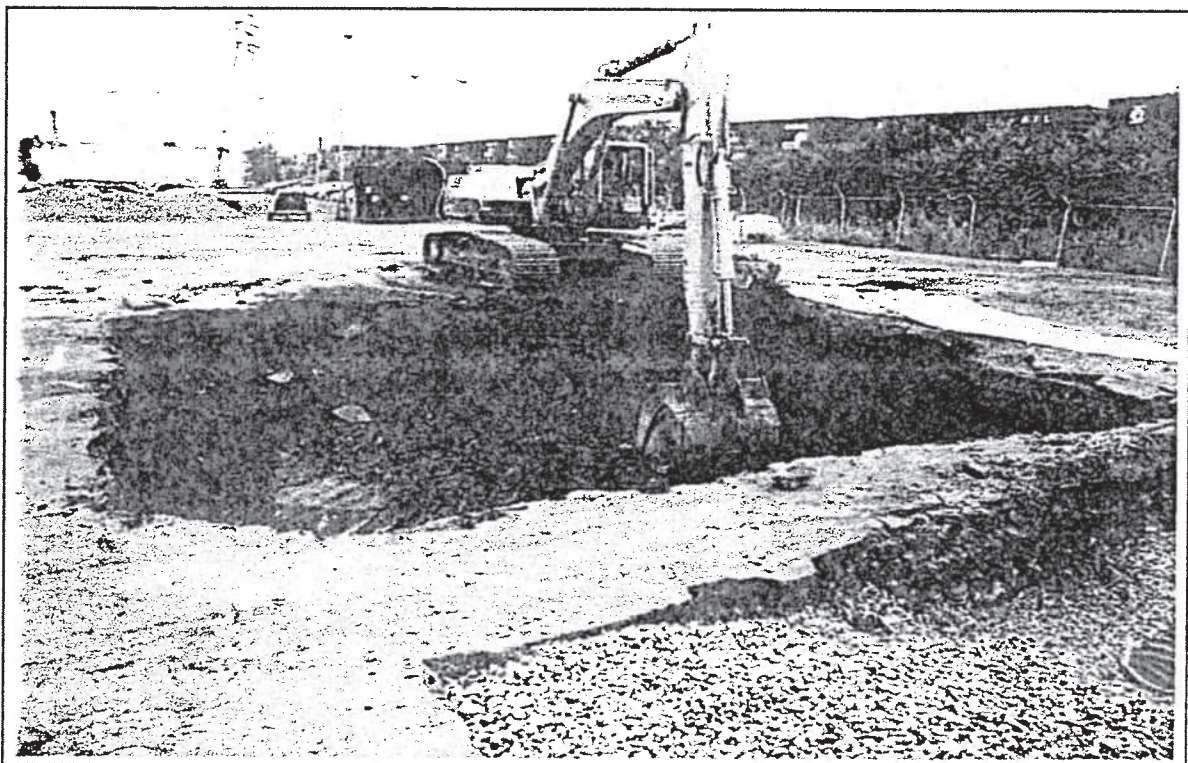
Photograph 2: Looking south at commencement of main excavation. South Dewatering pit in forefront.

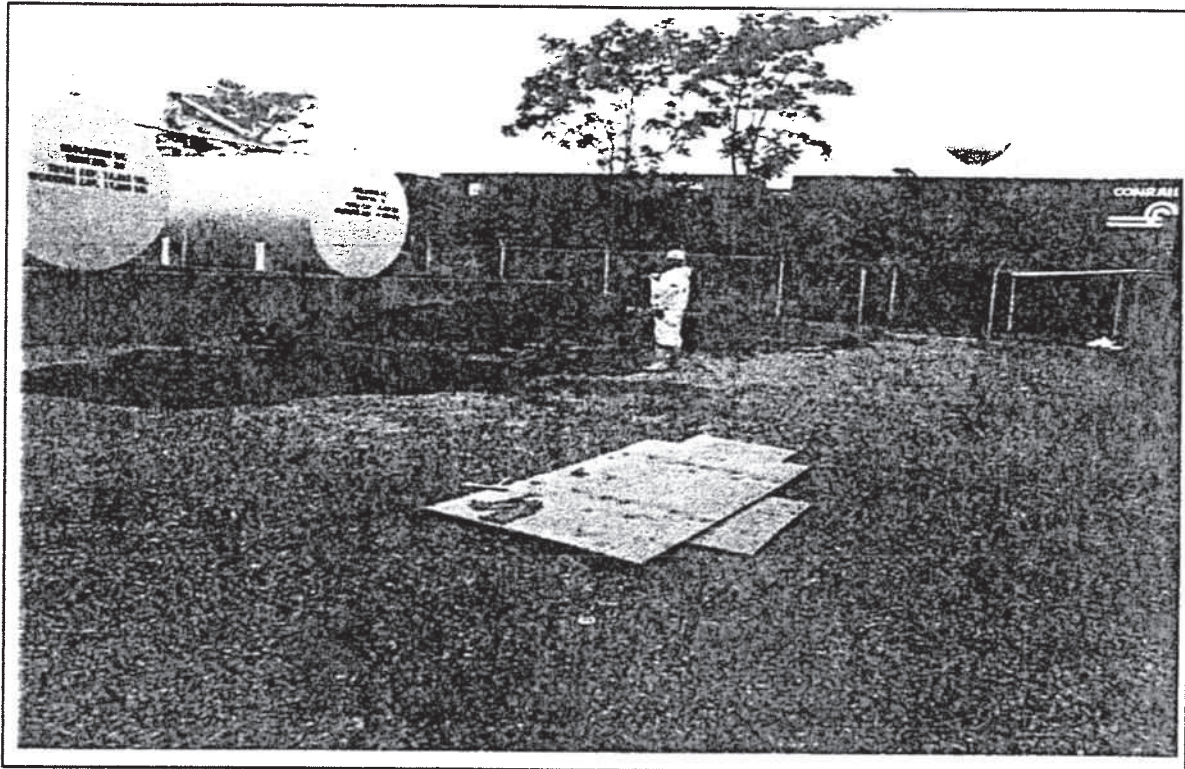
Photograph 3: Looking west-southwest at excavation of north trench area.

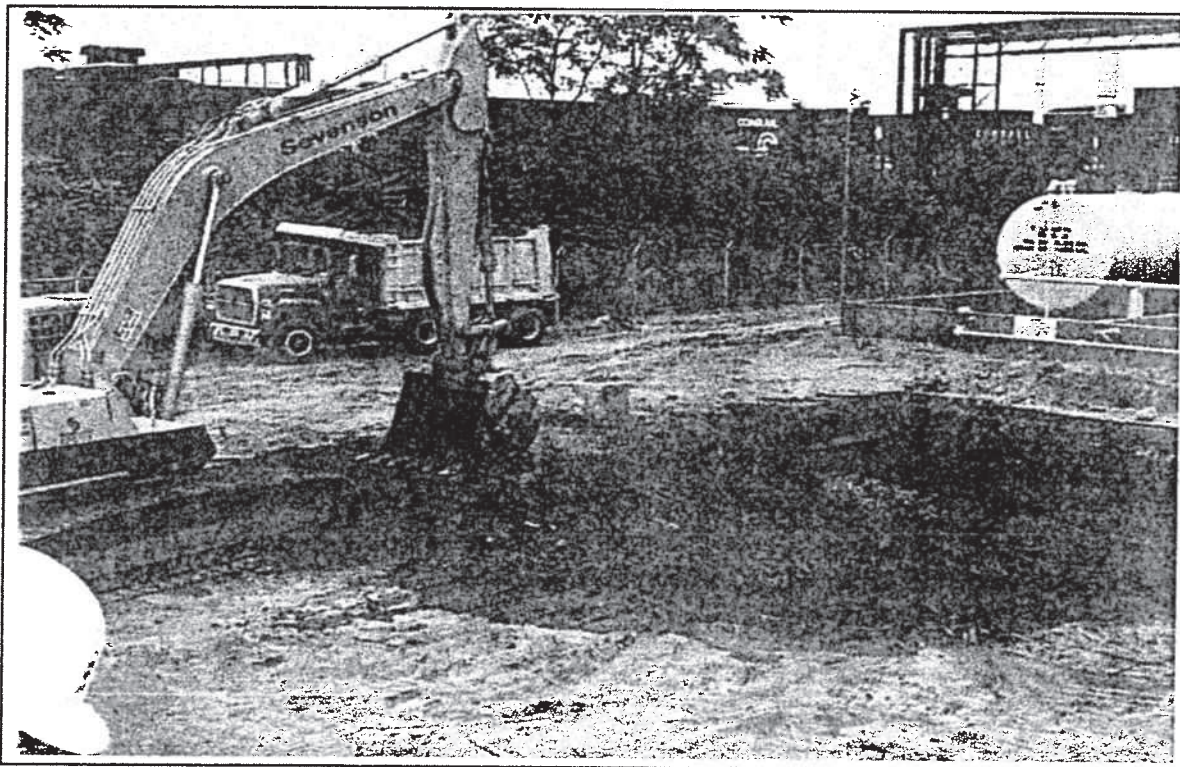
Photograph 4: Looking northwest toward main excavation.

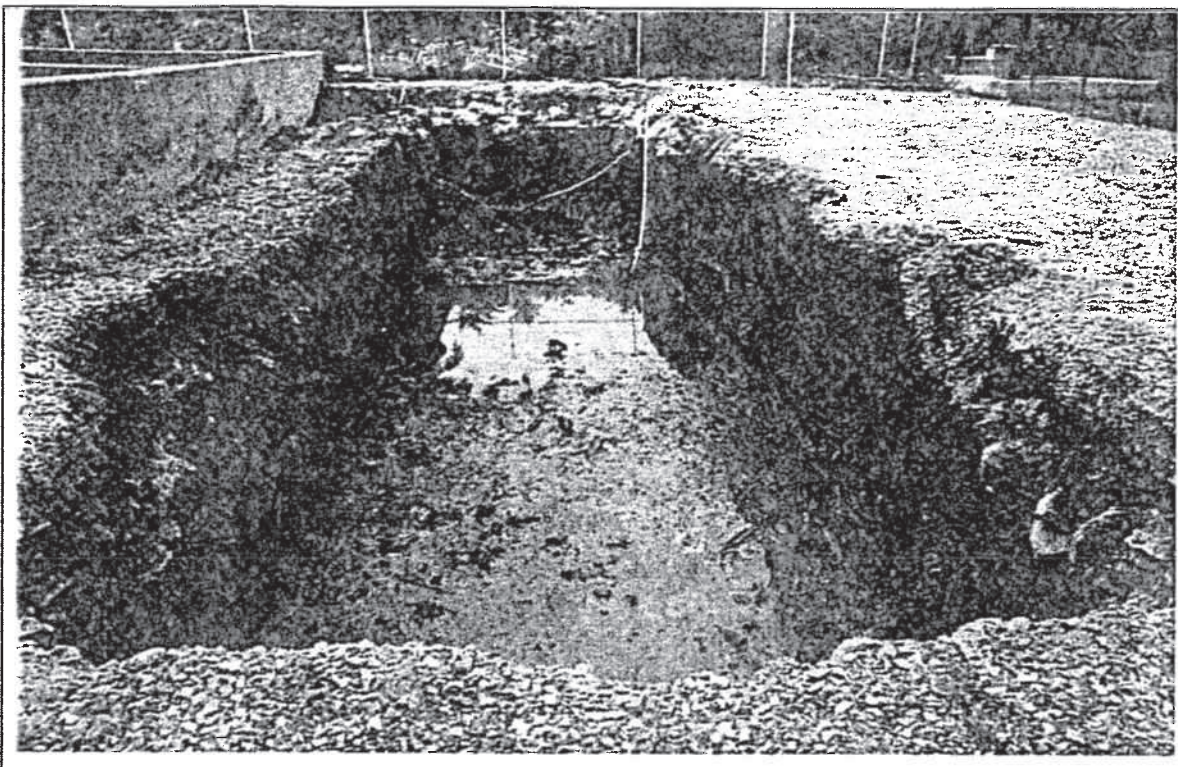
Photograph 5: Looking west across north trench.

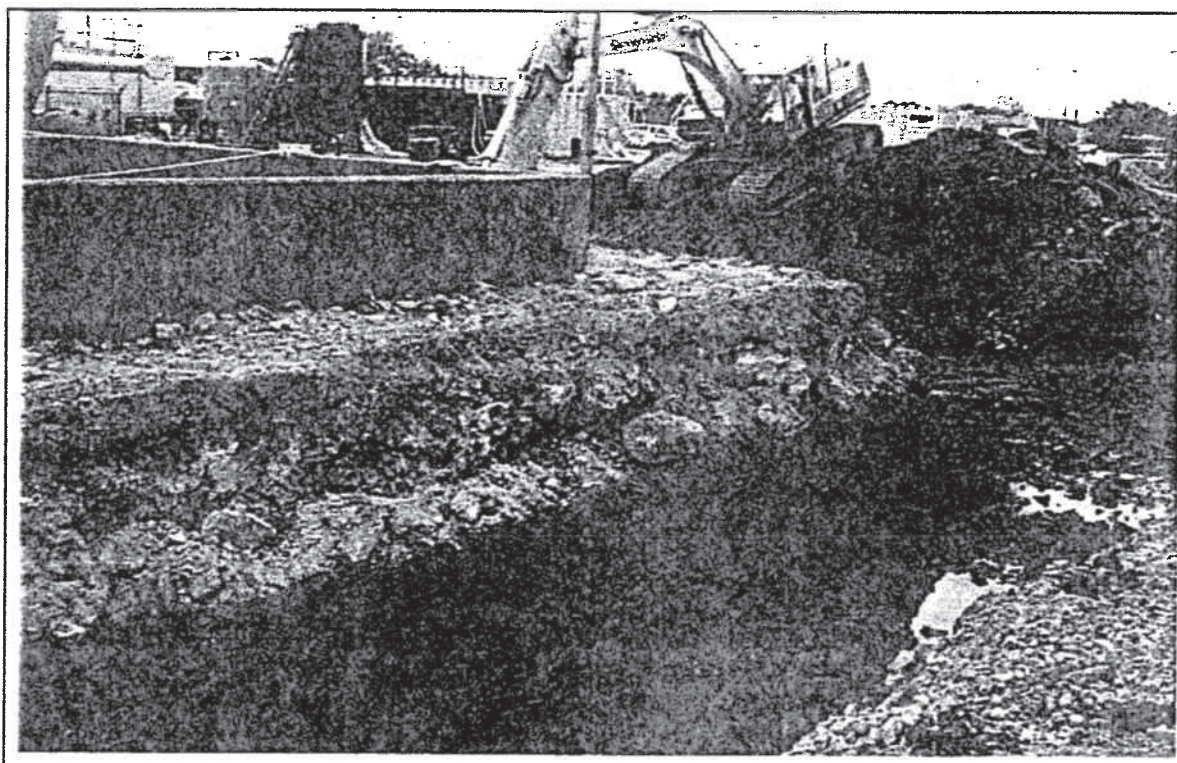
Photograph 6: Looking southeast across west trench toward main excavation.

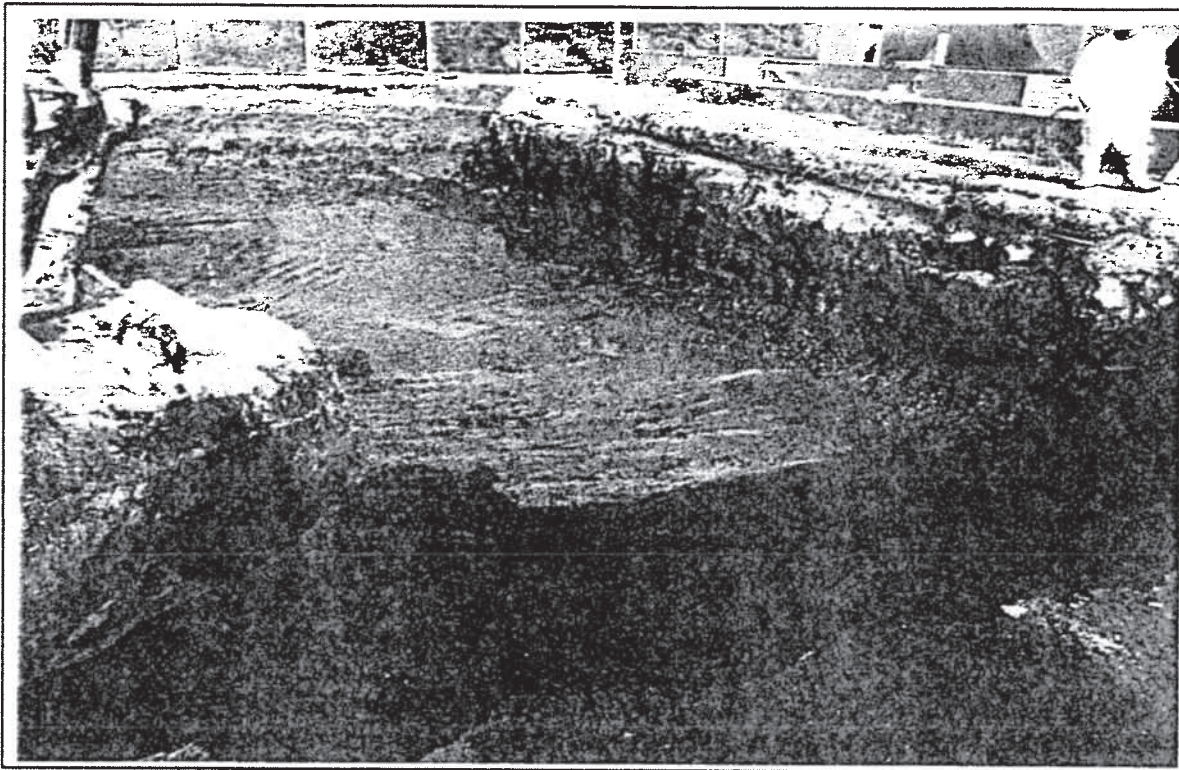
Photograph 7: Looking west across northern edge of main excavation.

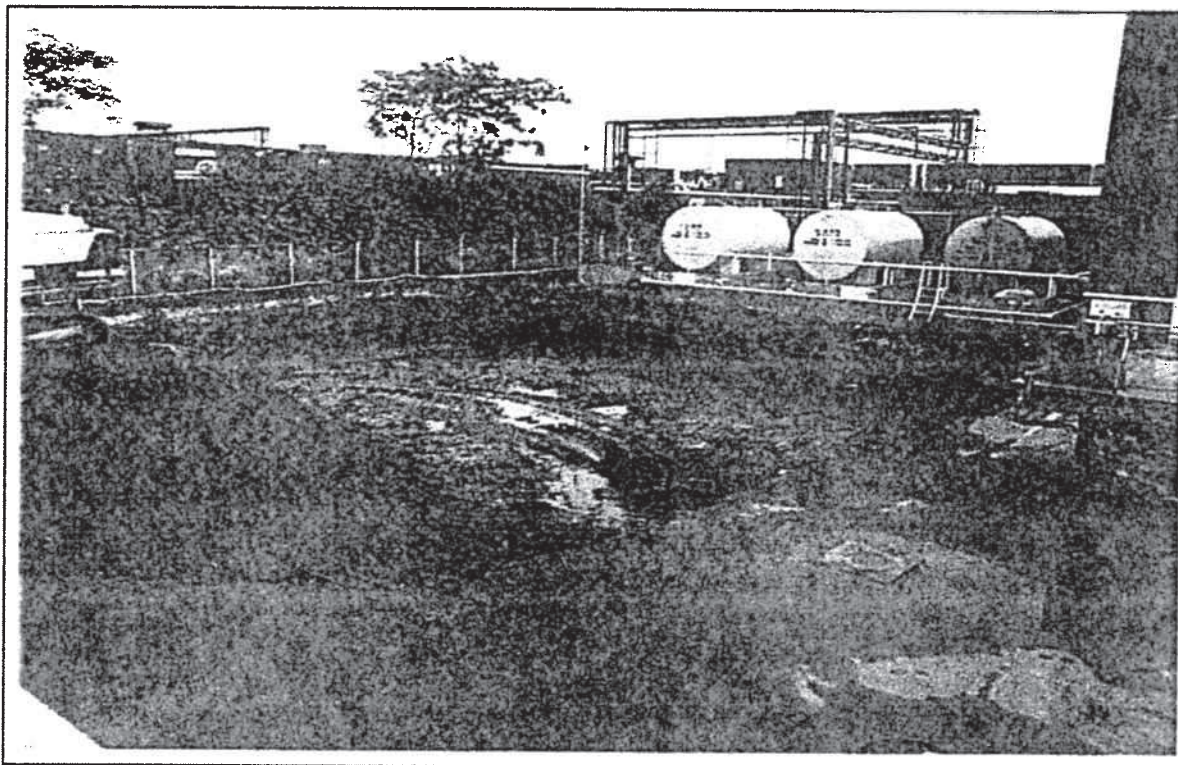
Photograph 8: Looking northwest across main excavation.

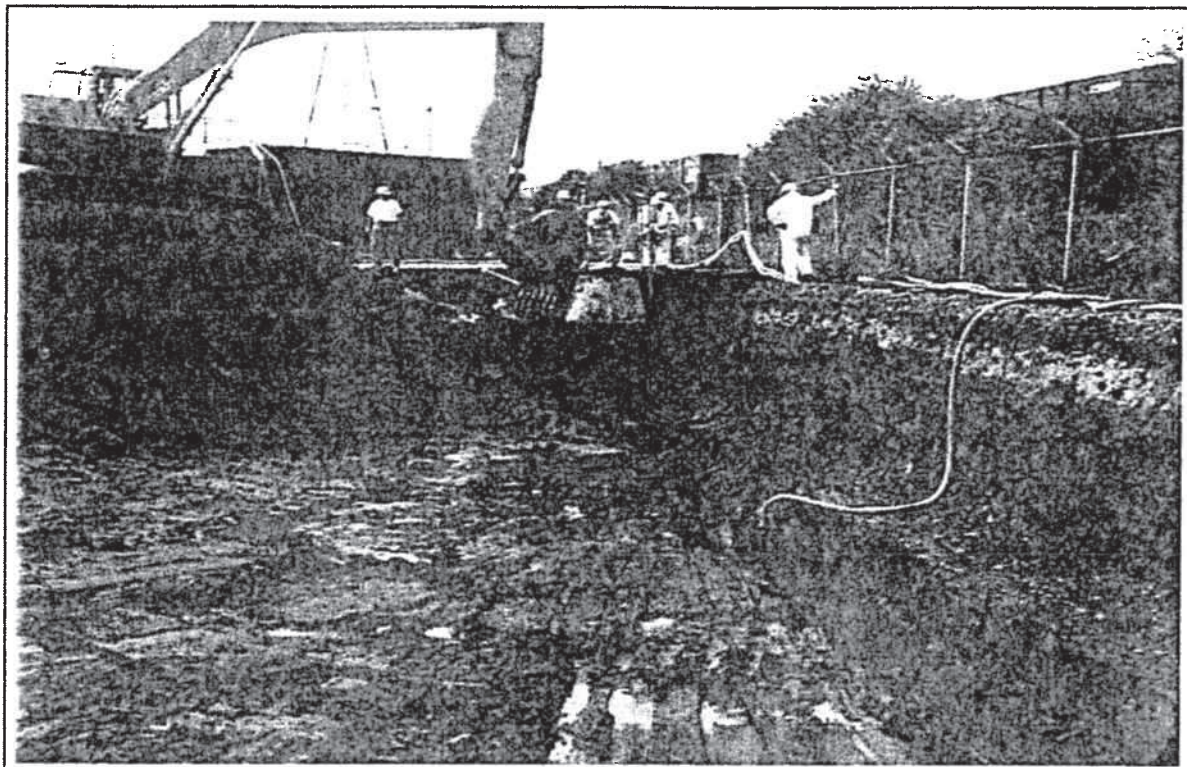
Photograph 9: Looking southwest across main excavation at removal of former GW Collection System manhole.

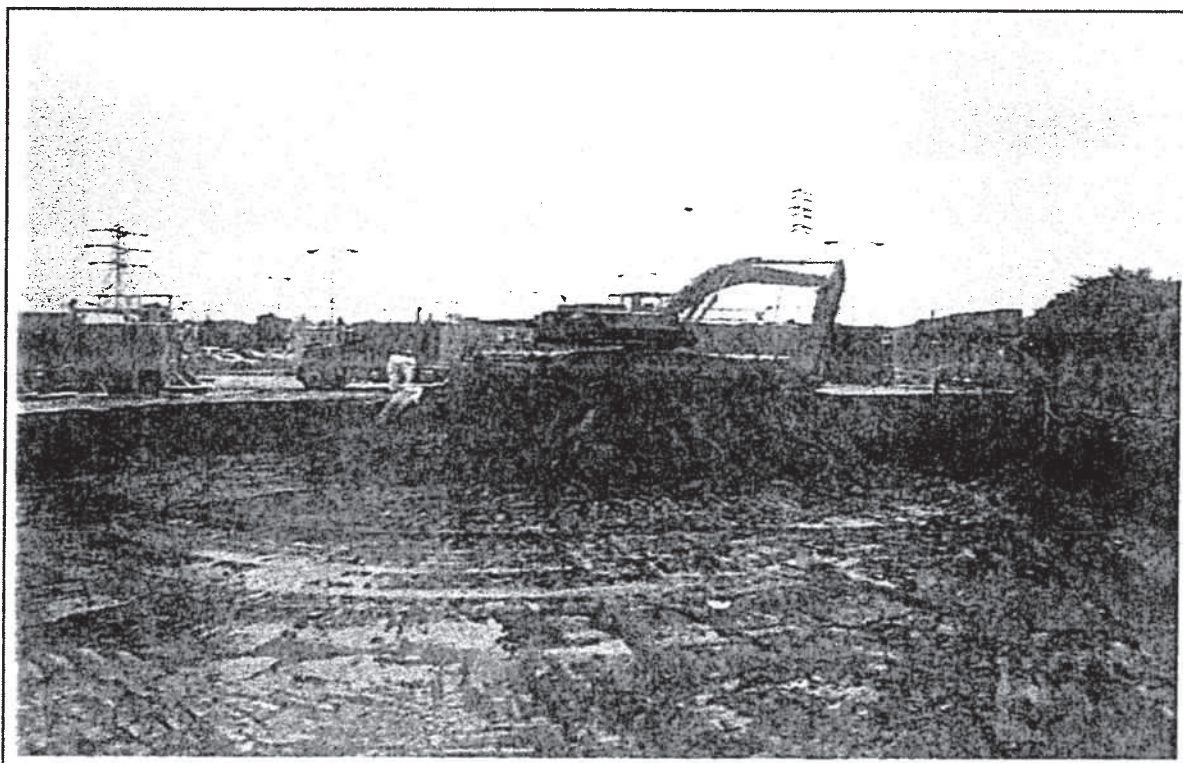
Photograph 10: Looking south across main excavation.

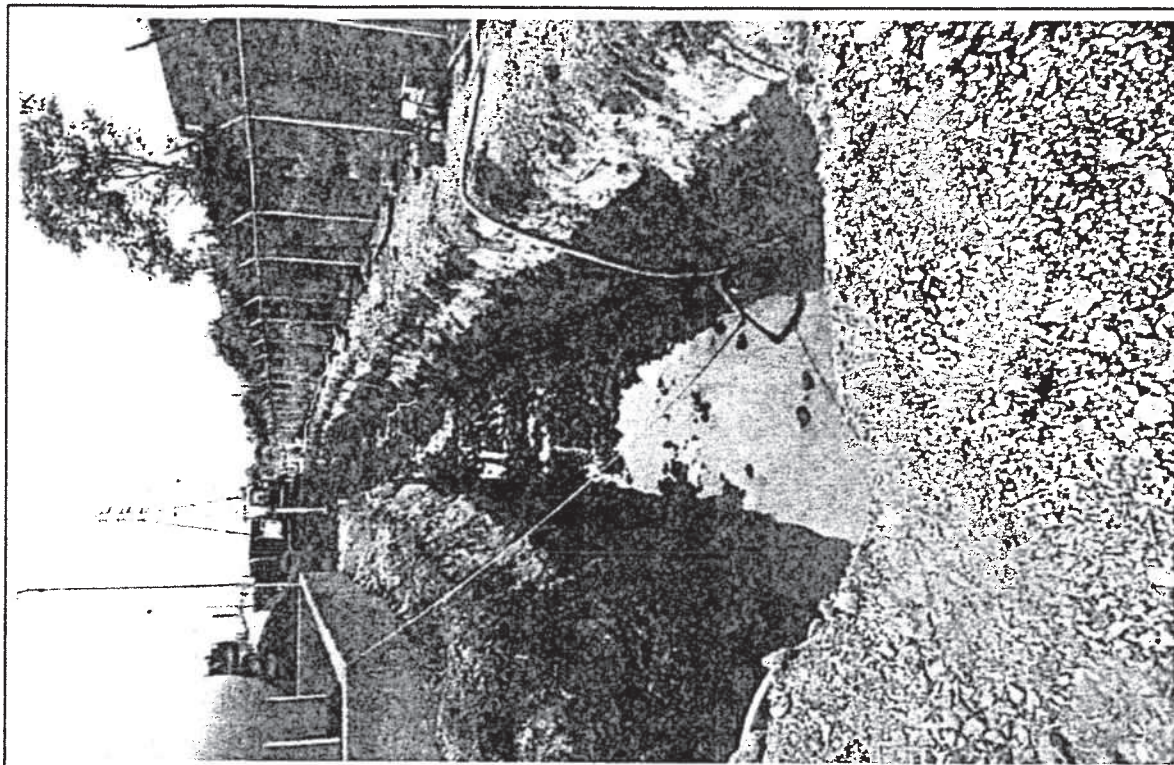
Photograph 11: Looking south along west trench.

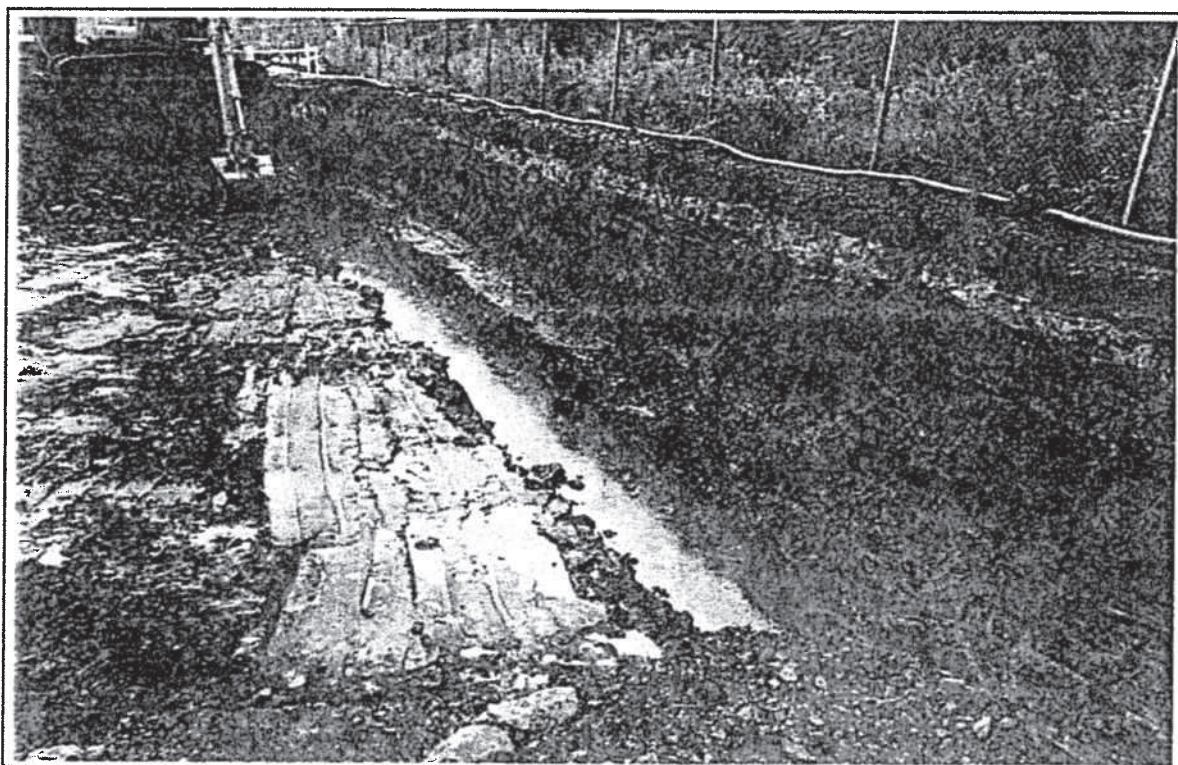
Photograph 12: Looking south along western edge of main excavation.

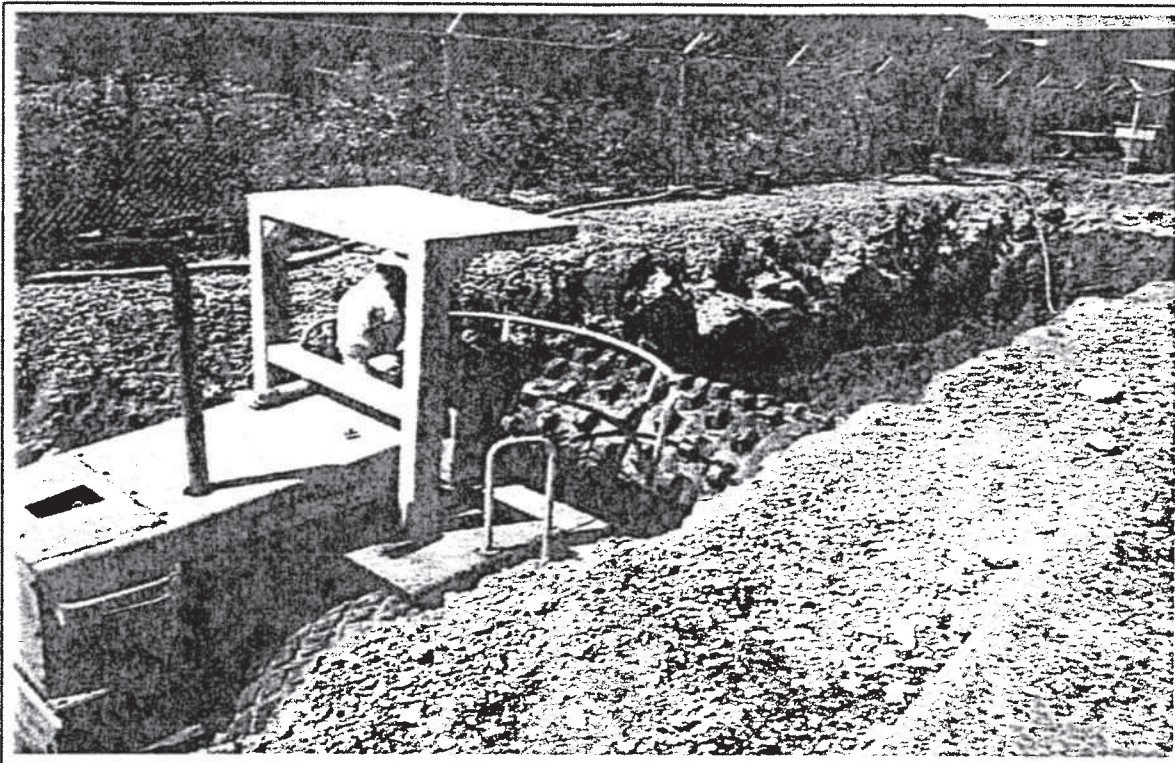
Photograph 13: Backfilling of the western trench.

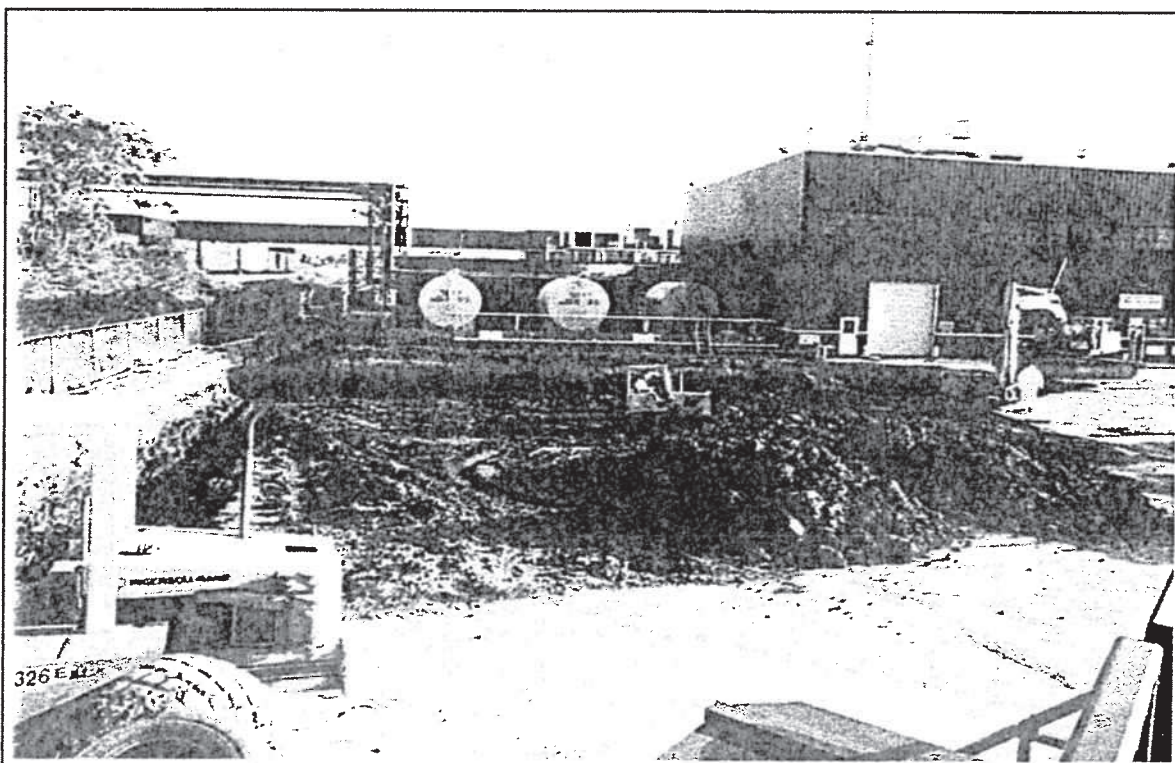
Photograph 14: Looking north at backfilling of main excavation. Removal of spill containment pad underway.

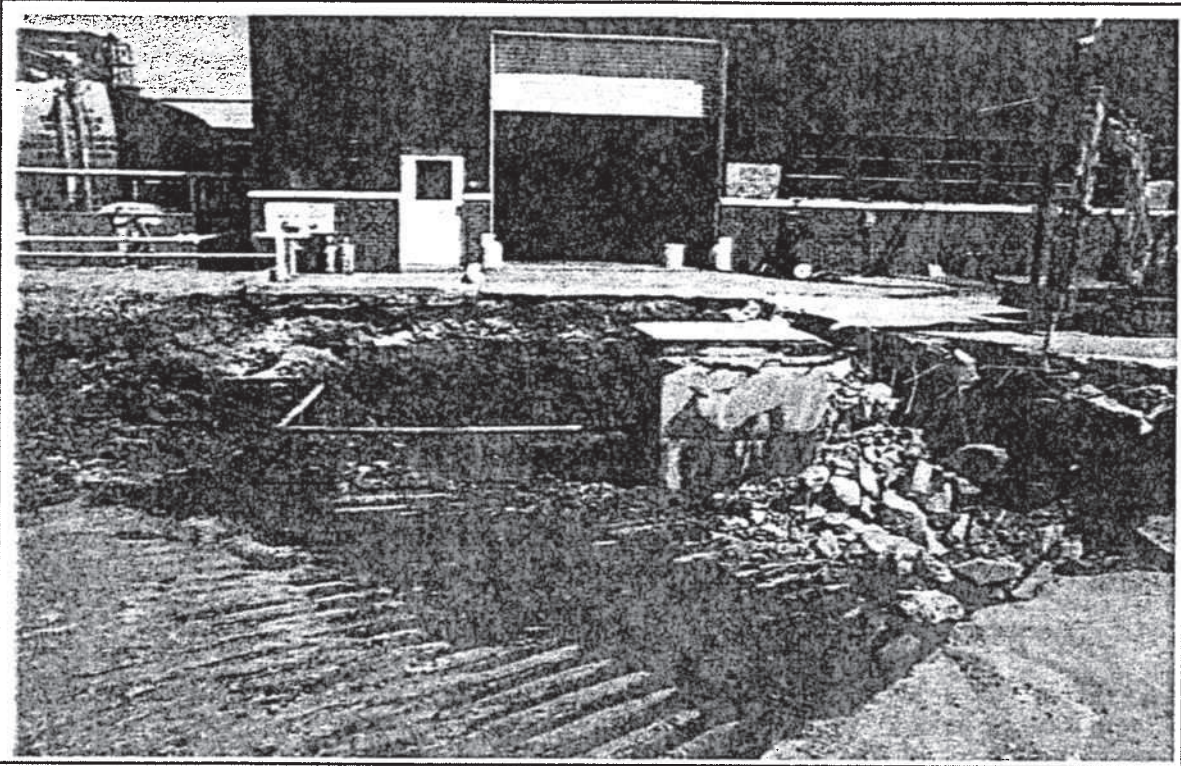
Photograph 15: Looking north at removal of spill containment pad.

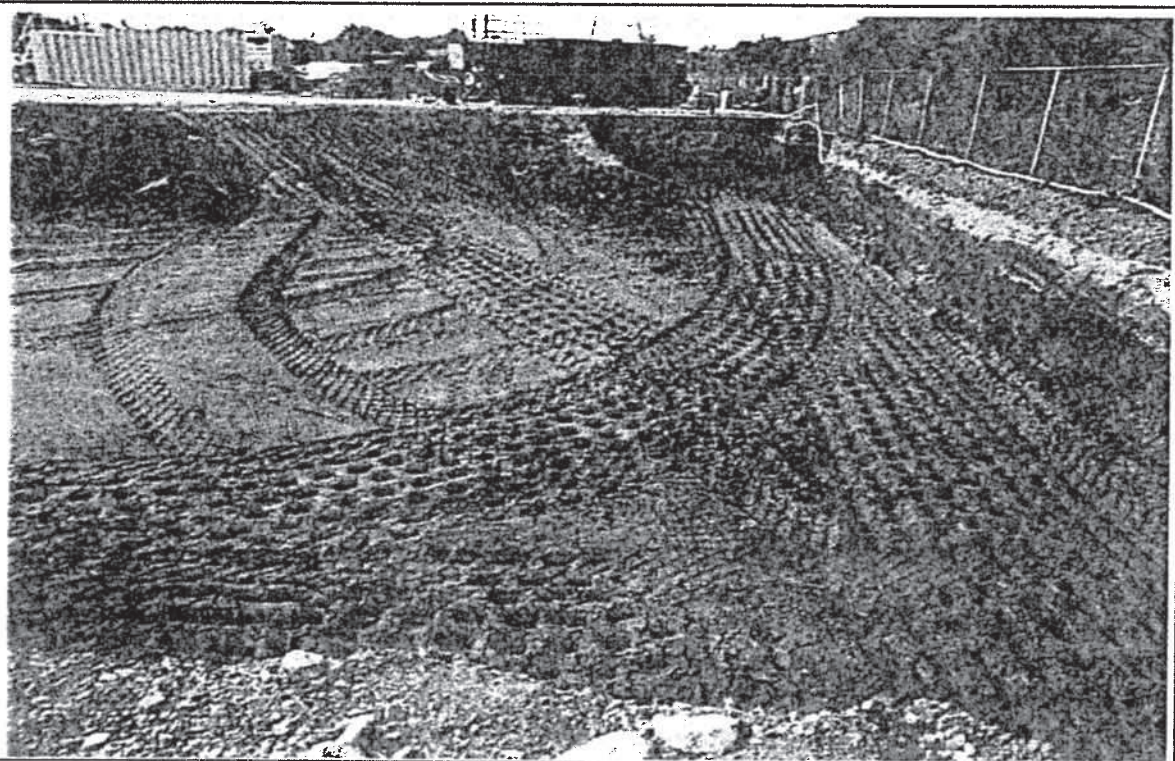
Photograph 16: Looking south at backfilling of main excavation.

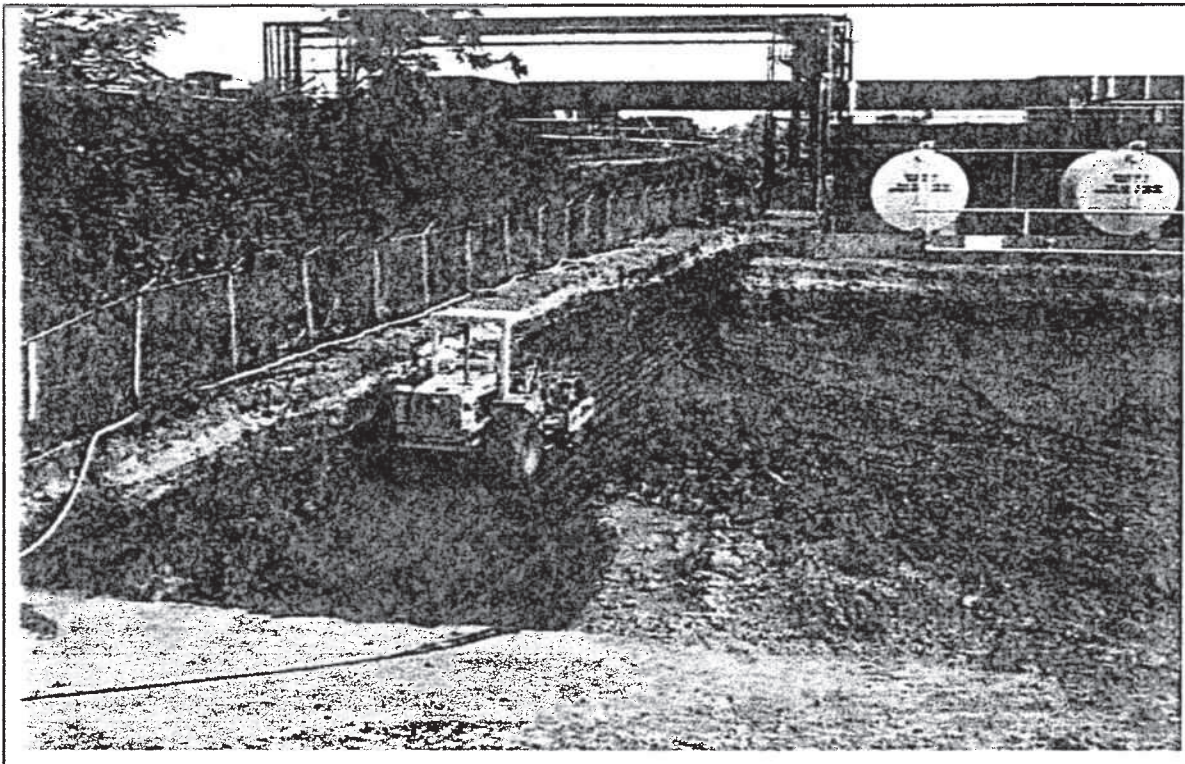
Photograph 17: Looking north at backfilling of main excavation.

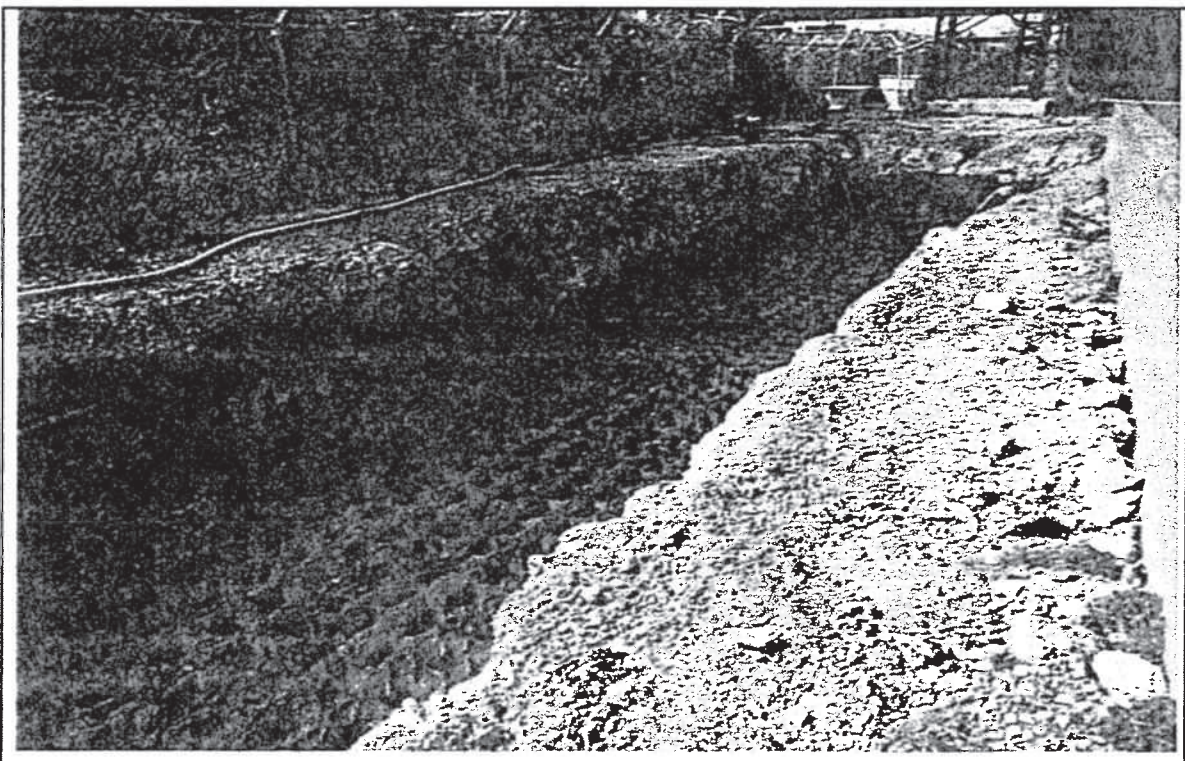
Photograph 18: Looking north at backfilling of western trench.

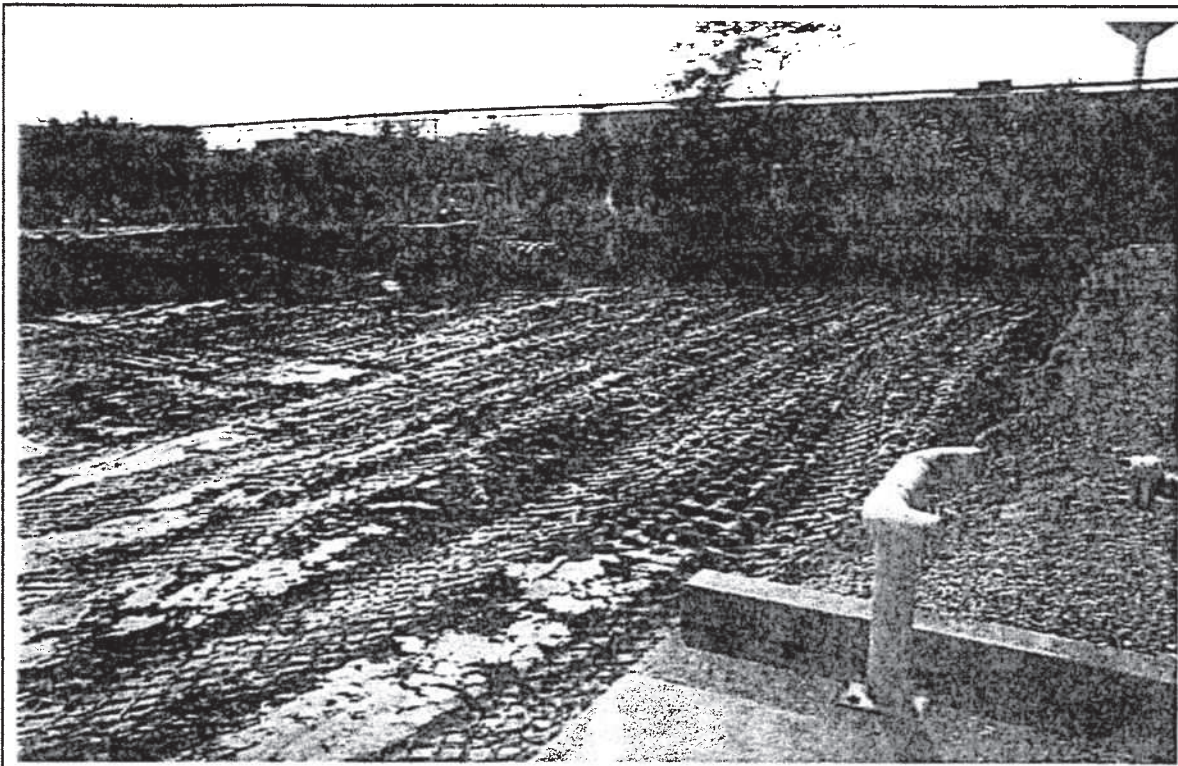
Photograph 19: Looking west across northern edge of main excavation. Backfilling in progress.

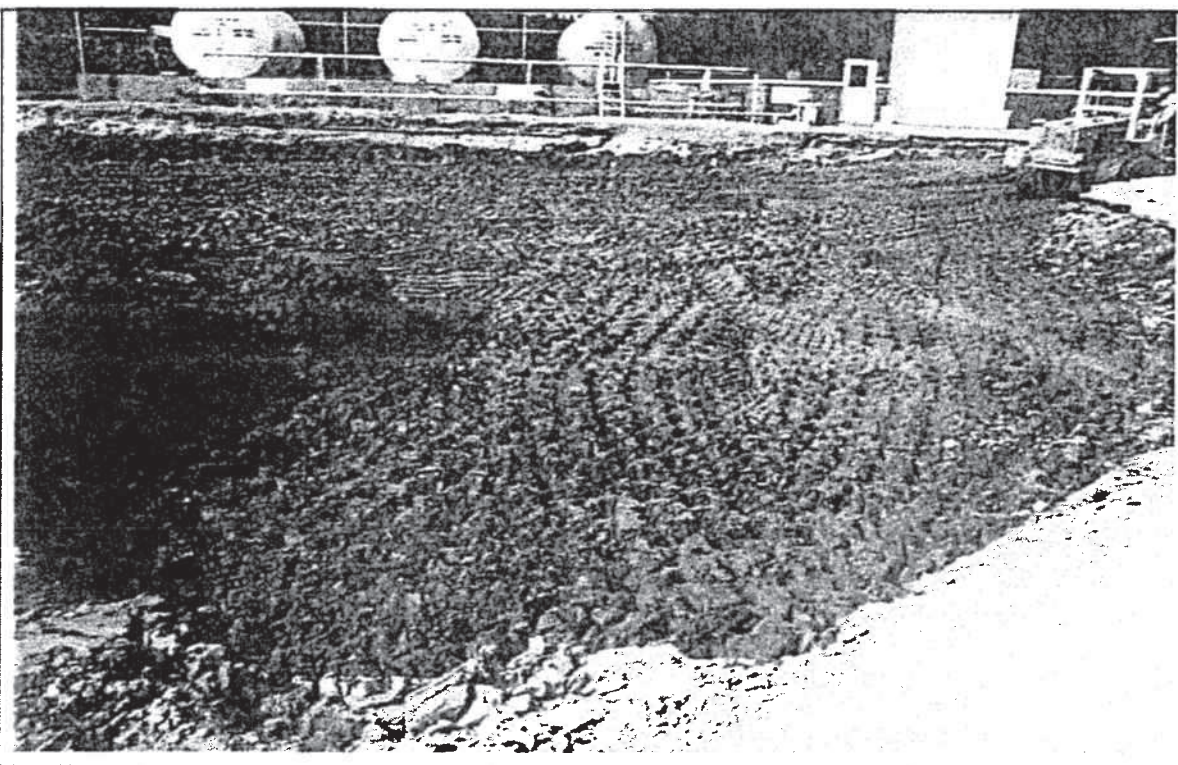
Photograph 20: Looking north across main excavation. Backfilling of spill containment pad area underway.

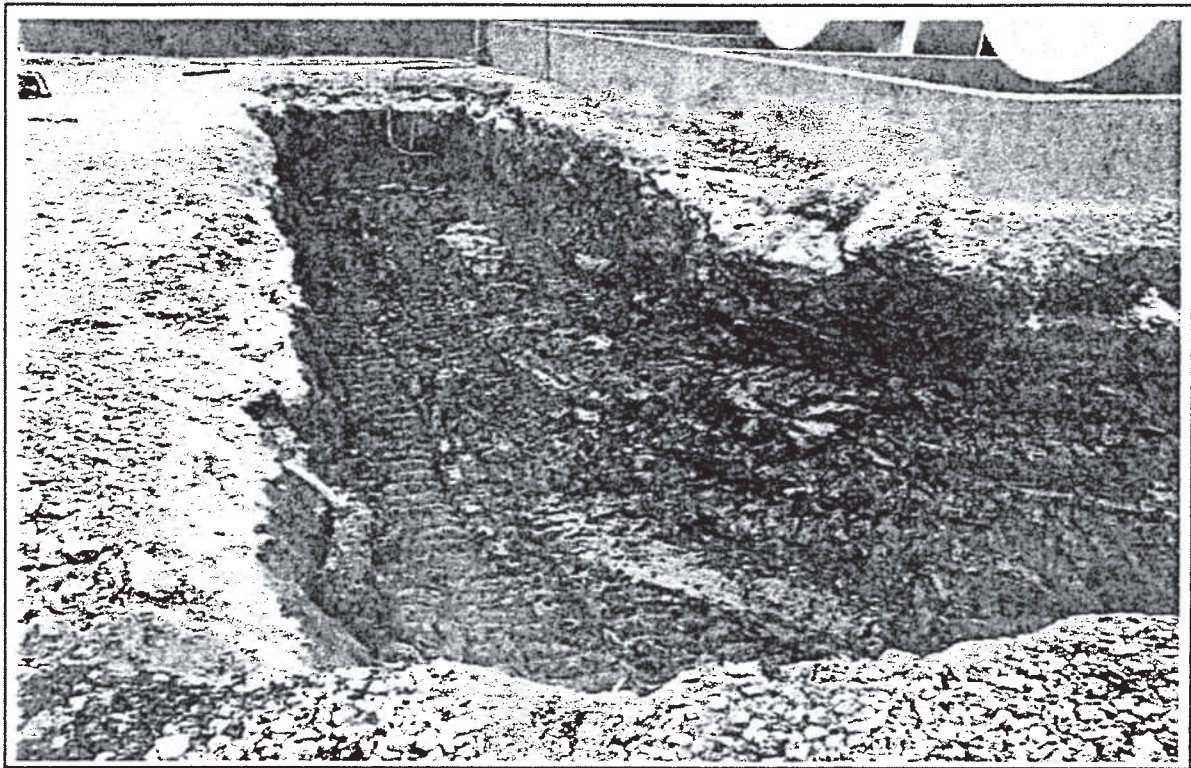
Photograph 21: Looking east at backfilling of north trench, prior to extension of cut to WWTP wall.

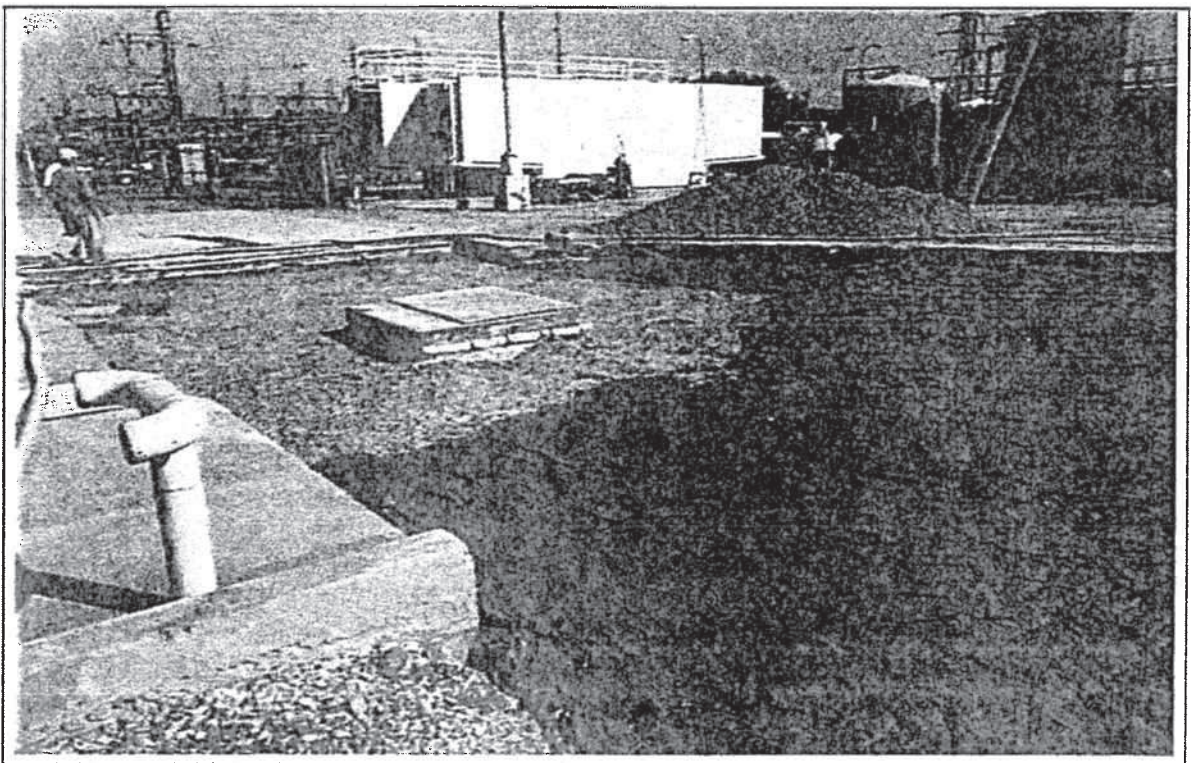
Photograph 22: Looking southeast at placement of stone in spill containment pad area.

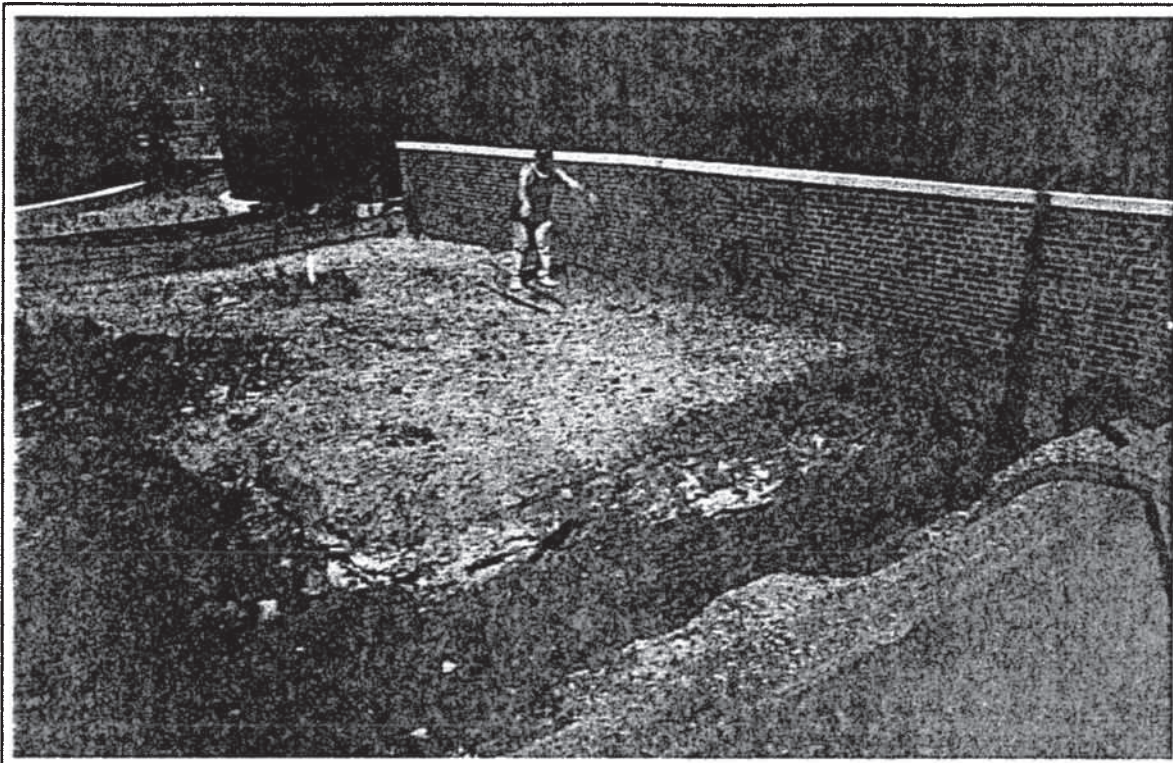
Photograph 23: Looking northeast at extension of north trench to WWTP wall.

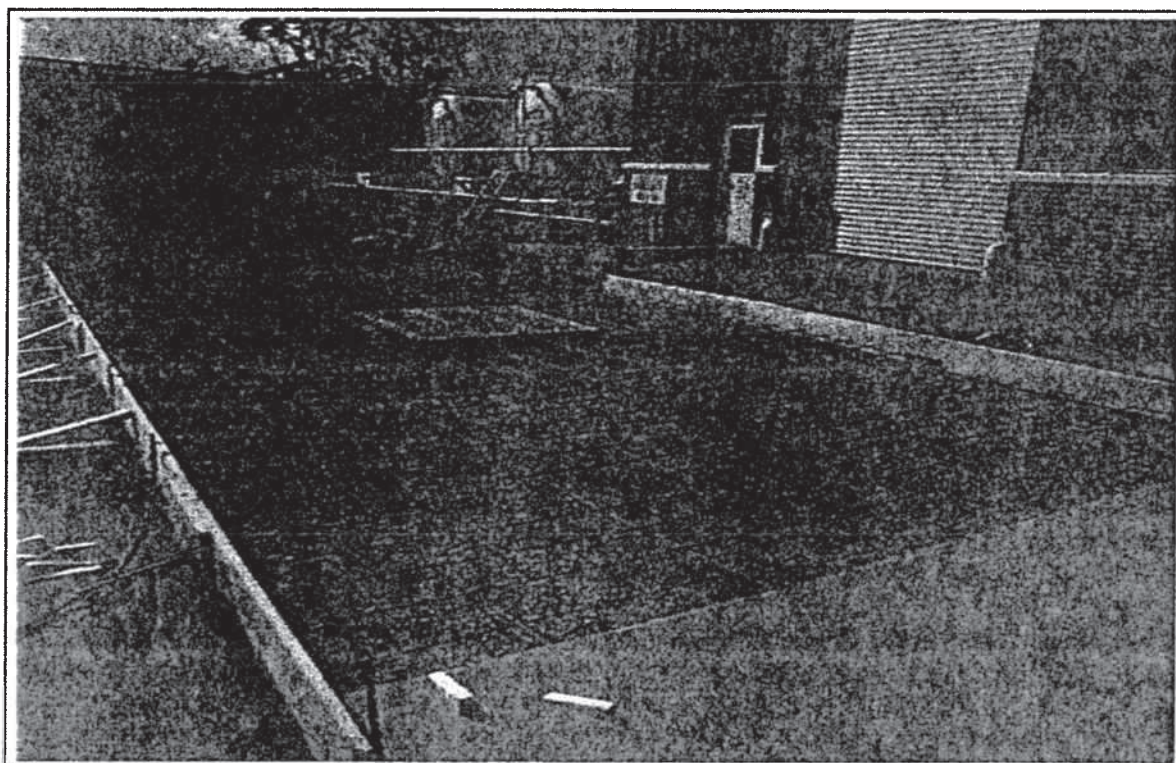
Photograph 24: Looking northwest at rebar placement for spill containment pad.

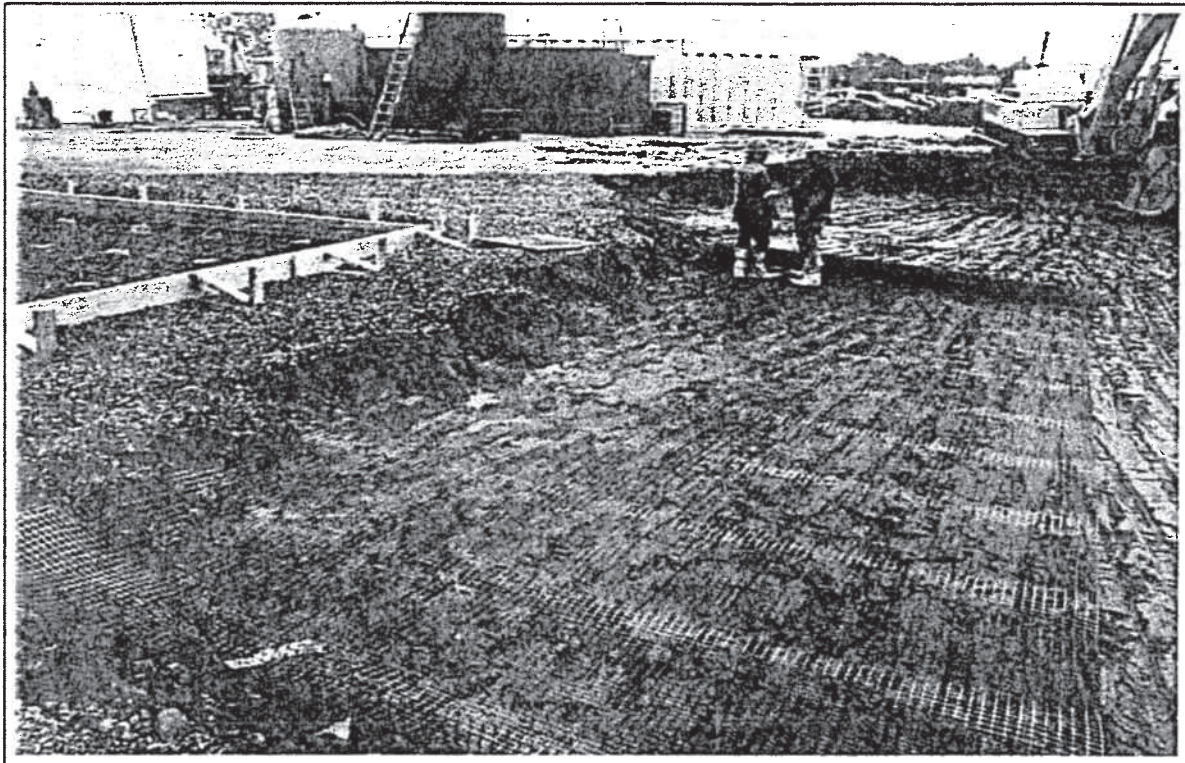
Photograph 25: Looking southward across main excavation at placement of Geogrid.
