Re: Remedial Construction Certification Report
Saginaw-Buffalo Site, Buffalo, NY
NYSDEC Site No. 915152

**REMEDIAL CONSTRUCTION CERTIFICATION
REPORT**

SAGINAW-BUFFALO SITE

NYSDEC SITE NO. 915152

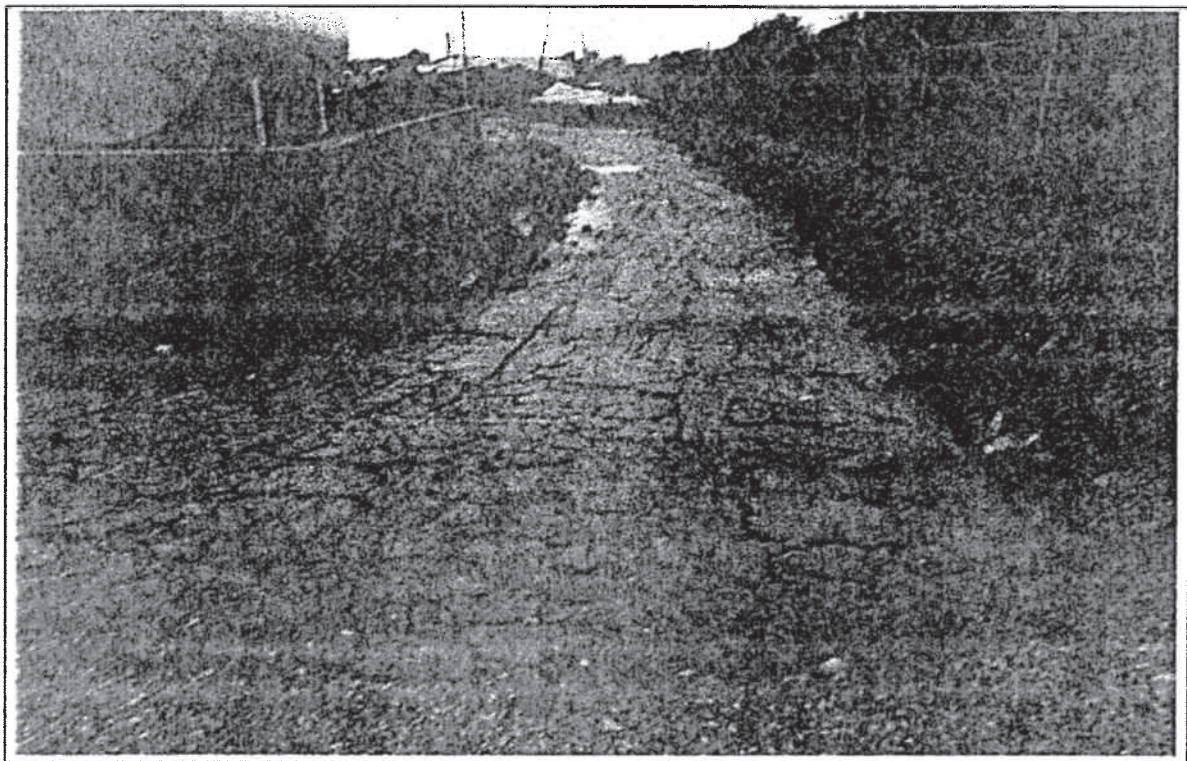
Photograph 26: Looking southward across western trench at top of clay backfill elevation.

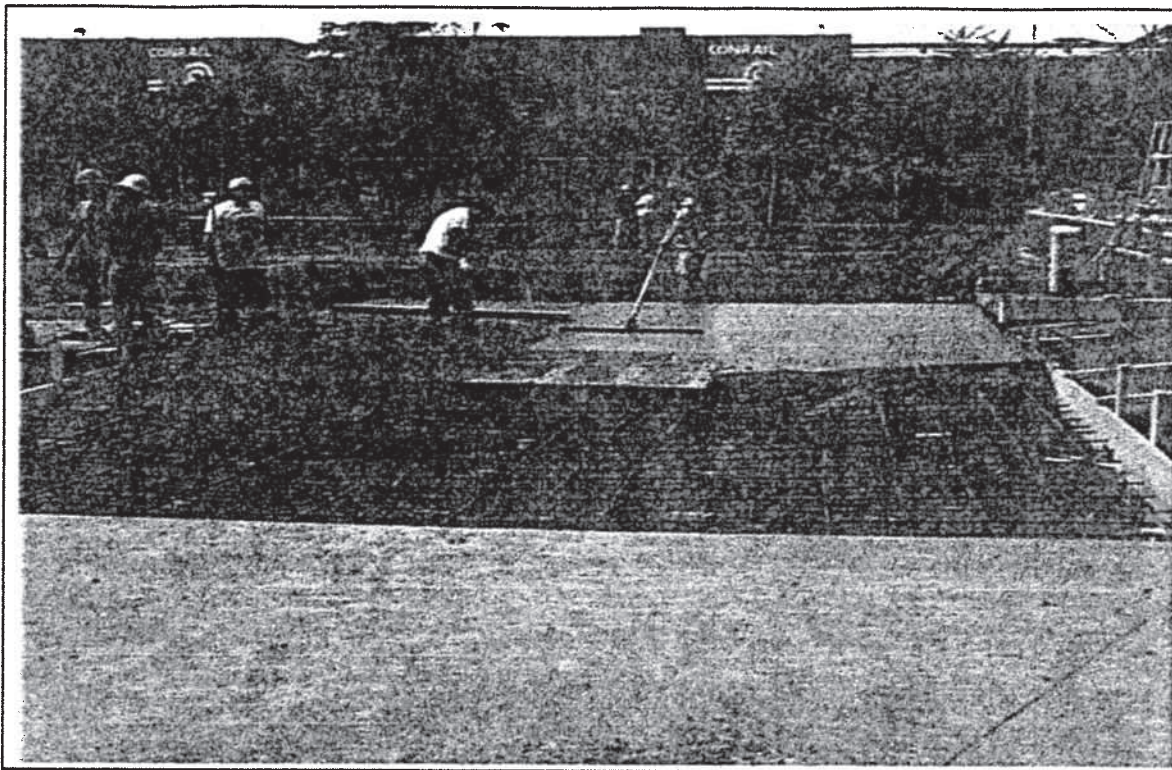
Photograph 27: Looking westward across spill containment pad during concrete work.

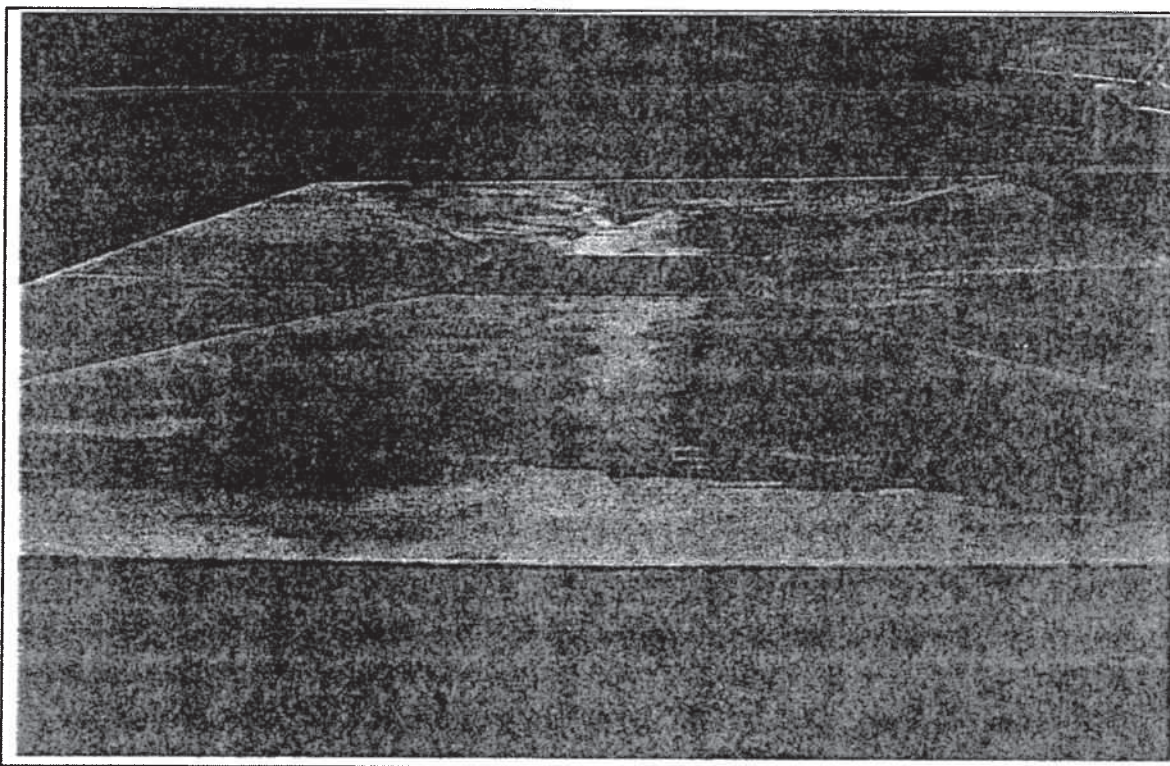
Photograph 28: Looking westward across finished spill containment pad.

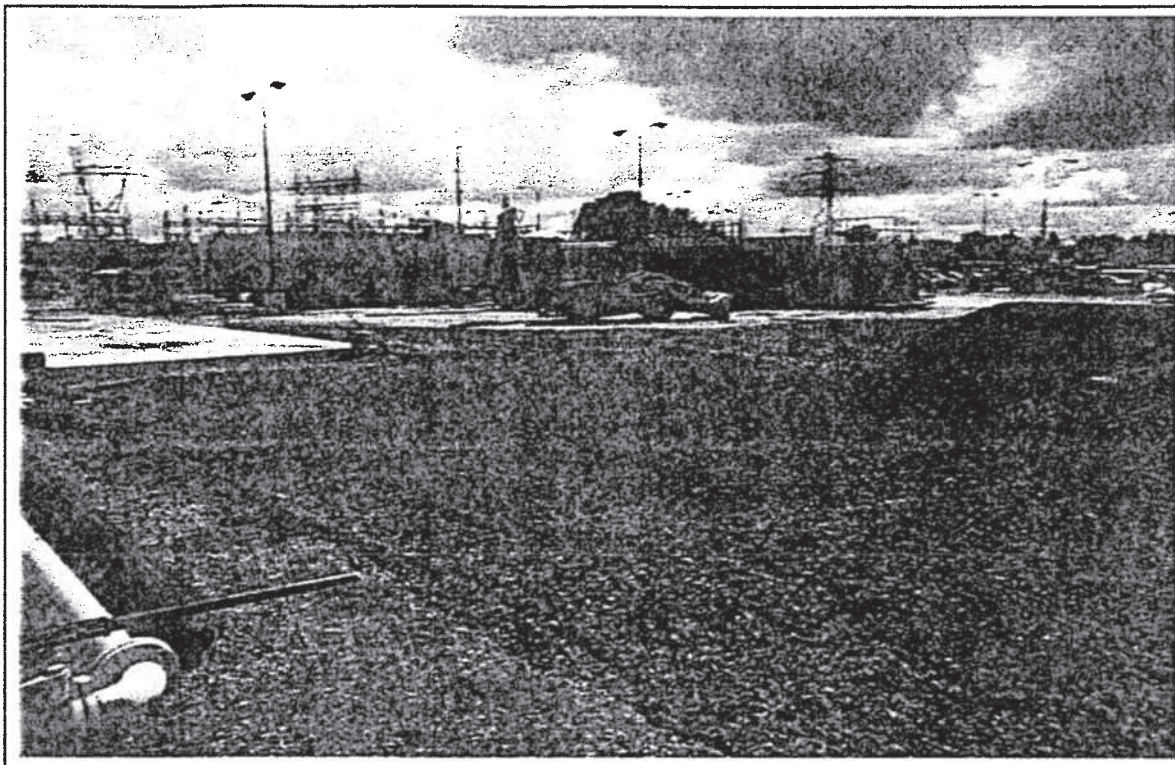
Photograph 29: Looking southeast across main excavation during stone placement.

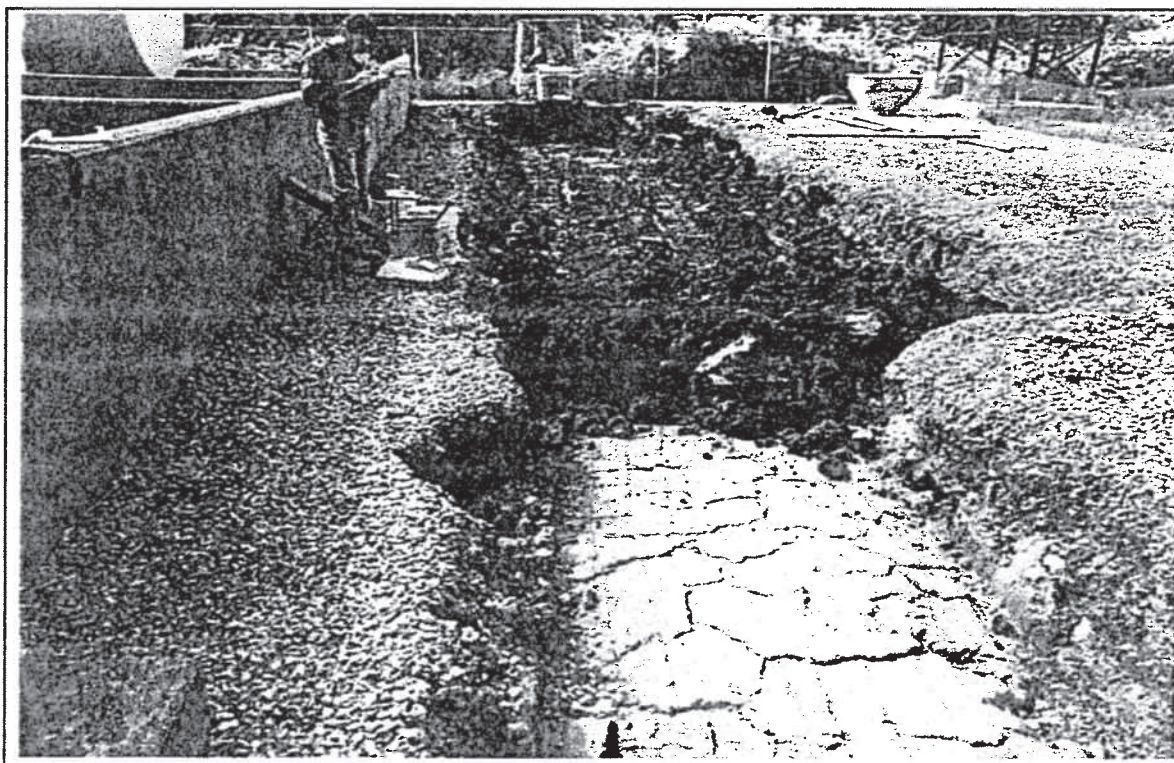
Photograph 30: Looking west across north trench during backfilling.

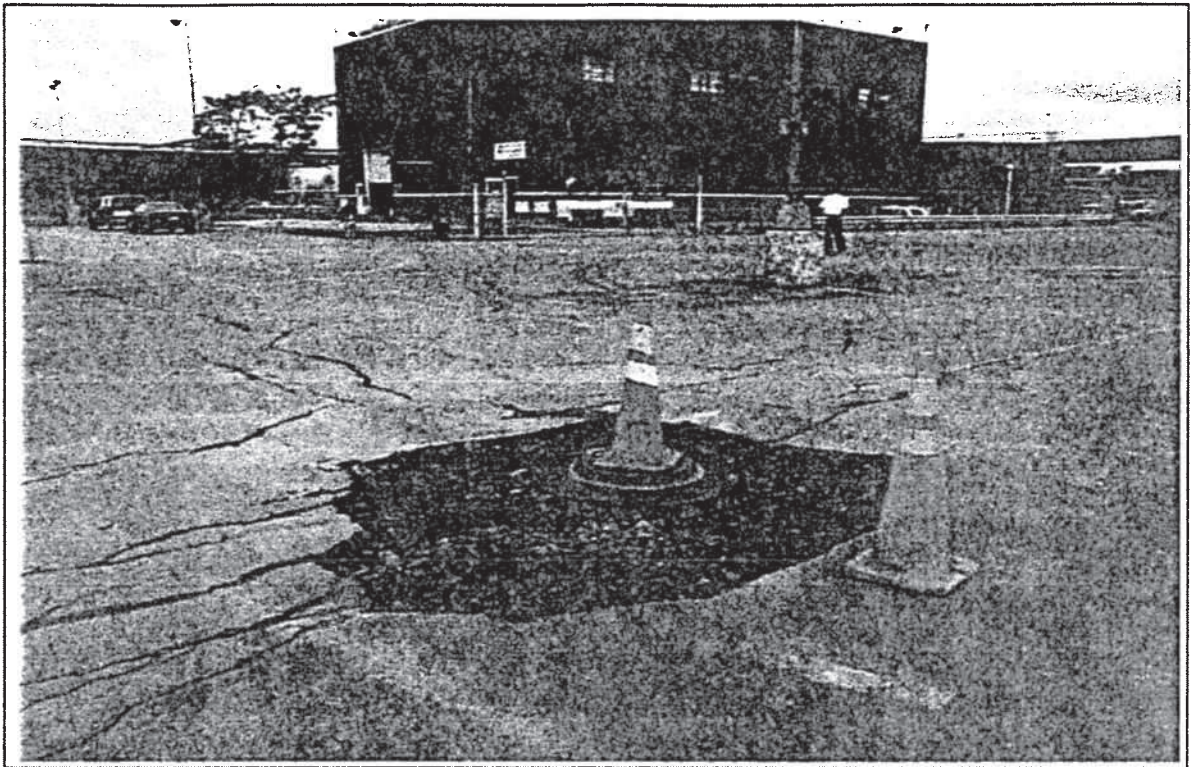
Photograph 31: Phase I paving area during prep work. Manhole repair area in forefront.

Phase II of the paving was conducted between October 26, 1998 and November 1, 1998. The Phase II area consisted of the parking area between the eastern and western entrance aisles. Activities included reconstruction of two damaged manholes, filling low areas with binder to level the surface, removal of 445 square feet of damaged asphalt, placement of petromat fabric, placement of a minimum of two inches of binder material over the petromat, placement of one inch of topcoat binder, and striping of the newly laid asphalt. New guardrails were also installed.

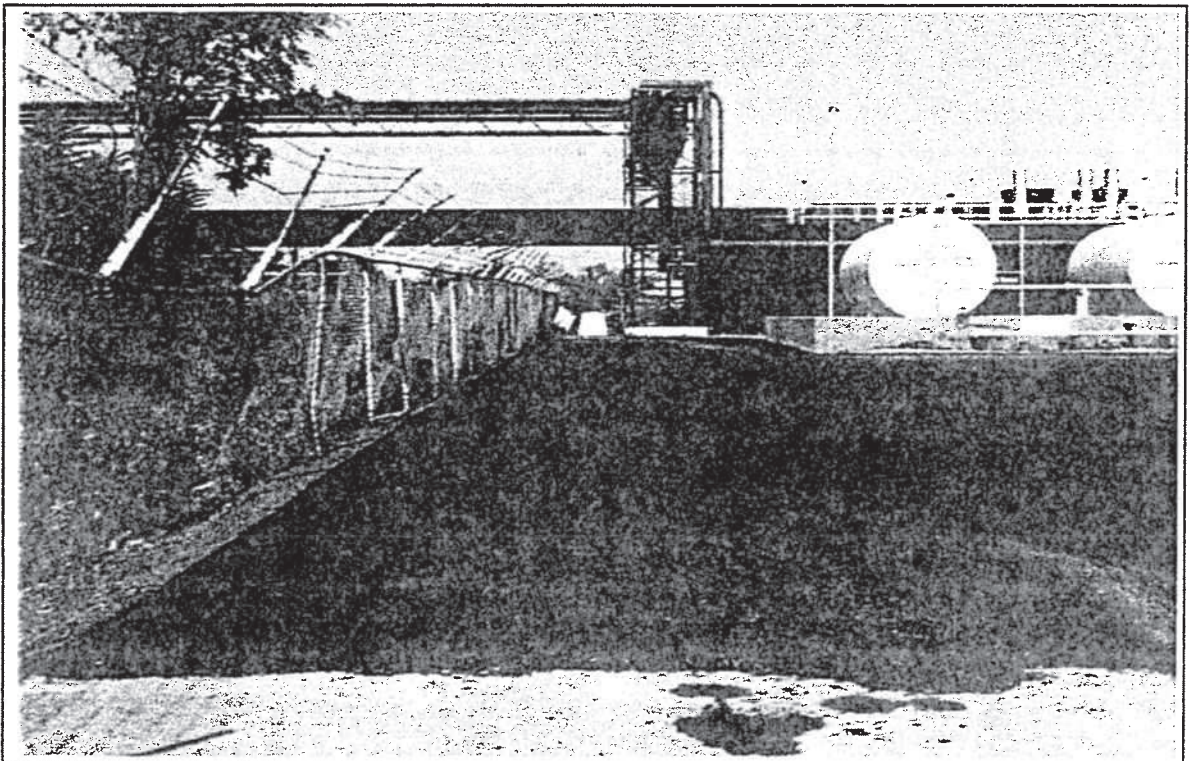
Photograph 32: Placement of initial binder above stone in excavation area.

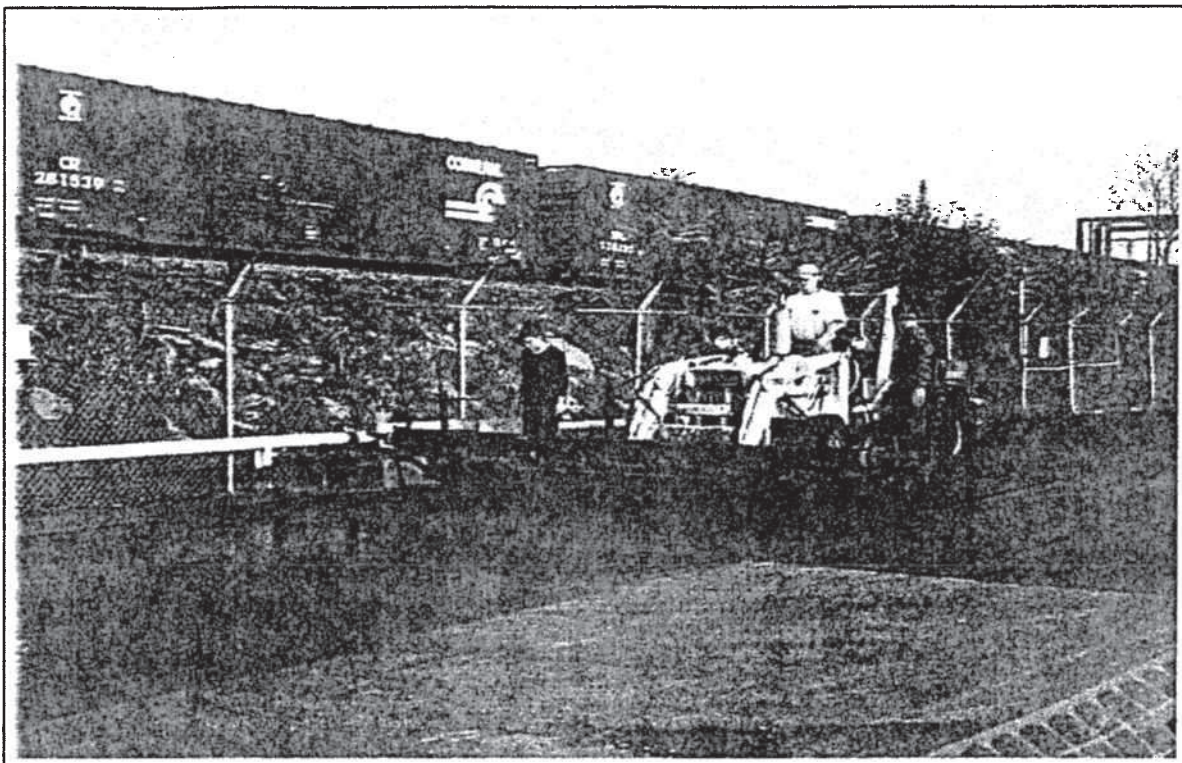
Photograph 33: Installation of Petromat fabric in Phase I area.

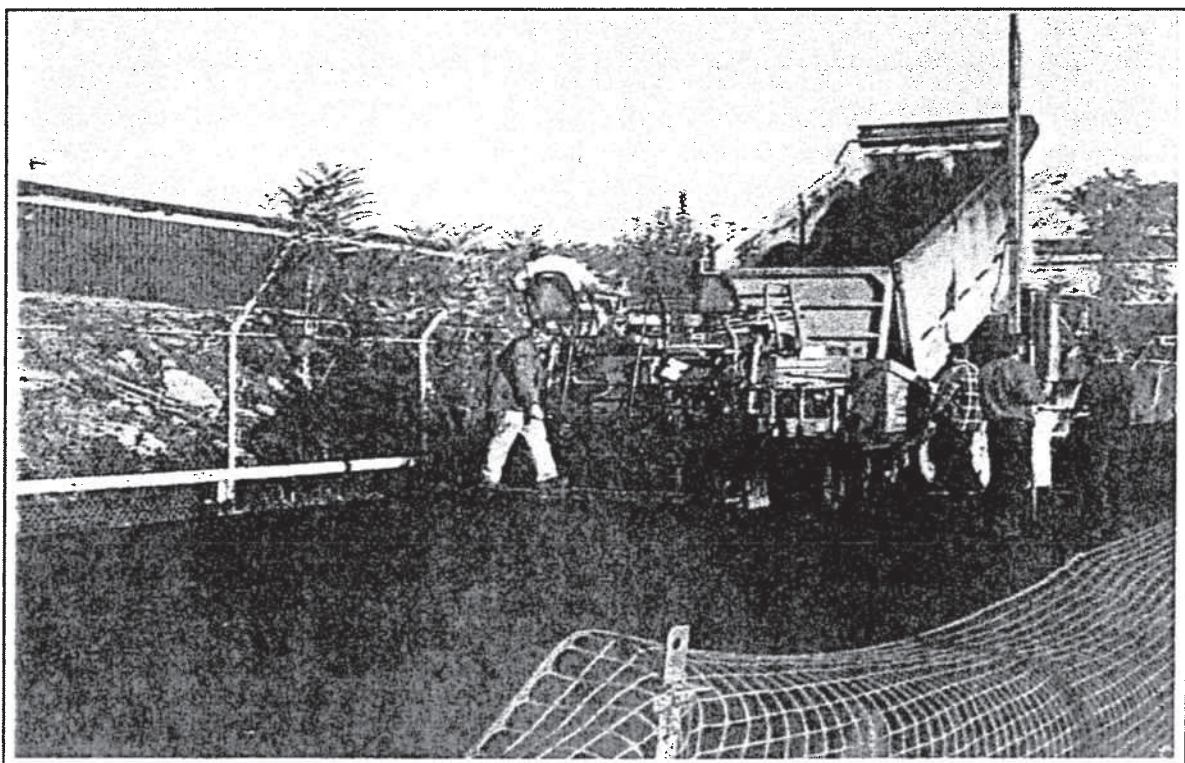
Photograph 34: Installation of final 2-inch binder coat in Phase I area.

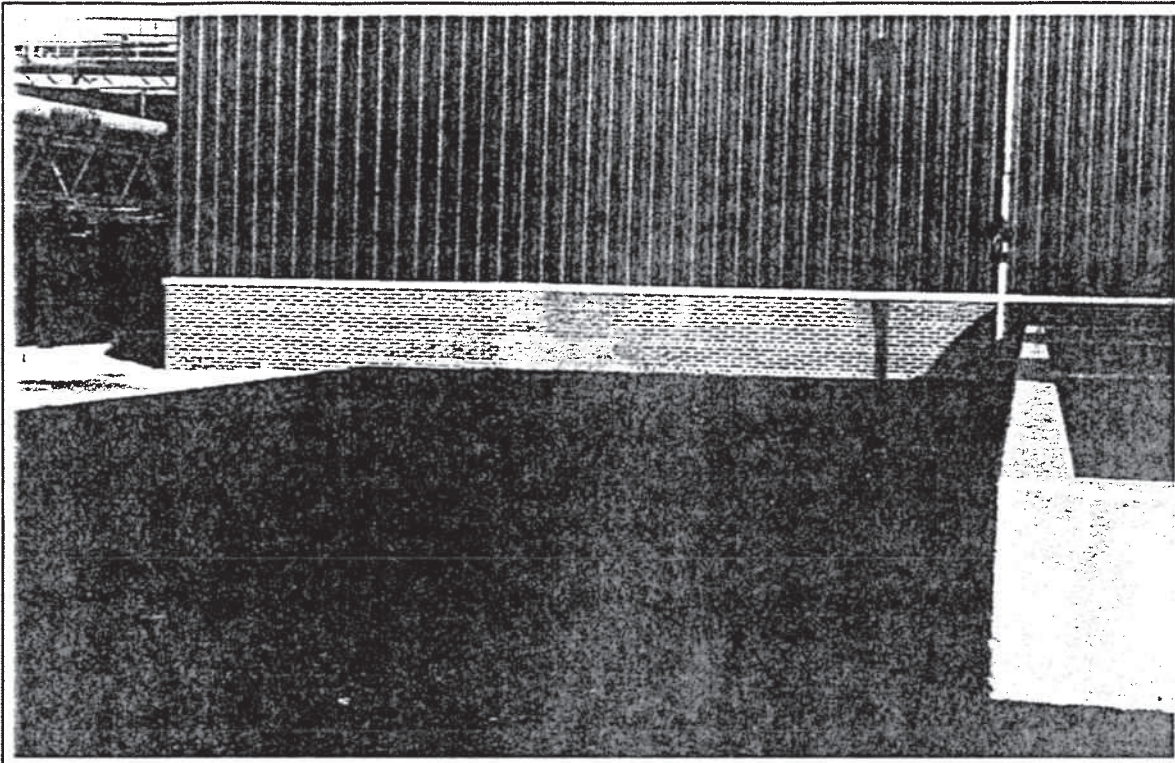
Photograph 35: View of final paving behind AST containment structure (looking eastward).

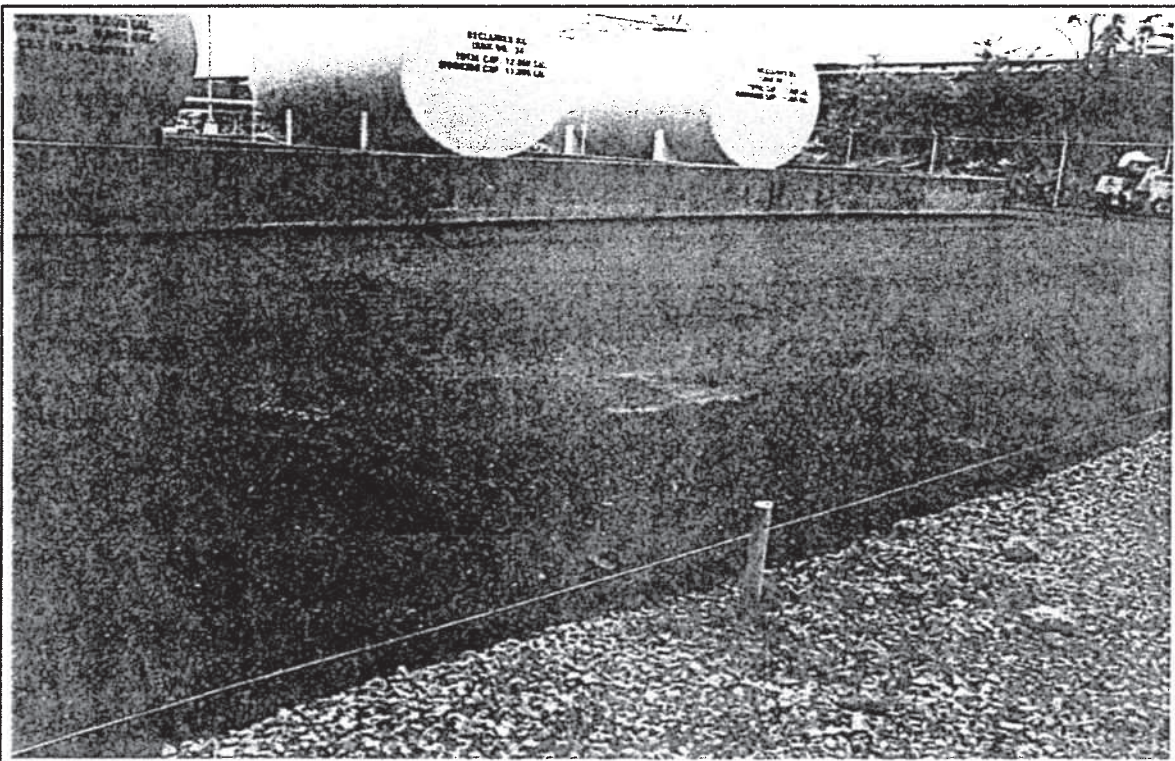
Photograph 36: View of final paving behind AST containment structure (looking southwest).

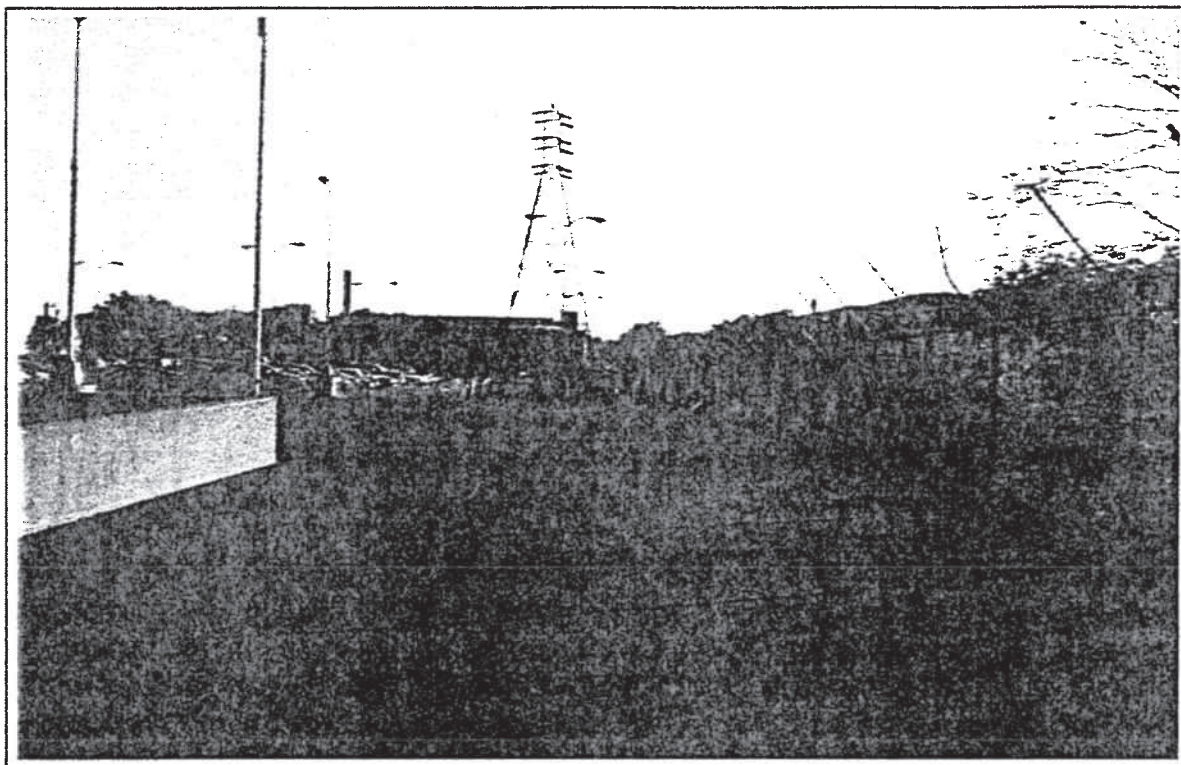
Photograph 37: View of final paving in excavation area looking southward.

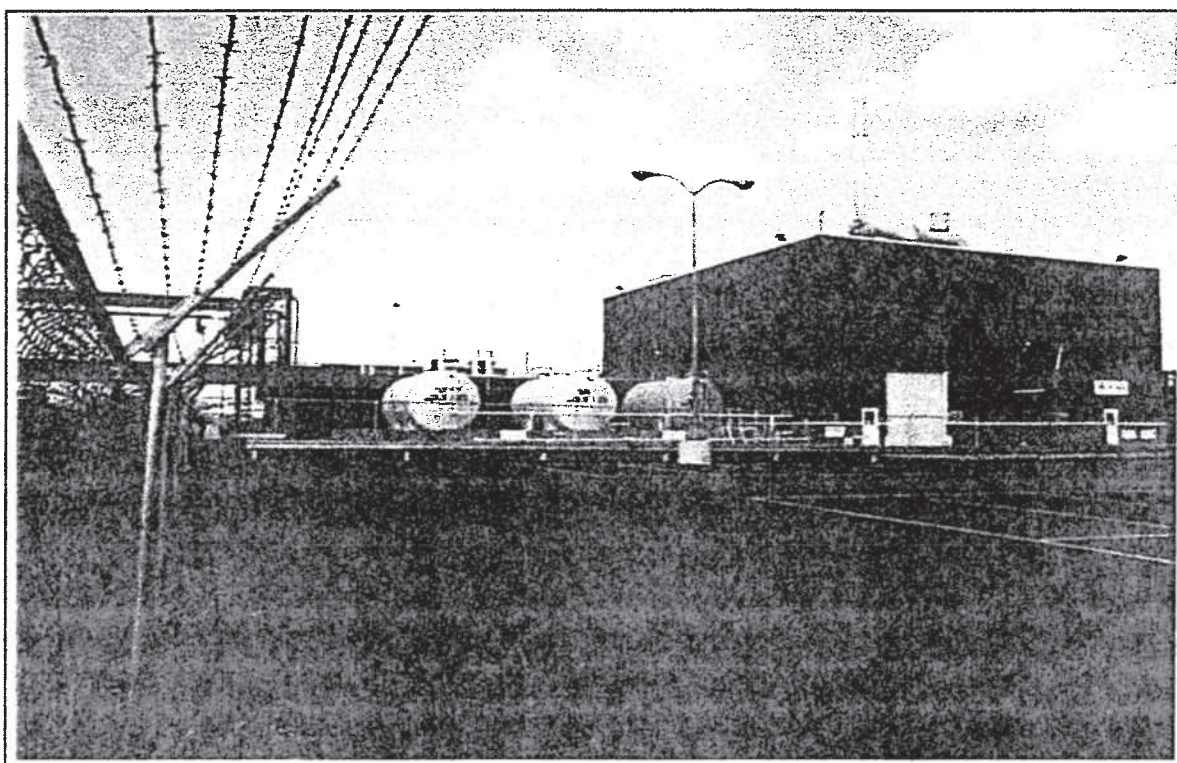
Photograph 38: View of final paving in excavation area looking northeast.

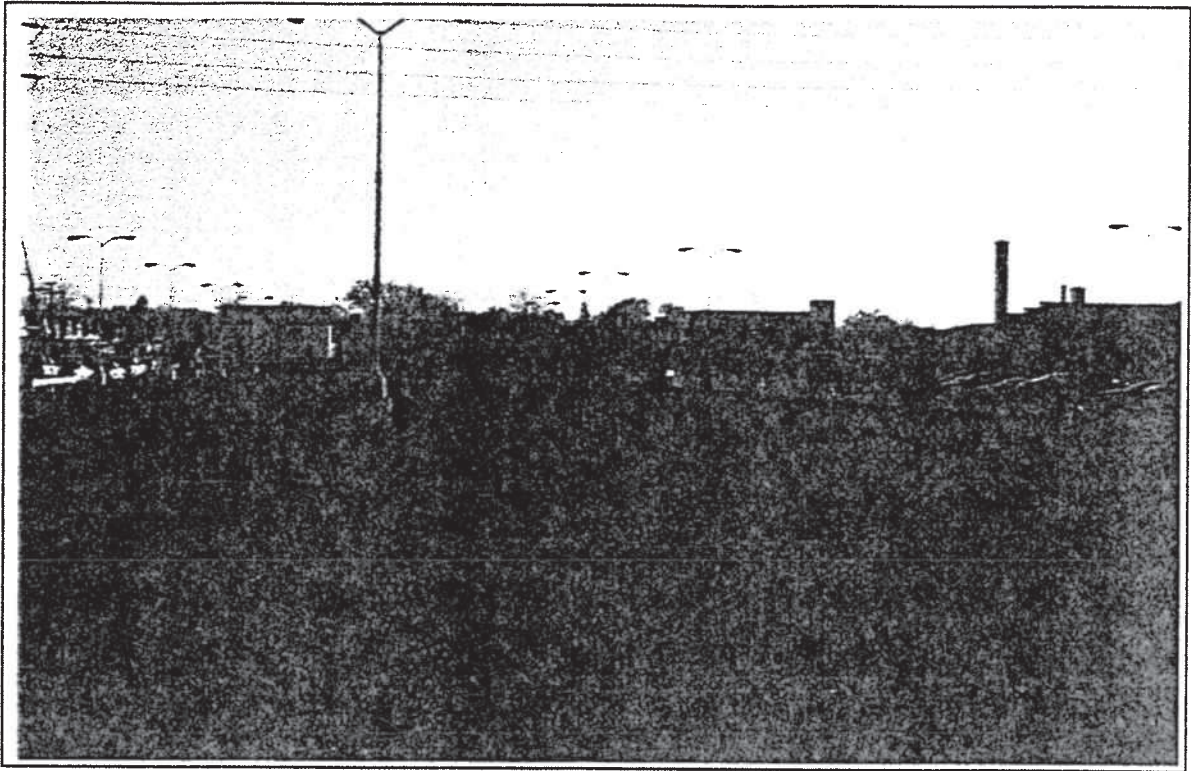
Photograph 39: View of Phase II paving area in progress.

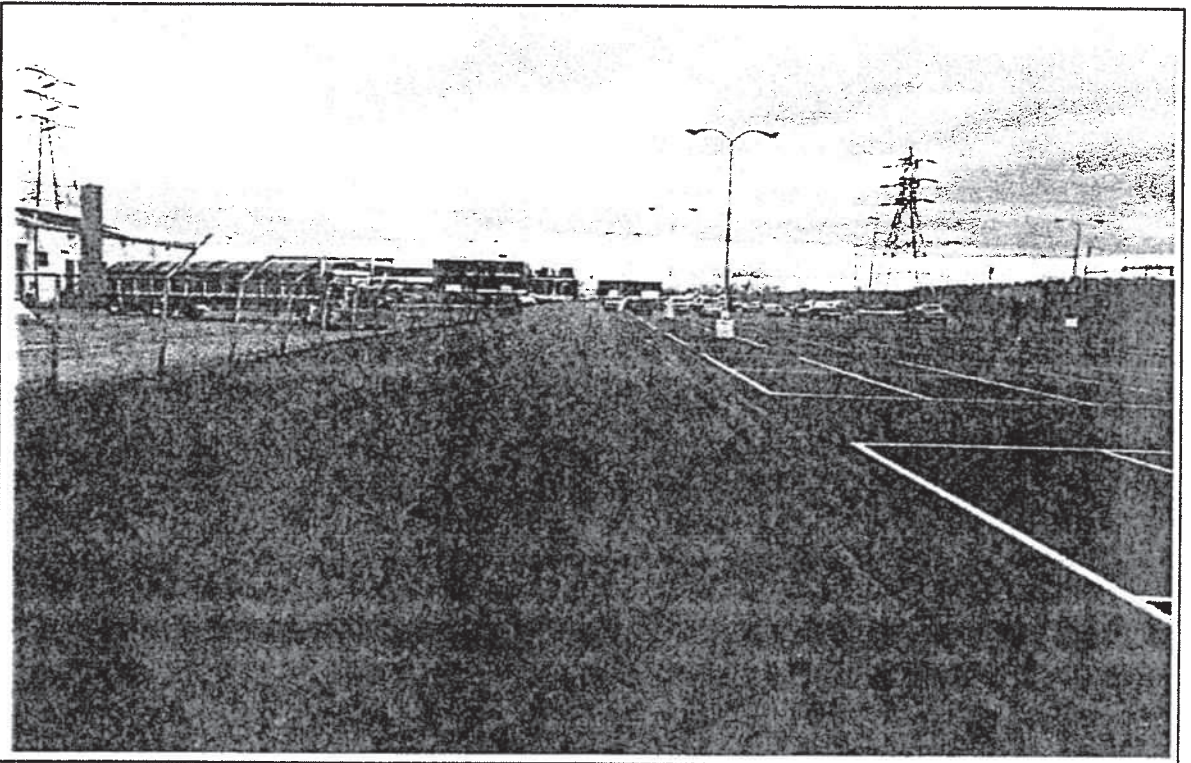
Photograph 40: View of completed Phase II paving area.

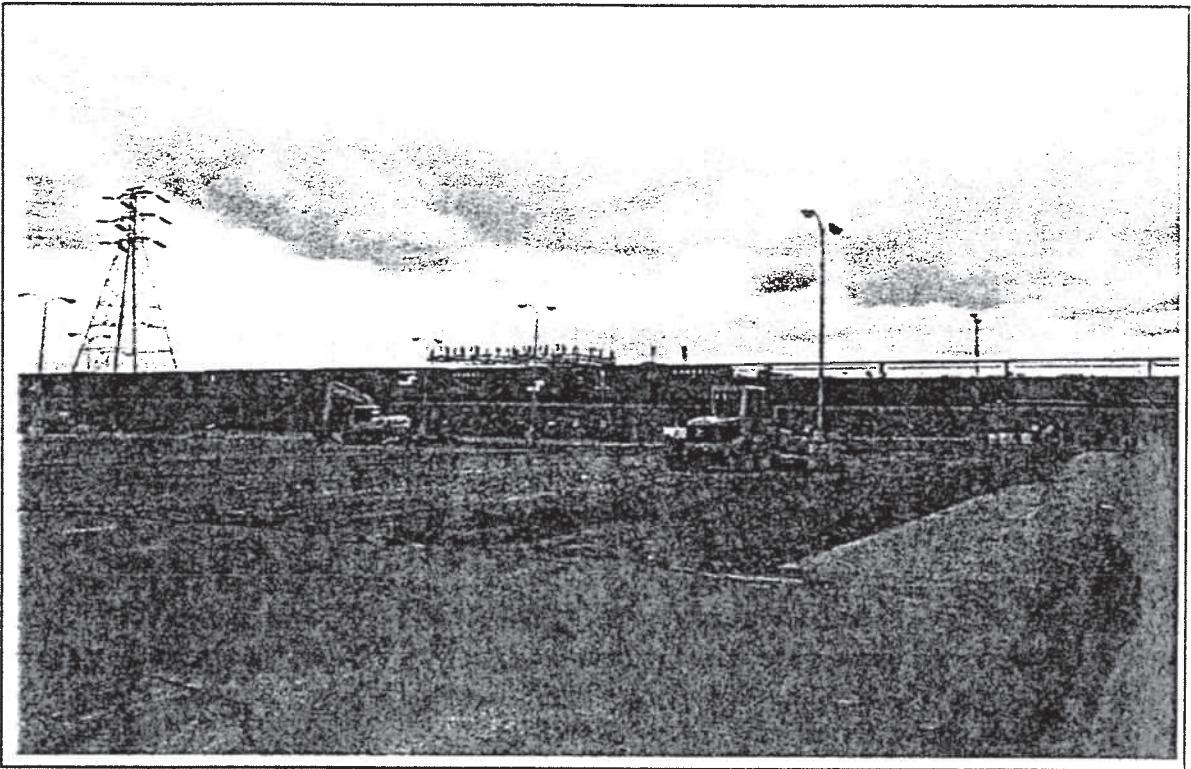
Core samples to evaluate the thickness of the asphalt and subbase were not completed. Alternatively, the contractor removed asphalt in damaged areas and did localized inspections of the subbase in those areas. It was determined that asphalt was degrading due to inadequate thickness of the asphalt binder material and not as a result of inadequate subbase.

Photograph 41: Grading of subbase in Phase III area (repairs prior to paving).

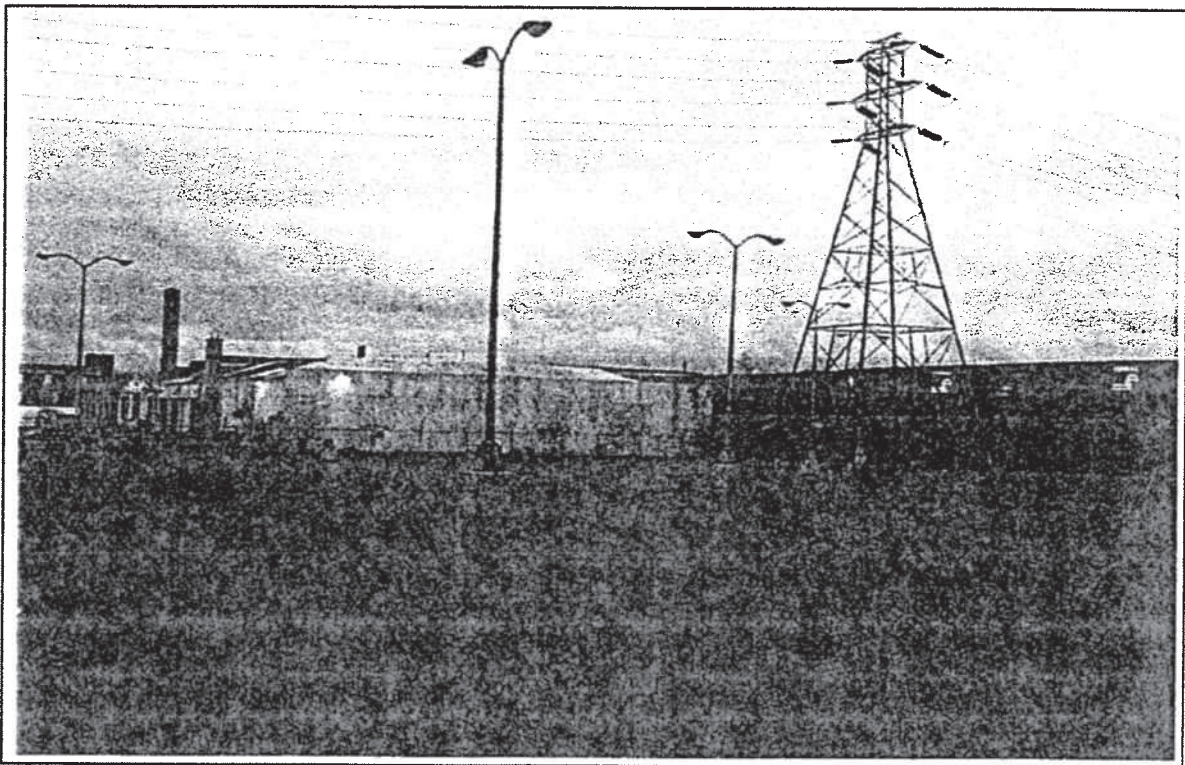
Photograph 42: View of completed Phase III paving area.
