Saginaw – Buffalo Site  
320 Scajaquada St  
Site Management Periodic Review Report

East Delavan Property, LLC  
NYSDEC Site Number 915152

Dates Covered by Report:  
May 4, 2018 to May 4, 2019

Rev. 2 – June 15, 2020

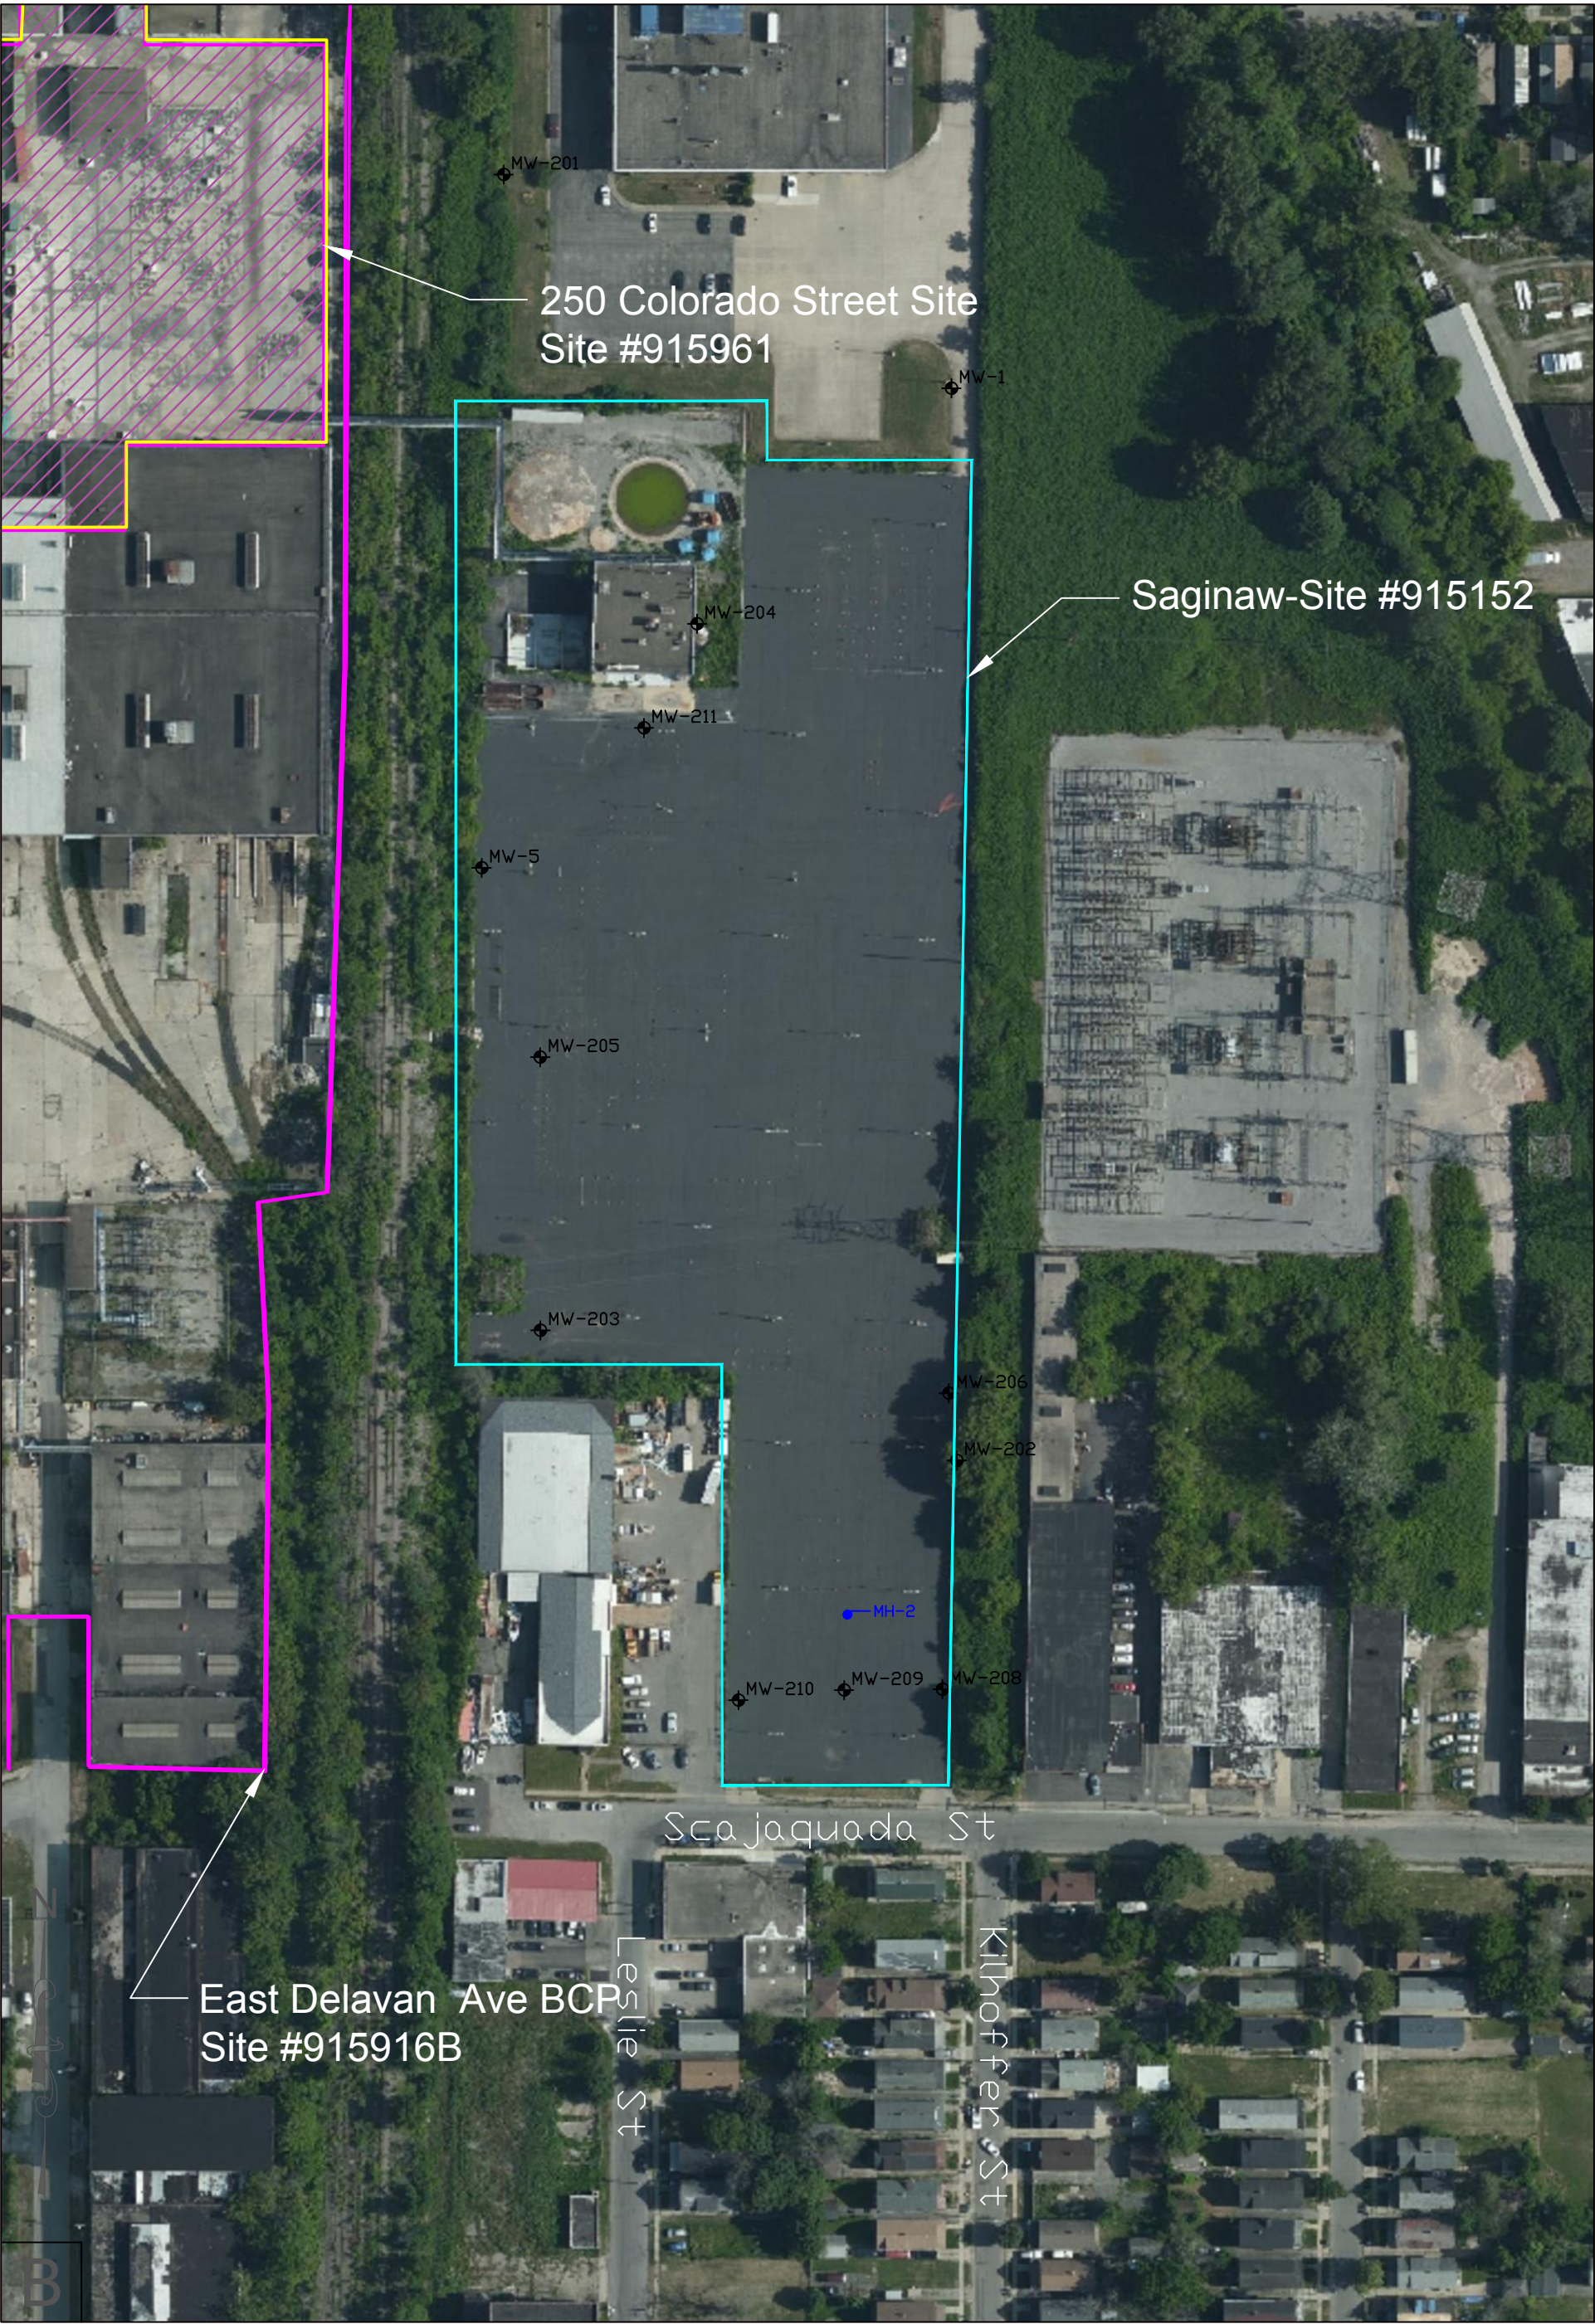
- Pavement inspection and maintenance conducted on an annual basis to ensure that the integrity of the asphalt surface has been maintained;
- Visual inspection of storm sewer manhole covers and manhole risers for structural damage;
- Groundwater sampling of Site monitoring wells for PCBs, Total Lead, and Soluble Lead (Figure 1); and
- Storm sewer sampling from Manhole #2 (Figure 1) for PCBs and Total Lead.

Groundwater and storm sewer sampling were initially conducted on a semi-annual basis and have been conducted on a biennial basis since 2008. Three (3) monitoring wells (MW-1, MW-201, and MW-205) were removed from the groundwater sampling program in 2004 (Figure 1).

- Biennial groundwater sampling of nine (9) monitoring wells (MW-5, MW-202, MW-204, MW-203, MW-206, MW-208, MW-209, MW-210, and MW-211) as shown on Figure 1;
- Annual water sampling from sewer Manhole #2.
