# **PERIODIC REVIEW REPORT**

Saginaw – Buffalo Site  
Site Number 915152  
320 Scajaquada Street  
Buffalo, New York

Dates Covered by Report  
August 31, 2024 to August 31, 2025

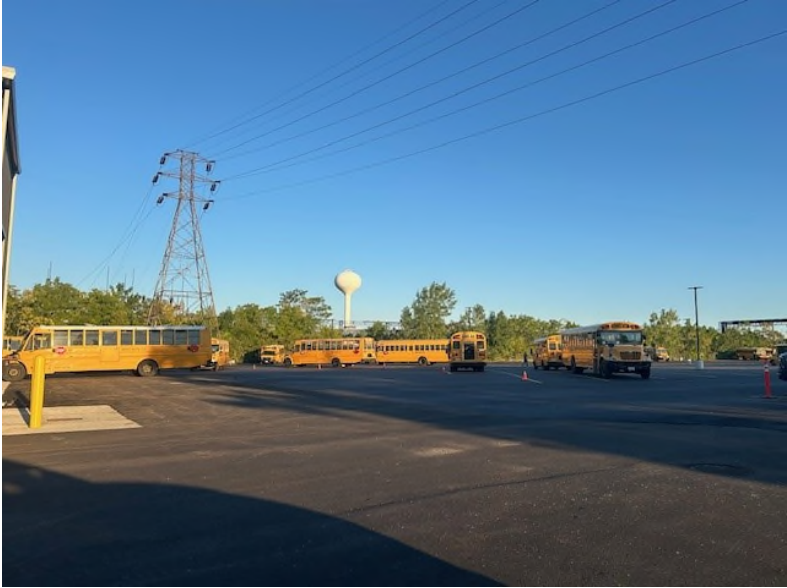
| <b>Photo No. 1</b><br><br><b>Direction Photo Taken:</b><br>Looking northwest | | |

| <b>Description:</b><br><br>Typical. Pavement in good condition. | | |

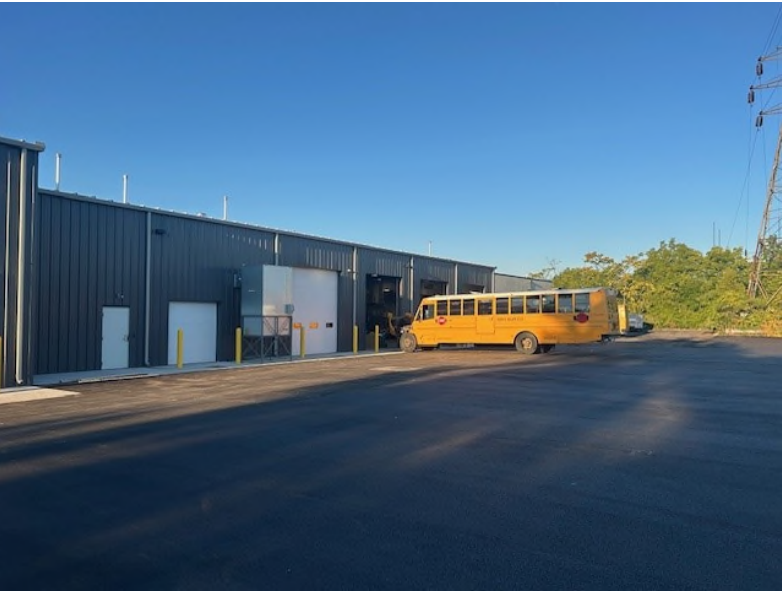
| <b>Photo No. 2</b><br><br><b>Direction Photo Taken:</b><br>Looking southwest. | | |

| <b>Description:</b><br><br>Typical. Pavement in good condition. | | |

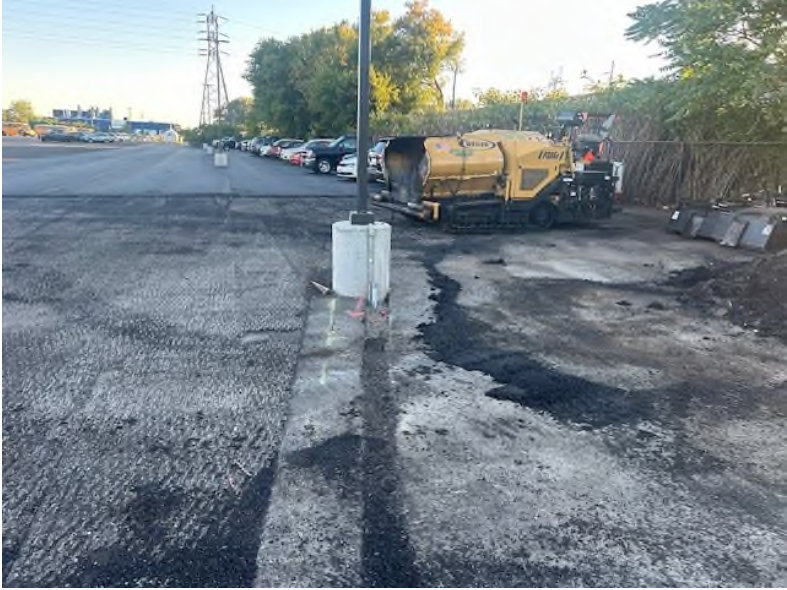
| <b>Photo No. 3</b> | | |

Explain: Surface is in good condition. Some areas were milled and require top coat.

| <b>Description:</b><br><br>Typical. Milling<br>conducted and top<br>coat is required. | | |

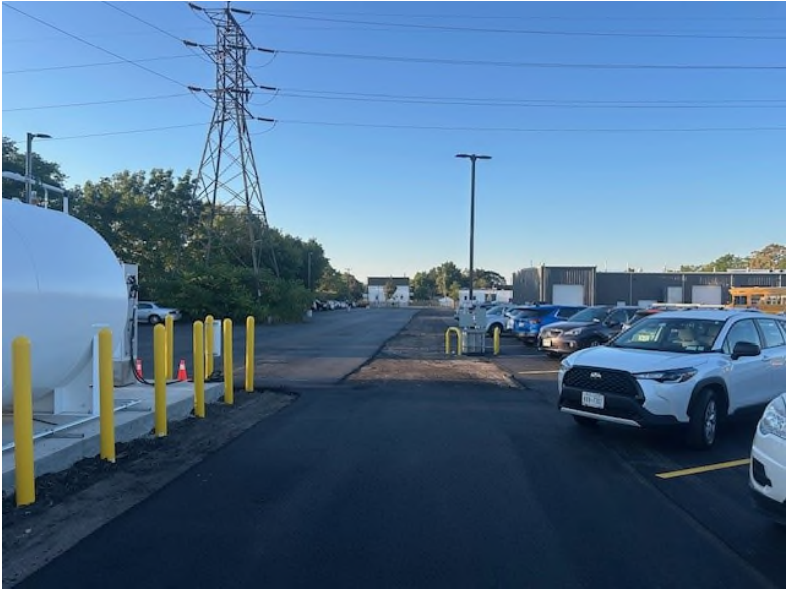
| <b>Photo No. 4</b> | | |

| <b>Description:</b><br><br>Typical. Pavement in<br>good condition. | | |

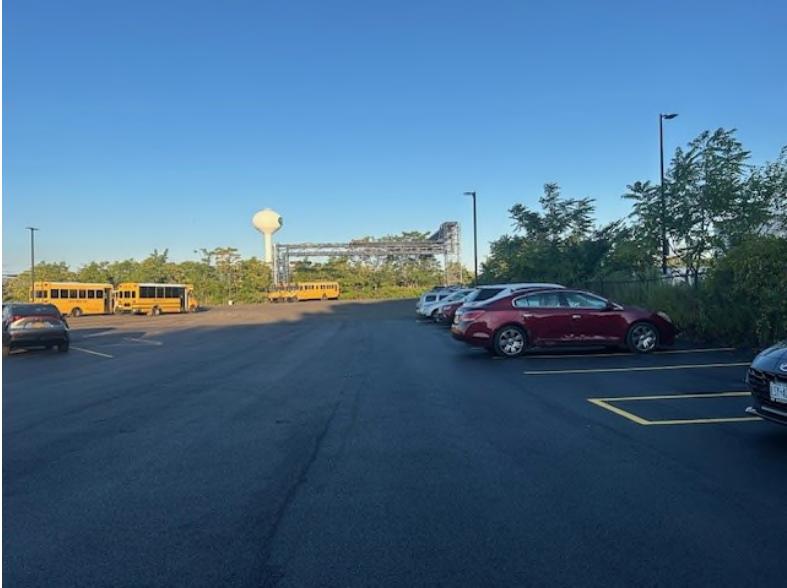
| <b>Photo No. 5</b> | | |

| <b>Description:</b><br><br>Typical. Pavement in good condition. Area in foreground is location of former wastewater treatment plant. | | |

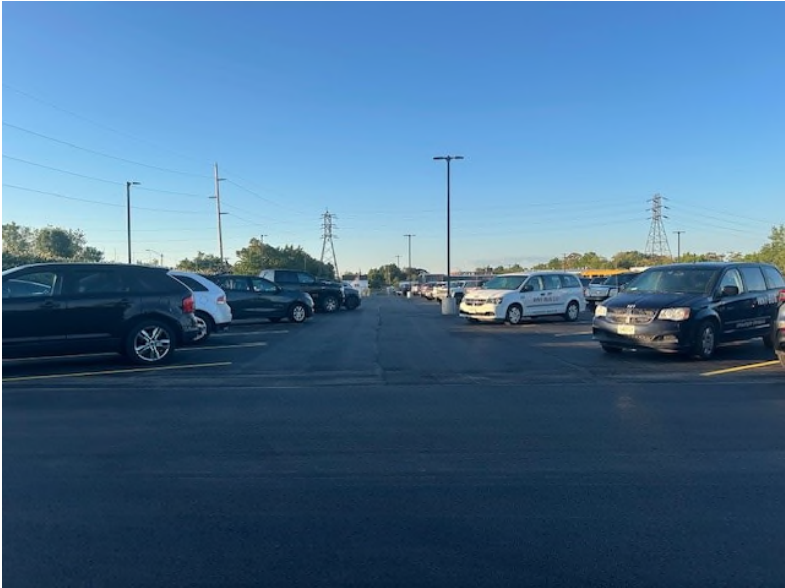
| <b>Photo No. 6</b> | | |

| <b>Description:</b><br><br>Typical. Pavement in good condition. | | |

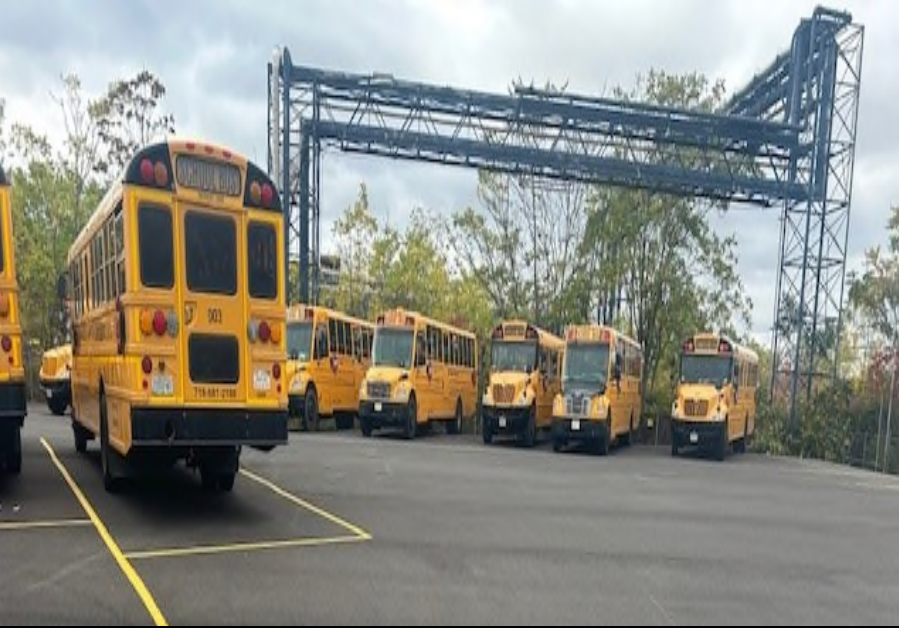
| <b>Photo No. 7</b> | | |

| <b>Description:</b><br><br>Prior location of monitoring wells MW-204 and Mw-211 covered by new asphalt | | |

- Monitoring well MW-201 decommissioned per CP-43 in spring/summer 2026.
- Monitoring wells MW-202, MW-204, MW-206, and MW-211 to be relocated, decommissioned, and/or re-installed prior to next sampling event scheduled for spring/summer of 2026.

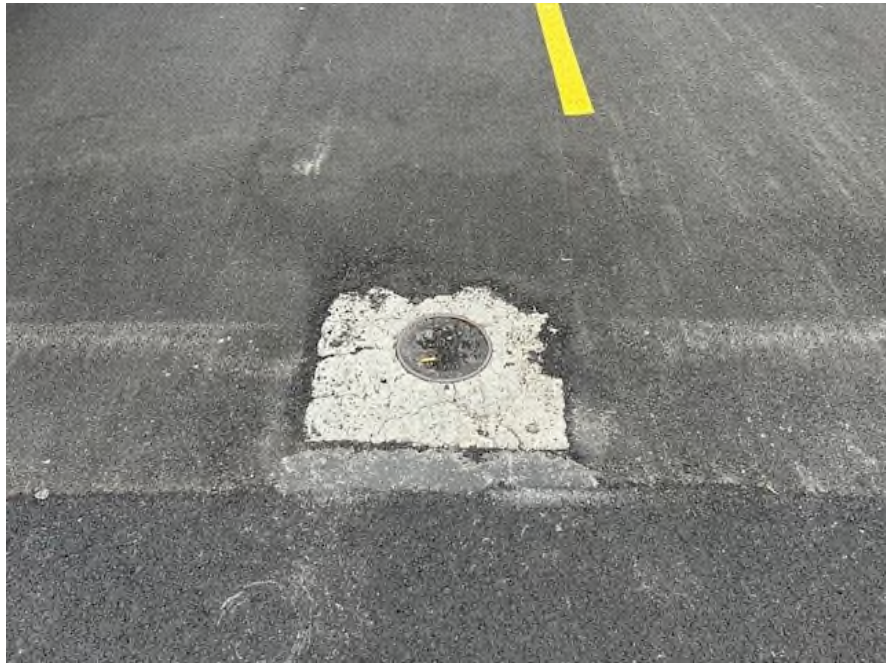
| <b>Photo No. 8</b> | | |

| <b>Description:</b><br>Monitoring well MW-2210 damaged curb box with no cover | | |

- Monitoring well MW-210 curb box/cover need to be repaired (to be completed in 2026 prior to the spring/summer groundwater sampling).

- Monitoring well MW-210 curb box/cover to be repaired prior to next sampling event scheduled for spring/summer of 2026.

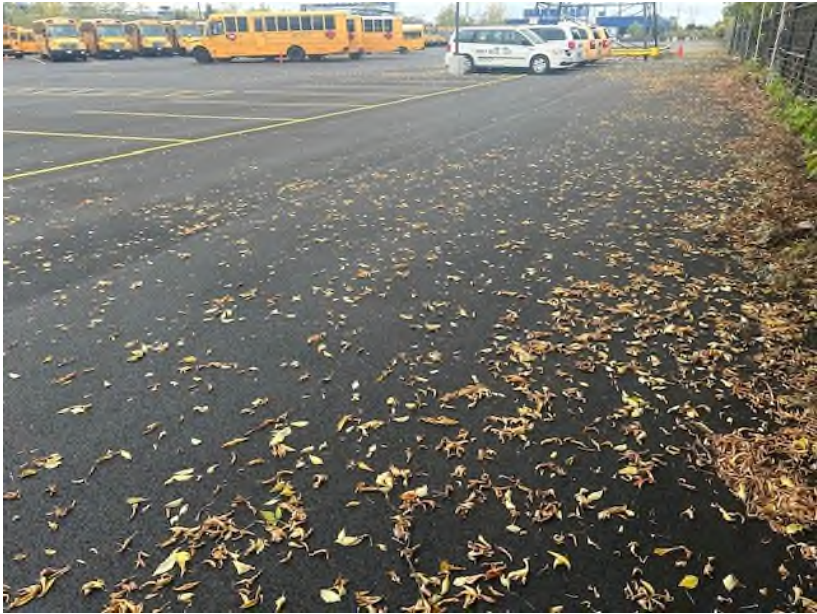
| <b>Photo No. 9</b> | | |

| <b>Description:</b><br><br>Monitoring Well MW-202 covered by new asphalt | | |

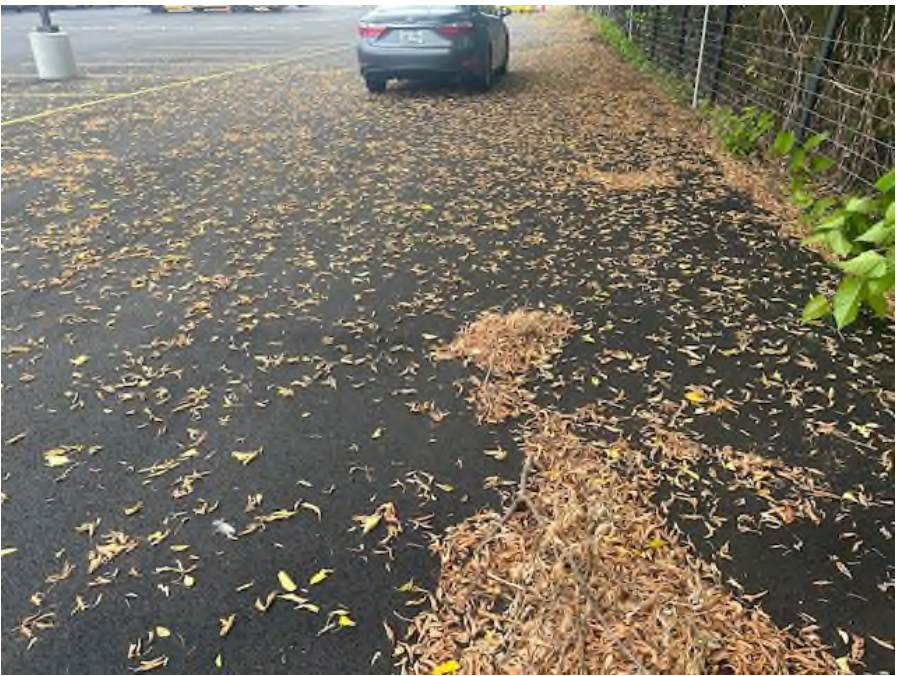
| <b>Photo No. 10</b> | | |

| <b>Description:</b><br><br>Monitoring Well MW-206 covered by new asphalt | | |
