DAILY OBSERVATION REPORT

Report No. 005

Mr. C's Dry Cleaner site

Monitoring Well Network Improvements

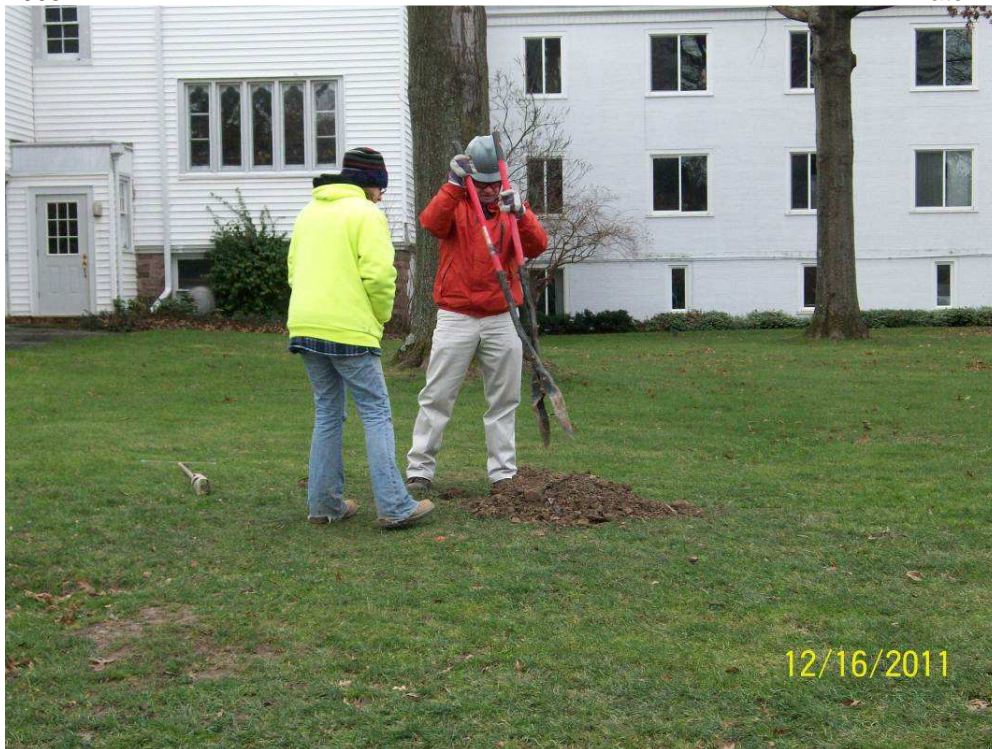
Figure 1: View of Hand Excavation to 5' for Utility Clearance at EE-3 (Looking South AM)

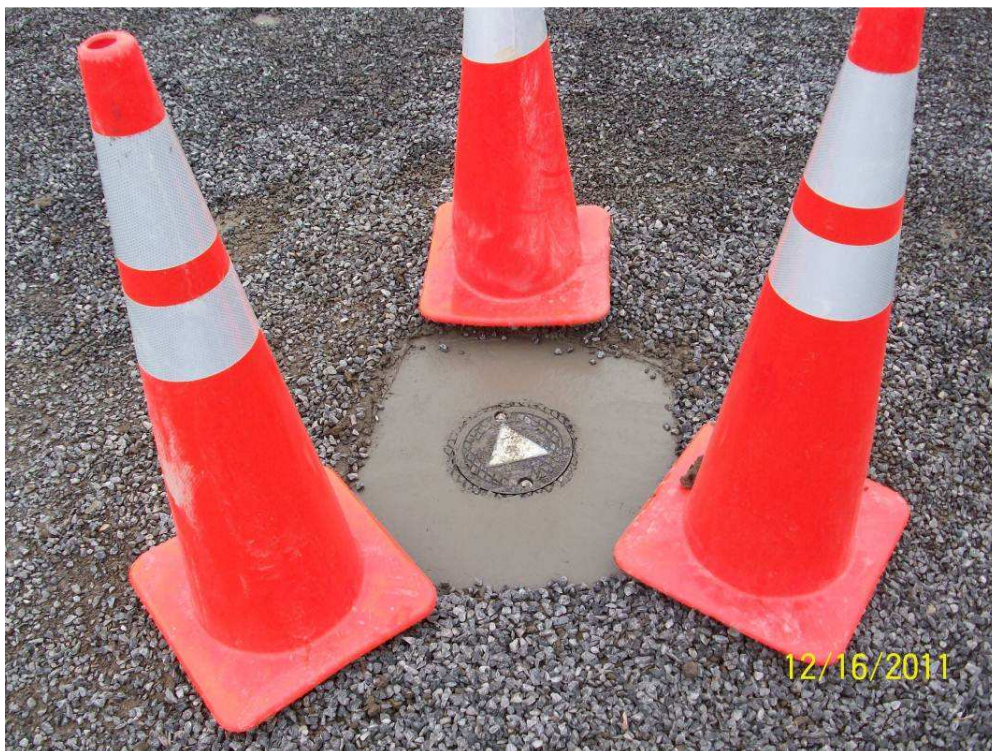
Figure 2: View of finished well pad at EE-4 (AM)

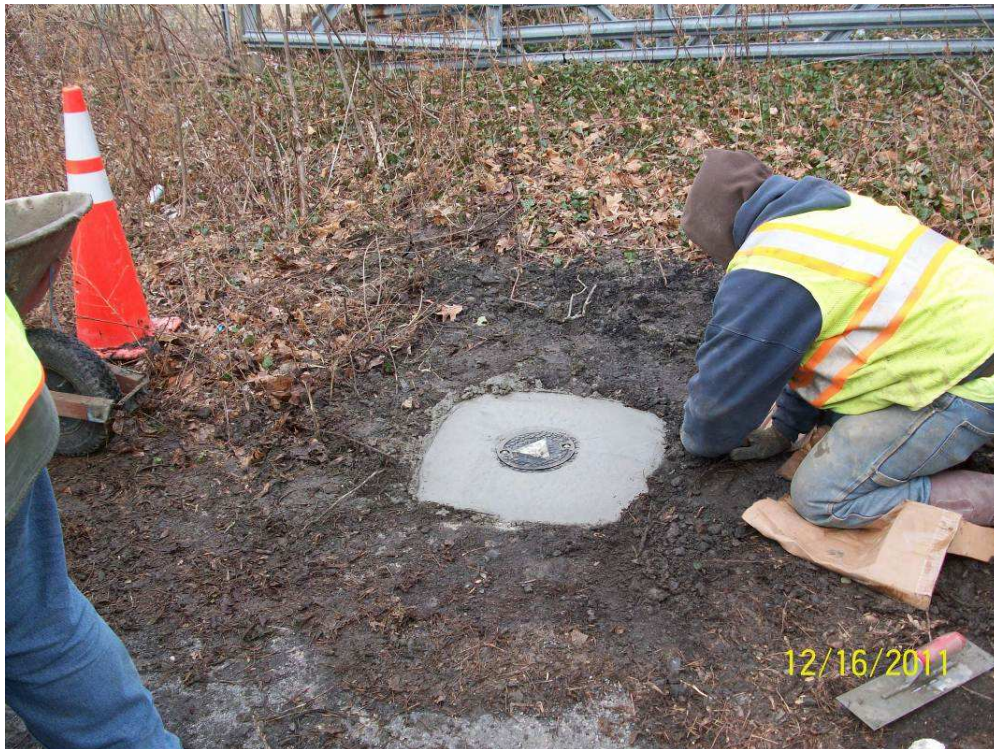
Figure 3: View of Finished Well Pad at ESI-2-R (AM)

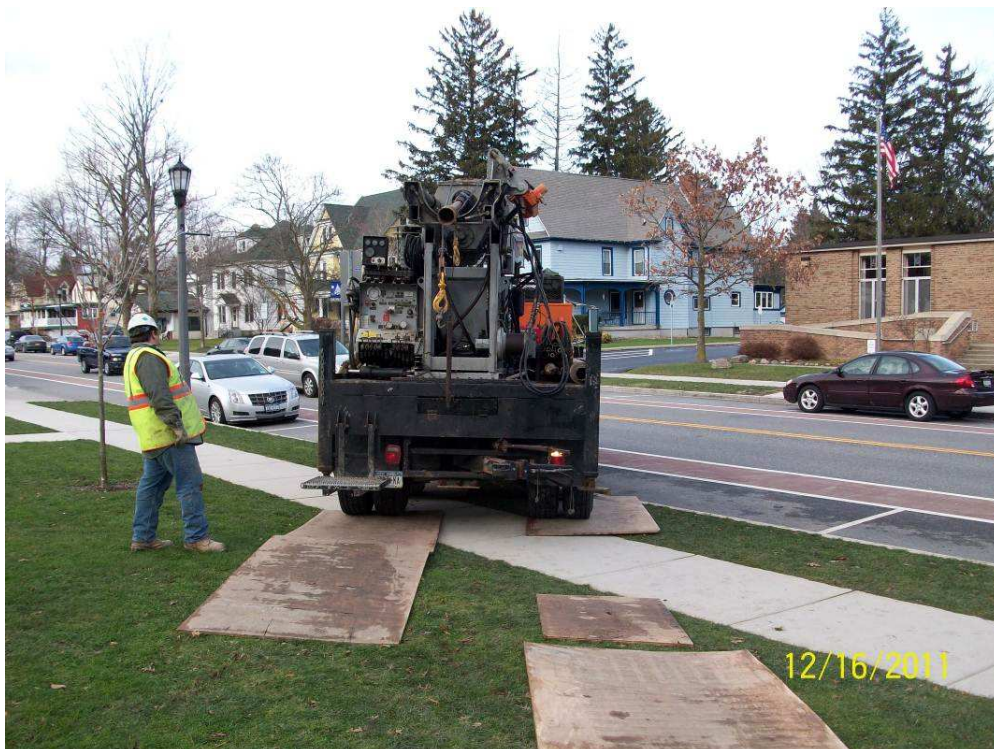
Figure 4: View of GES setting the rig on EE-3 (AM)

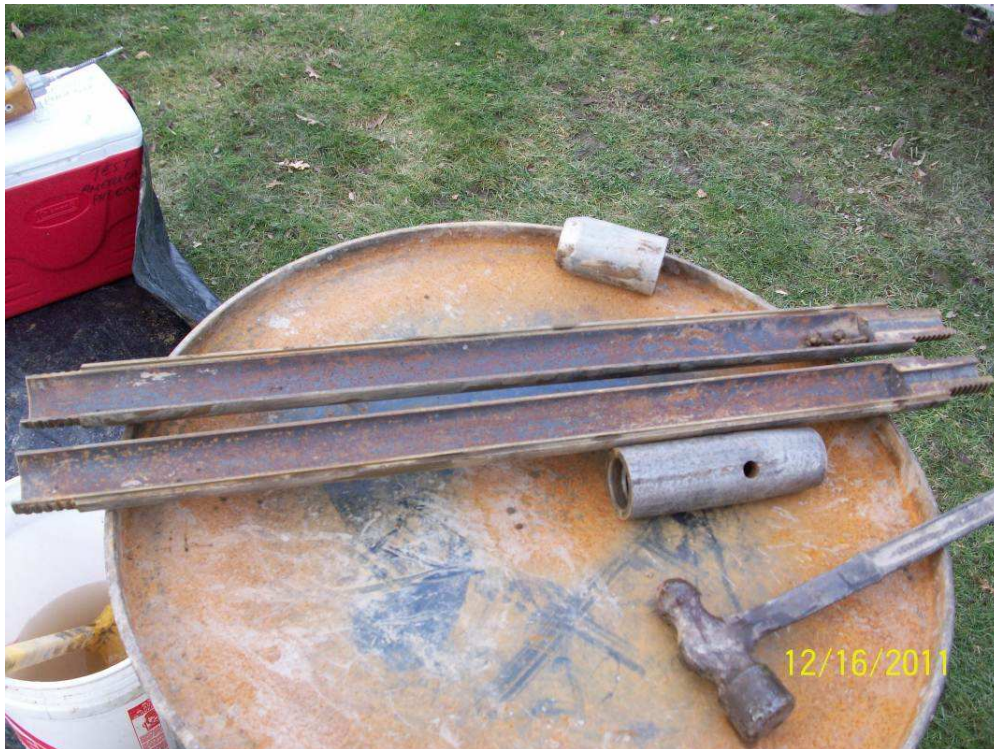
Figure 5: View of split spoon core 5'-6' bgs at EE-3 (No Recovery)

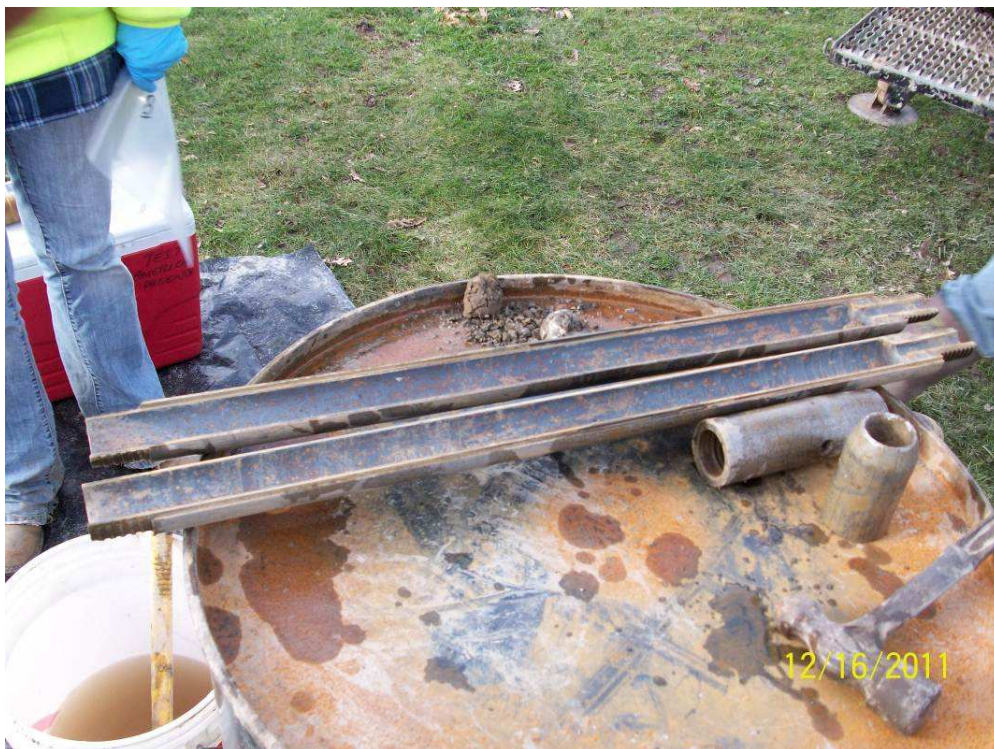
Figure 6: View of split spoon core 6'-8' bgs at EE-3 (No Recovery)

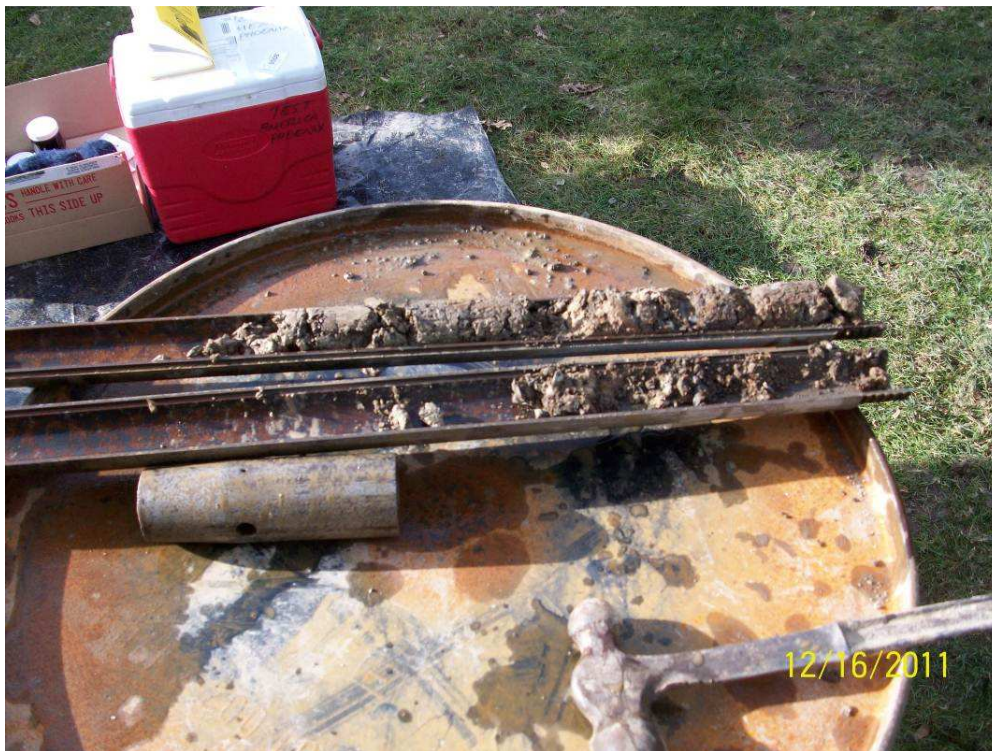
Figure 7: View of split spoon core 8'-10' bgs at EE-3

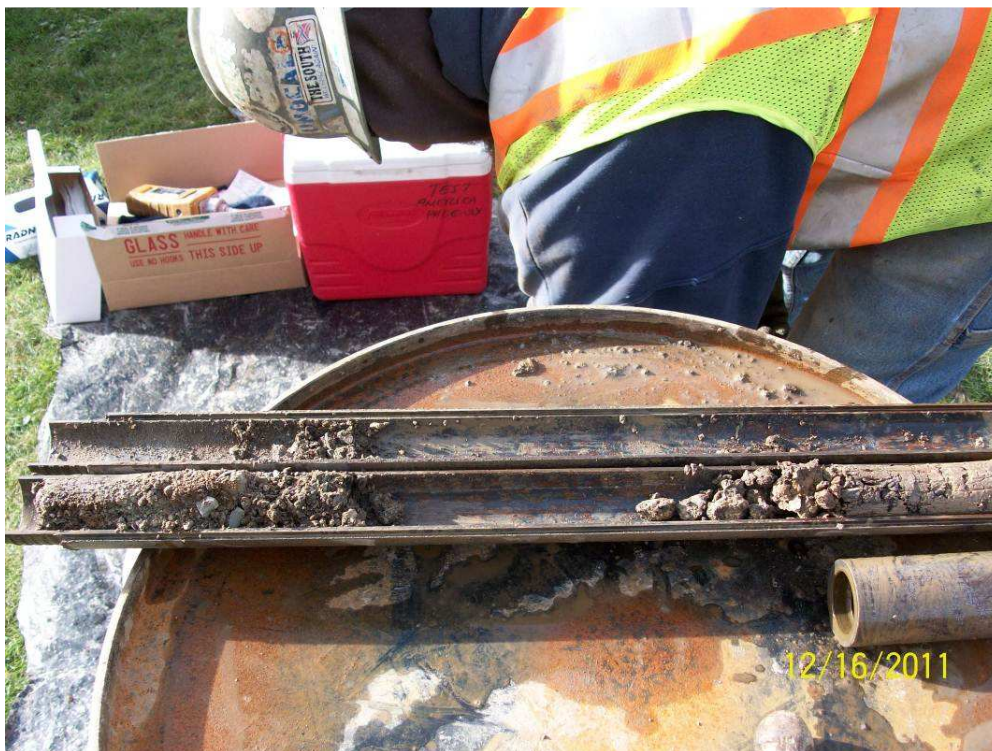
Figure 8: View of split spoon core 10'-12' bgs at EE-3

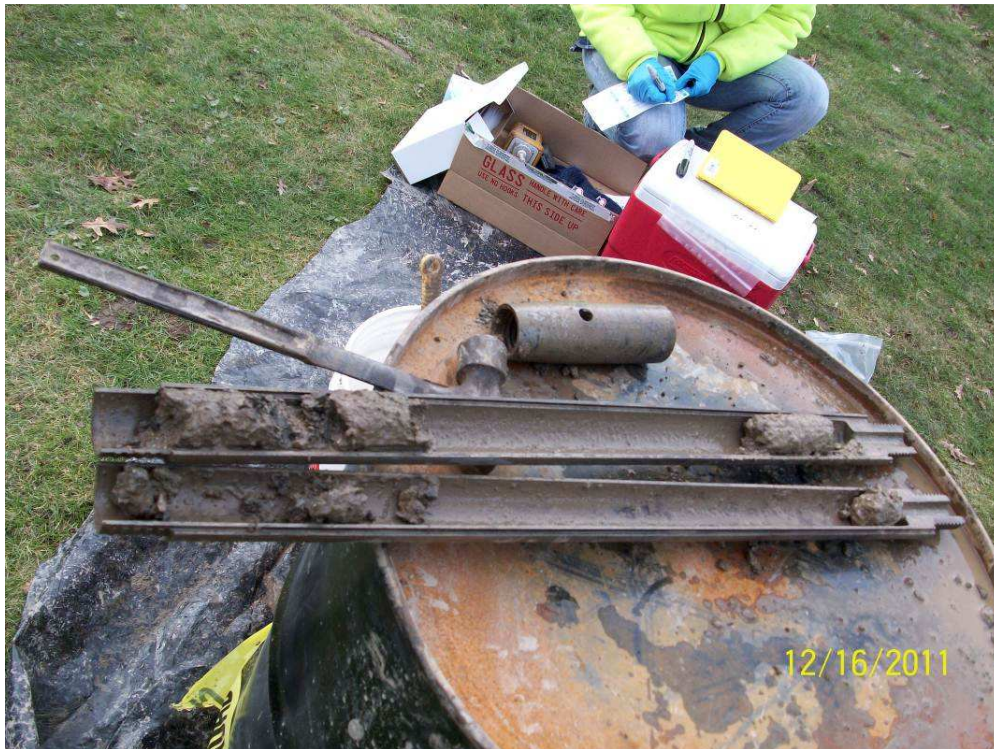
Figure 9: View of split spoon core 12'-14' bgs at EE-3

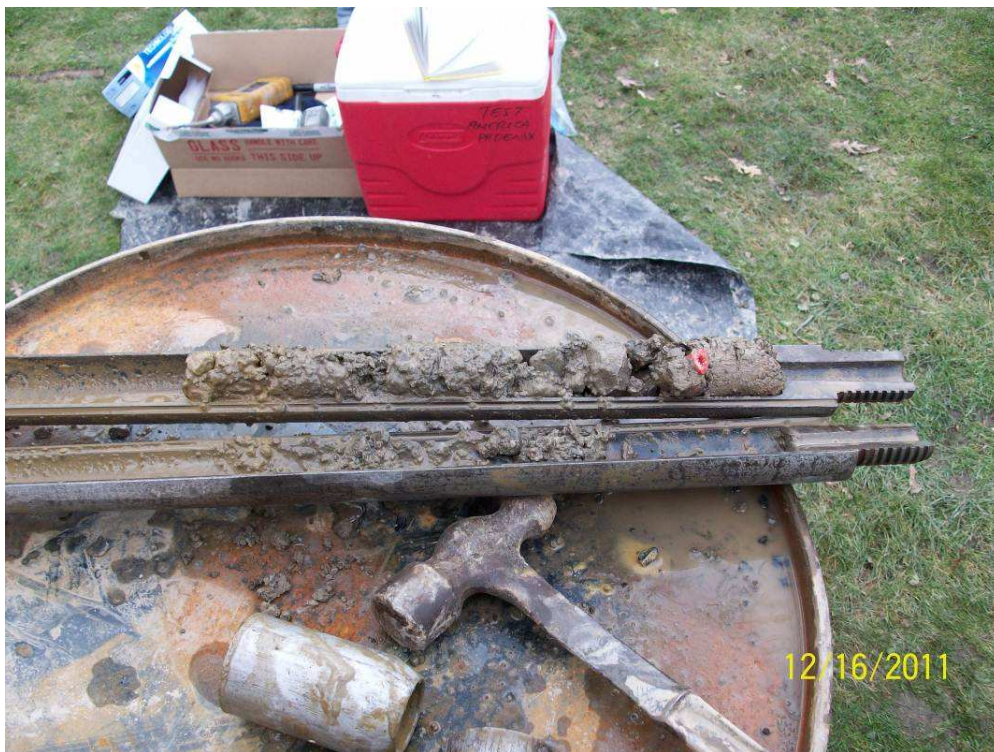
Figure 10: View of split spoon core 14'-16' bgs at EE-3

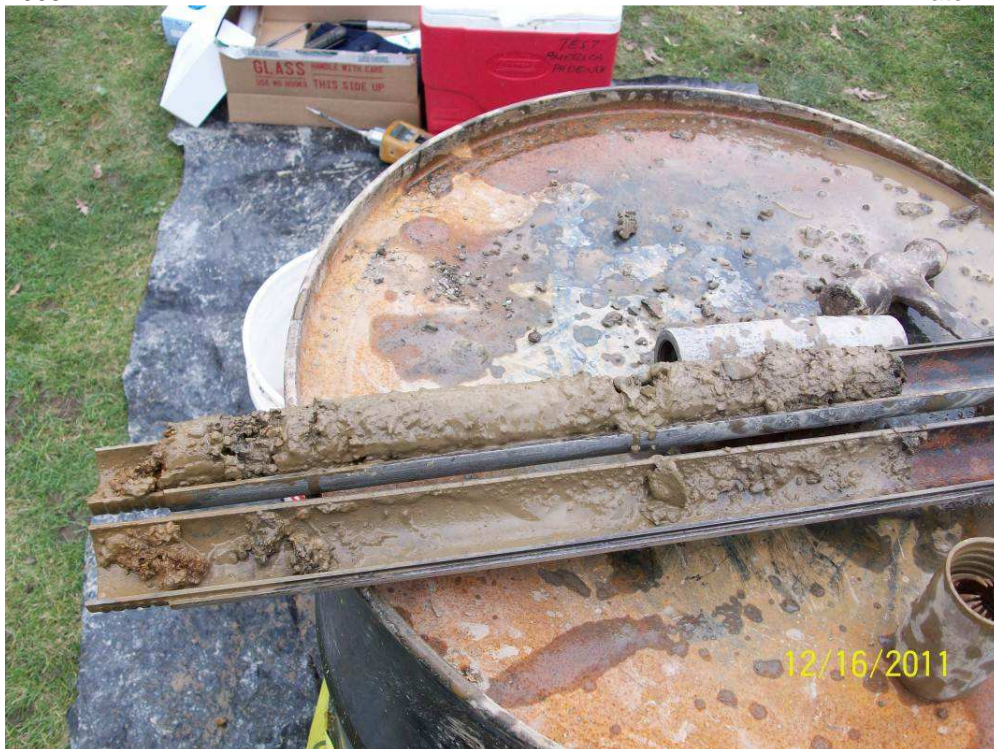
Figure 11: View of split spoon core 16'-18' bgs at EE-3

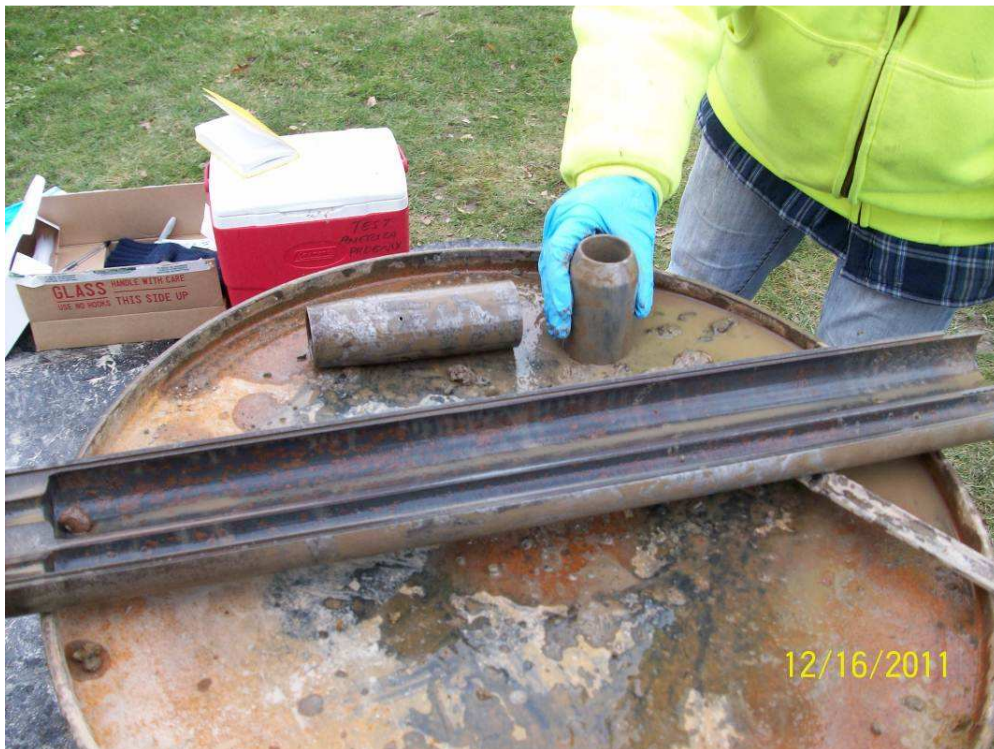
Figure 12: View of split spoon core 18'-20' bgs at EE-3 (No Recovery)

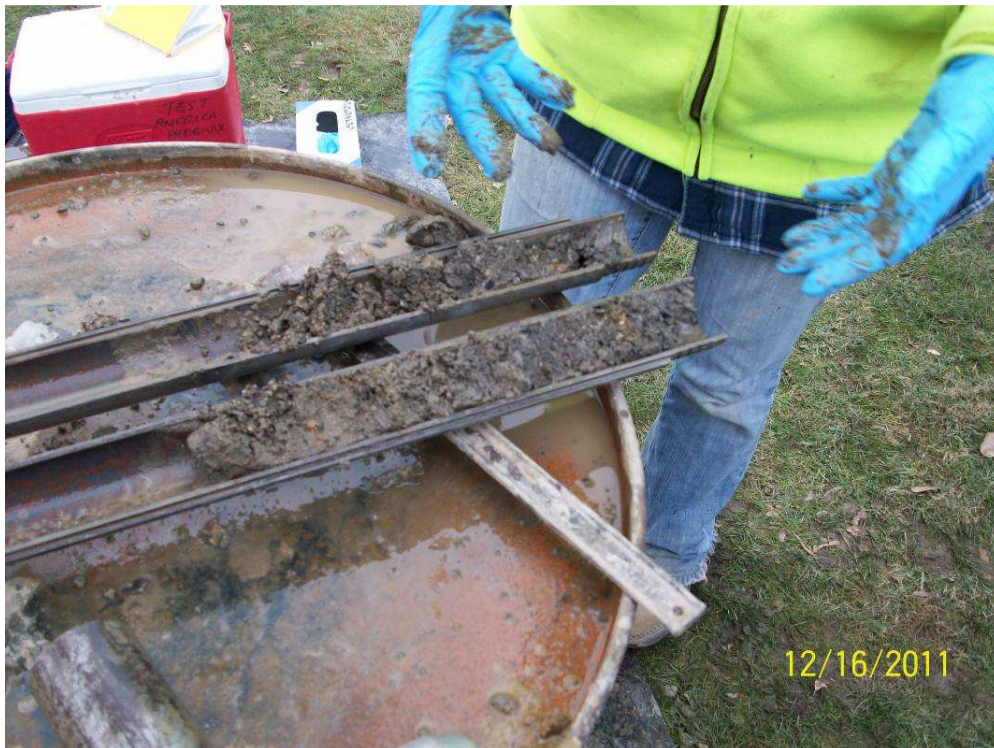
Figure 13: View of split spoon core 20'-22' bgs at EE-3

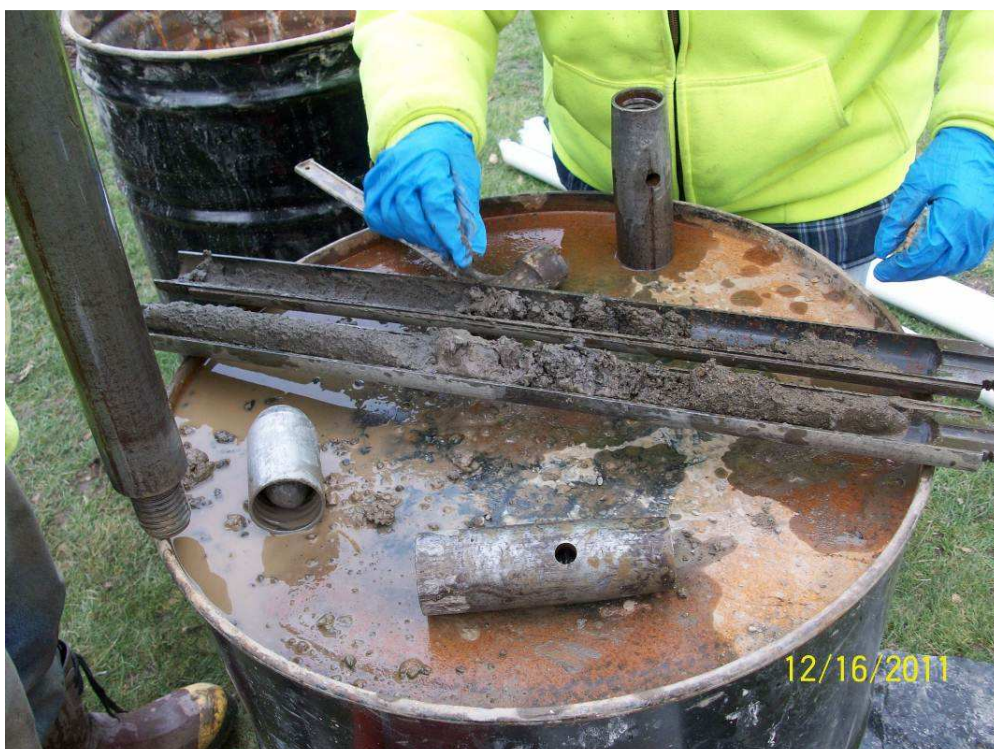
Figure 14: View of split spoon core 22'-24' bgs at EE-3

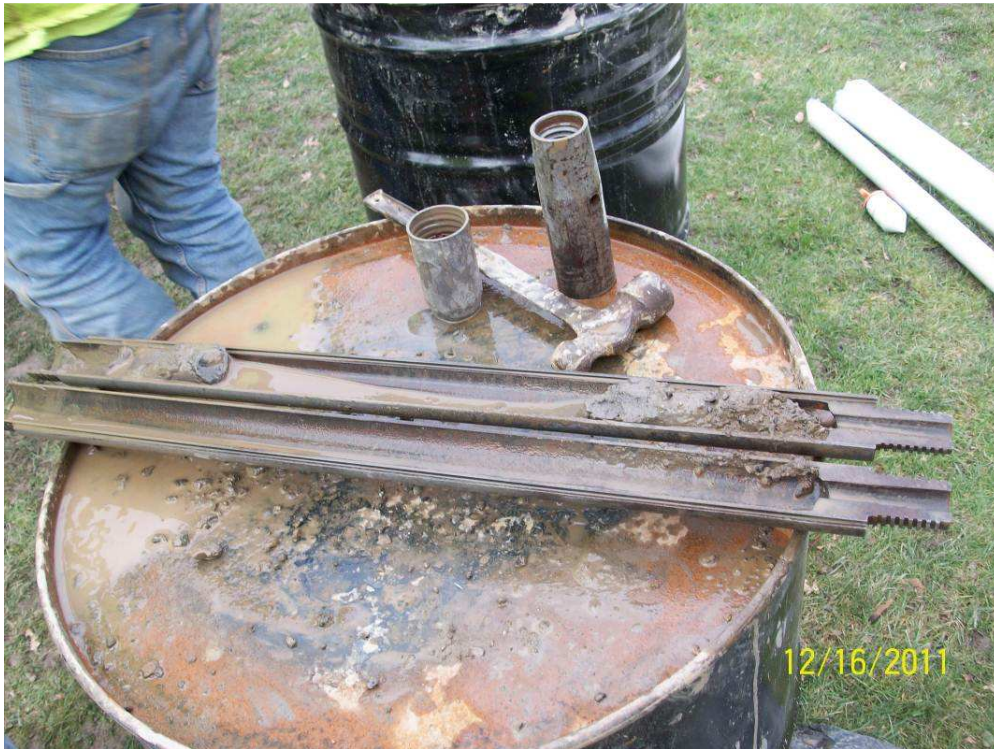
Figure 15: View of split spoon core 24'-26' bgs at EE-3

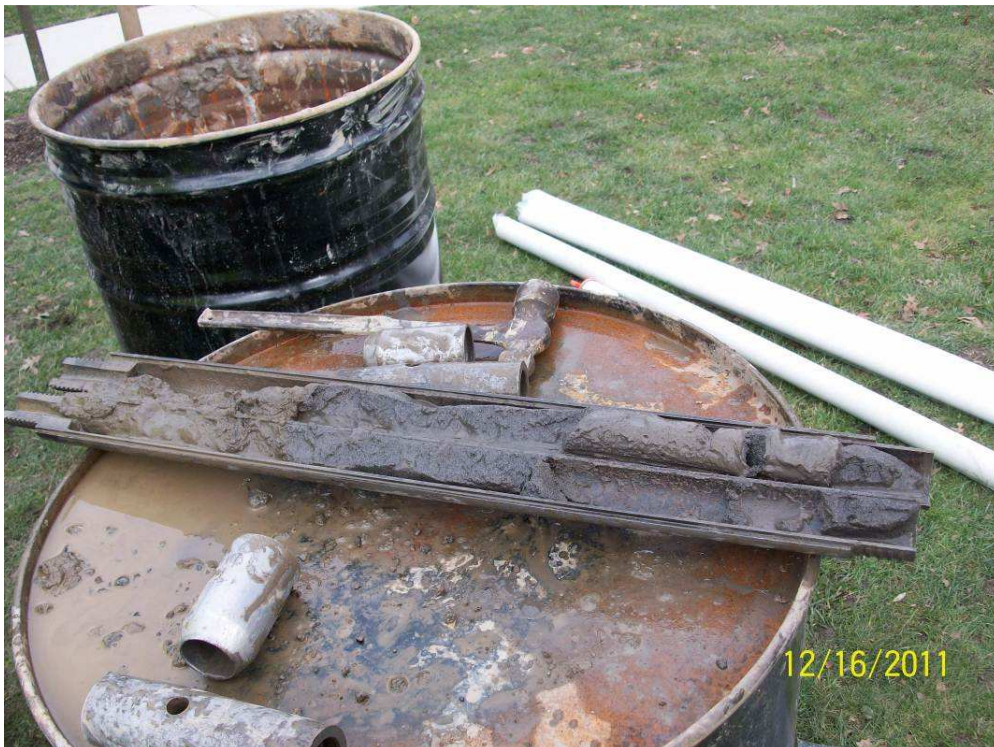
Figure 16: View of split spoon core 26'-28' bgs at EE-3

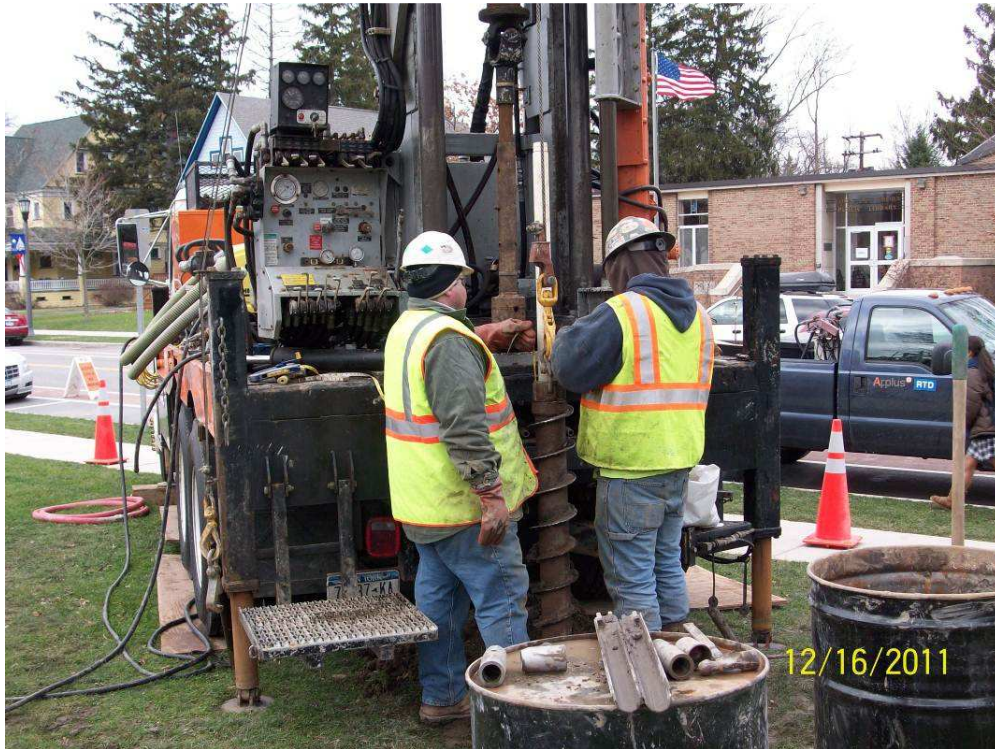
Figure 17: View of GES Setting well at EE-3

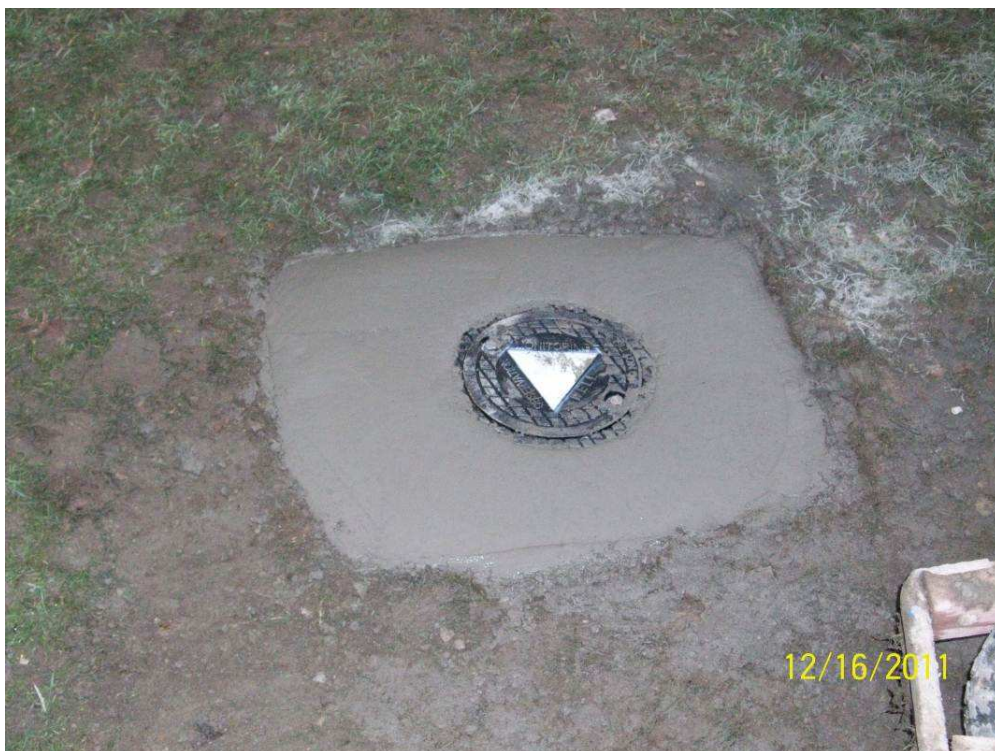
Figure 18: View of Finished Well Pad at EE-3

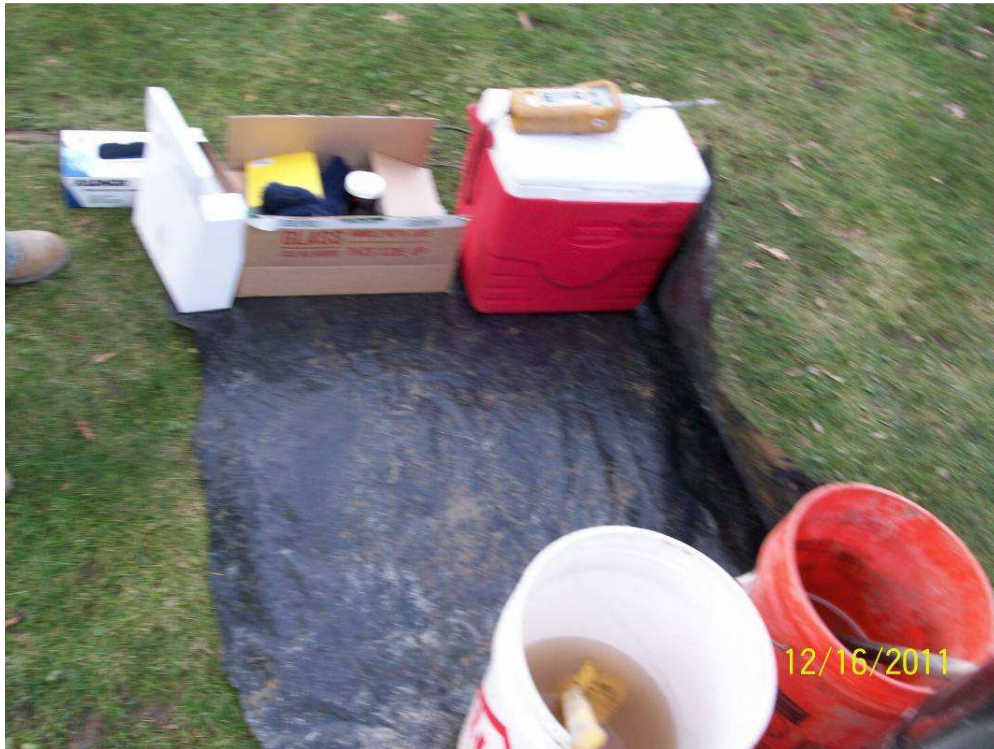
Figure 19: View of Work Area for Split Spoon Decon

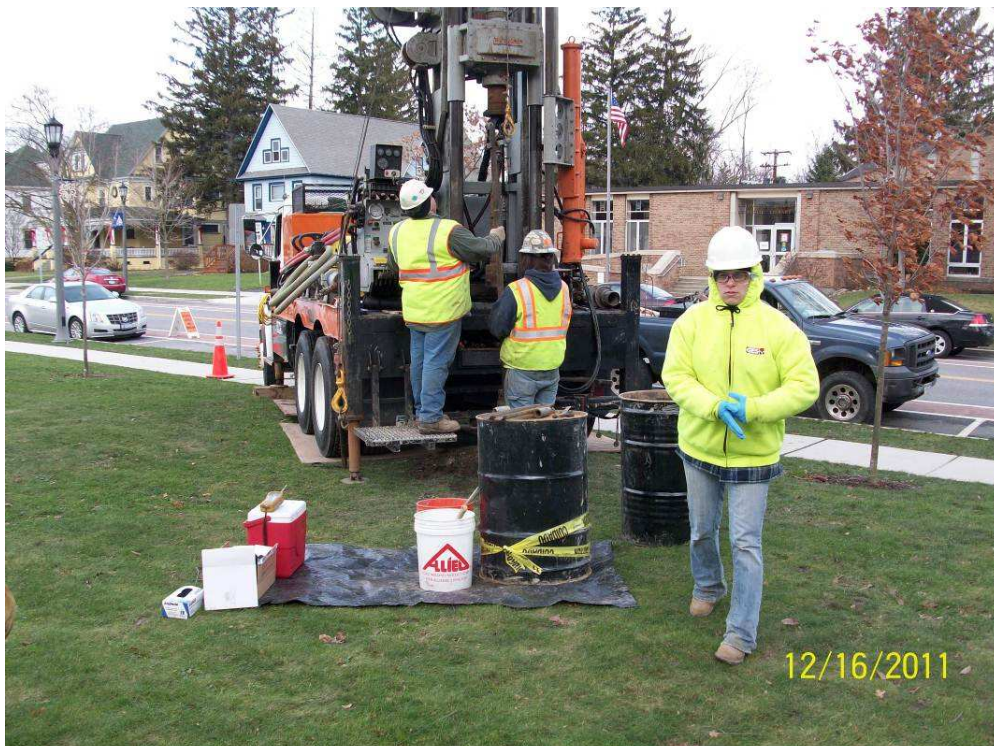
Figure 20: View of Work Zone during Drilling
