RE: Subslab Depressurization System Installation – Moog Plant 11

URS Corporation (URS) is pleased to present this letter report documenting the installation of a subslab depressurization (SSD) system at Moog, Inc.'s Plant 11 facility. The SSD system was installed by US Radon, Inc., Harmony, Rhode Island, on June 23 and 24, 2009 under direct oversight by URS.

PHOTOGRAPHIC LOG
Moog, Inc. Building 11 SSD System Installation
East Aurora, New York

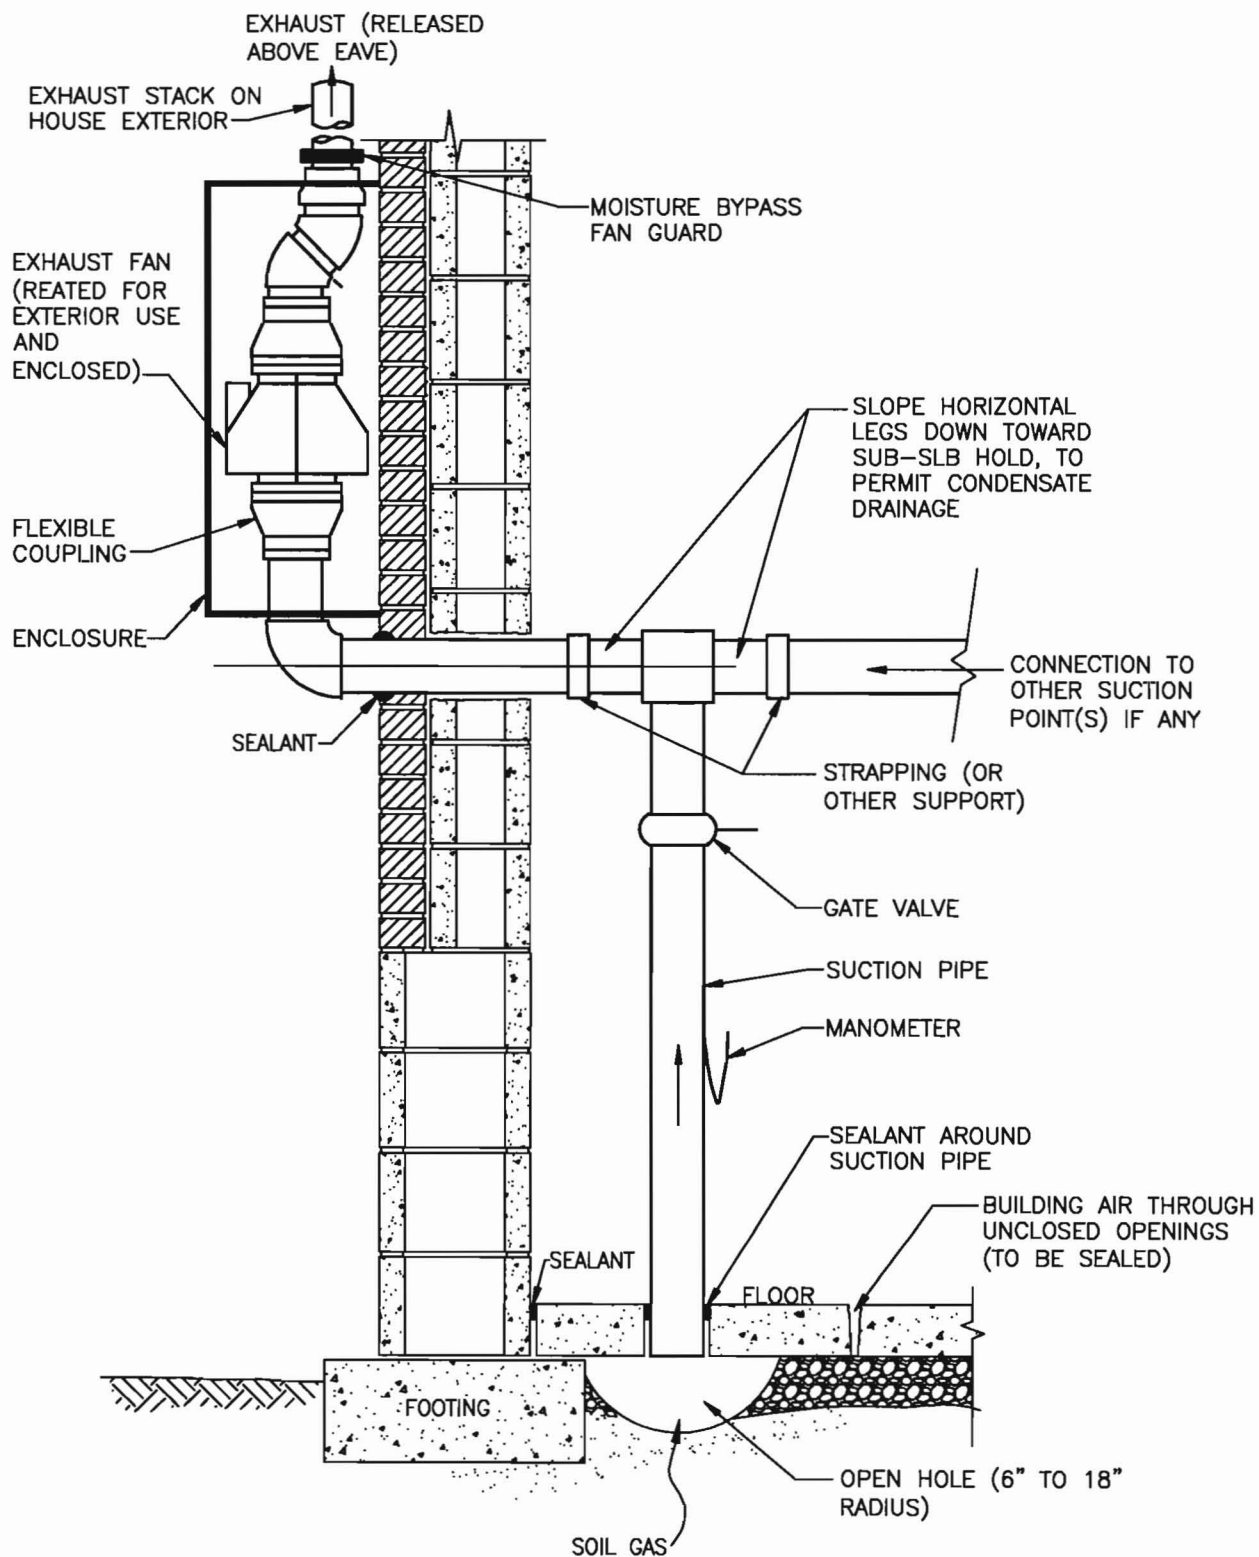
The SSD system consists of three, 4-inch inside diameter (ID), Schedule 40 polyvinyl chloride (PVC) pipes that penetrate the building floor at three locations (suction points). For the purpose of describing system construction, these suction points are designated Suction Points North, South and East, based on their locations within Building 11A. The suction points are connected to a suction fan by 4-inch ID Schedule 40 PVC piping. The suction fan, a Radonaway Model No. GP501, is mounted outside of the building's east wall about two feet below the roofline. A short 4-inch ID PVC pipe extends above the fan to place the system discharge about three feet above the roof line. The fan operates on 110 volts AC power. All electrical hookups were made by Moog electricians. A generalized view of the SSD system construction is shown on Figure 1.

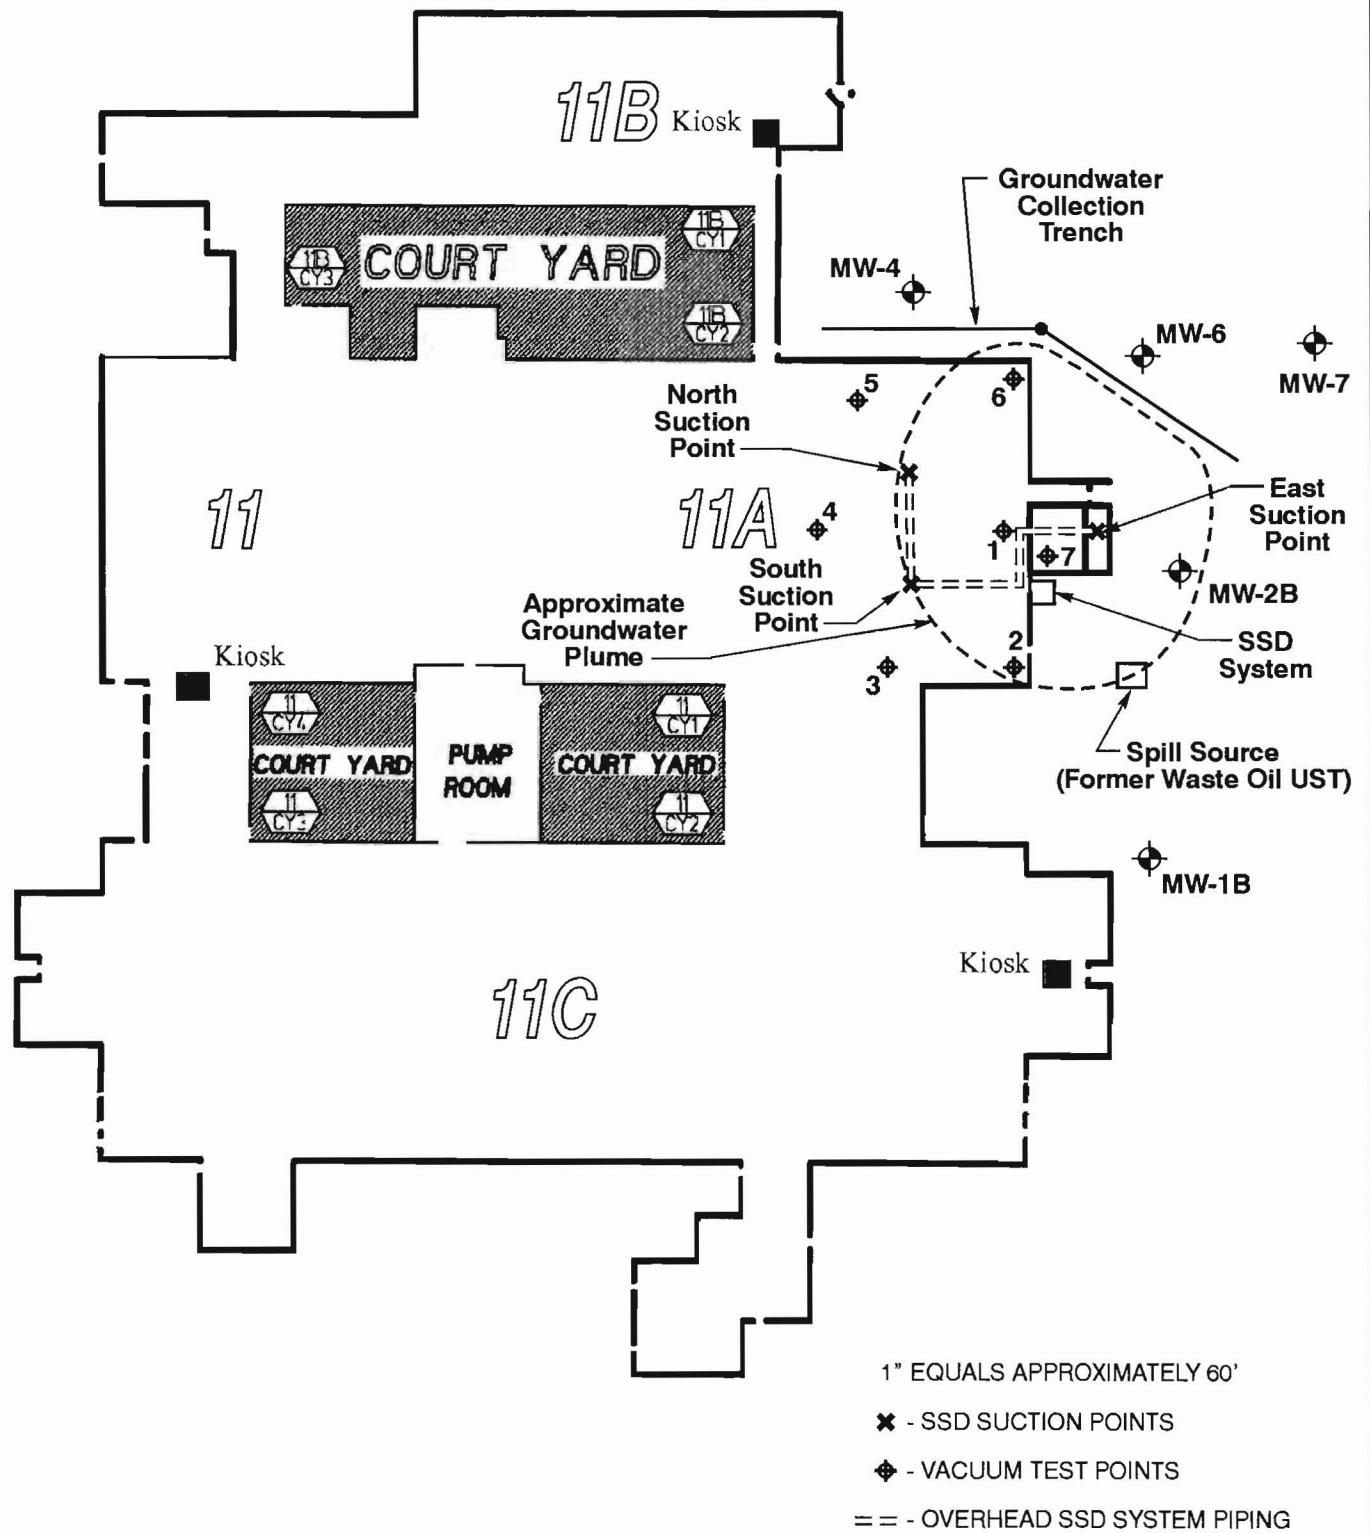
Two of the suction points (Suction Points North and South) are located in the eastern portion of the building adjacent to building roof support columns. The locations of these two suction points are dictated by the location of the support columns along which the suction pipe may run. The actual suction points at these two locations were offset approximately two feet from the base of the column to avoid the column footer. The third suction point (Suction Point East) is located in a small addition that is separated from the main building by a concrete structural footer. This addition is presently occupied by the maintenance department and also houses a groundwater remediation system. Suction point locations are shown on Figure 2. System construction is documented in a photographic log provided in Attachment 1.

Following construction and installation of the SSD system components, the fan was turned on and the system effectiveness measured by collecting vacuum readings from seven 3/8-inch diameter test holes. Vacuum readings were recorded using a portable differential pressure gauge. Test hole locations are shown on Figure 2. Measured vacuum readings from the test holes are provided in Table 1. Vacuum readings averaged 0.050 inches of water, and ranged from 0.001 inches of water in Test Hole 2, at the southeast corner of Building 11A, to 0.089 inches of water at Test Hole 7 in the building addition. Vacuum readings at the three suction points ranged from 1.1 to 1.6 inches of water as measured on the manometers affixed to each suction point. Final suction point

The lowest vacuum readings were measured in the two corners of Building 11A. Readings of 0.001 and 0.002 inches of water were recorded at Test Holes 2 and 6, respectively. Because these points were located at the building corners, they represent the most difficult area at which to obtain depressurization. Although these readings are low, the readings were steady and clearly show that the system has created a negative pressure field extending from well within the building to the walls at the northeastern portion of building 11A. The remainder of the vacuum readings from the test holes were 0.037 inches of water and higher which demonstrate excellent pressure field extension.

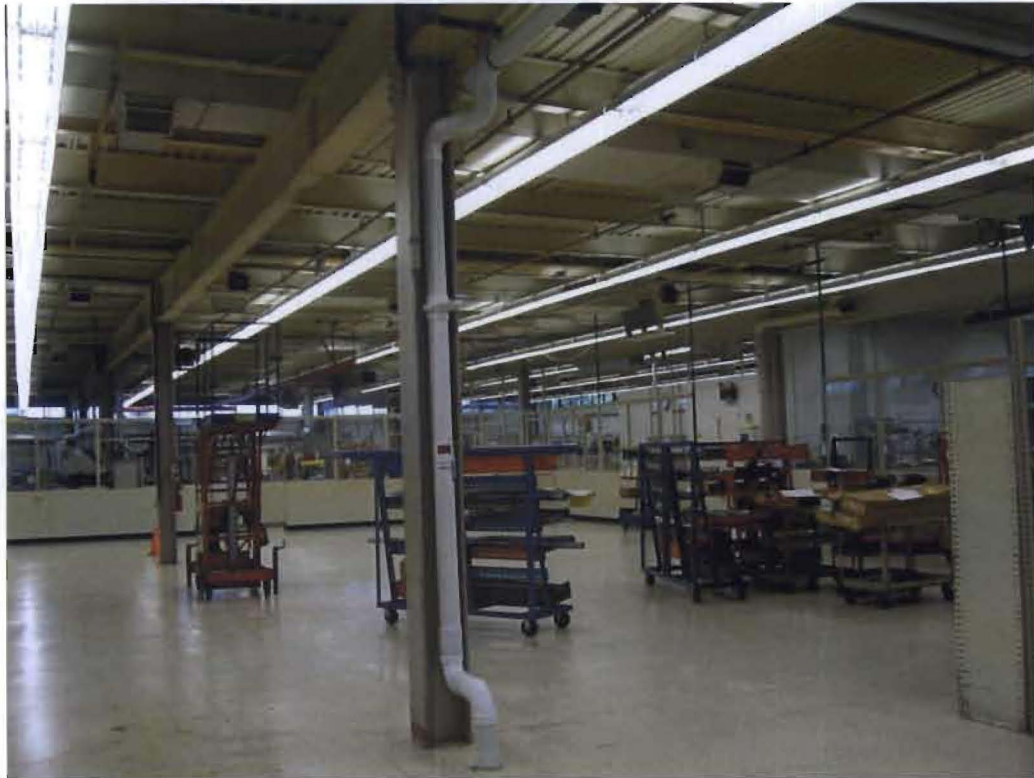
Looking west at “South” suction point, flow adjustment valve and manometer.

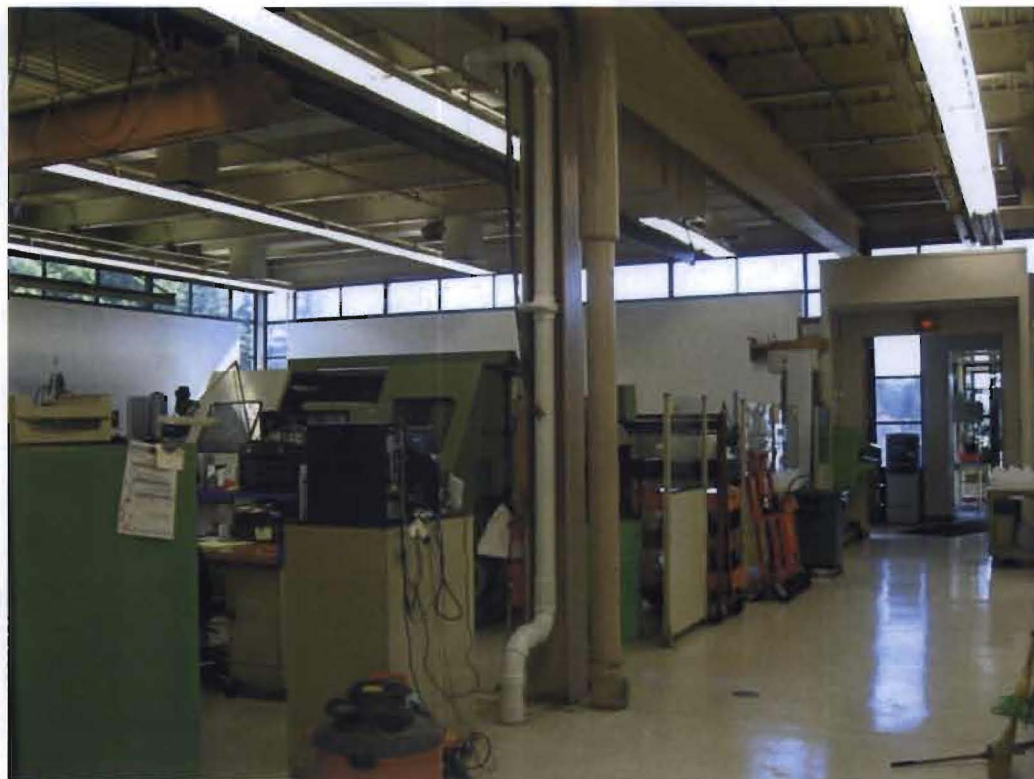
Looking northeast at “North” suction point and flow adjustment valve.

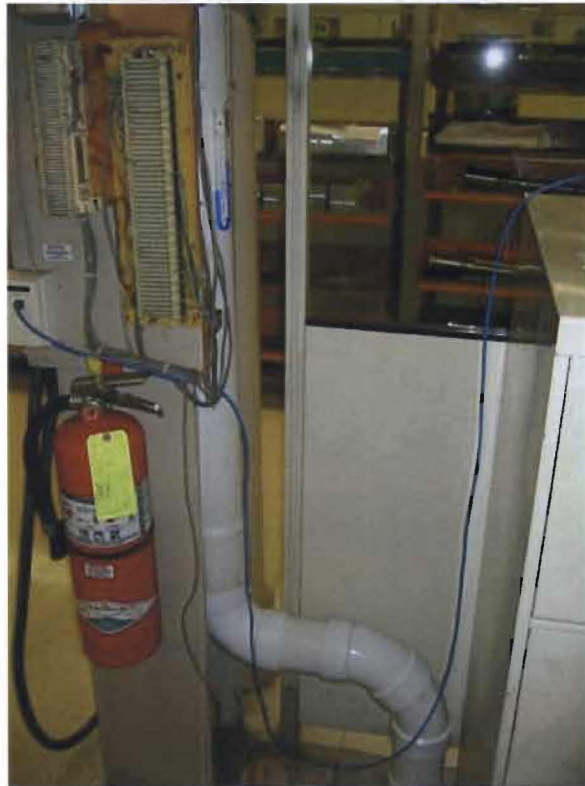
Looking south at “North” suction point and manometer.

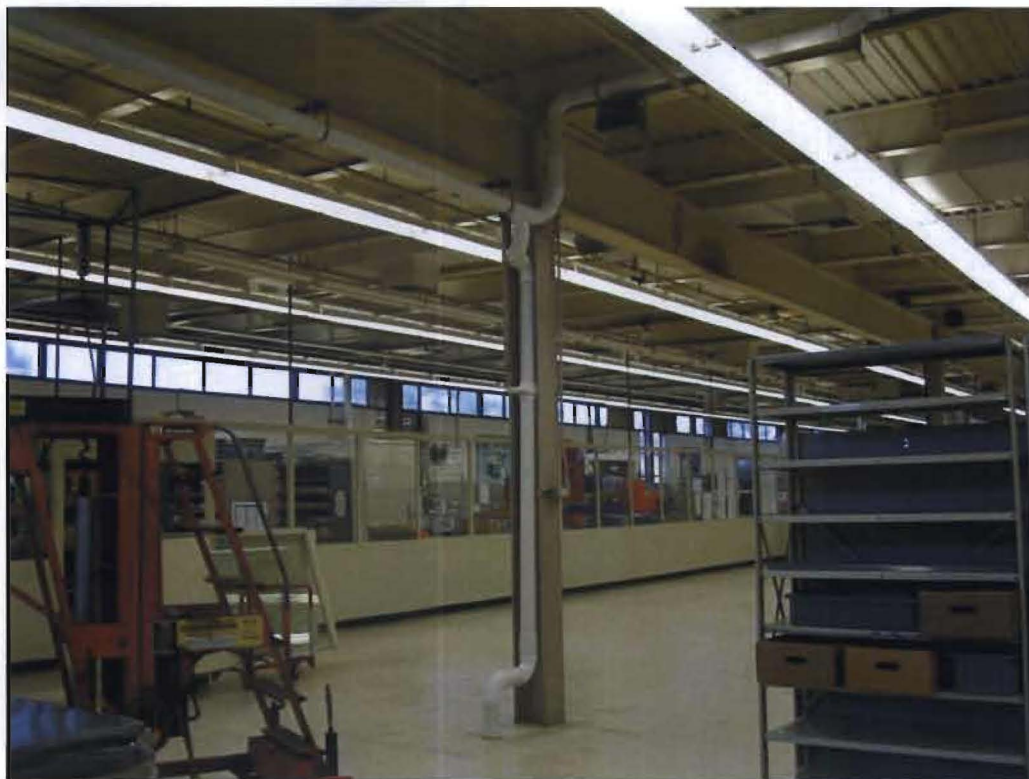
Looking southwest at routing of pipe from suction point “South” to system fan (left) and to suction point “North” (right).

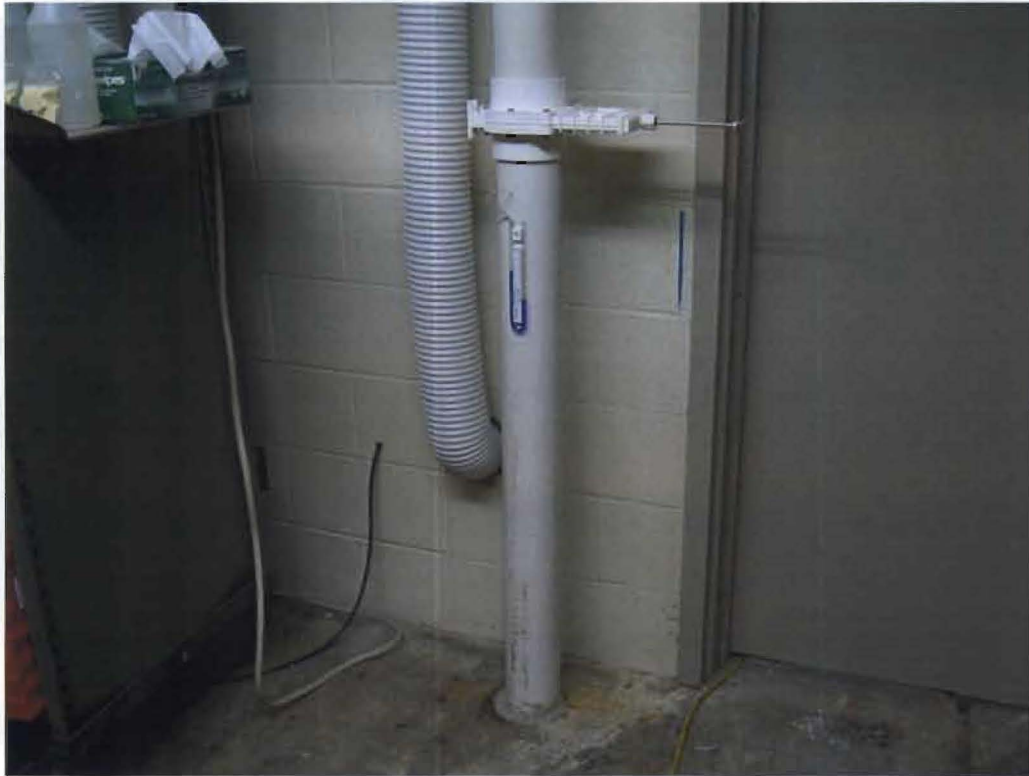
Looking west at suction point "East" with flow adjustment valve and manometer.

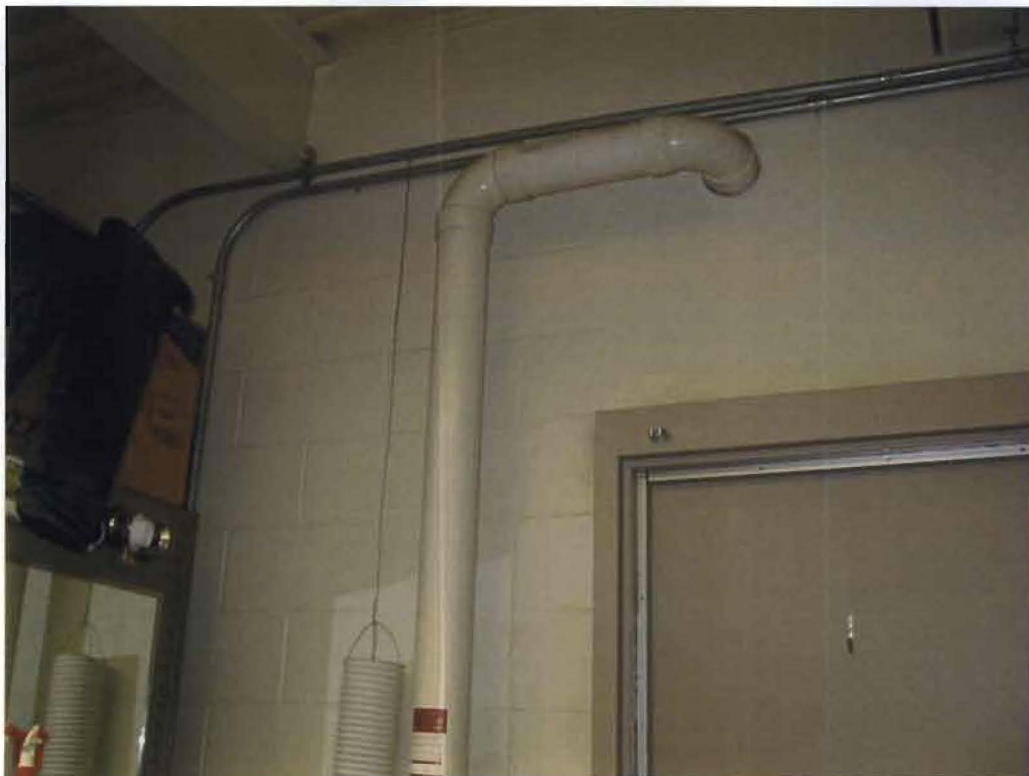
Looking west at piping from suction point "East" to main building via pipe-run through adjacent suspended ceiling.

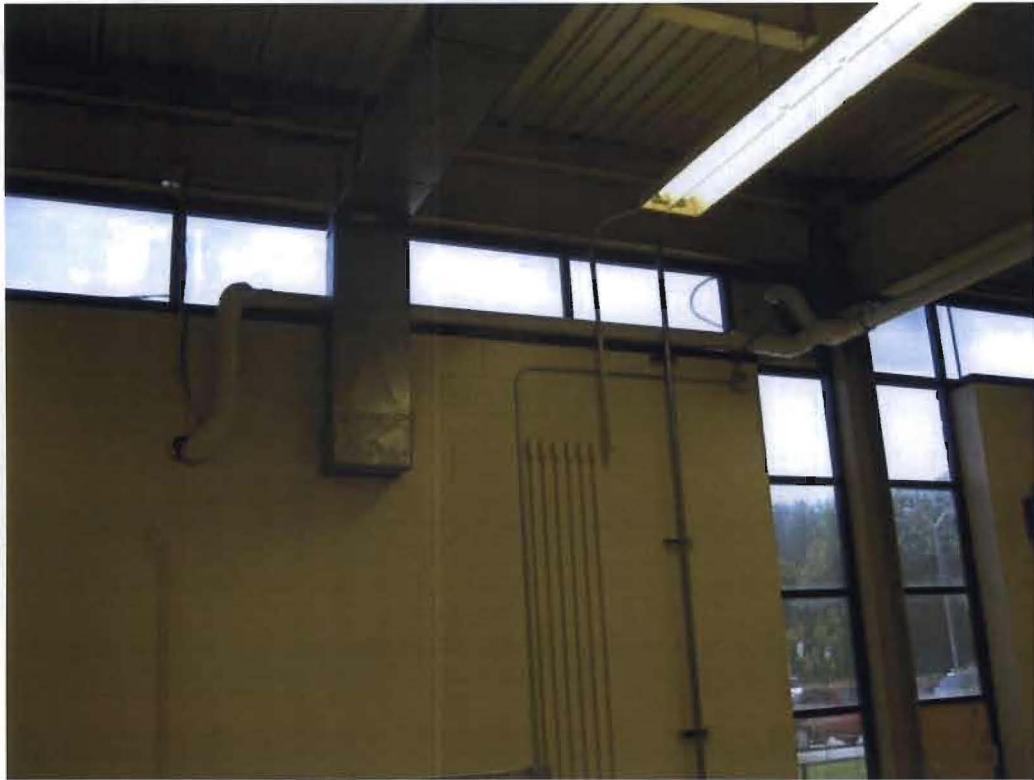
Looking east at junction of piping from suction point "East" (left), piping from suction points "South" and "North" (right) and exit of system piping to outside mounted fan.

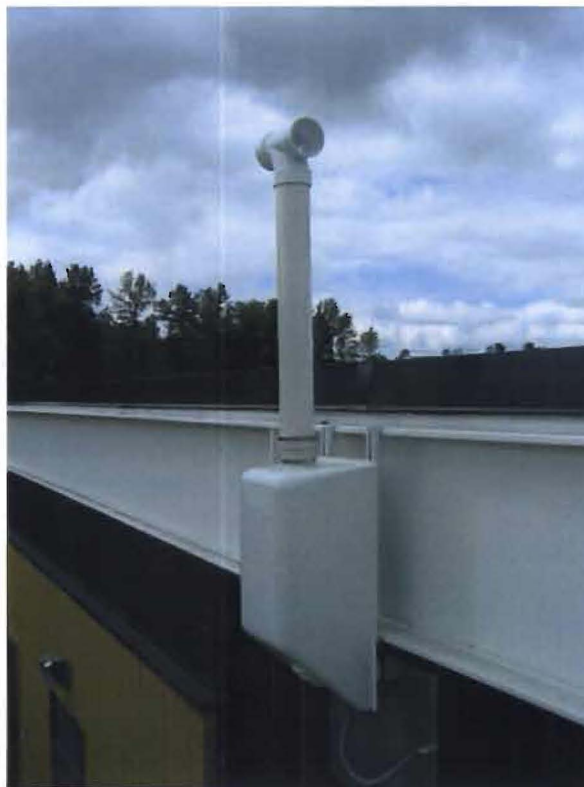
Looking south at system fan mounted on east wall of Building 11.
