Soil Vapor Intrusion Evaluation

CMS ASSOCIATES REMEDIATION SITE 210 French Road Building

Site no. 915168

September 2014

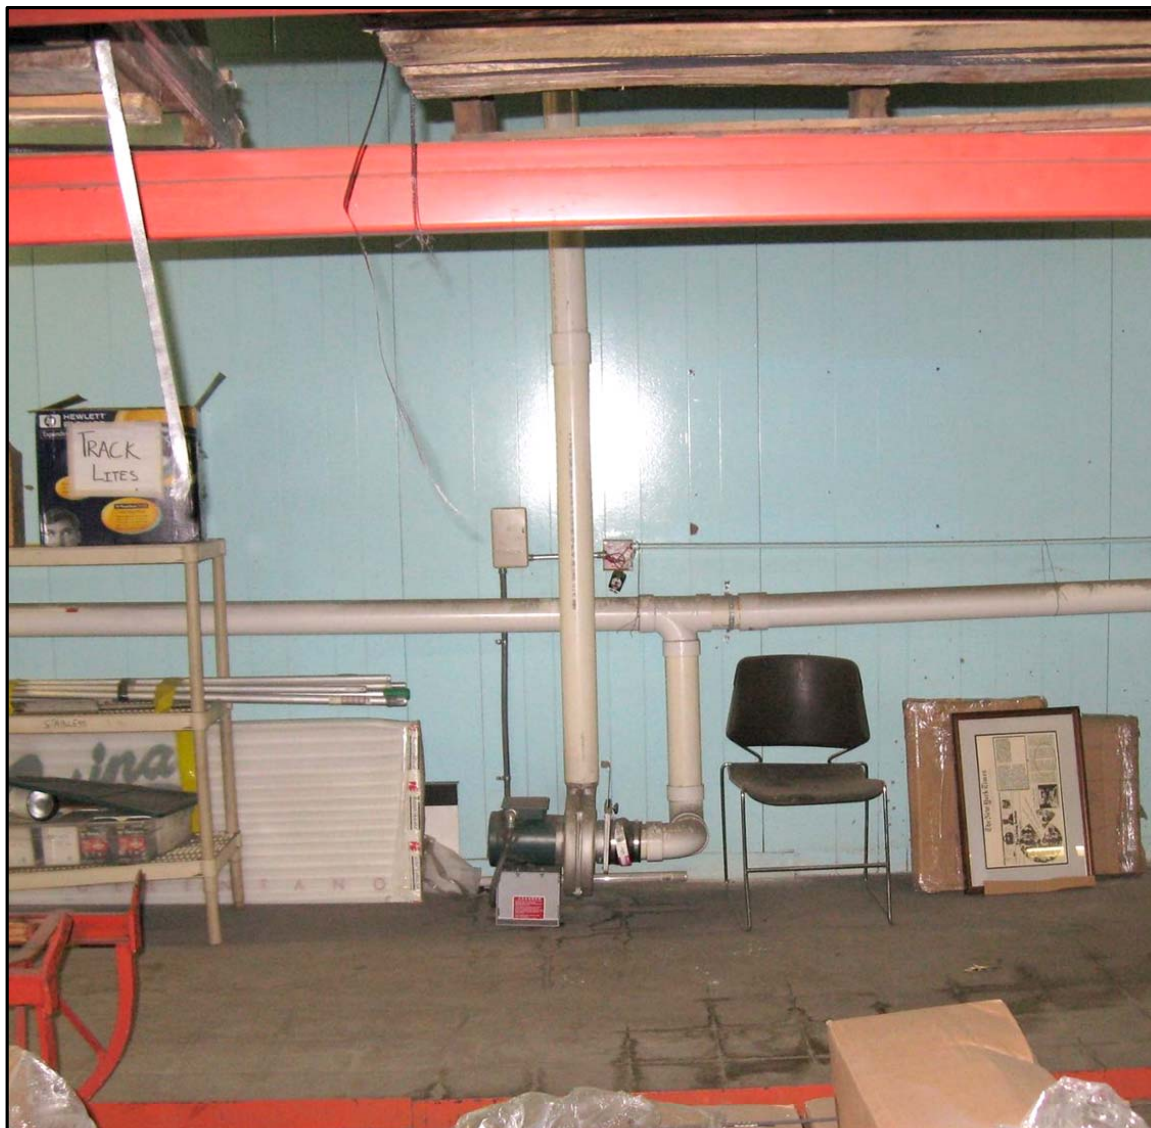
Photo Plate 1

The suction fans for the two systems are mounted on the floor slab inside the structure, and the two 4-inch PVC, higher-pressure discharge lines are hung on the adjacent walls and run from the fans to the roof. This configuration would allow a leak on the high-pressure (discharge) side to pump VOCs extracted from the sub-slab, into the building envelope.

When inspected, the pipe joints appeared to be sealed and no leakage was observed. There were however, minor leaks at the discharge point on the fan—which we sealed to prevent those from introducing VOCs into the building during the short term.

**Sub-Slab Depressurization System
On East Interior Wall of Building**

The improved SSD Systems must be inspected at least annually to verify proper fan operation and efficiency, that piping and joints are intact with no leaks, that negative pressure is maintained in the suction headers, and to ensure overall system performance. With manometers installed at key locations, a problem with the suction fans, a leak in the suction headers, or the overall operation of the system can be immediately observed by the building owner or operator and reported to CMS for correction.

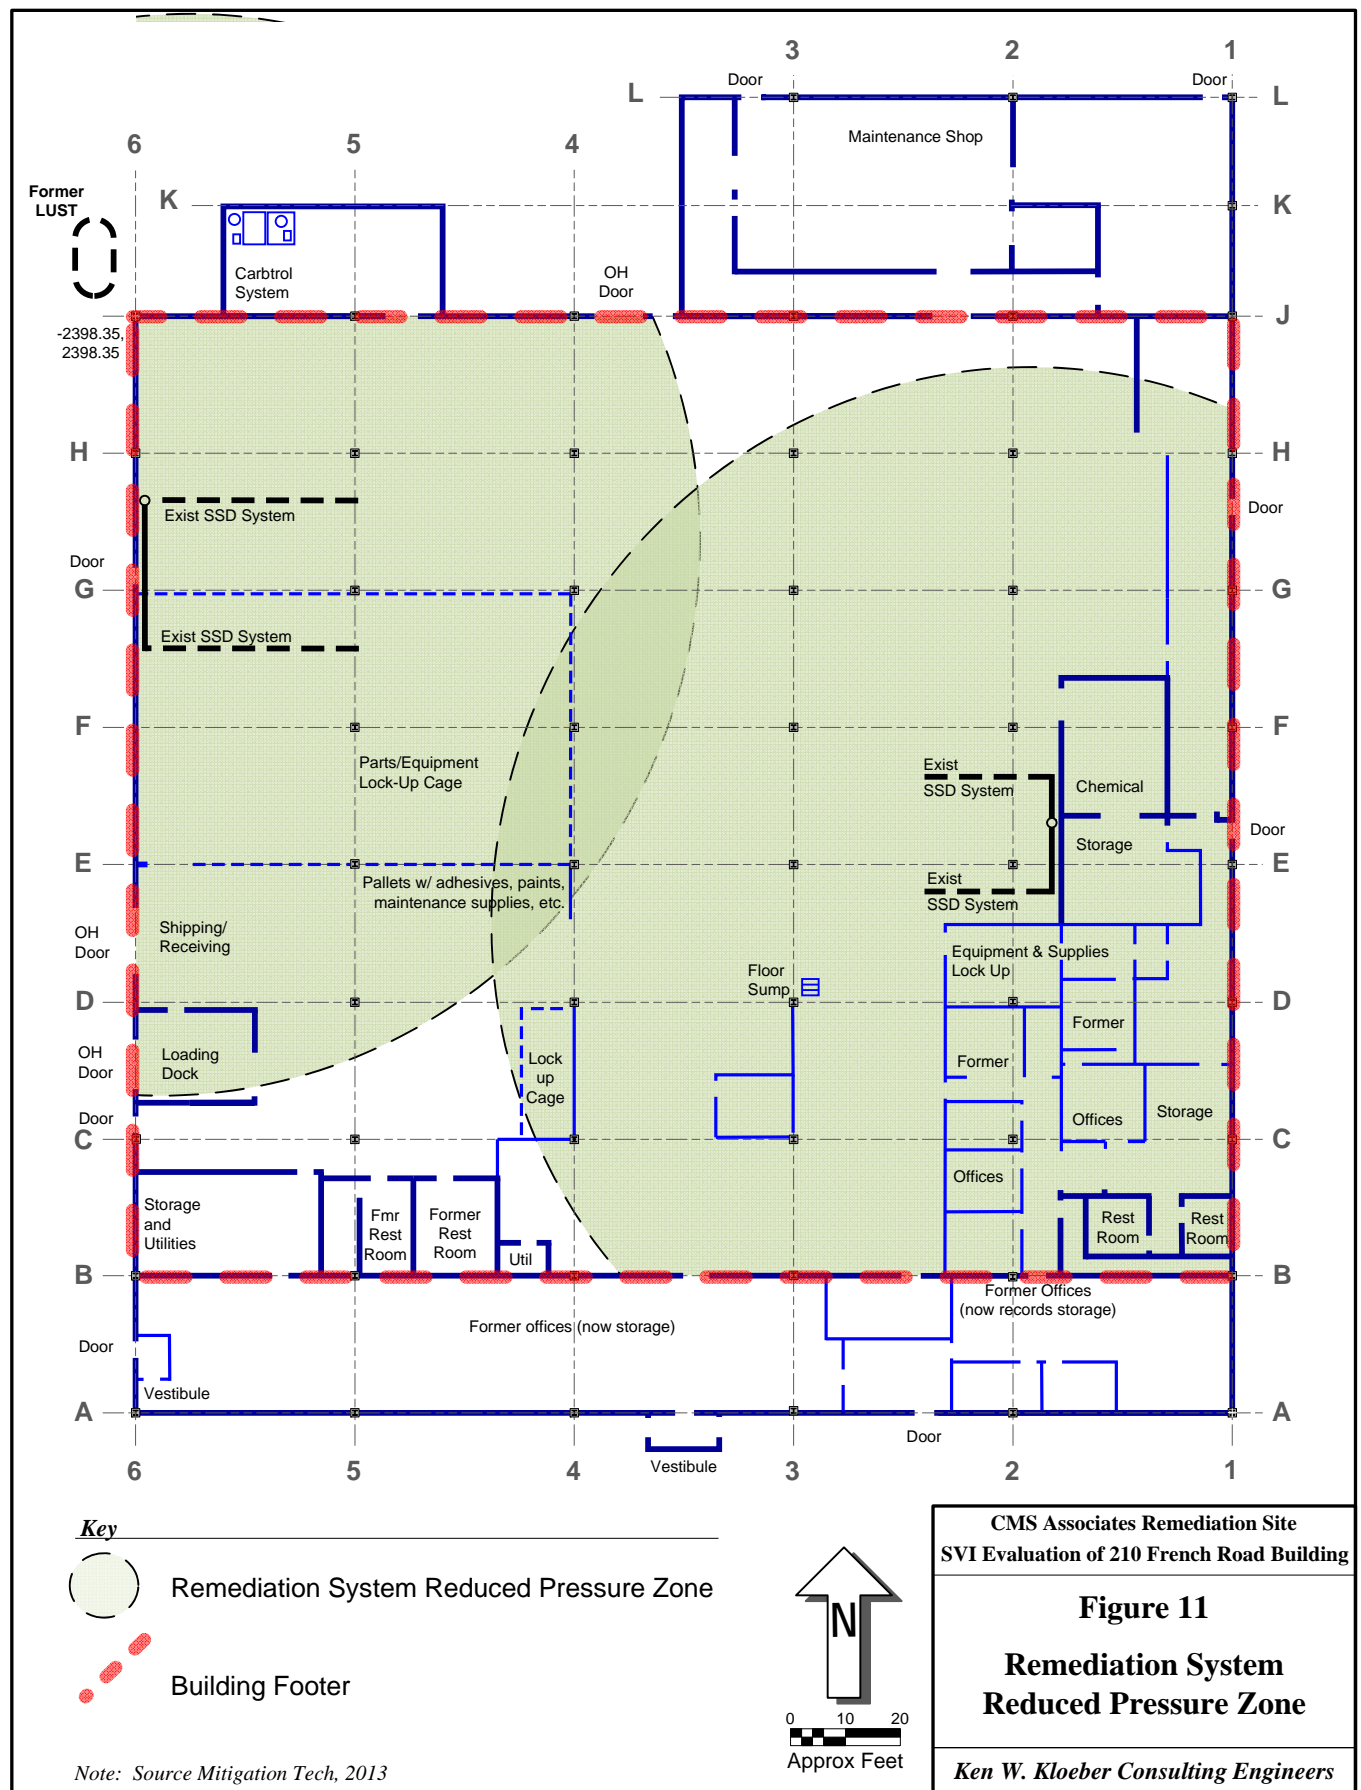
The building was tested after sealing the air leaks, first allowing the soil pores to dry out, and the sub-slab conditions to equilibrate. That was necessary in order to extend the below-slab “spider-like” pathways that transmit vacuum within the sub-slab media. The testing showed that negative pressures were observed over 80% of the central warehouse, with only the extreme northeast and southwest corners remaining uncovered.
