May 26, 2009

**Re: Sub Slab Depressurization System – Completion Report  
Former Gastown MGP Site  
Tonawanda, New York**

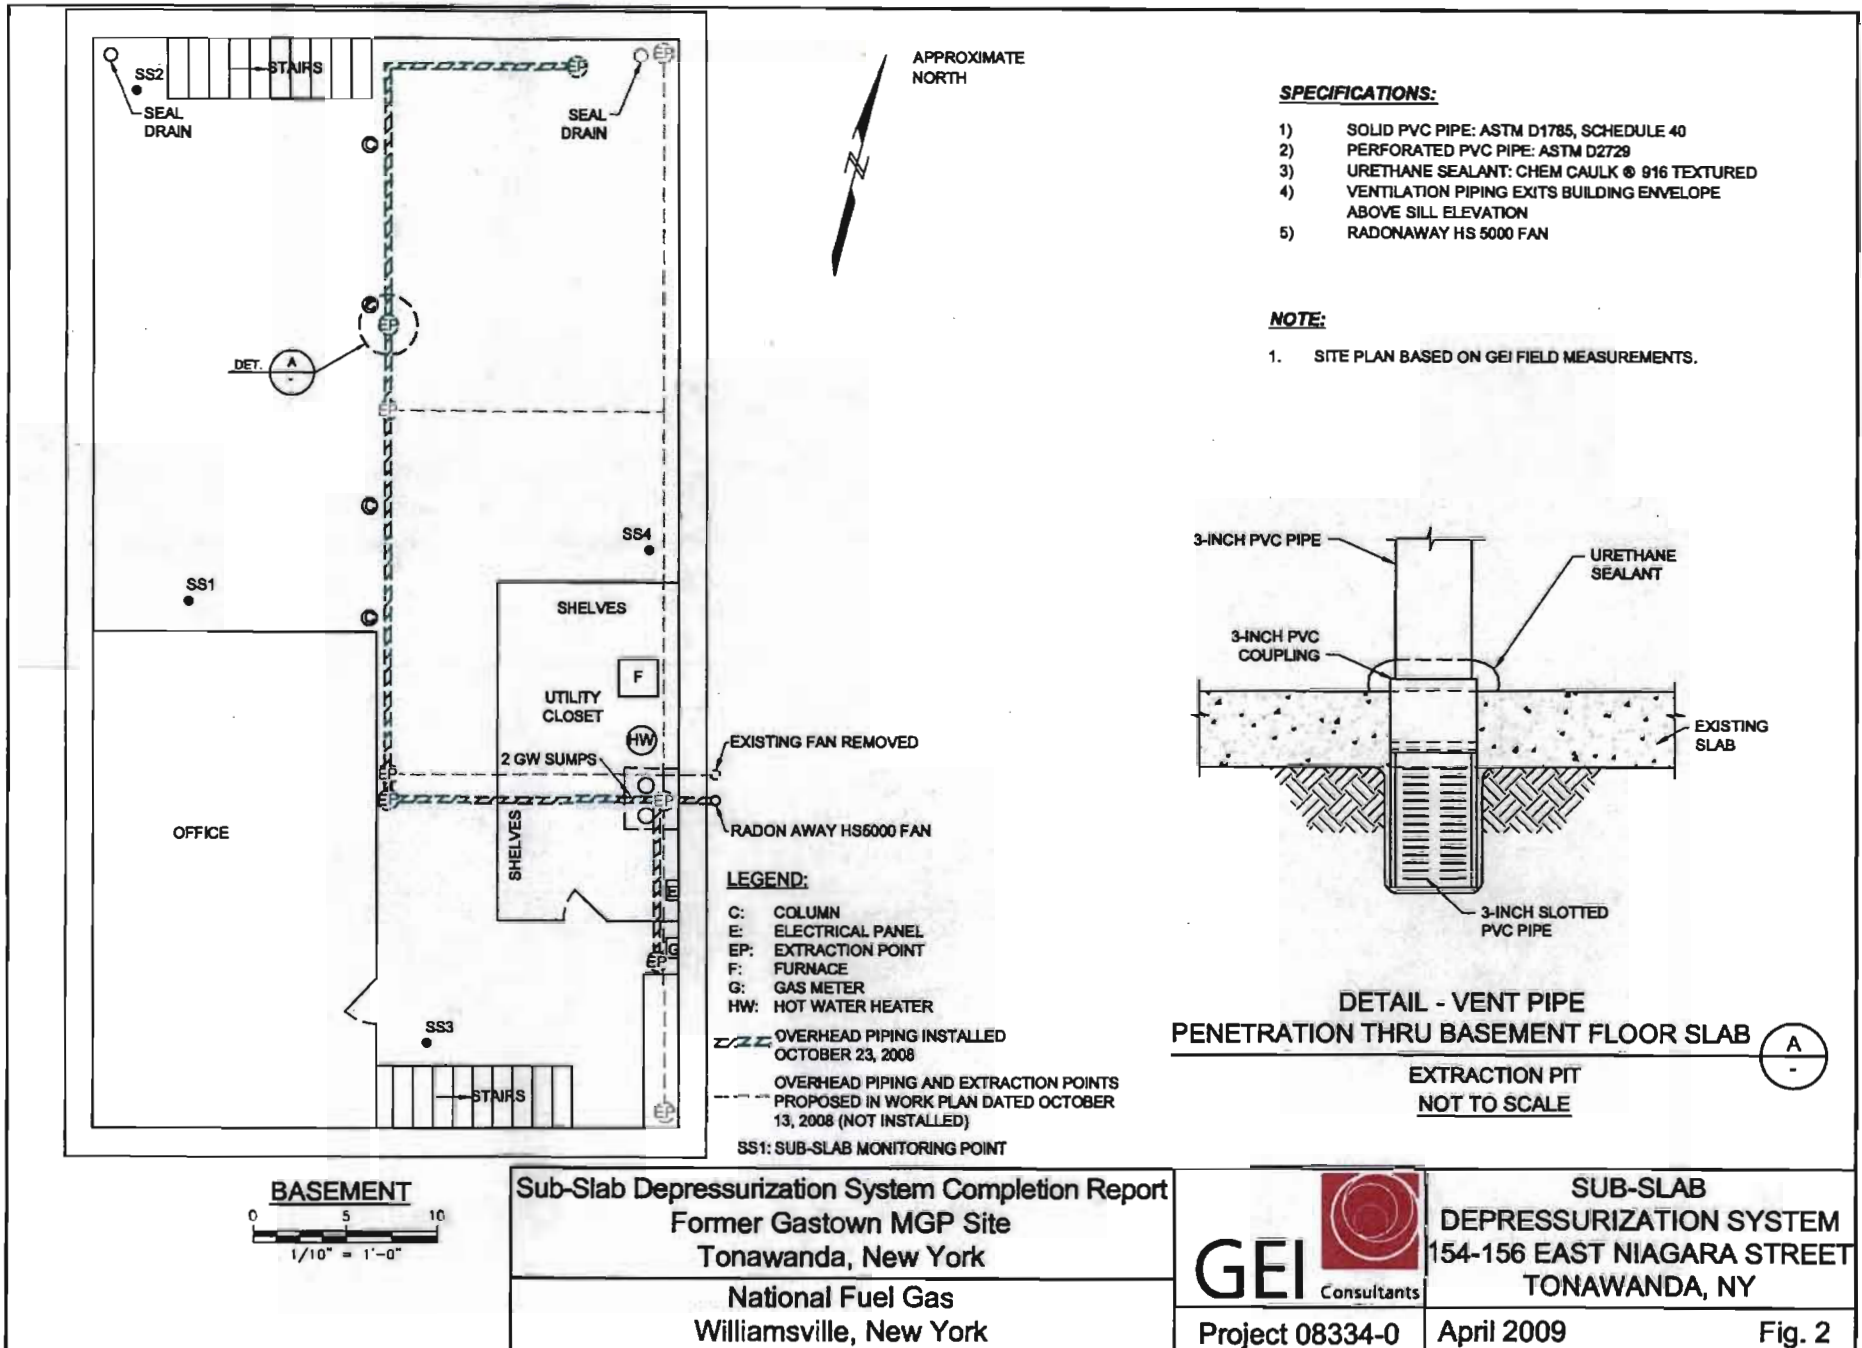
SUB-SLAB DEPRESSURIZATION SYSTEM  
 154-156 EAST NIAGARA STREET  
 TONAWANDA, NY  
 April 2009

We installed five extraction points (including one in the sump pit box) to ventilate sub slab soil vapor. Fig. 2 shows the differences between the Work Plan and the installed piping layout. A RadonAway™ HS-5000 high suction radon fan was installed outside the building envelope. A technical data sheet for this fan is provided in Appendix A. To prevent short circuiting, the two perimeter floor drains were sealed and larger cracks in the concrete floor slab were filled with a flexible sealant. The existing plywood sump cover was incorporated into the new SSDS ventilation piping, but was otherwise unaltered. A damper was installed on the sump pit ventilation piping to distribute vacuum more effectively under the entire slab. The previous ventilation fan for the plywood sump cover was removed and stored in the basement.

Sub-slab vacuum measurements were taken immediately following installation (October 23, 2008) and during post mitigation monitoring (December 1, 2008). Data from these measurements are presented in Table 1. These data indicate adequate sub-slab vacuum coverage to mitigate potential soil vapor intrusion.

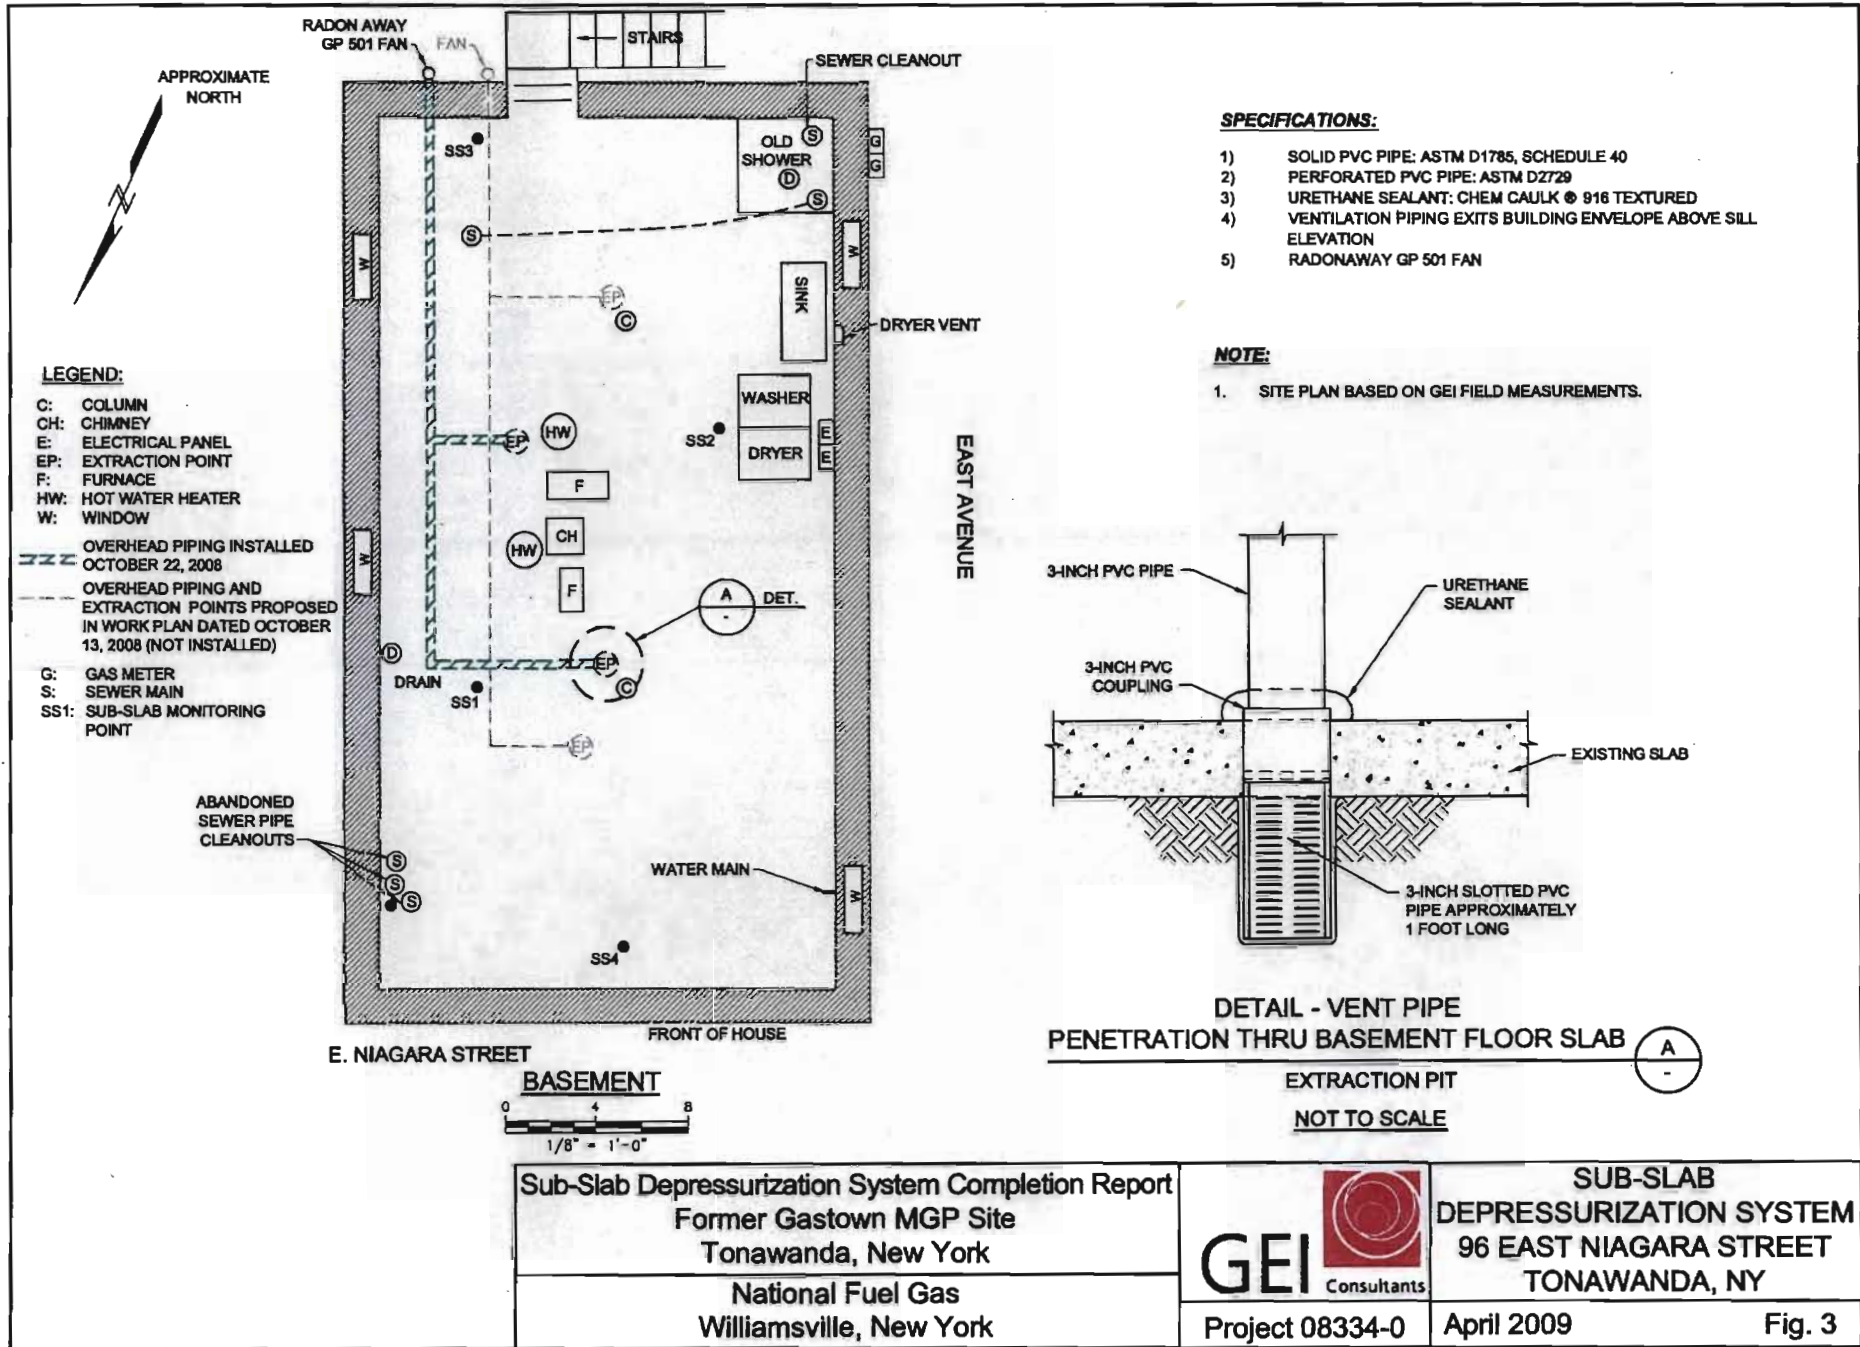
SUB-SLAB DEPRESSURIZATION SYSTEM  
96 EAST NIAGARA STREET  
TONAWANDA, NY  
April 2009  
Fig. 3

Two extraction points were installed to ventilate sub-slab soil vapor. The difference between the proposed and installed system was the piping and extraction point layout as shown in Fig. 3. A RadonAway™ GP-501 radon fan was installed outside the building envelope near the sill elevation. A technical data sheet for this fan is provided in Appendix A.

Sub-slab vacuum measurements were taken immediately following installation (October 22, 2008) and during post mitigation monitoring (December 3, 2008). Data from these measurements are presented in Table 2. These data indicate adequate sub slab vacuum coverage to mitigate potential soil vapor intrusion.

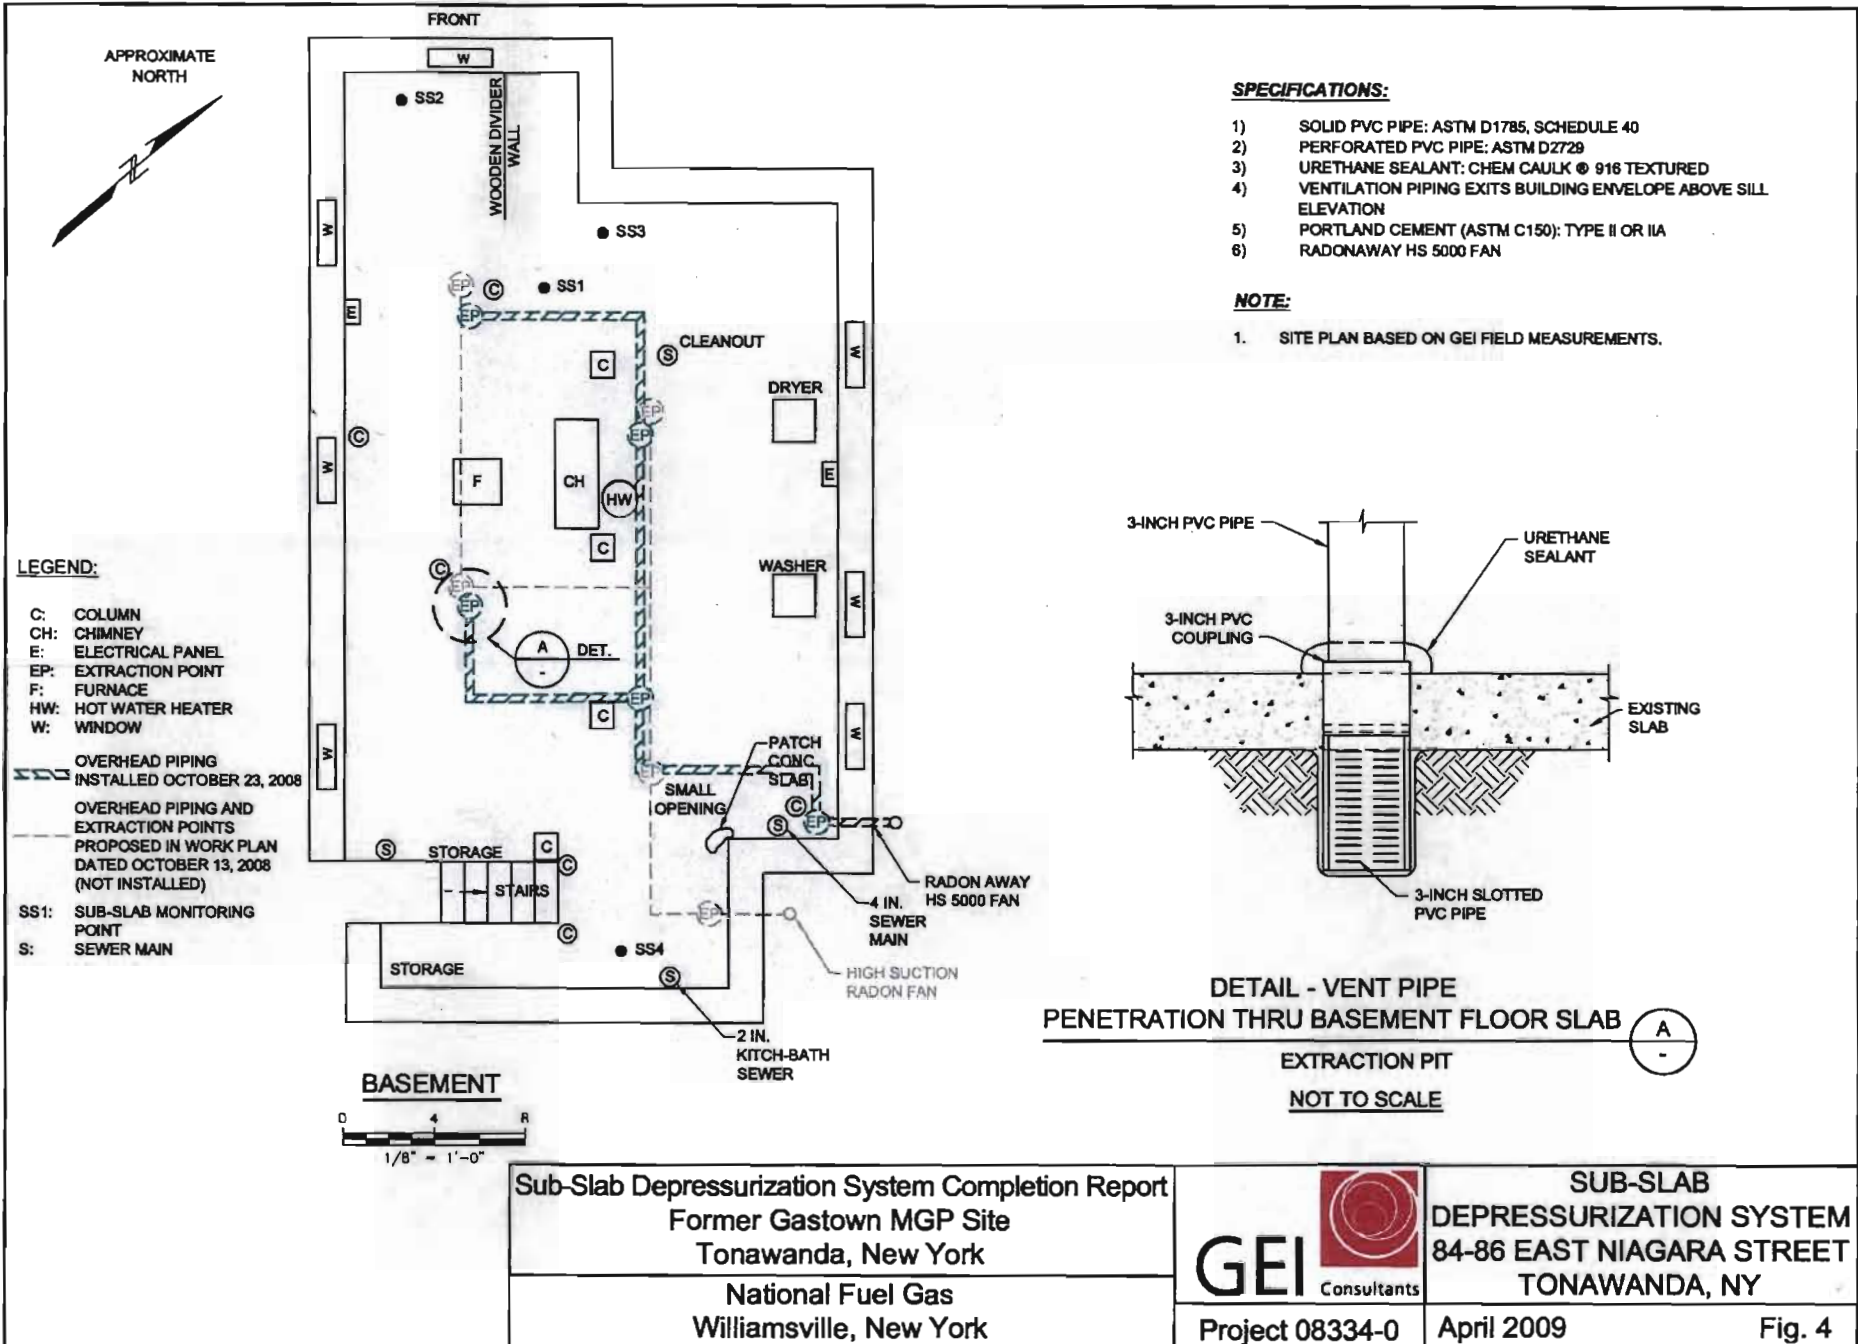
**SUB-SLAB DEPRESSURIZATION SYSTEM**  
 84-86 EAST NIAGARA STREET  
 TONAWANDA, NY  
 Project 08334-0 April 2009 Fig. 4

We installed five extraction points to ventilate sub slab soil vapor (Fig. 4). Several cracks and small openings in the slab were sealed with Portland cement to prevent short-circuiting. The difference between the proposed and installed system was the piping and extraction point layout as shown in Fig. 4. A RadonAway™ HS-5000 high suction radon fan was installed outside the building envelope near the sill elevation. A technical data sheet for this fan is provided in Appendix A.

Sub-slab vacuum measurements were taken immediately following installation (October 23, 2008) and during post-mitigation monitoring (December 3, 2008). Data from these measurements are presented in Table 3. These data indicate vacuum present beneath the slab in certain locations but not consistent distribution. The magnitude of observed vacuum beneath the slab decreased significantly between installation and post mitigation monitoring, which is indicative of perched surface water infiltration after rain events. We believe that low/intermittent vacuum is related to the presence of perched water, and these conditions are not related to an undersized fan or too widely spaced vapor extraction points.

On December 11, 2008, the homeowner notified National Fuel and GEI of “water gurgling” in the northwestern extraction point piping. On December 17, 2008, we installed a vacuum relief valve in the fan influent pipe and a magnehelic gauge to monitor vacuum more precisely. The purpose of the vacuum relief valve is to provide adequate air supply to the fan when surface water infiltration fills the sub slab extraction points. When surface water infiltrates into the extraction points, air flow is reduced significantly and vacuum increases enough to draw water vertically into the ventilation piping. By providing outside make-up air when the vacuum increases significantly, the vacuum is lowered enough to reduce “water gurgling” in the piping. The system typically operates at approximately 6.5 inches of water column (w.c.) during dry conditions. The vacuum relief valve was set to open at 15 inches of water column (w.c.), initially.

1. See Fig. 4 for monitoring point locations.
2. Sub-slab depressurization system (SSDS) began operation on 10/23/08.
3. Monitoring point SS3 is adjacent to a floor drain pipe that may cause localized short circuiting.
4. Monitoring point SS1 fluctuated between negative and positive values. Average is reported here.
5. w.c. = water column

On December 24, 2008, the homeowner again notified GEI of “water gurgling” in the northwestern extraction point. On January 7, 2009, CIR Electric personnel reduced the setting on the vacuum relief valve. The lower setting on the vacuum relief valve should have supplied adequate flow to minimize “water gurgling” in the ventilation piping under wet conditions.

In February 2009, the homeowner again notified GEI of “water gurgling” in the northwestern extraction point. On March 2, 2009, GEI reduced the setting on the vacuum relief valve to open at approximately 9 inches of w.c. and to further minimize “water gurgling”.

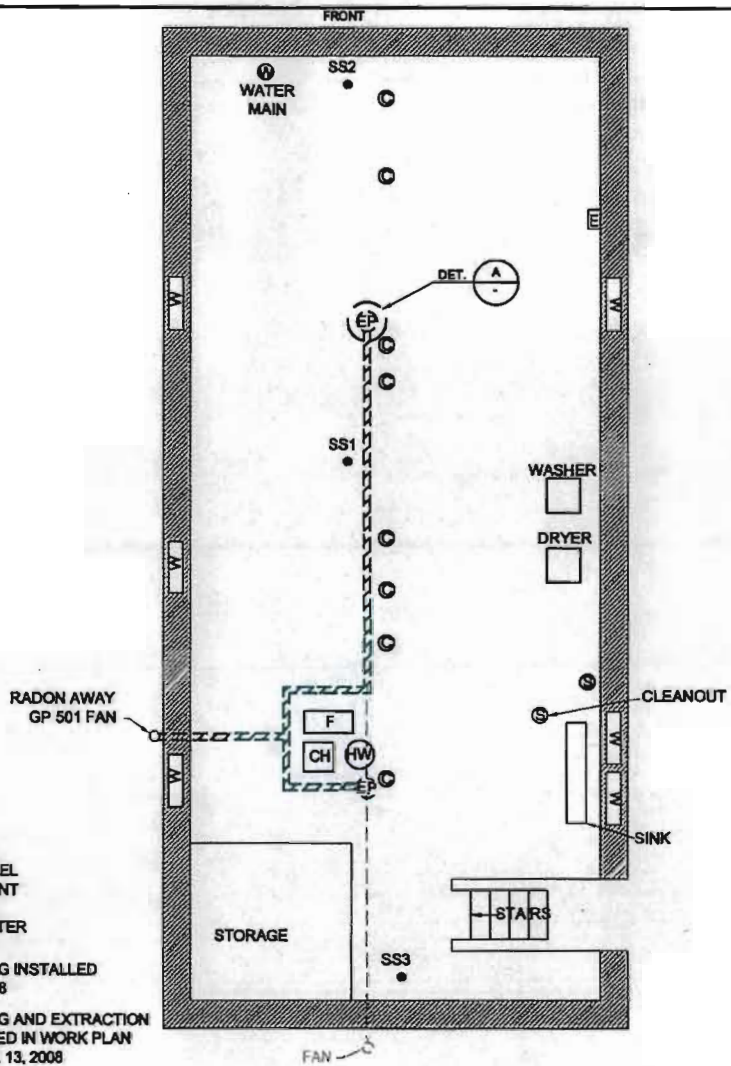
**SUB-SLAB DEPRESSURIZATION SYSTEM**  
80 EAST NIAGARA STREET  
TONAWANDA, NY  
April 2009

Two extraction points were installed to ventilate sub slab soil vapor. The difference between the proposed and installed system was the piping and extraction point layout and fan location as shown in Fig. 5. A RadonAway™ GP-501 radon fan was installed outside the building envelope near the sill elevation. A technical data sheet for this fan is provided in Appendix A.

During SSDS installation, the owner reported water seeping through basement walls during heavy rain. To help reduce surface water infiltration into sub slab vapor extraction pits, we applied a rubberized asphalt sealant to the cracks around the outer foundation wall at the ground surface. The sealant was only applied to cracks where the foundation abutted asphalt. Sealant was not applied to the foundation where it abutted landscaped areas.

Sub-slab vacuum measurements were taken immediately following installation (October 24, 2008) and during post mitigation monitoring (December 3, 2008). Data from these measurements are presented in Table 4. These data indicate adequate sub slab vacuum coverage to mitigate potential soil vapor intrusion.

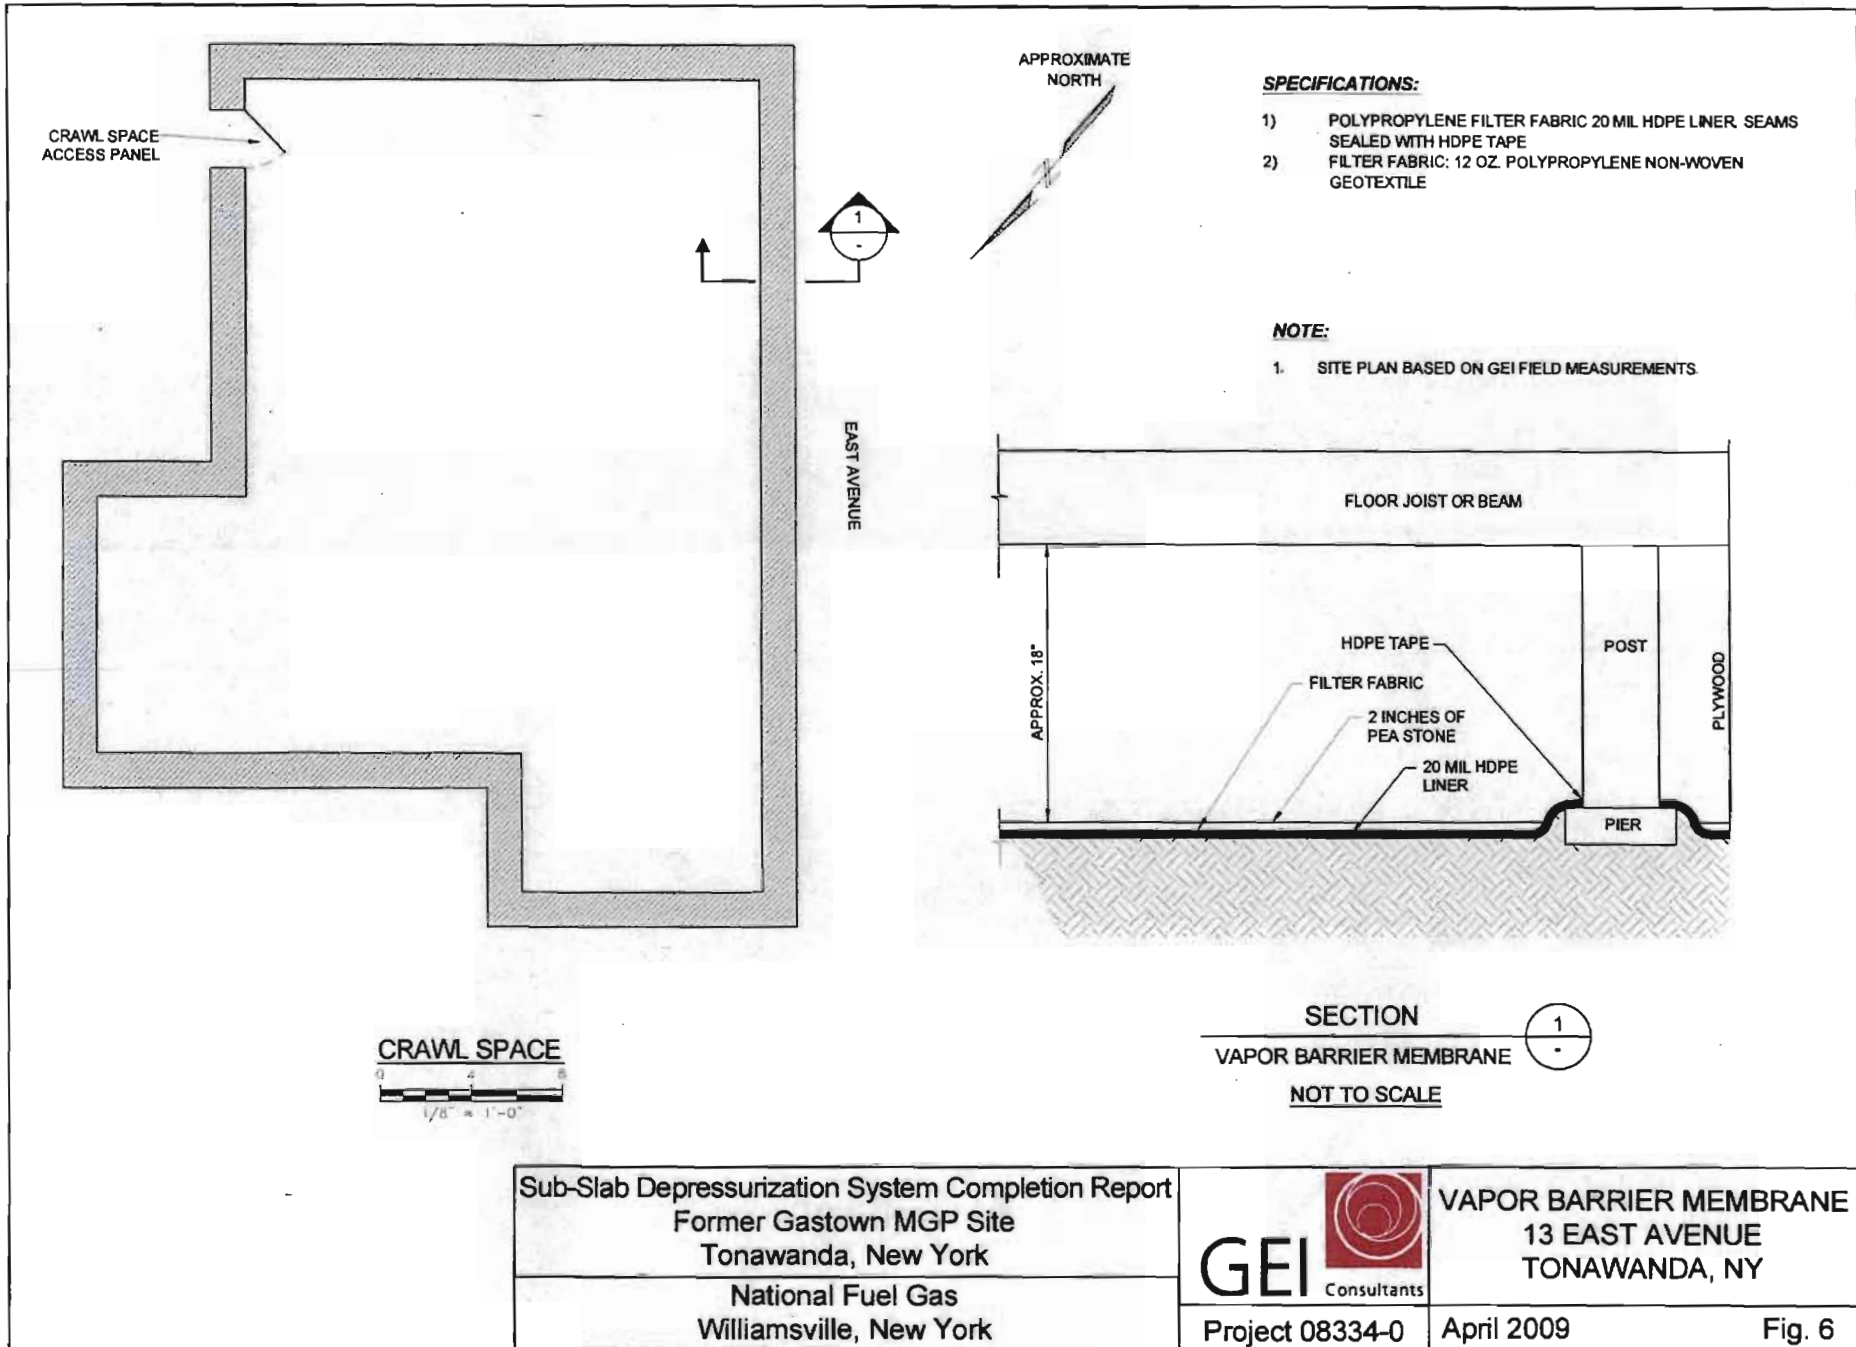
<b>VAPOR BARRIER MEMBRANE</b> 13 EAST AVENUE TONAWANDA, NY  Project 08334-0      April 2009      Fig. 6
--	---	---

We installed a 40-mil High Density Polyethylene (HDPE) vapor barrier membrane over the entire crawl space floor. The membrane is sealed to the concrete support piers using HDPE tape and mastic. This membrane is thicker than the 20-mil HDPE vapor barrier specified in the Work Plan and was installed at a greater thickness to replace the proposed filter fabric. With the exception of this modification, the vapor barrier was installed as described in the Work Plan. Figure 6 illustrates the vapor barrier installation.

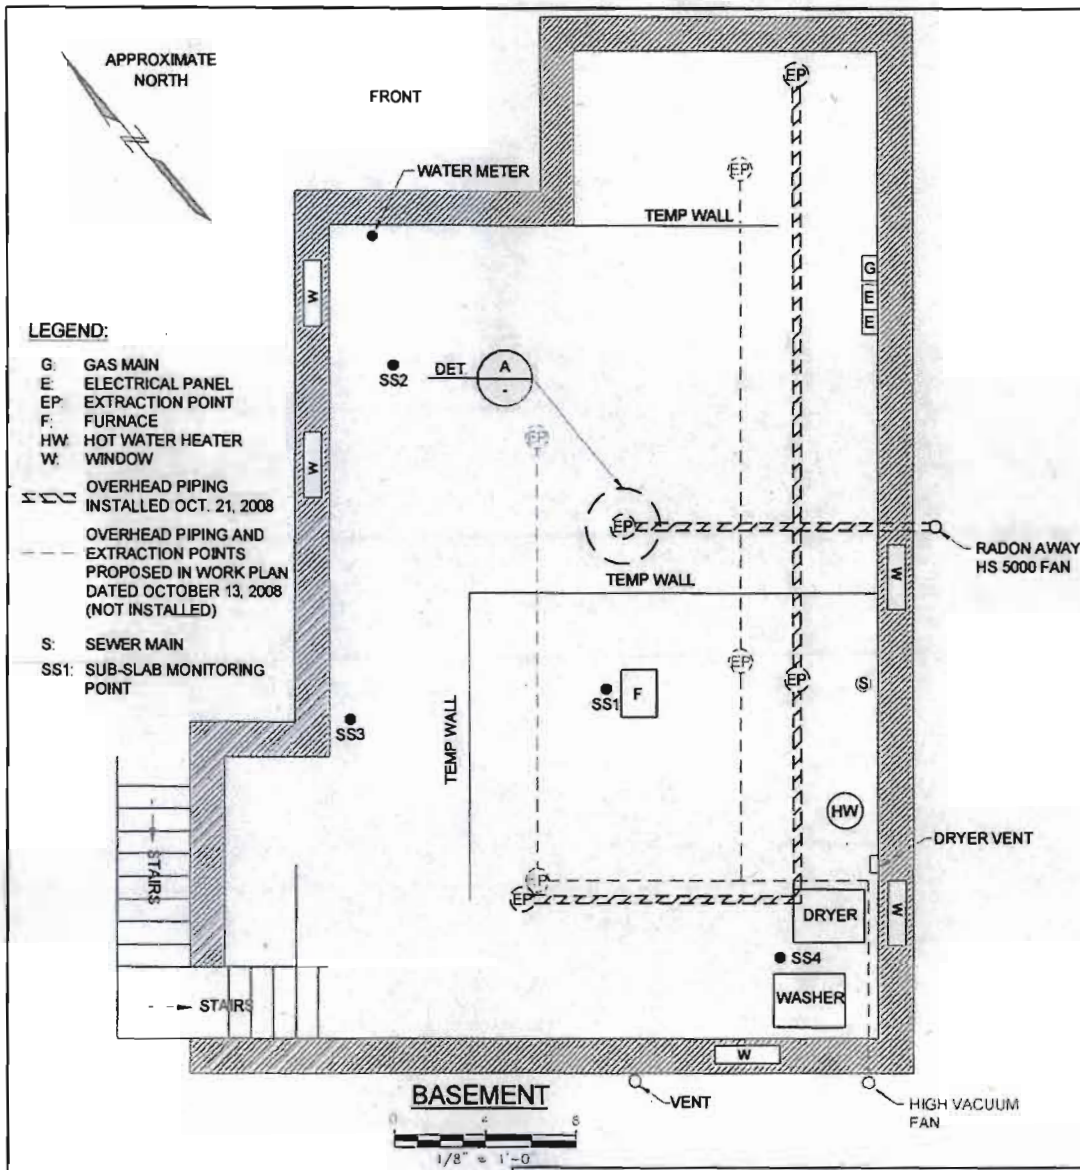
The difference between the planned and installed system was the location of the piping and the exhaust fan. Fig. 7 shows the differences between the Work Plan and installed piping layout. We installed the planned four extraction points to capture sub slab soil gas. A high suction RadonAway™ HS-5000 radon fan was installed outside the building footprint. A technical data sheet for this fan is provided in Appendix A.

Sub-slab vacuum measurements were taken immediately following installation (October 21, 2008) and during post mitigation monitoring (December 1, 2008). Data from these measurements are presented in Table 5. These data indicate adequate sub slab vacuum coverage to mitigate potential soil vapor intrusion.

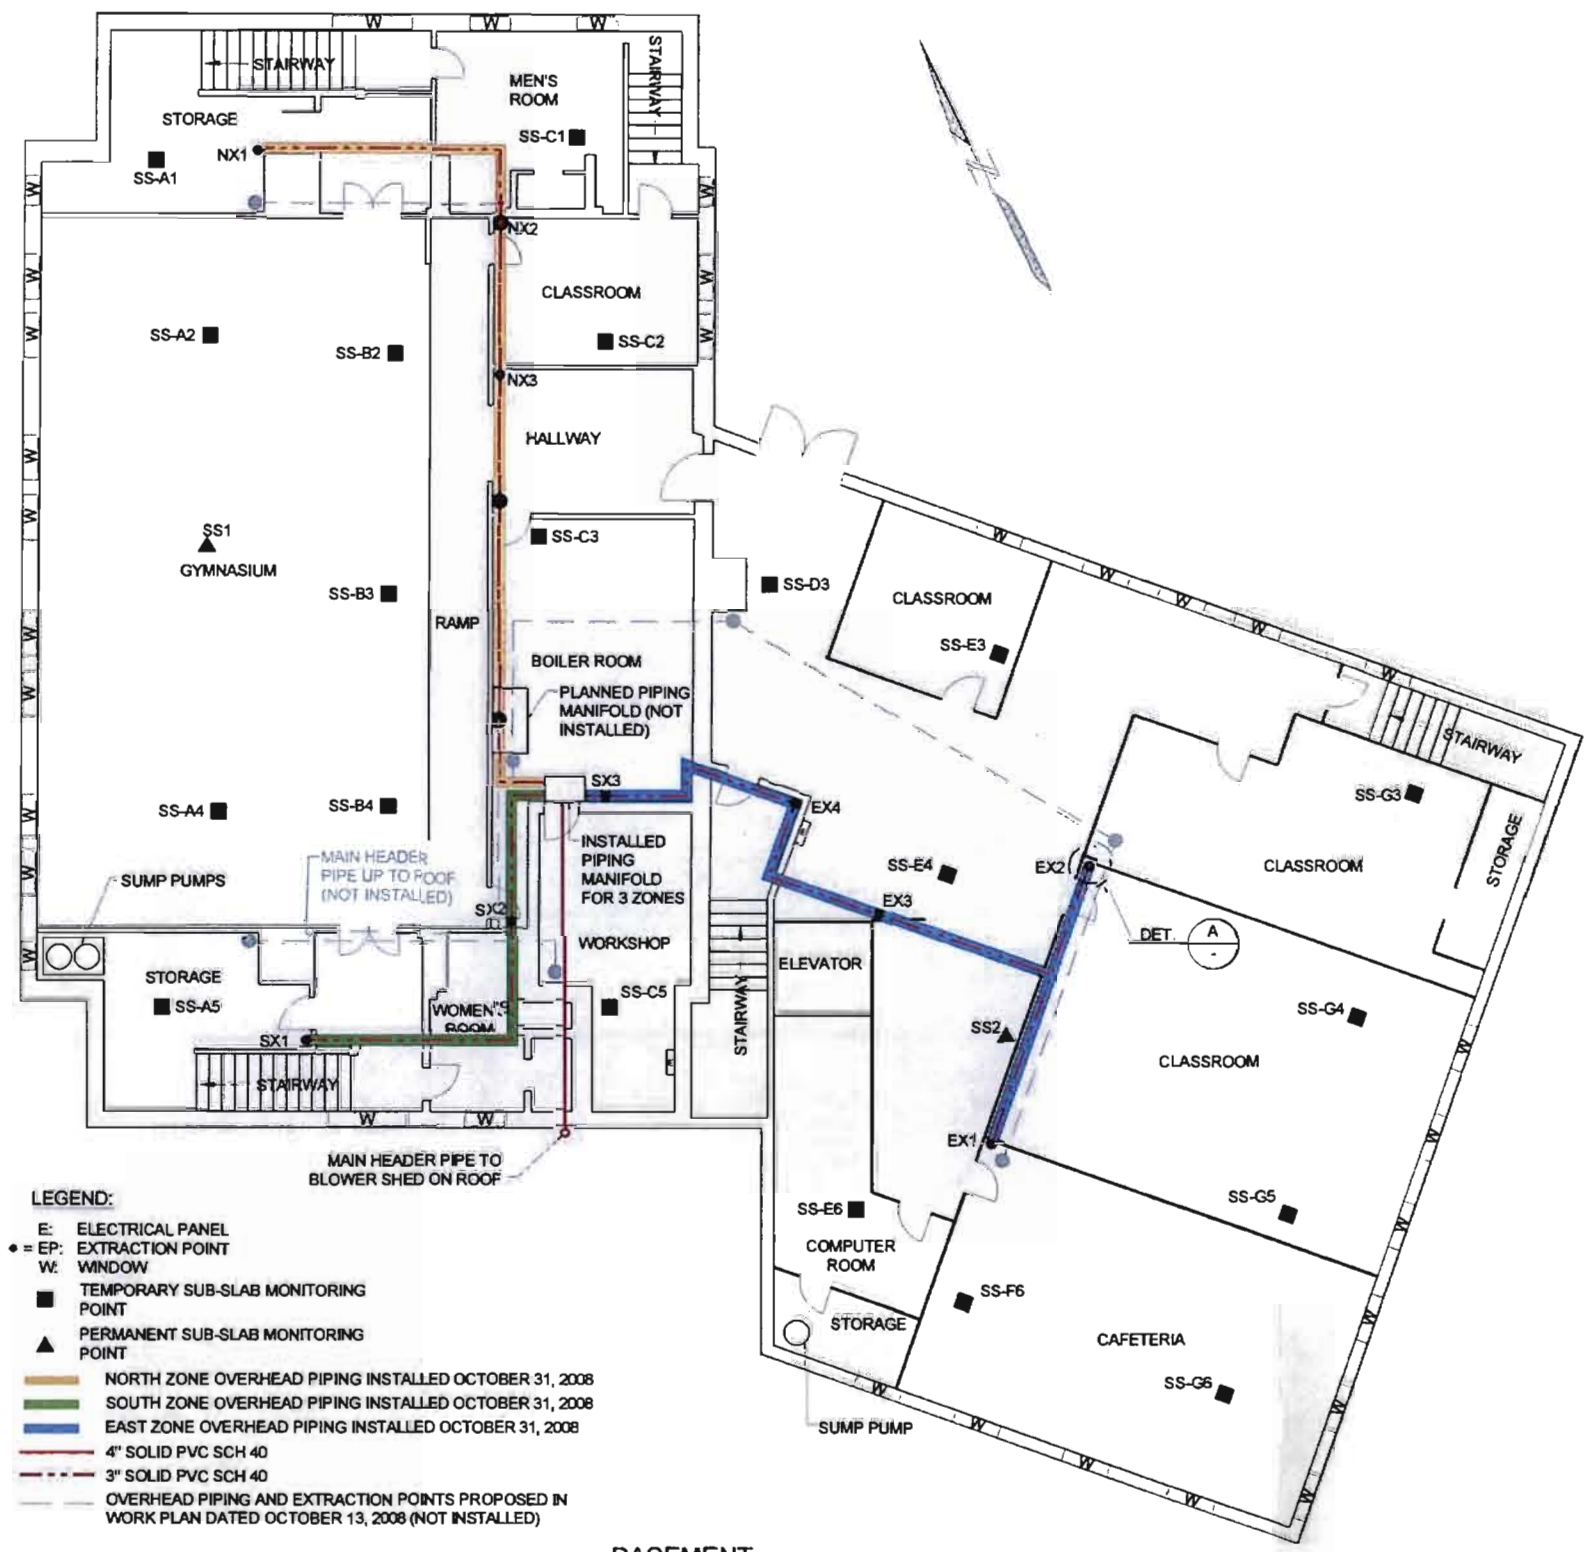
In the Work Plan, we referred to three separate areas of the buildings, the gymnasium elevation, boiler room elevation, and the new portion. During installation, we segregated the building differently and into the North, South, and East zones based on logistical layout of the piping network. These zones are illustrated in Figure 8.

Differences between the Work Plan and installed piping layout are shown in Fig. 8. Principle differences include the number of extraction points, and the precise location of piping, manifold, and main header pipe.

We installed ten instead of the planned nine extraction points among three zones to ventilate sub slab soil vapor. The north and south zones each include three extraction points and the east zone includes four extraction points. In certain instances, extraction points were located to also provide condensation drainage. Soil vapor from the three zones merge at a manifold located on the south wall of the boiler room instead of the planned west wall. The manifold includes three butterfly valves and four vacuum gauges to monitor system operation without accessing the roof. The butterfly valves are used to balance the flow and distribute vacuum more effectively.

Sub-slab vacuum measurements were taken immediately following installation (October 31, 2008) and during post mitigation monitoring (December 2, 2008). During post mitigation monitoring, piping in the vicinity of extraction point EX-3 was modified to mitigate condensation accumulation. Data from these measurements are presented in Table 6. These data indicate adequate sub slab vacuum coverage to mitigate potential soil vapor intrusion.
