# **Sump Discharge Pipe Investigation Report**

**Former Gastown MGP Site  
City of Tonawanda, Erie County, New York  
Registry Number 915171**

**April 2015**

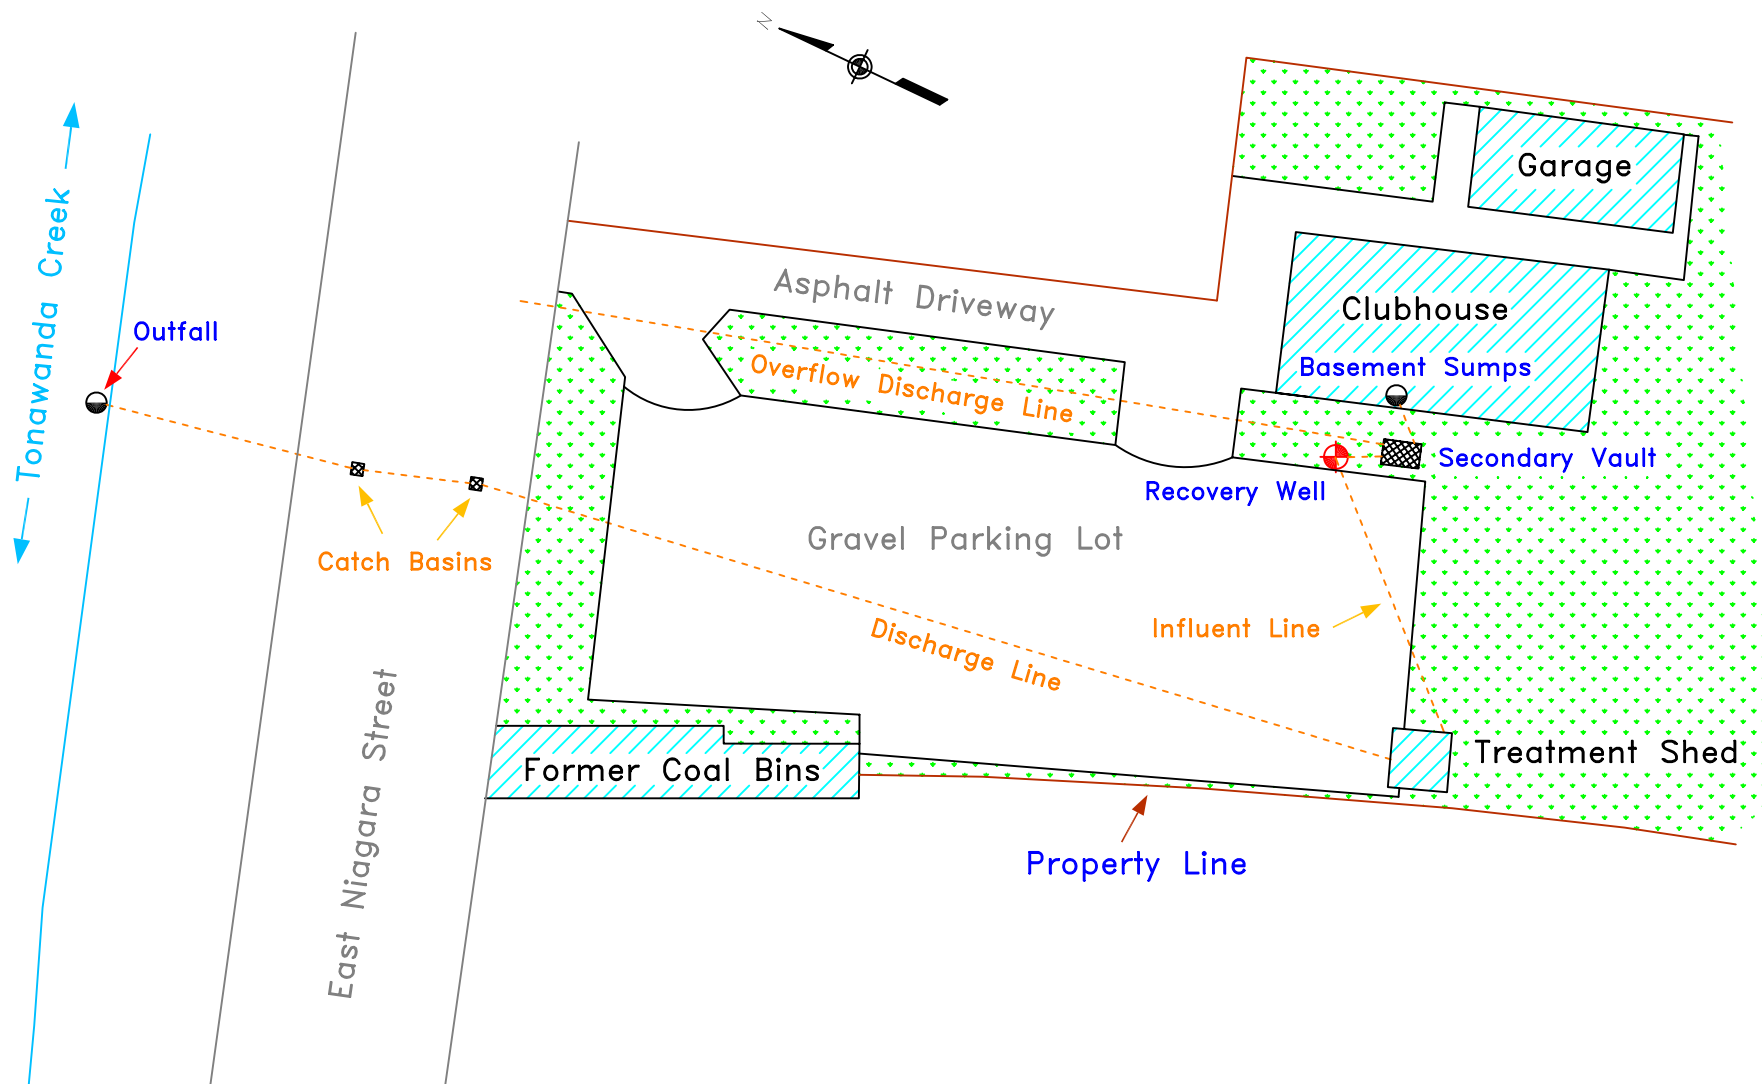
<b>DIVISION OF ENVIRONMENTAL REMEDIATION</b>		
<b>DATE:</b> 01/25/01	<b>DRAWING:</b> System.dwg	
<b>SITE:</b> FORMER GASTOWN MGP SITE		<b>FIGURE 1-3</b>

The groundwater/NAPL extraction system consists of a single, 10-inch diameter, recovery well, two submersible pumps and associated piping. The recovery well, designated PW-1, is located on the eastern portion of the NFTA property leased to the Gastown Sportsmen's Club for parking (Figure 1-3). The recovery well is equipped with two submersible pneumatic pumps, one to pump contaminated groundwater and the second one to pump DNAPL. Both pumps are air driven, with the groundwater pump designed to automatically cycle on and off in response to in-well fluid levels. The DNAPL pump is installed near the bottom of the well and pumps continuously at a low rate to maximize NAPL recovery. Each pump has a pressurized air supply line, a total fluids transfer line and a steel cable from which the pump is suspended. Discharge from the groundwater pump is routed to the treatment shed for phase separation and groundwater treatment, while discharge from the DNAPL pump is sent directly to an 85-gallon storage drum inside the treatment shed.

Water in the basement sumps of the Gastown Sportsmen's Club is contaminated; therefore, discharge from these sumps is directed to the treatment system. Water from the basement sumps is discharged directly to the secondary vault (Figure 1-3), and when reaching a pre-set height, activates a submersible pump that transfers the water through a 2-inch PVC pipe to the treatment

system. During a low-level or high-level fault, electrical power to the submersible pump is automatically shut off. In such cases, water from the secondary vault gravity flows through a 4-inch PVC pipe (the overflow discharge line; Figure 1-3) that was the original discharge pipe for the club's sumps. The discharge point of this pipe is unknown.

<b>GROUNDWATER/NAPL EXTRACTION AND TREATMENT SYSTEM</b>

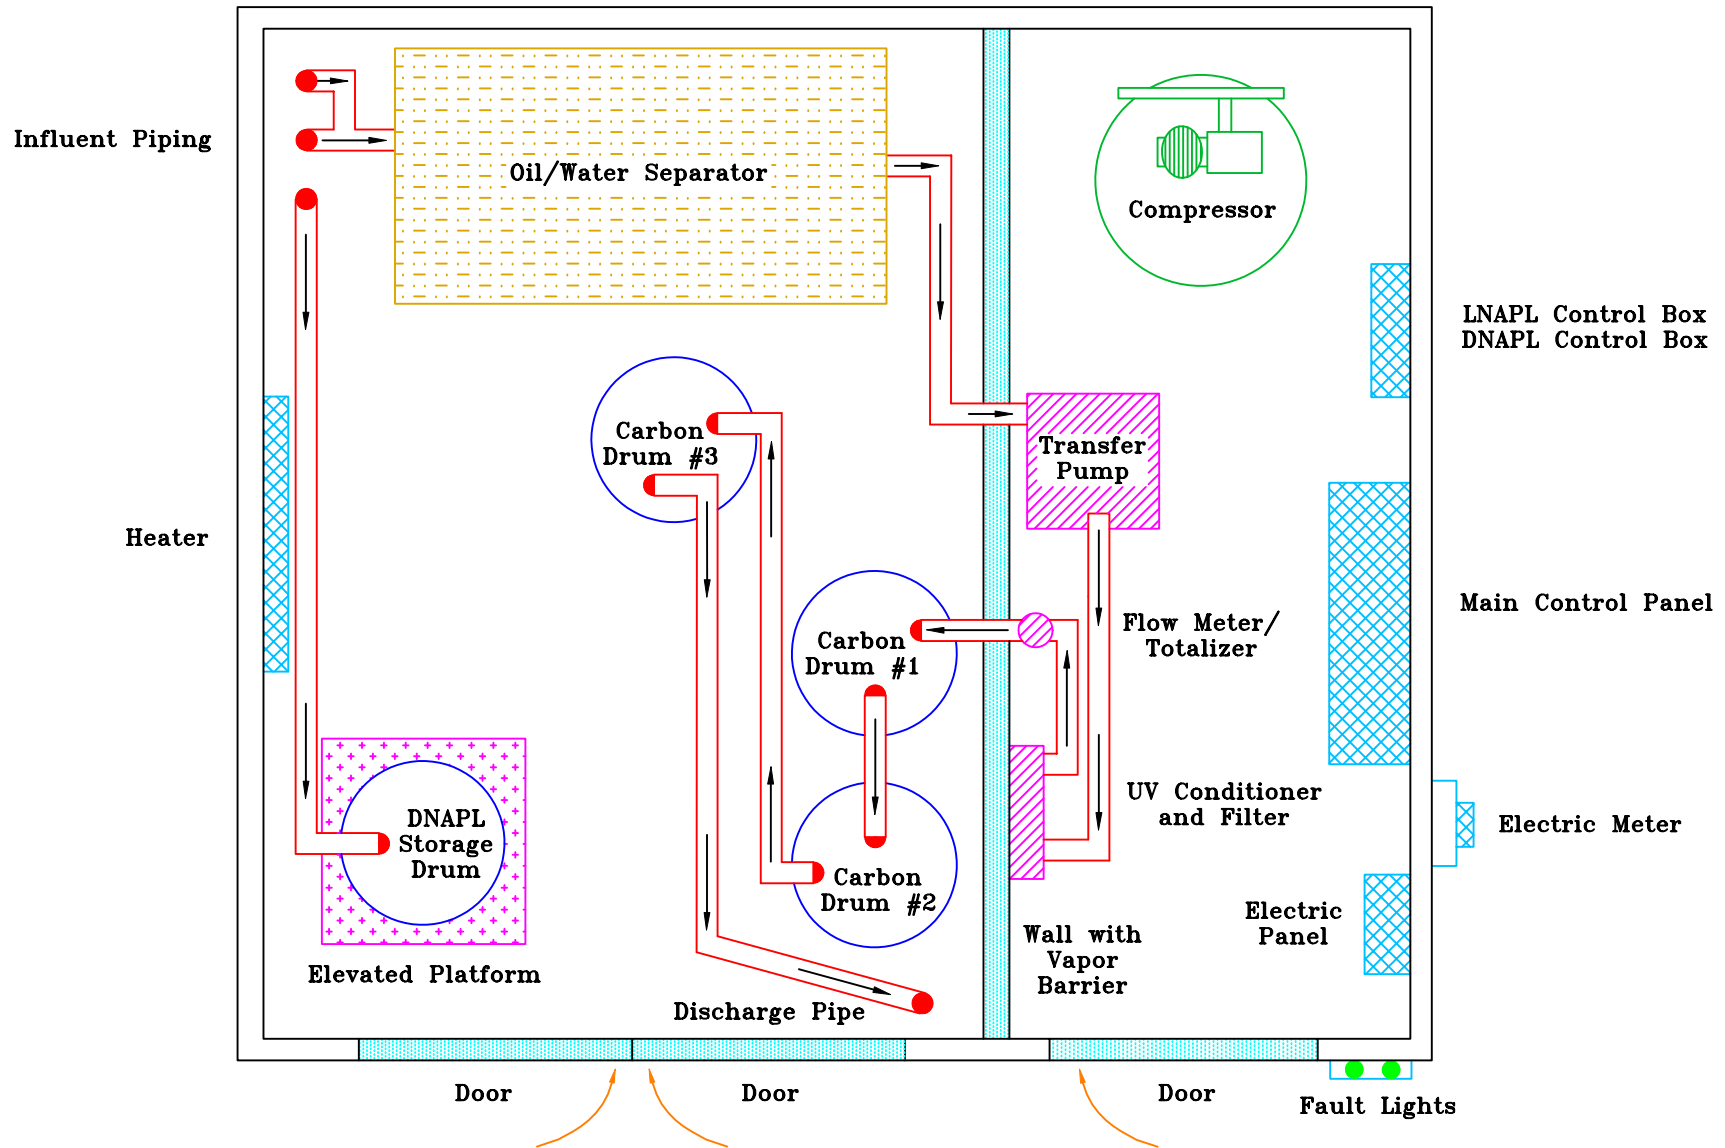
FIGURE 1-4

The groundwater treatment equipment is located inside a shed constructed during installation of the groundwater/NAPL extraction and treatment system (Figure 1-4). Fluids (groundwater and NAPL) are pumped from the recovery well to the treatment shed, where contaminated groundwater is sent directly to an oil/water separator and DNAPL is sent directly to an 85-gallon storage drum. NAPL and sludge are collected in the chambers of the oil/water separator, which are manually drained when necessary and poured into 55-gallon drums for later disposal. DNAPL collected in the 85-gallon drum is also manually drained and poured into 55-gallon drums. When water in the effluent chamber of the oil/water separator reaches a preset level (as determined by a float), a transfer pump activates and pumps water from the chamber through three granular activated carbon (GAC) drums (Figure 1-4) to remove organic contaminants. Treated water is discharged through a 4-inch PVC pipe to a catch basin along East Niagara Street (Figure 1-3). From this catch basin water is discharged directly into Tonawanda Creek.

# TREATMENT SYSTEM LAYOUT
